PART 1
EMERGENCY REPAIRS
FIRST BAPTIST CHURCH
BOSTON, MA

OWNER:
FIRST BAPTIST CHURCH OF BOSTON
110 COMMONWEALTH AVENUE
BOSTON, MA 02116

ENGINEER:
STRUCTURES NORTH CONSULTING ENGINEERS, INC.
60 WASHINGTON STREET
SALEM, MA 01970
978-745-6817

UPDATED:
3-1-17

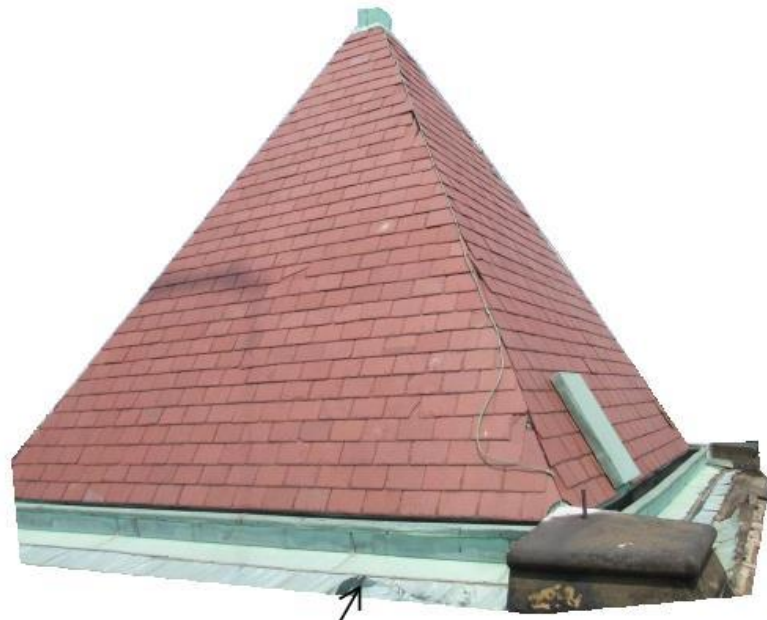
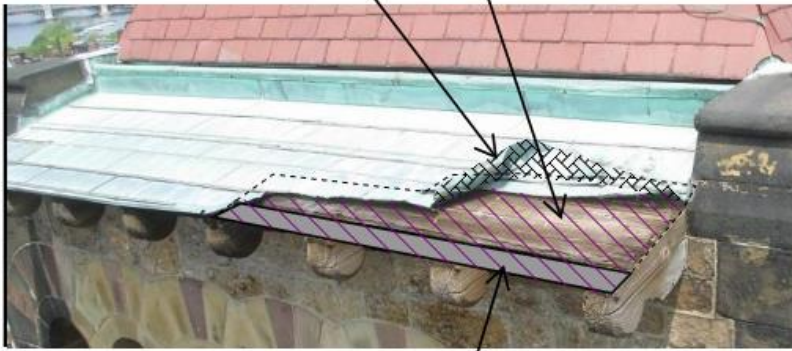
DETAIL WE-1

CUT OFF LOOSE, PEELED BACK COPPER FLASHING

INSTALL BONDED AND BATEDED EPDM MEMBRANE OUT TO EDGE OF NEW SHEATHING. FLATTEN AND NAIL DOWN REMAINING METAL FLASHING OVER THE EPDM.

REPLACE ROTTED AND MISSING SHEATHING BOARDS WITH NEW 5/4" BOARDS SCREWED DOWN INTO RAFTER TAILS.
