St. Gabriel's Monastery

THE MONASTERY, BRIGHTON. MASS.

August 23, 2016

St. Gabriel's Monastery Renovation

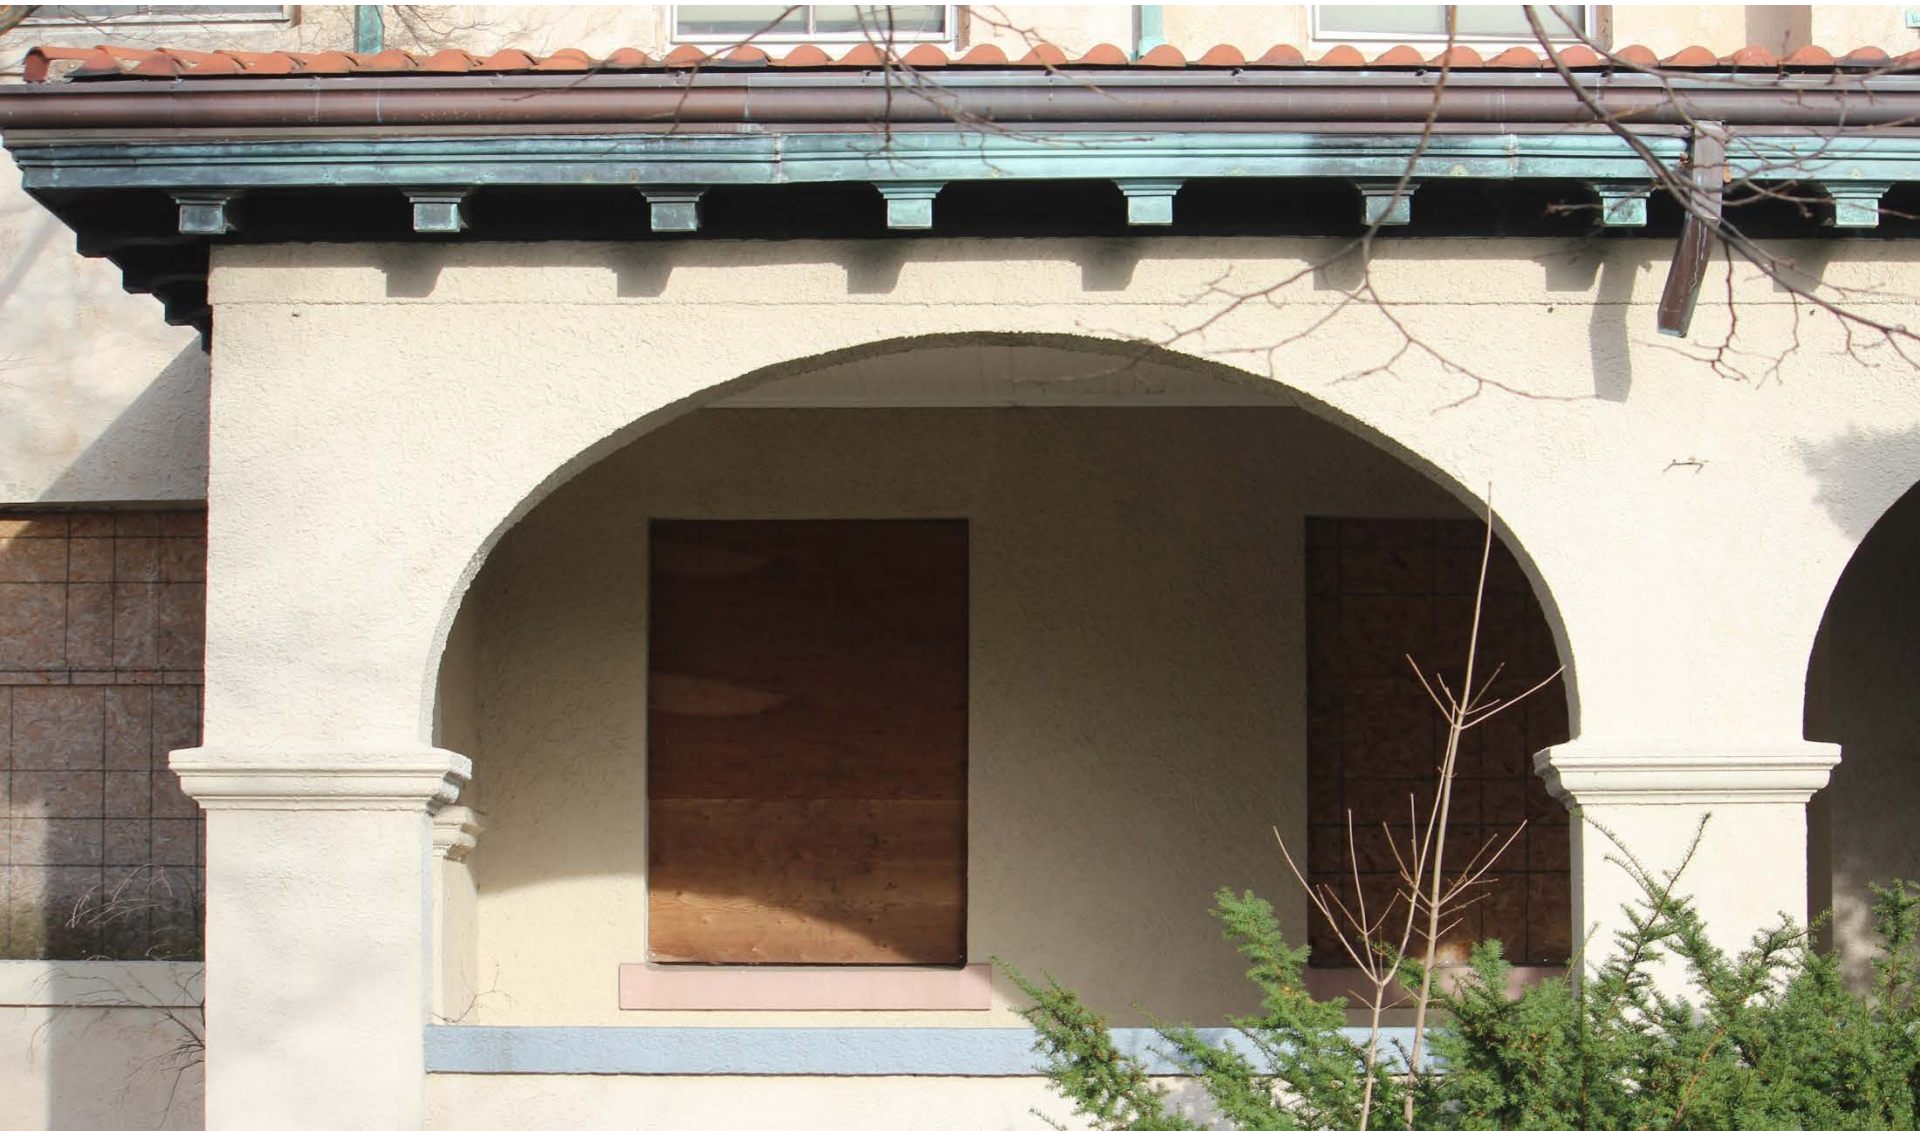
Entry Facade with Chapel on the right.

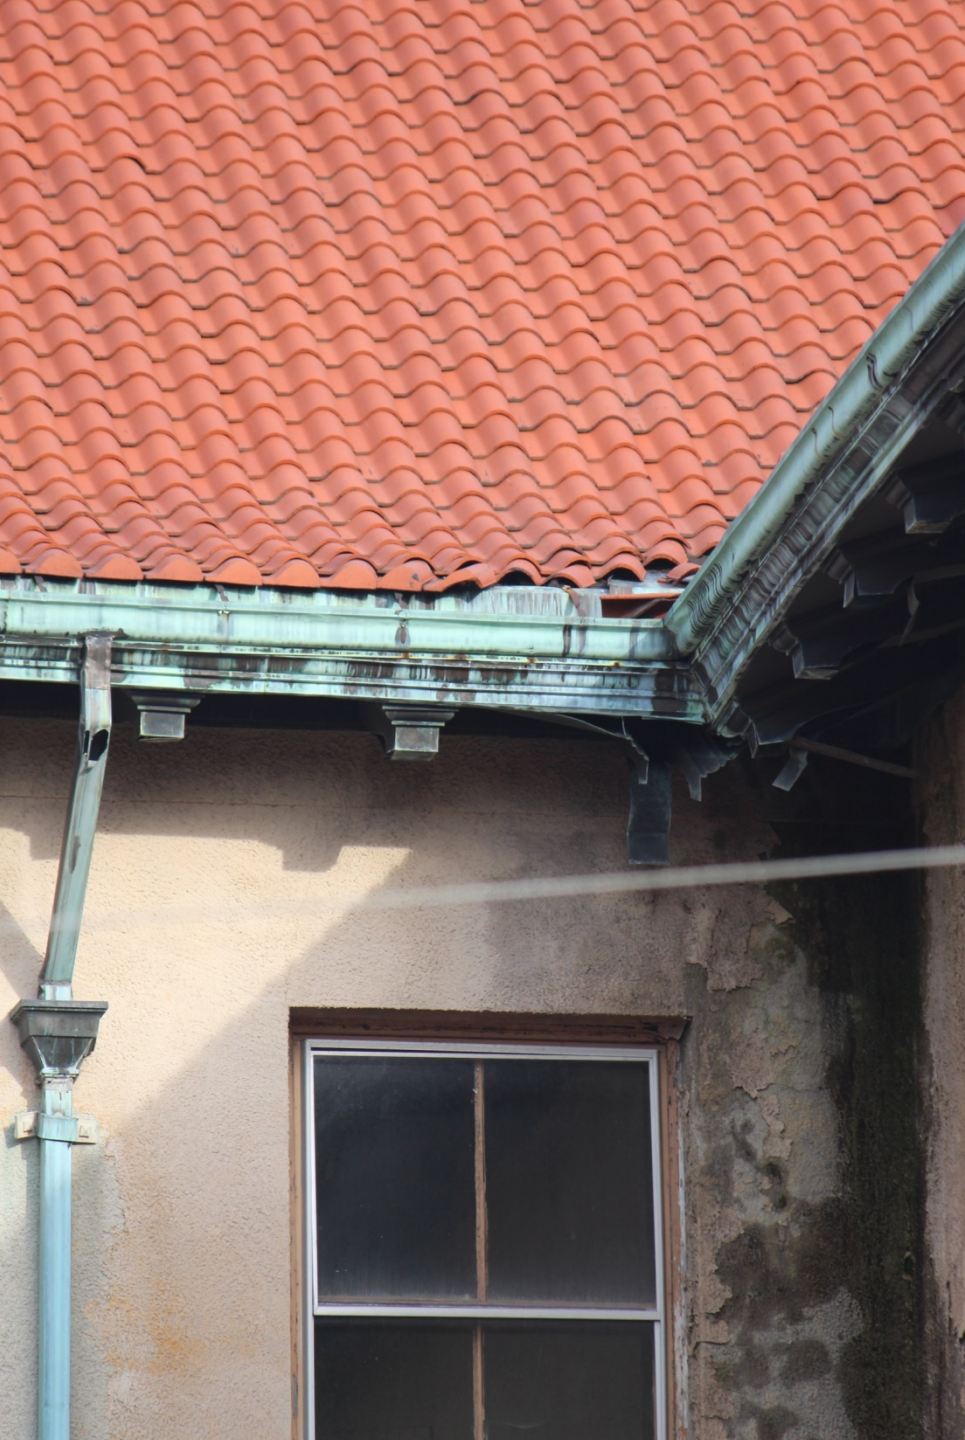
Detail of the "front" East Façade. This is an area where the conditions are better than for the rest of the building.

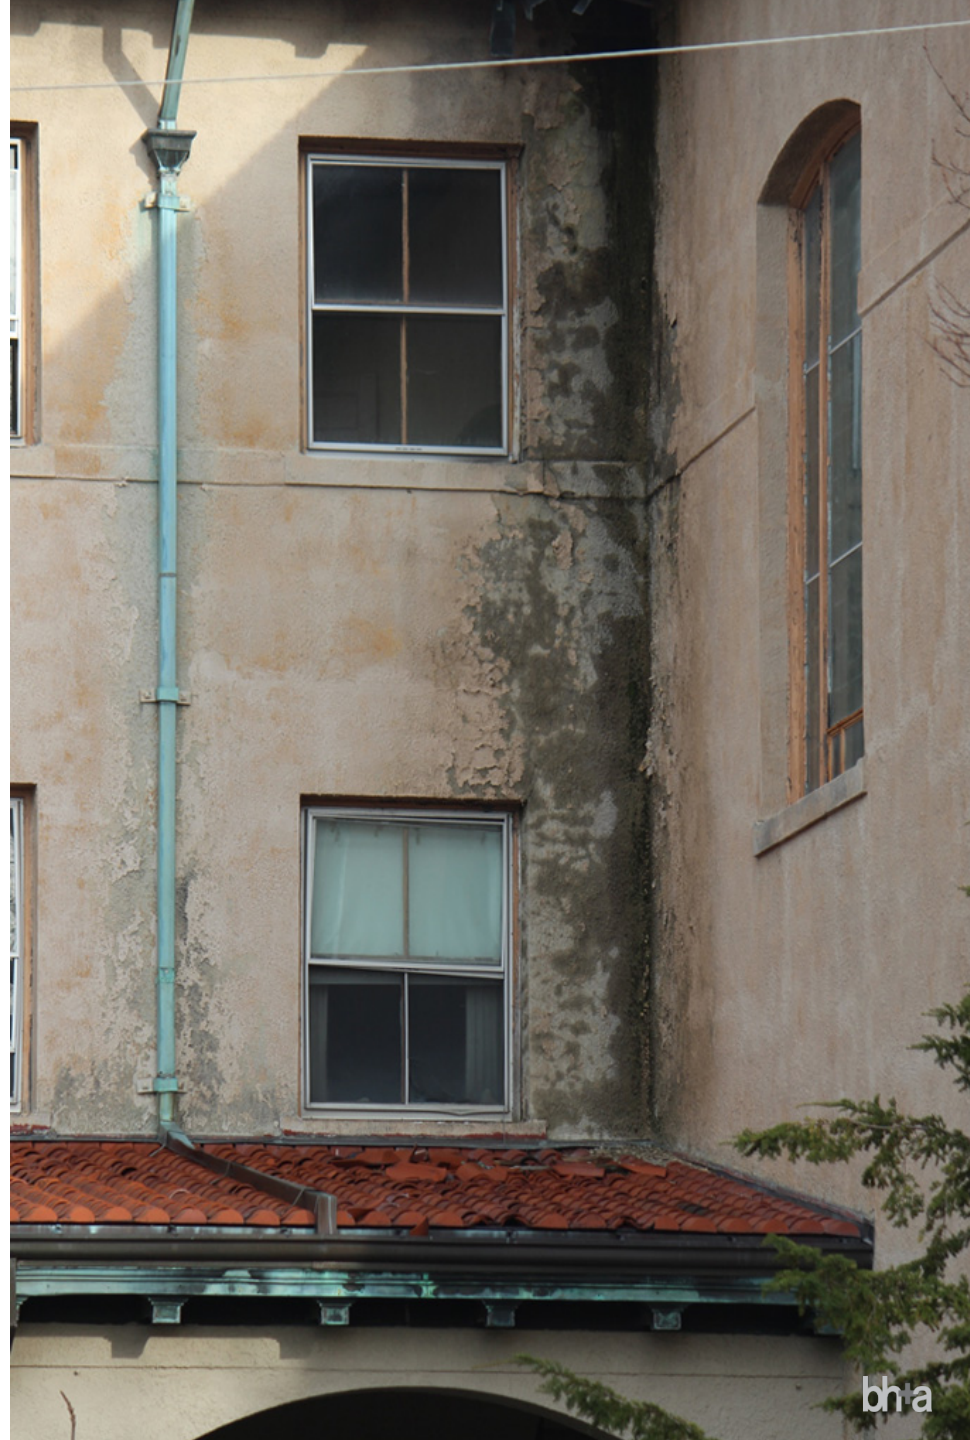
East (entry) Façade with necessary cornice repair due to water damage.
Roof Repair to utilize salvaged material from nurse's wing.
Water damage has manifested itself inside of building.

Drainage caused by water mostly done to missing downspout

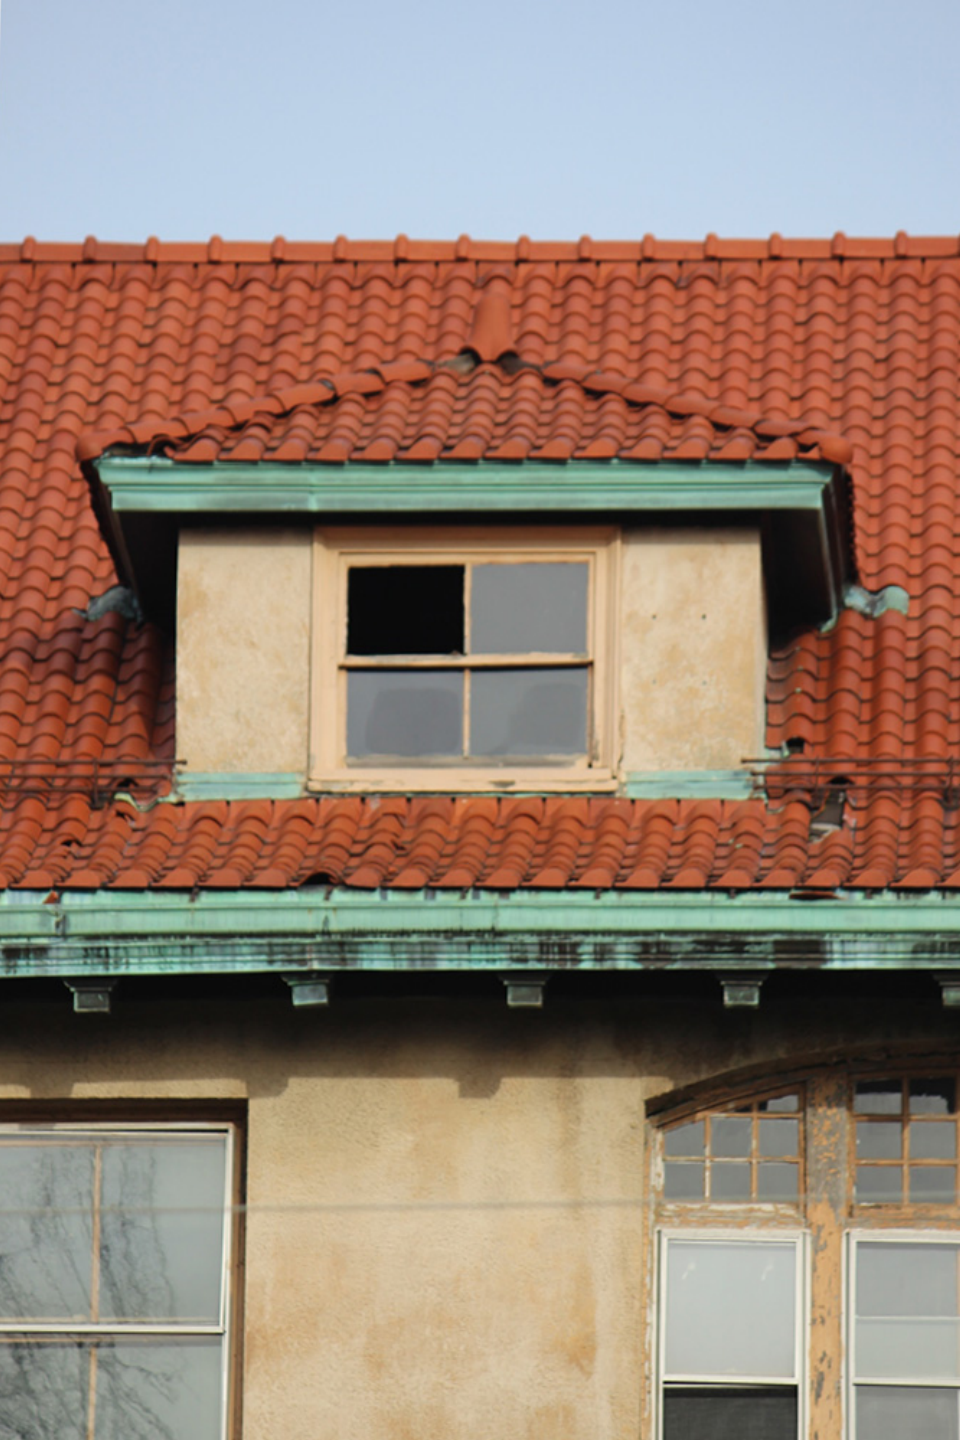
Another example of damaged cornice conditions to be restored. All gutters within the cornice need to be replaced. In general, all gutters here failed and approximately 50% of cornice sections have failed.

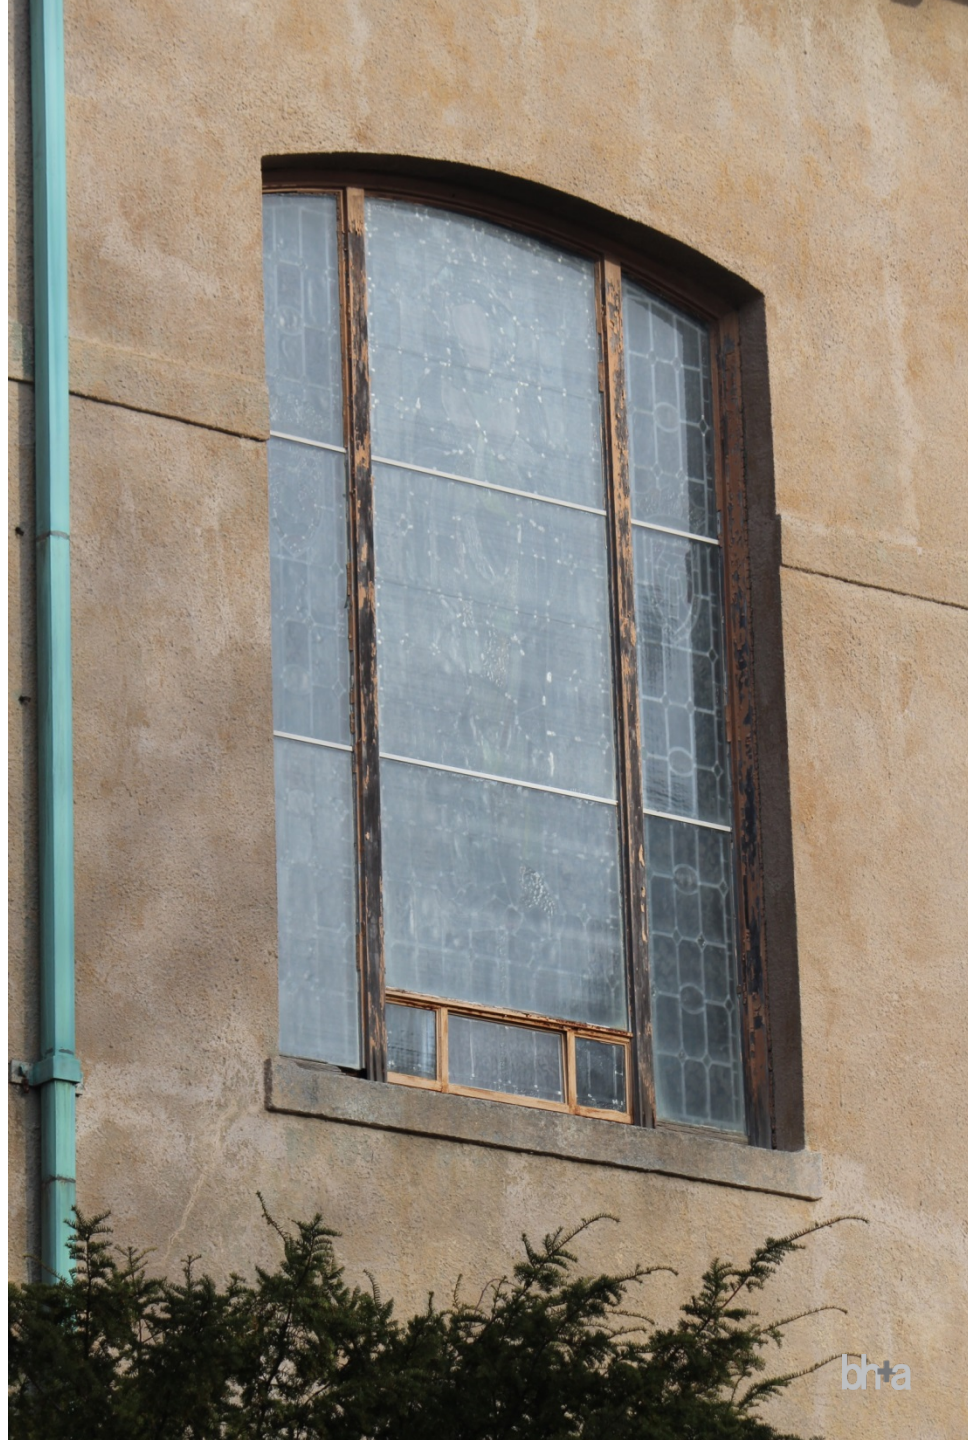
Typical Chapel Window with over clad protective glazing. Stained glass will be restored, protective glazing required.

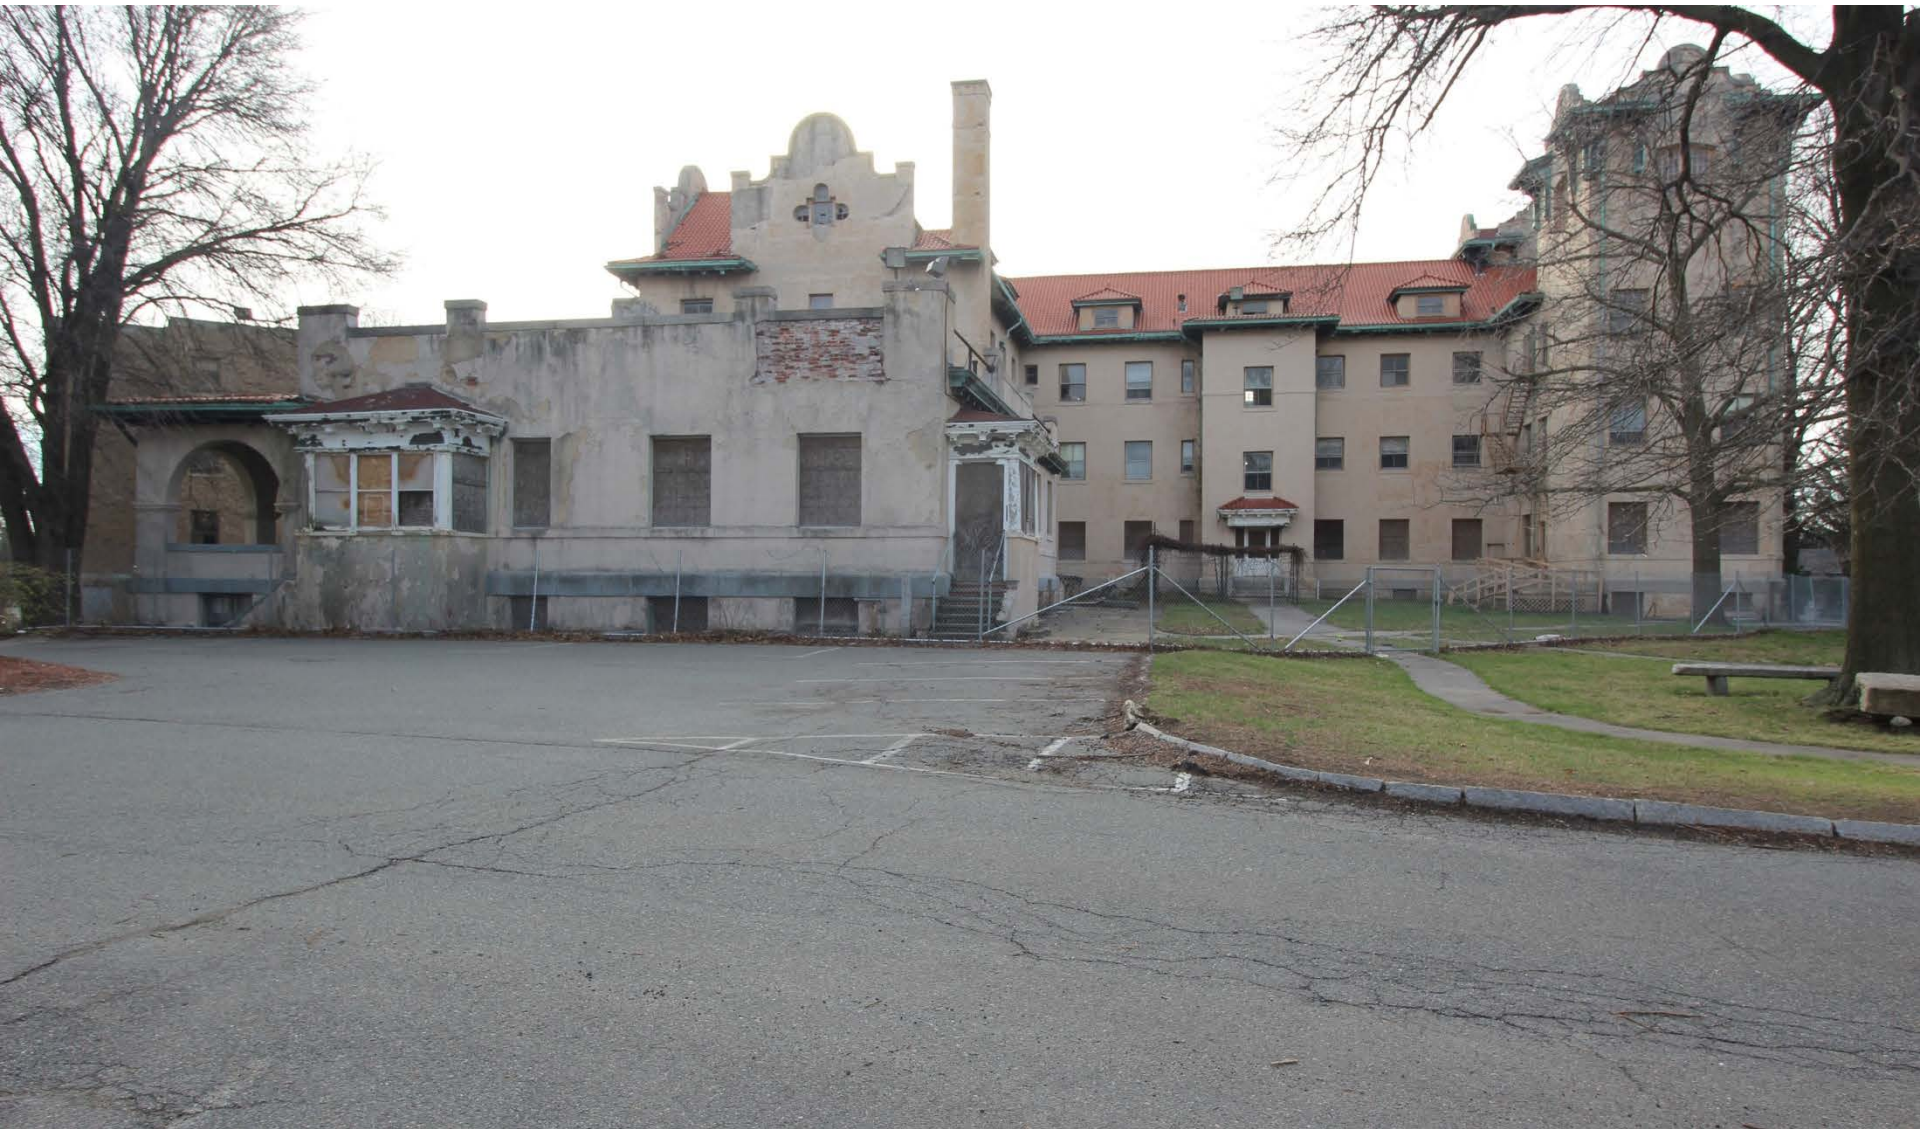
Rear Facade Conditions

The rear elevation includes altered entries. The courtyard elevation is at right in above image.

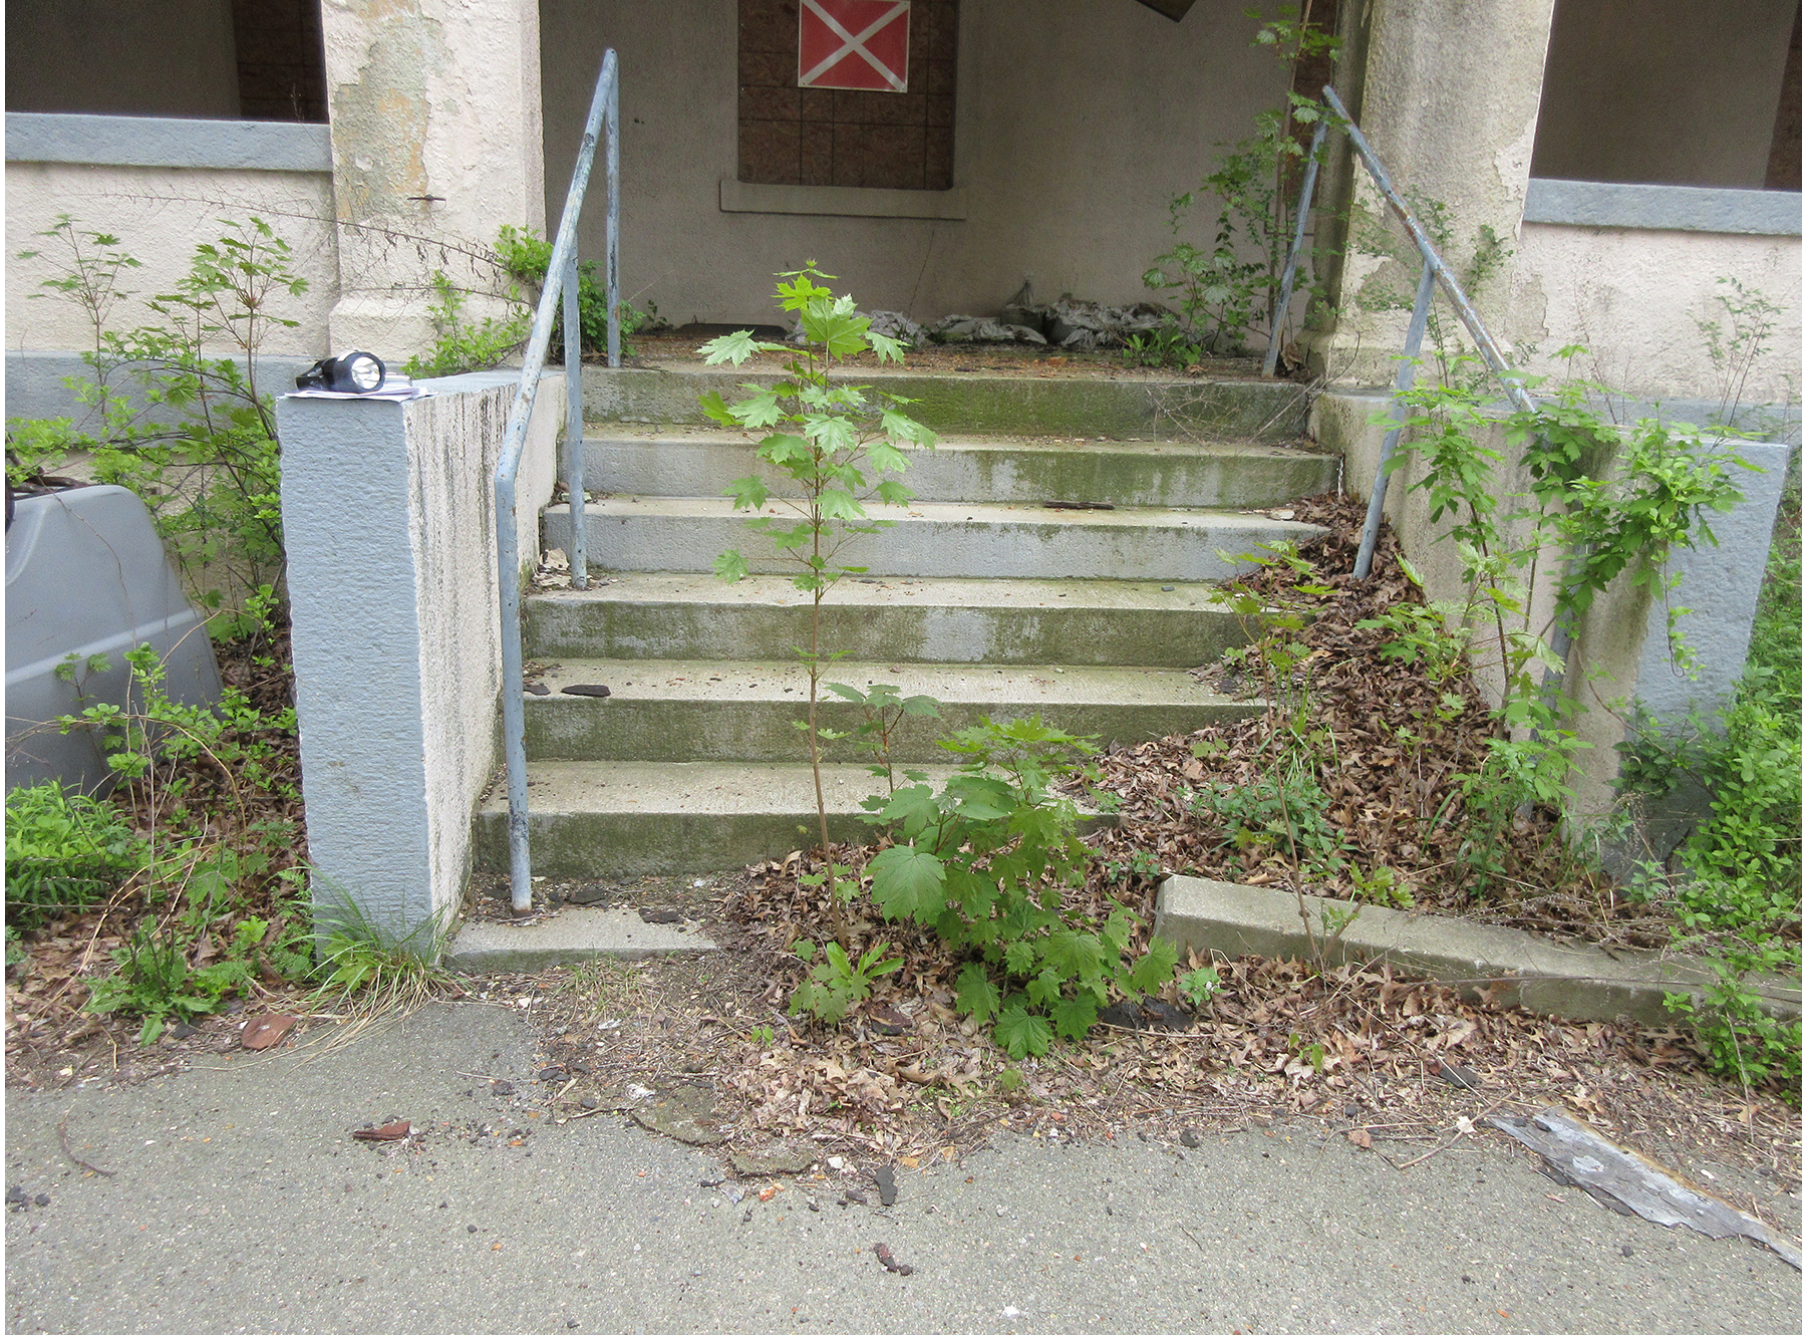
Interior of north porch to be restored due to massive damage caused by water infiltration. Accessible ramp to be concealed in porch at right side of incase.

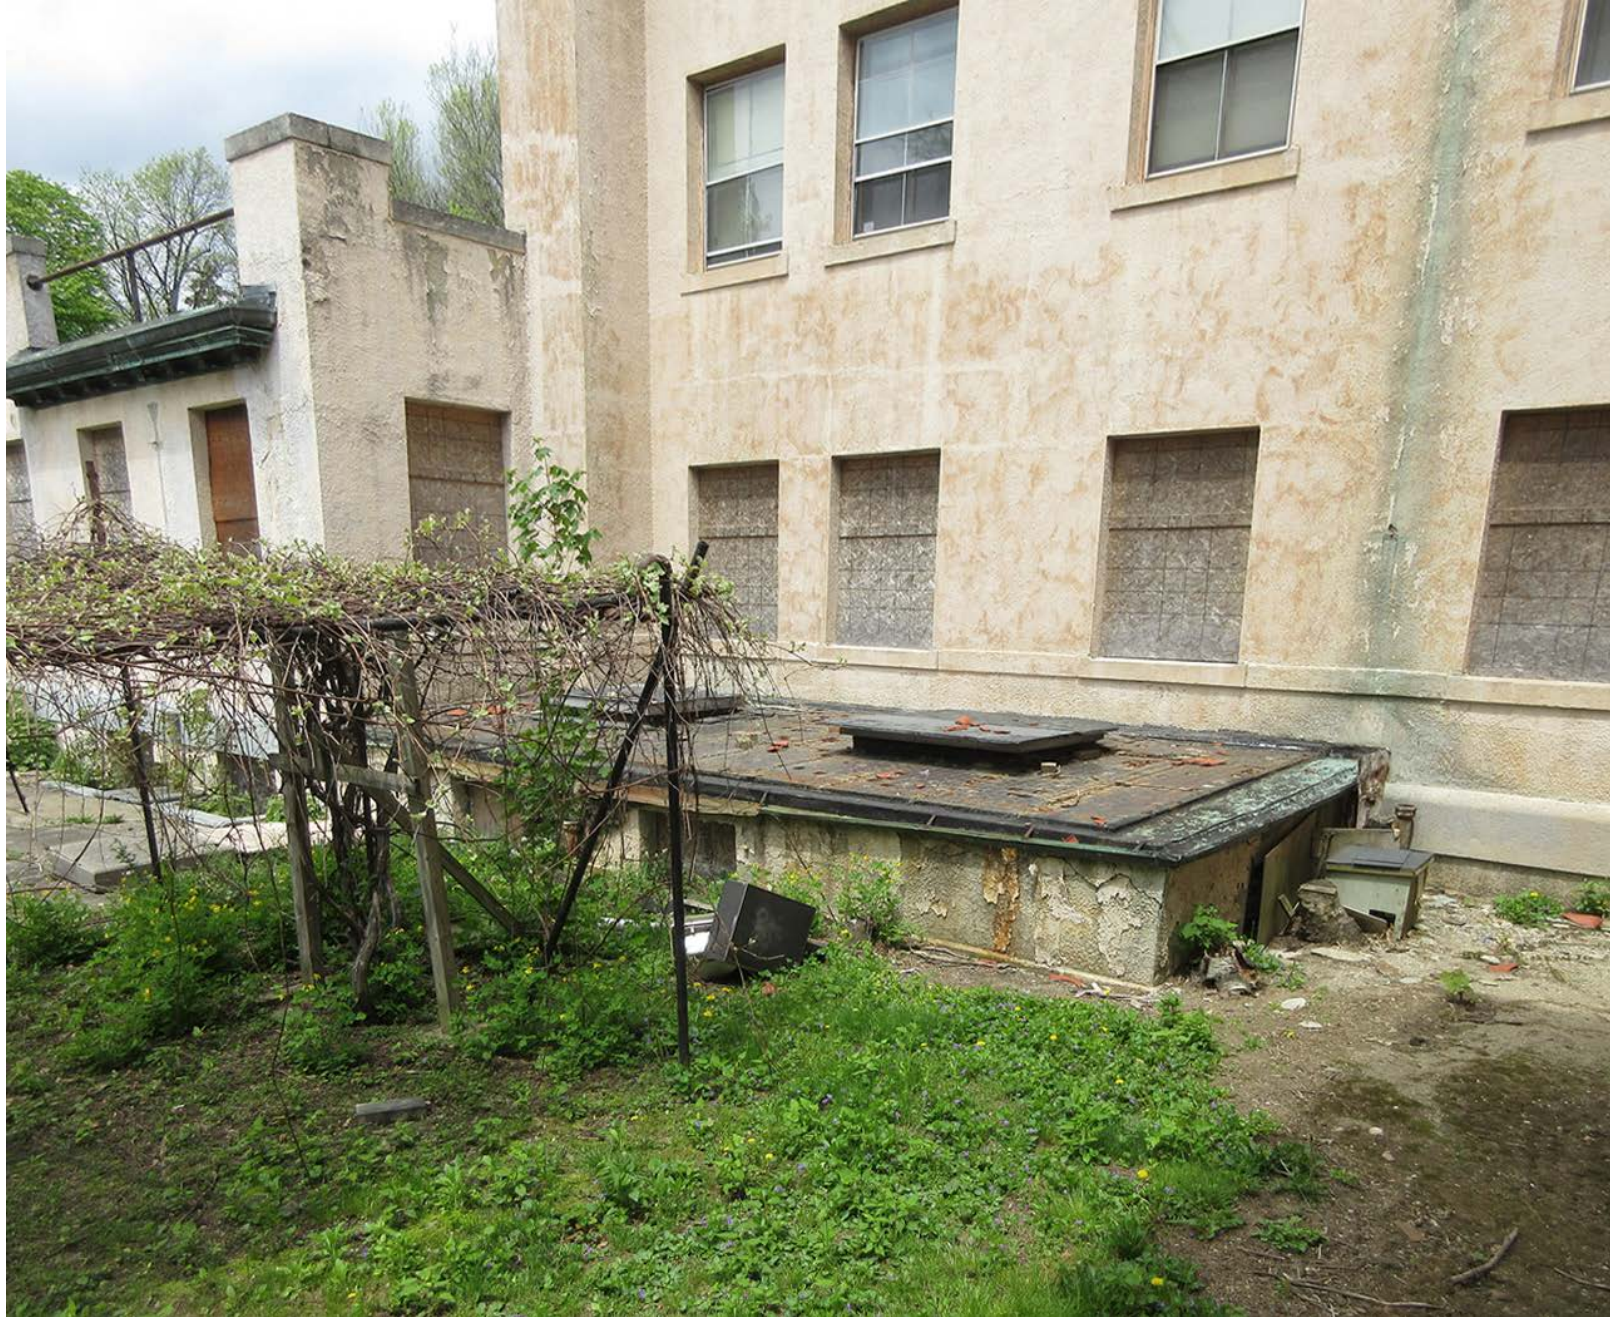
Existing overgrown front entry to Monastery at East Façade is not accessible and will be made accessible. Front Entry doors will be restored.

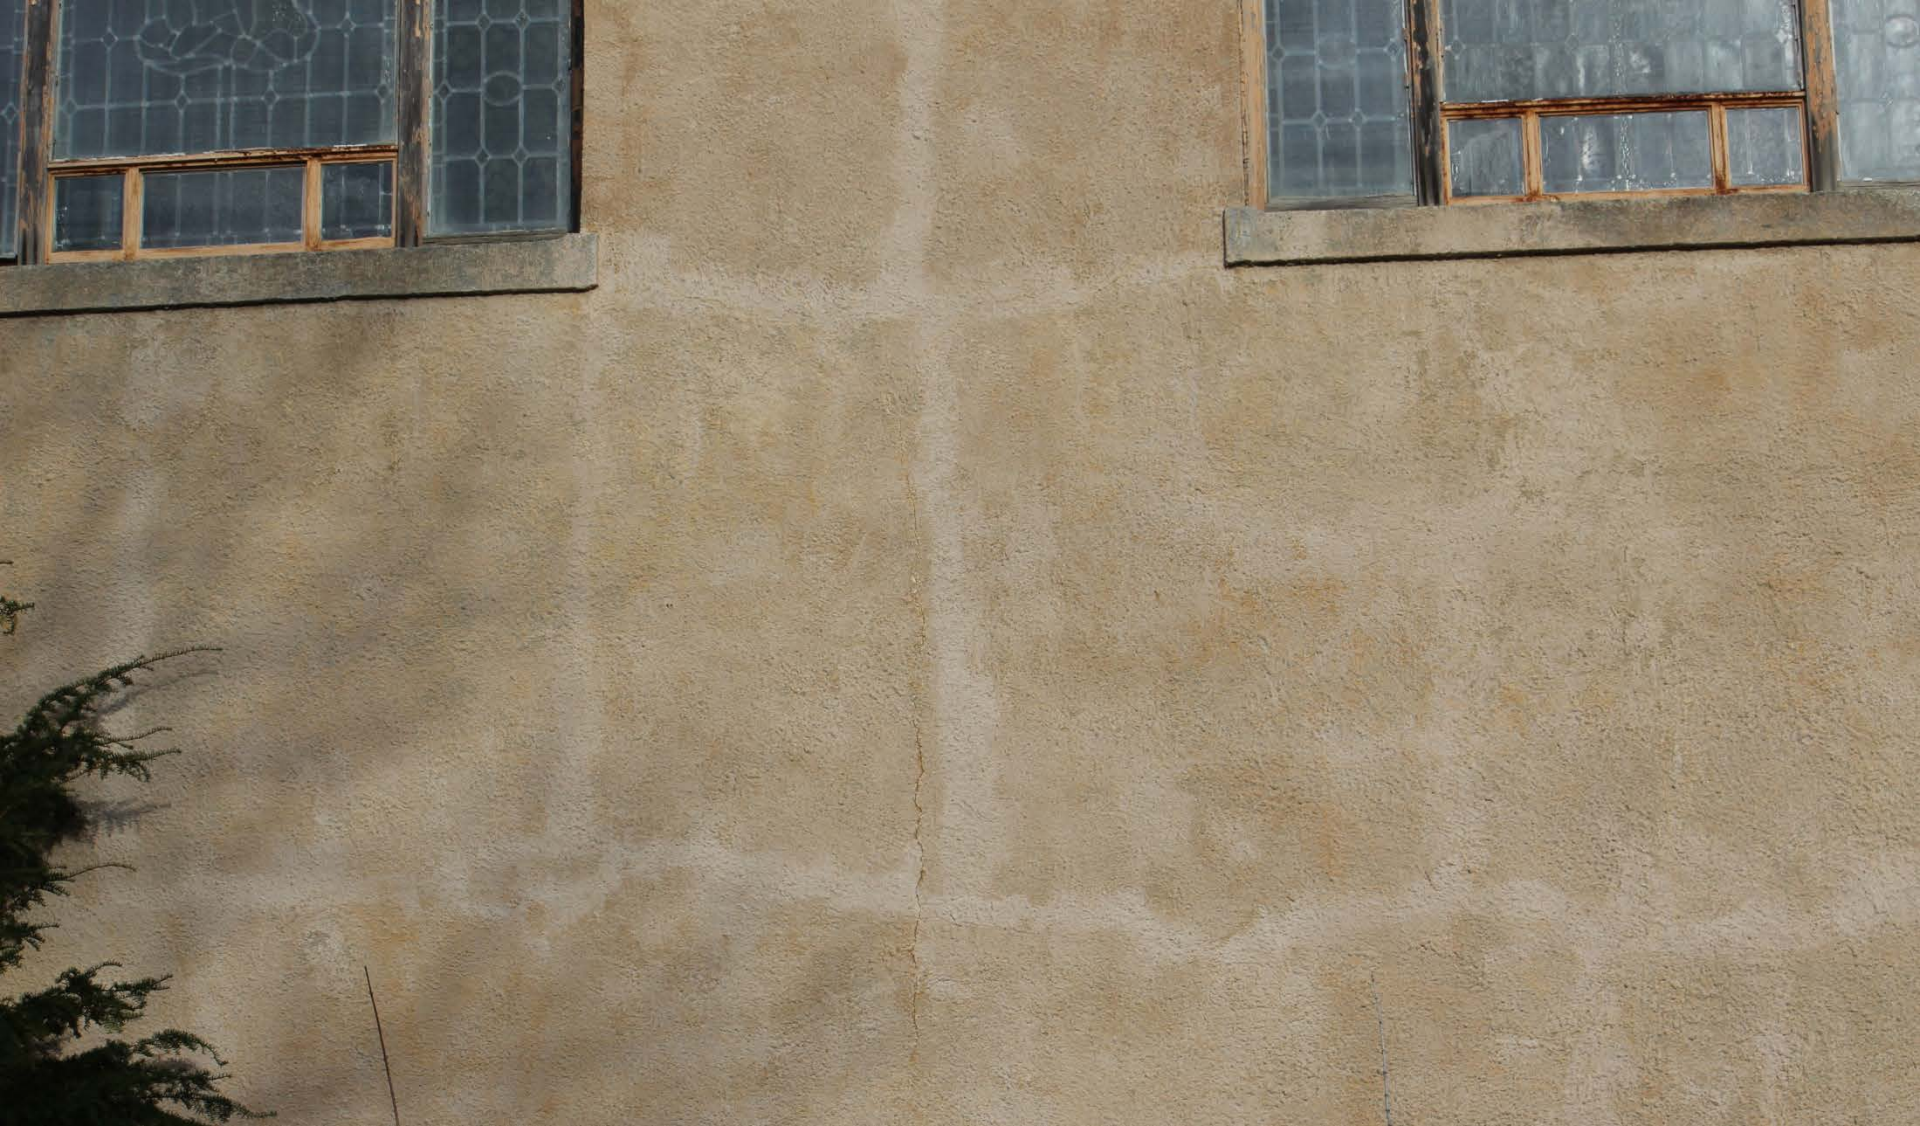
Stucco Conditions

Stucco Condition visible and implied cracking of underlying stucco layer. Stucco has been coated with uniform color on walls and window sills.

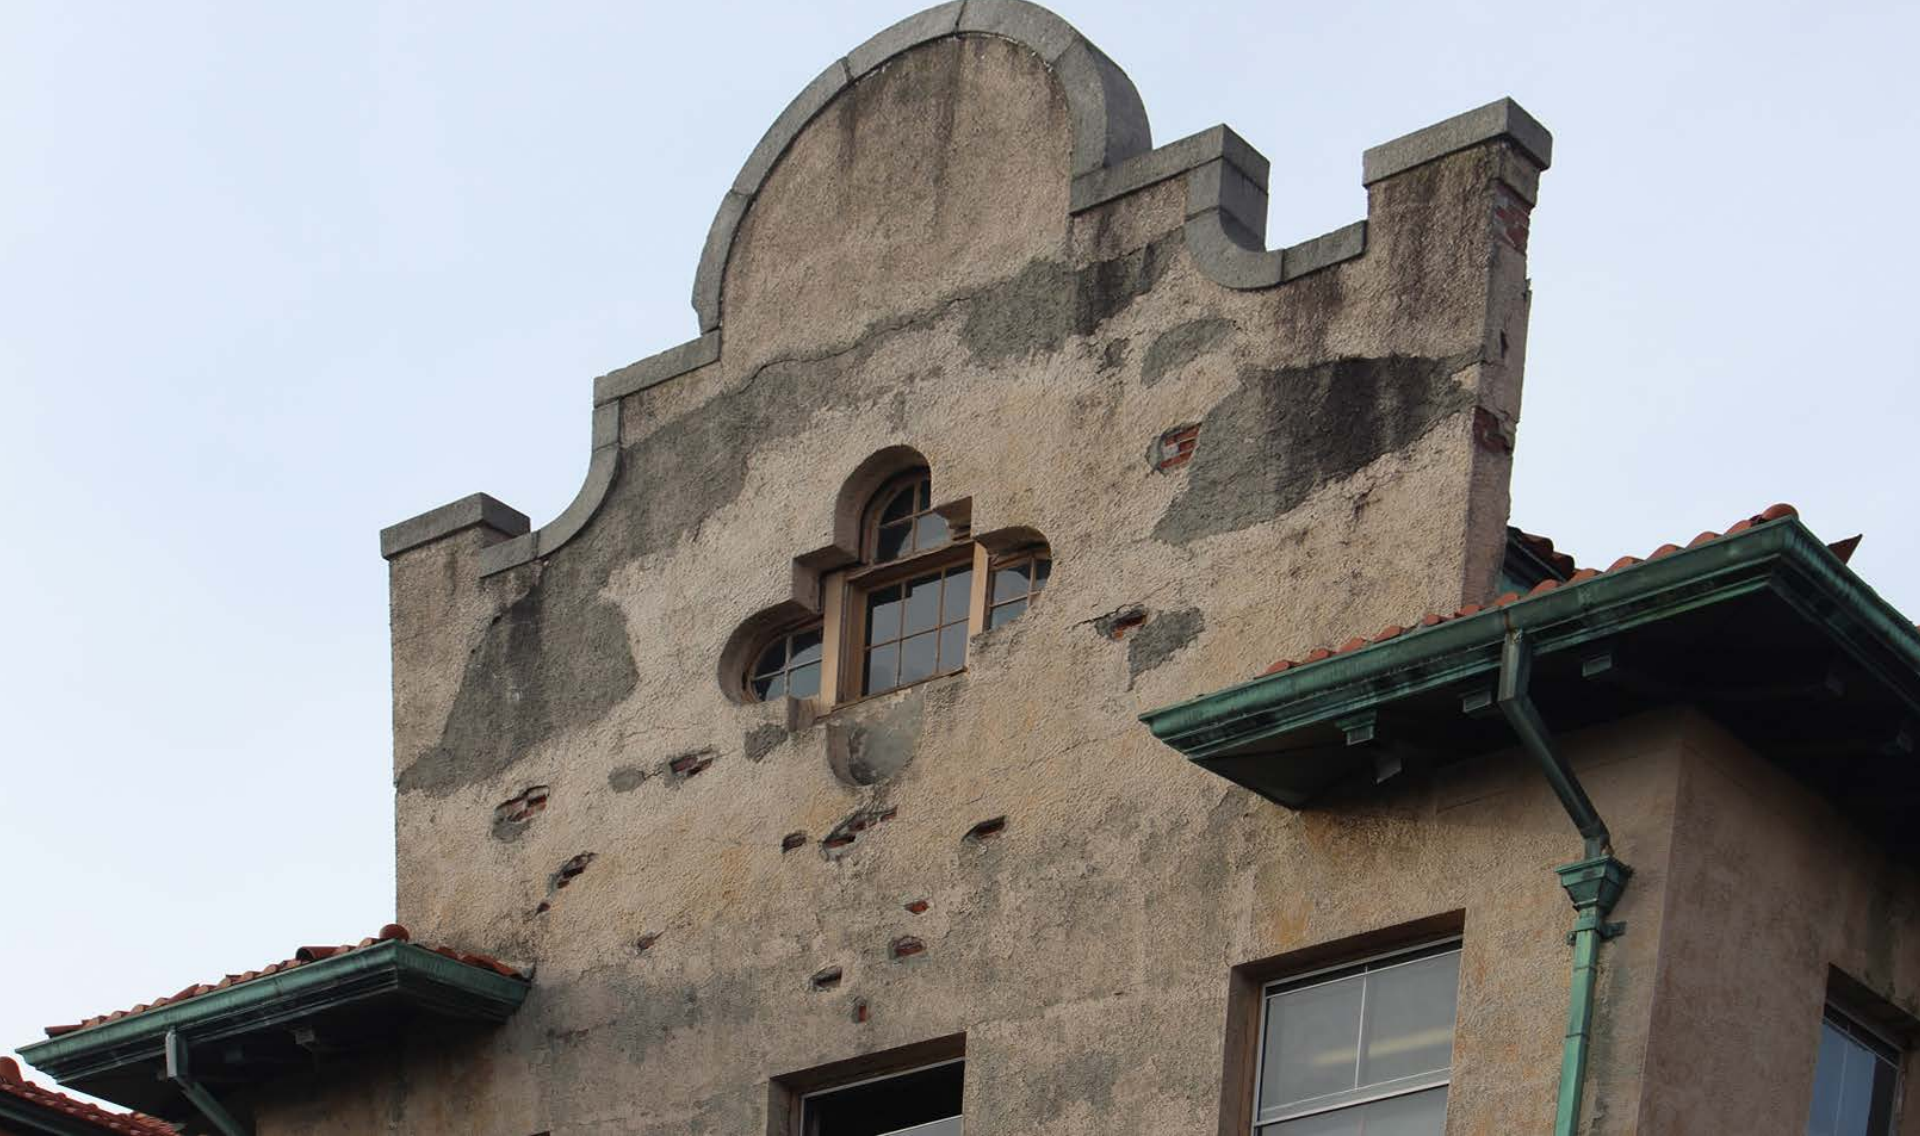
Stucco Conditions: Evidence of Previous Coating

Evidence of above roofline water penetration.

Bottom window of 4 part opening was filled in likely due to water infiltration.

Stucco appears more damaged in areas where wall had opportunity to freeze (areas above heated portions of the roof).

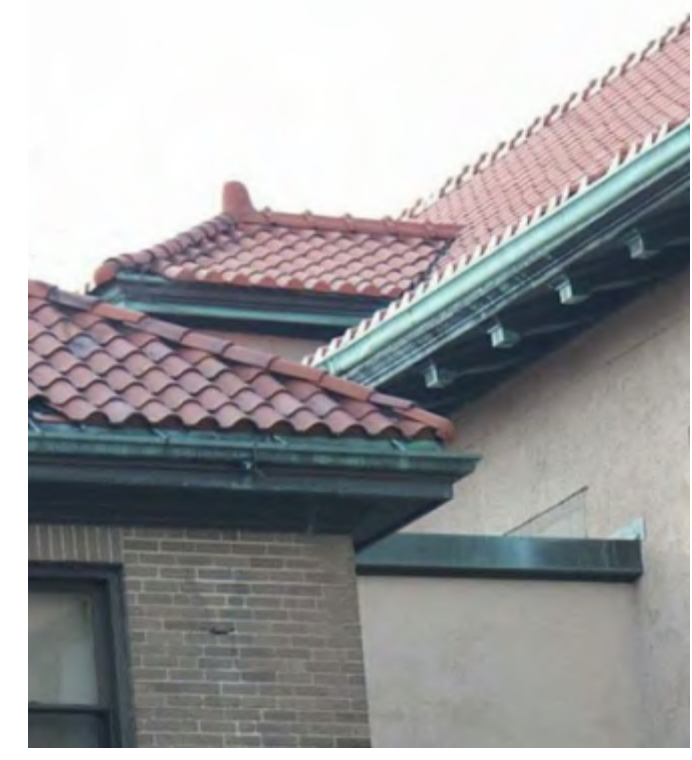
EXISTING COPPER DOWNSPOUTS ARE MISSING OR DAMAGED AT SOME LOCATIONS

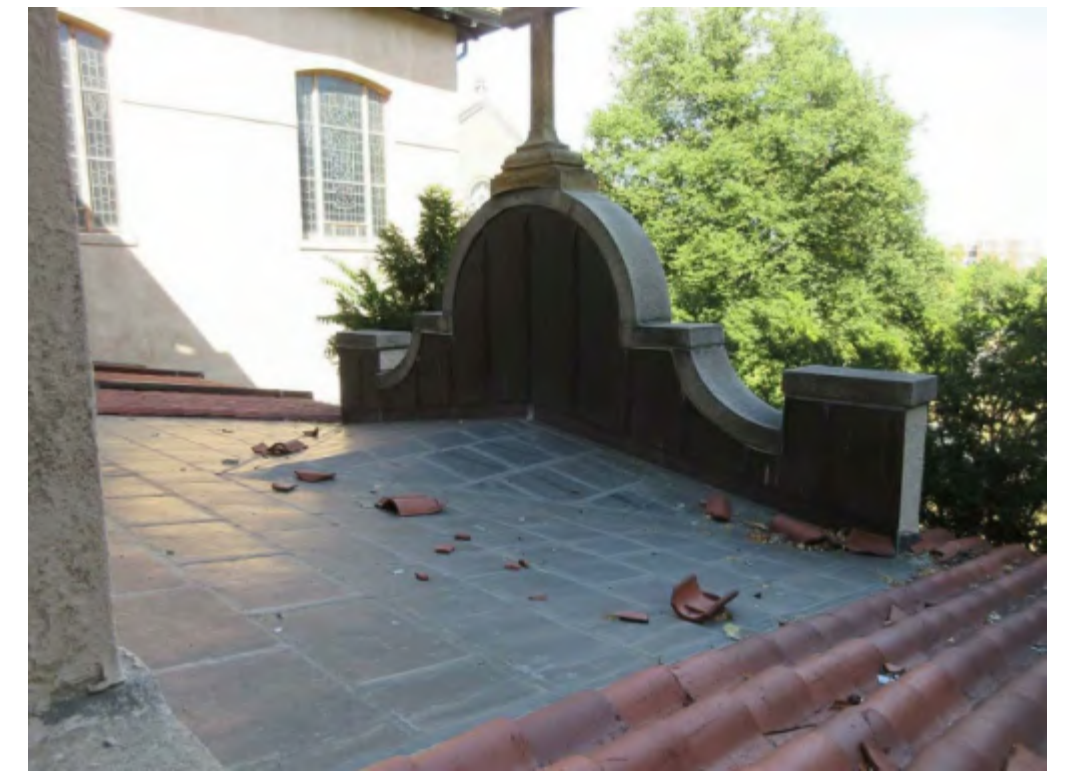
EXISTING REPLACEMENT COPPER TRIM AT PREVIOUS REPAIRS TO FRONT ENTRY PORCH, WITH MISSING DOWNSPOUT

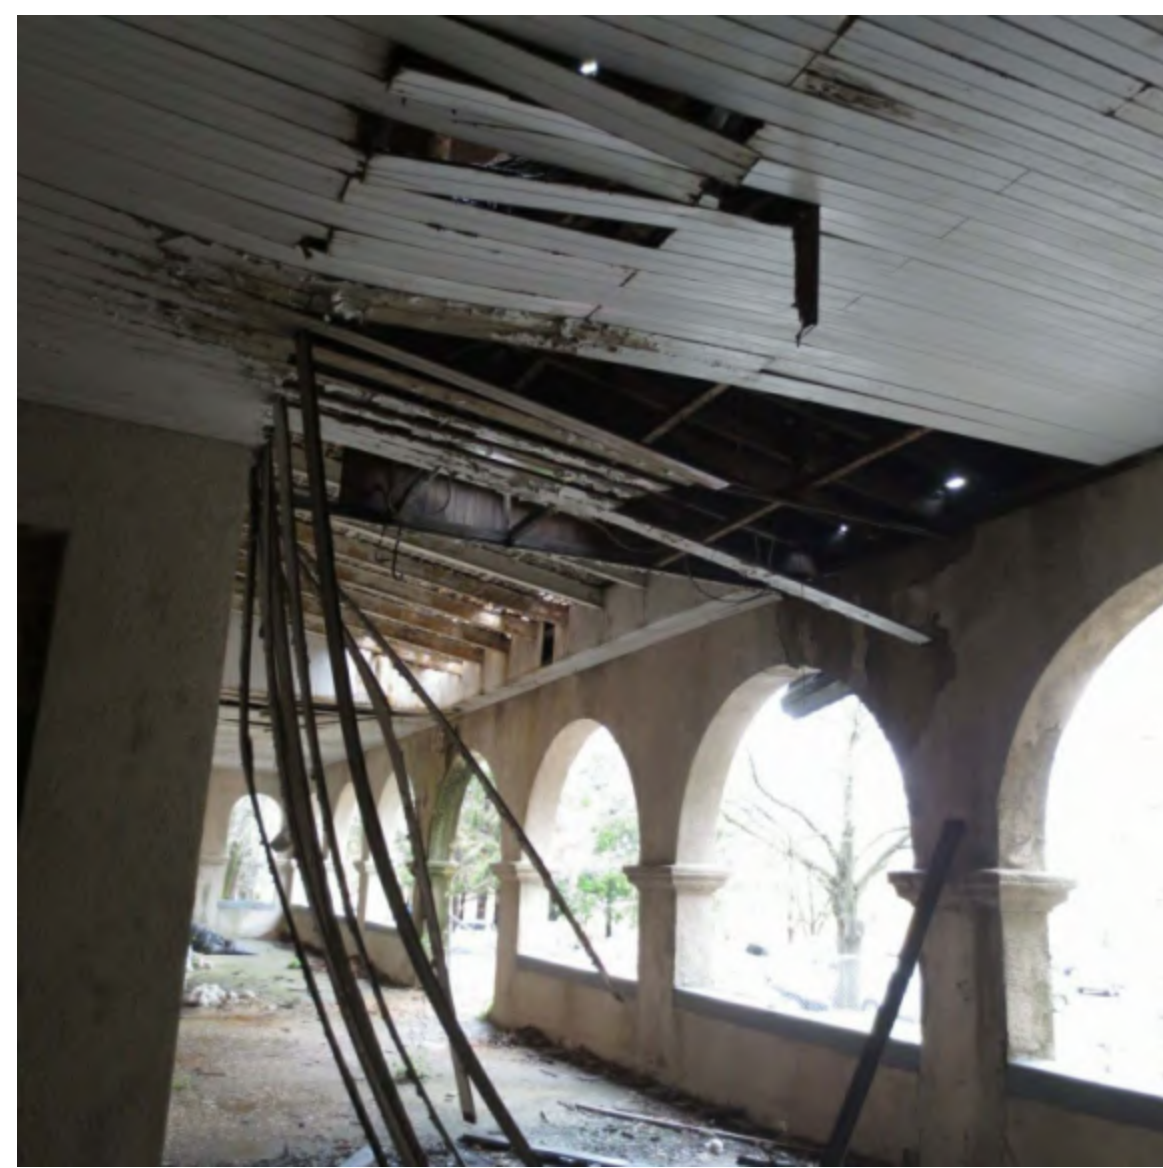
DAMAGED WOOD CEILING AT NORTH PORCH

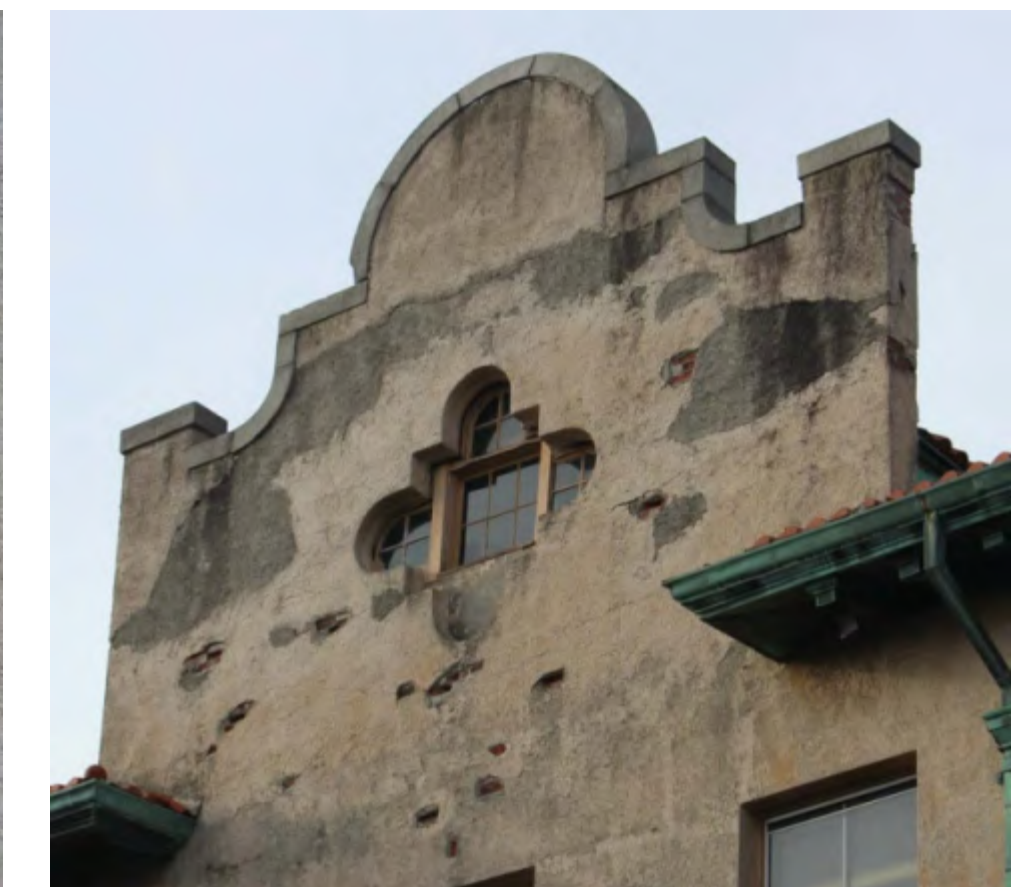
STUCCO HAS AREAS OF WATER DAMAGE AND MISSING MATERIAL, BUT GENERALLY SOUND.

THE INTENT WILL BE TO RE-COAT TO PROVIDE UNIFORM APPEARANCE.
