St. Gabriel's Monastery

THE MONASTERY, BRIGHTON. MASS.

August 23, 2016

St. Gabriel's Monastery Renovation

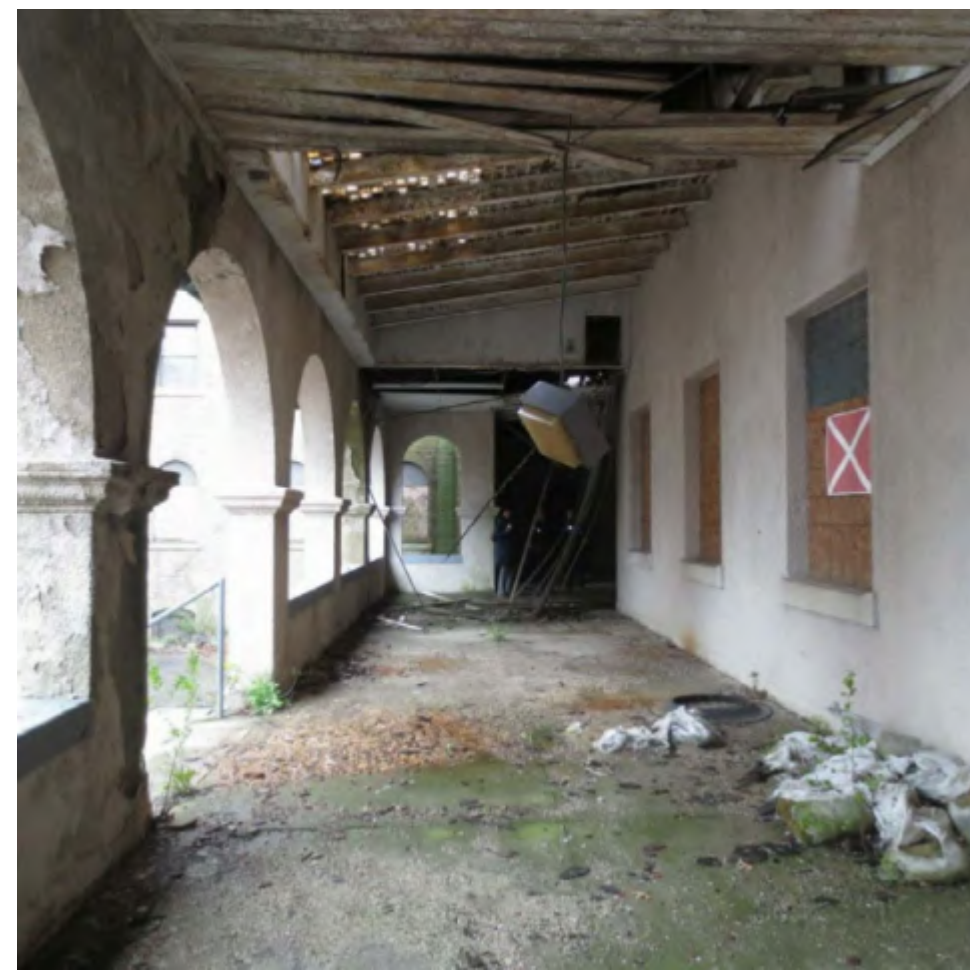
NORTH PORCH HAS DAMAGED CEILING.

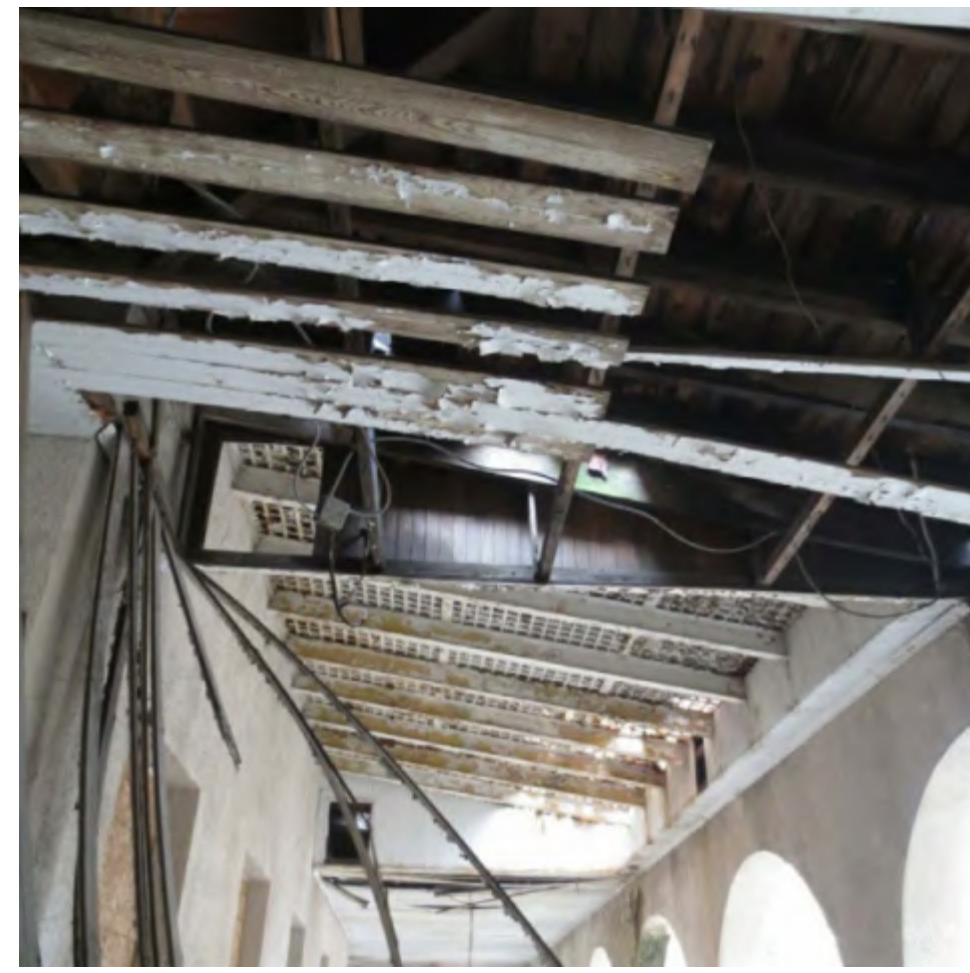
DETAIL VIEW OF DAMAGED CEILING, SHOWING WOOD AND METAL FRAMING (ORIGINAL SKYLIGHT?).
