A101
PROPOSED ENTRY
PLANS AND
ELEVATIONS

EXTERIOR RESTORATION AND
RELATED WORK
123 NEWBURY STREET
BOSTON, MA

MEMORANDUM

RE: BUILDING ENVELOPE CONDITIONS
123 NEWBURY STREET
BOSTON, MASSACHUSETTS

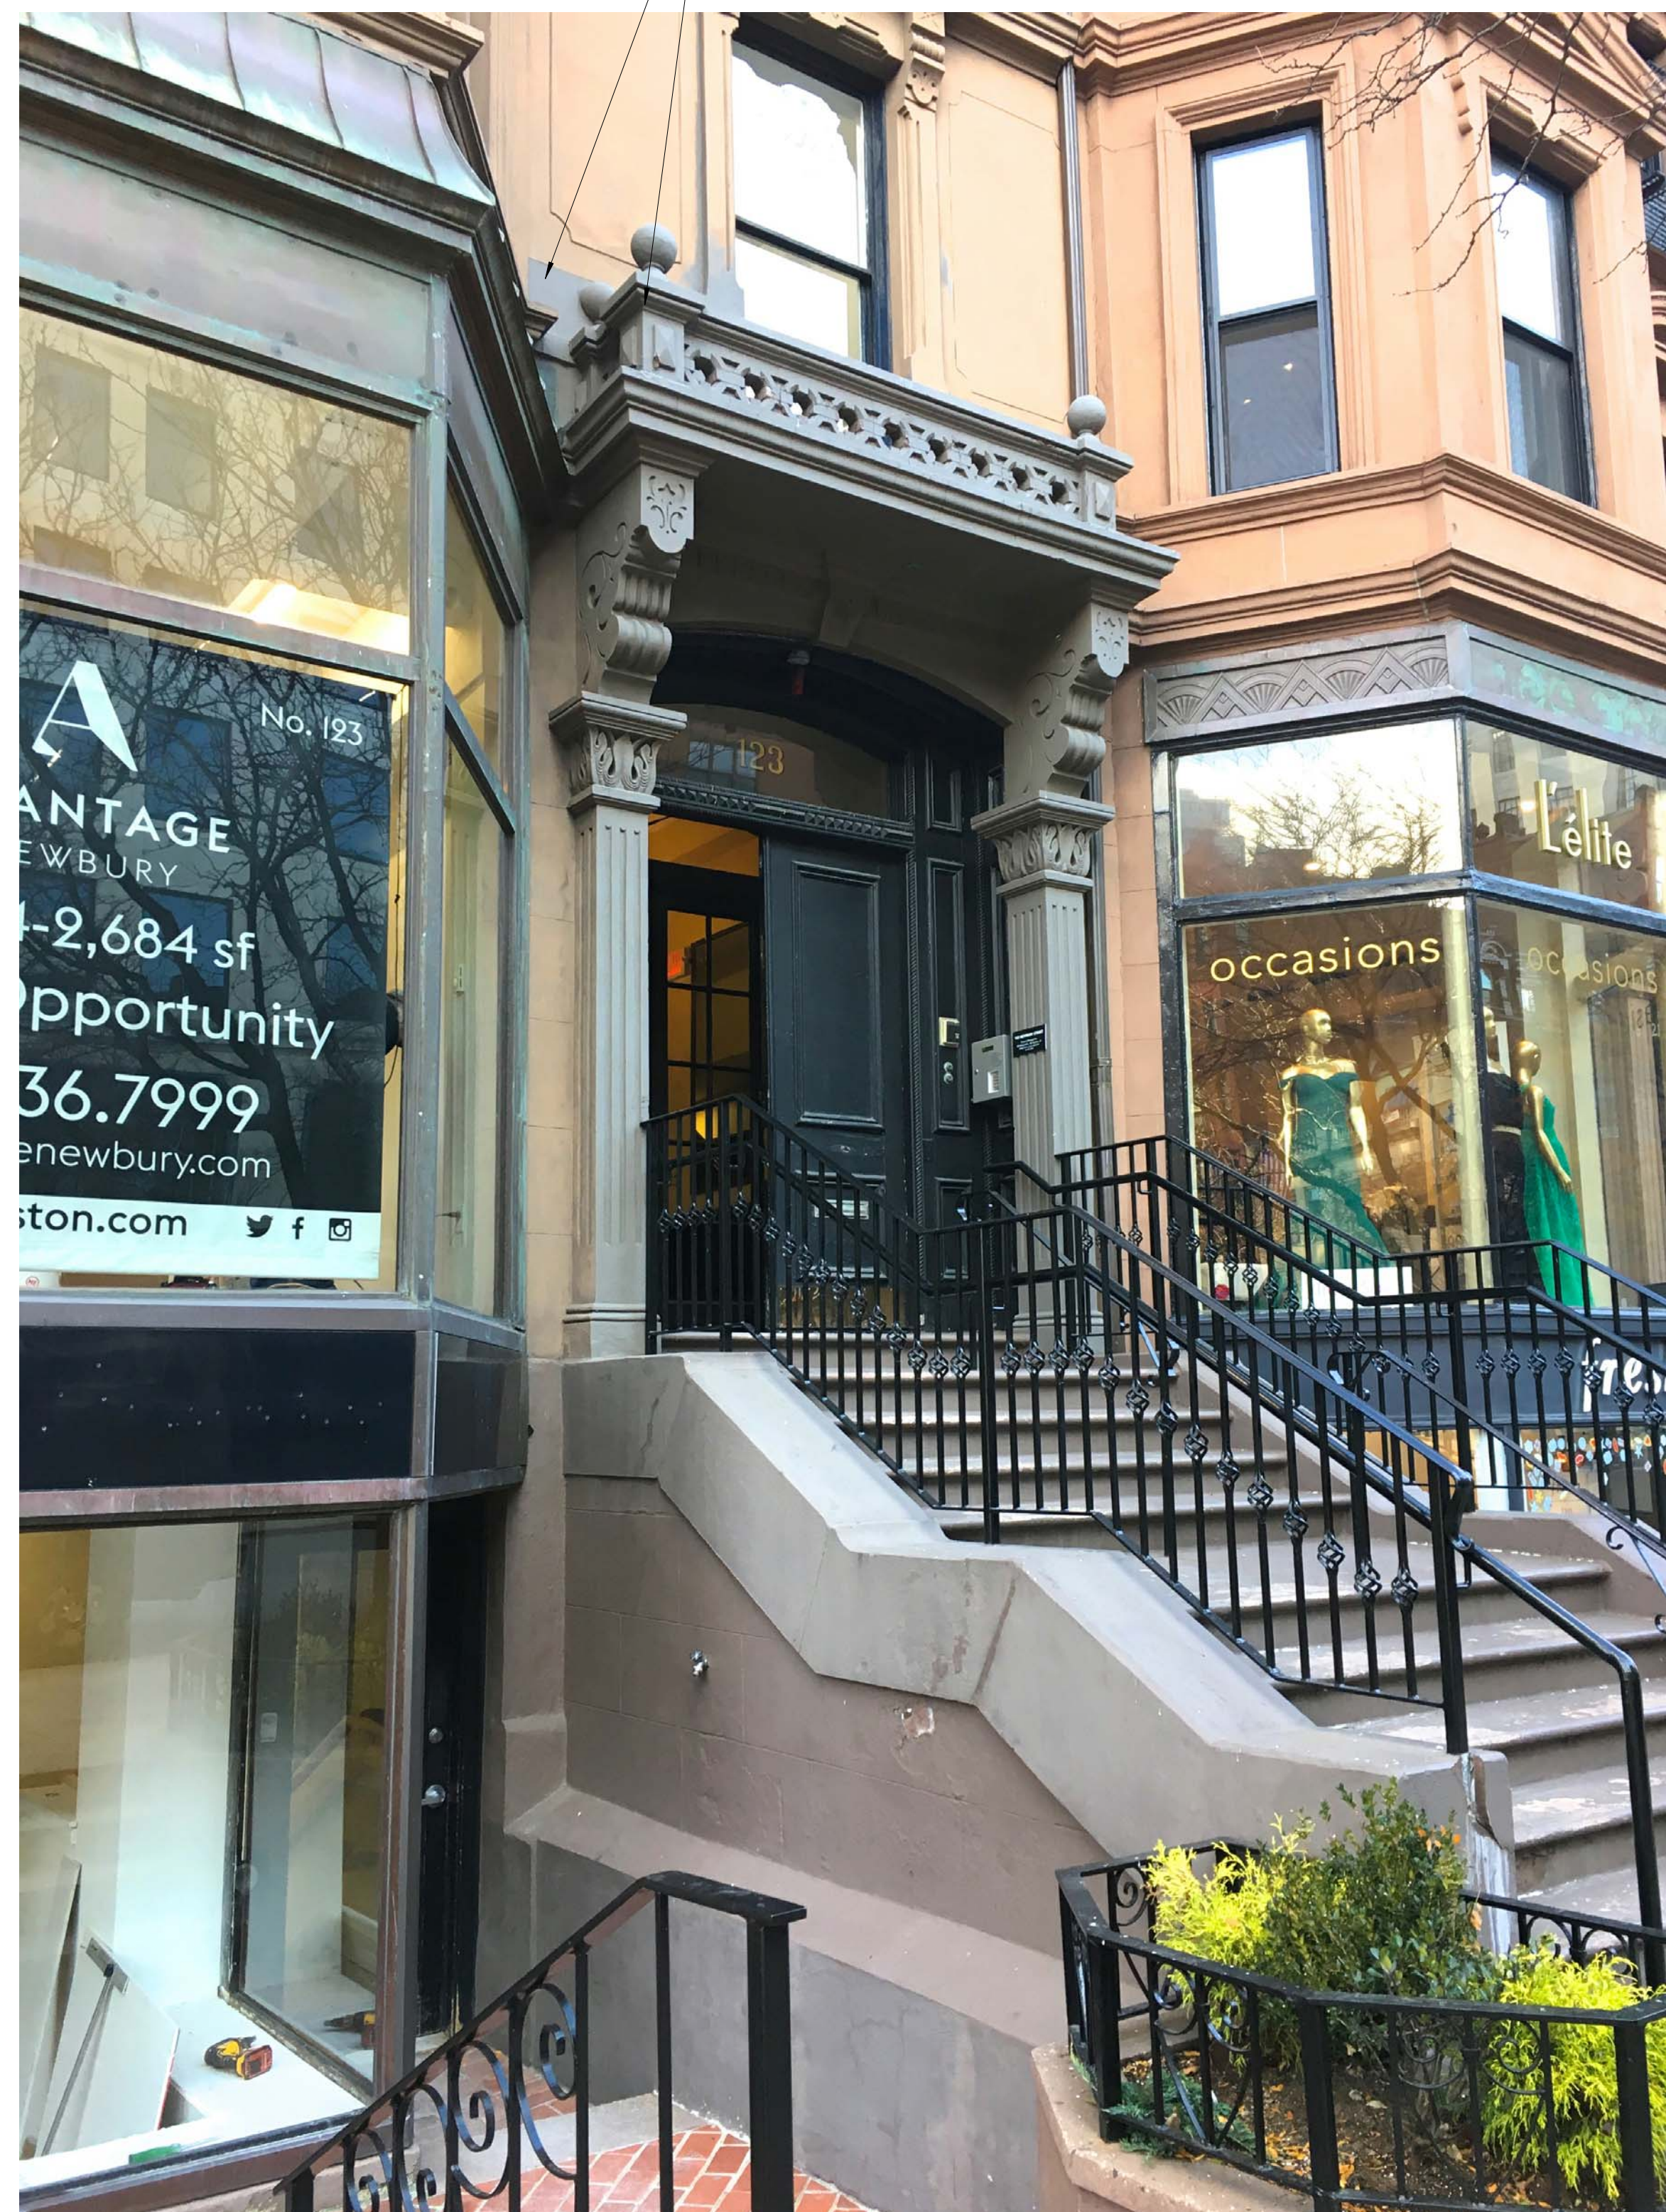
BEFORE

AREAS TO BE CORRECTED

RECOATED AREAS OF BUILDING TO CORRECT COLOR DISCREPANCY

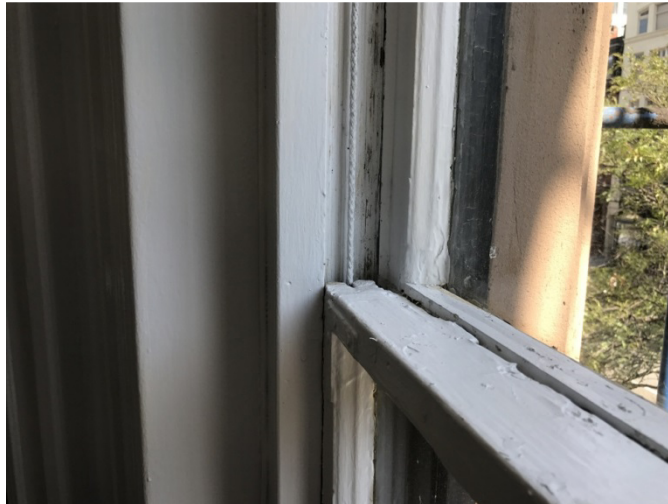
- Existing windows are wood framed hung units with single pane glass. The existing windows are in poor condition. During our site inspection, building tenants reported cold air drafts and difficulty of operation. In summary, the existing glazing is thermally inefficient, the window hardware is aged and difficult to operate, and the wood frames and sashes are deteriorated with age (see photos below). Full replacement is recommended.

Typical existing window conditions. Note deteriorated wood, single pane glass, and aged hardware.

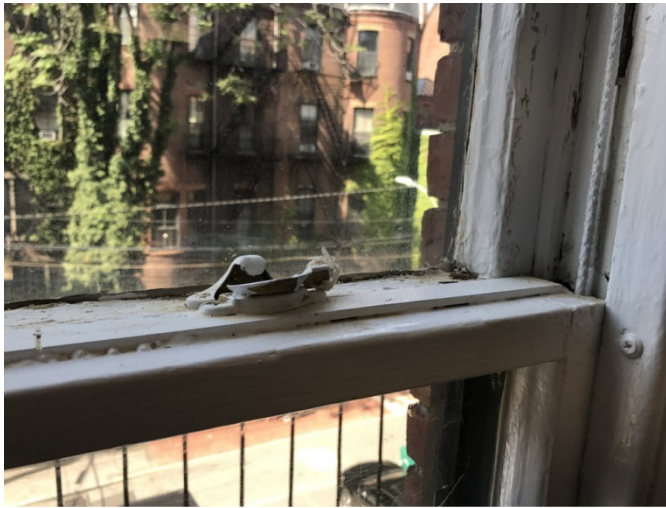
Typical existing window conditions. Note deteriorated wood, single pane glass, and aged hardware.

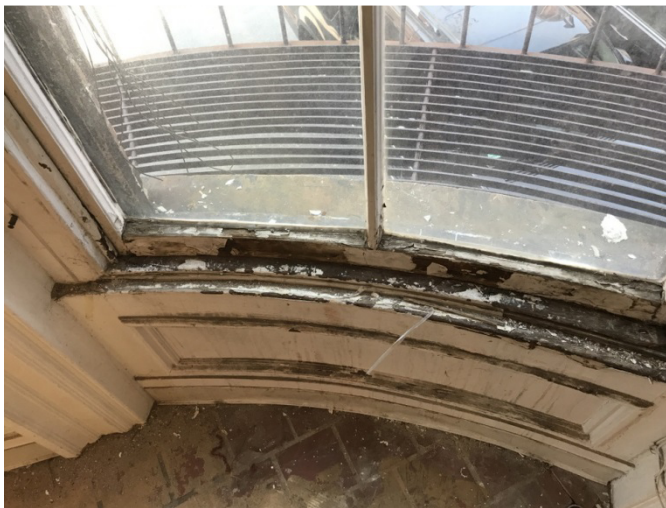
Note rotted wood and water damage at existing rear window sash and sill.

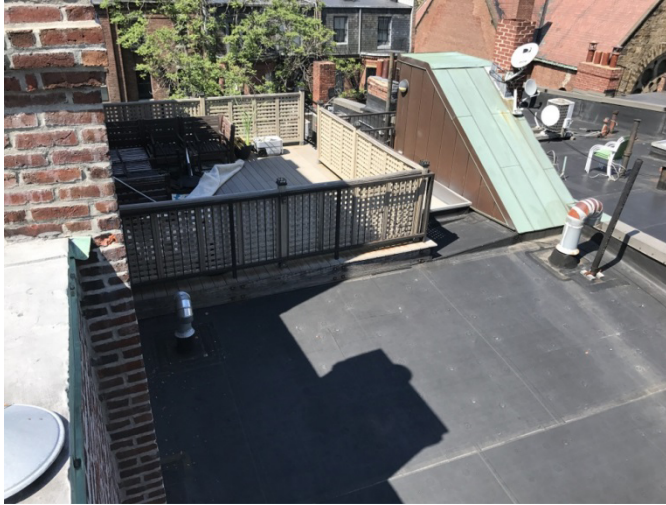
- The main portion of the building is covered with an adhered single ply EPDM membrane roof system, which is installed over mechanically fastened polyisocyanurate foam insulation. The rear window bay roof consists of a built-up asphalt roofing assembly. Photographs of existing roof area conditions are shown below.
- There is an acrylic dome skylight located between deck and stair headhouse. The skylight is cracked and should be replaced. The skylight can be replaced with a similar double-dome acrylic, curb-mounted unit to match the existing opening. No modifications to the skylight opening will be needed.

Overview of main roof, which is covered with an adhered EPDM membrane roof system. .

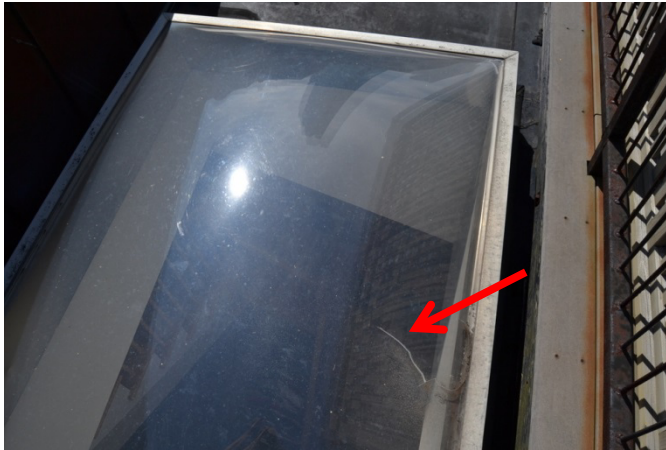
Overview of existing skylight. Note crack.

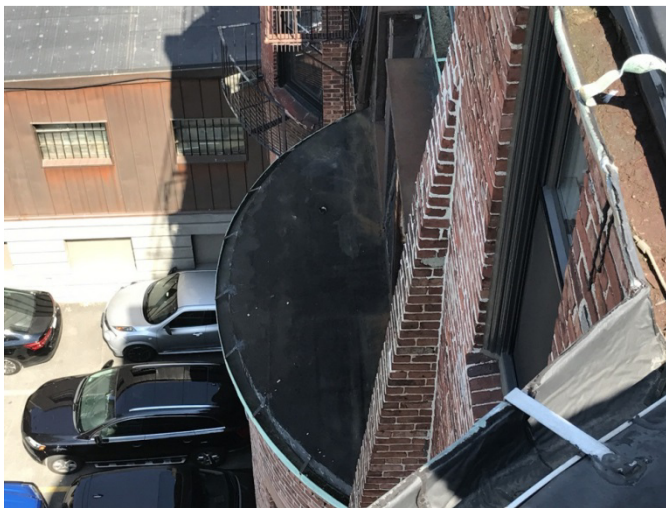
Overview of rear window bay roof. Roof consists of built-up asphalt roofing.
