ROOME & GUARRACINO, LLC

Reference: 40 Hereford Street
Boston, MA

Subject: July 24th, 2018 Structural Review of Rear Yard and Tree Roots

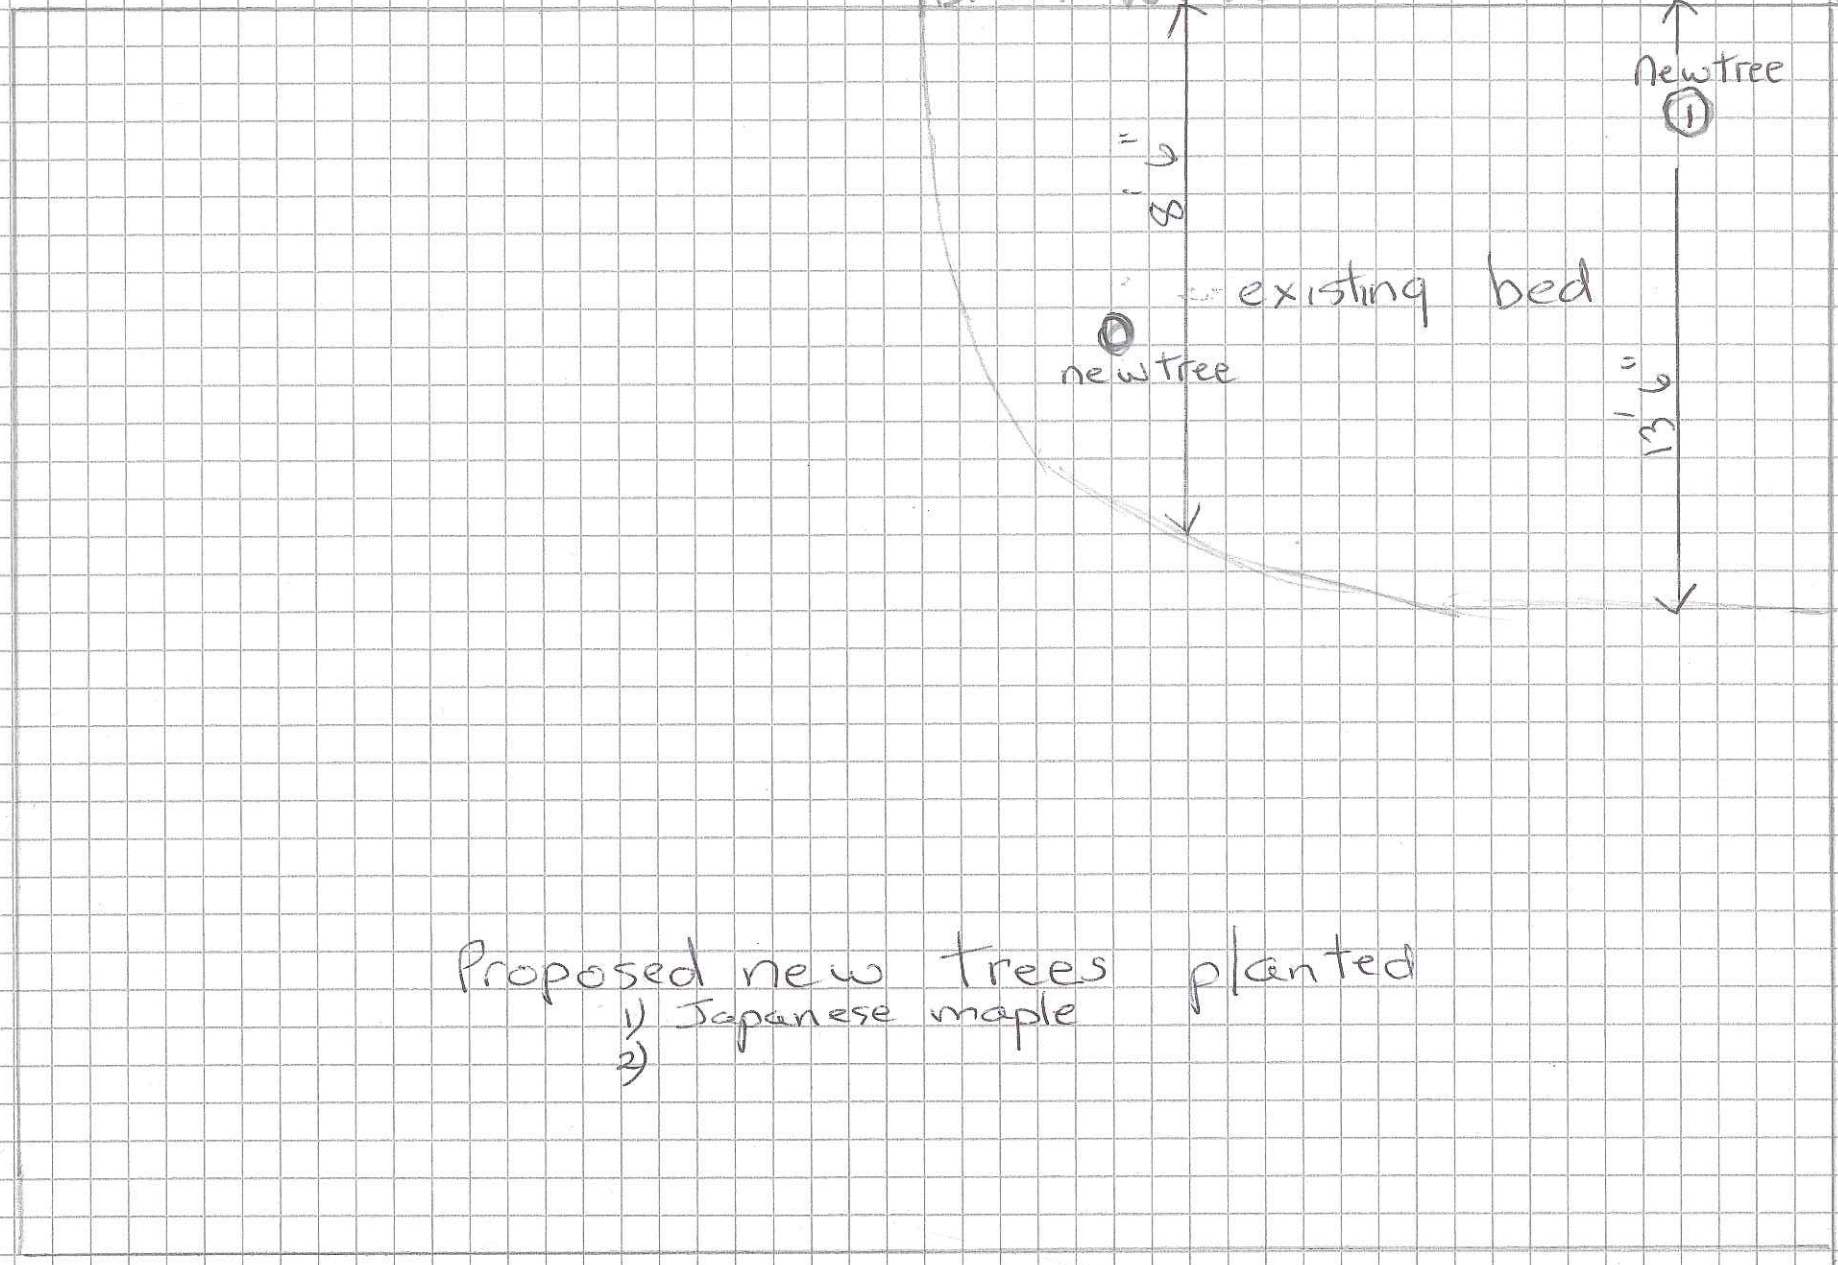
Proposed new trees planted
1) Japanese maple
2)
