Existing Conditions and Proposed Scope of Work

Brownstone Facade Restoration: Existing Conditions

<p>BOSTON ANTHENAUEUM FACADE RESTORATION AND TERRACE REHABILITATION 10 1/2 BEACON STREET BOSTON, MA</p>	<p>BROWNSTONE RESTORATION - NORTH ELEVATION</p>	<p>SIMPSON GUMPERTZ & HEGGER Engineering of Structures and Building Enclosures</p> <p>480 Totten Pond Road Woburn, Massachusetts 02451 Phone: 781.907.7000 Fax: 781.907.7009 www.sgh.com</p> <p>Boston Chicago Los Angeles New York San Francisco Washington, DC</p>	<p>Project No. _____ Drawing No. _____ Scale: AS NOTED Date: _____ Checked: HMC Drawn: RML</p> <p>Project No. _____ Drawing No. _____ Scale: AS NOTED Date: _____ Checked: HMC Drawn: RML</p>
--	--	---	---

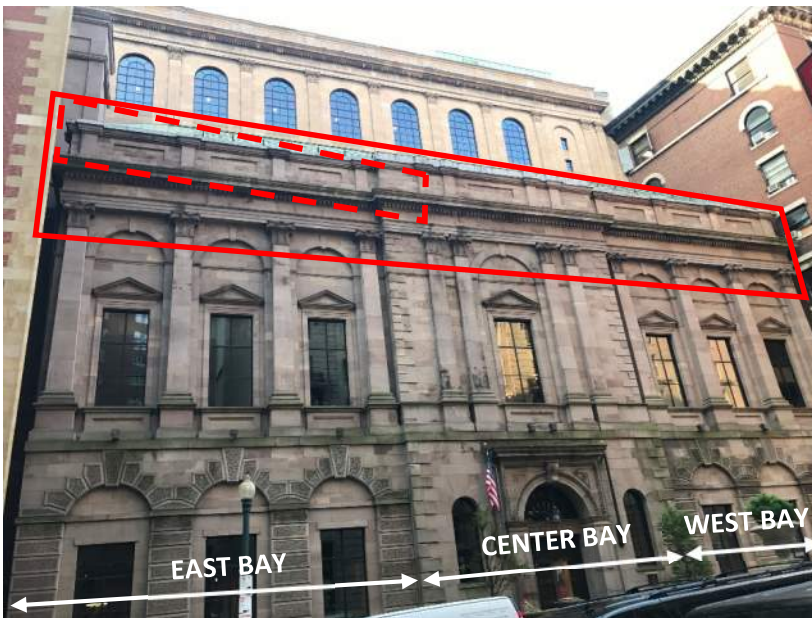
Photo 1

Overview of the Beacon Street (north) facade. The approximate location of interior humidified storage (lock) spaces is indicated by the solid red line. Refer to Photo 2 for close-up of the exterior masonry wall indicated by the red dotted line at the third floor in the east bay.

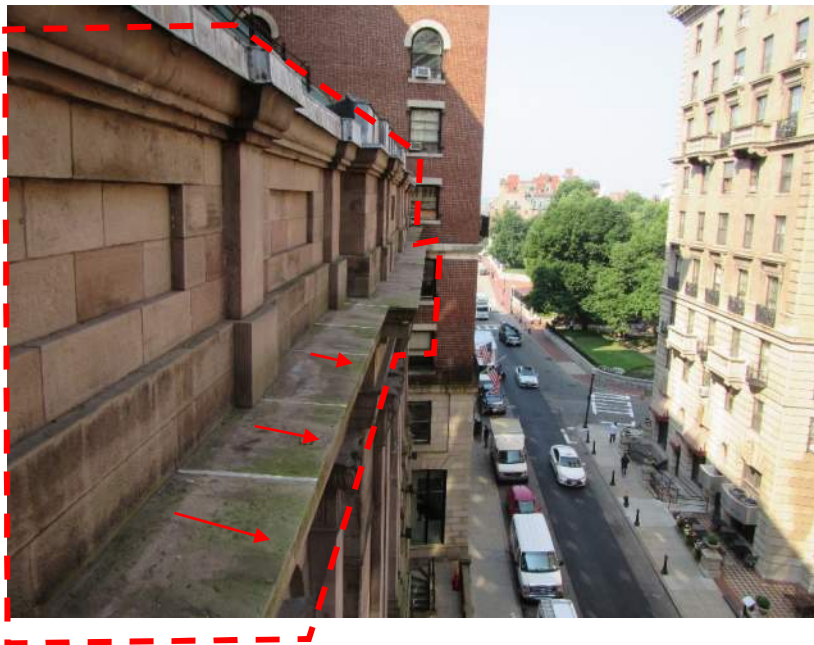
Photo 2

Close-up of the exterior masonry wall and projecting ledges (indicated in red dashed box) that are adjacent to the third-floor humidified lock spaces where leakage is reported. The projecting stone ledge is covered with biological growth and sloped toward the exterior (red arrows). Photograph taken from northeast corner looking west.

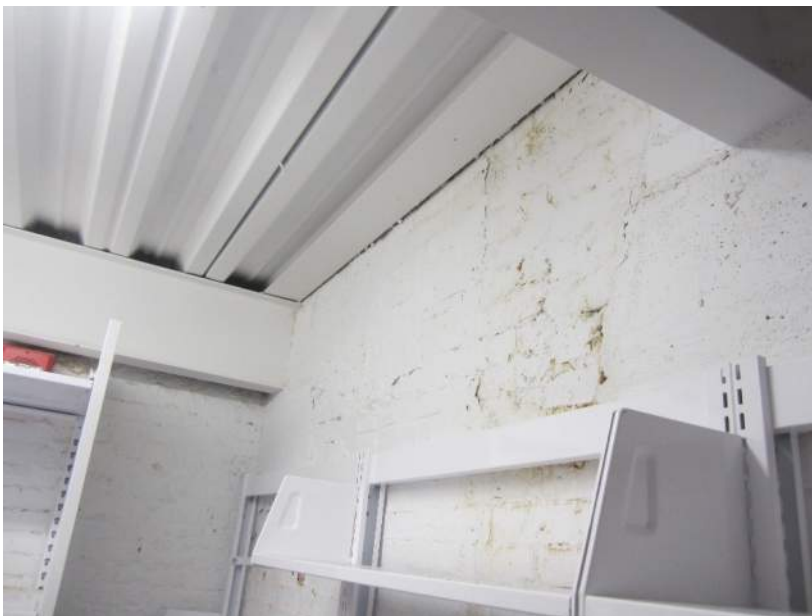
Photo 3

General view of paint peeling and staining at interior surfaces of exterior masonry walls adjacent to humidified lock spaces where recurring moisture-related issues are reported in the east bay.

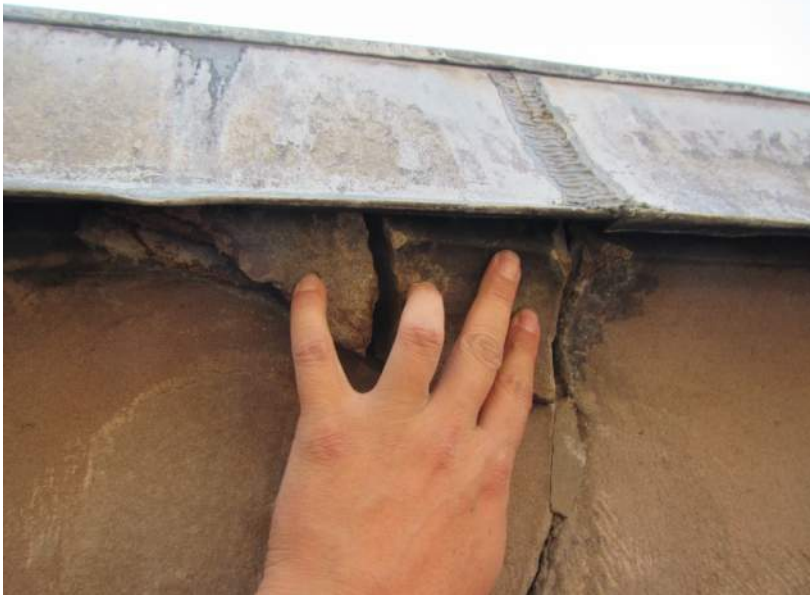
Photo 4

SGH and VA identified and removed several masonry spalls along the underside of the sheet metal roof flashing during our hands-on masonry assessment.

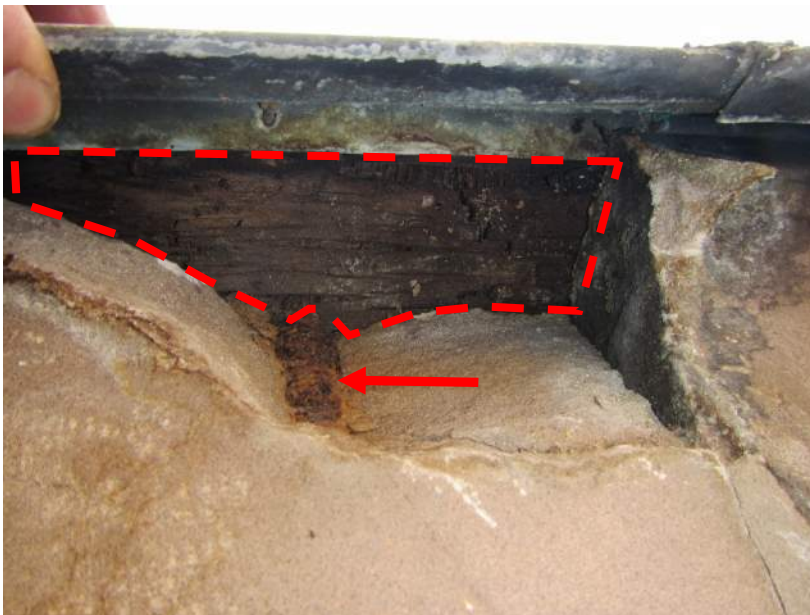
Photo 5

Corroded anchors (red arrow) and deteriorated wood blocking (indicated in red) are visible after removal of one of the stone spalls at the underside of the third-floor built-in gutter.

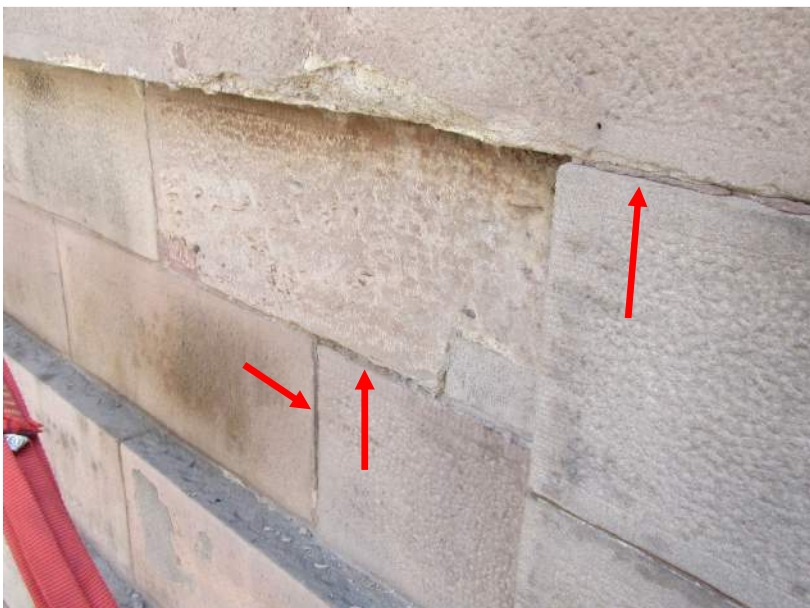
Photo 6

Arrows identify missing, loose, and deteriorated mortar within the field of the masonry wall adjacent to the lock spaces where moisture-related issues are reported at the east bay.

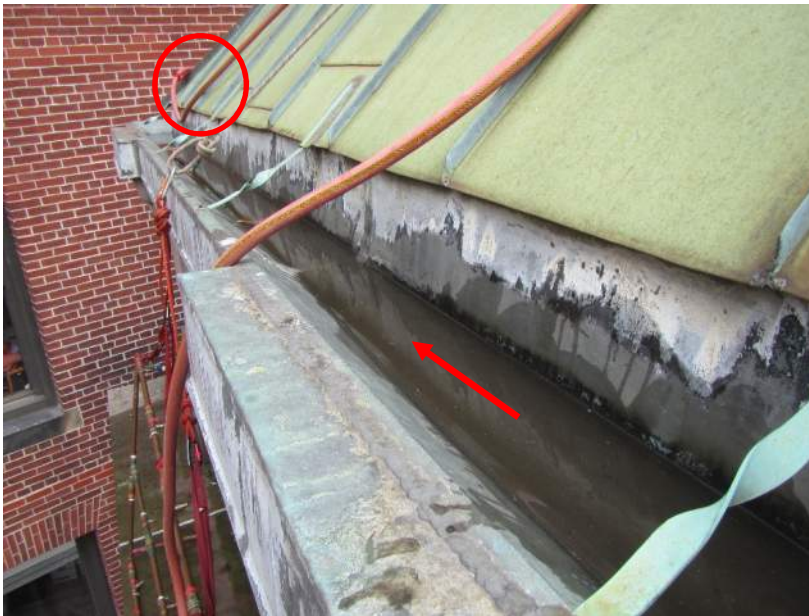
Photo 7

Overview of the standing-seam copper roof with built-in gutter located directly above the lock spaces in the east bay. The built-in gutter is sloped (red arrow) toward the east elevation to a single down leader that is obstructed by debris (indicated in red). Refer to Photo 9 for condition of down leader prior to water testing.

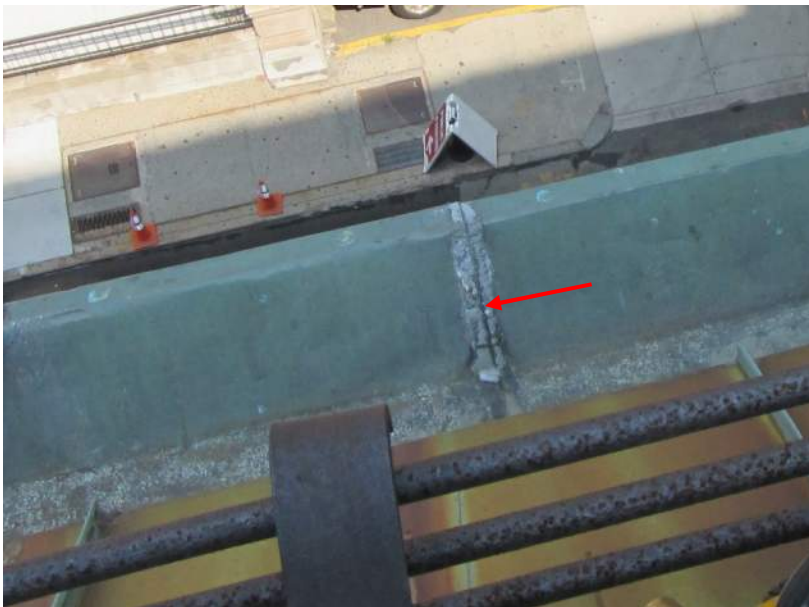
Photo 8

Cracked transverse seam (red arrow) at built-in gutter above lock spaces where moisture-related issues are reported.

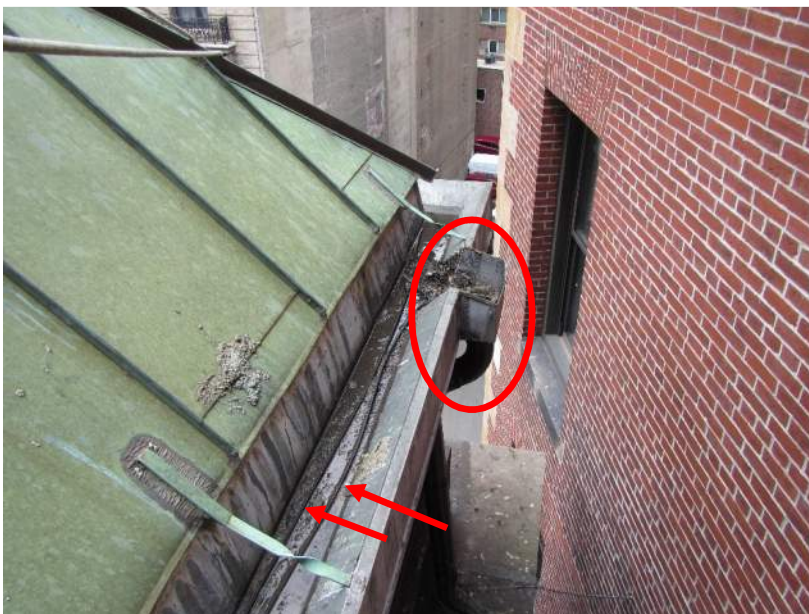
Photo 9

A 2 in. diameter down leader is present (indicated in red) at the east elevation. Debris obstructs drainage in the down leader. Heat-trace cables (red arrows) are present, although cable operability is unknown.

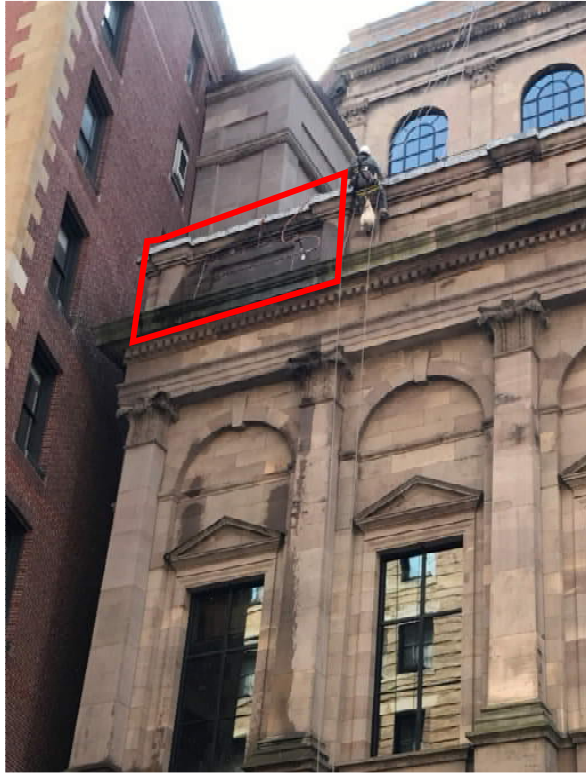
Photo 13

Water Test No. 1 (indicated in red) in progress at the exterior masonry wall. Refer to Appendix B for an annotated third-floor plan with water testing and moisture-monitoring observations.

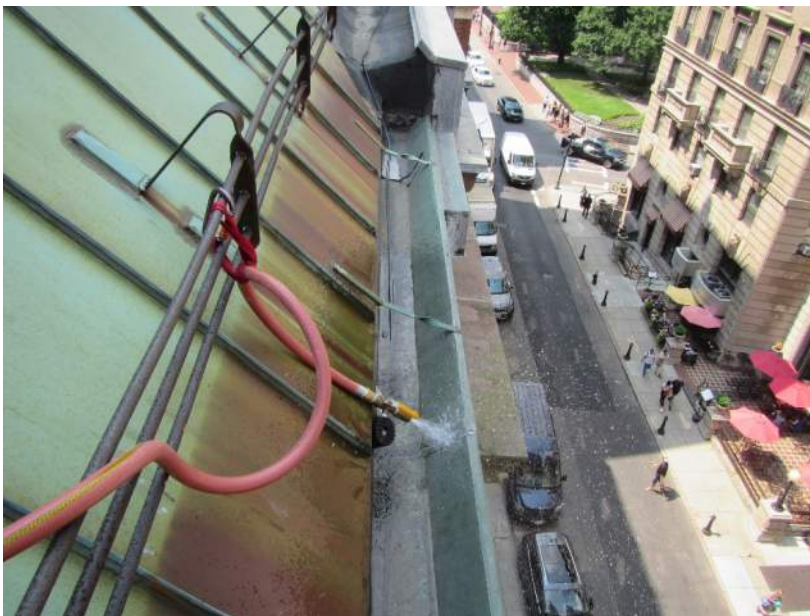
Photo 14

Water Test No. 2 in progress at a cracked solder joint of a transverse seam in the built-in gutter directly above one of the humidified lock spaces where leakage is reported at the interior.

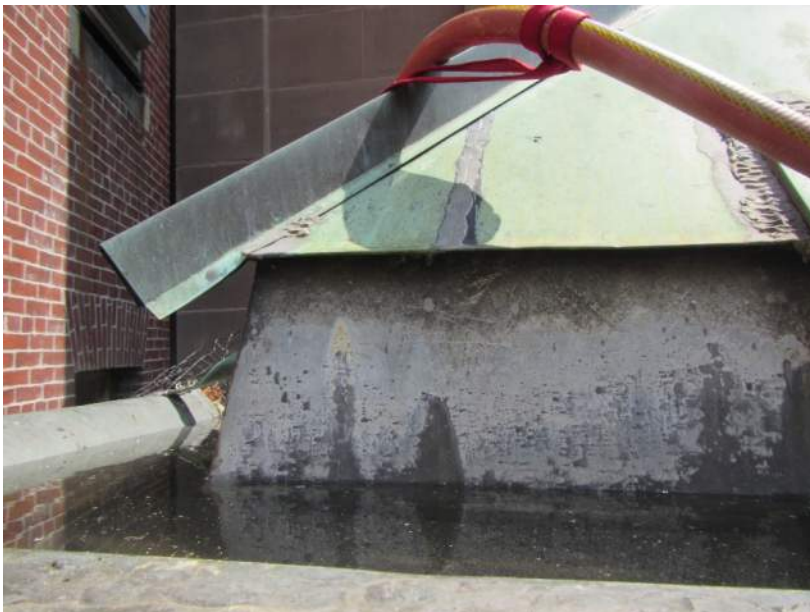
Photo 15

Water Test No. 3 consisted of flood testing the built-in gutter located at the northeast corner of the third-floor roof, which is located directly above one of the humidified lock spaces where interior leakage is reported.

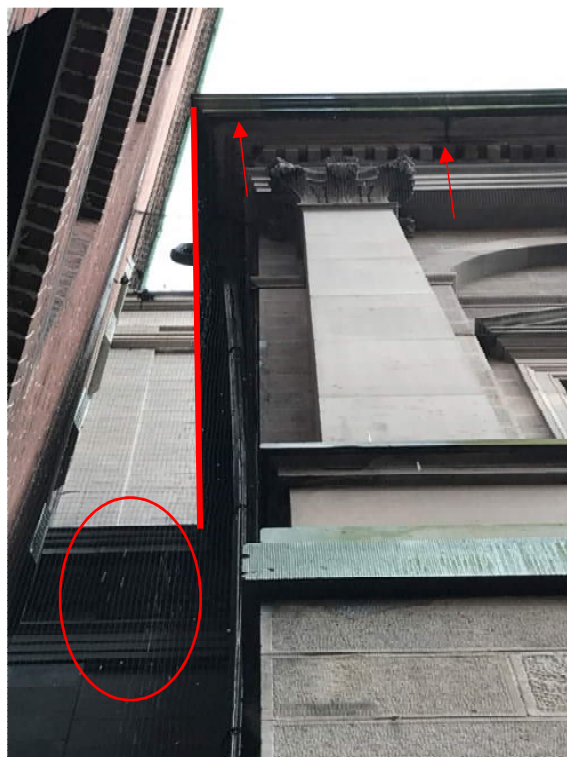
Photo 16

Due to the pitch of the built-in gutter at the northeast building corner, water overtopped the gutter on the east elevation (indicated in red) prior to completely filling the north gutter. Water is visibly dripping (indicated in red) at the exterior from the gutter overtopping. We also observed moisture (red arrows) at the underside of the projecting masonry ledge beneath the built-in gutter throughout Water Test No. 3.

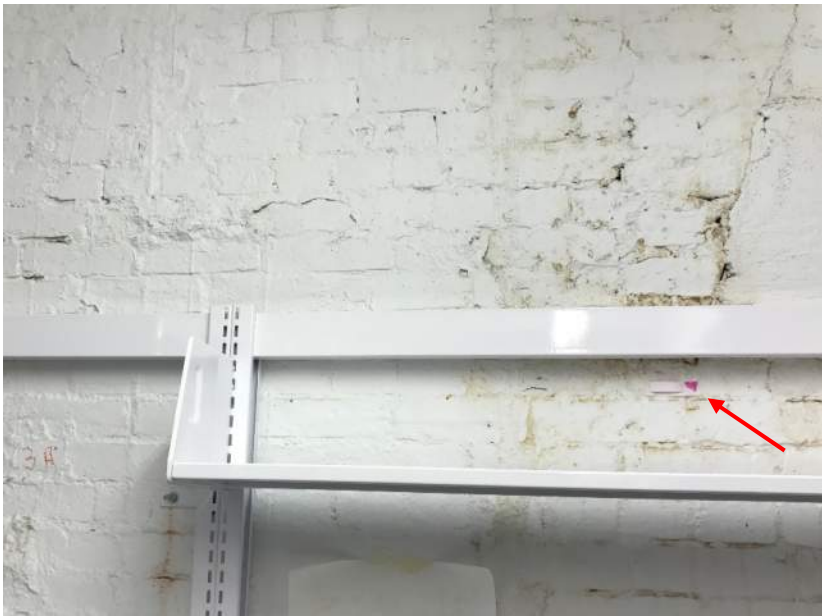
Photo 17

Water-indicator paper (red arrow) turned pink when in contact with water leakage through cracks on the masonry wall on the east elevation during Water Test No. 3.

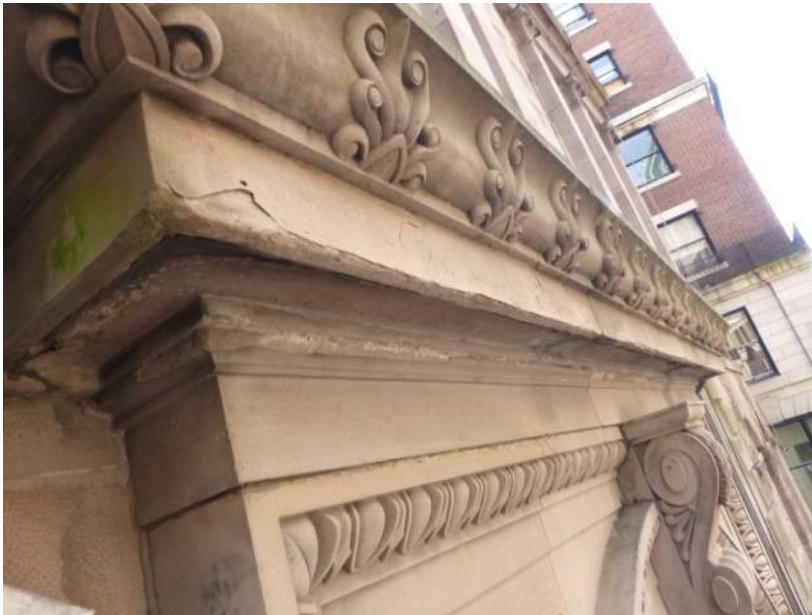
Photo 18

Eroded and soft masonry at underside of projecting masonry ledges.

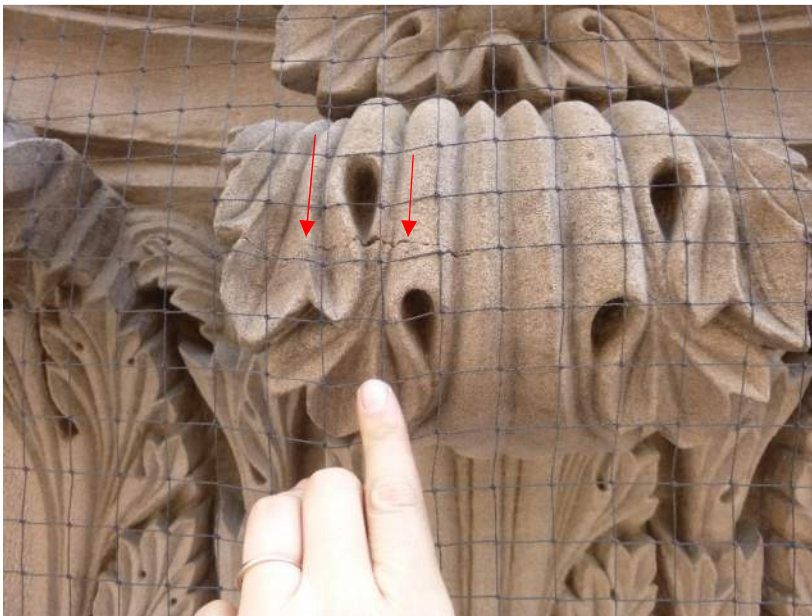
Photo 19

Eroded and soft masonry at carved column capitals. Cracks in masonry indicated by red arrows.

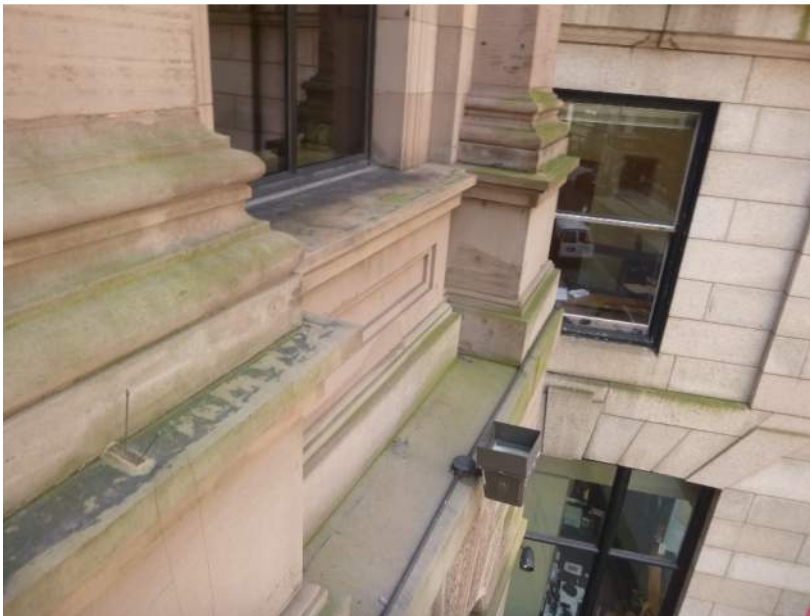
Photo 20

The skyward-facing surface of projecting ledges is generally exposed masonry that is covered in biological growth and sloped slightly toward the exterior.

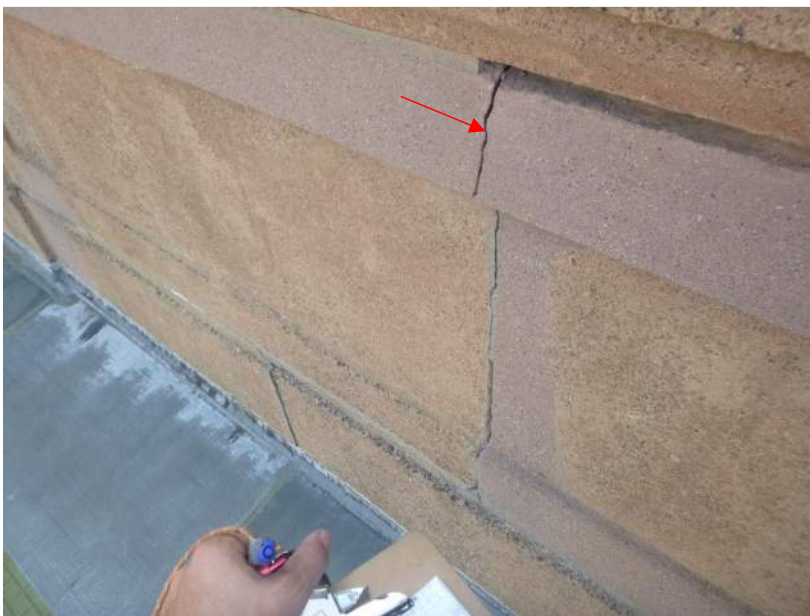
Photo 22

Previous repair does not aesthetically match the existing adjacent stone and is cracked (arrow).

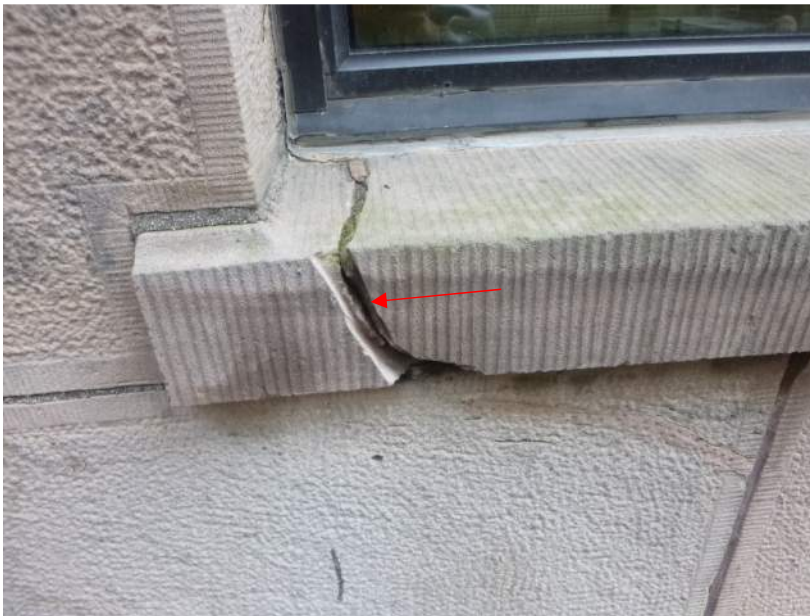
Photo 23

Cracks (arrow) in masonry window sills are generally open.

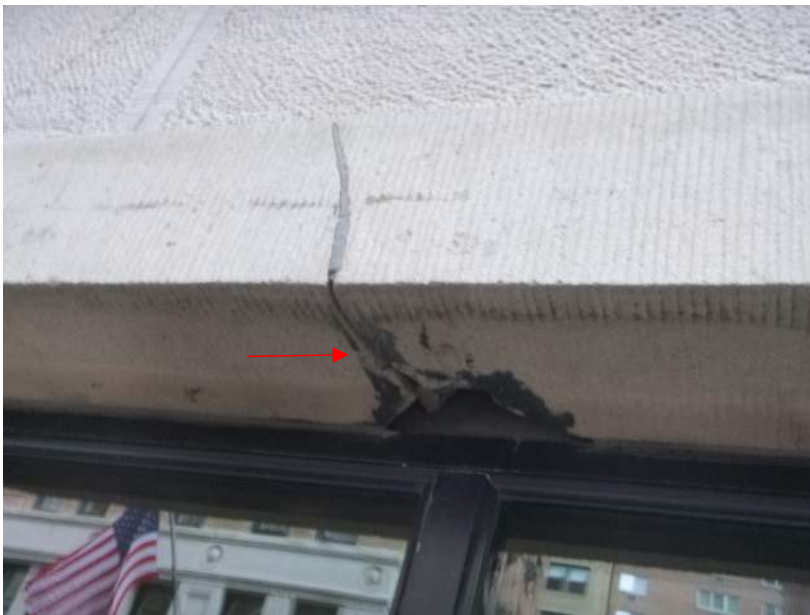
Photo 24

Crack (arrow) in a spanning masonry lintel.

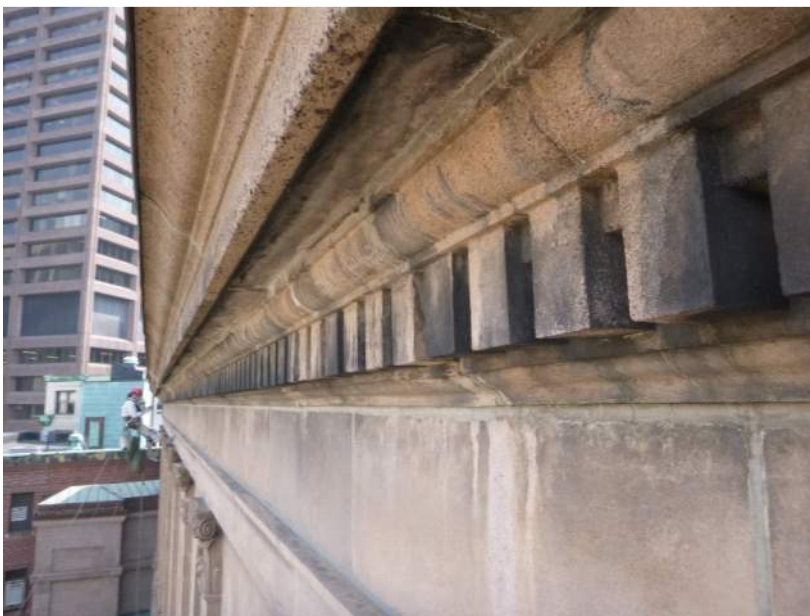
Photo 25

Dark carbon staining is present throughout the facade, particularly at the underside of projecting ledges and between carved elements and dentil moldings.

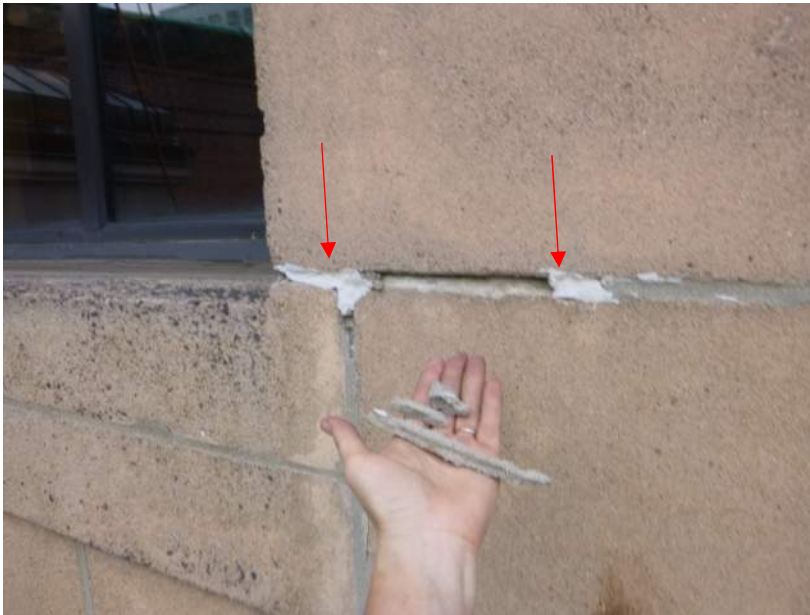
Photo 26

Loose mortar removal adjacent to previous sealant repairs (arrows).

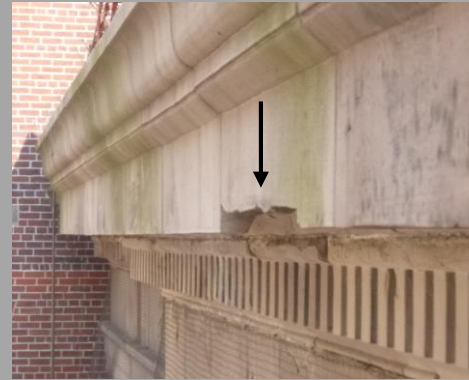
PHOTO 1 – EXAMPLE OF FRIABLE AND SPALLED BROWNSTONE (ARROW) AT UNDERSIDE OF PROJECTING LEDGE.

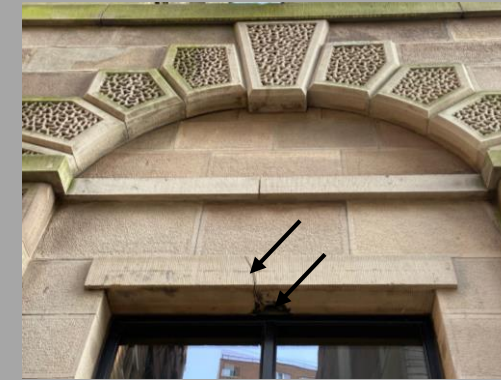
PHOTO 2 – EXAMPLE OF CRACKED AND SPALLED SPANNING STONE (ARROWS).

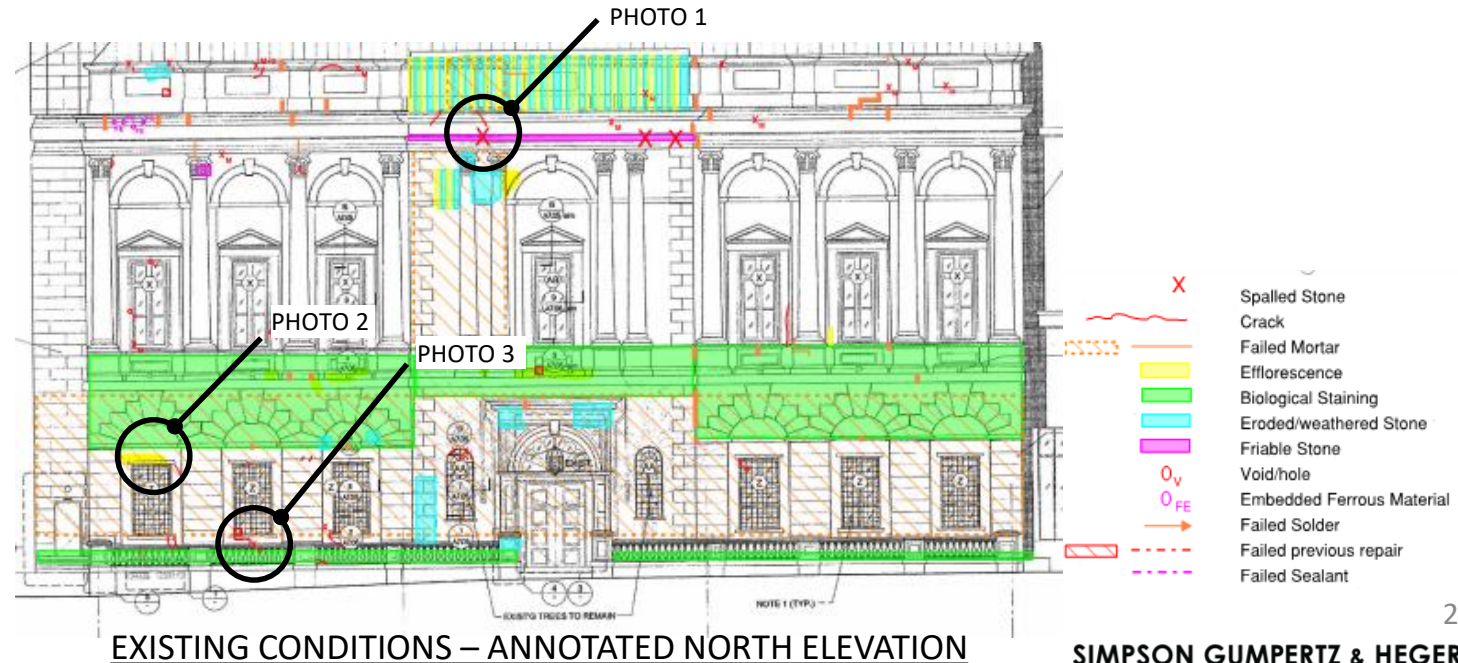
EXISTING CONDITIONS – ANNOTATED NORTH ELEVATION

- In addition to scattered brownstone issues described previously (e.g. at lintels, sills, field stones), there are concentrated areas of spalled, eroded and delaminated brownstone are primarily due to:
 - Leakage at the third-floor gutter (Photos 4 to 6).
 - Unprotected sky-facing ledges, such as above the main entry (Photos 7 and 8).
- The fundamental cause for third-floor gutter leakage is inadequate provision for drainage (only two down leaders are present at small alleyways (returns) on the north elevation, indicated by red in the elevation at right, and inadequate provision for thermal movement).

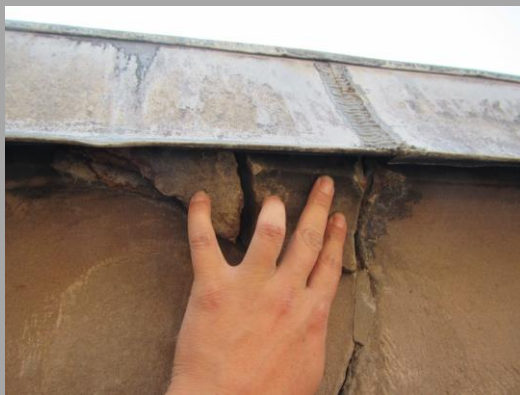
PHOTO 5 – EXAMPLE OF SPALLED STONE BELOW THIRD-FLOOR GUTTER.

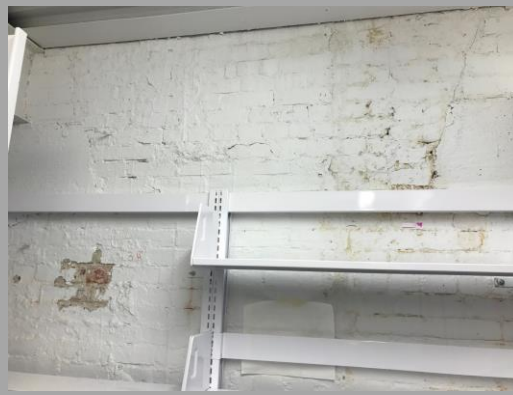
PHOTO 6 – WATER DAMAGE AT INTERIOR (WHERE SENSITIVE COLLECTIONS ARE STORED) FROM THIRD-FLOOR GUTTER.

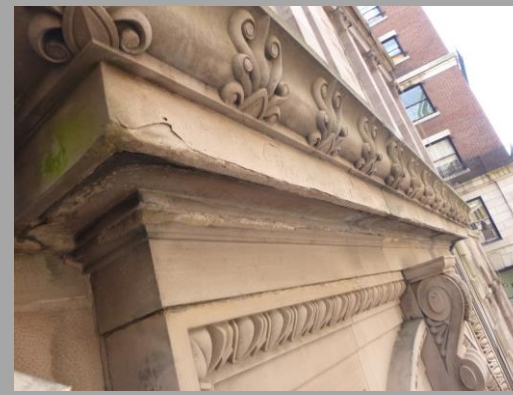
PHOTO 7 – ERODED STONE BELOW UNPROTECTED LEDGE ABOVE MAIN ENTRY..

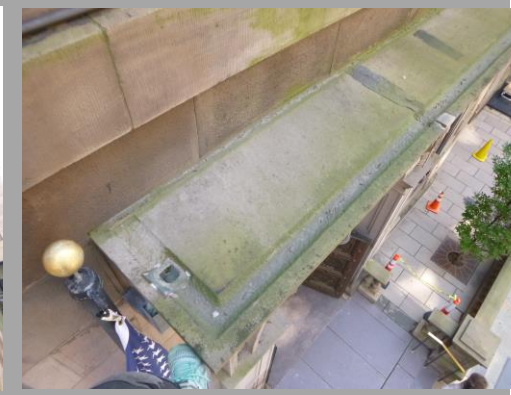
PHOTO 8 – VIEW OF TOPSIDE, UNPROTECTED LEDGE ABOVE MAIN ENTRY.

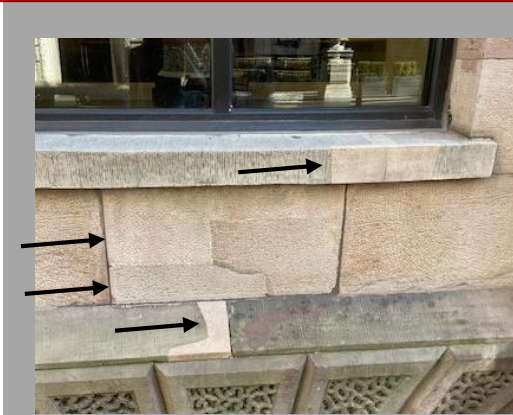
- Previous repair campaigns relied on pigmented repair mortar mixes, rather than in-kind replacement with natural stone, and create a range of mis-match repairs on the primary north façade (Photos 9 to 11).
 - Some previous repairs are not durable and/or are already failed (e.g. eroded, cracked, debonded from the parent stone, etc.).
 - Some previous repairs provide a better visual match to the existing natural stone than others, both in color and texture.
 - Some previous repairs are more conspicuous due to their geometry and proximity to the main entrance and terrace.
- The brownstone features a variety of surface stains, such as biological growth, dark carbon staining, water staining, etc. (see elevation).

PHOTO 9 – EXAMPLE OF MIS-MATCH PREVIOUS REPAIRS (ARROWS).

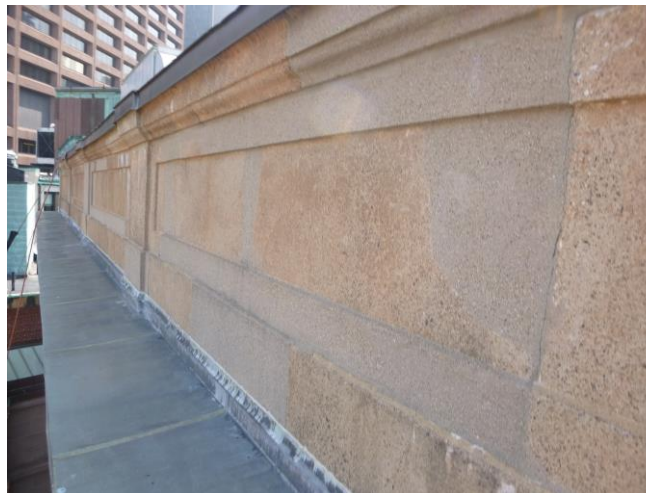
PHOTO 21 – EXAMPLES OF PREVIOUS CAST STONE REPAIRS, SOME OF WHICH ARE NO LONGER INTACT AND POSE FALLING HAZARDS.

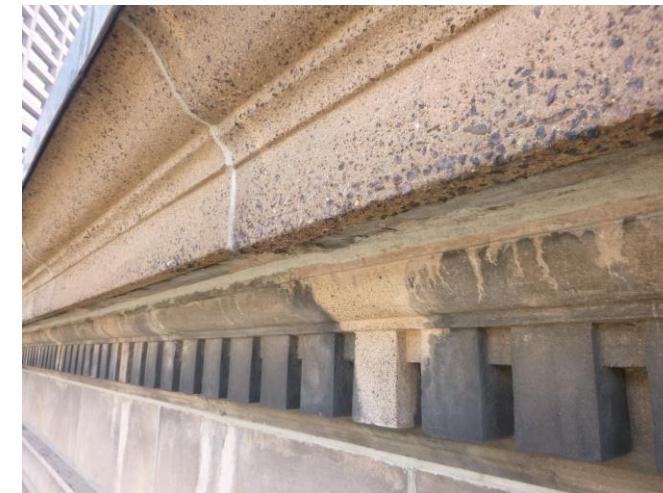
PHOTO 22 – EXAMPLES OF HEAVILY STAINED CAST STONE AT UNDERSIDE OF PROJECTING LEDGES AND DENTILS.
