22 BRADDOCK PARK - STREET VIEW

WINDOW ELEVATION AND DETAILS

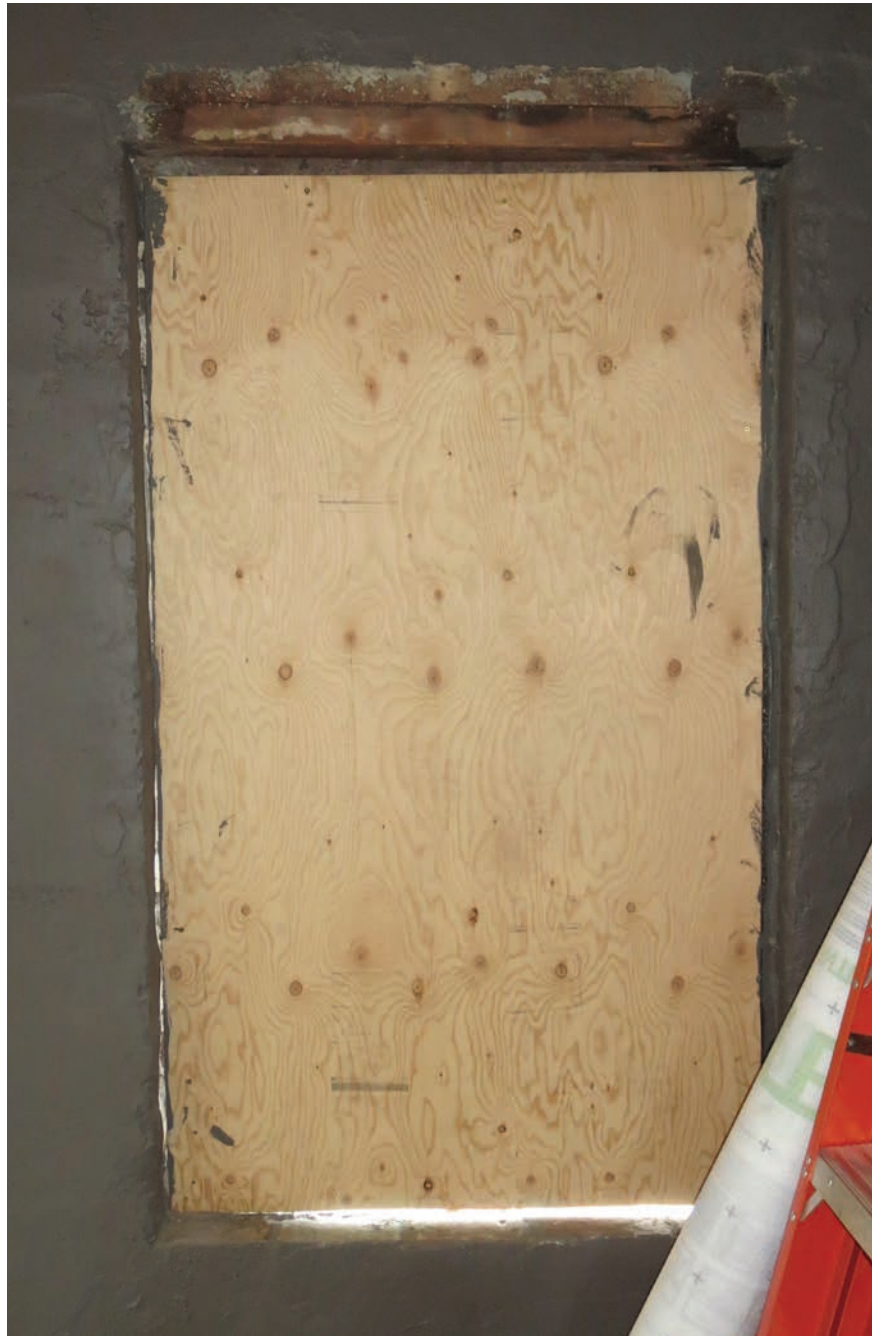
WINDOW 'A' - FOURTH FLOOR (MISSING)

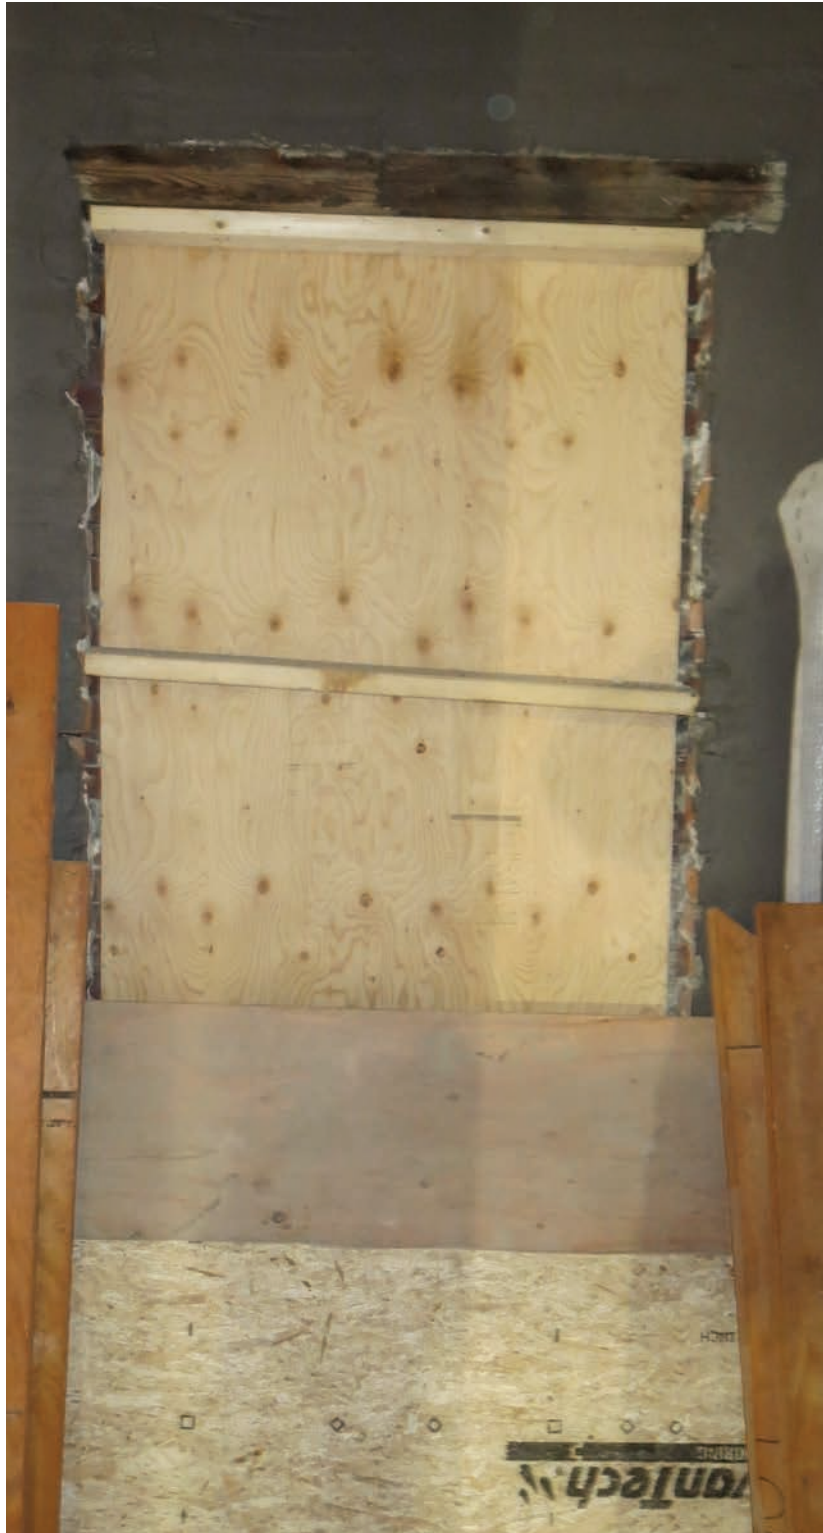
WINDOW 'D' - FOURTH FLOOR (MISSING)

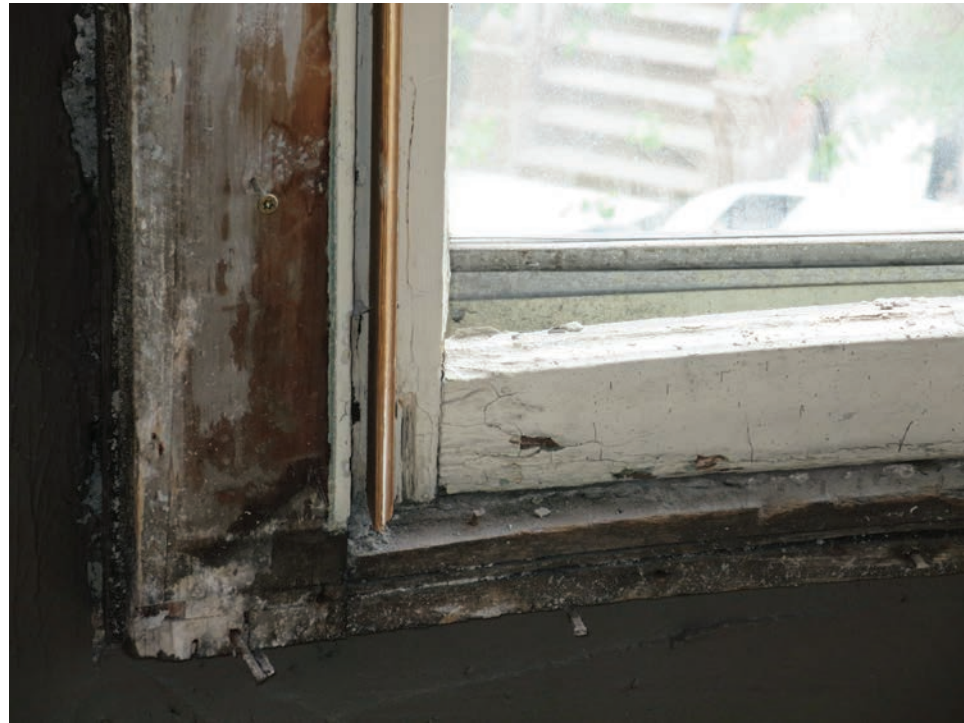
WINDOW 'C' - FRAME AND SASH DAMAGE
BROKEN GLASS PANE

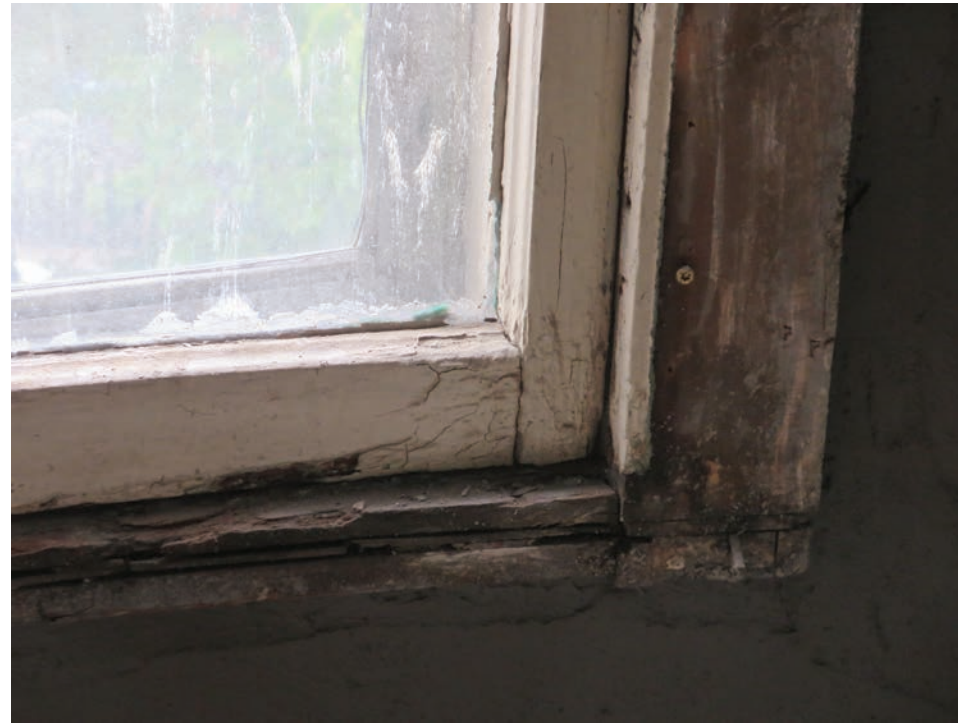
WINDOW 'C' - FRAME AND SASH DAMAGE

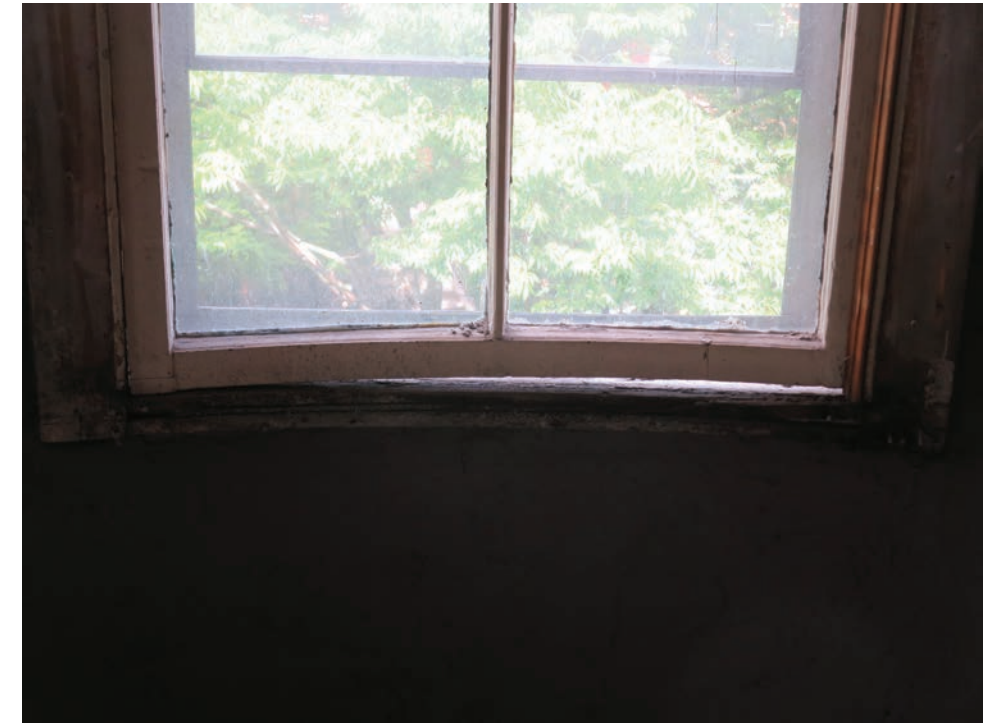
WINDOW 'B' - FRAME AND SASH DAMAGE
MISSING WINDOW STOP

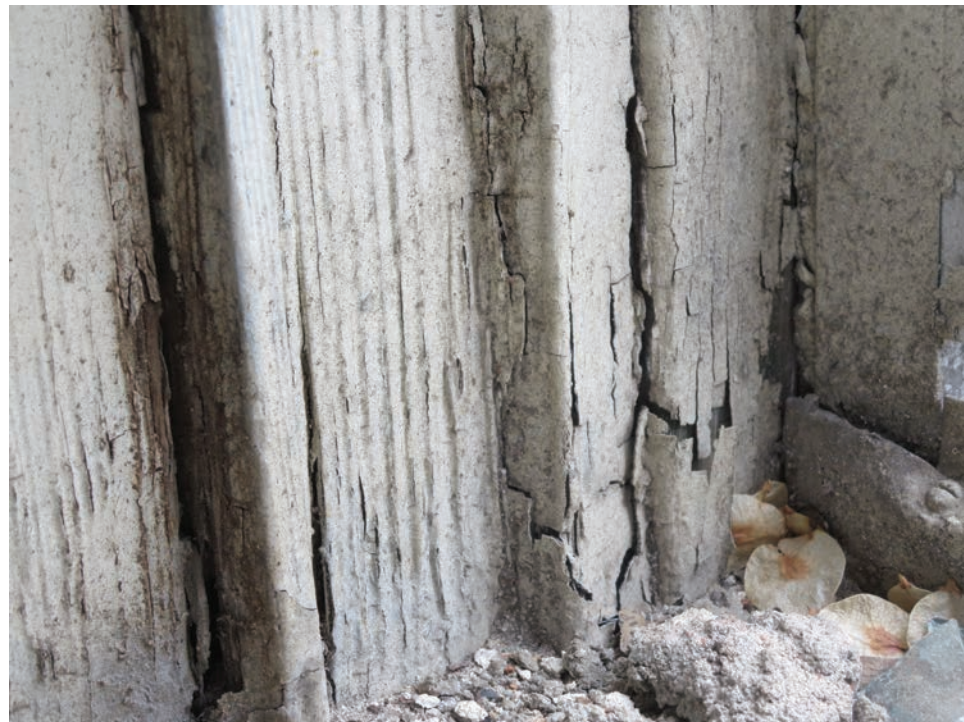
WINDOW 'E' - FRAME DAMAGE

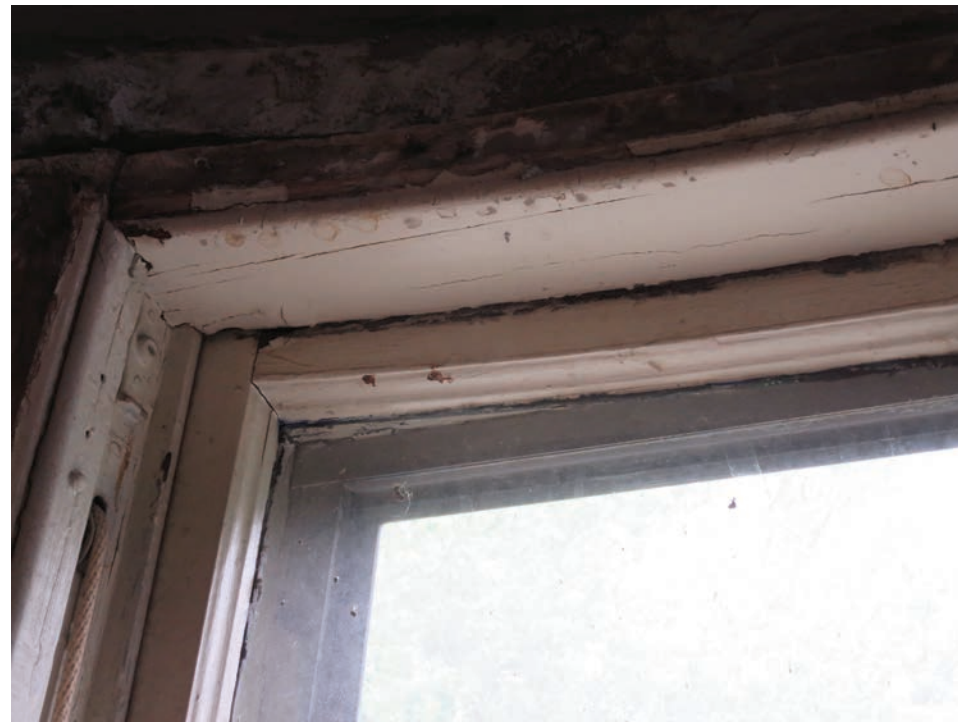
WINDOW 'E' - FRAME AND SASH DAMAGE

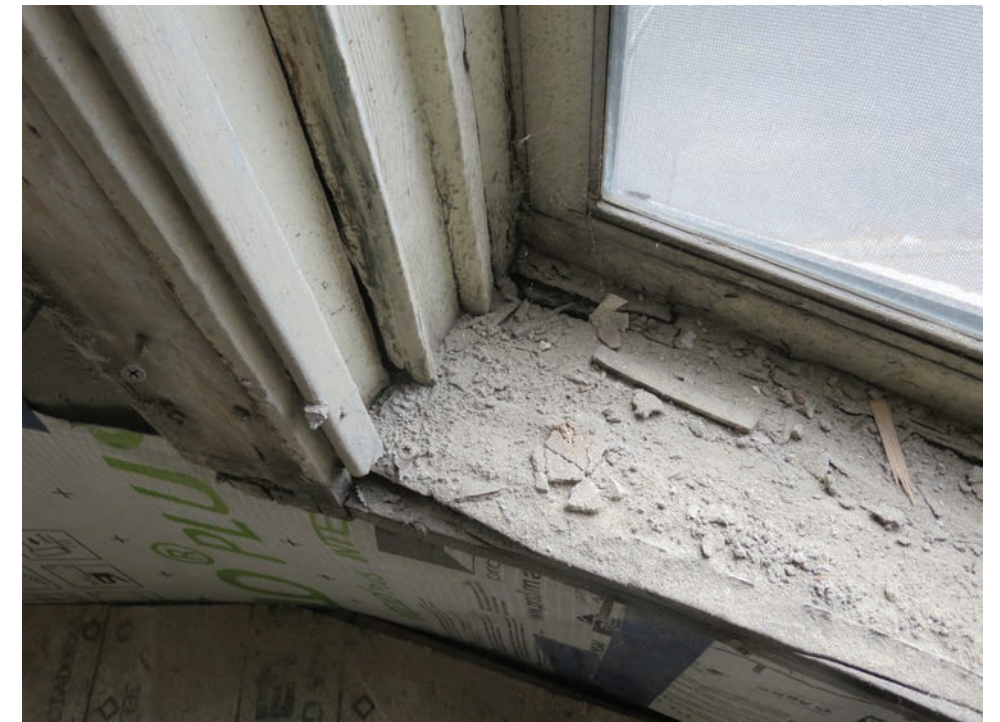
WINDOW 'F' - SILL AND FRAME DAMAGE

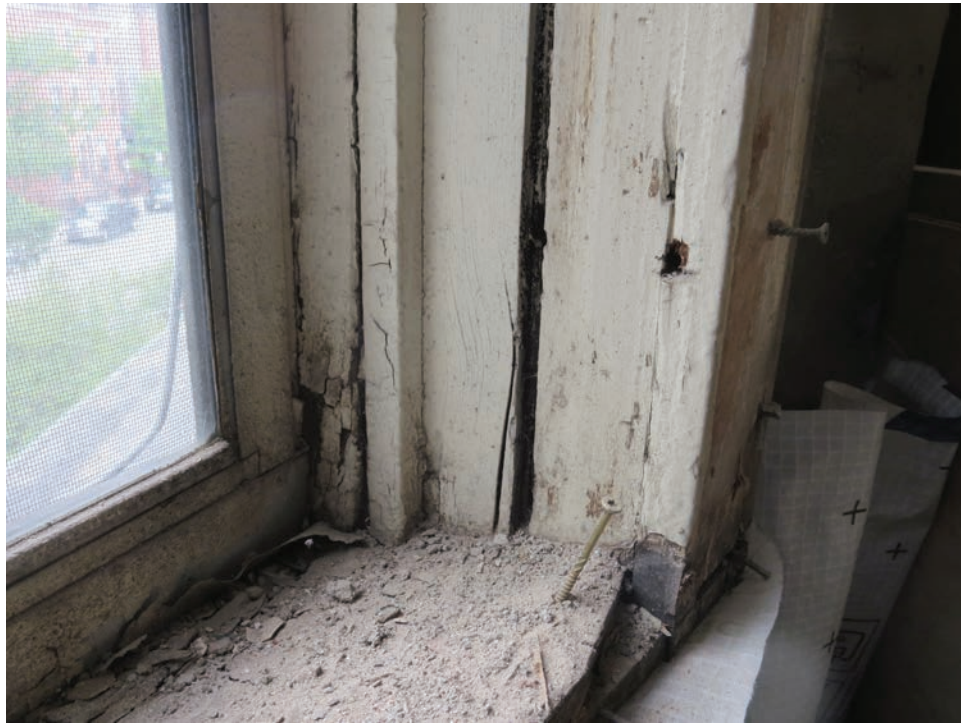
WINDOW 'F' - SILL AND FRAME DAMAGE

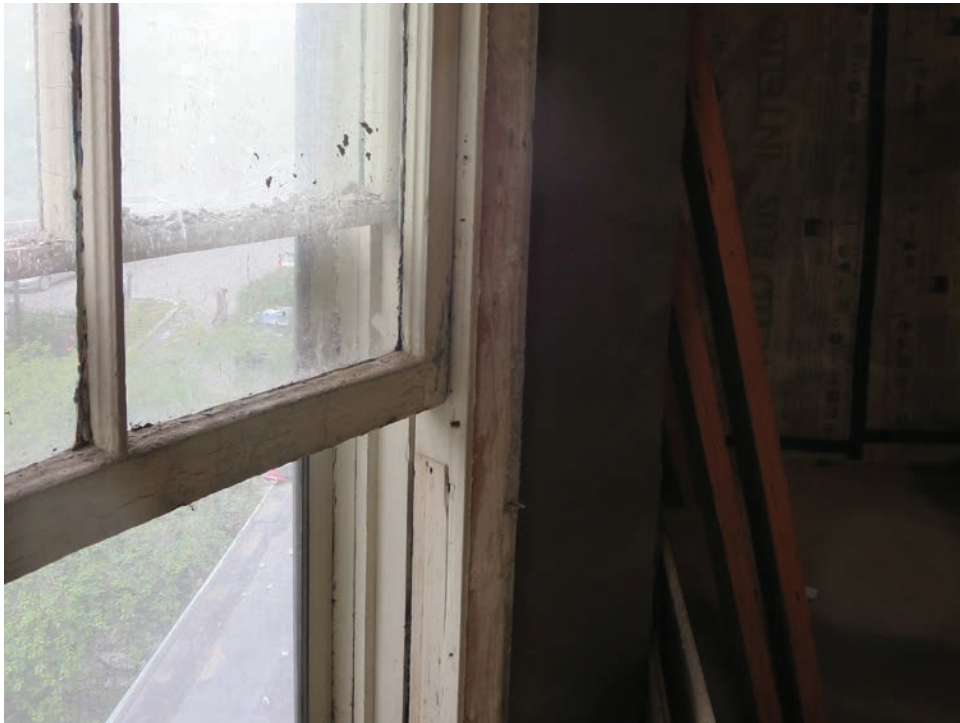
WINDOW 'F' - MISSING WINDOW STOP

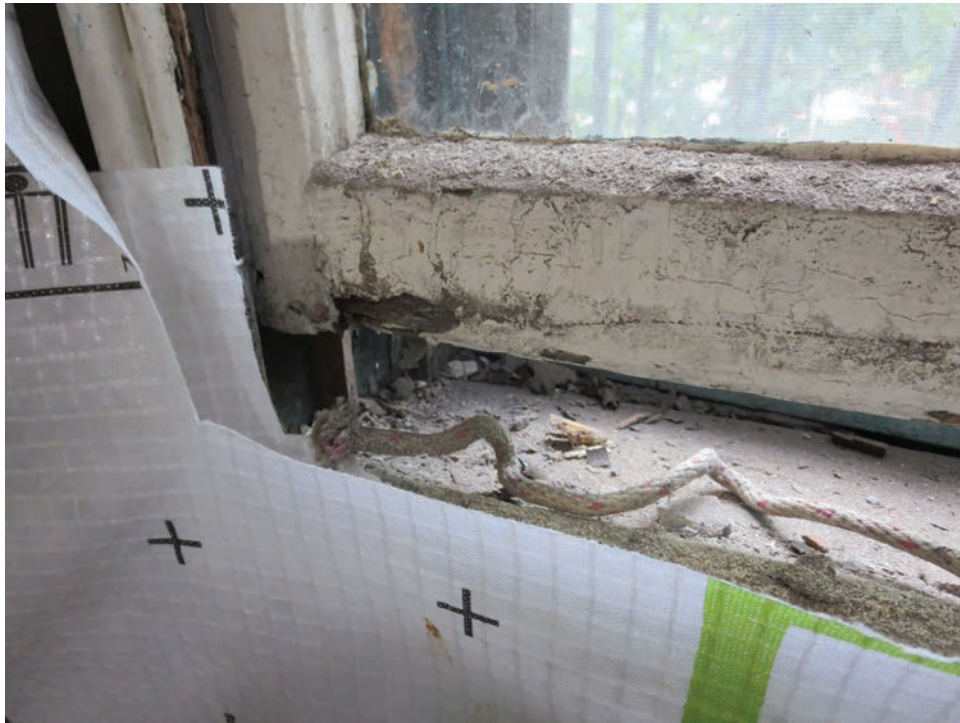
WINDOW 'H' - SASH DAMAGE
COUNTER-WEIGHT NEEDS REPLACED

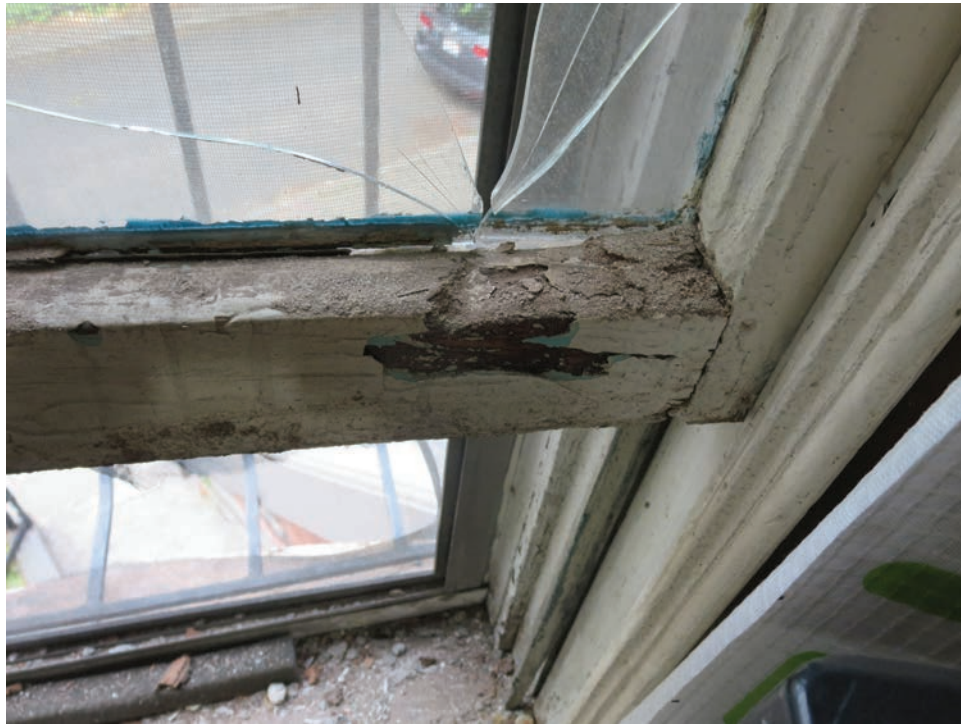
WINDOW 'G' - SASH DAMAGE
BROKEN GLASS PANE

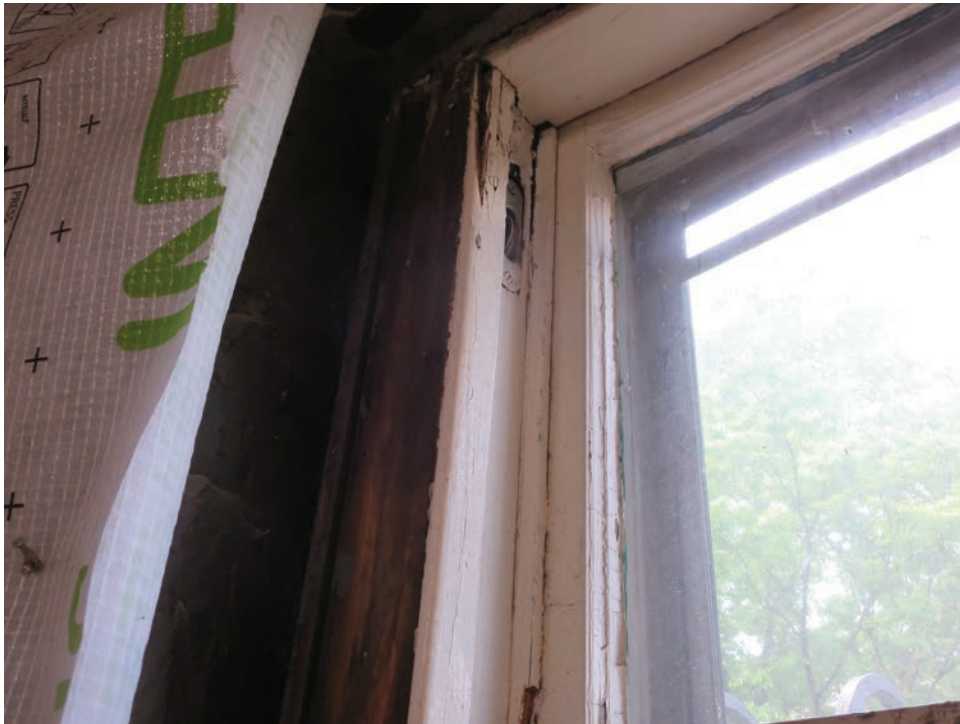
WINDOW 'G' - COUNTER-WEIGHT

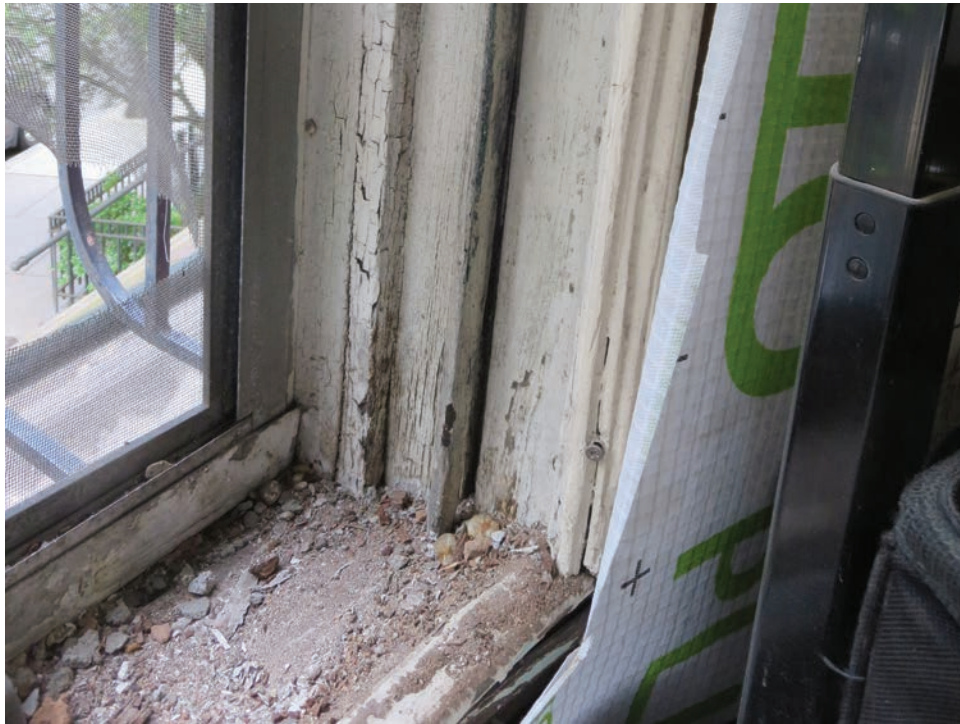
WINDOW 'G' - SILL AND FRAME DAMAGE

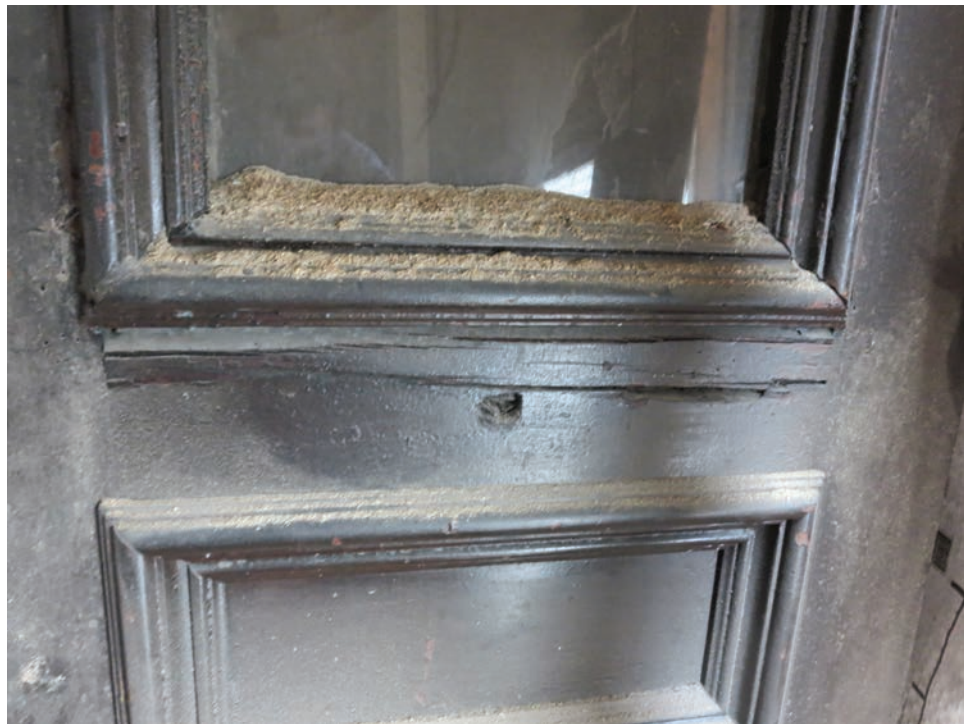
CRACKED RAIL

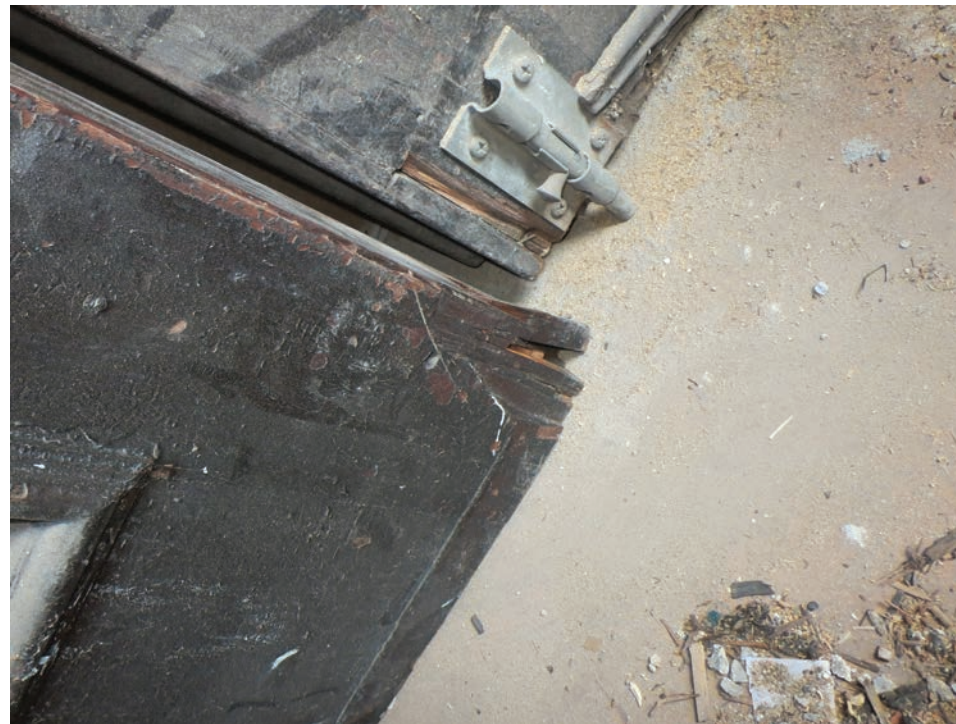
SPLINTERING AT DOOR CORNERS

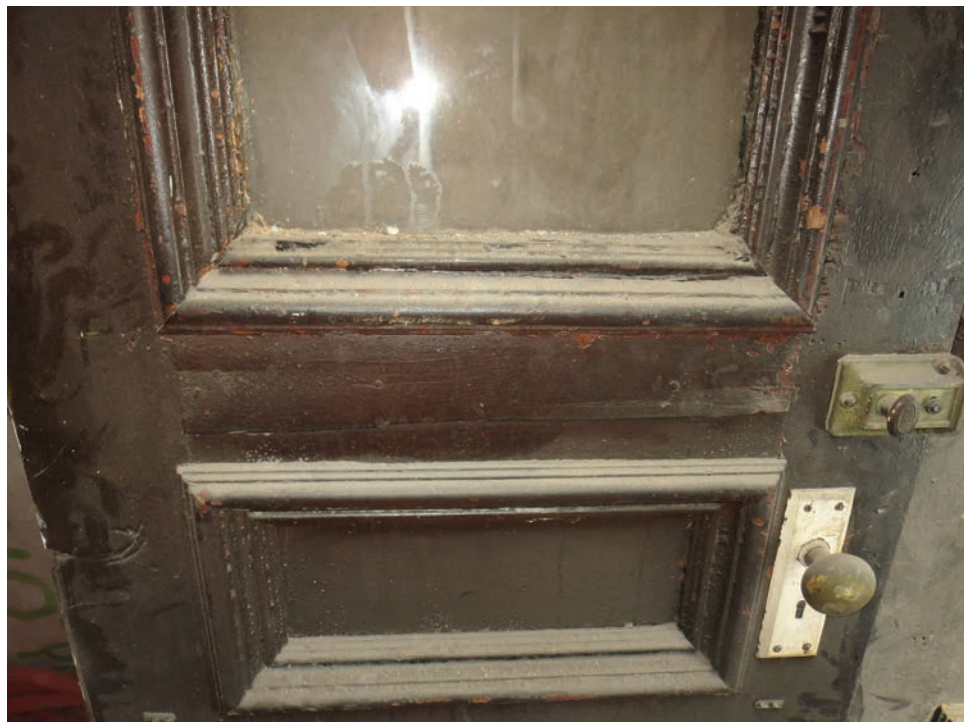
CRACKING AT RAIL

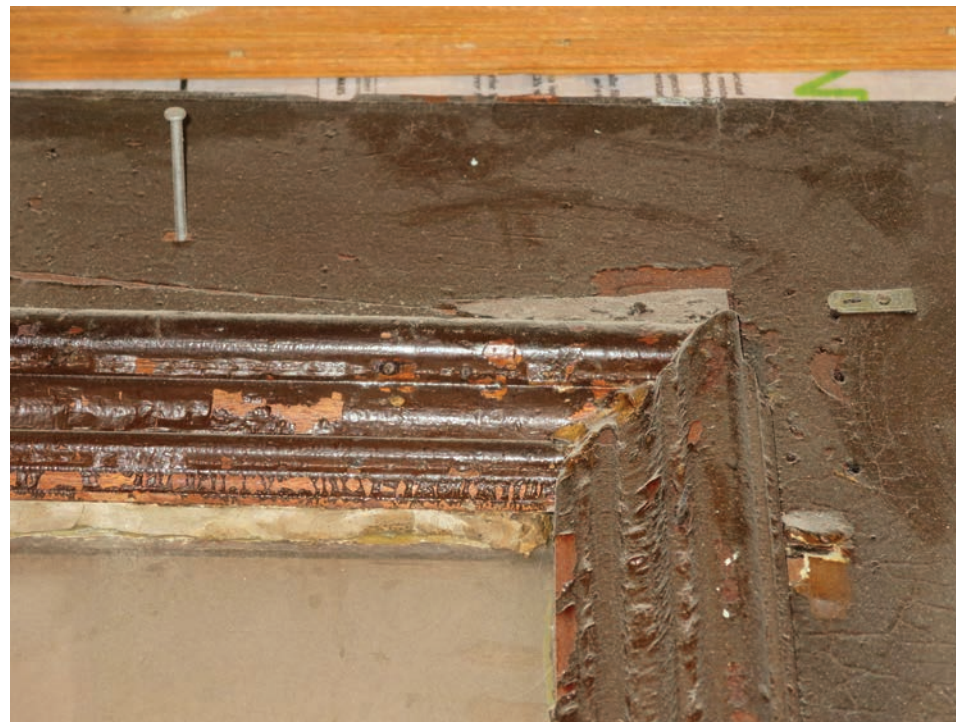
MOULDING IS SEPERATING FROM THE DOOR

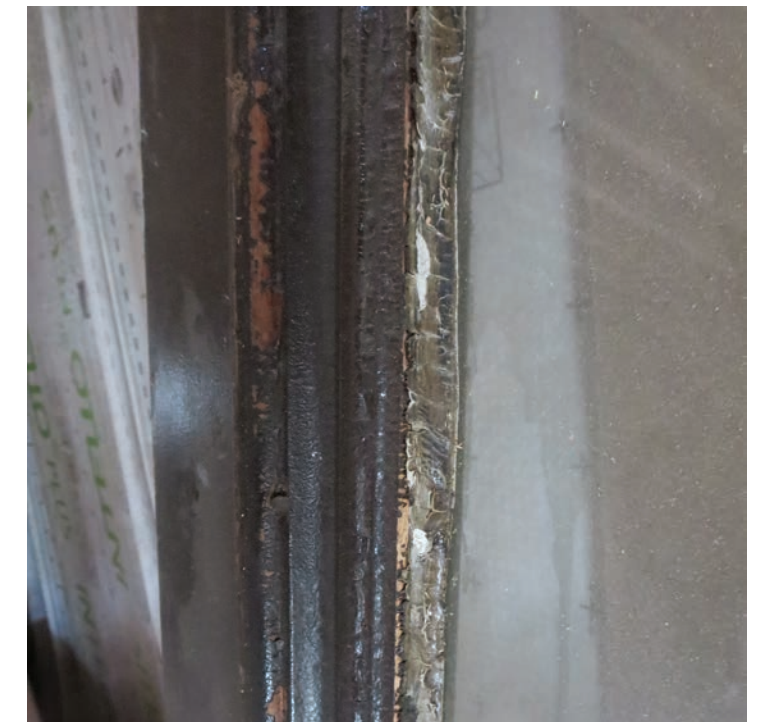
PUTTY GLAZING CRACKING
