CURLEY HOUSE EXTERIOR RESTORATION

350 JAMAICAWAY JAMAICA PLAIN, MA

ROOF PLAN

ROOF **PHOTOGRAPHS**

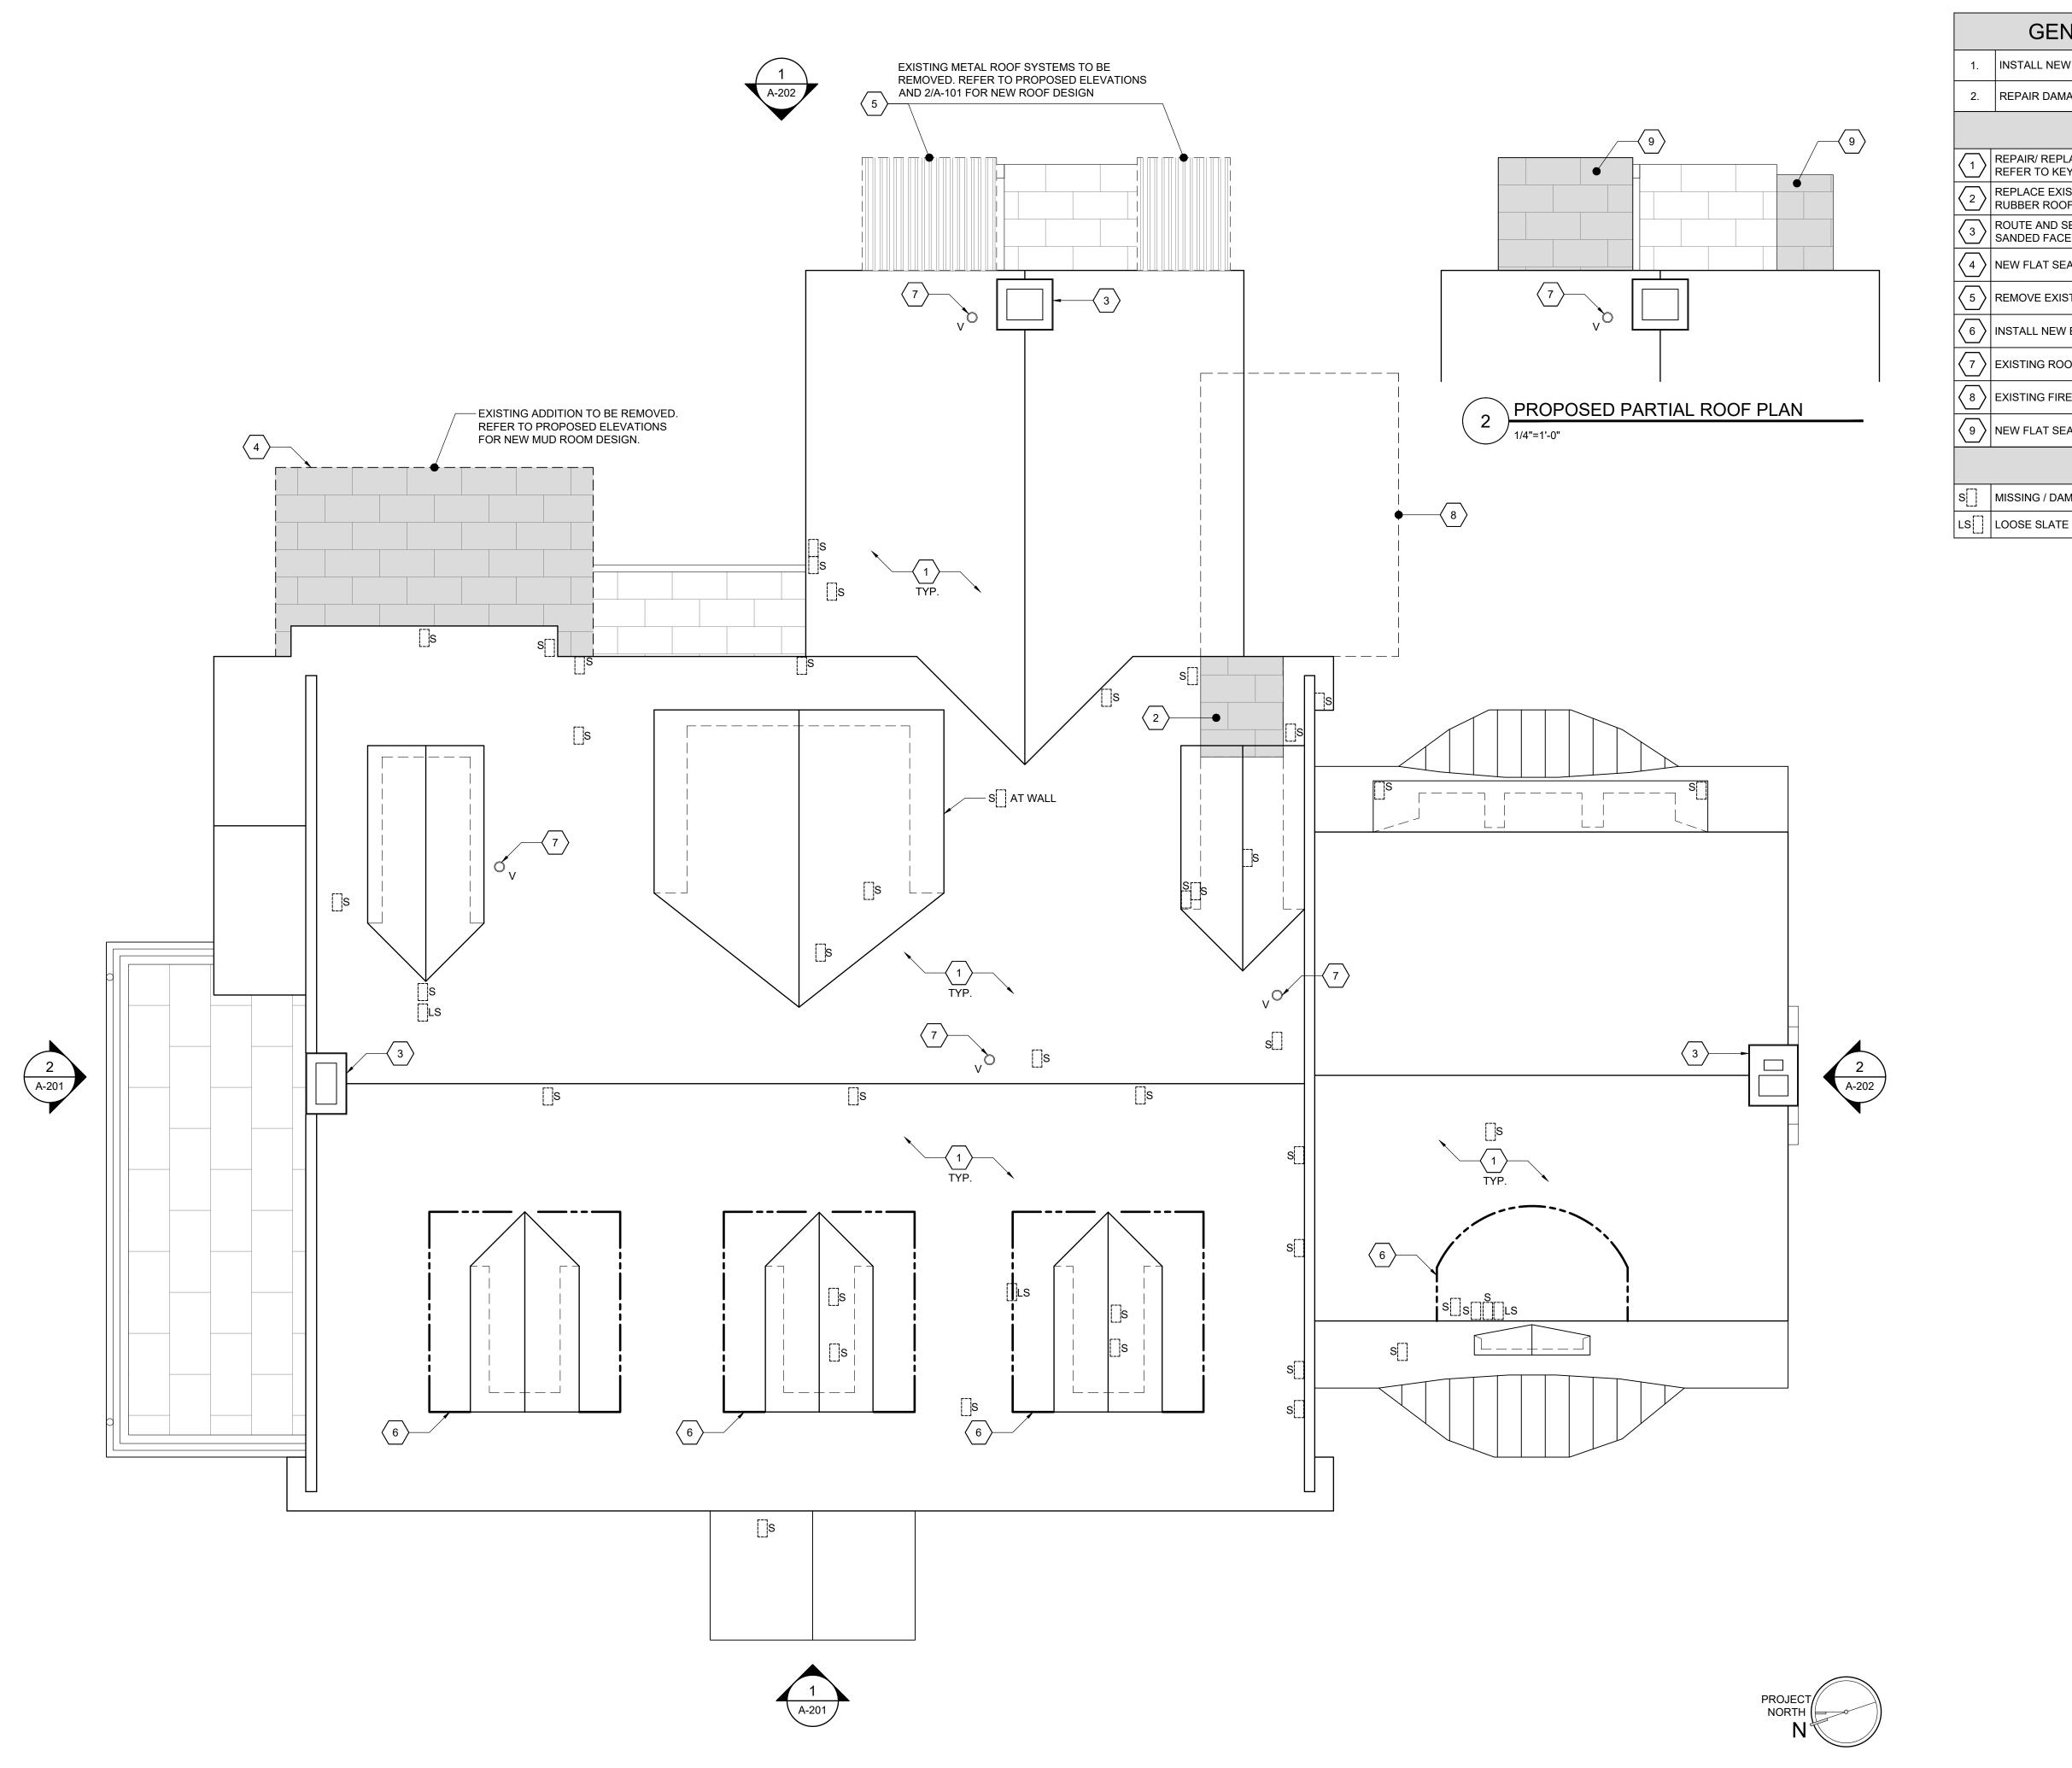
EXISTING ROOF PLAN

- REPAIR/ REPLACE MOVING, DAMAGED, OR MISSING SLATE SHINGLES. REFER TO KEY TAG FOR LOCATIONS.
- REPLACE EXISTING ROOF MEMBRANE WITH NEW FLAT SEAM COPPER ROOF WITH RUBBER ROOF PAVERS AT THIRD FLOOR FIRE ESCAPE DOOR.
- ROUTE AND SEAL CRACKS IN CONCRETE CHIMNEY CAPS. NEW SEALANT TO HAVE SANDED FACE TO MATCH EXISTING CONCRETE.
- $\langle 4 \rangle$ NEW FLAT SEAM COPPER ROOF OVER NEW CONSTRUCTION AT MUDROOM.
- 5 REMOVE EXISTING METAL ROOFS.
- $\langle 6 \rangle$ INSTALL NEW ENGINEERED SNOW GUARD SYSTEM.
- 7 EXISTING ROOF VENT TO REMAIN.
- 8 EXISTING FIRE ESCAPE NOT SHOWN FOR CLARITY.
- $|9\rangle$ NEW FLAT SEAM COPPER ROOFS TO MATCH EXISTING.

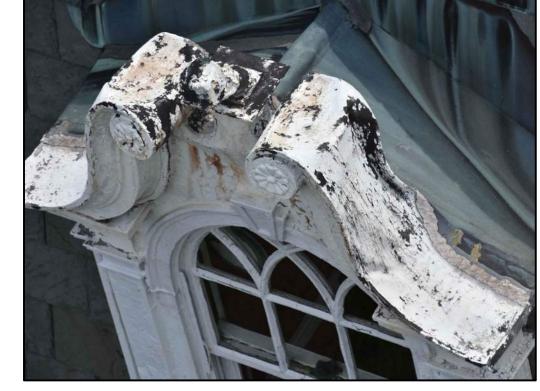
FAILED SEALANT AT FLASHING

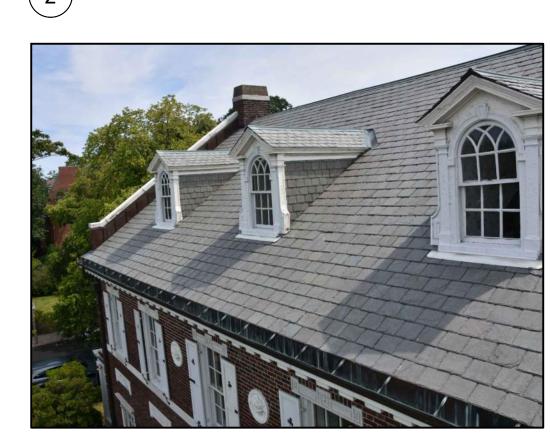
DAMAGE AT ROOF DORMER - WEST

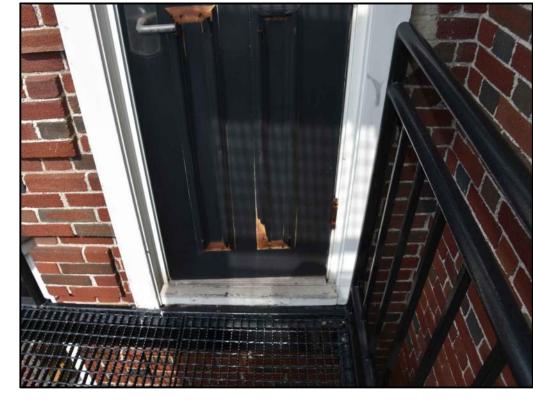
DAMAGE AT DOOR

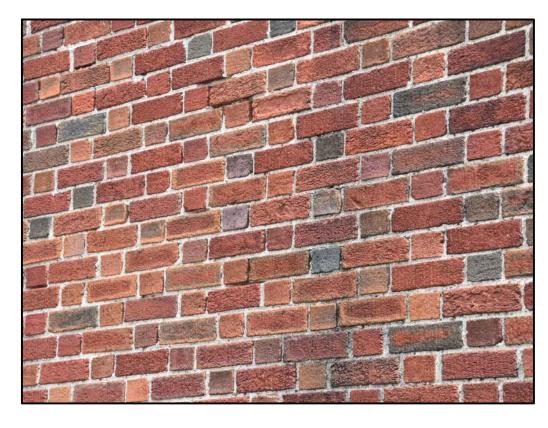
MASONRY JOINTS TO BE REPOINTED

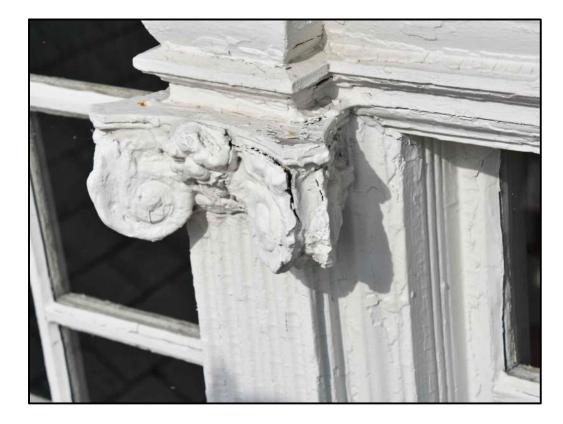
8 DAMAGED CAPITAL AT DORMER

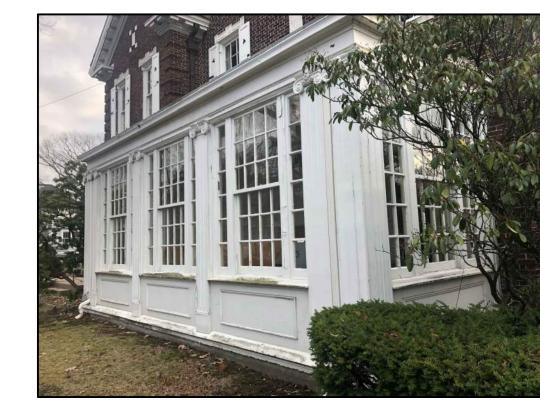
DETERIORATING COLUMN BASES

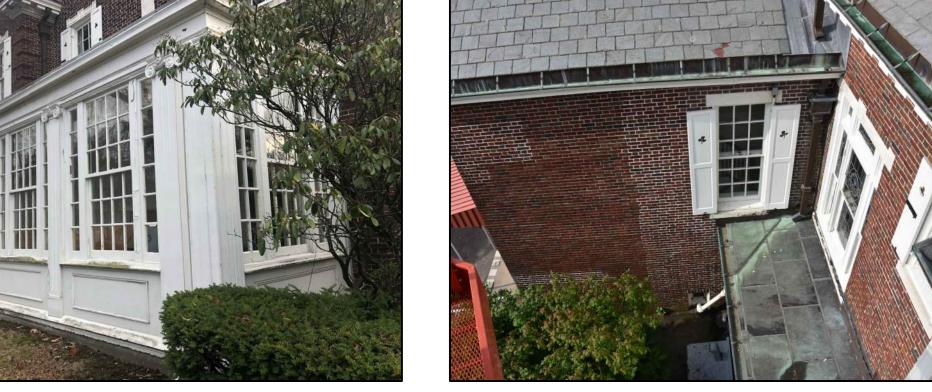
MASONRY JOINTS TO BE STAINED

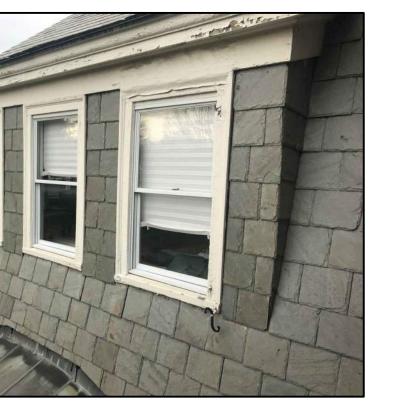
9 WINDOWS TO BE REPLACED
