CERTIFICATE OF APPROPRIATENESS APPLICATION

Date: April 29, 2021

Re: Replacement of Downspout Brackets
119 Tremont Street / Park Street Church

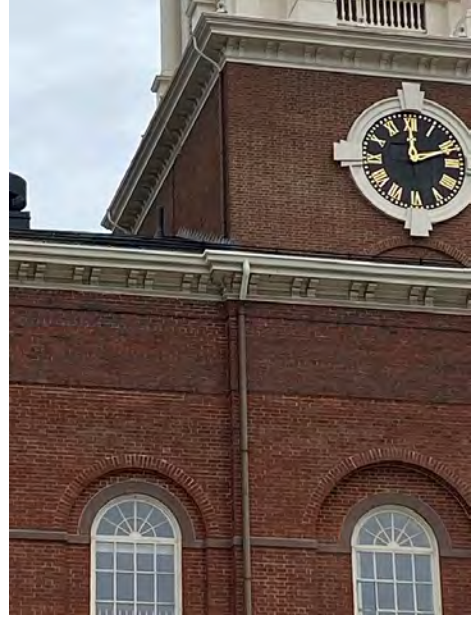
210428-IMG_9043.JPG

DETAIL OF FACADE WITH PAINTED DOWNSPOUTS

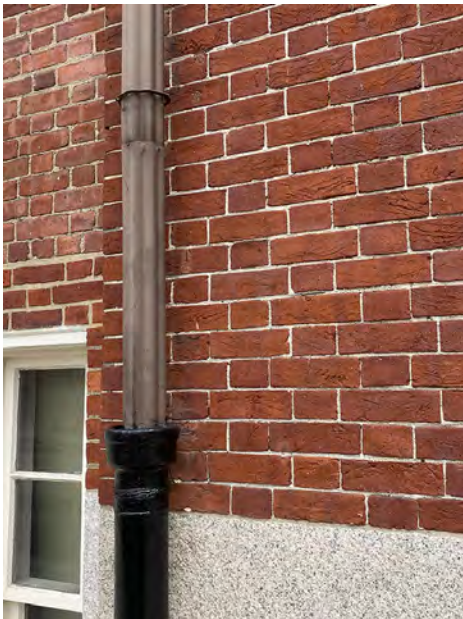
210428-IMG_9046.JPG

*BASE OF PAINTED COPPER DOWNSPOUT
AT STREET LEVEL CONNECTION TO
PAINTED CAST IRON RAIN LEADER BOOT*

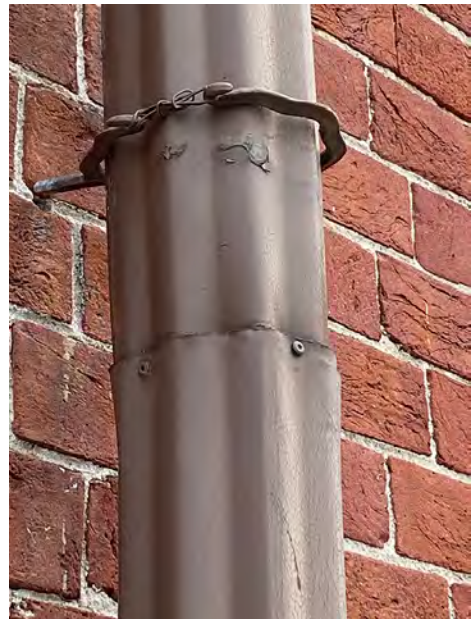
210428-IMG_9047.JPG

Park Street Church requests approval for replacing existing deteriorated downspout brackets at all of its painted copper downspouts. This involves replacing approximately 36 brackets on existing downspouts at the various facades of the church. Two sections of downspouts were recently blown off the wall during heavy winds due to bracket failure.

*EXISTING BRACKET WITH STEM
BROKEN AT CONNECTION TO WALL*

- Remove painted metal and wire brackets from existing painted copper downspouts.
- Install painted copper downspout brackets with secure attachment to downspouts and walls.
- Provide fasteners into mortar joints in order to avoid damage to individual bricks.
- Replacement brackets shall be painted to match existing downspouts.

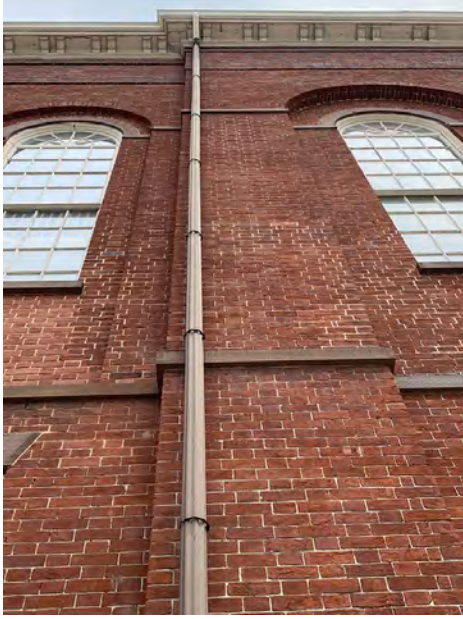
210428-IMG_9050.JPG

PARK STREET FACADE DOWNSPOUT WITH INTERMITTENT BRACKETS

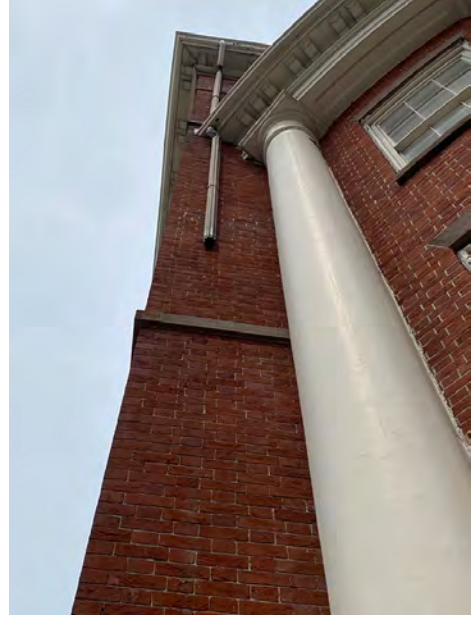
210428-IMG_9051.JPG

SECTION OF DOWNSPOUT RECENTLY DISLODGED DURING WIND STORM

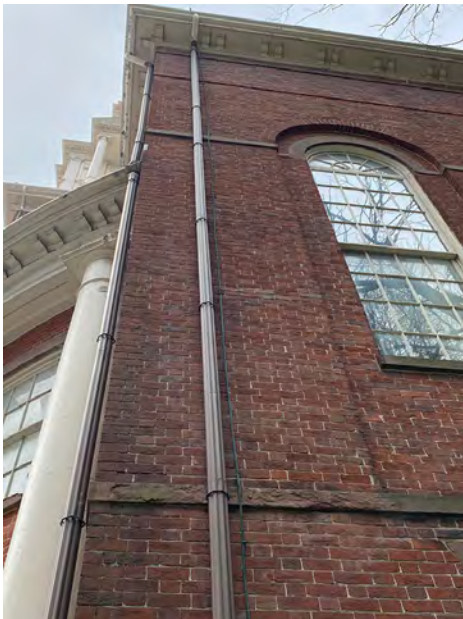
210428-IMG_9056.JPG

GRANARY BURYING GROUND FACADE DOWNSPOUT WITH INTERMITTENT BRACKETS

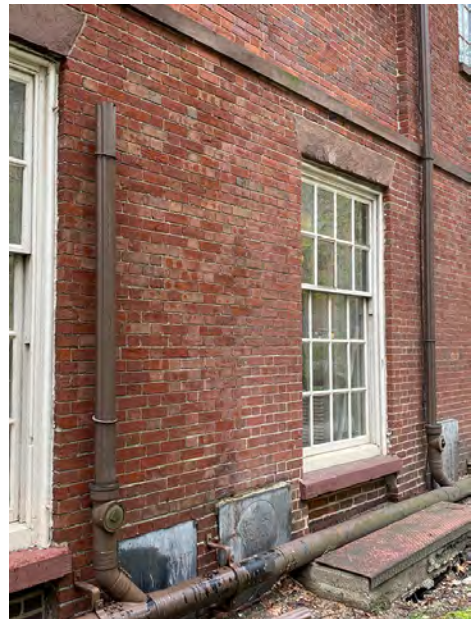
210428-IMG_9058.JPG

SECTION OF DOWNSPOUT AT GRANARY FACADE RECENTLY DISLODGED DURING WIND STORM
