83 Montgomery #3

Proposed New Windows. Marvin with 6 over 6 SDL Grilles

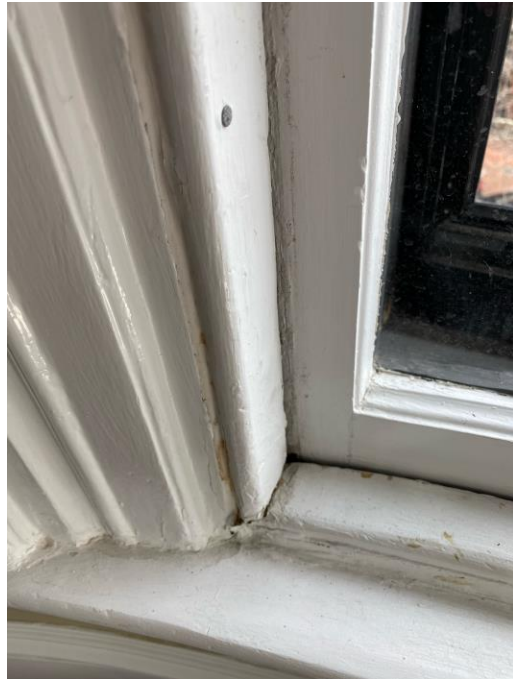
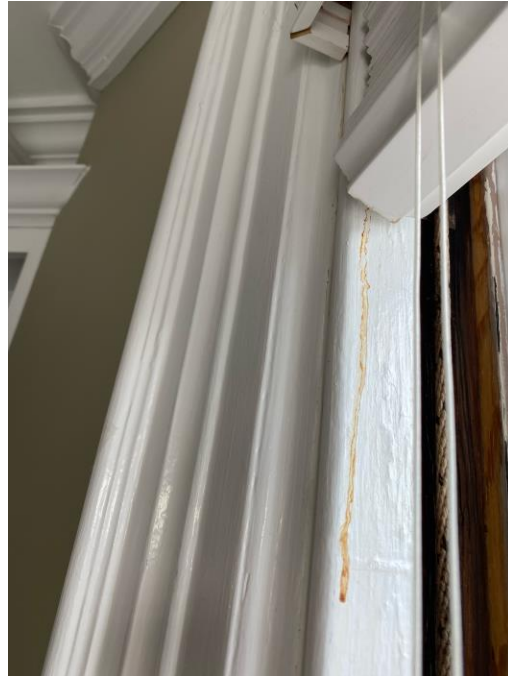
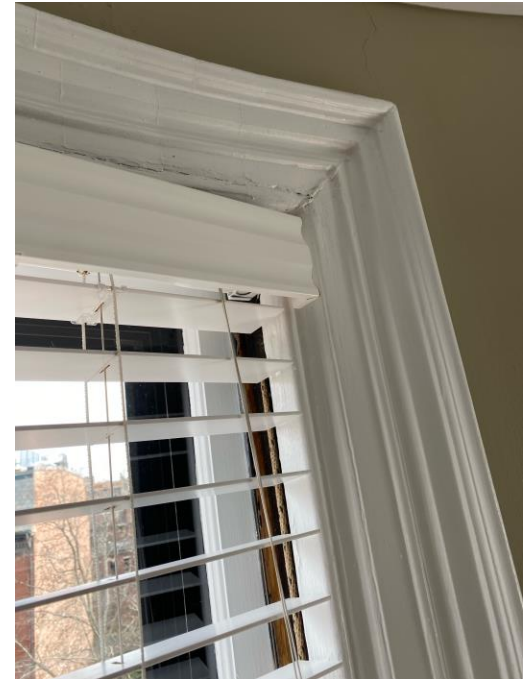
DAMAGE

- We are proposing the replacement of these two Double Hung windows with new ones. The current windows are leaking water into the home, every time it rains.
- The current windows are wood and are covered by an aluminum storm window. We believe the water is coming in through the storm window as well as the trim around the window and the window itself.
