Residing Head House
223 West Newton Street

Description of Work – Current Condition

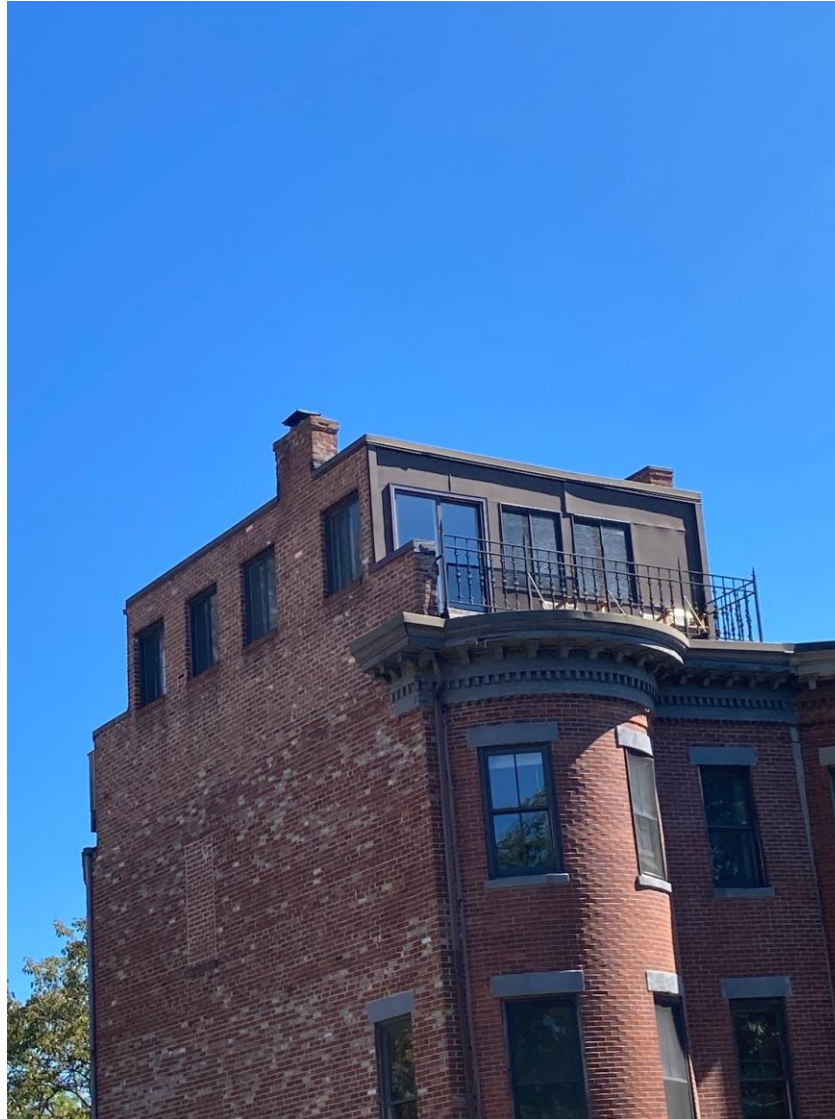
Current Condition – Front

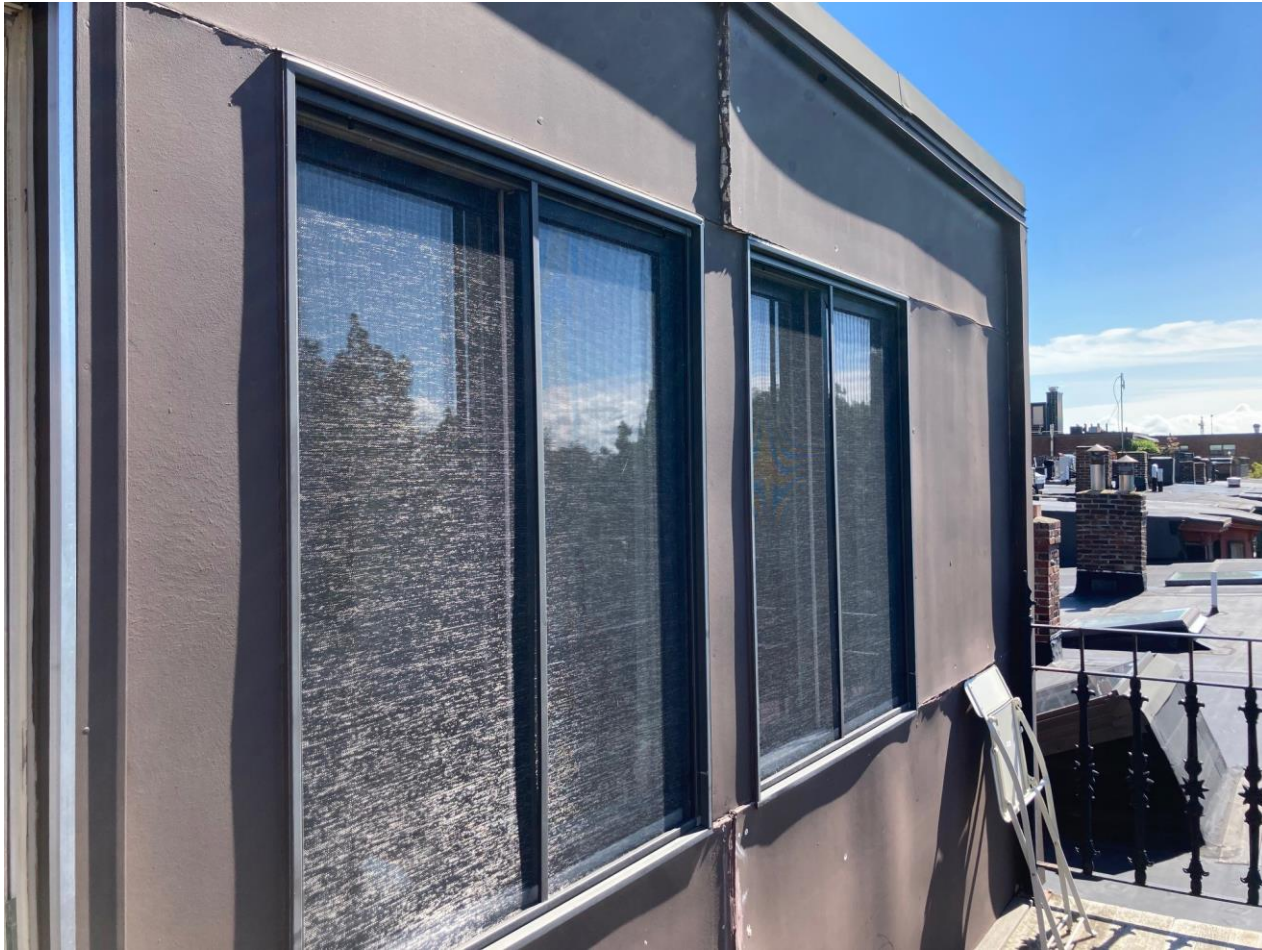
Current Condition – Front Wall

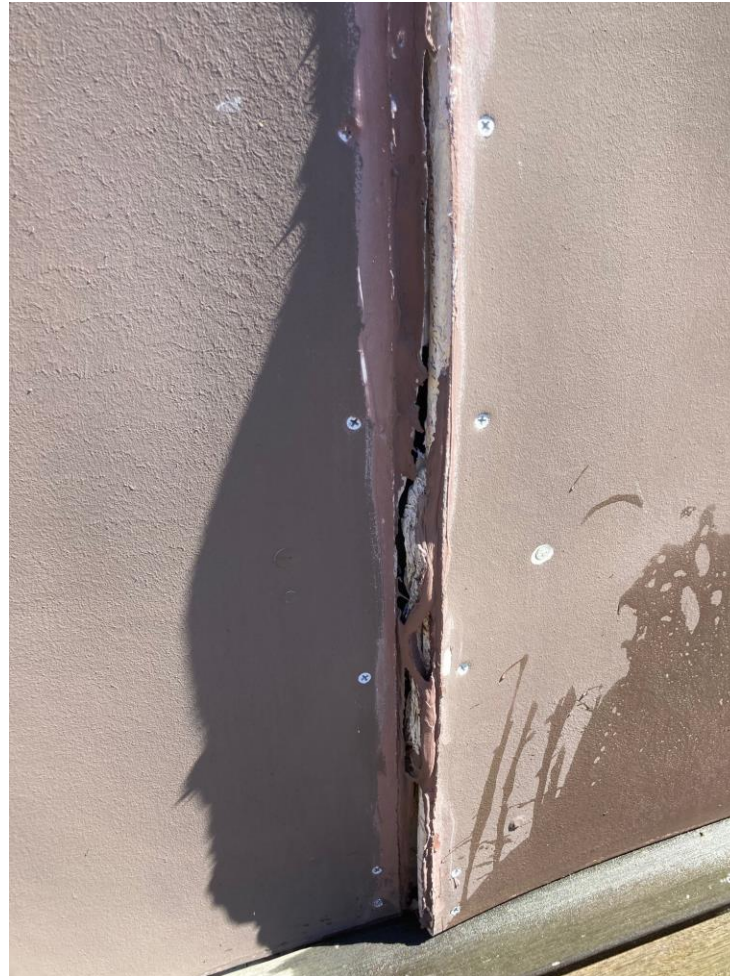
Current Condition – Front Wall Panel Separation from Wall and Gap Between Sections

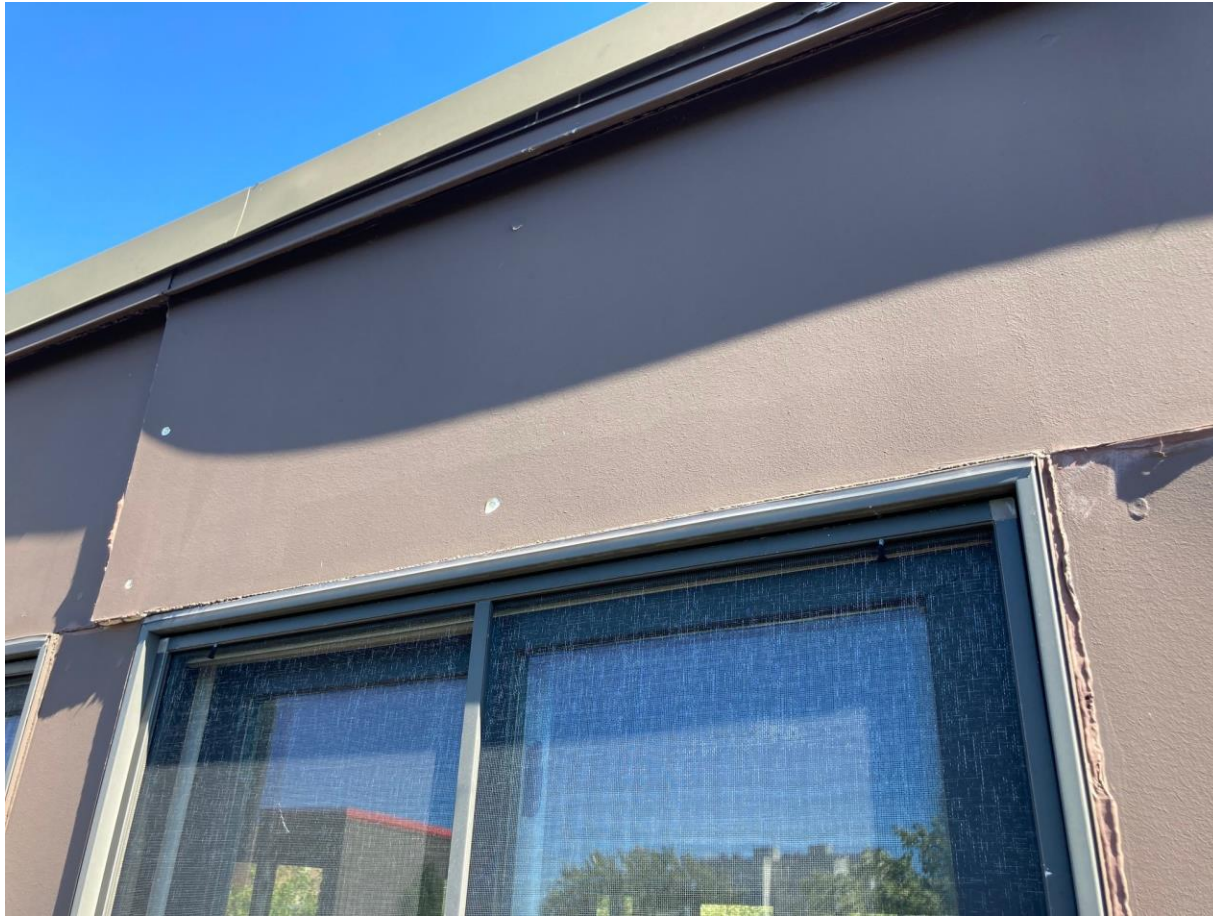
Current Condition – Front Panel Separation and Crack Between Sections

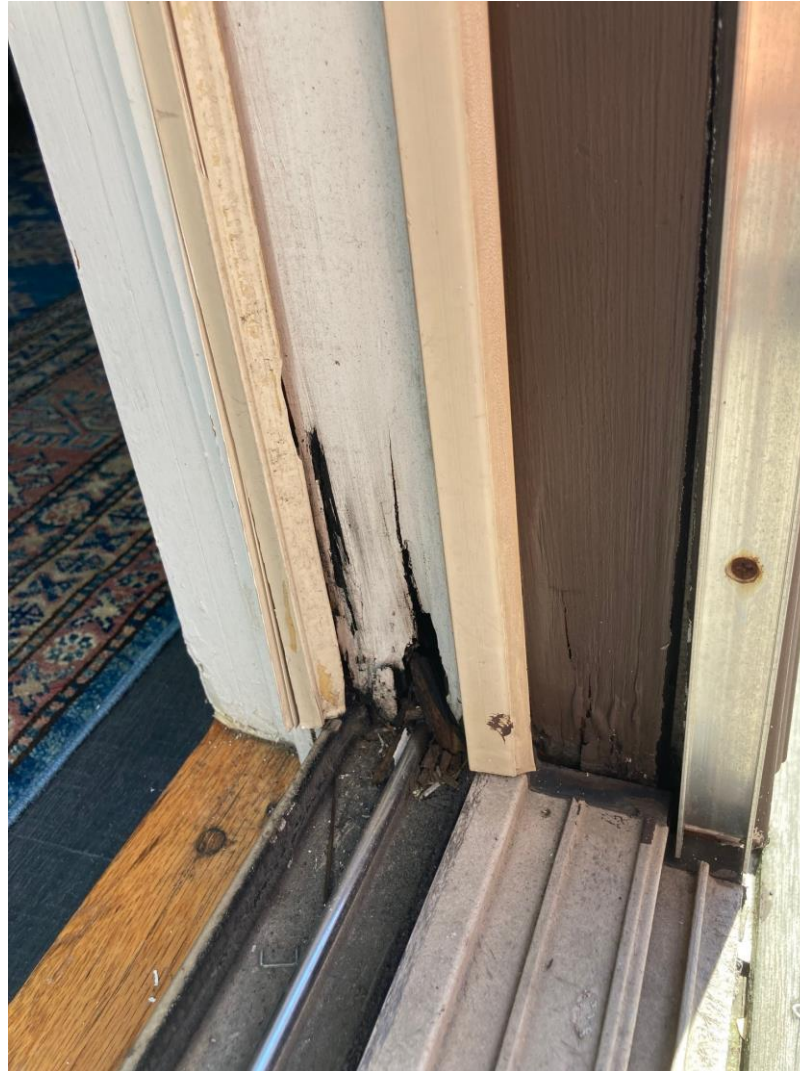
Current Condition – Front Sliding Door Frame Rot from Water Leaks

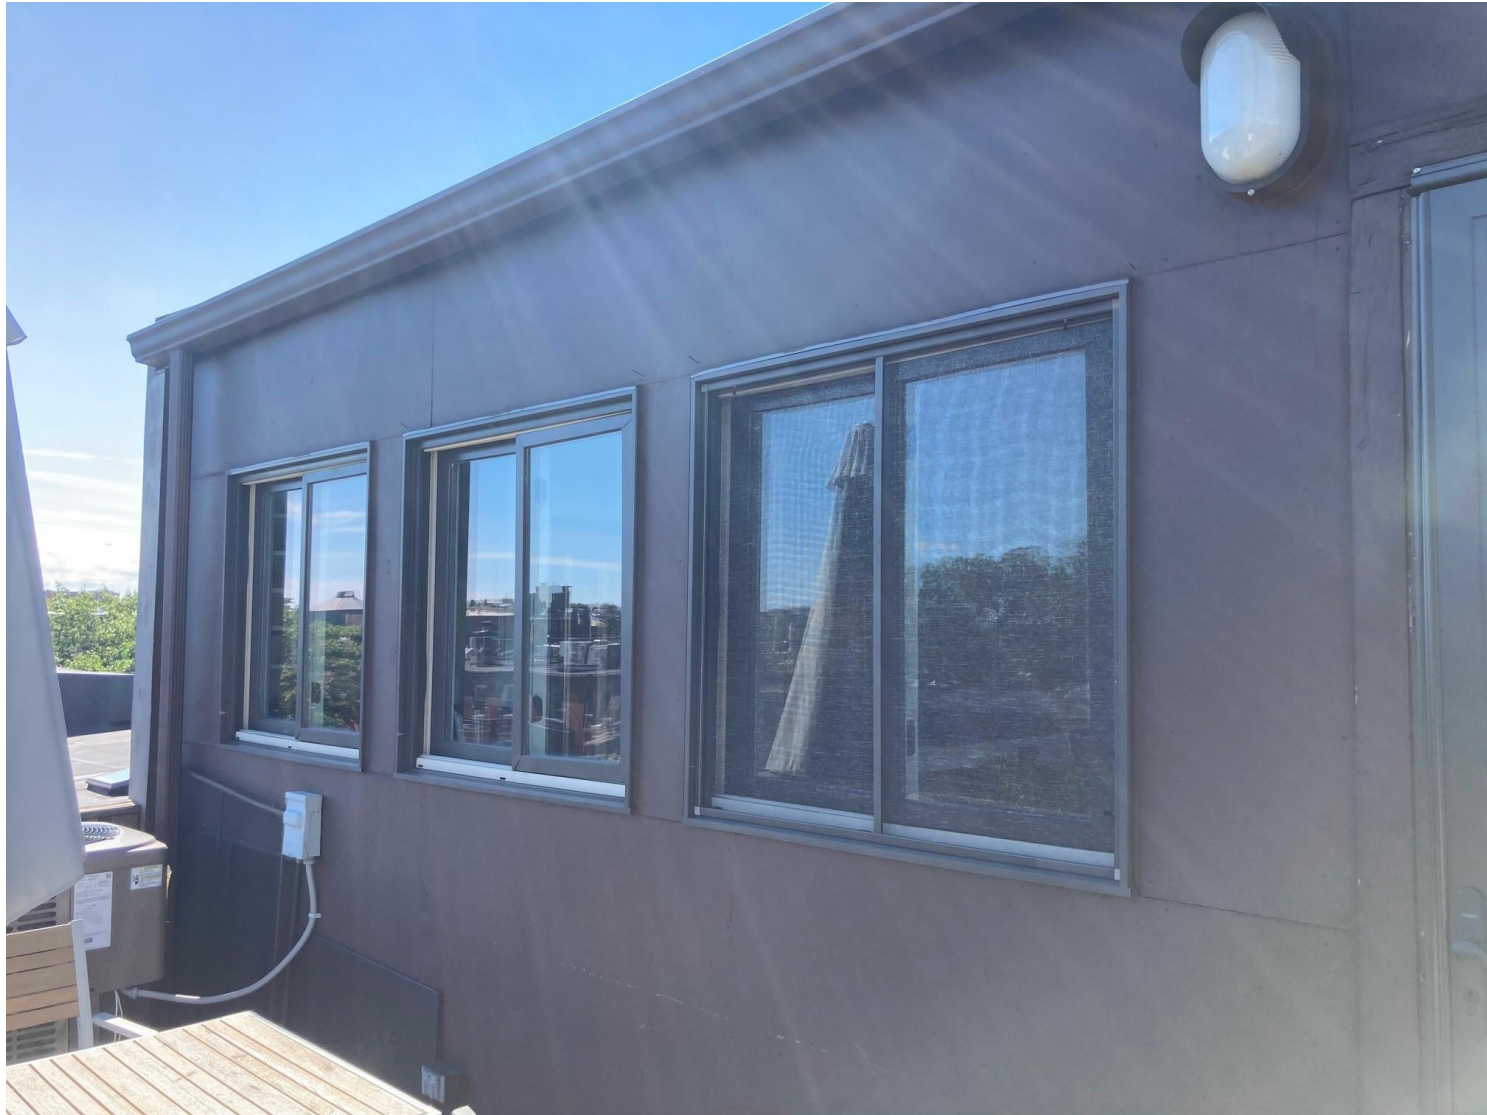
Current Condition – Back Wall

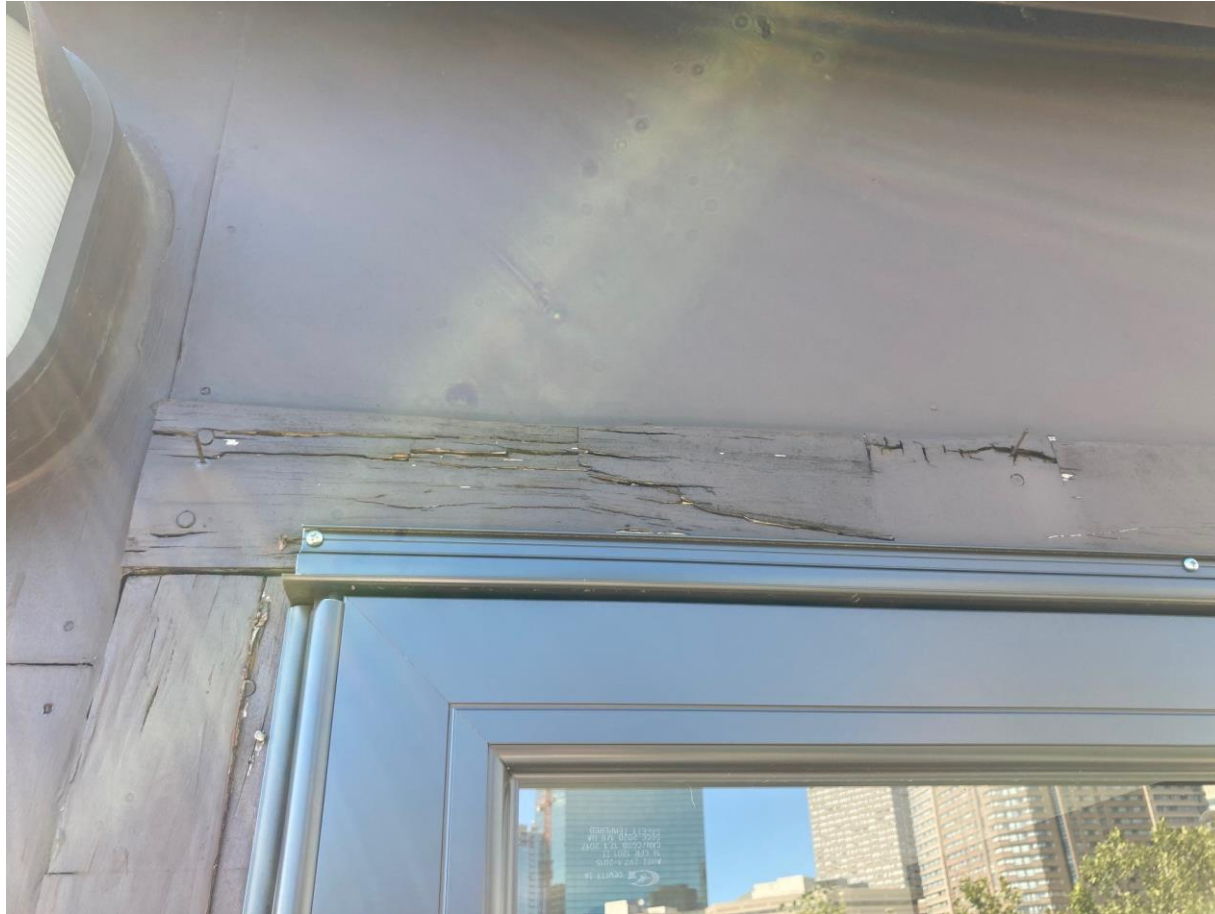
Current Condition – Rot Around Back Door Frame
