Date: October 4, 2022

Re: **123 Saint Botolph Street, Façade Repair Recommendation, Boston, MA**

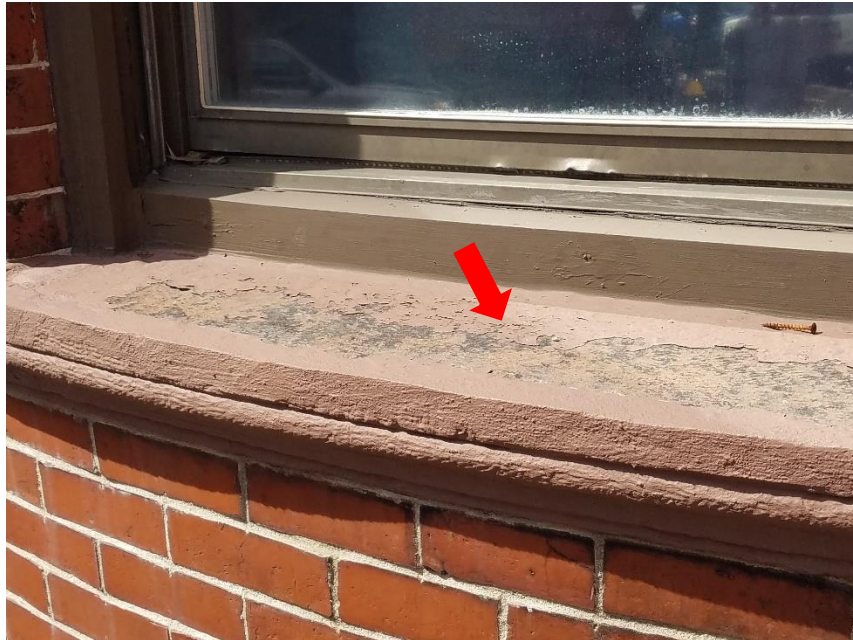
Photo 1: Deterioration of existing paint on concrete band, recommend repainting with compatible material.

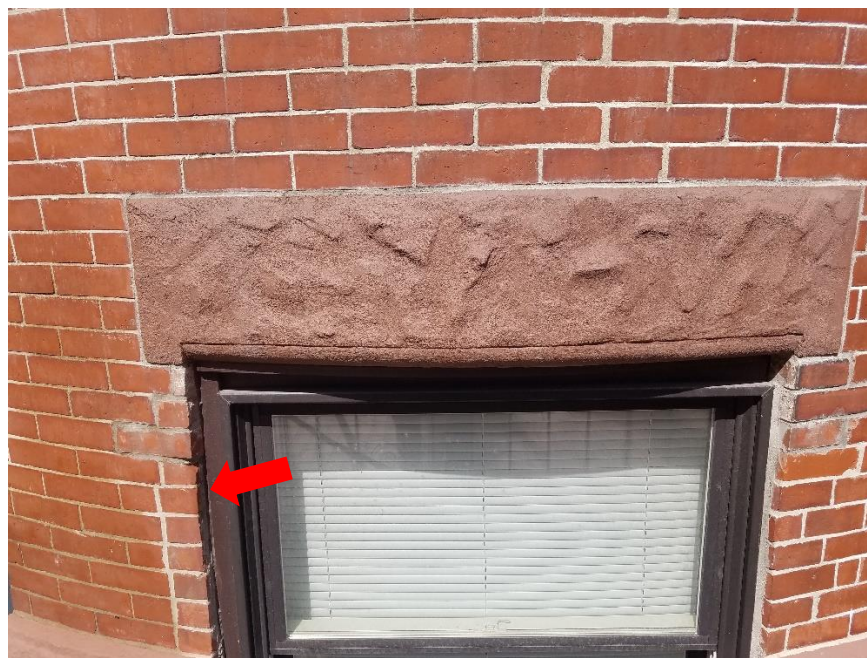
Photo 2: Seal open joint between brick veneer and window frame with approved bronze colored sealant.

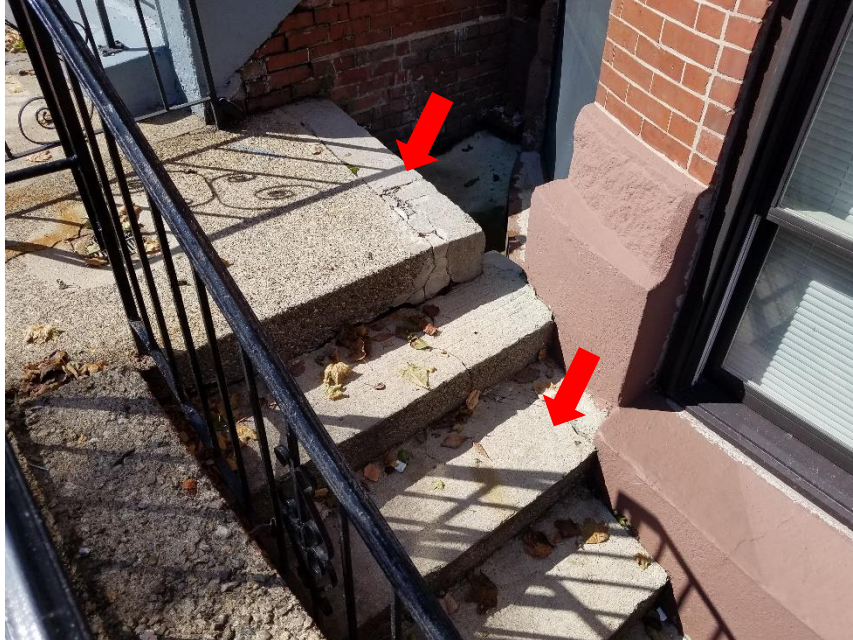
Photo 3: Replace cracked/deteriorated concrete steps leading to low level unit.

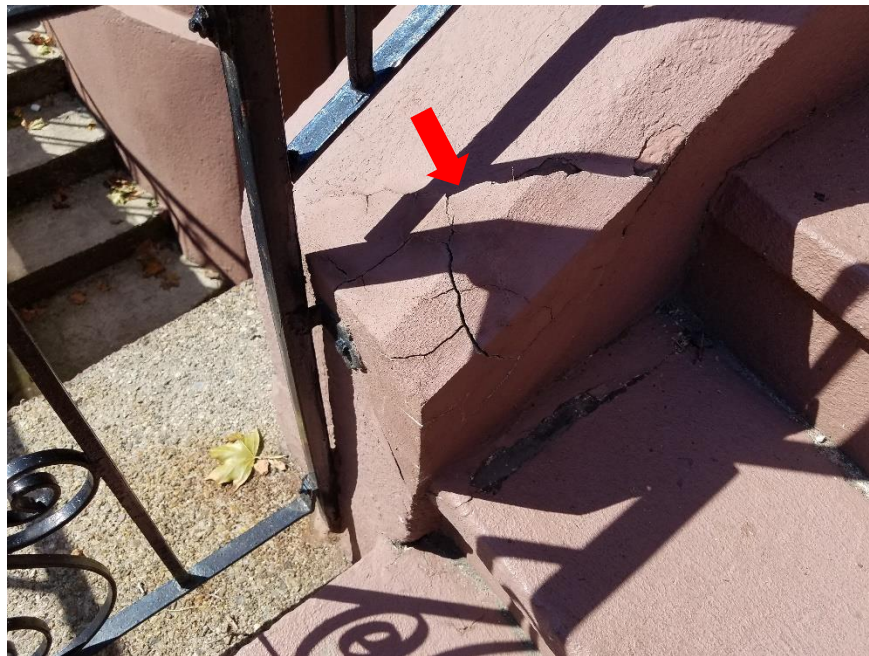
Photo 4: Perform random masonry repairs to defective concrete at front entrance stairway.

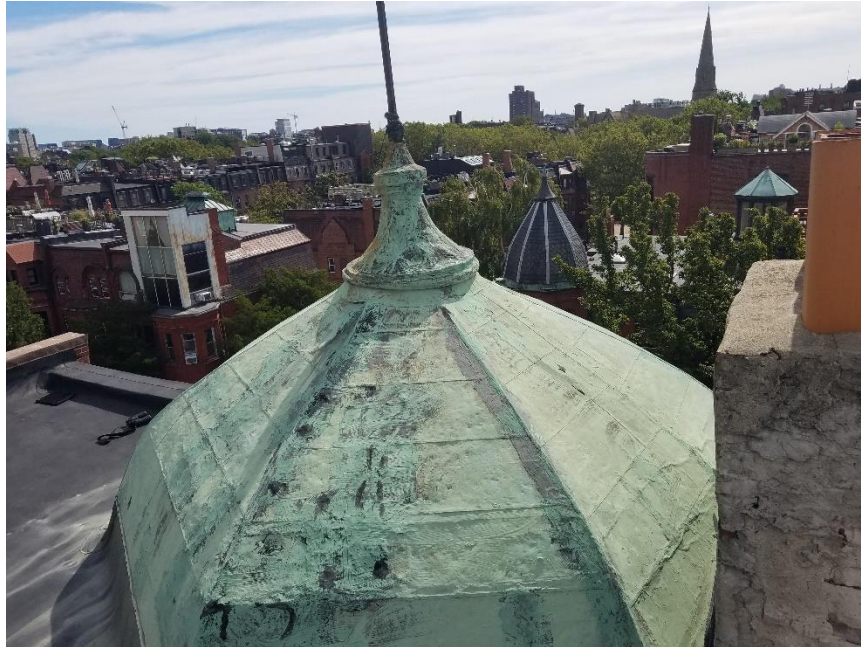
Photo 5: This photo shows existing coating and repairs to dome roof utilizing asphalt cement.

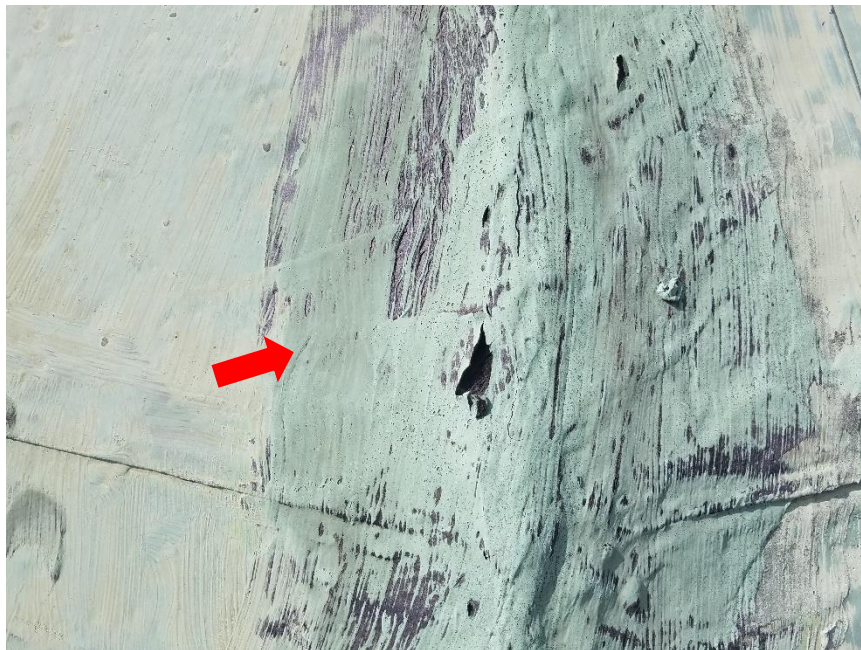
Photo 6: Photo shows close-up of incompatible asphalt repair and existing paint/coating on dome roof.

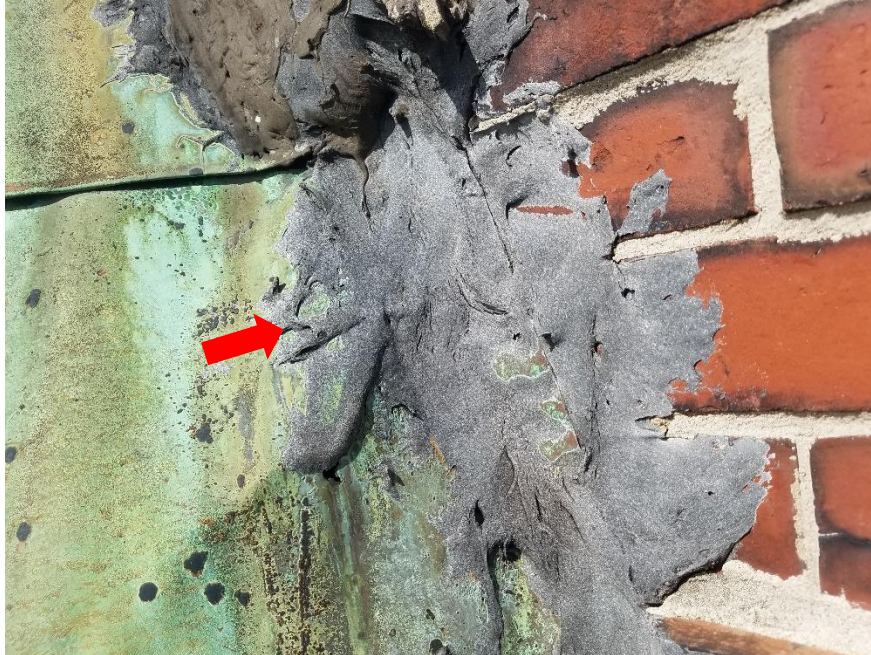
Photo 7: incompatible repair material (asphalt cement) on copper dome and flashings.

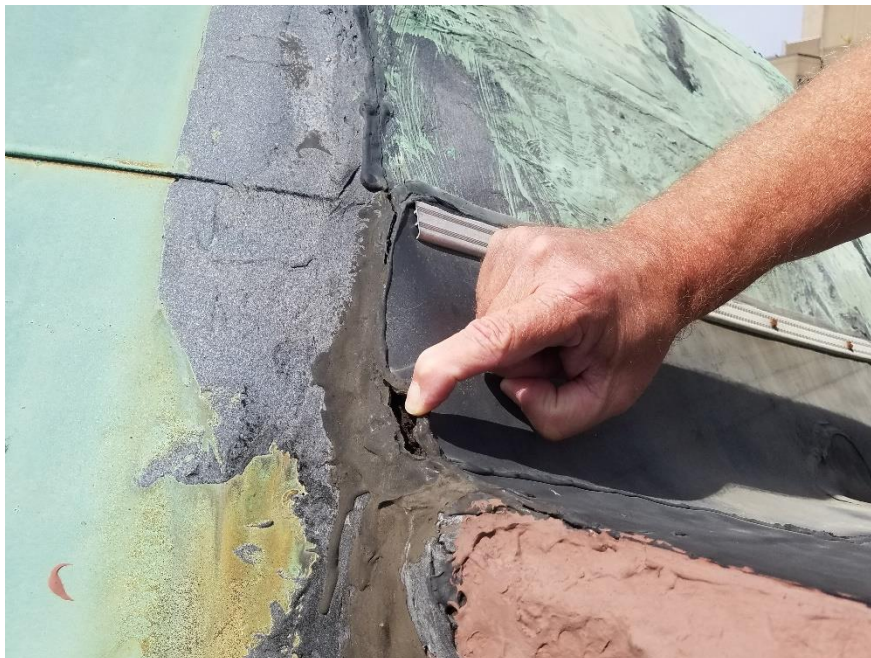
Photo 8: Improper flashing installation and repair, at copper dome roof flashing.

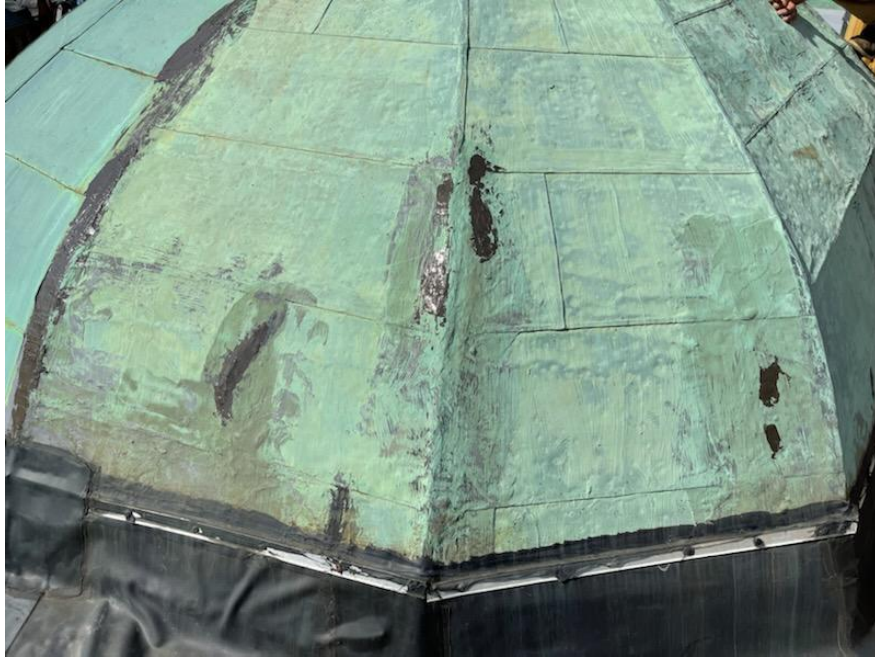
Photo 9: During prep work, loose sections of coating and asphalt required removal.

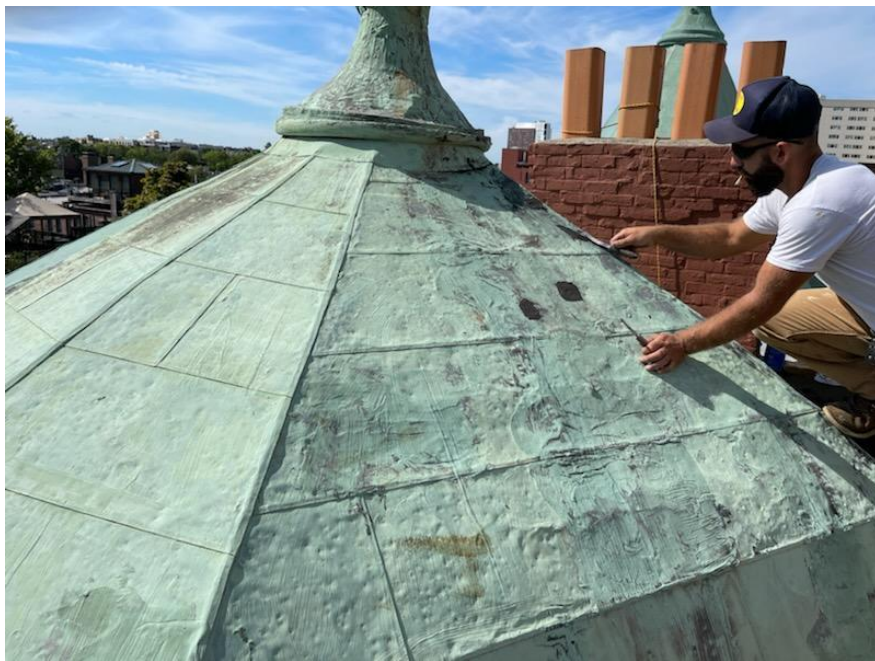
Photo 10: Contractor removing loose sections of coating and asphalt.

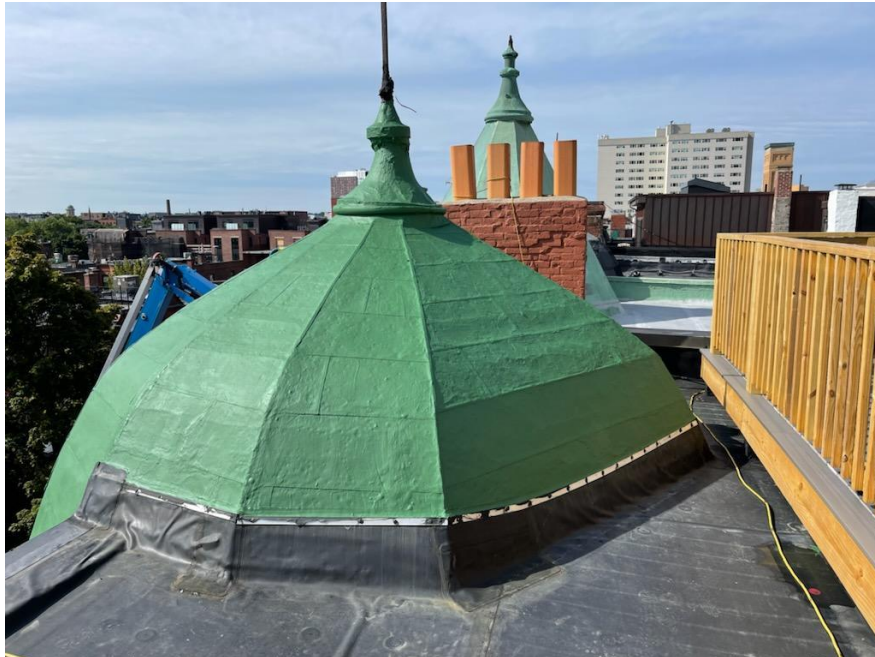
Photo 11: New coating application on dome roof.

- Most Viable Repair Option: Recoat and/or paint the new dome coating a lighter patina green, to better match its original appearance and color of adjacent dome roofs.

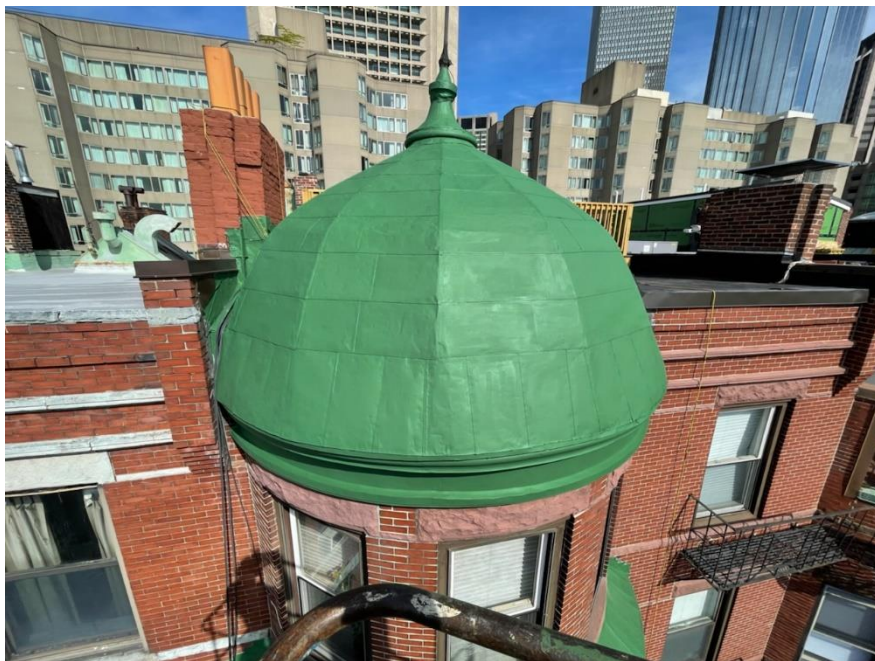
Photo 12: Another view of recoated dome roof.
