February 9th, 2023

Arborist Report: Tree Diagnosis for Alianthus Tree Removal

349 Marlborough St Rear Garden.

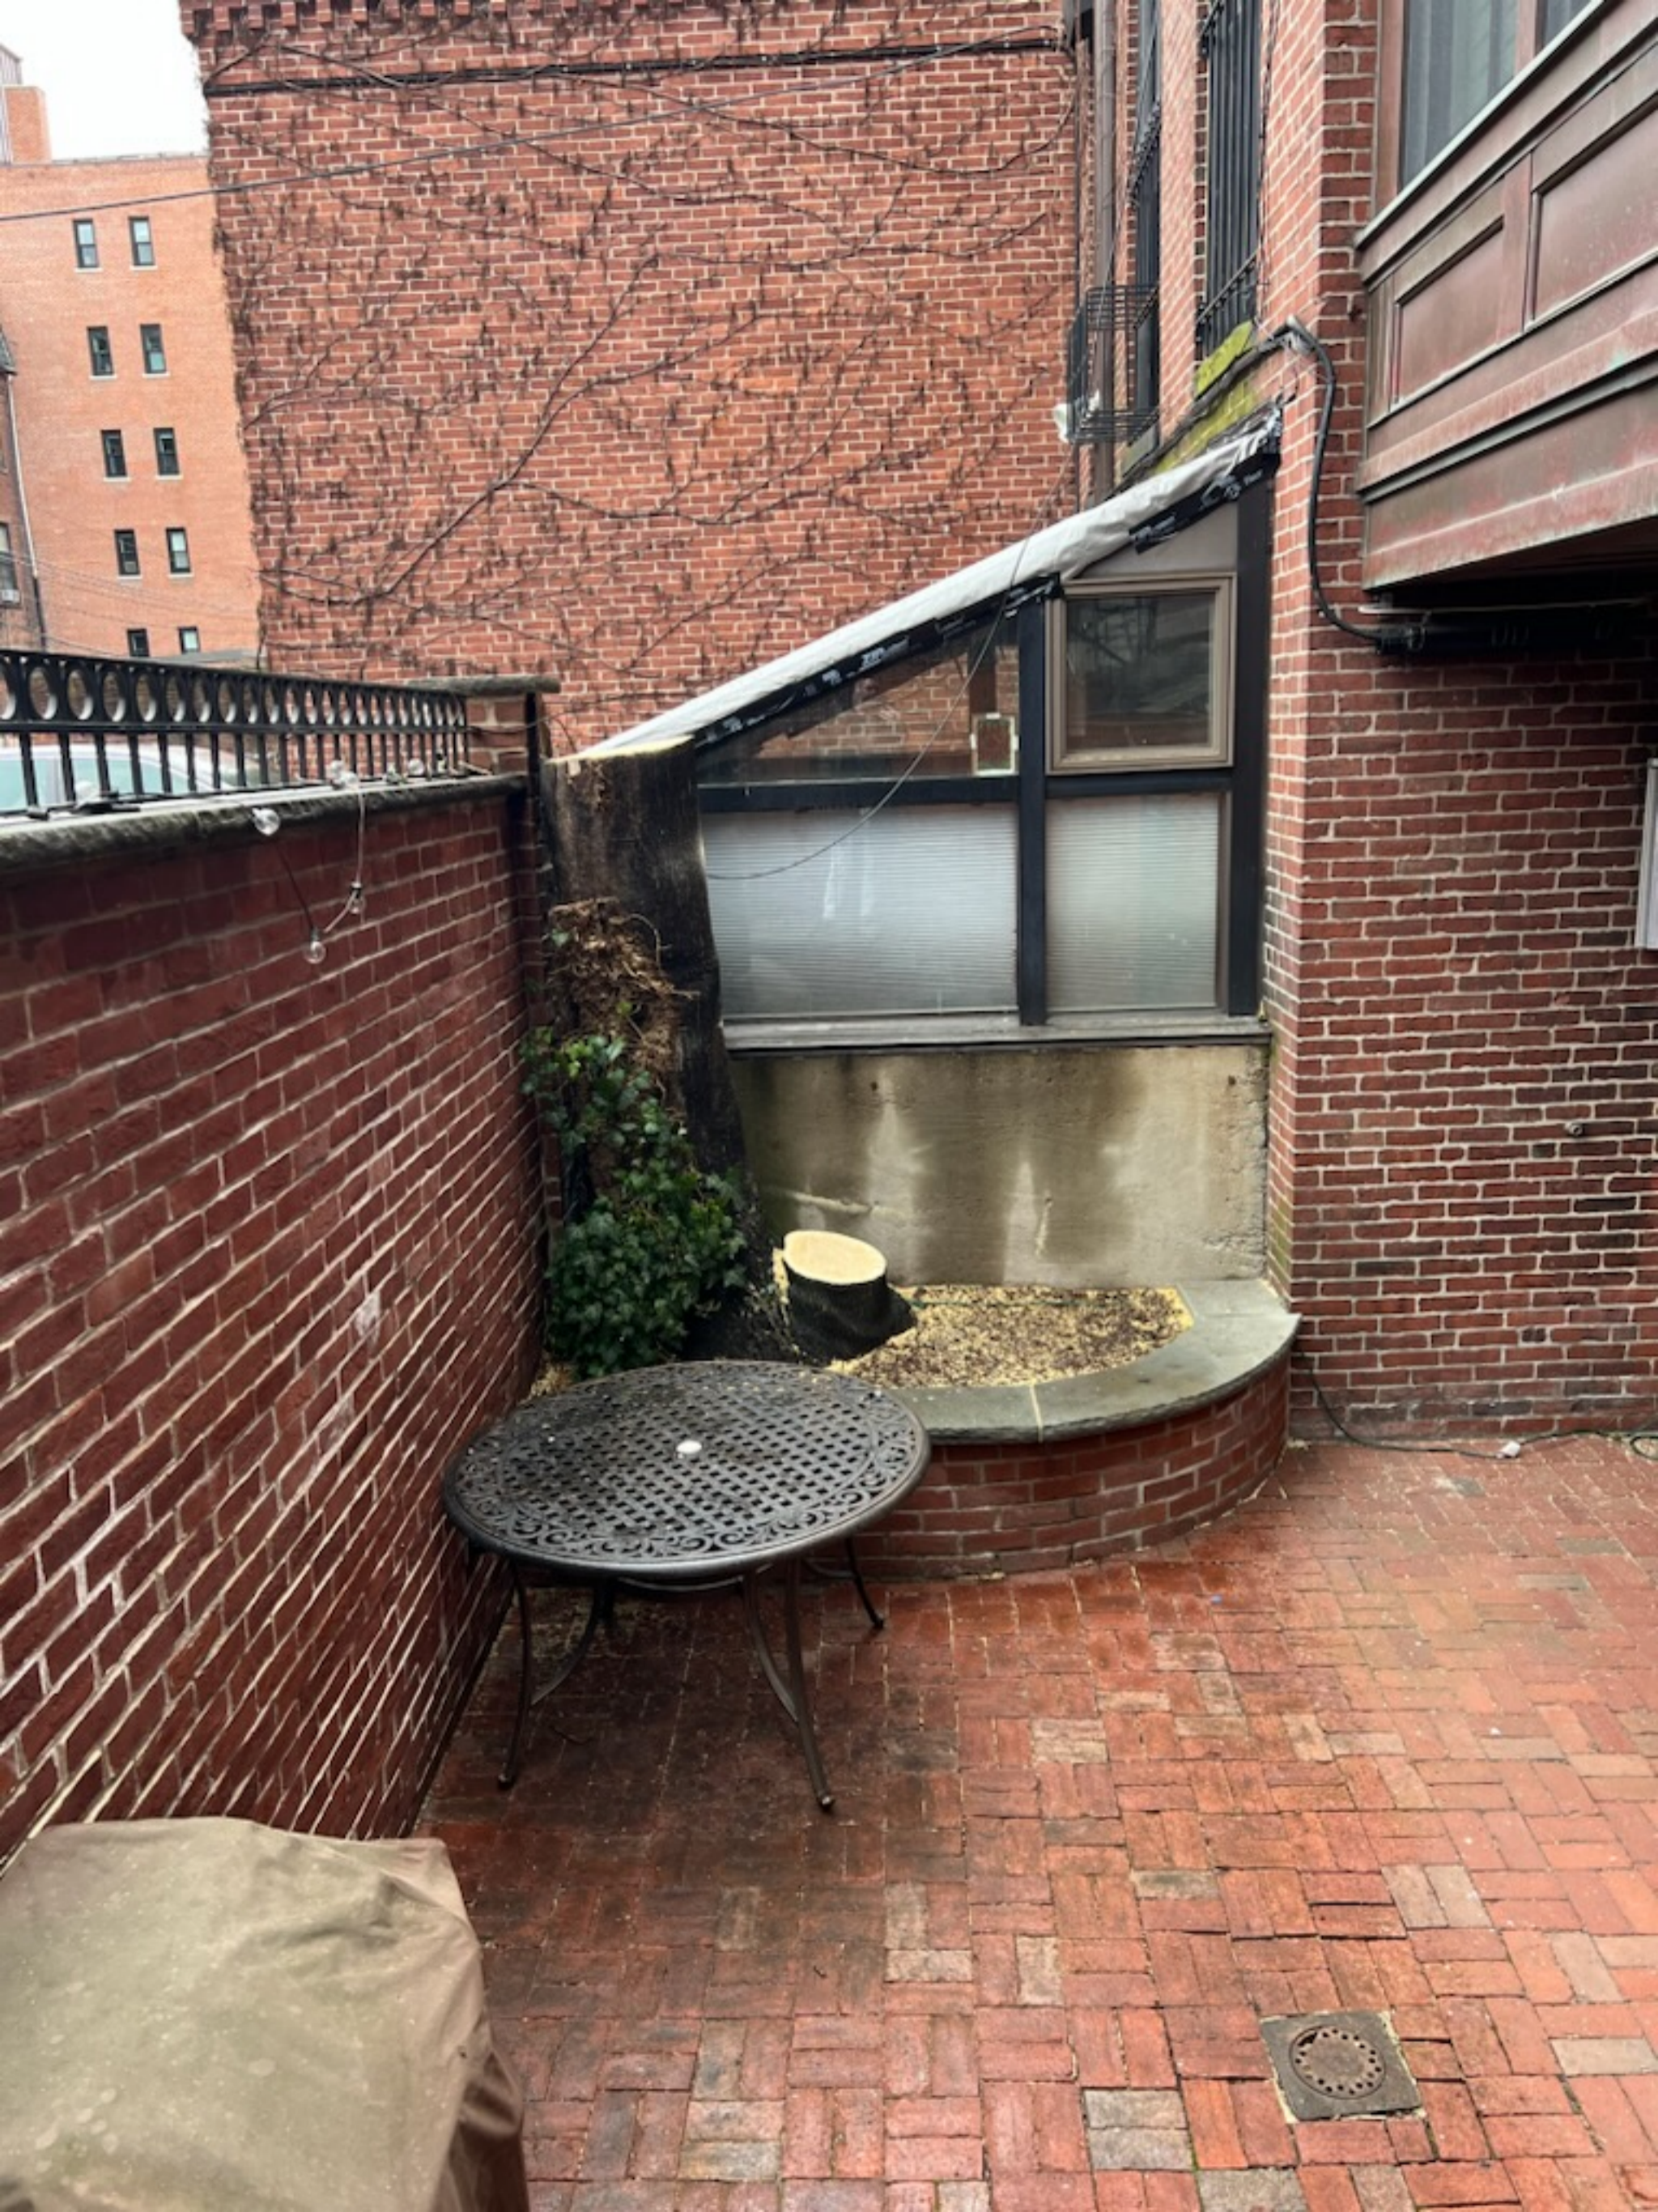
Hartney Greymont was contacted by the homeowner to evaluate the dead Alianthus tree located in the rear garden area behind 349 Marlborough St. After evaluating the tree it has had a very large limb fall out of the canopy and crash down on a neighbor's house that contained fungus surrounding the limb. The trees bark is completely exfoliating from the trunk of the trees base to the top and has large dead limbs with decay pockets throughout. There are vertical cracks running up the trunk of the tree at about 4-8 feet high. After sounding the trunk of the tree using an arborist sounding hammer the trunk sound was noticeably hollow throughout the interior. Due to the location of the tree and the amount of decay and dead/dying branches and main trunks the tree is deemed to be an extreme hazard and could cause imminent danger from the lack of structural integrity.

Regarding a replacement plan for the Alianthus tree that is to be removed, the existing stump and roots will have to be grinded down or even excavated so that a new tree could be properly planted in its place. Due to the location of the existing tree, stump grinding would not be logistically possible with the tree being located behind a wall inside a raised planter. There is also surrounding pavement, and brick that covers the base of the tree and wall. The tree is also located extremely close to the foundation of the property which causes concerns for digging up roots etc. Planting a new tree especially on the larger scale will not be possible in the current location. The existing Alianthus tree has grown in an area where it was not planted but seems to have seeded in on its own and became established. With the lack of root space, no young deciduous tree would survive in such location. The surrounding areas suggested would also be incredibly difficult to plant unless the city performed some excavation to create enough space for a planter or a permeable surface that would allow water to seep down onto the roots. If a new location would be created by the city in the given area for replacement tree, that would be the only logical way for any recommended tree to survive.
