DRAFT 02.16.18

Esplanade Tree Management & Succession Plan

Prepared for The Esplanade Association and Department of Conservation & Recreation 2018

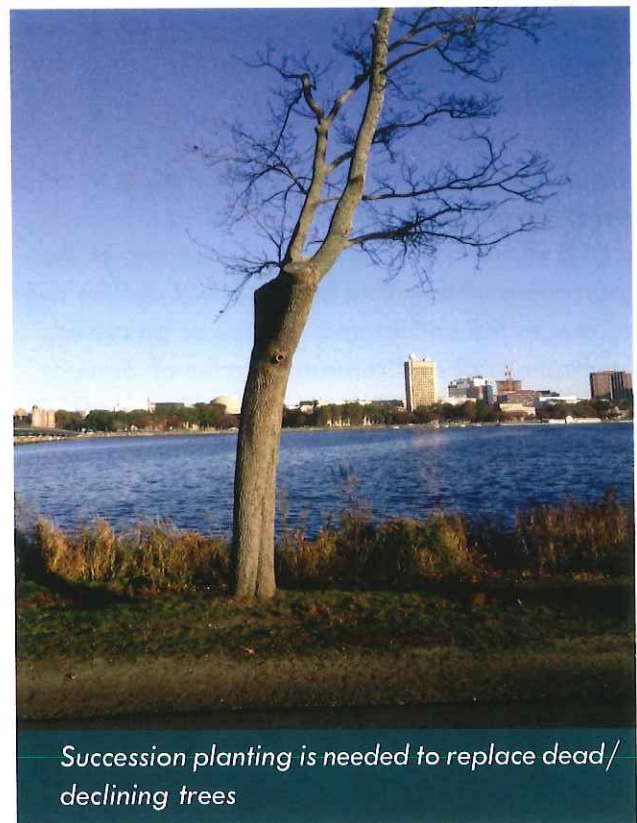
Succession planting is needed to replace dead/declining trees

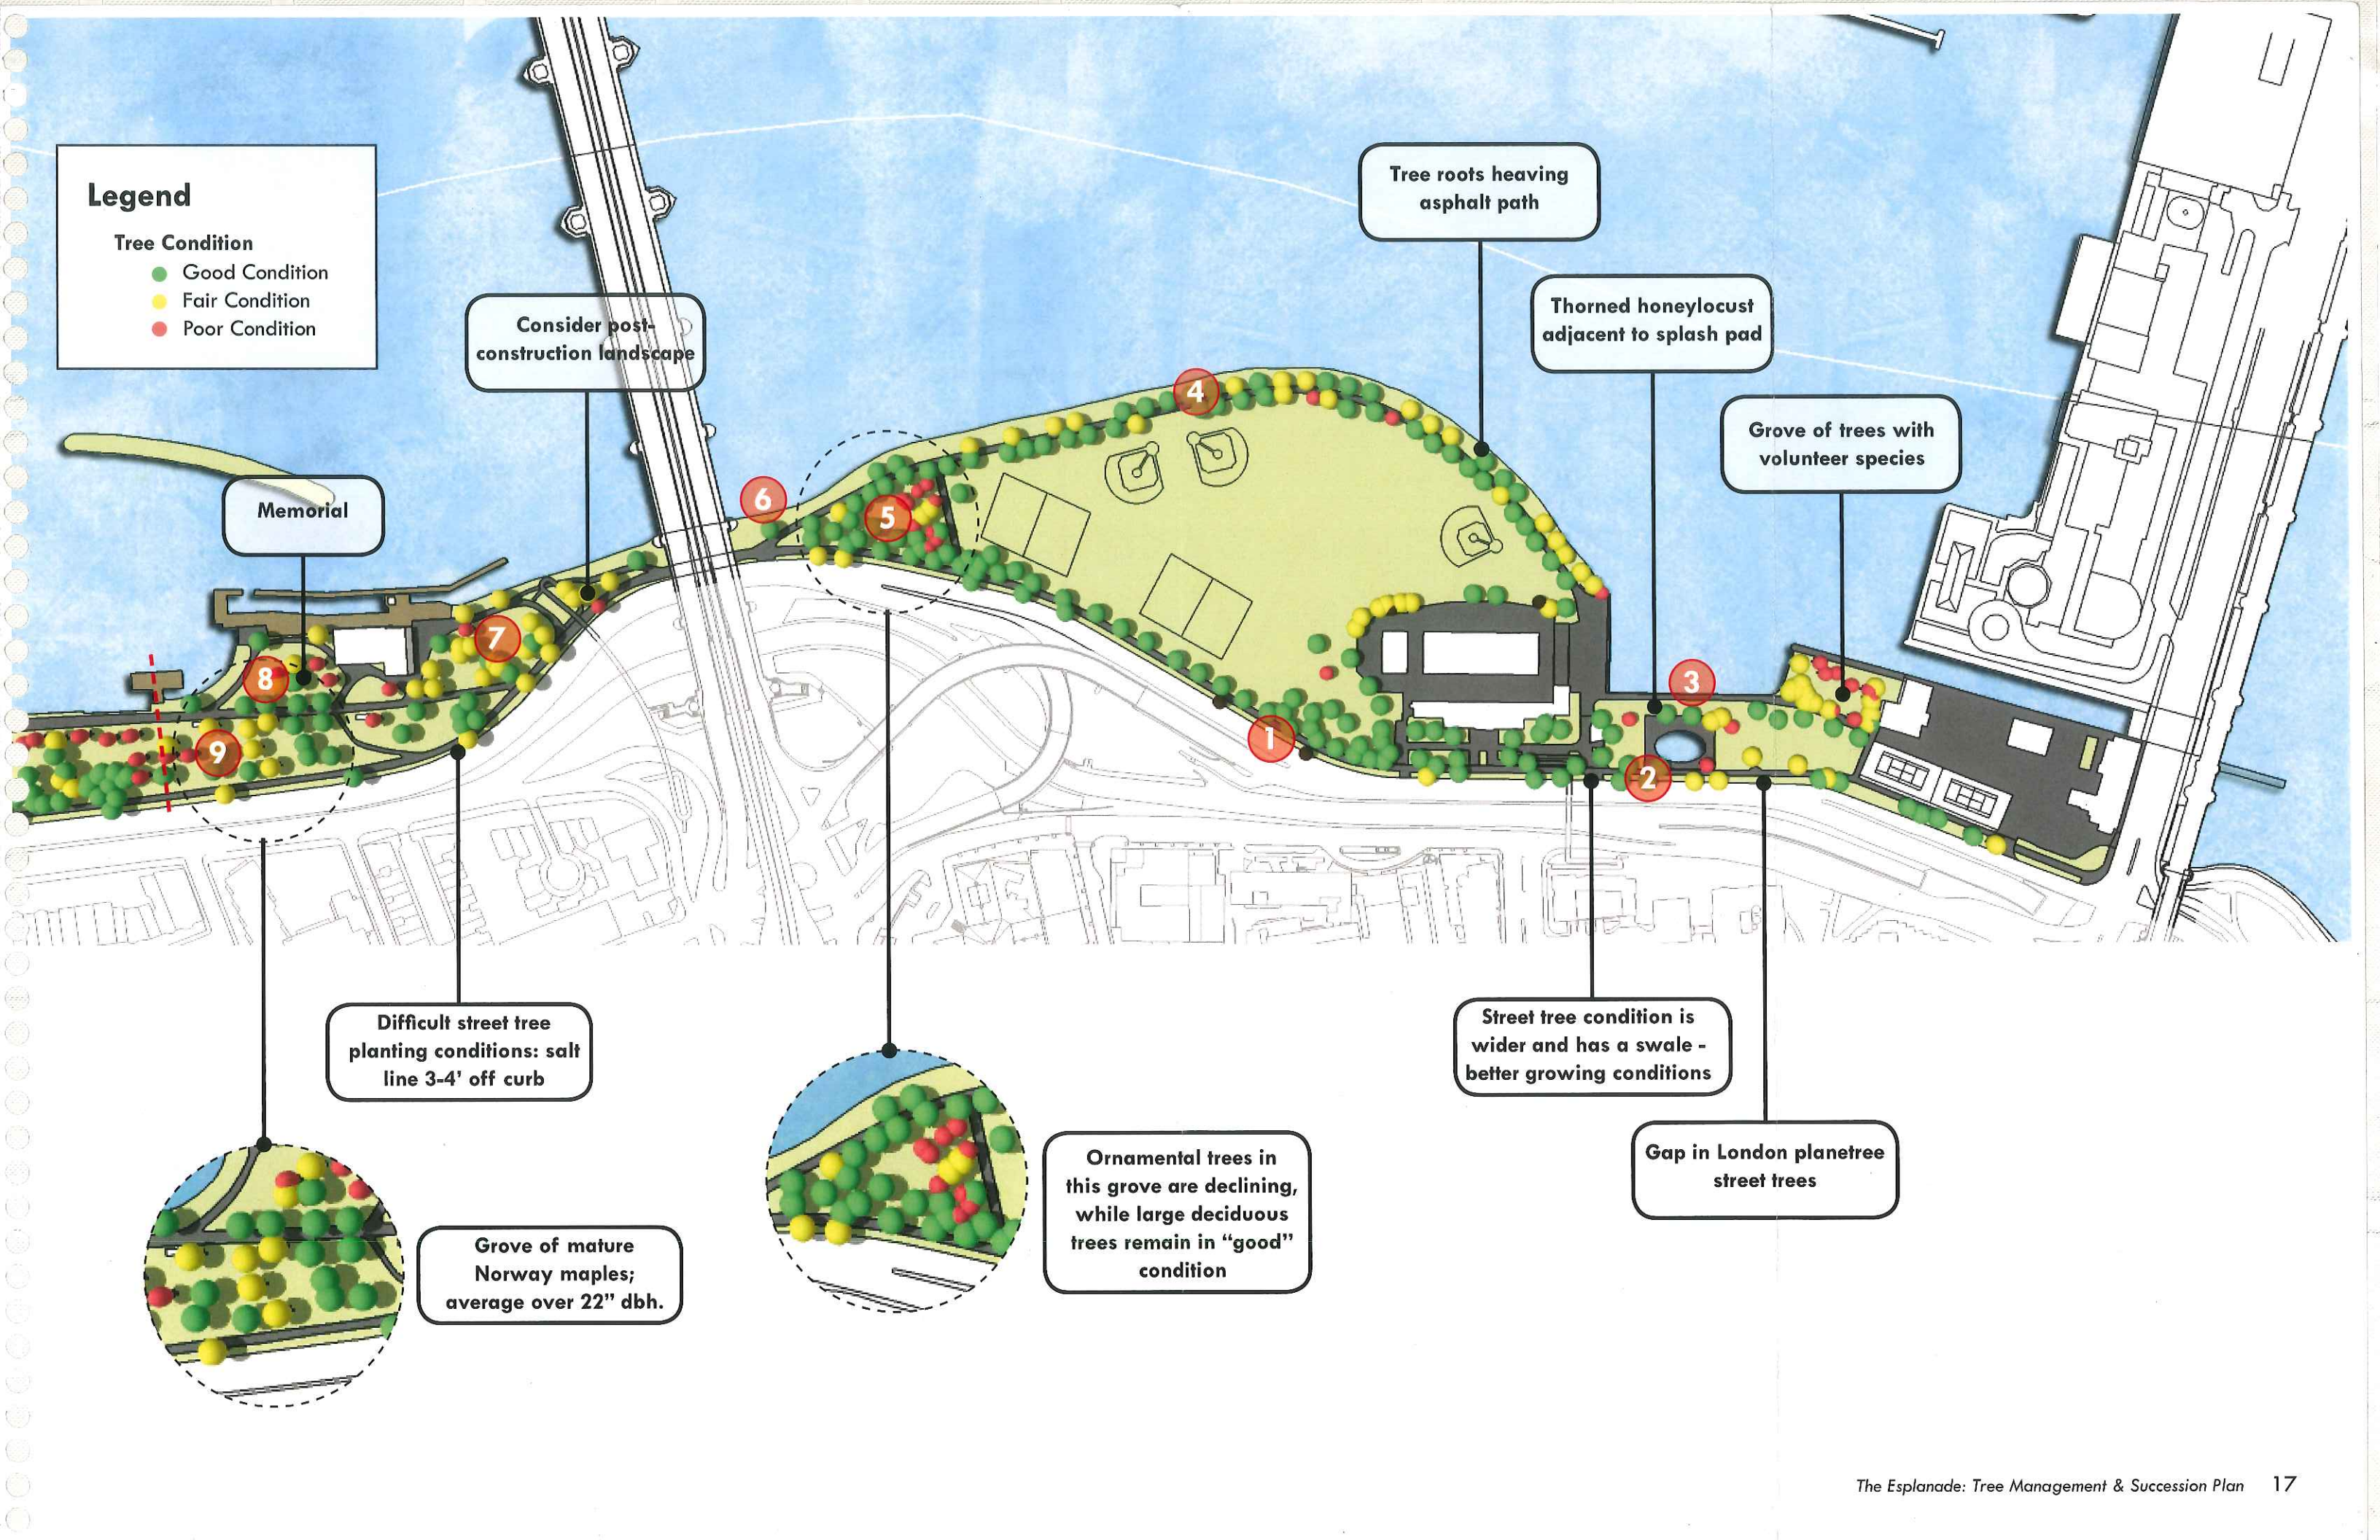
Tree roots heaving asphalt path

Street tree condition is wider and has a swale - better growing conditions

Difficult street tree planting conditions: salt line 3-4' off curb

Ornamental trees in this grove are declining, while large deciduous trees remain in "good" condition

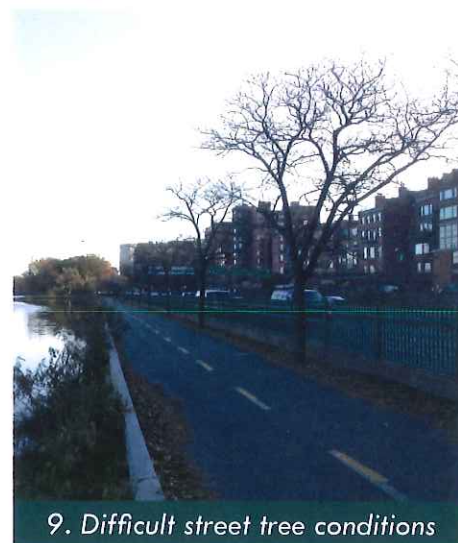
9. Difficult street tree conditions

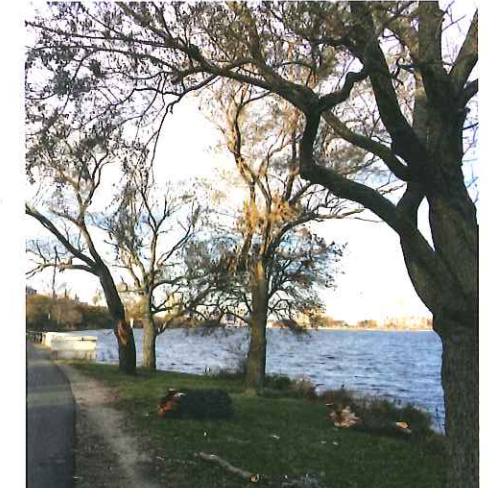
6. Tree suffered from decay

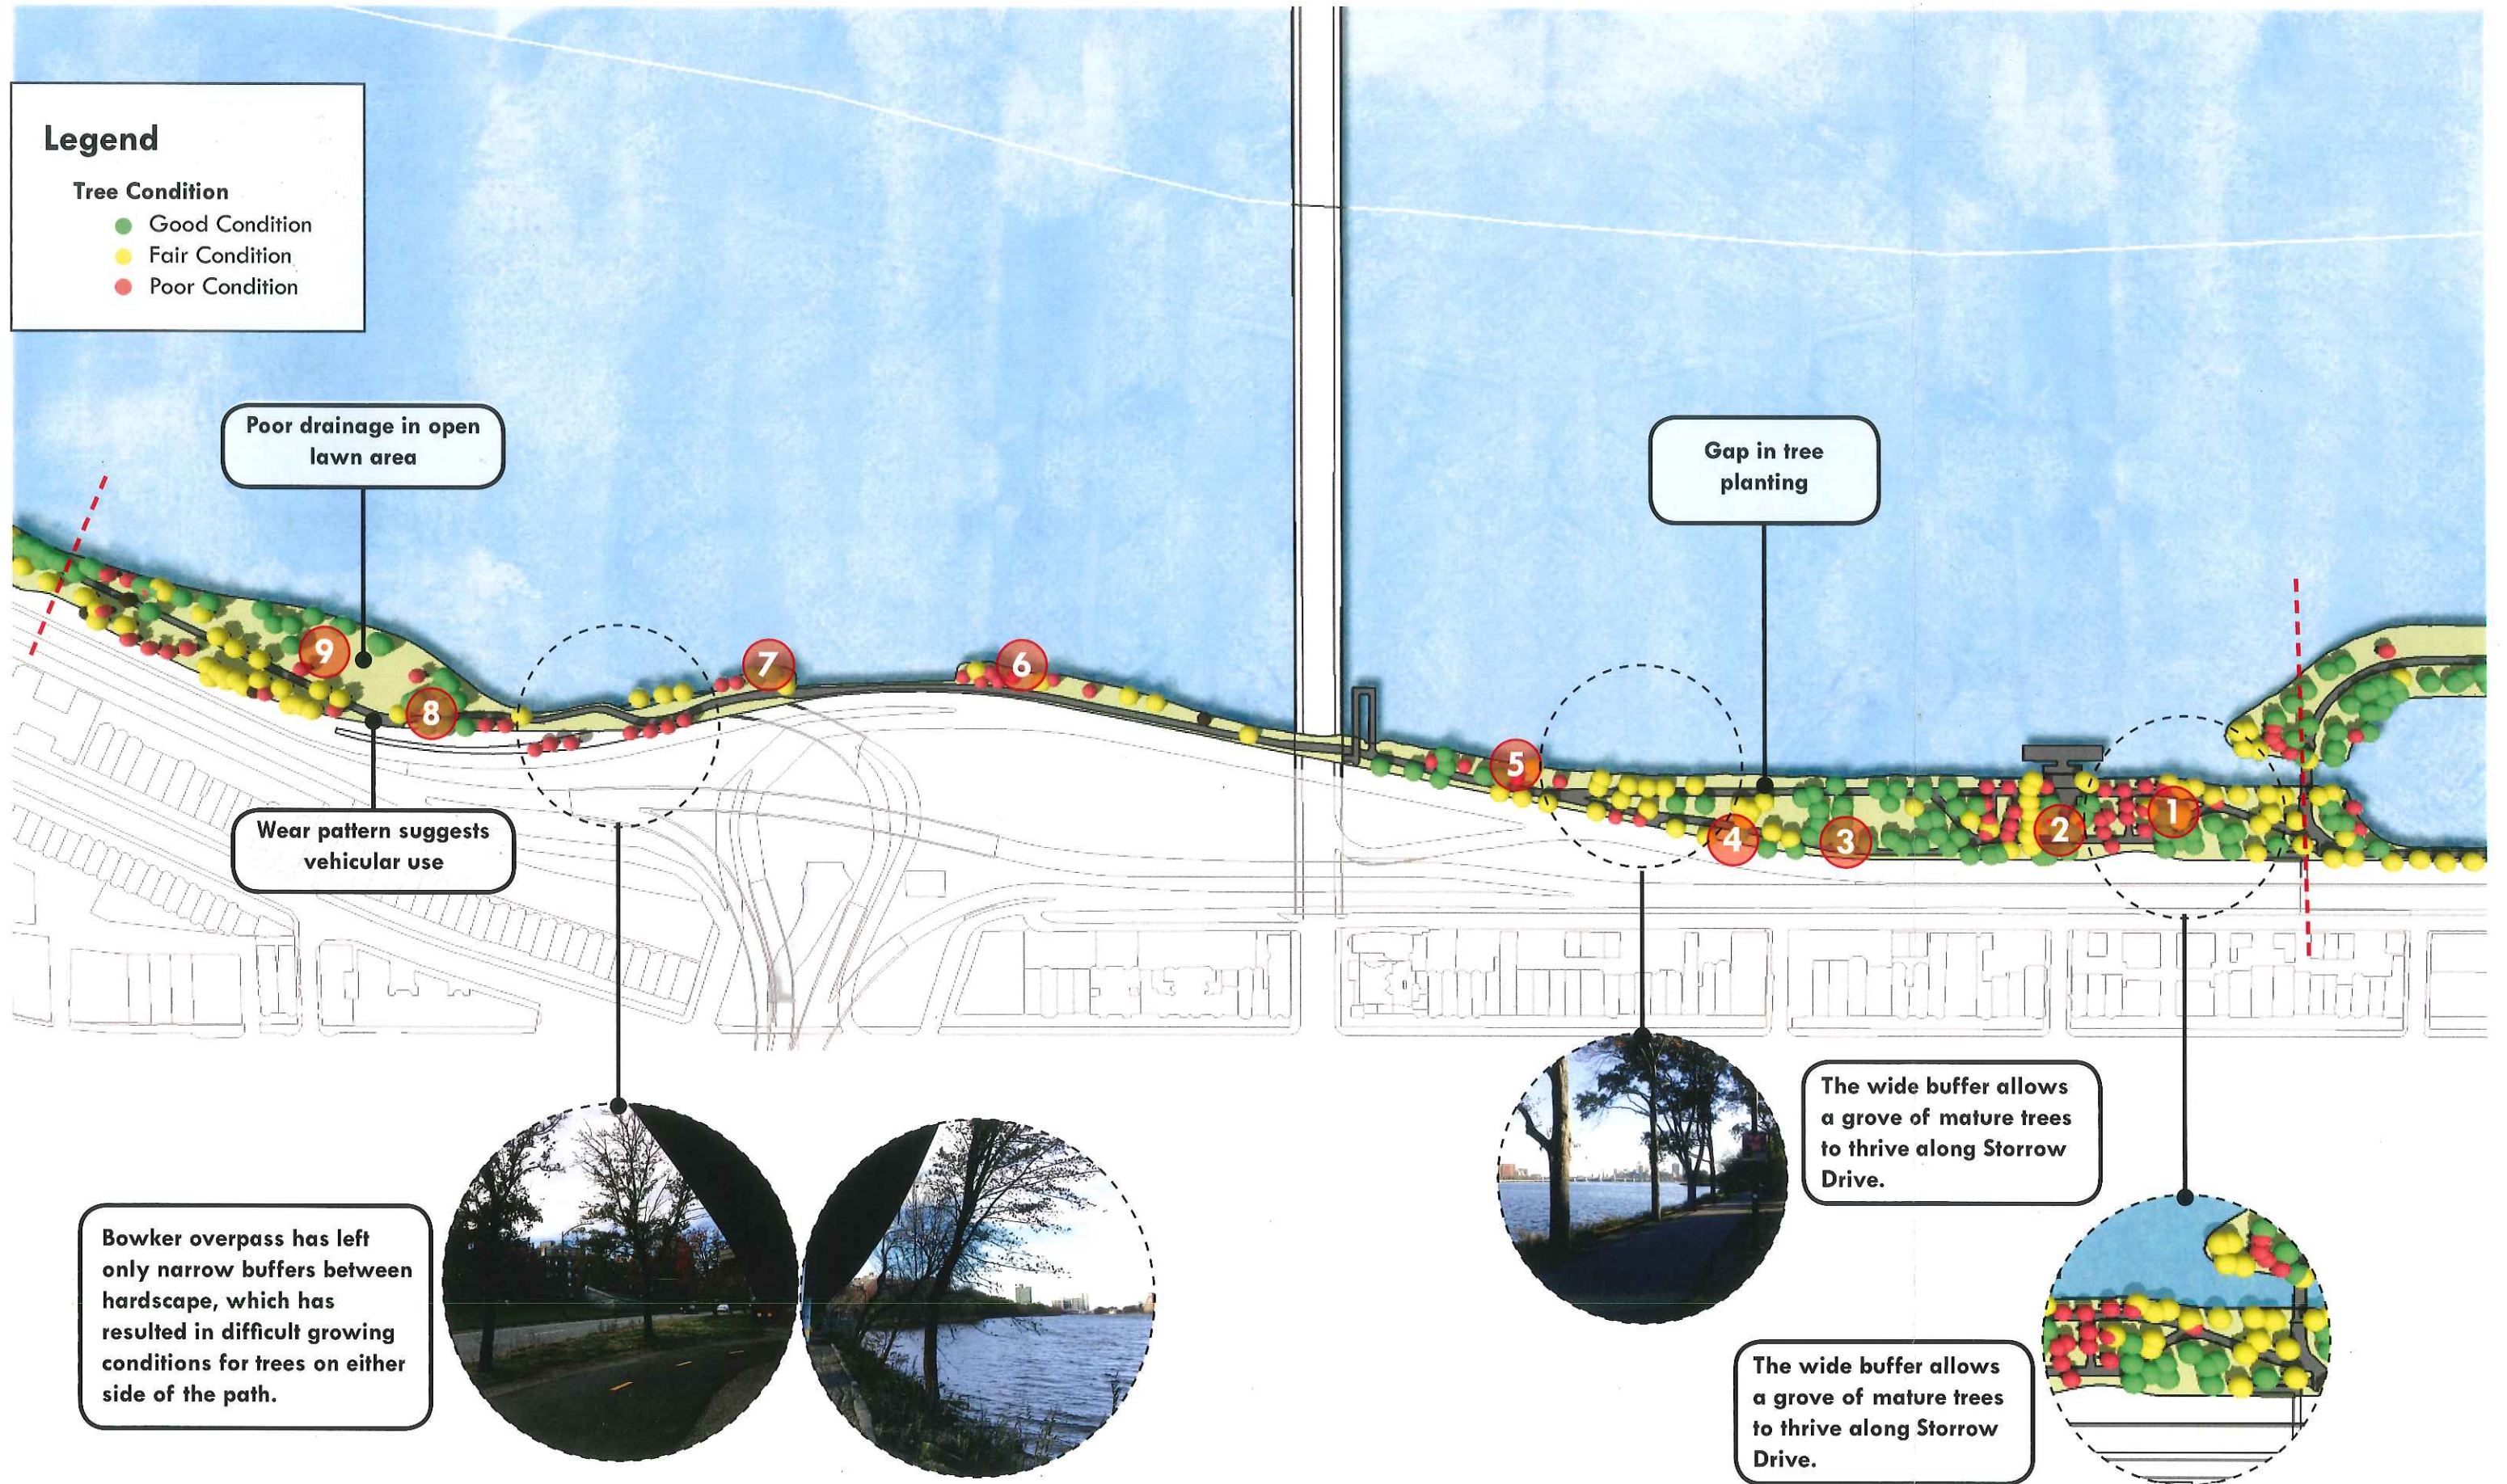
Poor drainage in open lawn area

Gap in tree planting

Wear pattern suggests vehicular use

Bowker overpass has left only narrow buffers between hardscape, which has resulted in difficult growing conditions for trees on either side of the path.

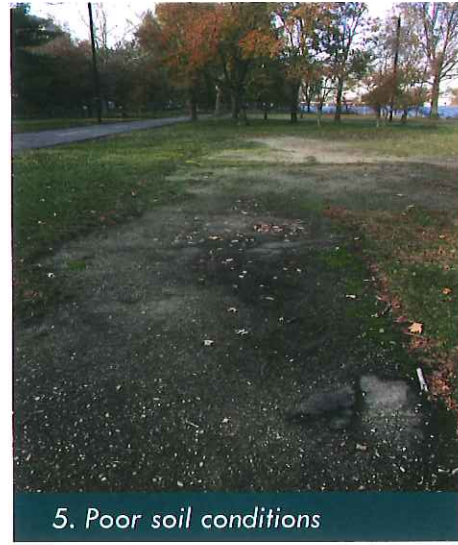
5. Poor soil conditions

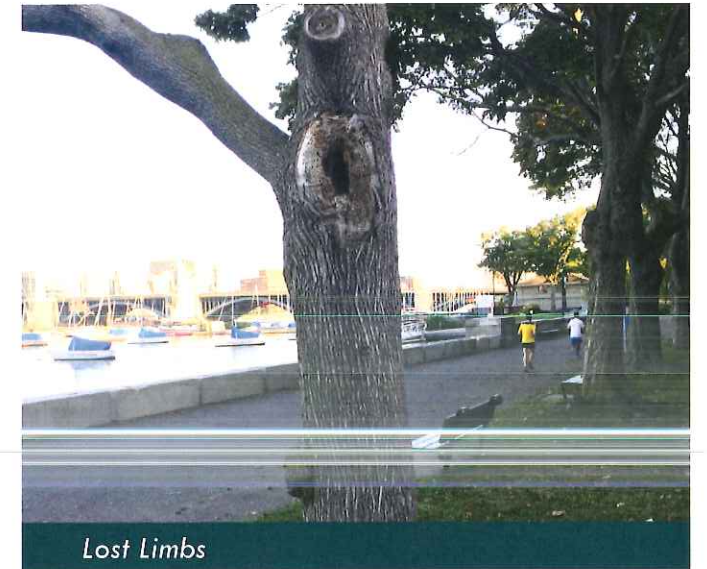
Lost Limbs

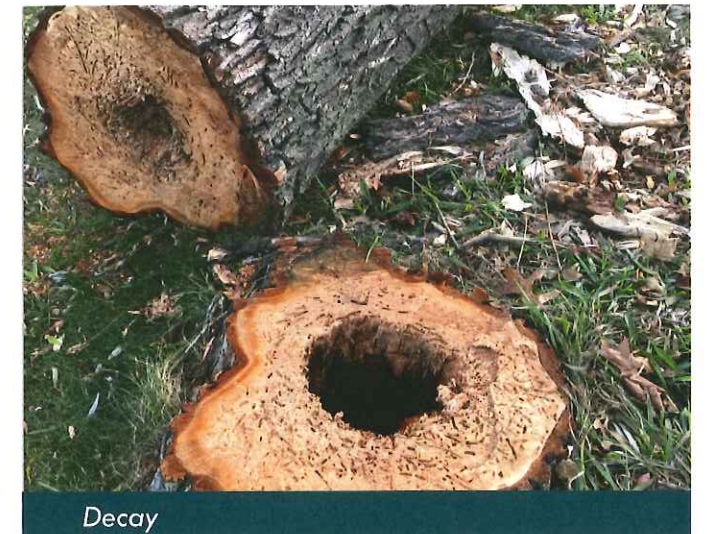
Decay

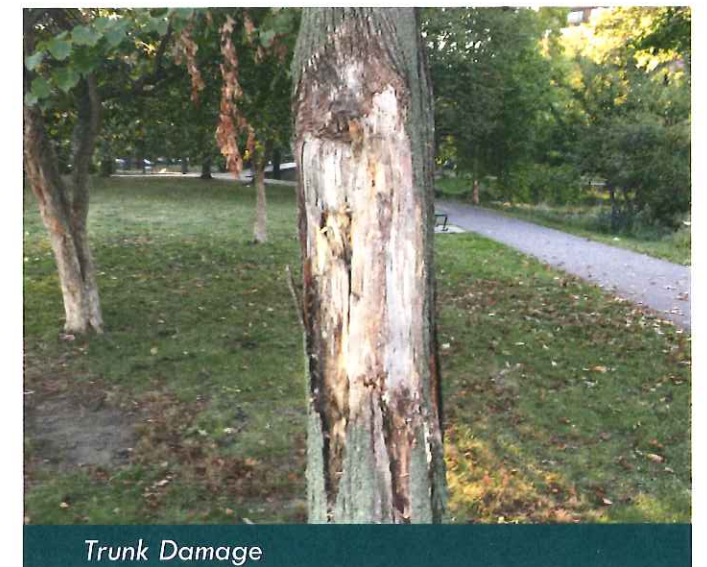
Trunk Damage

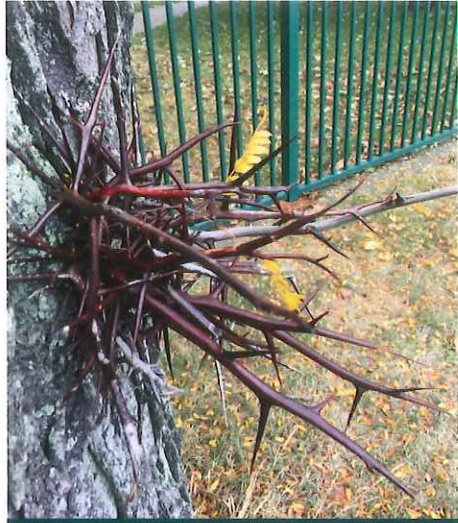
Thorns/Hazardous Species

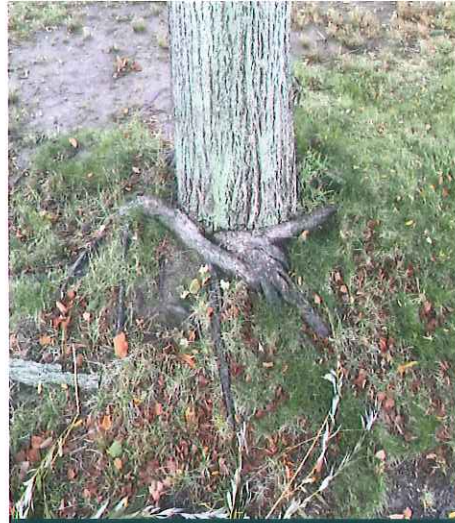
Girdling Roots

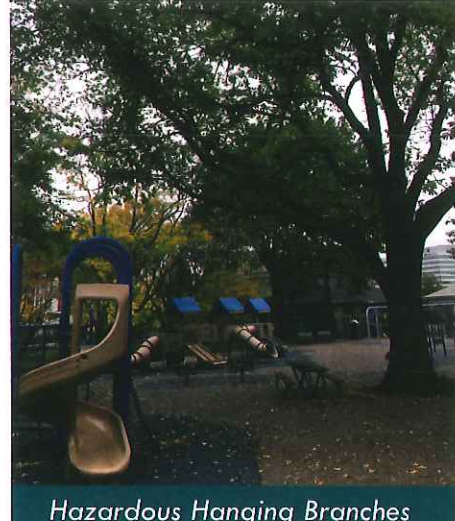
Hazardous Hanging Branches

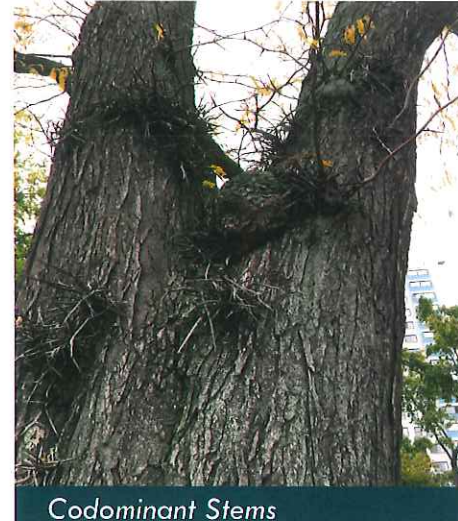
Codominant Stems

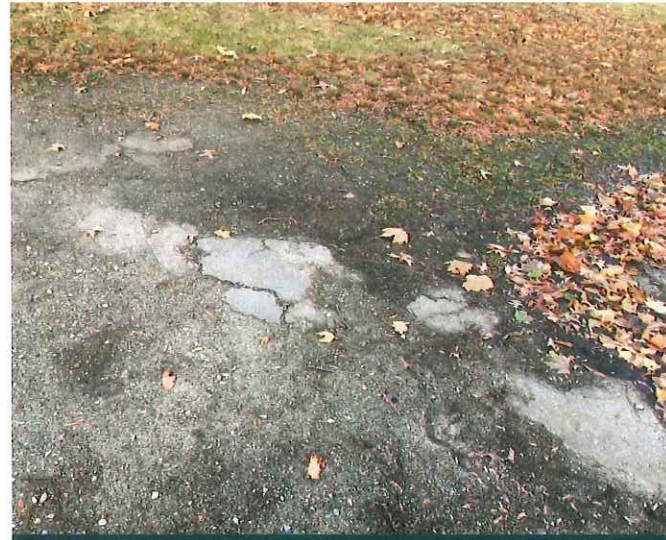
Abandoned asphalt should be fully excavated

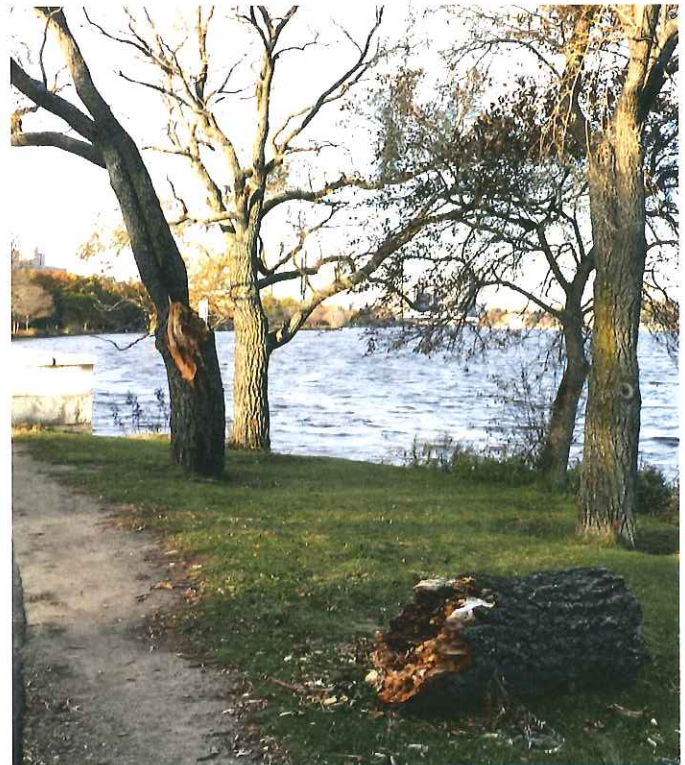
This willow tree recently lost a large limb due to decay. The wound is beyond what the tree could repair, and will likely result in the necessary removal of the tree.

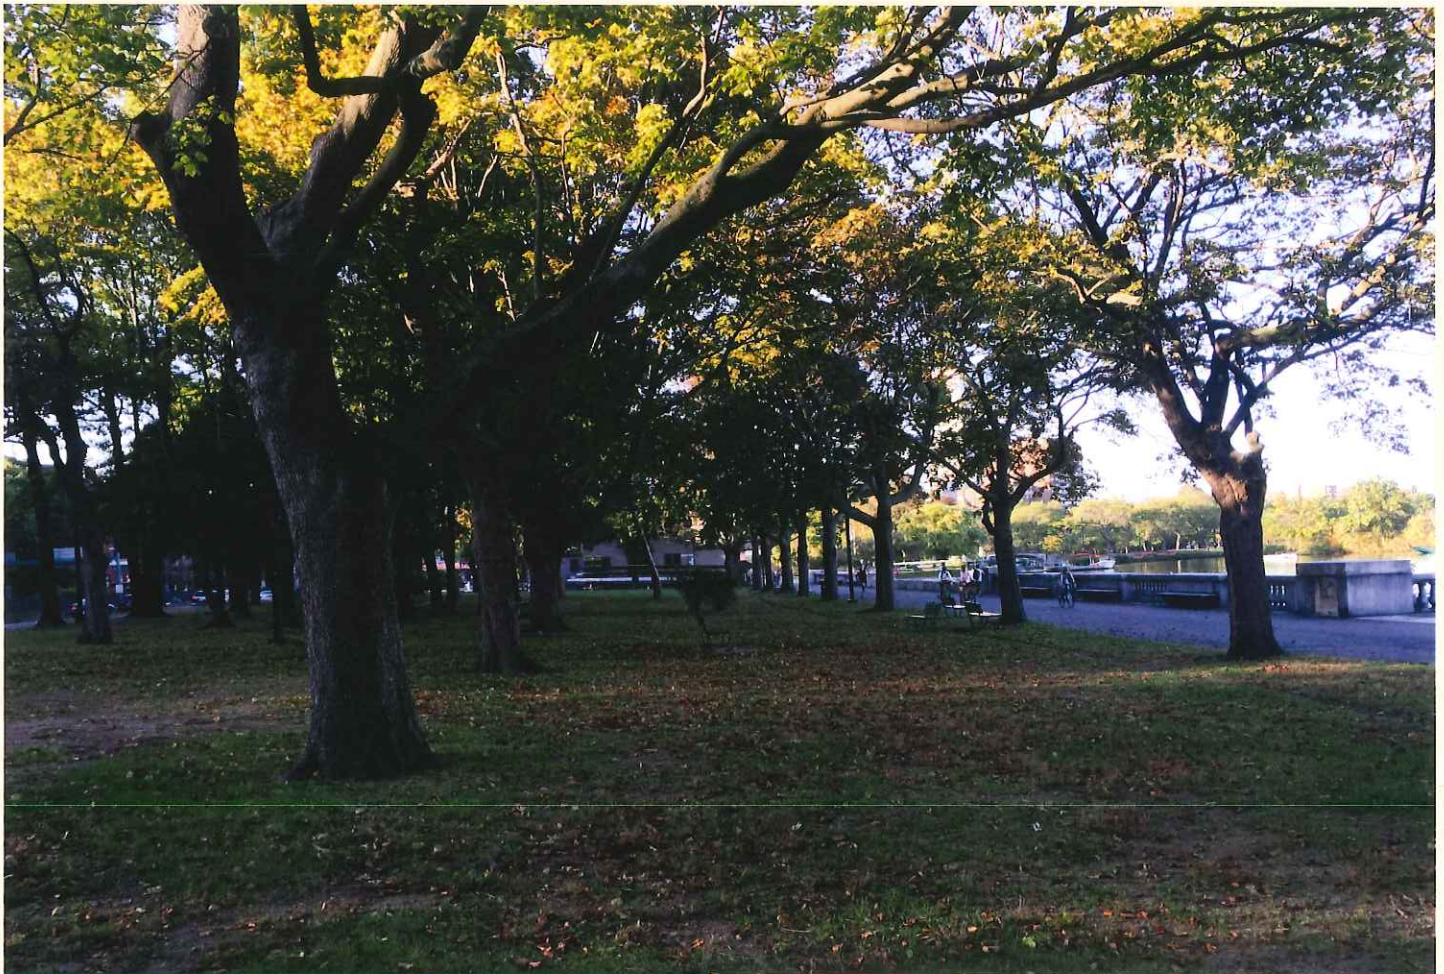
Lawn space that is used for equipment storage

In addition to testing the chemistry of the soil, the compaction level of soil should be tested and amended. Soil can become overly compact from vehicular or heavy pedestrian use, which limits the ability for trees to intake water and air from the soil. Areas that are compacted may also experience flooding, which can negatively impact trees that might not be tolerant of wet conditions. Compacted soils should be aerated using either manual or mechanical equipment.
