ROOF REPLACEMENT AND PATIO EXPANSION AT THE WILLIAM J. DEVINE CLUBHOUSE

1 CIRCUIT DRIVE
DORCHESTER, MASSACHUSETTS 02121

PREPARED FOR
CITY OF BOSTON PUBLIC FACILITIES DEPARTMENT
CAPITAL CONSTRUCTION DIVISION
26 COURT STREET, 10TH FLOOR
BOSTON, MA 02108

**ROOF REPLACEMENT AND PATIO EXTENSION
AT THE WILLIAM J. DEVINE CLUBHOUSE
BOSTON, MASSACHUSETTS
GALE JN 833770**

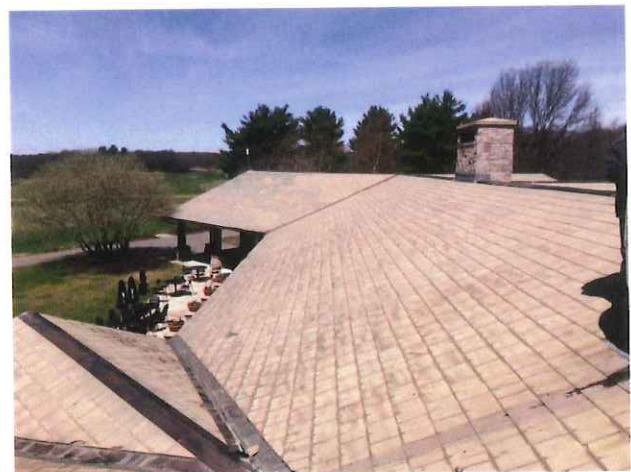
1. The existing synthetic slate shingles appeared to be in poor condition overall. Several areas were noted to have missing, broken, or cracked shingles. In addition, the shingles are heavily weathered and fading in color.

Partial view of roof

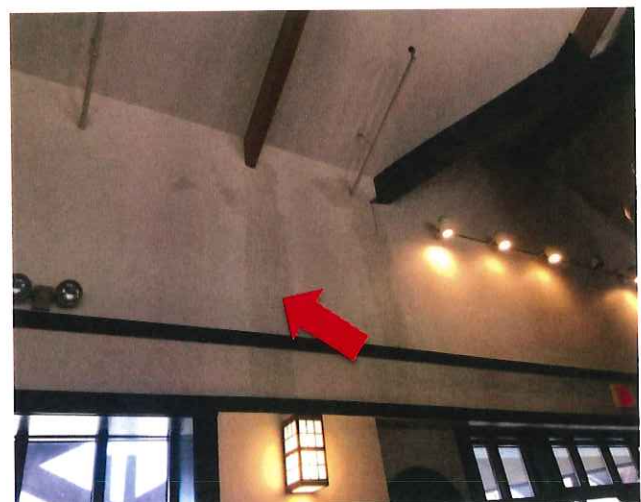
Water staining at the upper wall locations

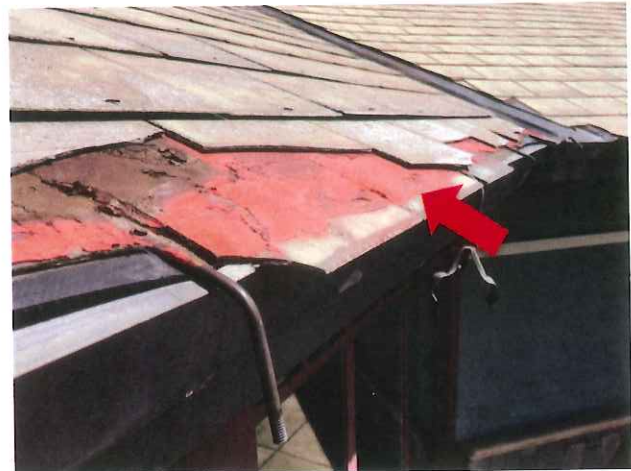
3. An approximate 3'-0" overhang runs along the perimeter of the building at the roof edge.
4. Two gutters with downspouts were observed along the west side of the roof. Due to ice damming the gutters appear to have been broken in several areas and have become displaced from the roof.

View of the broken and displaced gutter at the west side of the roof. Broken, cracked, loose, and missing shingles were noted throughout the various roof areas.

8. Remove and replace the existing gutters and downspouts and the west roof areas above the patio.

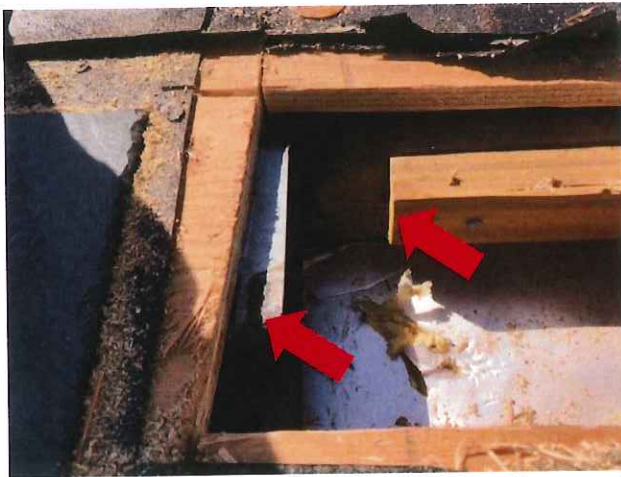
View of the intersection between the two different roof systems. Metal deck is on the left and wood framing is on the right.

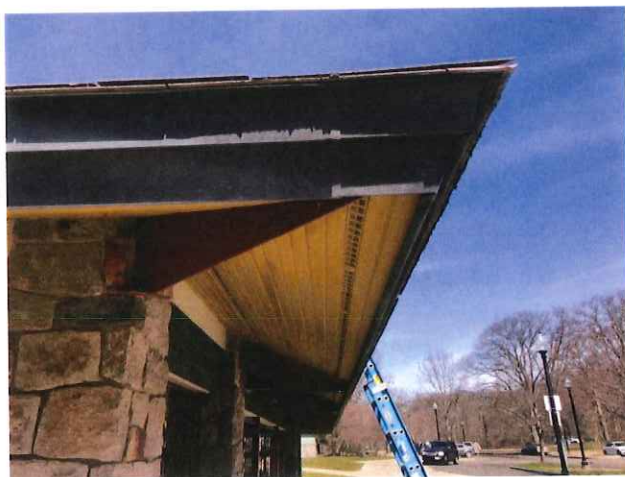
Typical roof overhang and vented soffit.

9. Install snow guards above building entrances. The wood soffits will be scrapped, prepped, primed, and painted to match the existing in color. A unit price will be carried in the project specifications for spot replacement locations where damaged wood soffits are encountered.

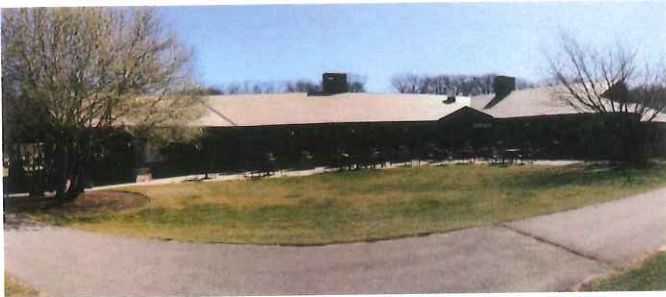
View of existing patio space from lawn area.

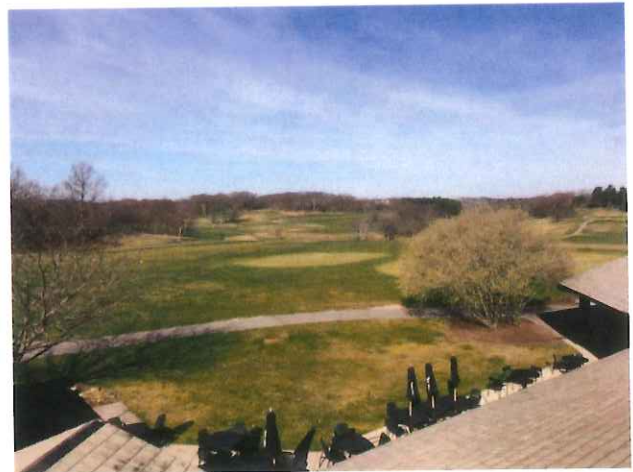
View of existing patio space from roof.

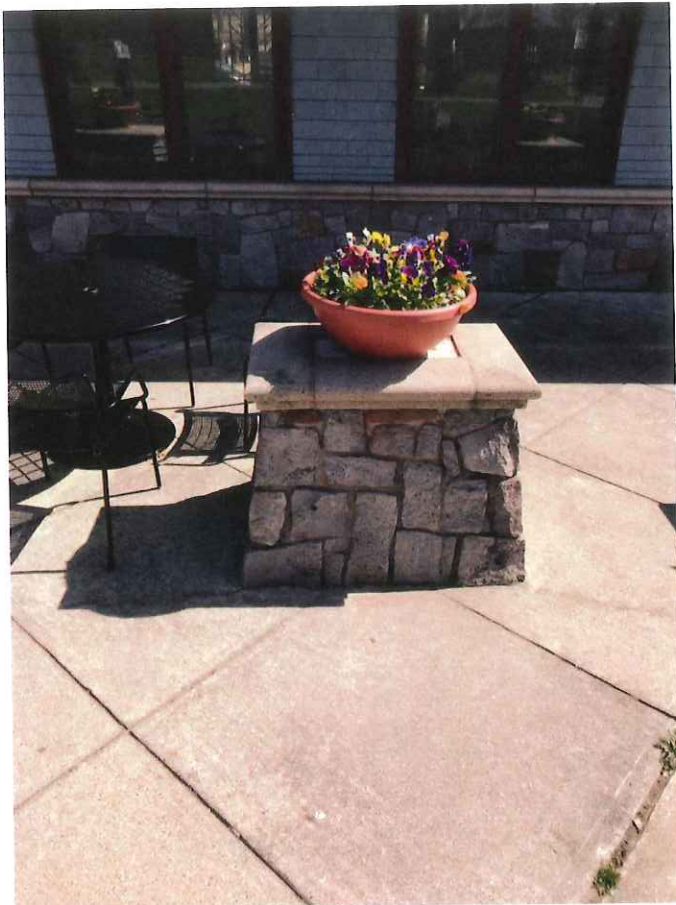
1. The concrete has intermittent cracks and the foam backer rods have deteriorated and weeds were observed in the voids of the expansion joints.
2. The support pillars appear to be the remains of a pergola structure and now host movable flower planters.
3. A cart path adjacent to the patio has a crown that is higher in elevation than the patio which directs water back to the patio. The lawn area between the cart path and patio does not drain quickly and reportedly exhibits standing water after heavy rainstorms. This slow drainage may be exacerbated by the presence of ledge, which was evident upon visual inspection in a couple places. Additionally, the building roofs drain to gutters and downspouts and drain onto the patio adding additional runoff.
4. The northern edge of the patio connects to the cart parking area.

Detail of support pillars (that no longer are needed) and failing concrete paving.
