**CHARLES RIVER SPEEDWAY
BOSTON LANDMARKS COMMISSION APPLICATION**

Date: MARCH 5, 2019

1420-1440 SOLDIERS FIELD RD
BOSTON, MA 02135

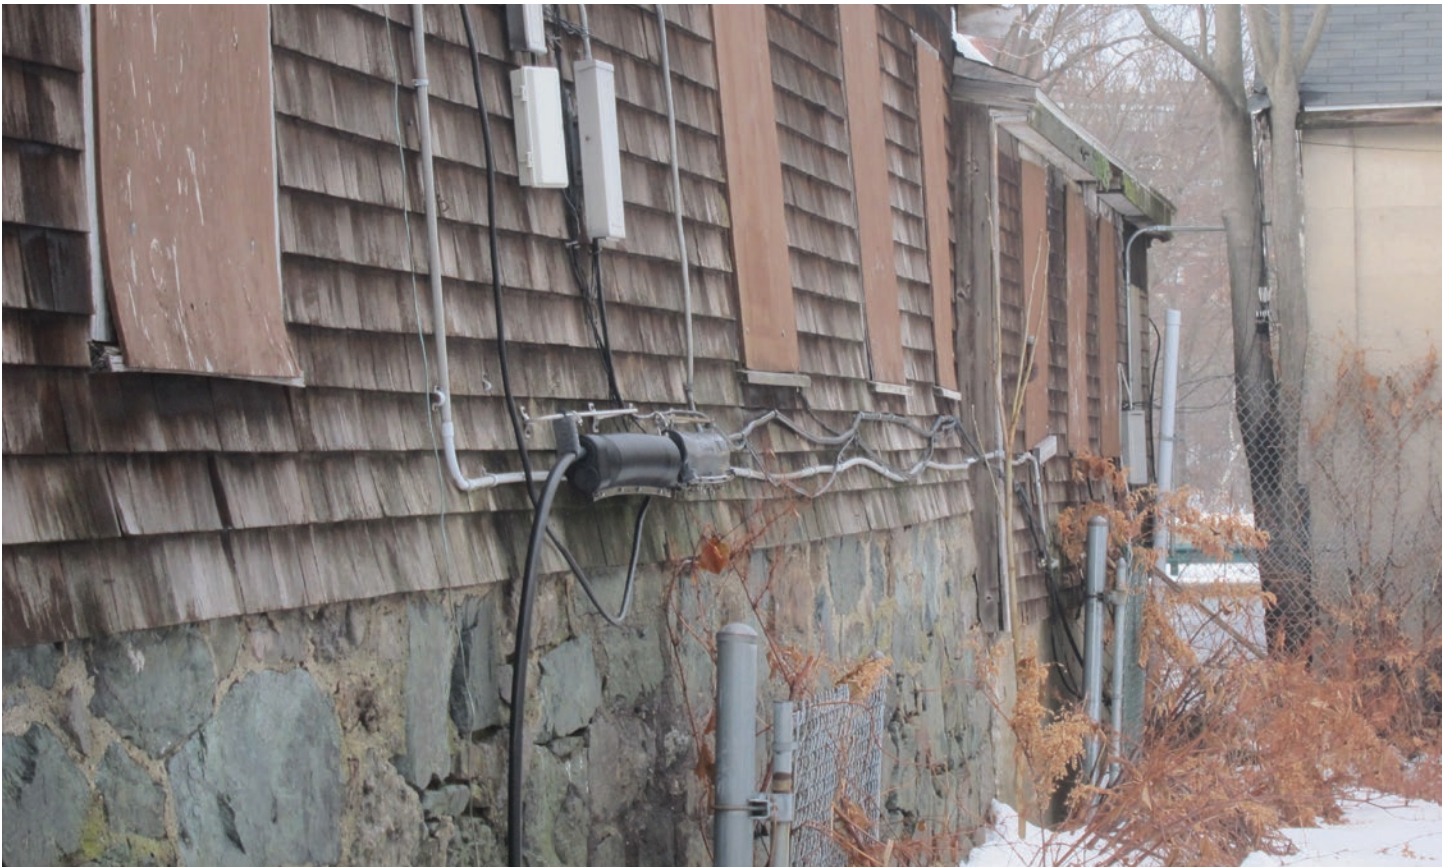
Figure 12: Building C Foundation Deterioration

At Building C, the west face of outer stonework (where collision with equipment has torn away stone) will be repaired to match the surrounding stone. Parging will be removed to expose stone masonry that will be repointed.

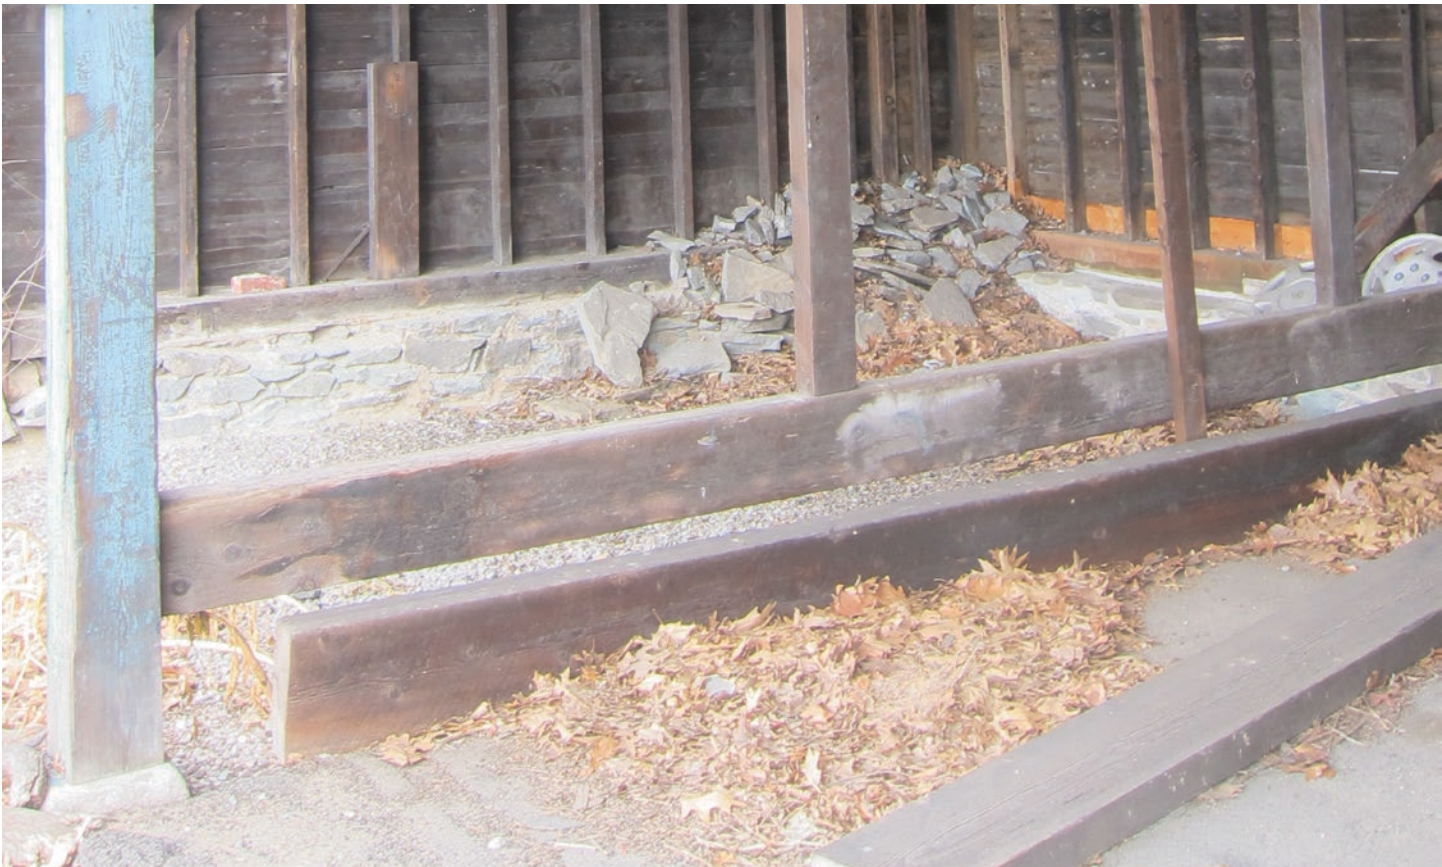
Generally, the foundations are sound except for a 30' long bulging failure and outward rotation along the east wall of Building D. Overall, the fieldstone foundations have lost pointing although the most intact stonework is in the earliest buildings.

Figure 13: Building D Foundation Bulge

At Building D, the existing east foundation will be stabilized at the area of rotation. This may require shoring, disassembly, and reconstruction, but connection to a new floor slab may suffice. Most of the wall requires repointing on its outer face. Mortar will match the historic.

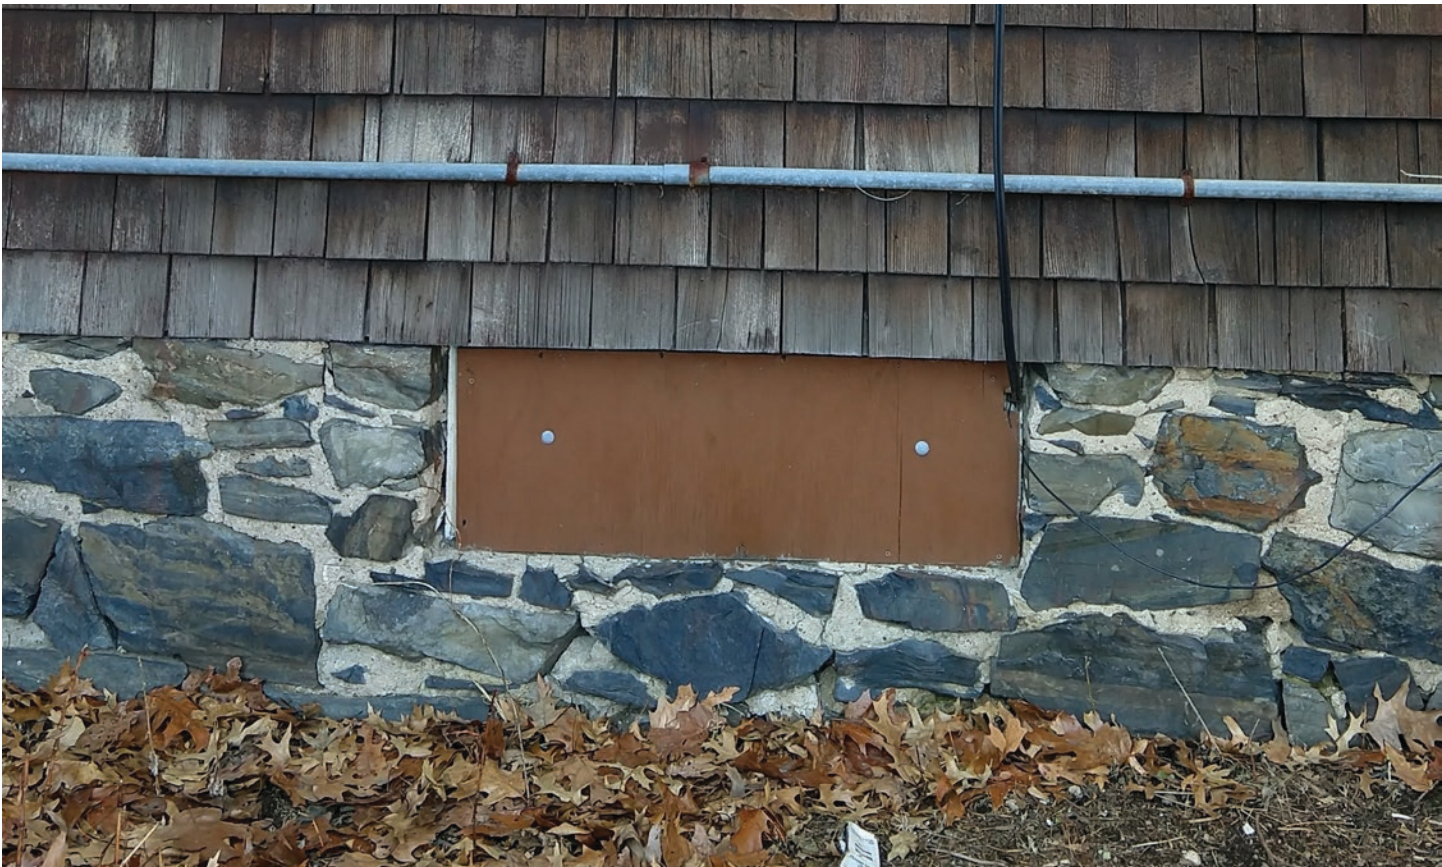
Figure 14: Building E Restored Foundation and Post Base

At Building E, new cast concrete foundations to support curtain walls at open bay fronts and existing wood-framed walls that were built on grade will be coordinated with upper Courtyard pavement levels. The glazed curtain walls will extend to an abbreviated precast base to match the elevation of adjacent stone column bases.

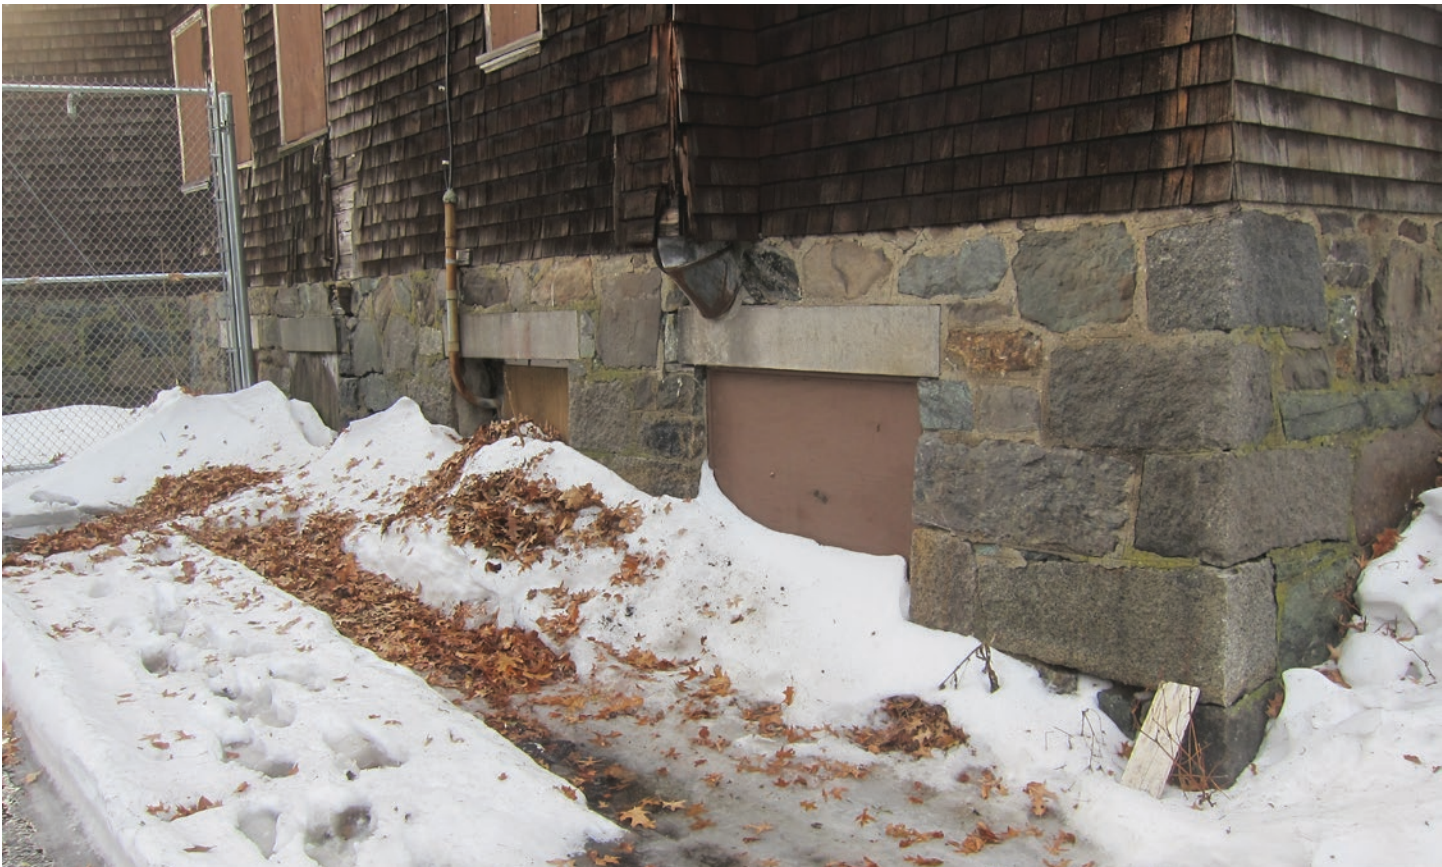
Figure 15: Building F Typical Foundation

At Building F and G, local repointing of the existing foundation will take place.

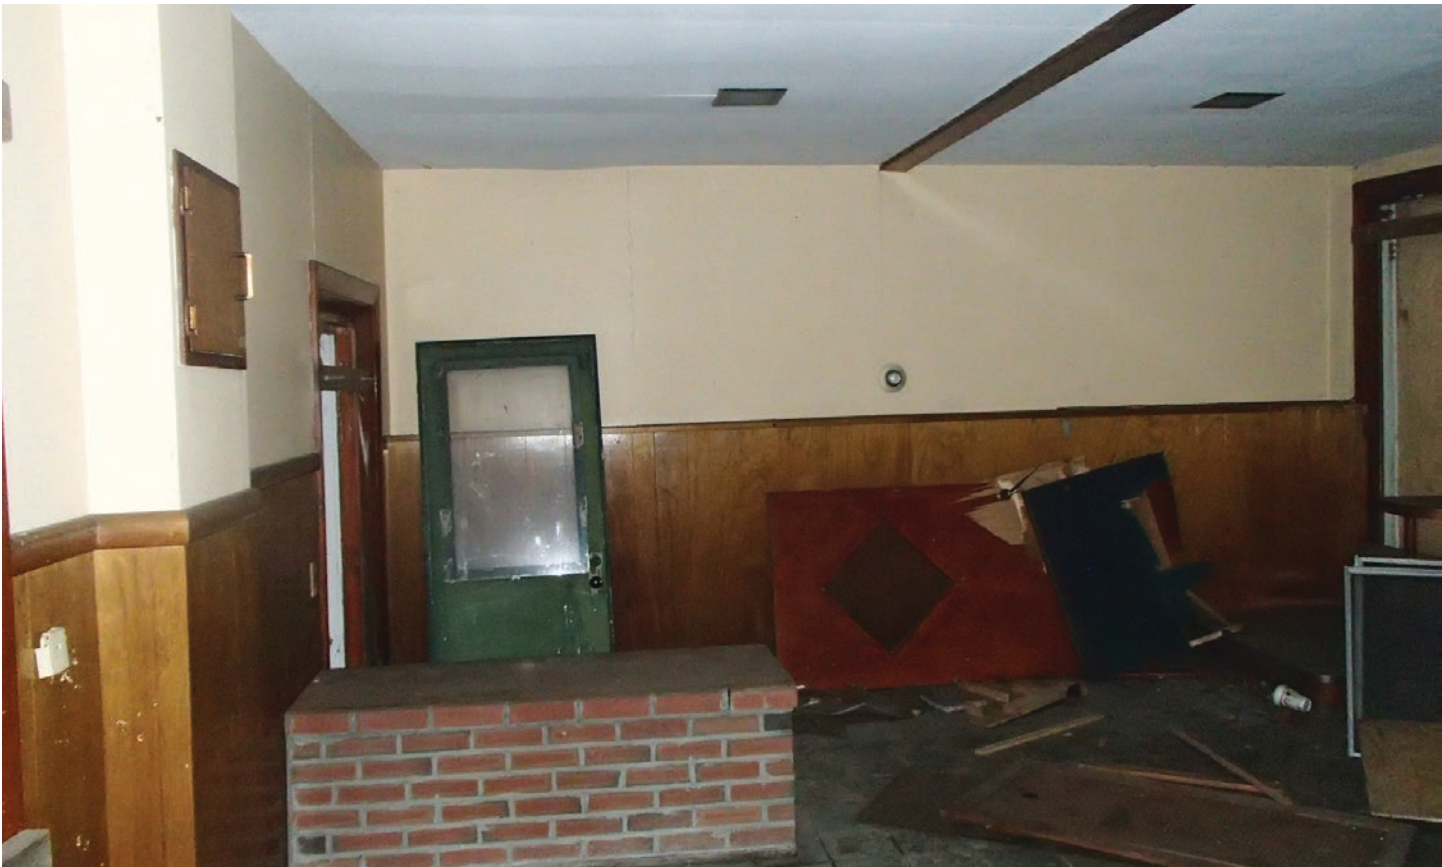
Figure 76: Building G Interior at Fire Damage
