# 71 Beacon Street, Unit 5

**Proposed Work: Replace five fourth story, front/rear/side façade, six-over-six, true-divided light windows in-kind**

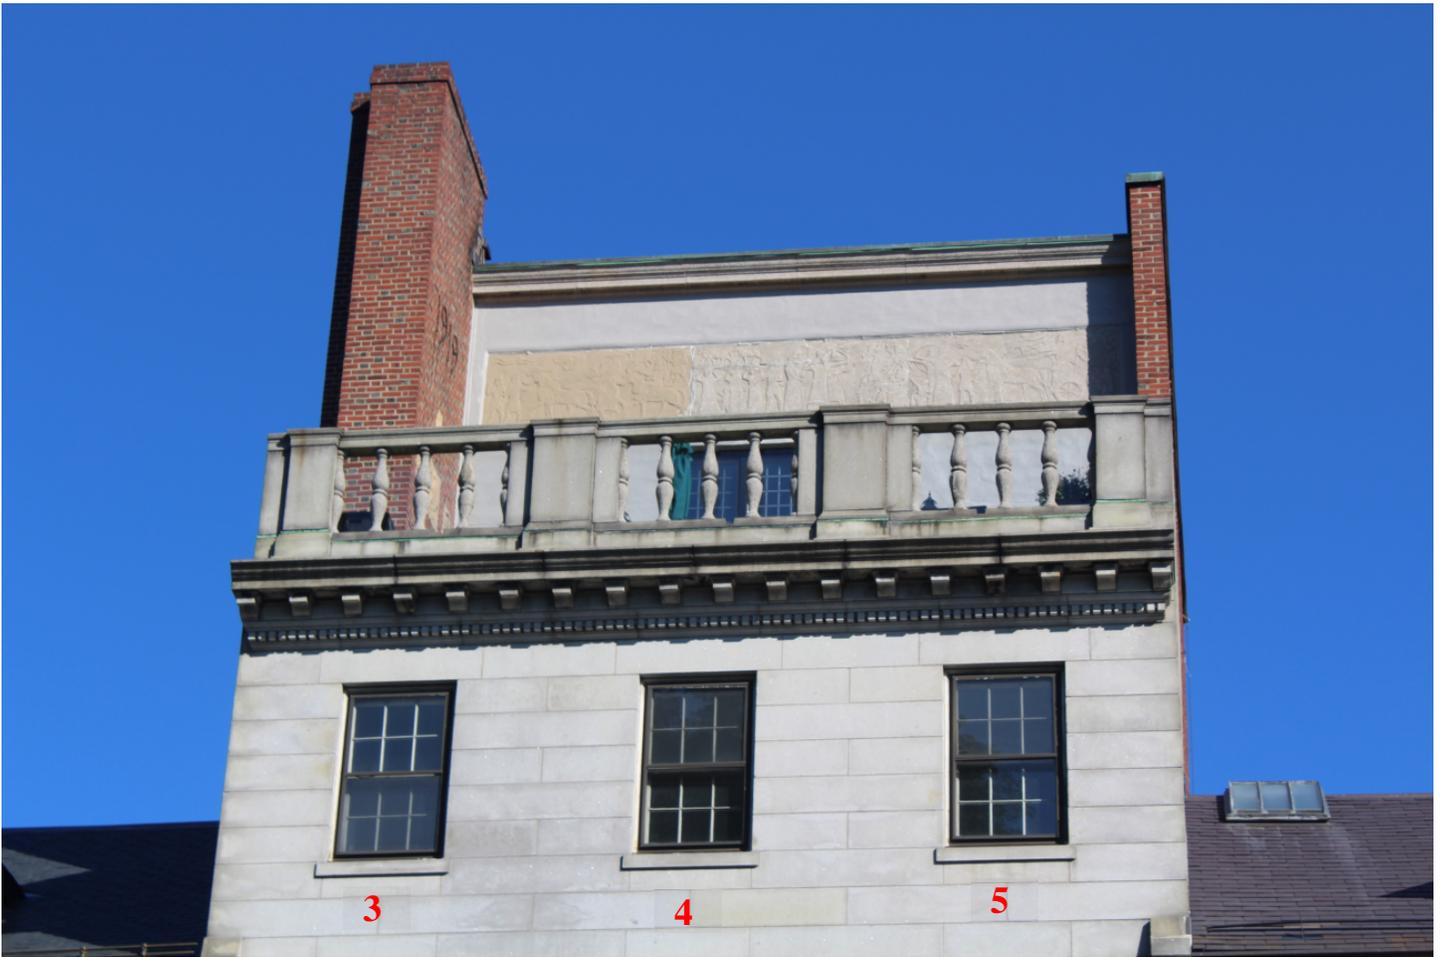
**Close-up of Windows 3-5 on Beacon St.**

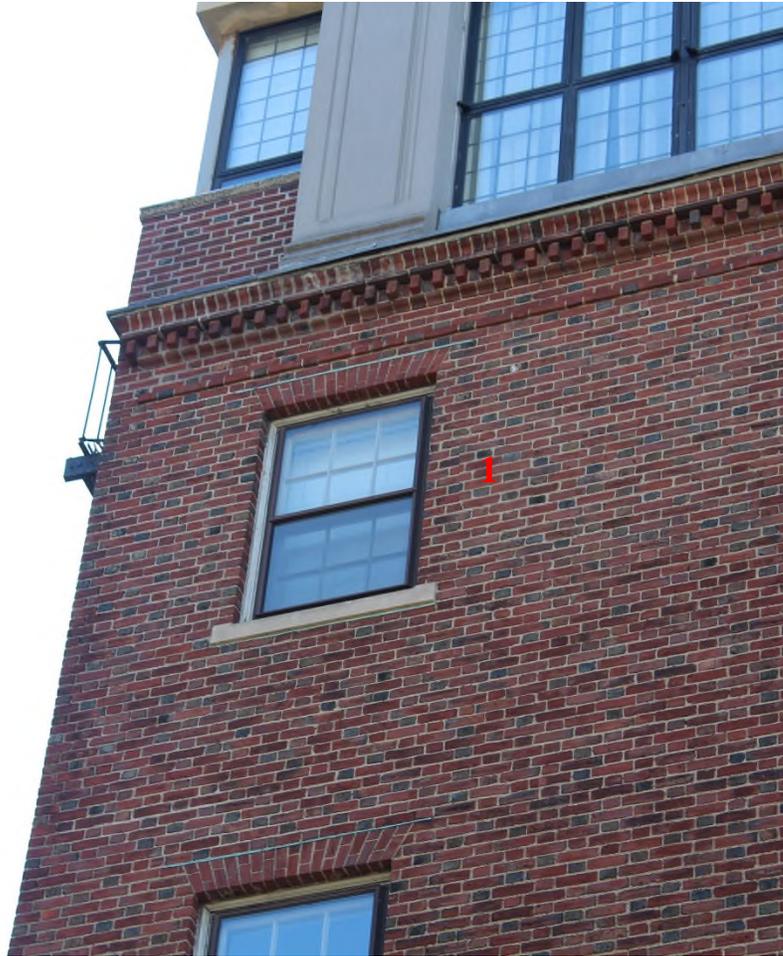
**Close-up of Window 1 on Byron St.**

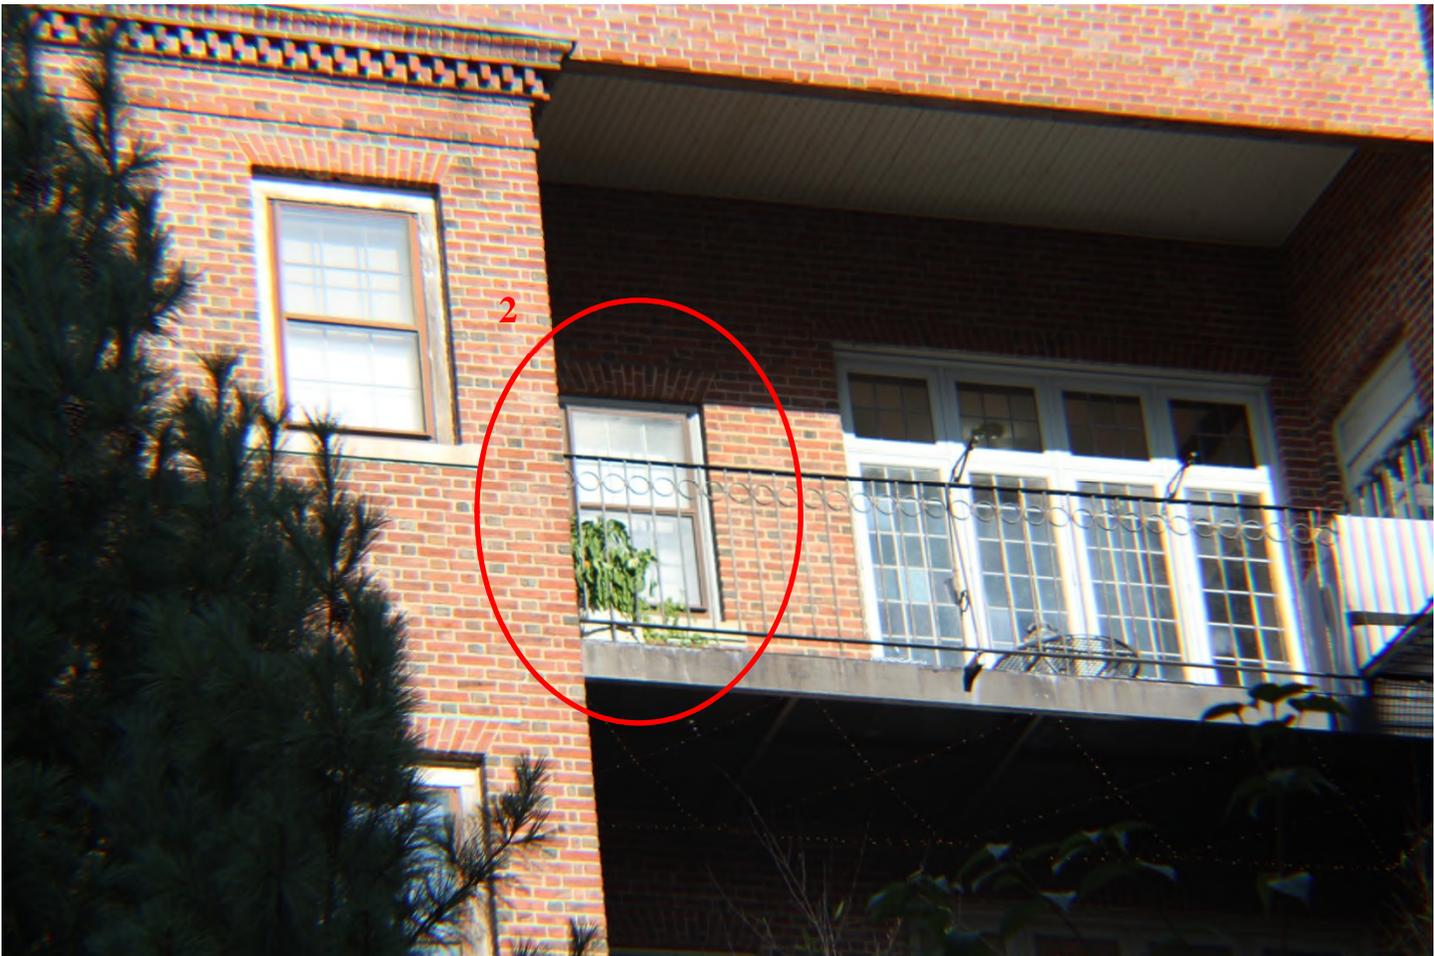
**Close-up of Window 2 from Private Garden**
