HISTORIC FACADE RESTORATION

14 BEACON STREET
BOSTON, MA 02108

MARK	DATE	DESCRIPTION
	04-25-18	HISTORIC REVIEW SUBMISSION

EXISTING WEST ELEVATION

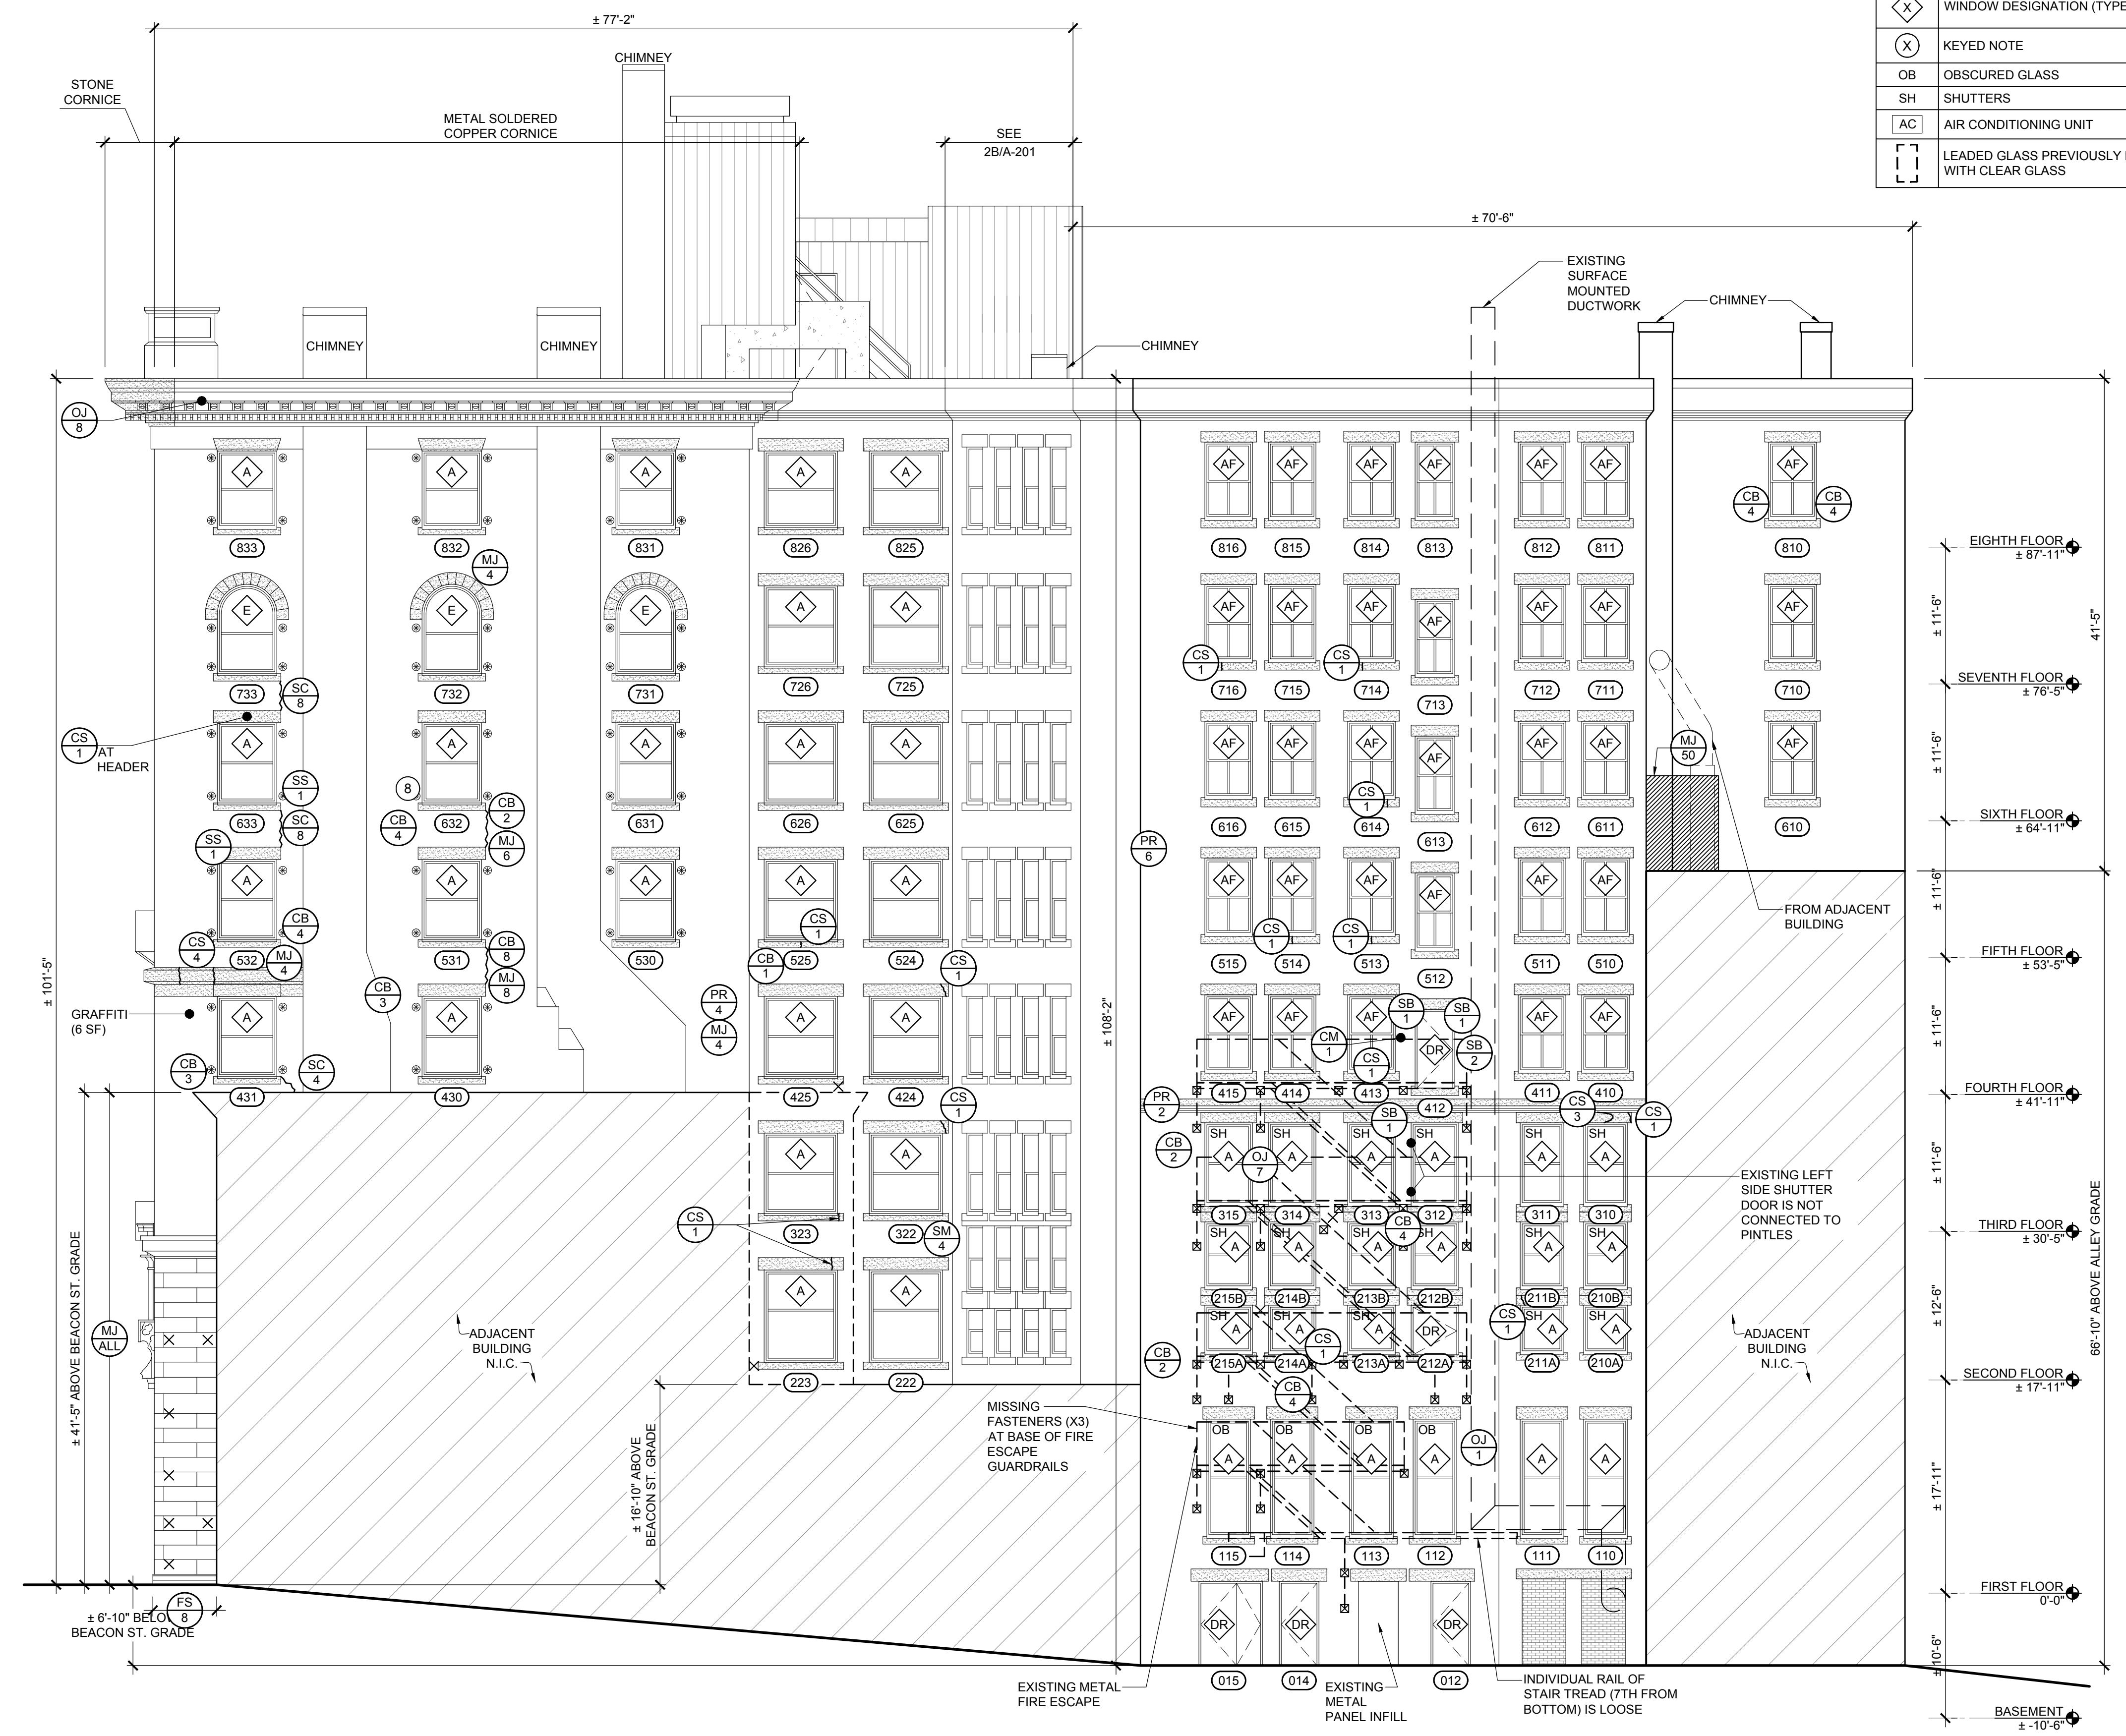
1 WEST ELEVATION
1/8"=1'-0"

GENERAL NOTES	
1)	ROUNDED EDGES OF STONE ON BEACON STREET ELEVATION ARE WORN/ERODED.
2)	CARBON STAINING AT 90% OF SURFACE AREA OF BEACON STREET CORNICE/OVERHANG. SIGNS OF PREVIOUS CRACK REPAIRS EVIDENT.

3)	NO LEADED T JOINTS AT STONES ON HORIZONTAL LEDGE AT 3RD FLOOR CORNICE ON BEACON STREET ELEVATION.
4)	ROWLOCK BRICK UNITS AT ALL ELEVATIONS EXCEPT LIGHTWELLS ARE BLACK/BROWN GLAZED BRICK. 60% OF UNITS ON THESE ELEVATION ARE CRACKED.

5)	HEAVY CARBON AND RUST STAINING AT STONE HEADERS AND SILLS AT AND ADJACENT TO WEST ELEVATION FIRE ESCAPE.
6)	MAJORITY OF SHUTTER DOORS CANNOT COMPLETELY CLOSE. HEAVY RUST STAINING IS EVIDENT ON THE SKYWARD FACING DOOR SURFACES.

7)	FIRE ESCAPE GUARDRAIL EMBEDMENT LOCATIONS HAVE NO PERIMETER SEALANT AND MULTIPLE SPALLED BRICK AROUND THEM. 8 LOCATIONS AND 4 SPALLED BRICK UNITS EACH.

8)	EXISTING DELAMINATED PAINT/COATING IS PRESENT ALL THE LIGHTWELL ELEVATIONS.

KEYED NOTES	
①	BALCONY EMBEDMENT OK. 65% OF BALCONY IS RUSTED AND HAS FLAKING PAINT. NEWER FASTENERS.
②	EDGES OF STONE ARE SPALLED. PREVIOUS MORTAR JOINT REPAIRS ARE EVIDENT.
③	STEP CRACK THROUGH STONE AT "U" IN THE WORD "HOUSE".
④	ANCHOR/PIN LOCATION COVERED WITH INFILL. SEPARATING MORTAR JOINTS (16 LF) ALL AROUND TABLET.
⑤	CARBON STAINING AT ALL ORNAMENTAL STONWORK.
⑥	DETAILS AND SCROLL EDGES SPALLED. WIDESPREAD CARBON STAINING.
⑦	COPPER PREVIOUSLY PAINTED. JOINT BETWEEN COPPER AND STONE OPEN, FASTENERS/RIVETS POPPED/MISSING.
⑧	BROKEN SHUTTER PINTLE.
⑨	ARCH APEX STONE HAS HARD JOINT - NO SPACE.
⑩	WOOD AND CHICKEN WIRE AT GAP.
⑪	RUSTED METAL FAUX BALCONY.
⑫	DETERIORATED MORTAR JOINT (9 LF) AT STONE AROUND BALCONY.
