223 West Newton St.
Head House Re-Siding

Amended Submission – October 26, 2022

Original Submission – September 12, 2022

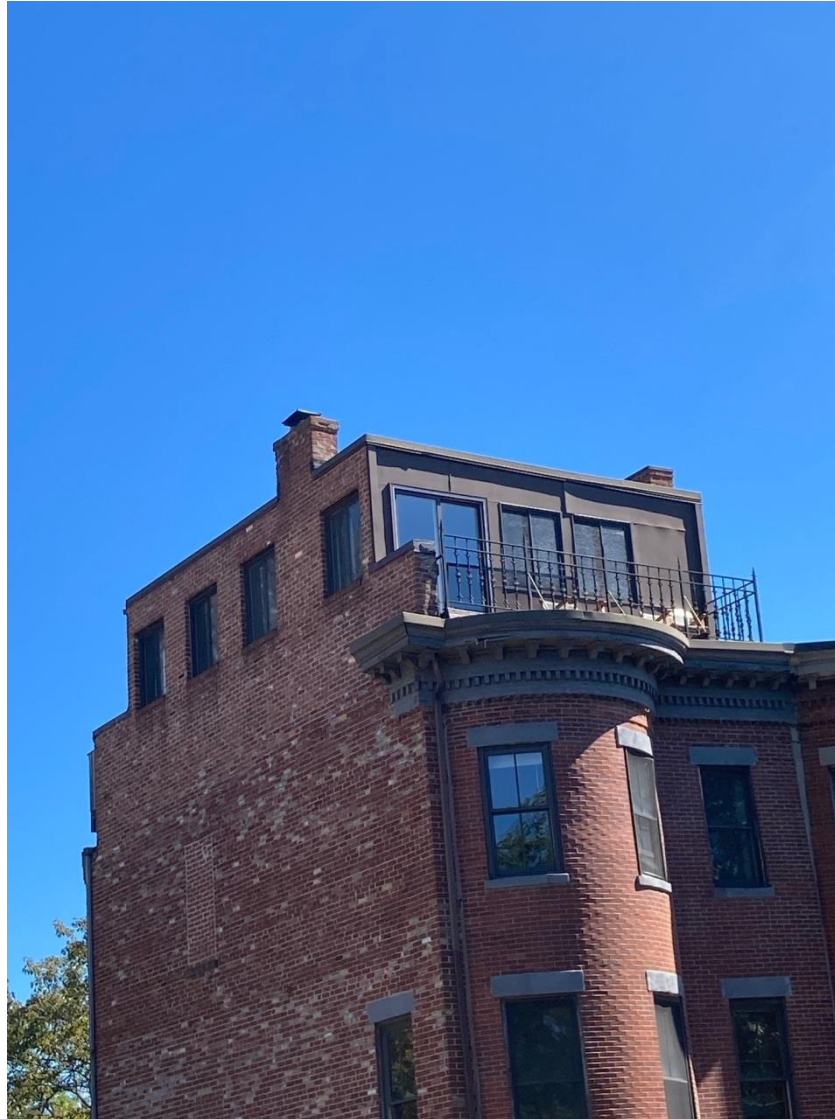
Current Condition – Front

- We would like to reside the front and back walls of a head house at 223 West Newton Street.
- The current siding is a composite board that is separating from the wall and delaminating.
- There are large gaps between sections of the siding letting water into the wall.
- There is also no flashing above the windows and doors letting water into the wall and rotting out the door and window frames.
- The current siding is unsightly.

- We would like to replace the siding with synthetic slates, which will be much more in keeping with the surrounding buildings.
- We looked at using real stone, but the head house was not designed to support heavy siding material as the weight of the structure is supported by the roof and is inset from the front and back outside walls.
- We have engaged Secure Roofing at 141 Bayside Rd Quincy to complete the work.
- The estimated cost is \$21,000.

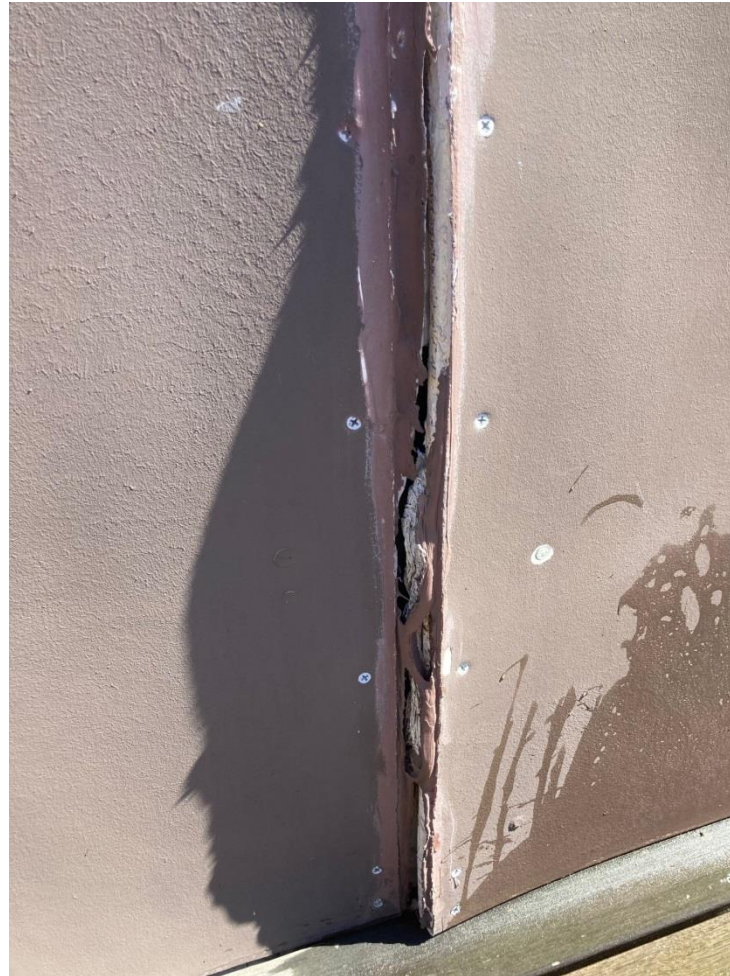
Current Condition – Front Wall Panel Separation from Wall and Gap Between Sections

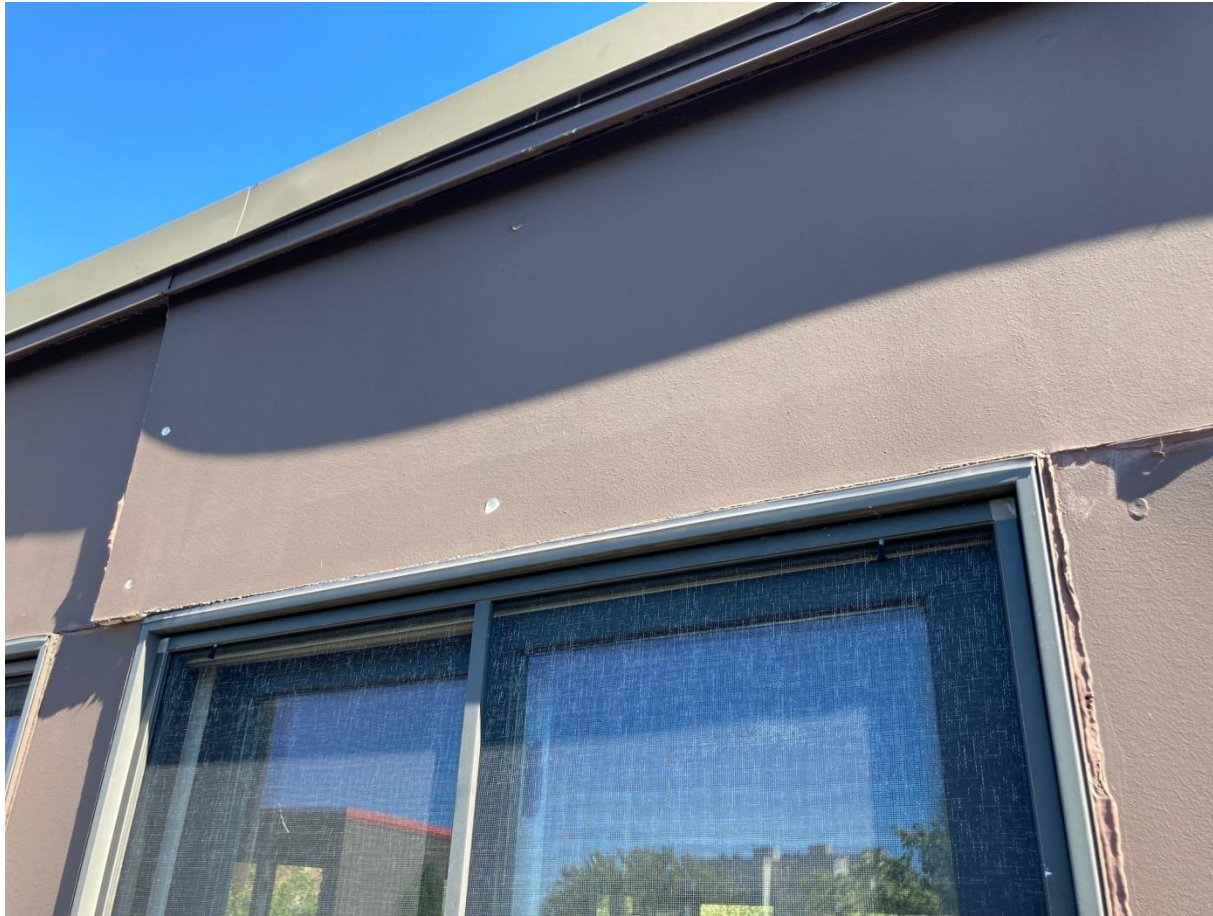
Current Condition – Front Panel Separation and Crack Between Sections

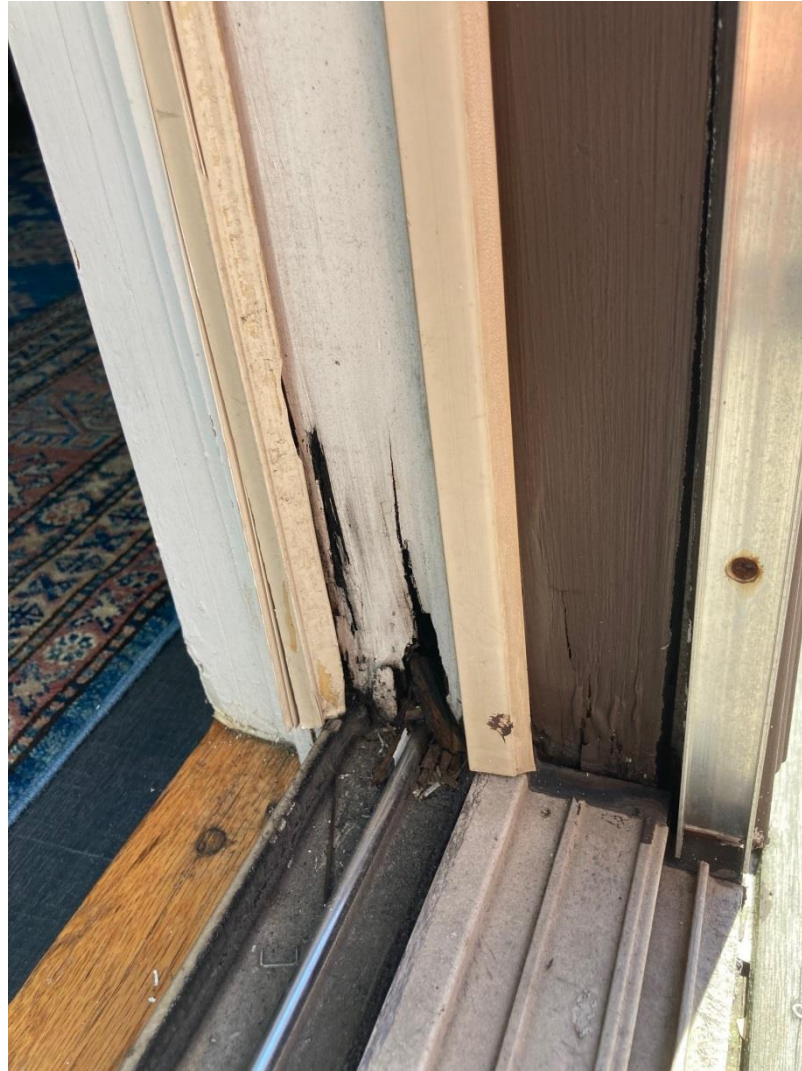
Current Condition – Front Sliding Door Frame Rot from Water Leaks

- **Flashing Type, Color:**
 - Contractor will use step flashing, which is available in copper. This will replace the current condition, where there is only wood above windows and doors and there is consequent wood rot.

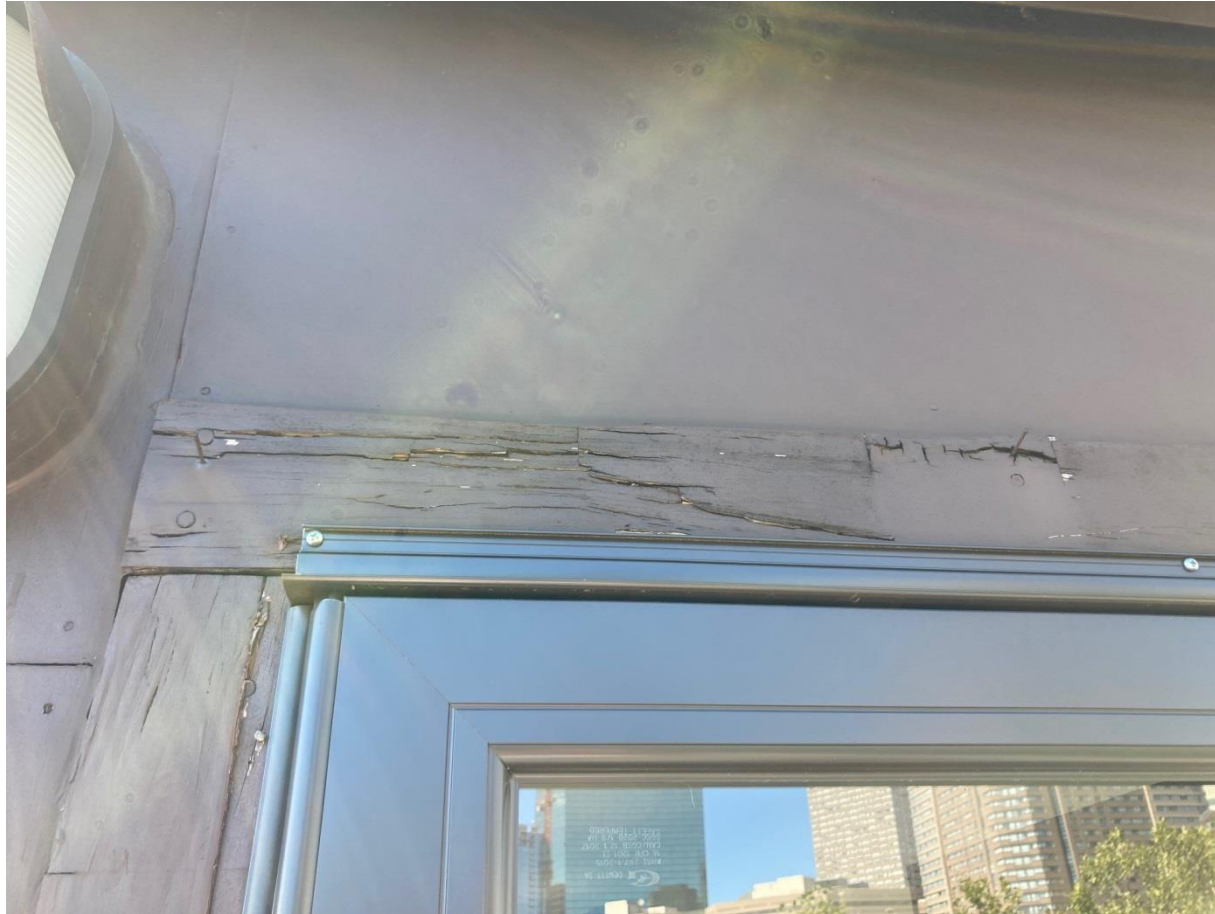
Current Condition – Rot Around Back Door Frame
