## The Cornerstone Project

# 97-101 NEWBURY St. – FRONT ENTRY LANDSCAPE BACK BAY ARCHITECTURAL COMMISSION

01 / 11 / 2023

Tree Report at 97 Newbury St, Boston, MA

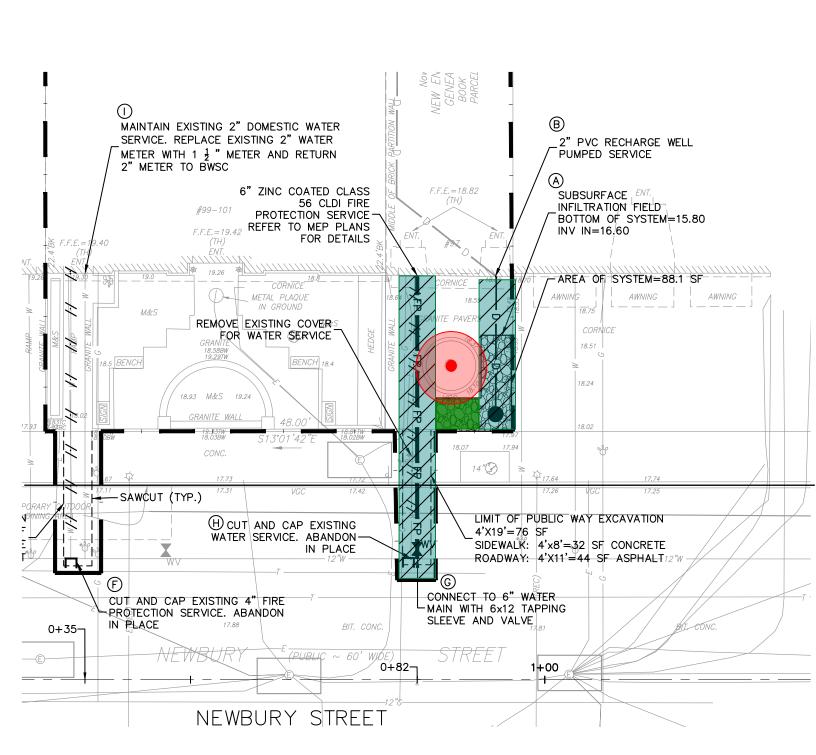
The drawing below illustrates the Code required excavation around the existing tree at 97 Newbury Street. The red zone is the expected root ball, the green shading shows the width of the trench for the utilities being installed.

New Fire Service line trench is 4' deep and will have the most impact to the root ball. This needs to be installed in this location because it is an increase in size from existing and it aligns with the new fire pump in the building.

New drain line and stone infiltration is mandated for ground water recharge per Boston Water and Sewer. This area is three feet deep,filled with stone and a new drainage pipe.

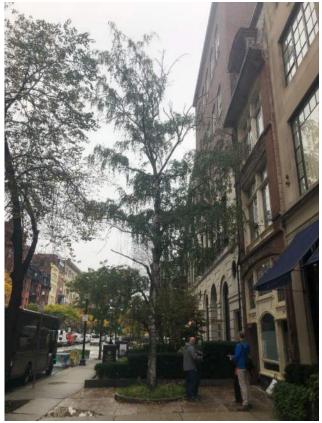
A European birch (*Betula pendula*) tree was growing within a raised granite planter in front of the building. This tree was determined to be in poor condition (Photo 1). The birch had a trunk diameter of 13 inches and was located within a raised planter with limited soil volume.

The tree is in poor condition. There is significant dieback in the upper canopy. European birch is especially susceptible to bronze birch borer. The dieback may be attributed to these borers. Additionally the upper canopy was thin and leaf size was reduced when compared to the lower canopy. These are symptoms of a decline in tree health/vigor.

The construction documents detail existing plans to install fire protection and other lines on each side of the planting bed. Excavation of the trench will be within a foot of the stem on the West and within 2 feet on the East. Severe root damage will occur if excavation occurs as planned. The tree is likely to decline and expire quickly or may fall over as much of the supporting root mass will have been removed

**Photo 1**: Image of observed tree location on the property. Note the trees location in the small raised planter in an existing granite paver sidewalk.

This birch tree will be recommended for removal in order to complete this construction
