238 Marlborough Street

Façade Restoration

Landmarks Hearing June 14th, 2023

Springer Architects

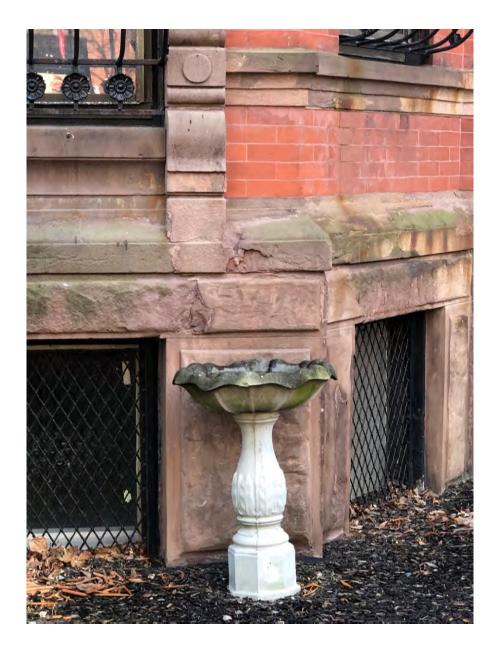
Damaged brownstone

- Repair all damaged brownstone and paint with Tammscoat waterproof paint, HC69.
- Restore metal mansard window surrounds in kind and paint with Tammscoat color HC69.

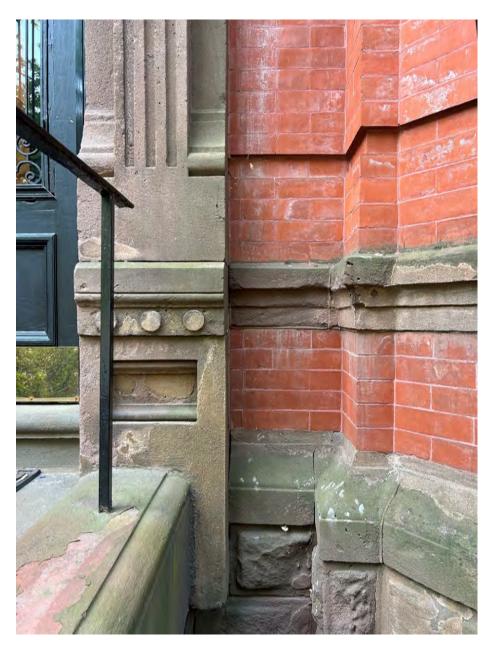
Damaged brownstone and efflorescence

- Restoration of the North and South Facades in kind.
- Repoint brickwork on North and South facades as well as 5th floor East and West facades.
- Remove brick staining and efflorescence.

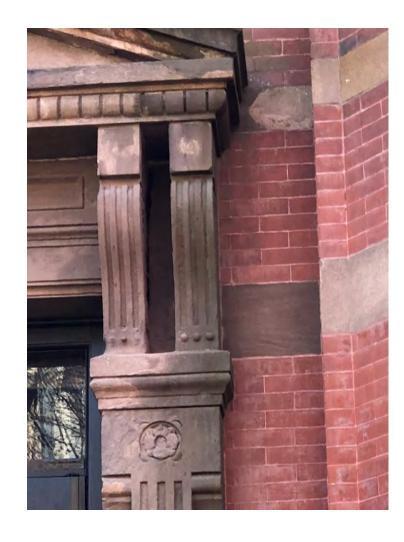
Front entrance staining and damage detail

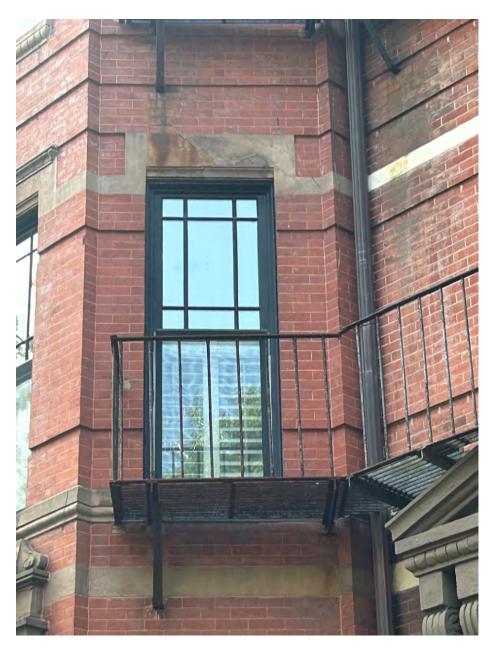
Third floor window with staining

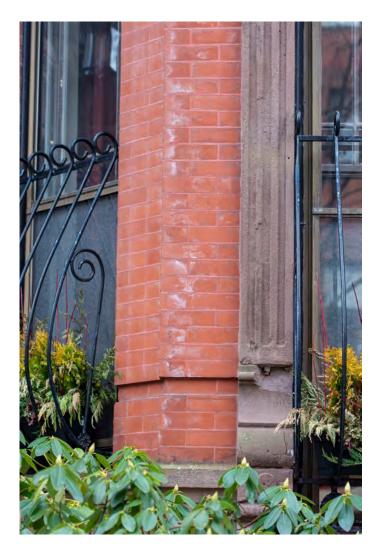
Brown stone and brick damage and staining detail

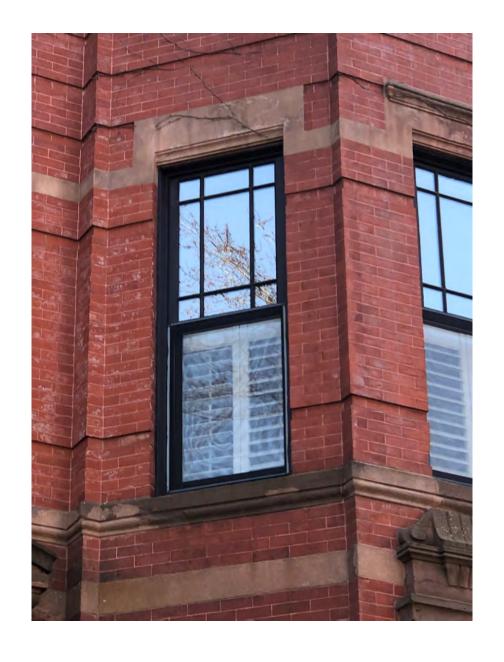
Brick efflorescence and staining
