CLOSURE ASSESSMENT REPORT

Underground Storage Tank Removal 8 Old Road Boston, Massachusetts

CHES Job No. SB-1134649

April 17, 2006

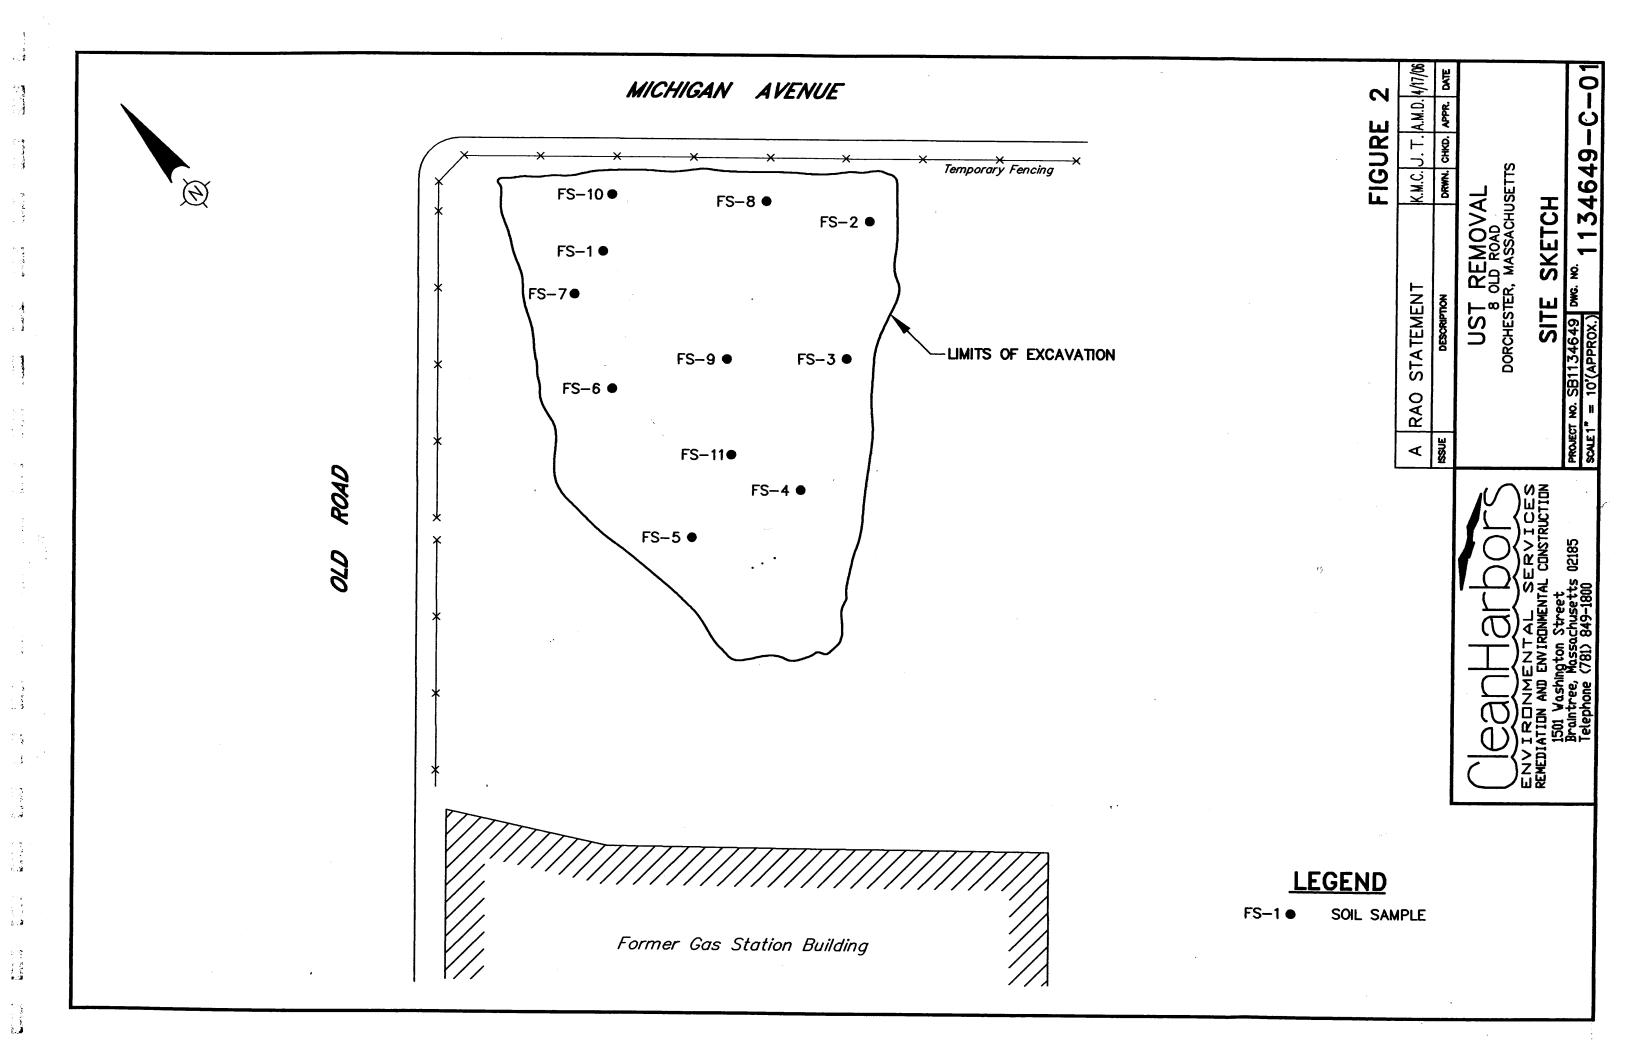
The first tank removed, a 5,000-gallon UST, showed definite signs of corrosion with several spots on the tank having rusted completely through. The sand below and the soil around the tank however, revealed no olfactory or visible evidence of petroleum impact and was stockpiled onsite for subsequent reuse. The five remaining USTs and all associated piping showed no visible signs of damage or leakage. All tanks were resting on a poured concrete pad which extended beneath the entire tank grave area. On March 9, 2006, a CHES Project Scientist visited the site to document and sample the excavation limits. The site had been partially backfilled with the excavated soil as directed by the DEP representative. As shown on Figure 2, the final excavation measured approximately 50 feet by 40 feet including the area that was the location of the pump island, with a maximum depth of approximately 15 feet to the concrete pad. Groundwater was not encountered and no visual or olfactory evidence of petroleum was noted. CHES did not excavate beneath this concrete pad structure. As shown on Figure 2, twelve grab soil samples,

designated FS-1 through FS-12, were obtained from various locations in the excavation. The samples were field screened for volatile organic compounds (VOC) using standard headspace methodologies and a photoionization detector (PID) calibrated to a benzene response. The samples, which represent both the backfill soil and the soil at the excavation limits, exhibited no visual or olfactory evidence of petroleum and as summarized in Table 1, VOC screening results varied from 0.0 to 7.2 parts per million (ppm). At the direction of the DEP representative, splits of these samples were composited for laboratory analysis. Therefore, CHES submitted four samples to GeoLabs, Inc. analytical laboratory in Braintree, Massachusetts for Volatile Petroleum Hydrocarbon (VPH) analysis, two samples for Extractable Petroleum Hydrocarbon (EPH) analysis and two samples for total lead analysis. Samples VPH-1 and EPH-2 were composites of samples FS-3 & FS-4, VPH-2 and EPH-1 were composites of samples FS-2 & FS-8. VPH-3 was a composite of samples FS-1 & FS-7 and VPH-4 was a composite of samples FS-6 & FS-11. Two composite samples (C-1 and C-2) were also obtained for laboratory analysis for lead. Sample C-1 was collected from three areas, FS-1, FS-2 and FS-3 sample areas, while C-2 was collected from the FS-5, FS-6 and FS-9 sample areas. The laboratory results are summarized in Tables 2, 3 and 4 and a copy of the Laboratory Report is presented in Appendix C.

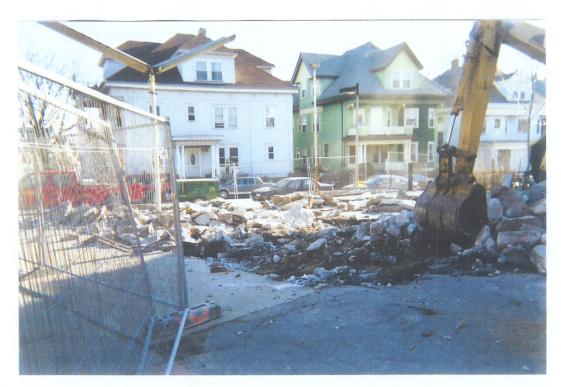
Photo 1: Excavator removes the concrete broken up earlier with a hoe-ram: photo taken facing east on 3/7/06.

Following a site inspection, CHES began the excavation on Monday, March 6, 2006 using a Hoeram to break up the concrete and asphalt that overlay the USTs. The following day, March 7, 2006, CHES removed 15.87 tons of concrete (including a small pump island) from the site and transported it to Recycle Technology, LLC in Charlton City, MA for recycling under a Straight Bill of Lading (Document No. 80016). The Bill of Lading and the weight slip are attached in Appendix B. A CHES vacuum truck was then used to remove residual liquid and sludge from the tanks. In all, 1,712 gallons were removed from the tanks and transported under Uniform Hazardous Waste Manifest # MAU-190465 to Clean Harbors of Braintree in Braintree, MA. A copy of the manifest is attached in Appendix B. Following the UST cleaning an excavator was utilized to remove the soil around the tanks. On March 7, 2006, a 5,000 and a 2,000-gallon capacity UST were unearthed. On March 8, 2006, two more 5,000-gallon and one 2,000-gallon capacity USTs were pulled from the ground and five of the six USTs were transported to Tank Yard Number 008 of the James G. Grant Co., Inc. at 28 Wolcott St. in Readville, MA. The following day, March 9, 2006, the remaining UST (with a 5,000-gallon capacity) was pulled from the ground, and along with the underground piping, these materials were loaded onto a flatbed trailer, and transported to the James G. Grant Co. facility in Readville, MA. All USTs were inerted by venting and application of dry ice, prior to individual inspection and sign off by BFD Fire Inspector that each UST was safe for transport off site. On March 13, 2006, CHES removed and shipped the remaining 18.27 tons of concrete to Recycle Technology, LLC under a Straight Bill of Lading (Document No. 75310: see Appendix B).

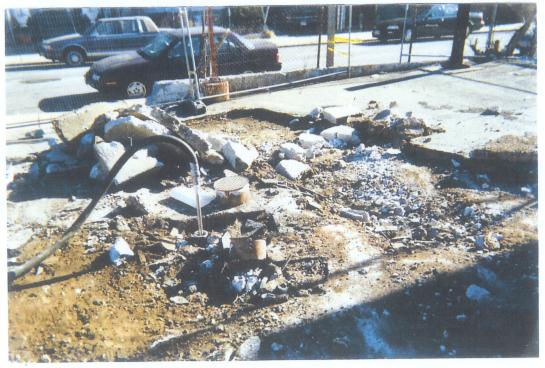
Photo 2: Following the removal of overlying concrete, USTs were pumped out: photo taken 3/7/06.

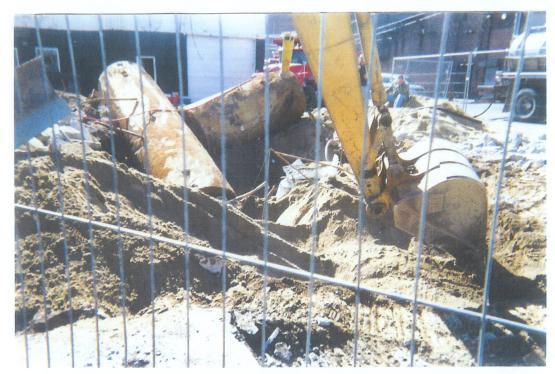
Photo 3: USTs are unearthed, vented, and dry ice is added to inert: photo taken facing north on 3/8/06.

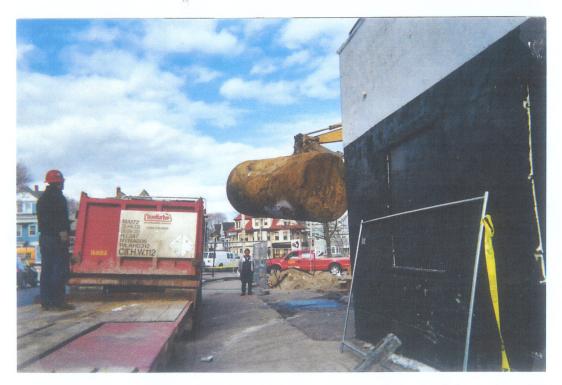
Photo 4: UST is lifted onto flatbed trailer for transport to disposal facility: photo taken facing north on 3/8/06.

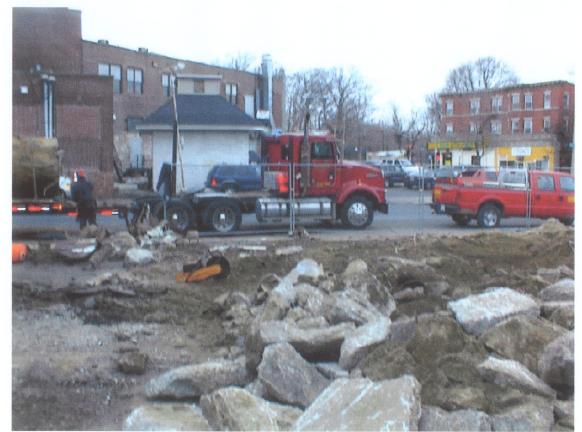
Photo 5: Last UST is prepared for transport to disposal facility: photo taken on 3/9/06 while facing west.

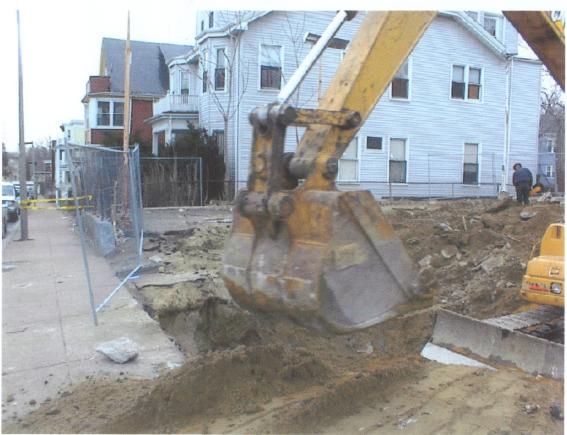
Photo 6: Backfilling process begins: photo taken while facing south on 3/9/06.

The UST Closure excavation resulted in an irregularly shaped pit that measured approximately 40 feet in width at the northern edge which ran along the Michigan Avenue sidewalk, was approximately 50 feet in length at both the eastern and western sides and tapered to approximately 10 feet at the southern edge closest to the former gas station building (see Figure 2). The depth of the excavation was consistent at approximately 15 feet under the USTs and was less than a foot at the southern edge under the vent line and the eastern edge at the location of the remote fill piping. Six USTs and associated underground piping, a mix of approximately 1,700 gallons of waste gasoline, sludge and water, and approximately 34 tons of concrete were removed from the site. There was a concrete pad present below the USTs that was left in place. To replace the material removed, approximately 168 tons of backfill was added to the site over a two-day period (March 9 and 10, 2006), compacted and returned to the original grade minus a two-inch allowance for asphalt. CHES has contracted and scheduled US Paving Co. to repave the site.
