Project A - Remove four leaded clearstory windows on the Church Court side of the building and replace them with clear glass.

Project B - Removal of the First Floor Iron Grates from the windows on the Church Court Side of the Building.

Project C – The clock will be restored to working order.

Picture Table of Contents

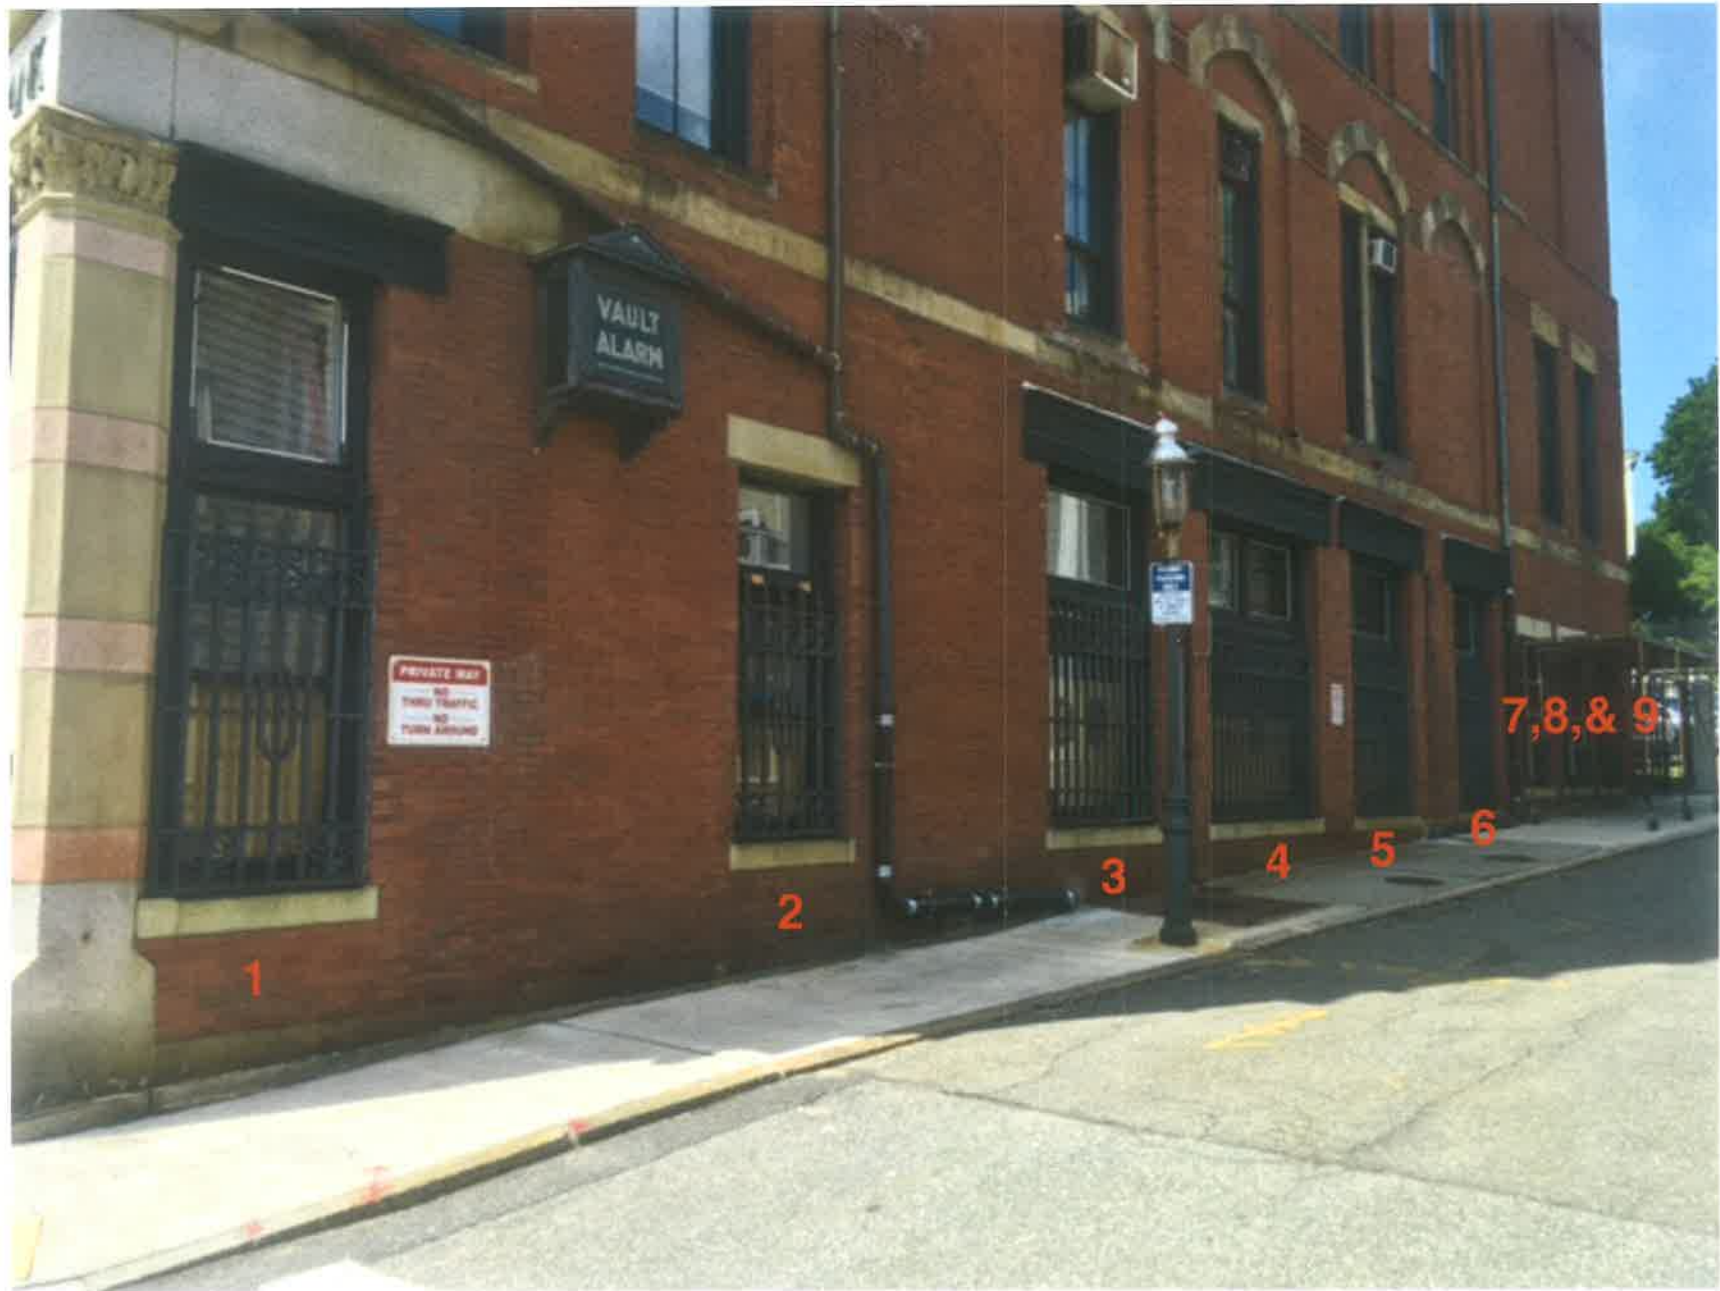
Church Court Windows – A - Depicting window locations on the building

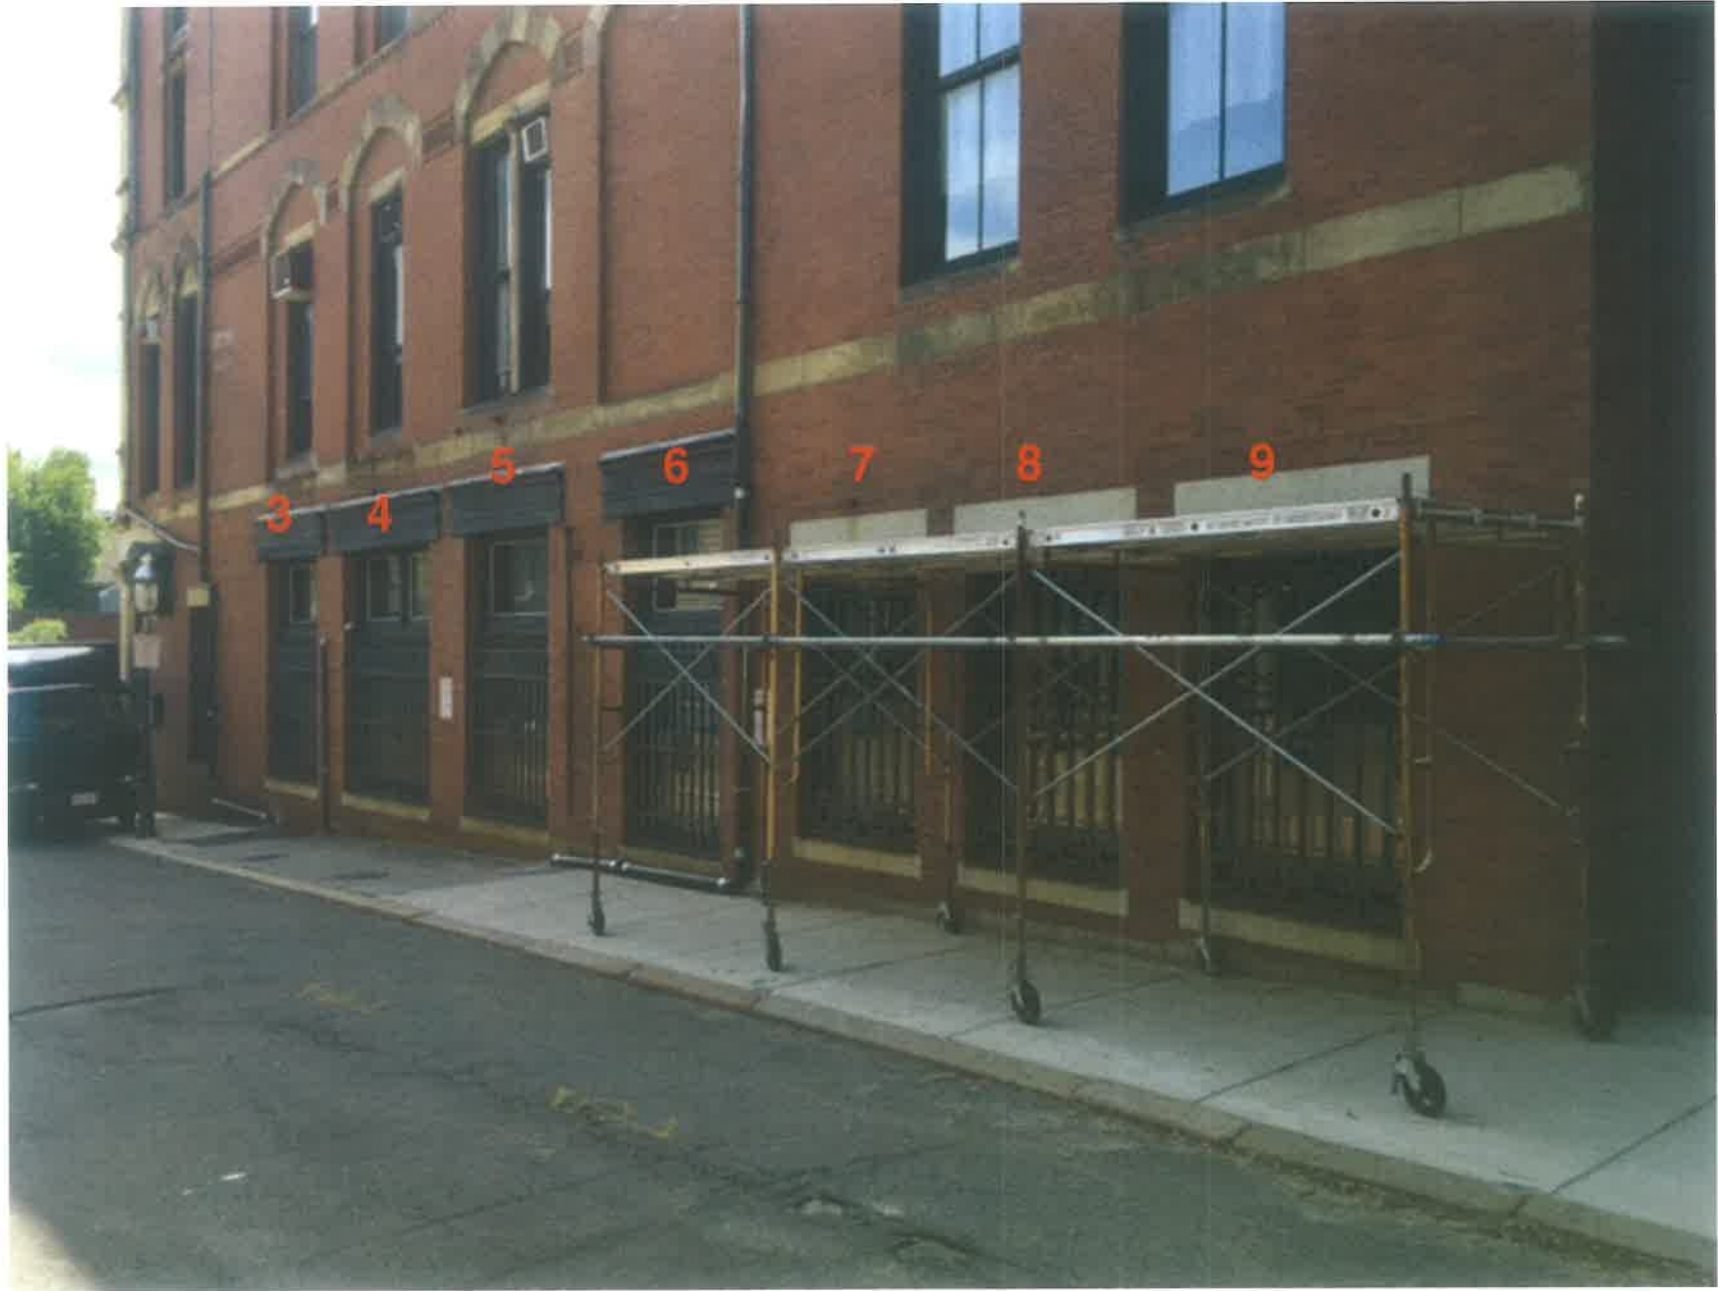
Church Court Windows – B - Depicting window locations on the building

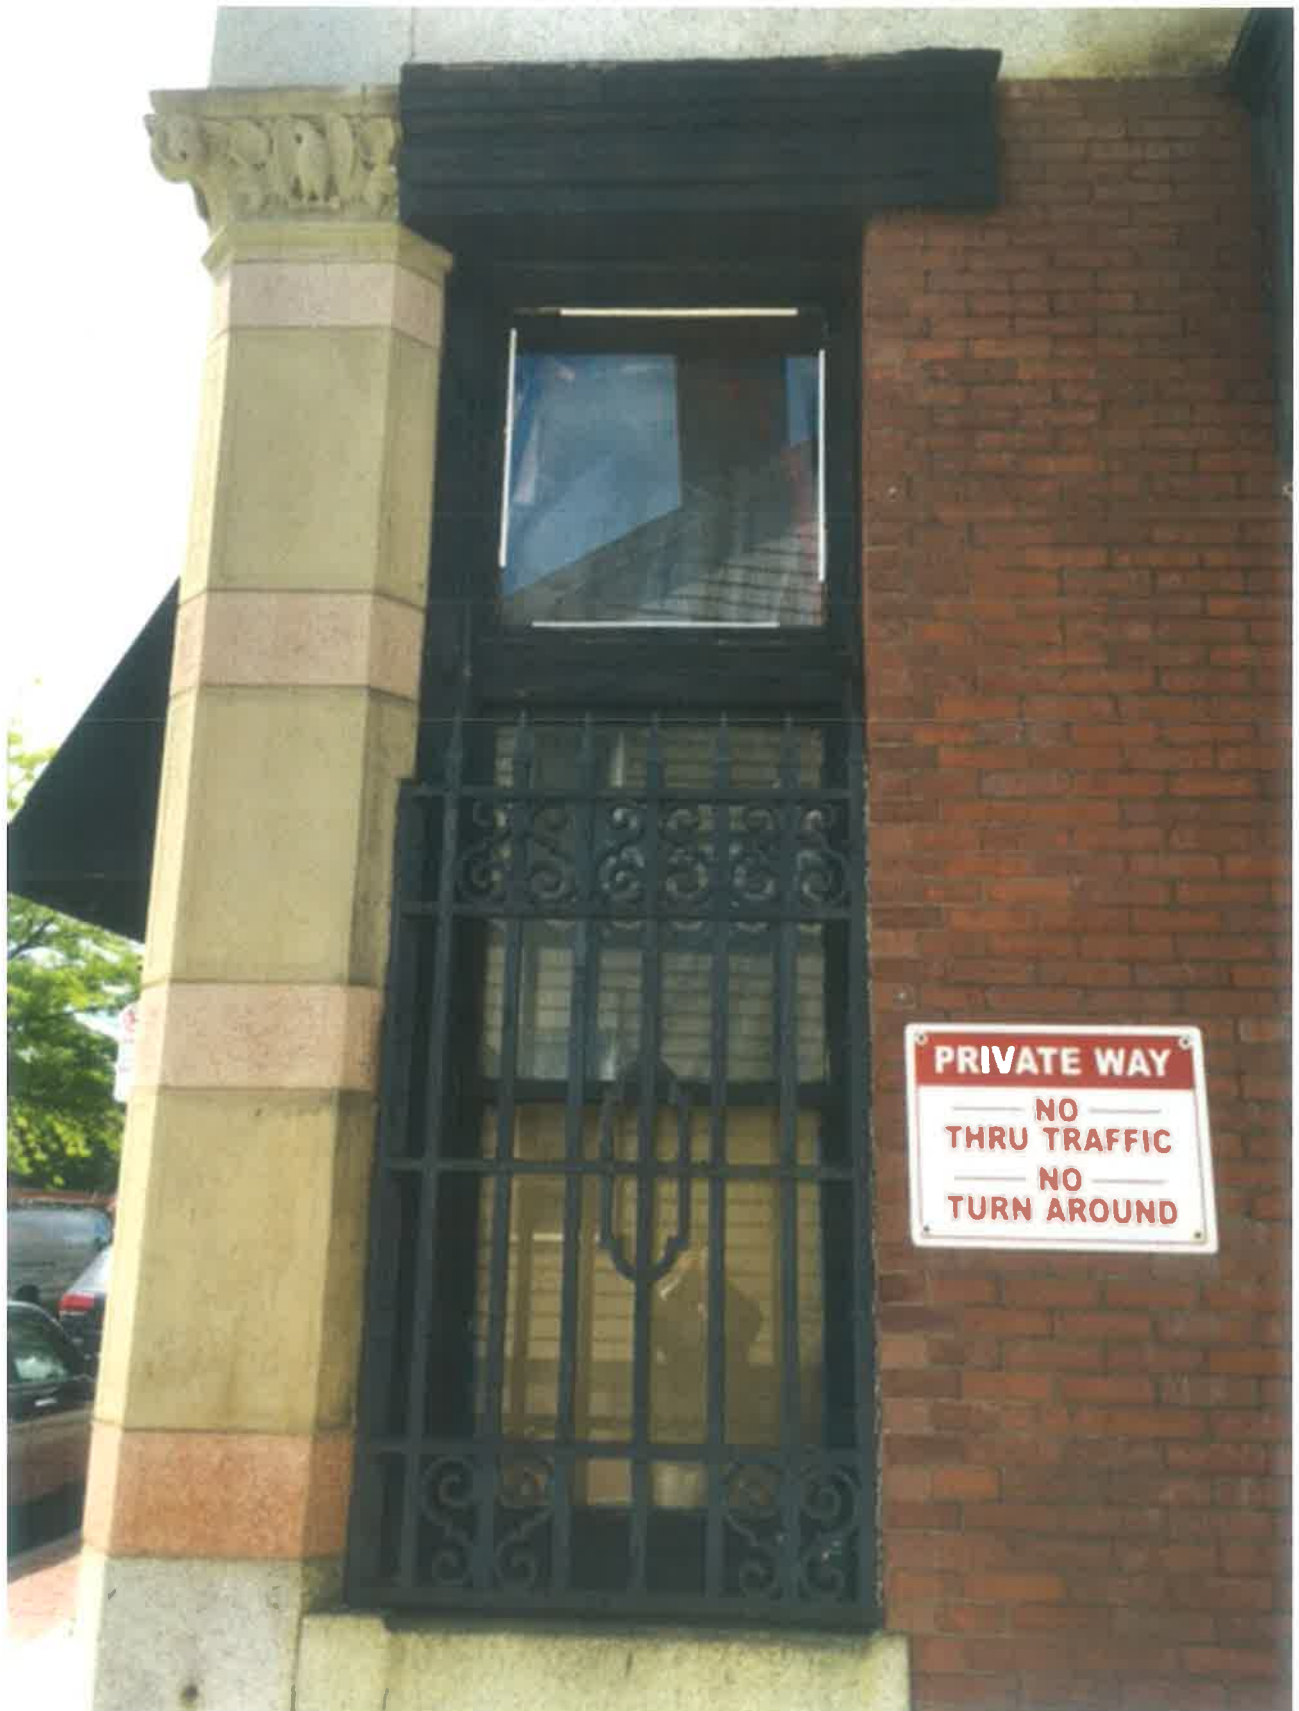
Church Court Window 1

Church Court Window – 1

Removed damaged clearstory leaded glass replaced with new clear glass
Remove and dispose of iron grate
Putty as required, scrape, sand, prime and paint

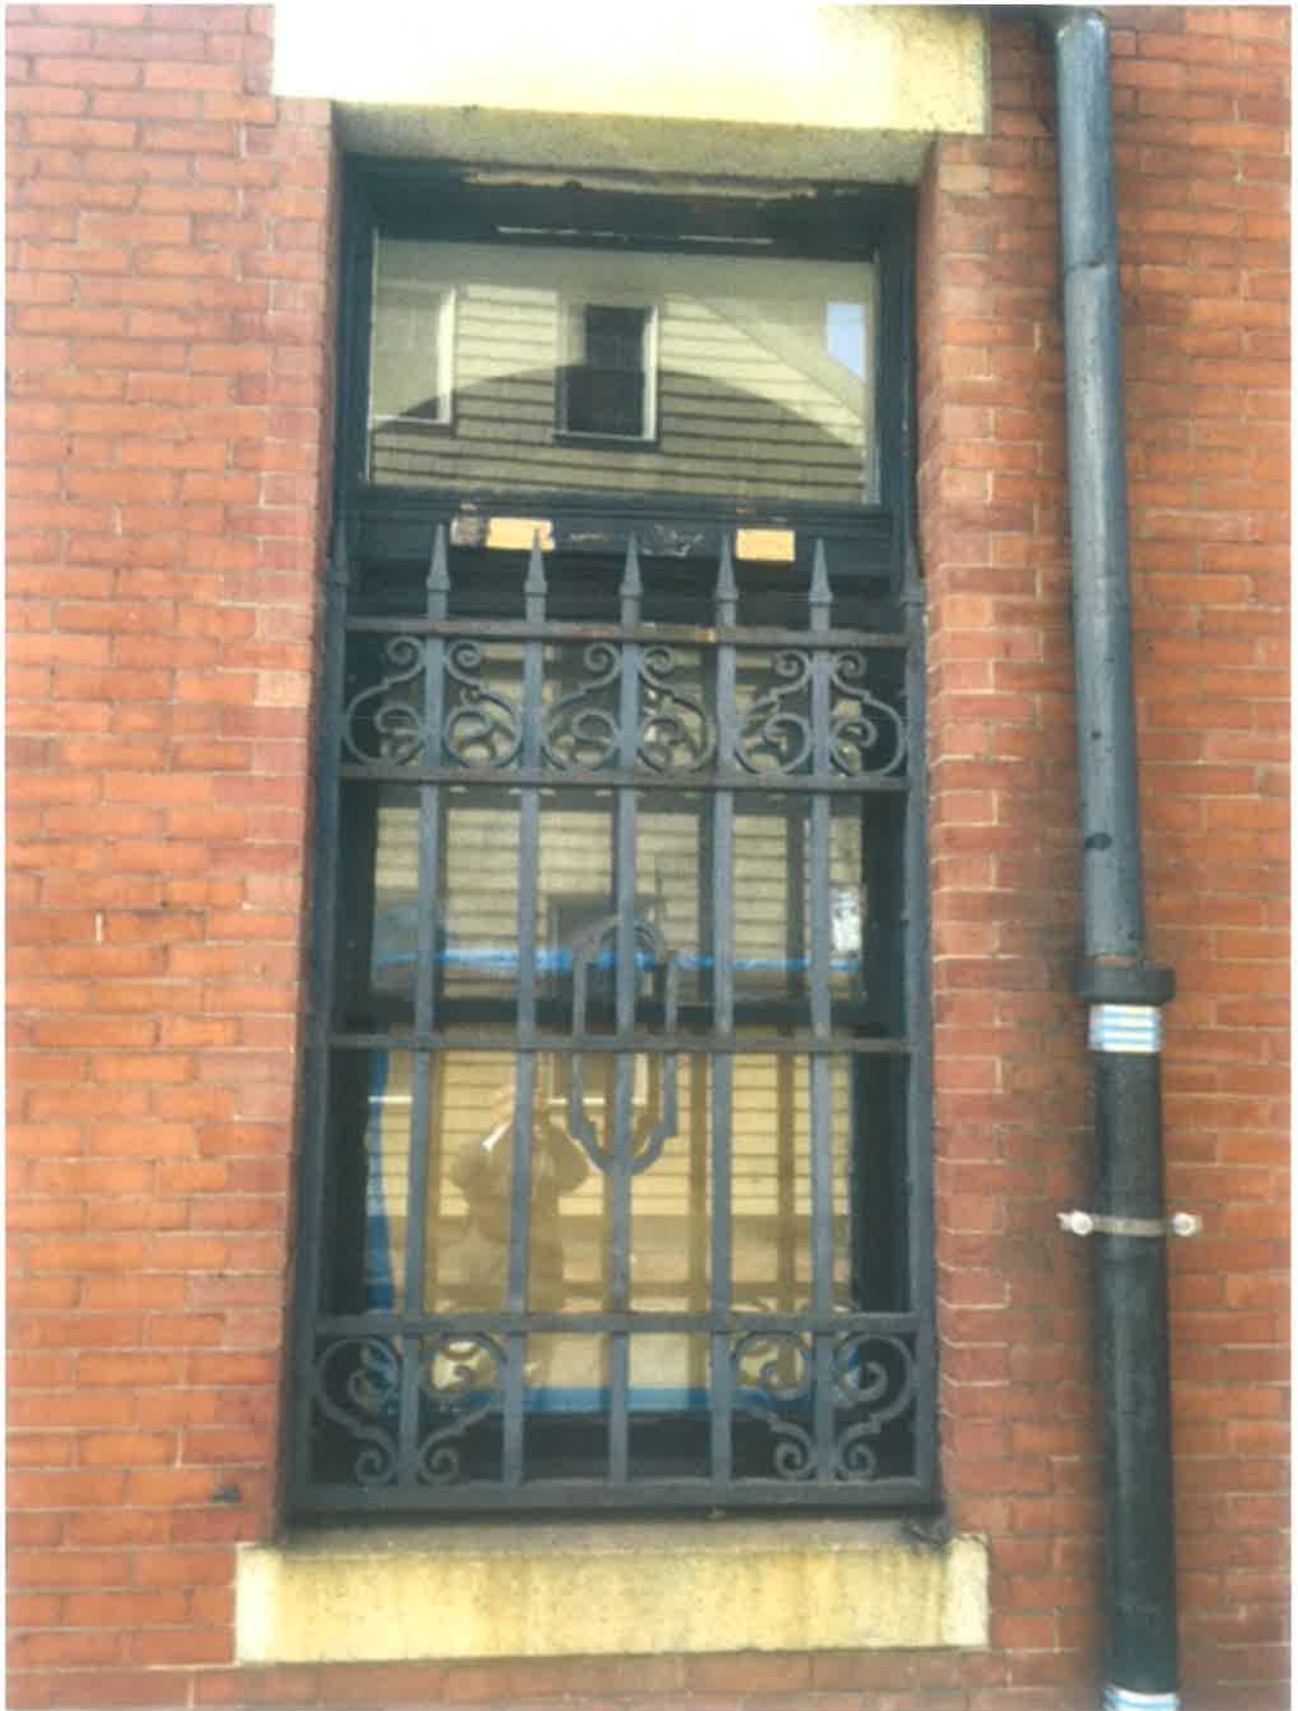
Church Court Window 2

Church Court Window – 2

Leaded clearstory glass was removed at some unknown time in the past and
a window air conditioning unit was installed. The air conditioning
unit was removed and new clear glass installed.
Remove and dispose of iron grate
Putty as required, scrape, sand, prime and paint

Individual clearstory window leaded pieces have been lost from the sashes over the years. The voids in the sashes have been covered with plastic. At some unknown time in the past a clearstory window unit (Window 3 in the attached pictures) was replaced with Plexiglas because the entire sash completely fell apart. Many years ago a clearstory window was removed to install a window air conditioning unit (Window 2 in the attached pictures).

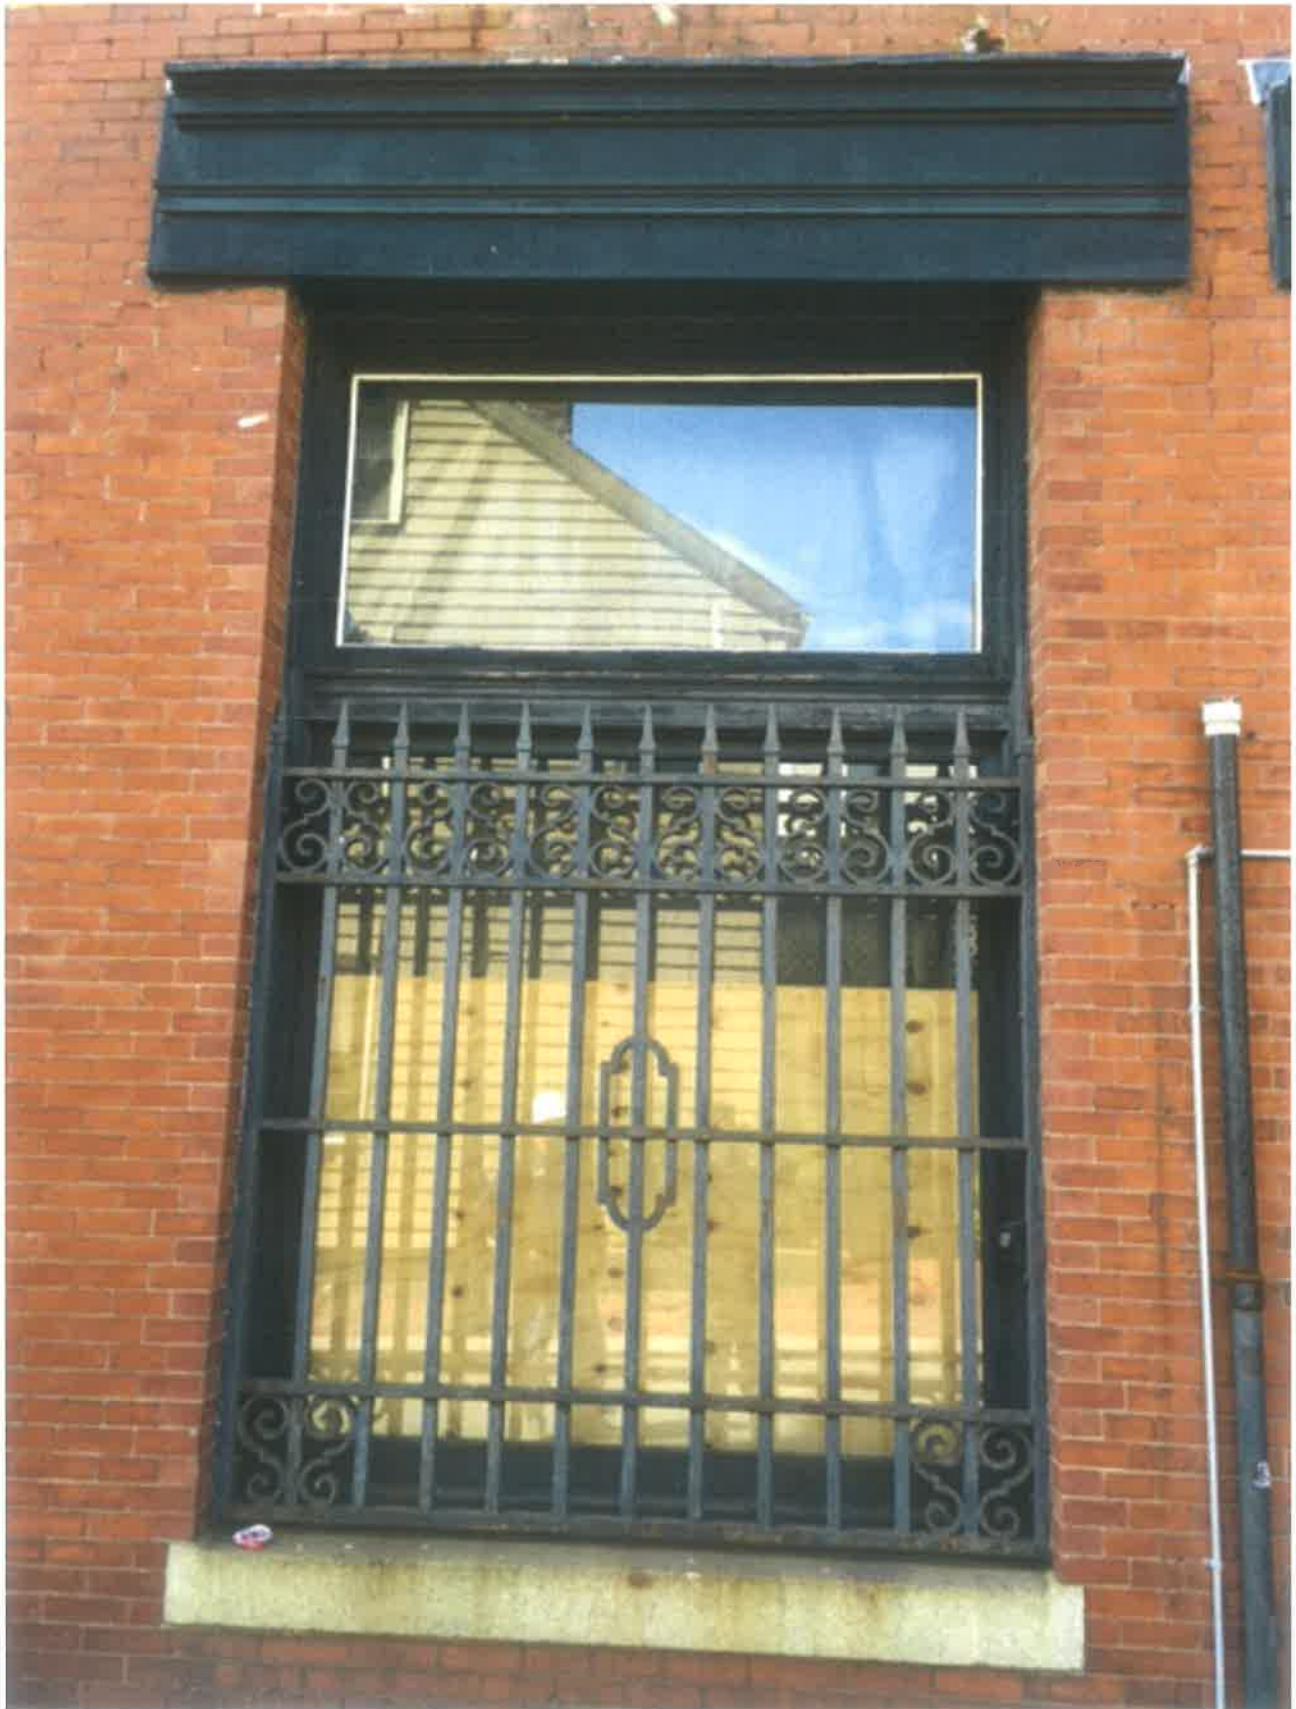
Church Court Window 3

Church Court Window – 3

Leaded clearstory glass was removed at some unknown time in the past and
Plexiglas installed.
The plate glass was cracked during construction and will be replaced
Remove and dispose of iron grate
Putty as required, scrape, sand, prime and paint

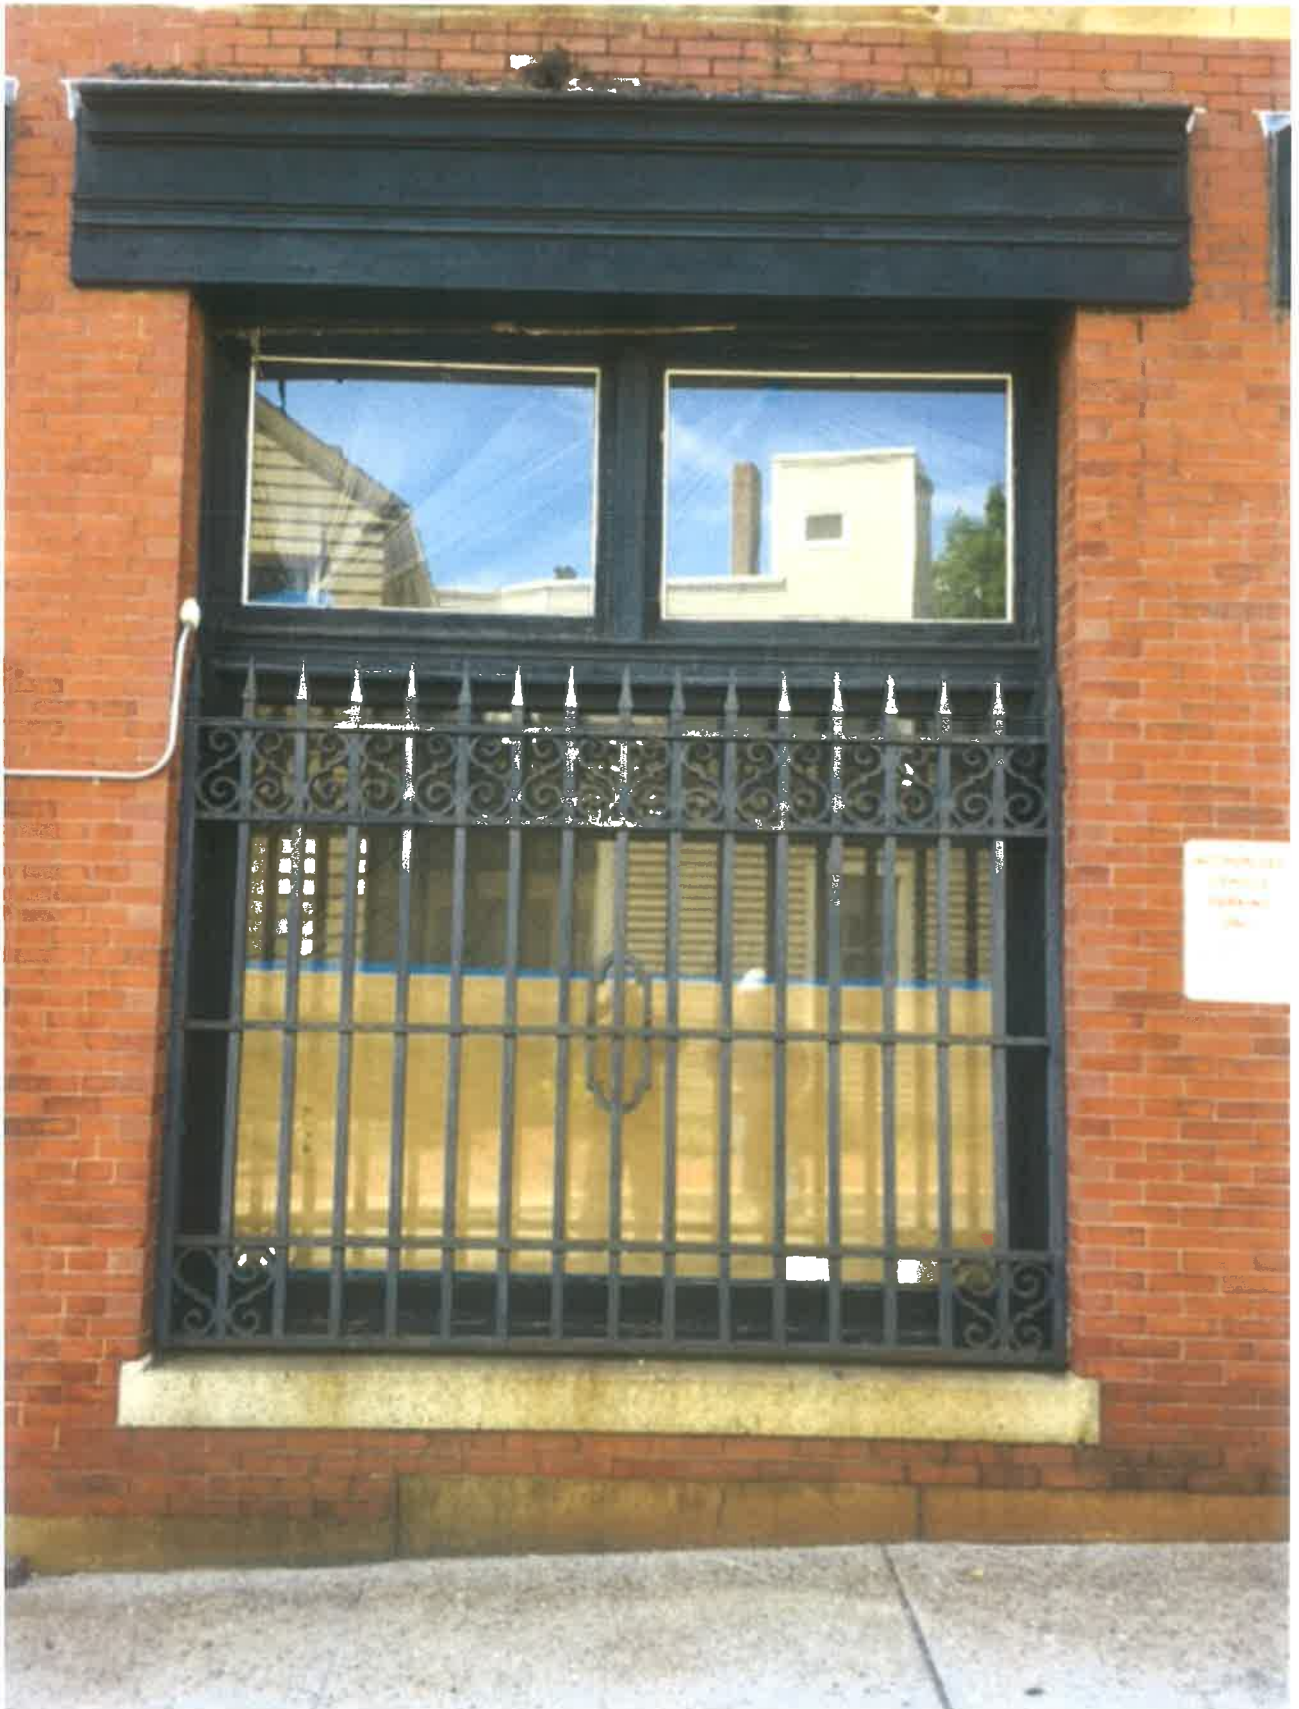
Church Court Window 4

Church Court Window – 4

Removed damaged clearstory leaded glass replaced with new clear glass
Remove and dispose of iron grate
Putty as required, scrape, sand, prime and paint

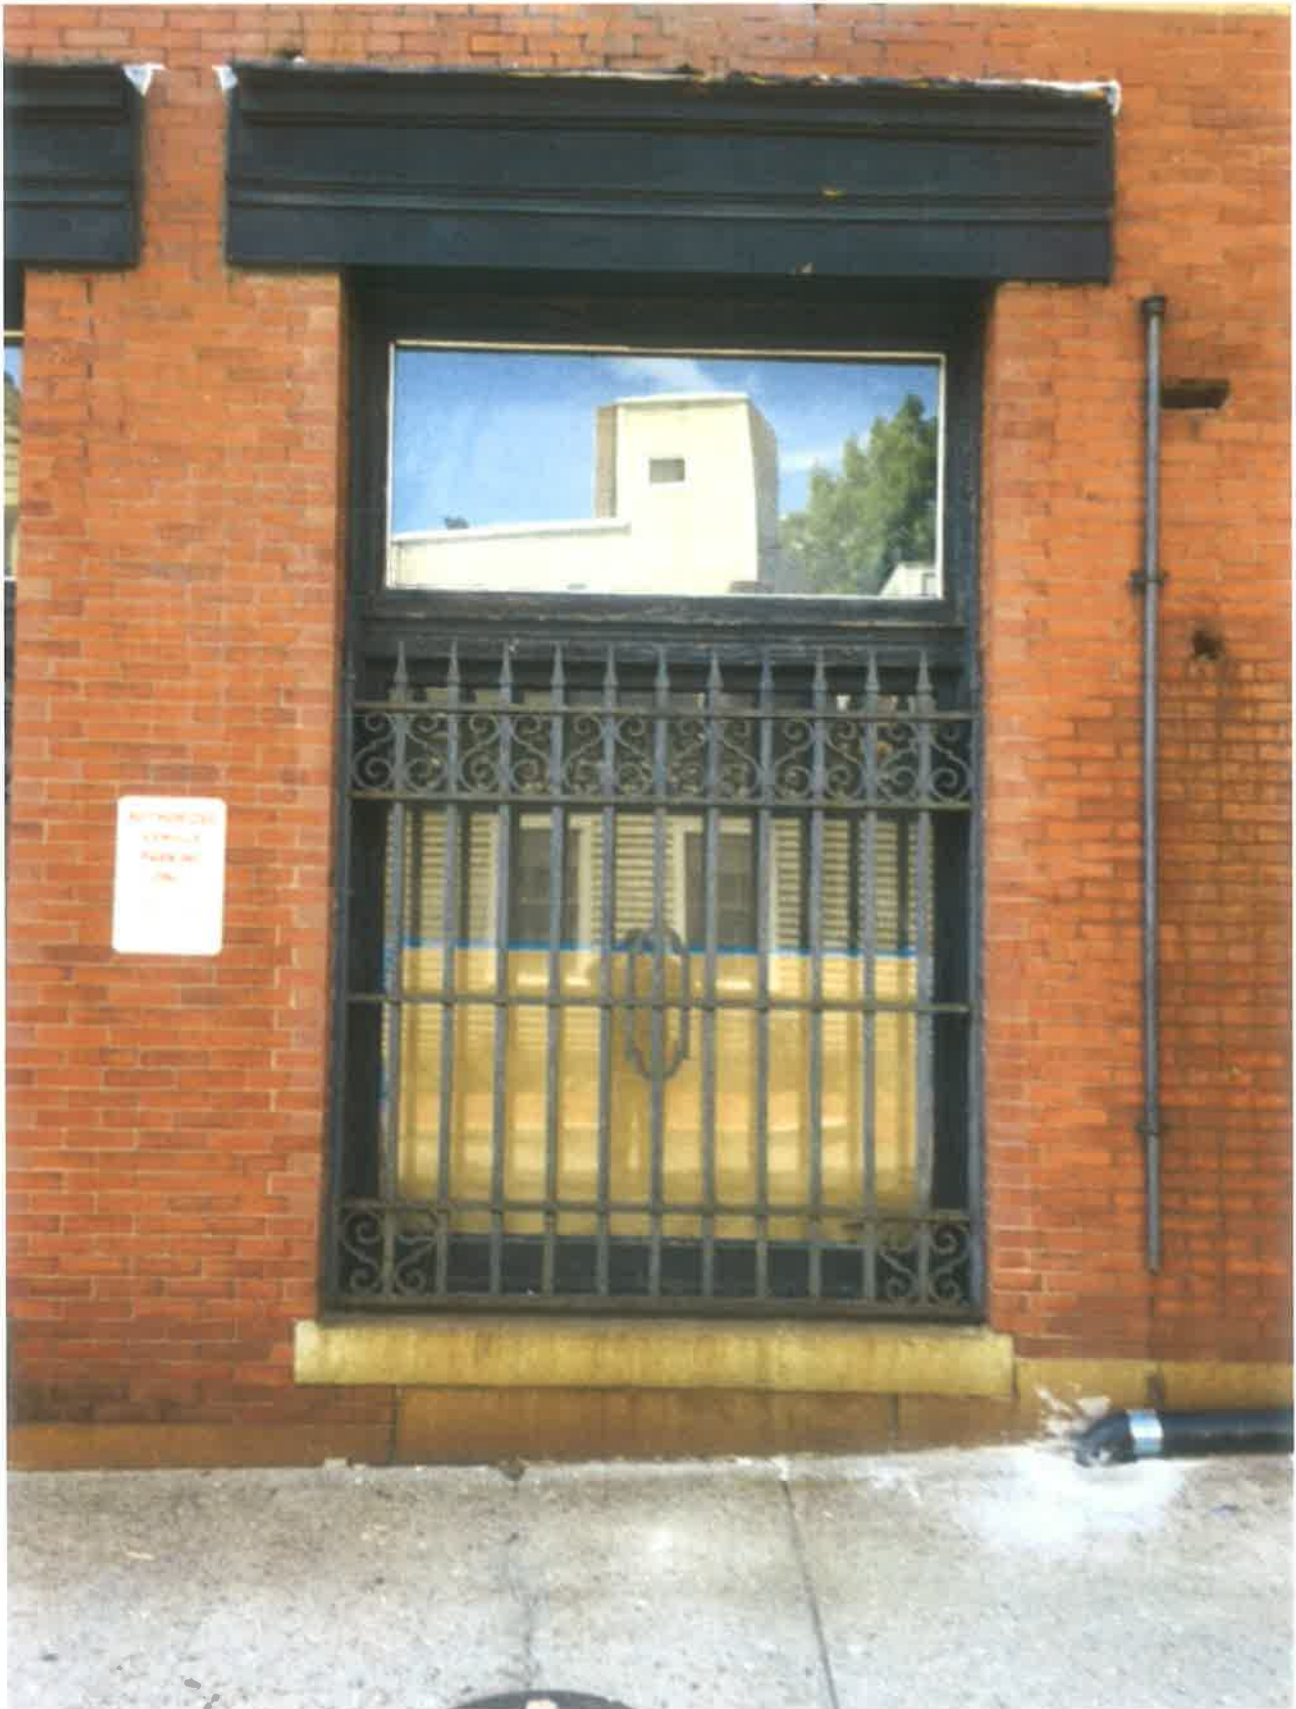
Church Court Window 5

Church Court Window – 5

Removed damaged clearstory leaded glass replaced with new clear glass
Remove and dispose of iron grate
Putty as required, scrape, sand, prime and paint

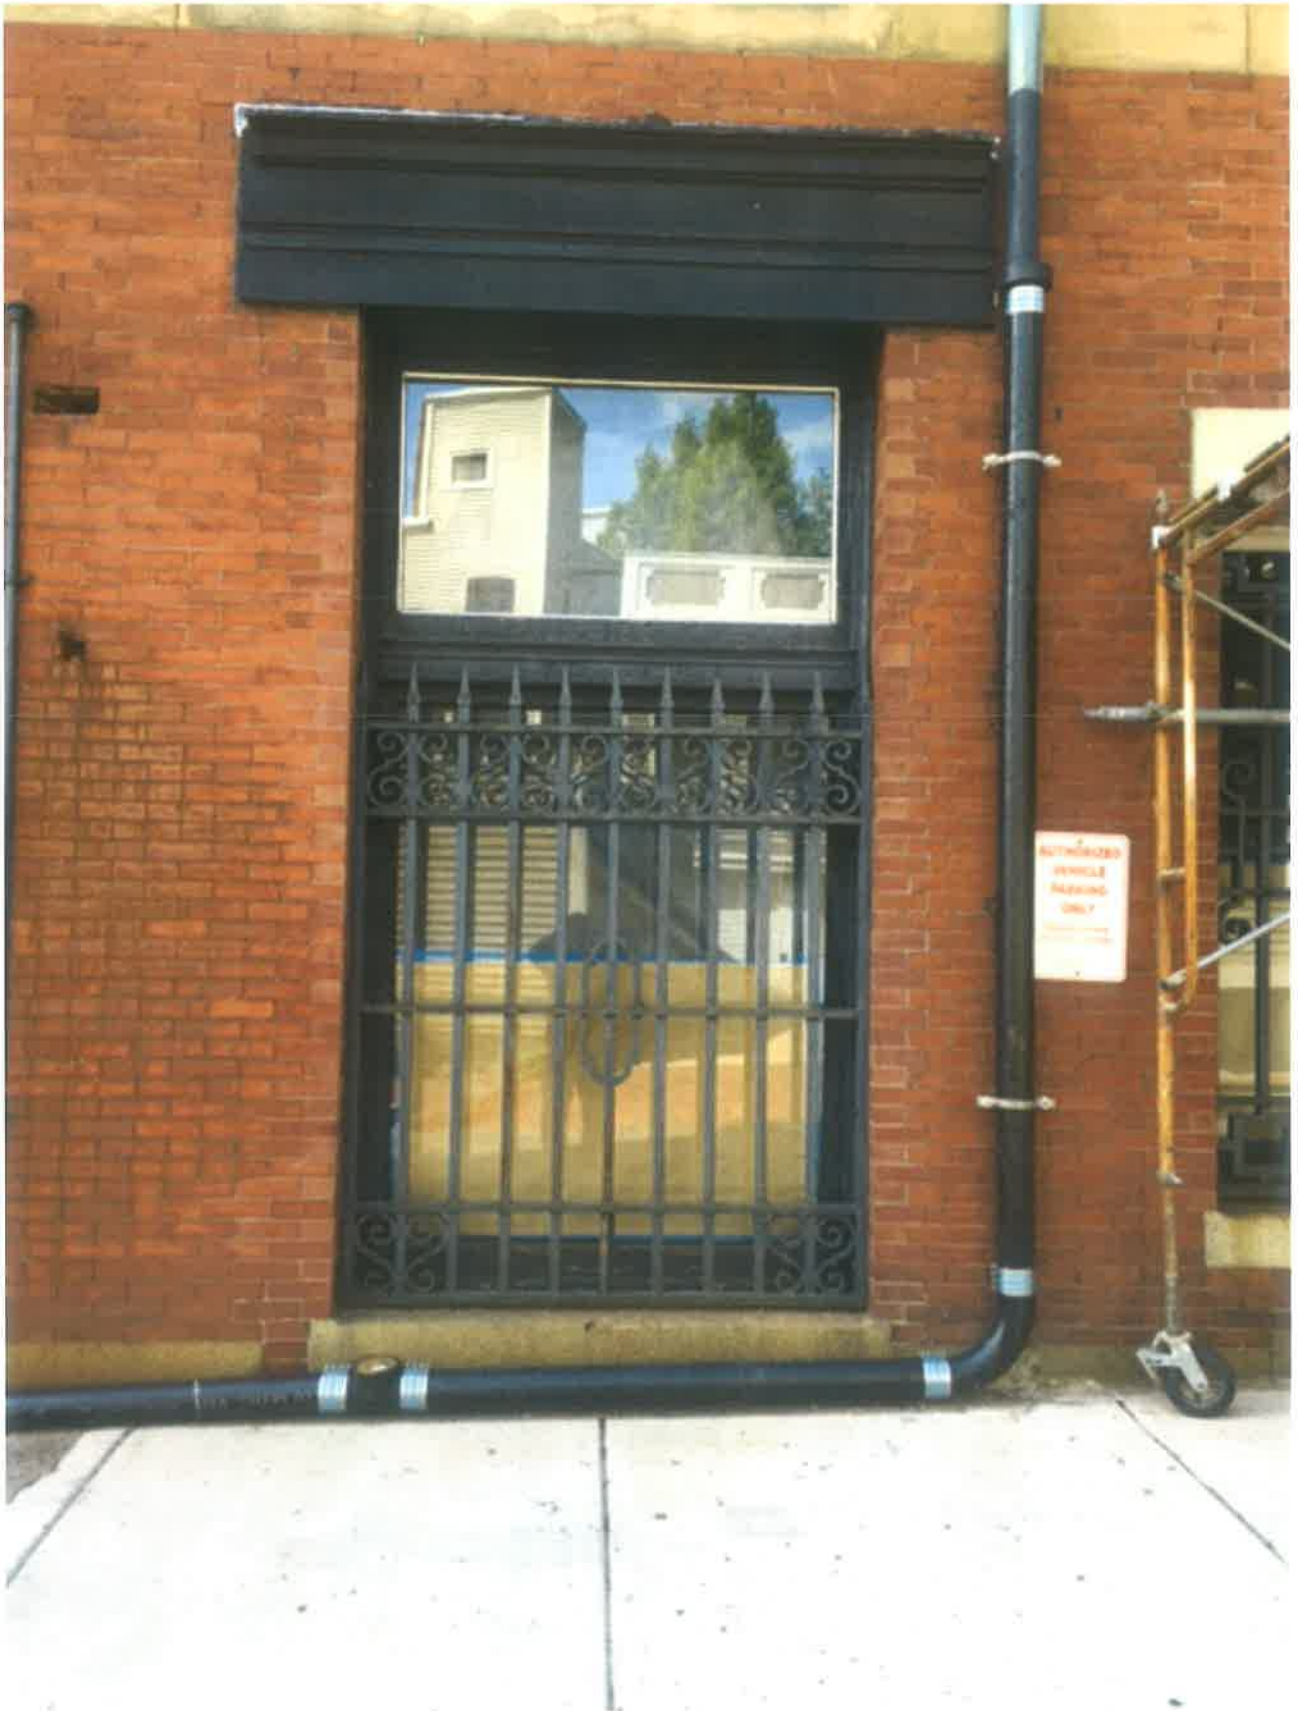
Church Court Window 6

Church Court Window – 6

Removed damaged clearstory leaded glass replaced with new clear glass
Remove and dispose of iron grate
Putty as required, scrape, sand, prime and paint

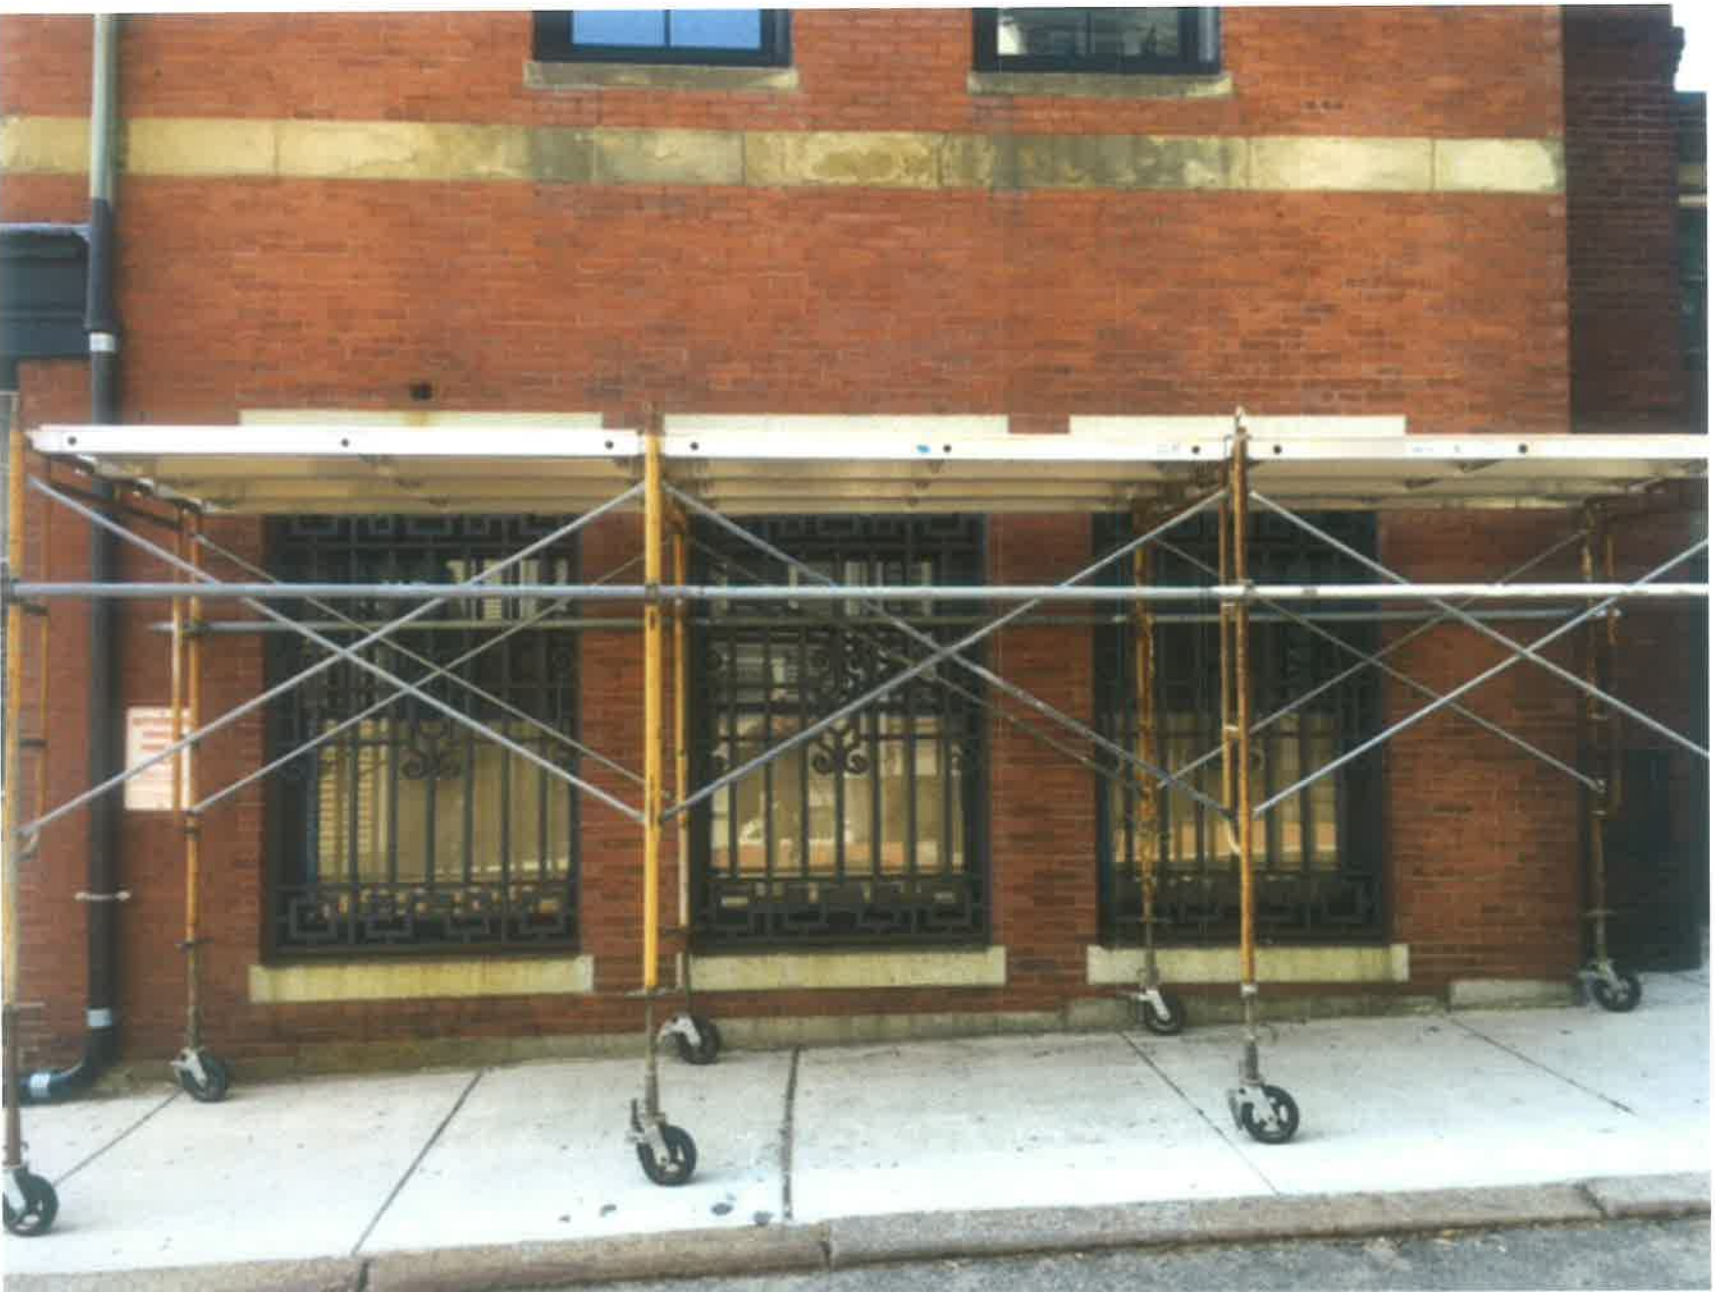
Church Court Windows 6, 7 and 8

Church Court Windows– 7, 8 & 9

Remove and dispose of iron grate
Putty as required, scrape, sand, prime and paint
