Project A - Remove four leaded clearstory windows on the Church Court side of the building and replace them with clear glass.

Project B - Removal of the First Floor Iron Grates from the windows on the Church Court Side of the Building.

Project C – The clock will be restored to working order.

Picture Table of Contents

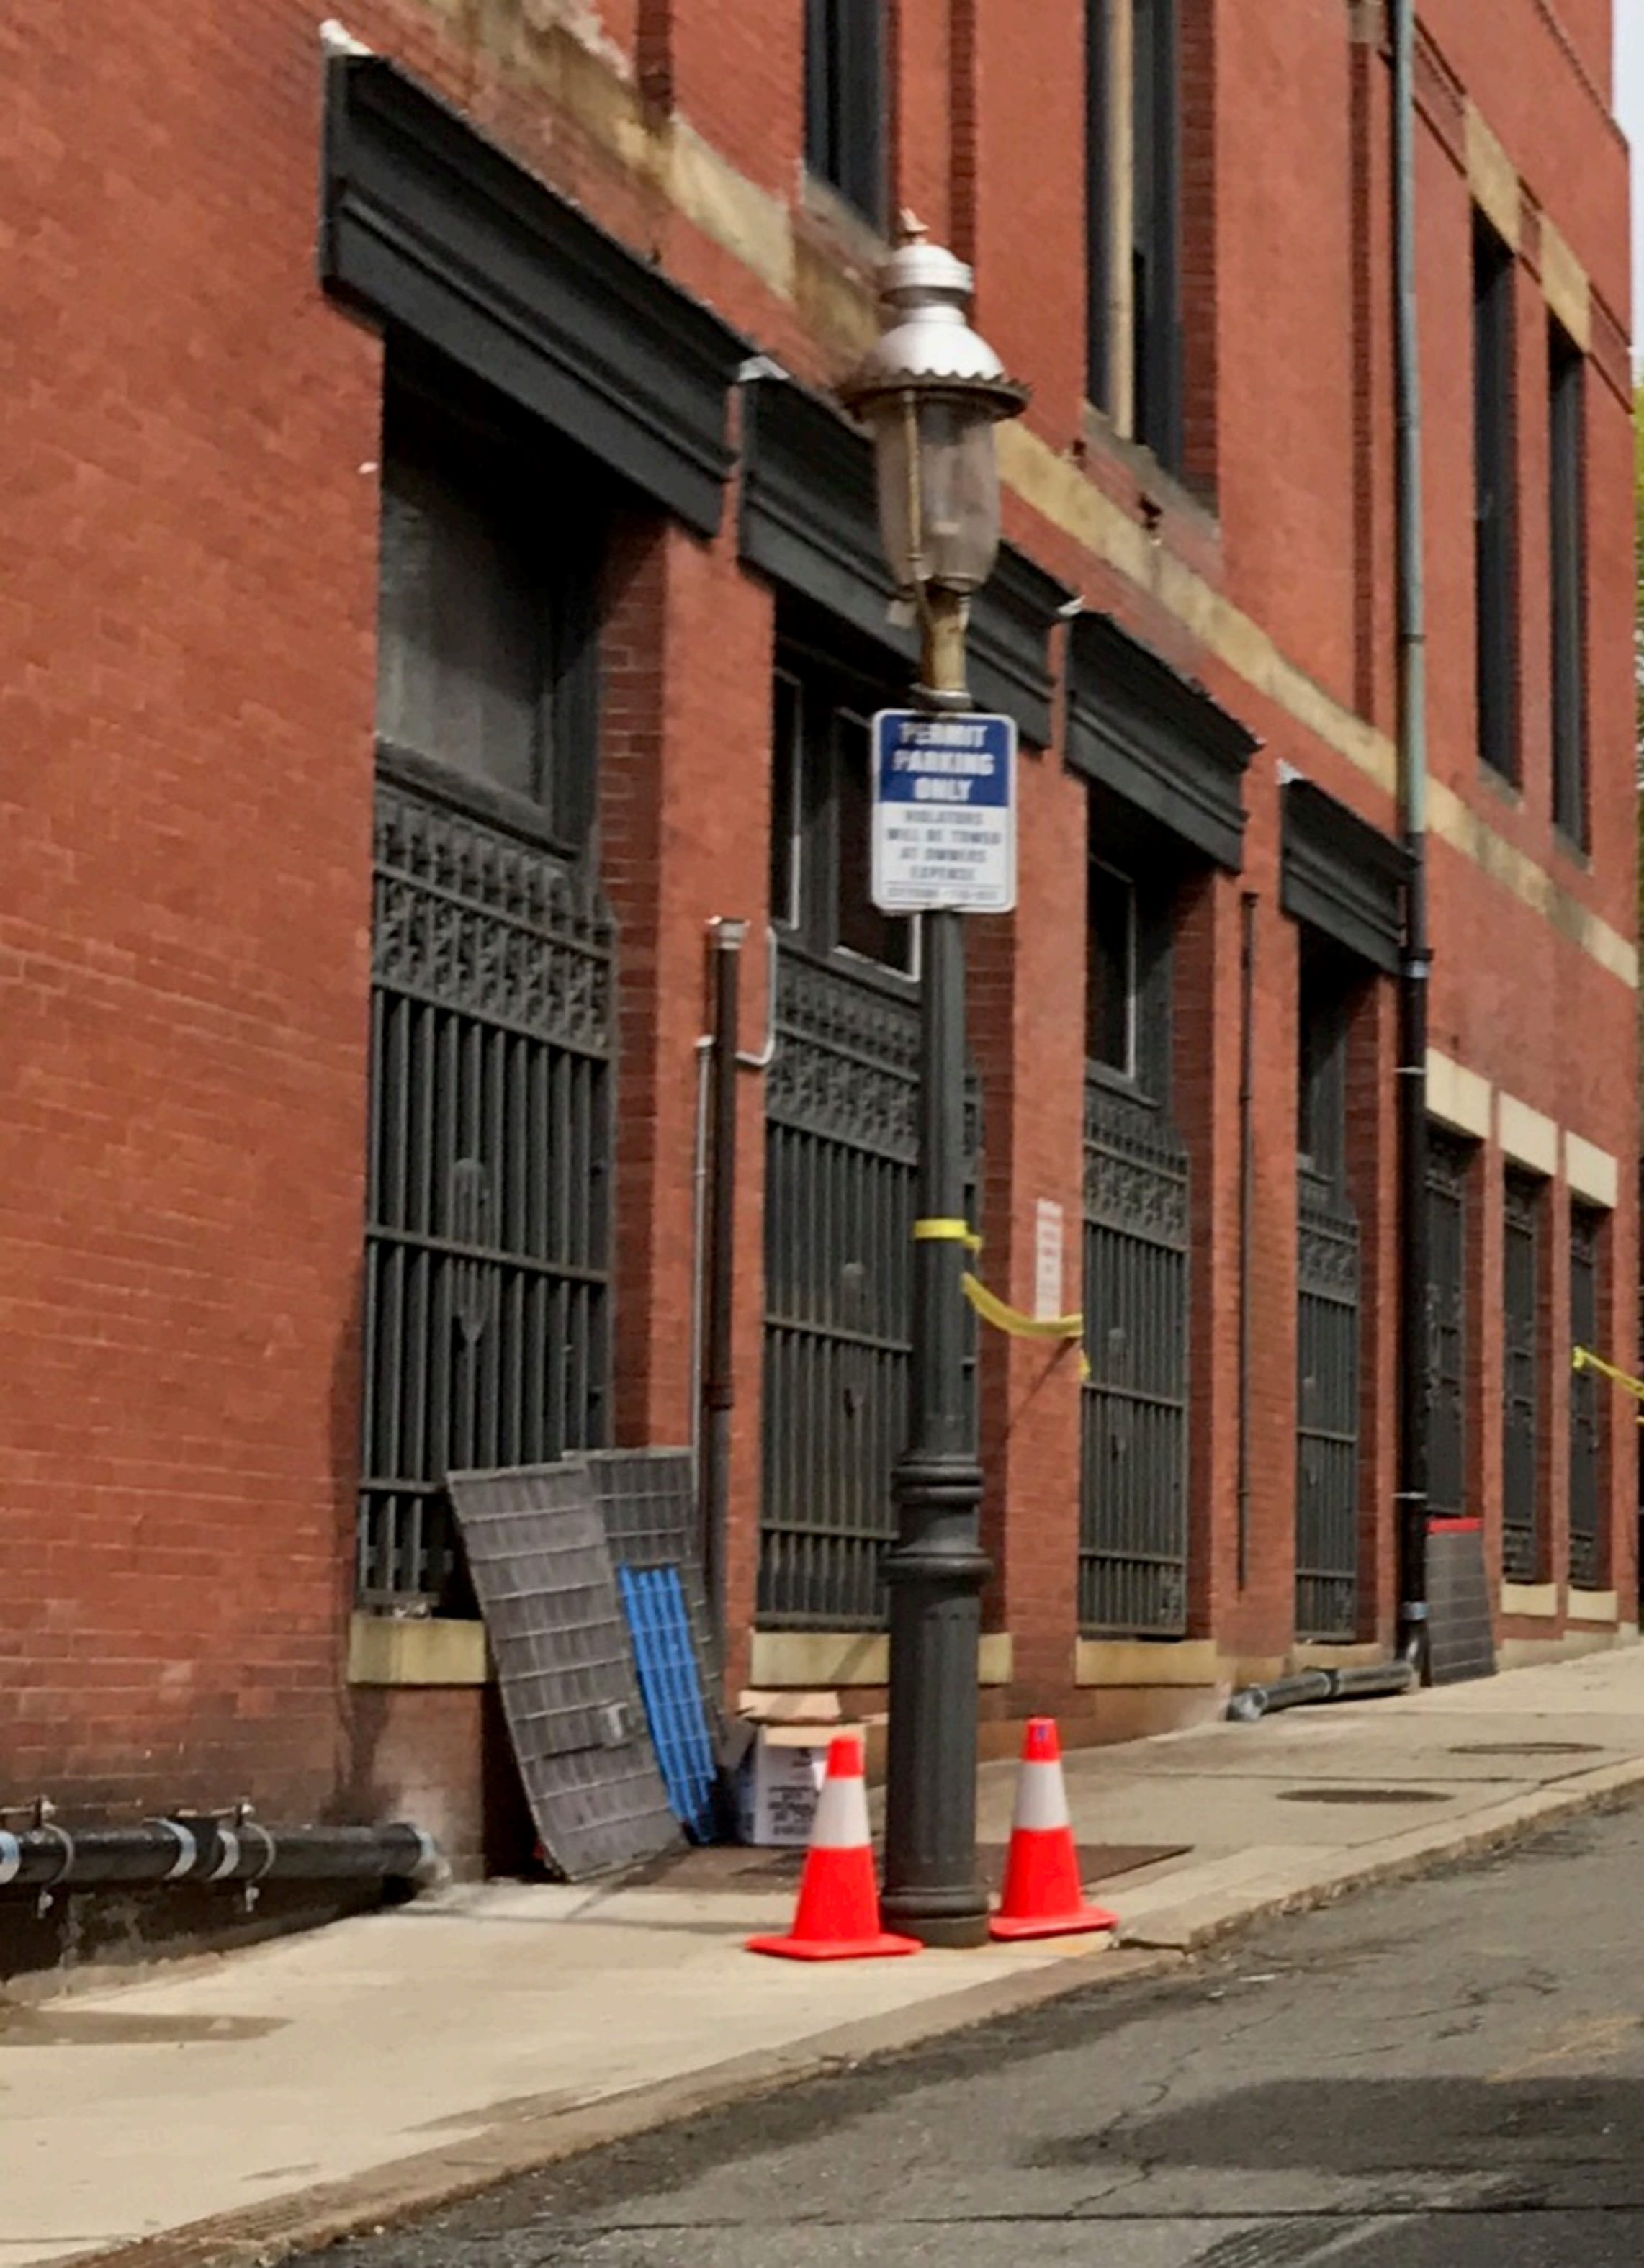
Clock On Front of Building

Electric Time Company, Inc. of Medfield, MA will be restoring the three faces of the clock to mechanical working order. The Owner's internal crew will scrape, prime and paint the body of the clock to its original base color.
