Vegetation Management Plan

Head of the Charles Regatta Reunion Village Hospitality Area

2018

Re: Head of the Charles Regatta Reunion Village Hospitality Area

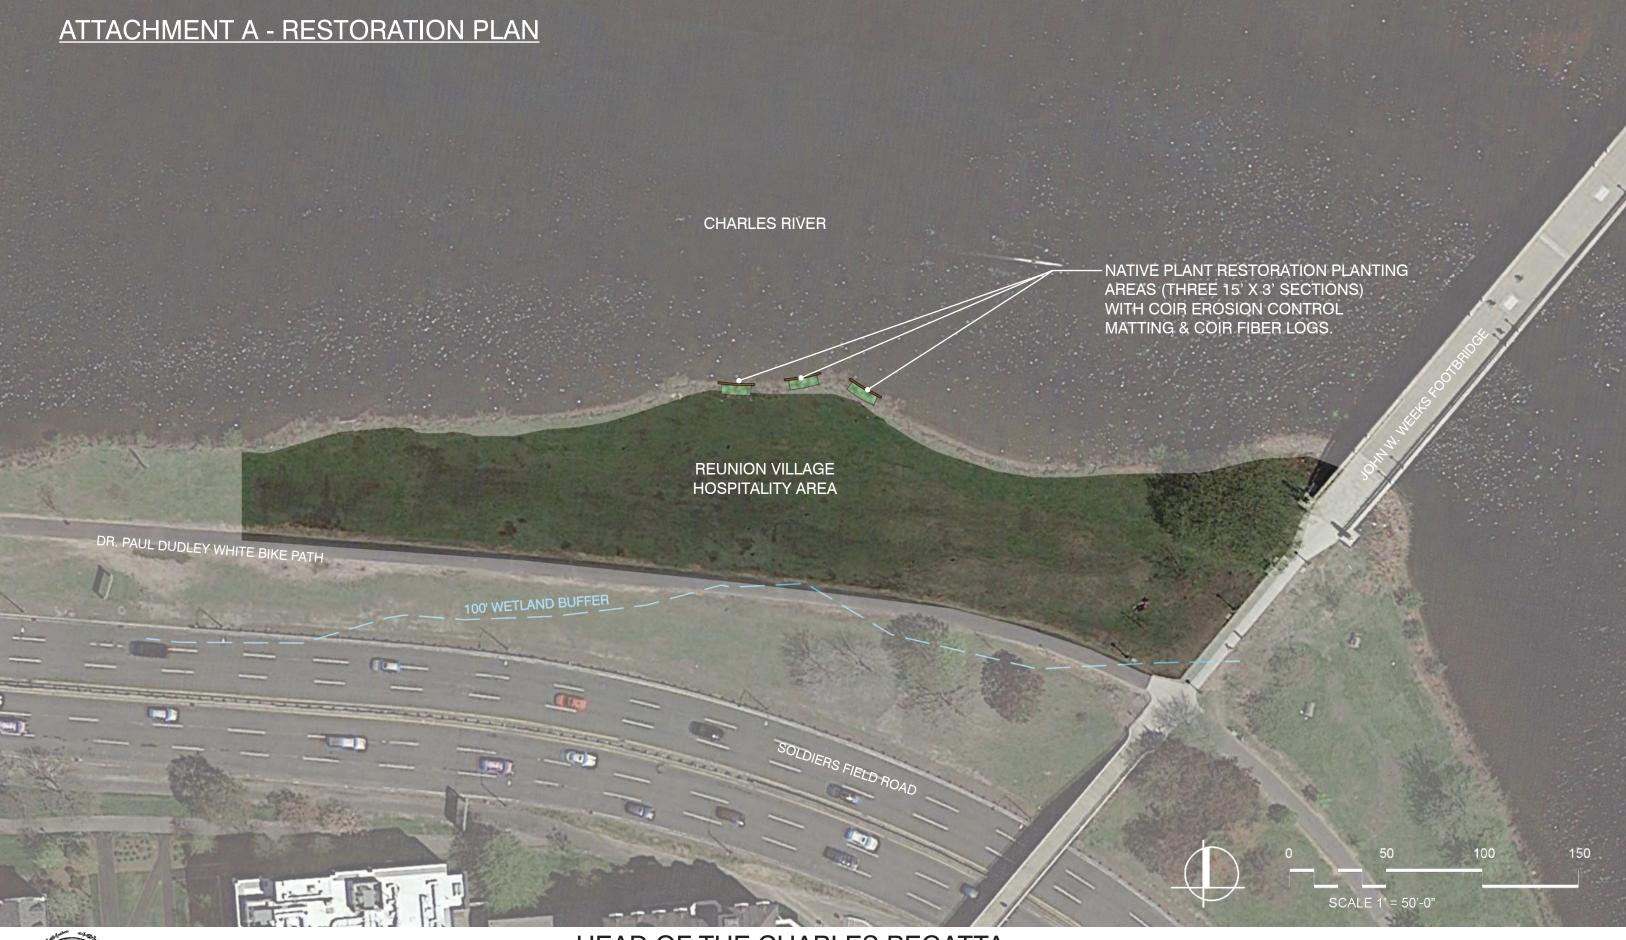
ATTACHMENT A - PLANTING DETAILS

PLANTING LAYOUT

up to the edge of the eroded bank. A coir erosion control mat will be attached to the coir log and staked into the ground over the backfilled soil. Plantings will be placed directly into the erosion mat in a clustered pattern (refer Appendix A: Planting Details).
