Narrative Scope of Work - Boylston Street Landscape and Entry Steps Restoration

Arlington Street Church

Boston Landmarks Commission Boylston Beatification Project

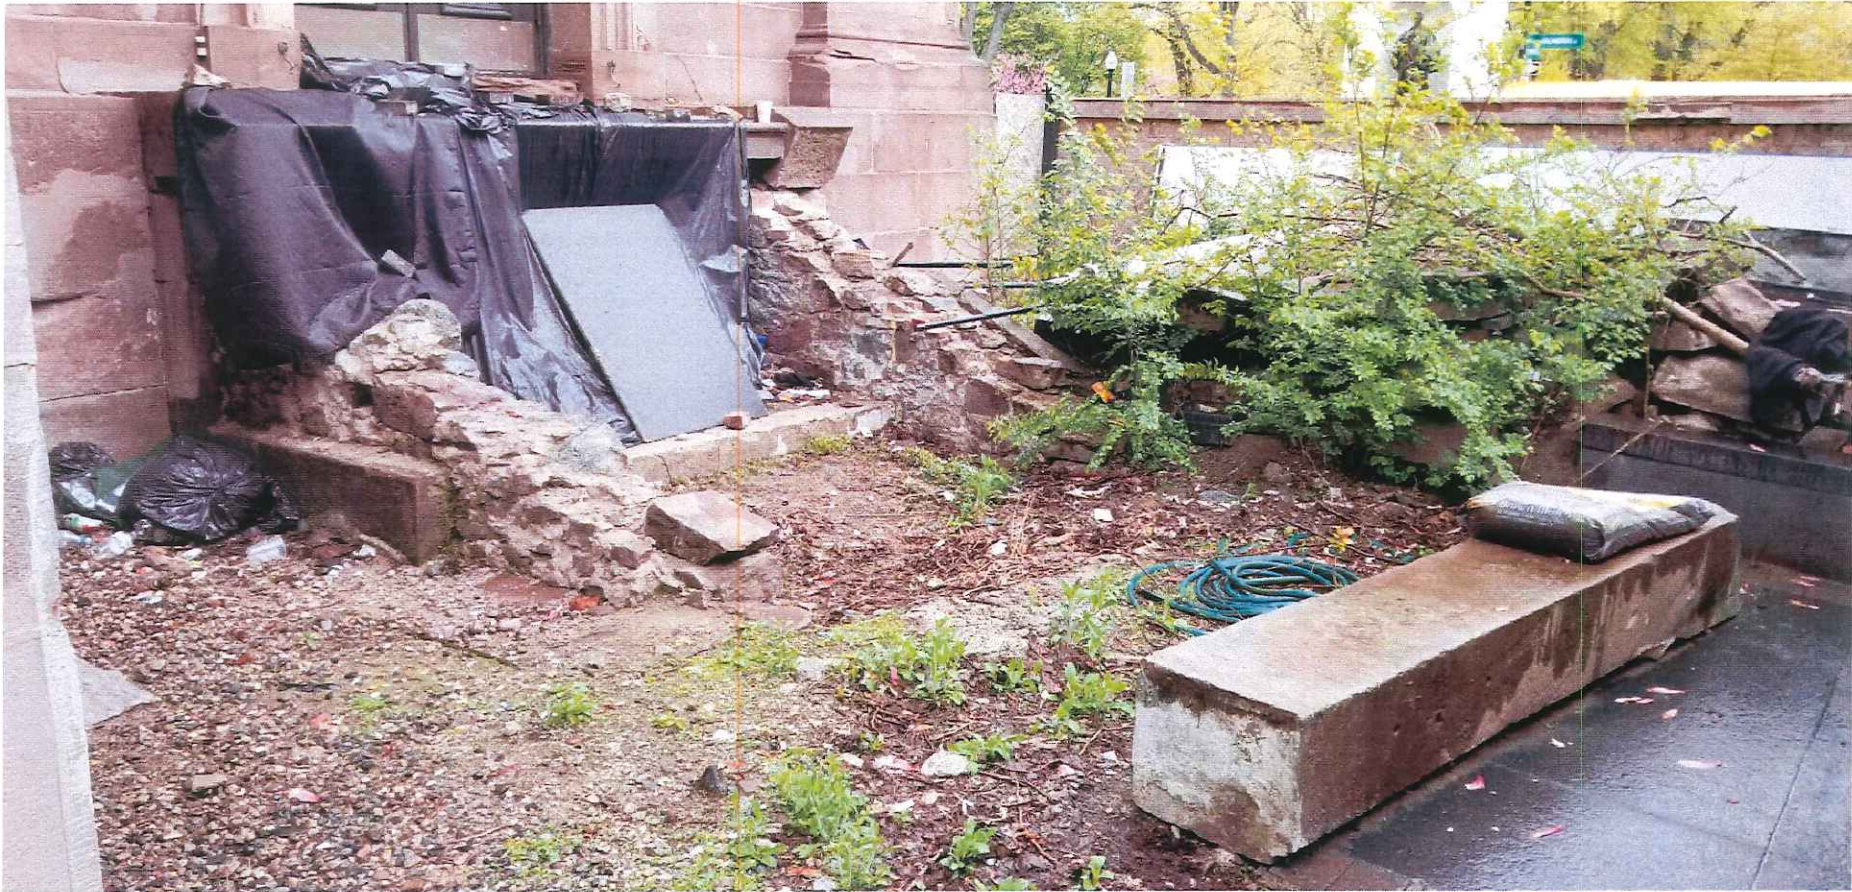
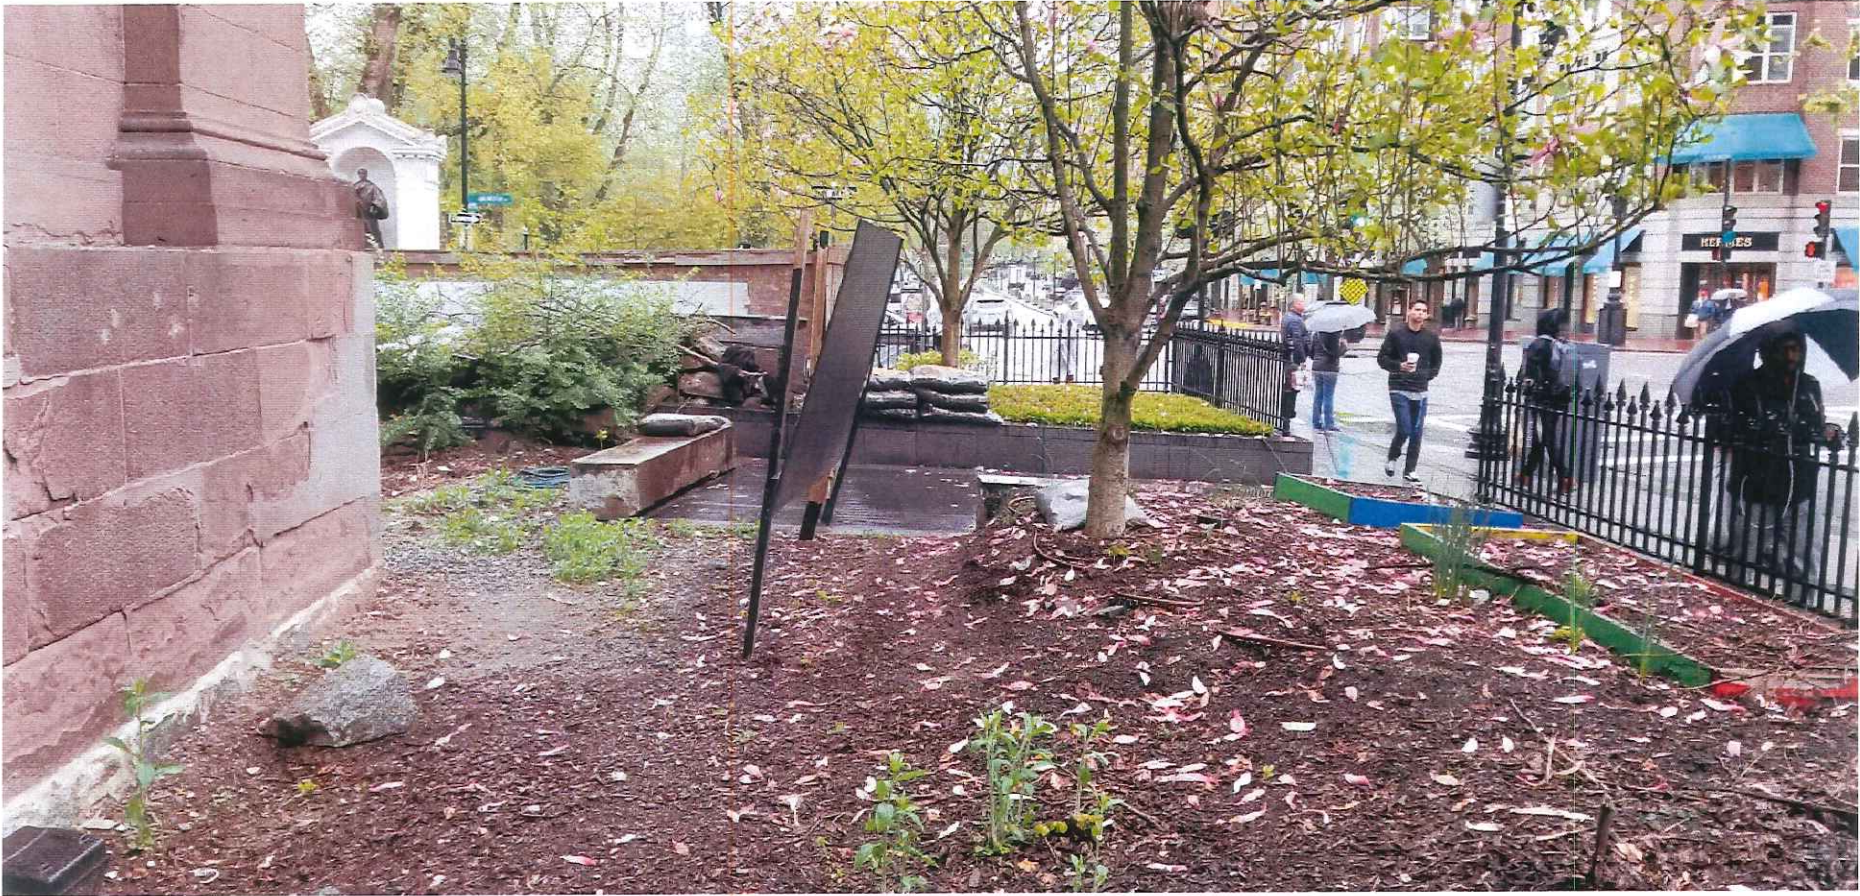
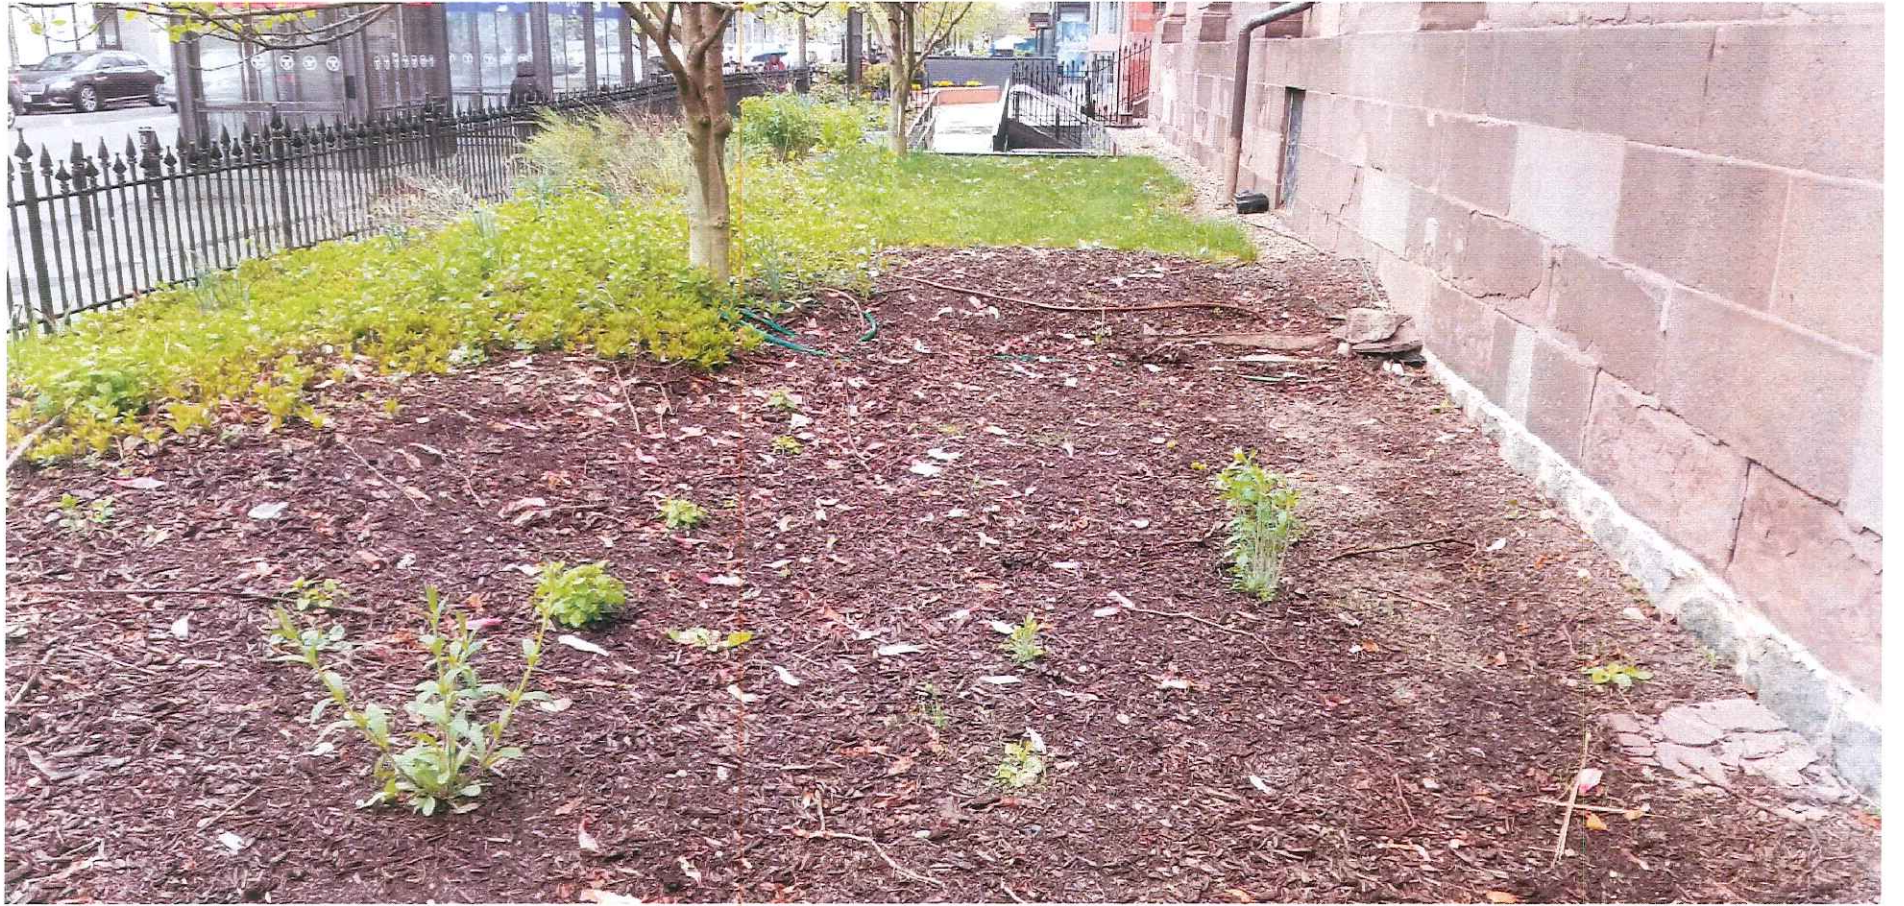
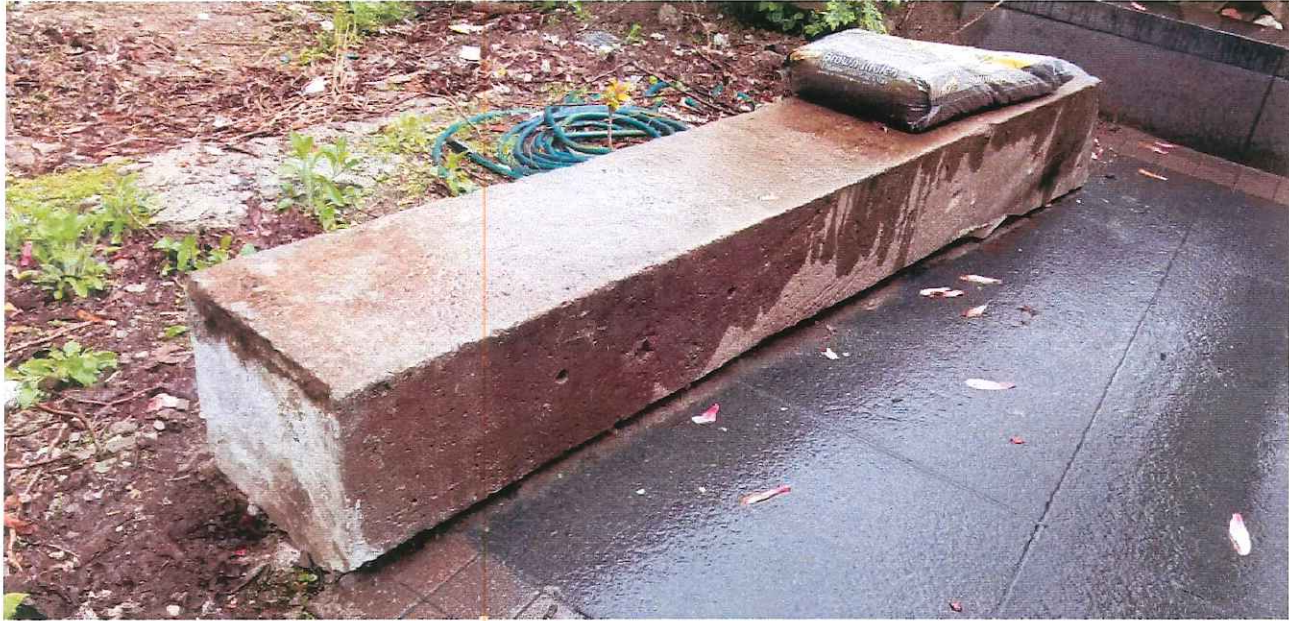
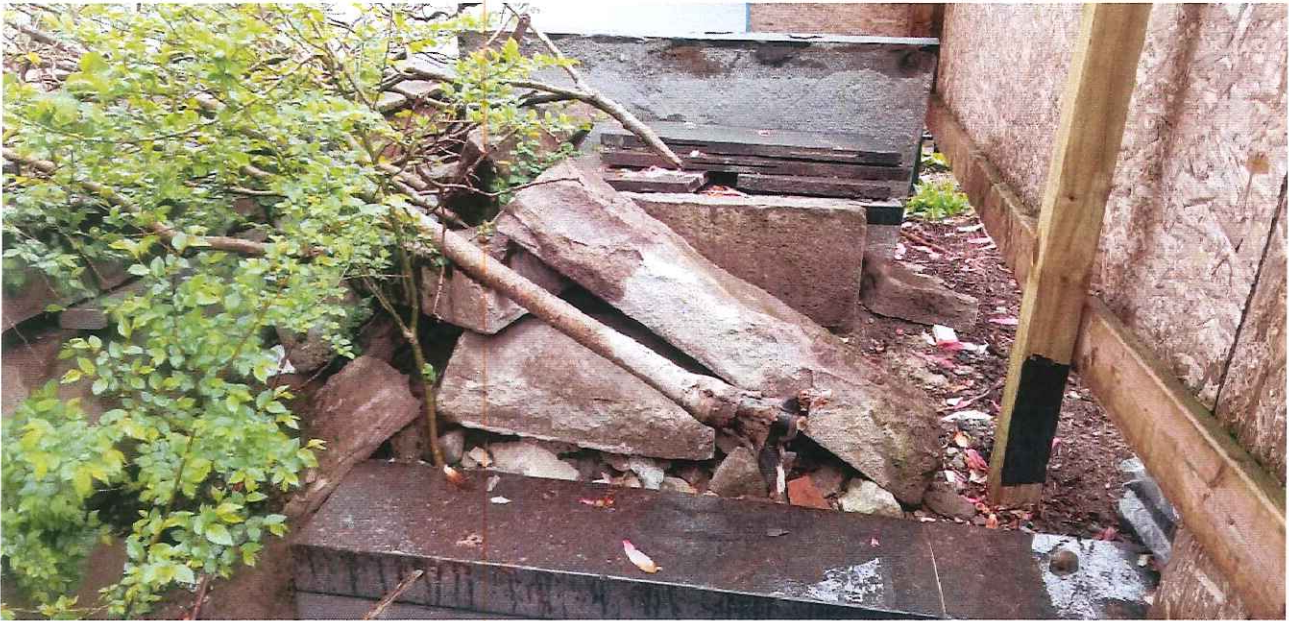
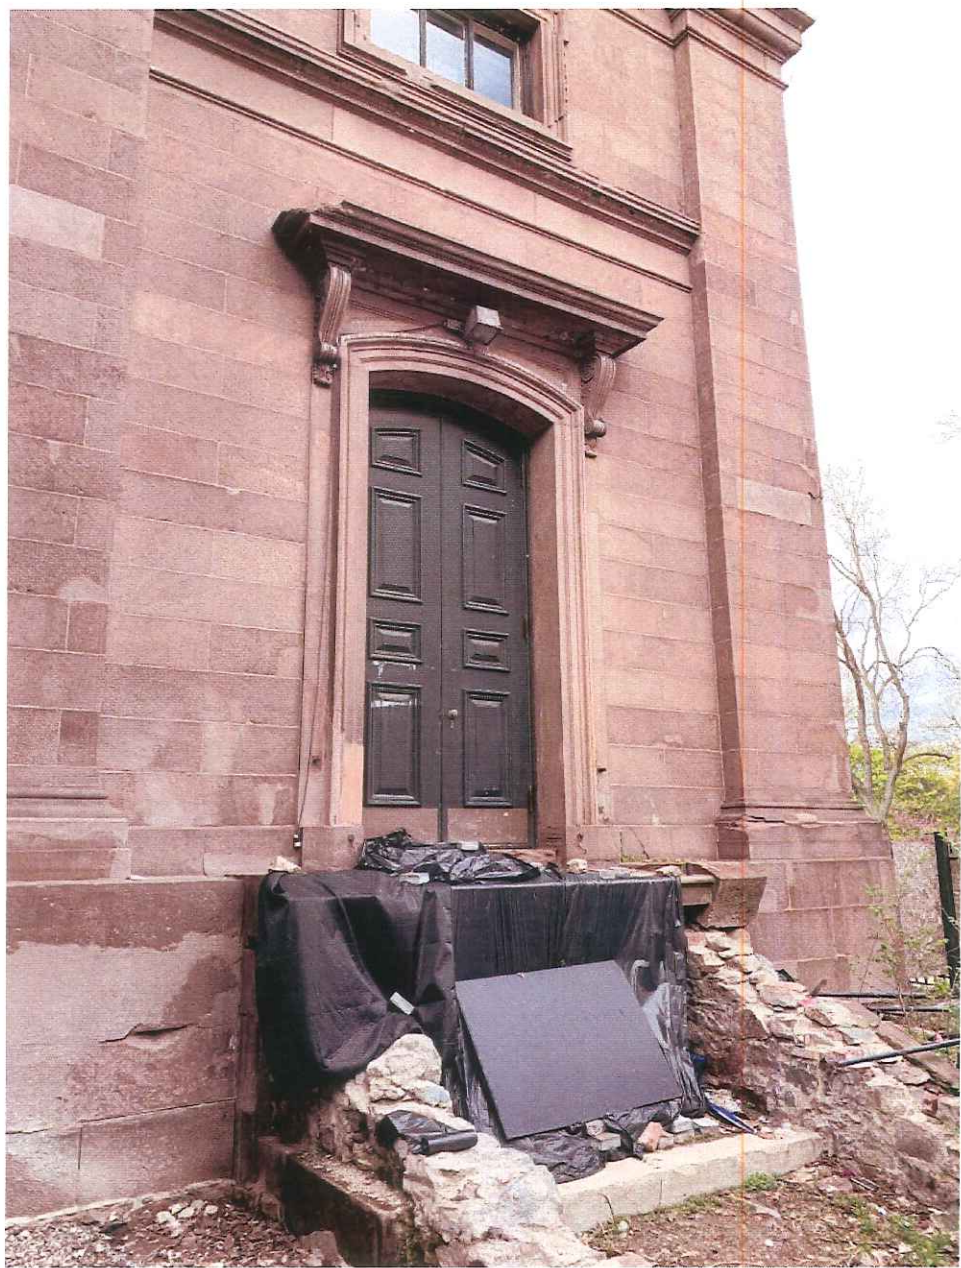
Boylston Beautification Project
Existing Conditions:

Discuss potential approach to stair restoration

Unfortunately, during the early stages of the previous project, the south steps had already been removed. The scope of this project is now to restore those steps, as historically accurate as possible guided by available photo documentation and the north steps as a model, while incorporating other regulatory requirements. The intent is to utilize original brownstone pieces to the extent that they are available, structurally sound and suitable for reuse. A detailed inventory of available pieces and an assessment of their suitability will be led by a preservation design consultant and engaging a masonry conservator specializing in brownstone, historic mason advisor and structural engineer specializing in historic stone structures.

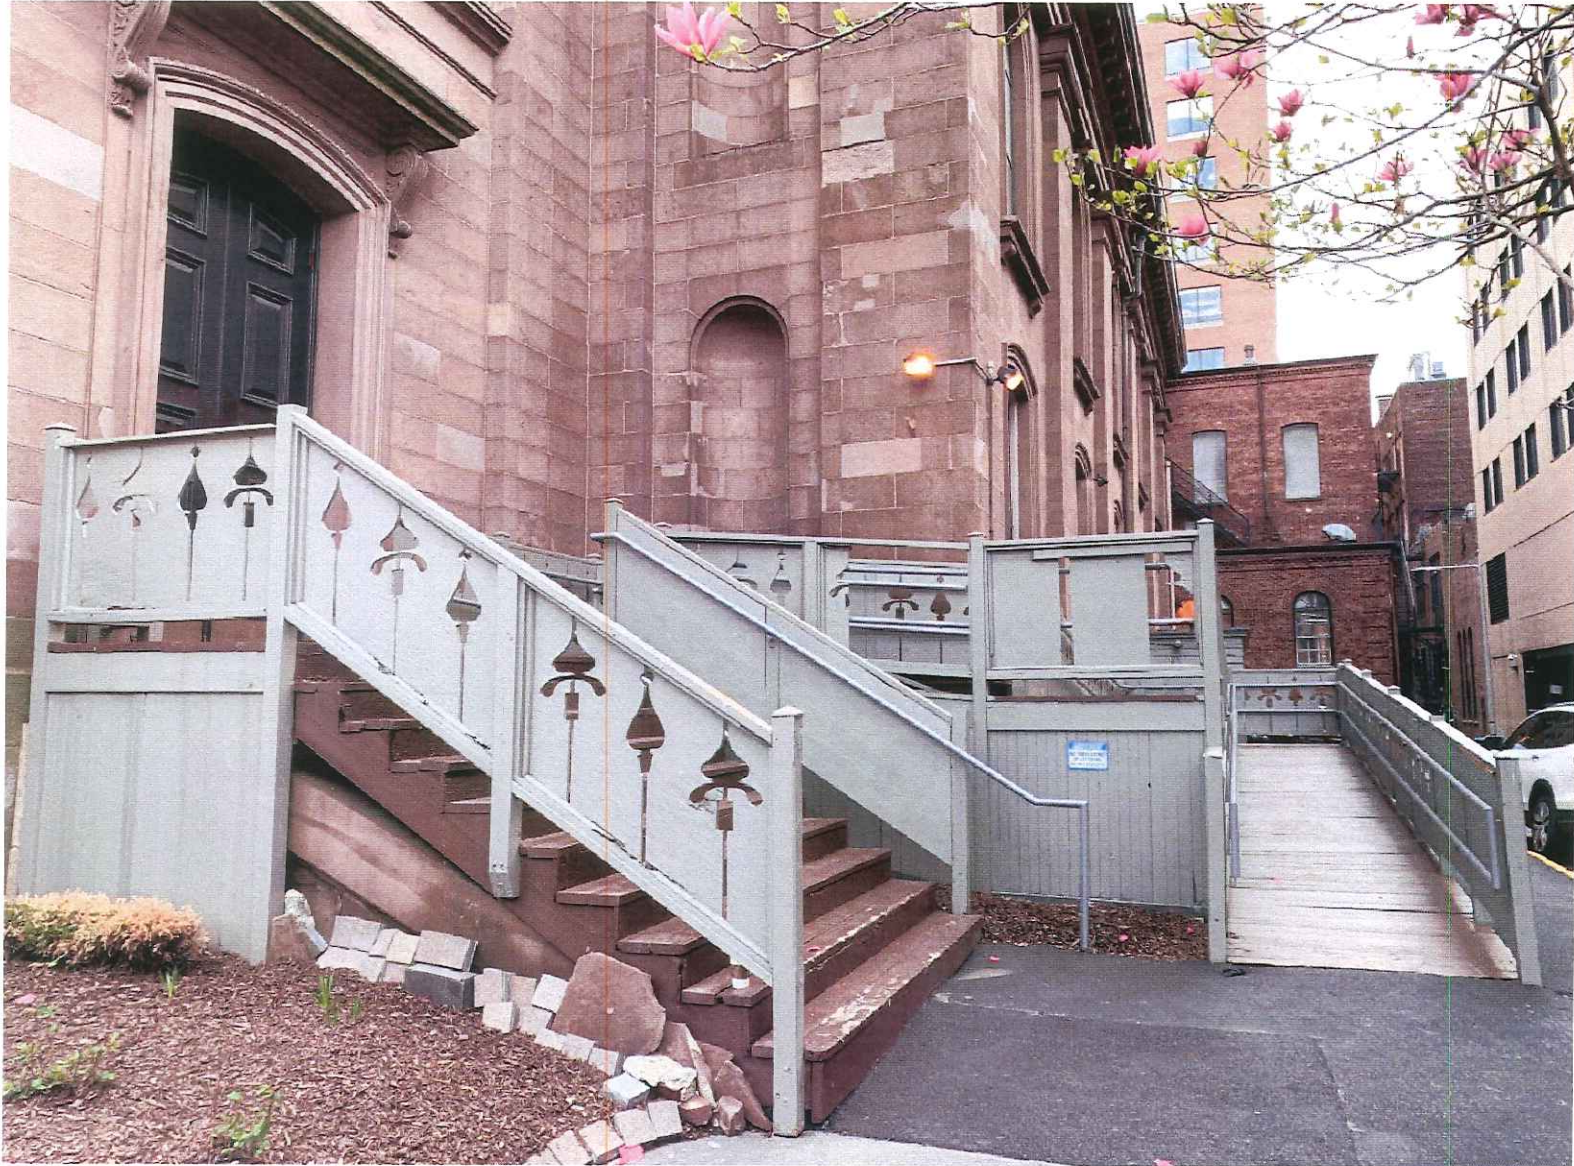
North Alley Accessible Stair/Ramp Reconstruction

Existing Conditions:

Discuss potential approach to wood stair/ramp
