94 Beacon Street - View of Roof
February 28, 2019

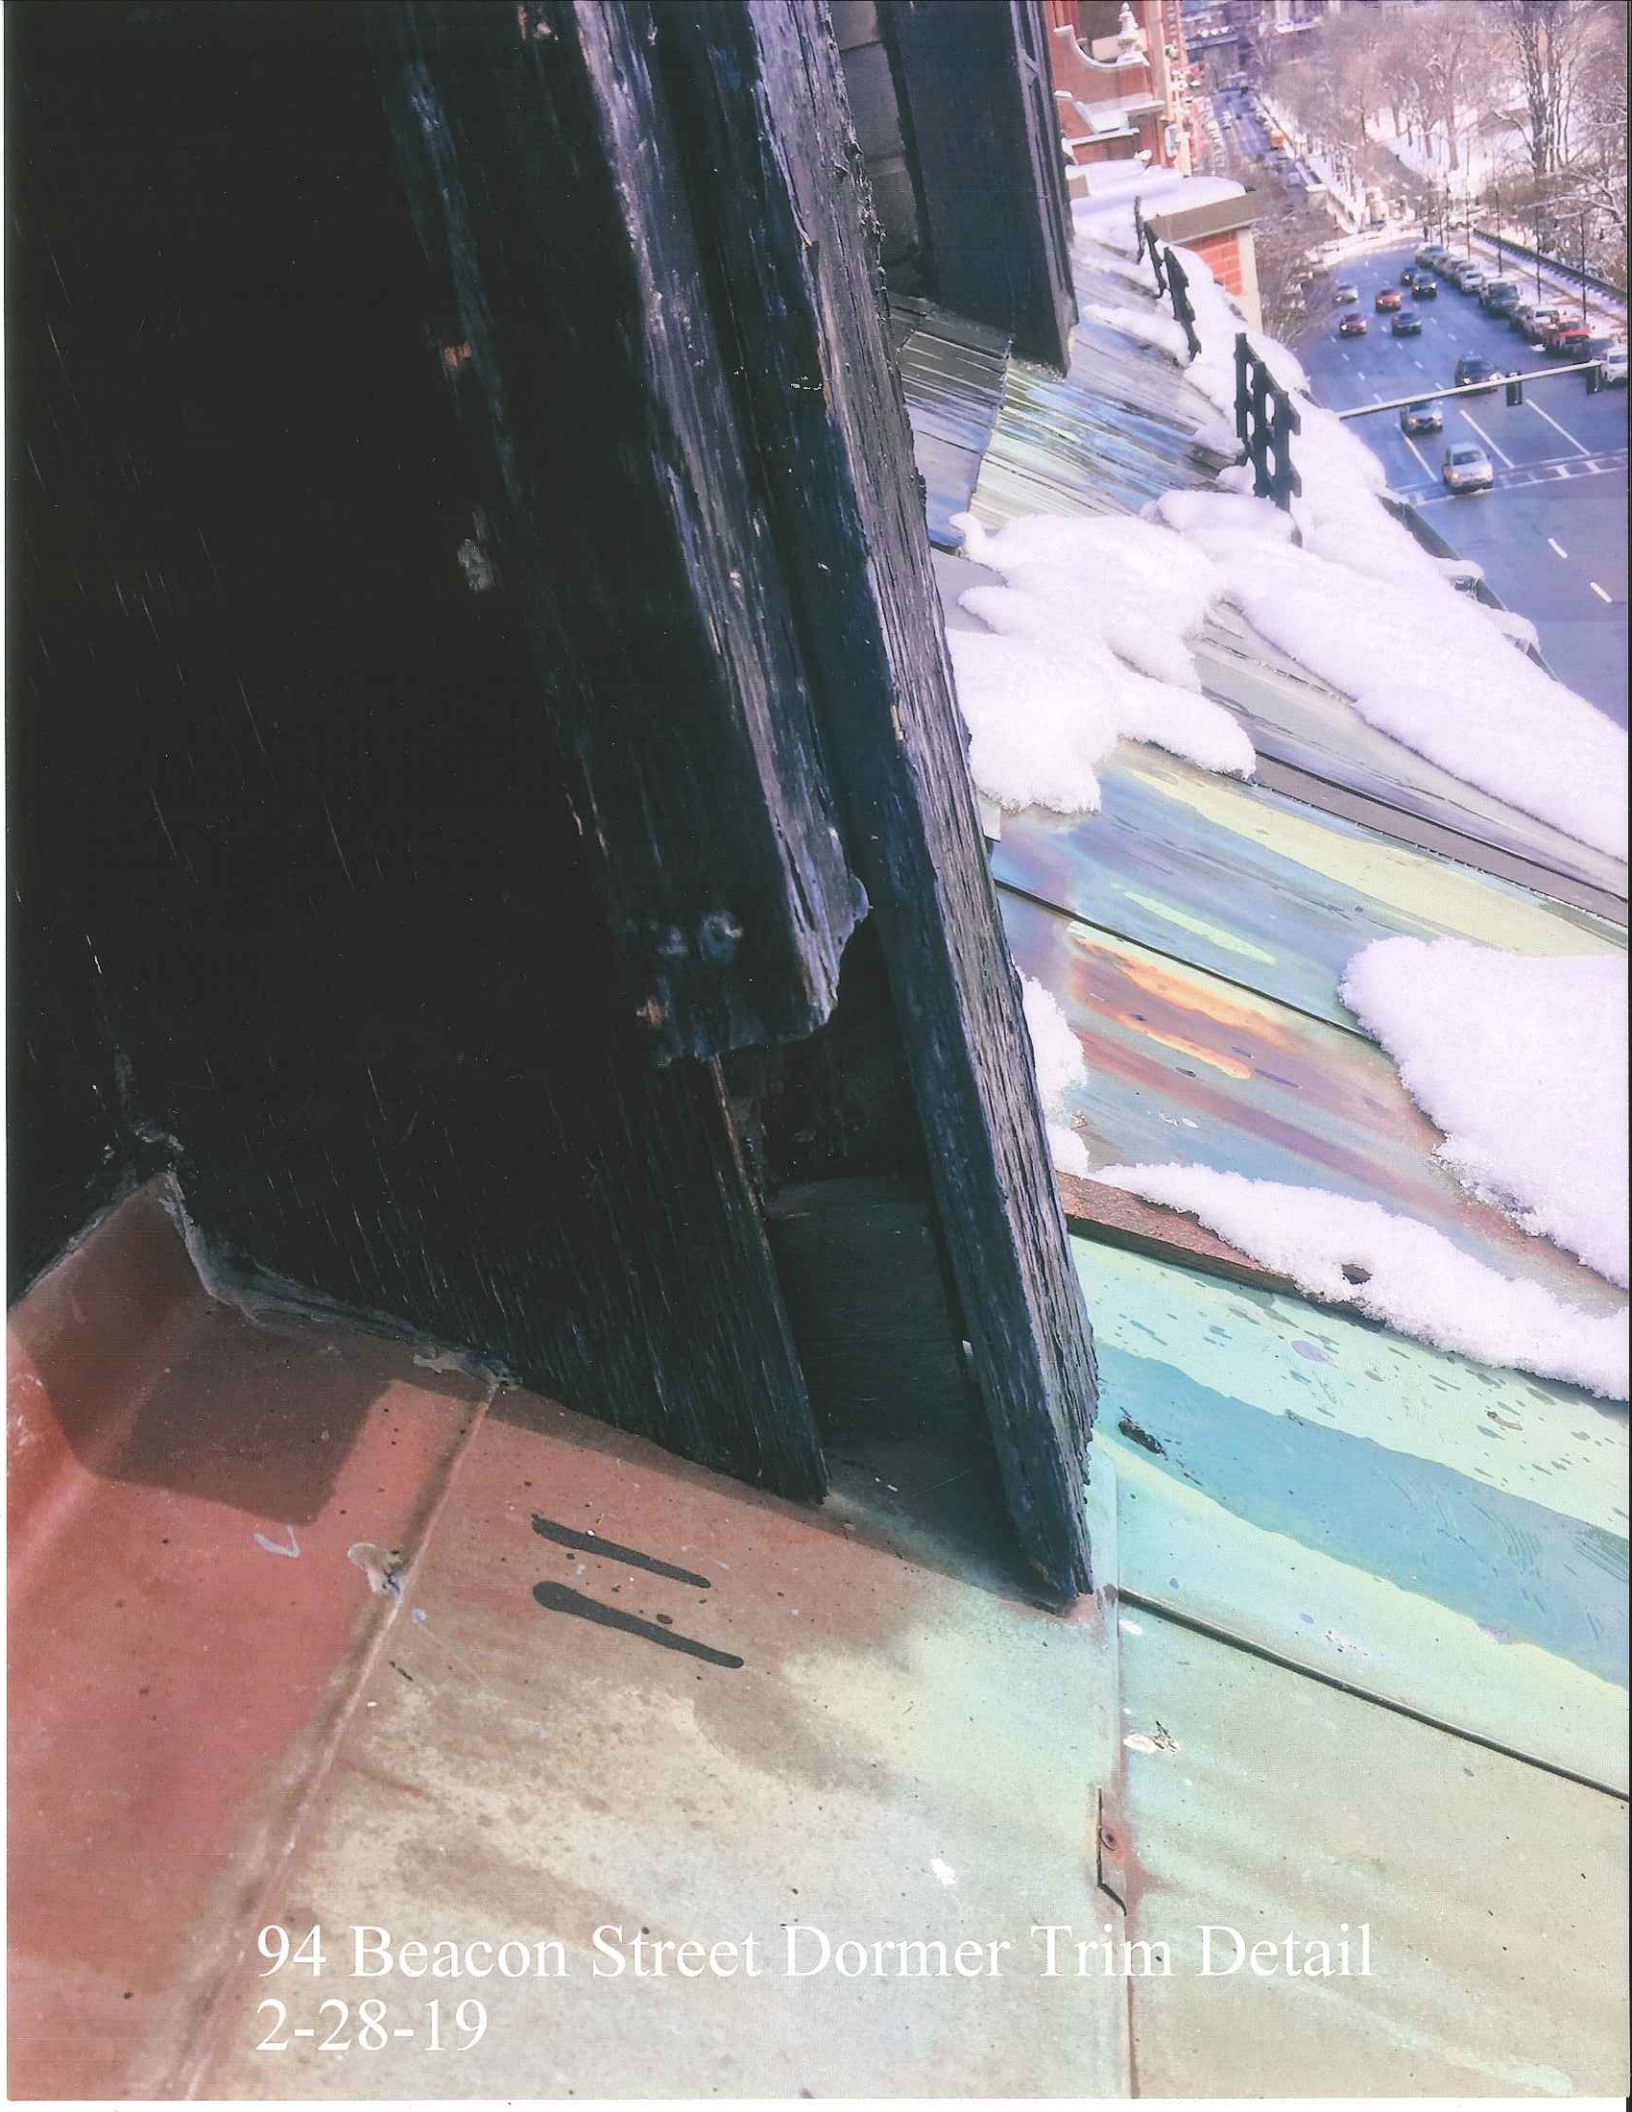
94 Beacon Street Dormer Trim Detail
2-28-19

94 Beacon Street View of Dormer
2-28-19

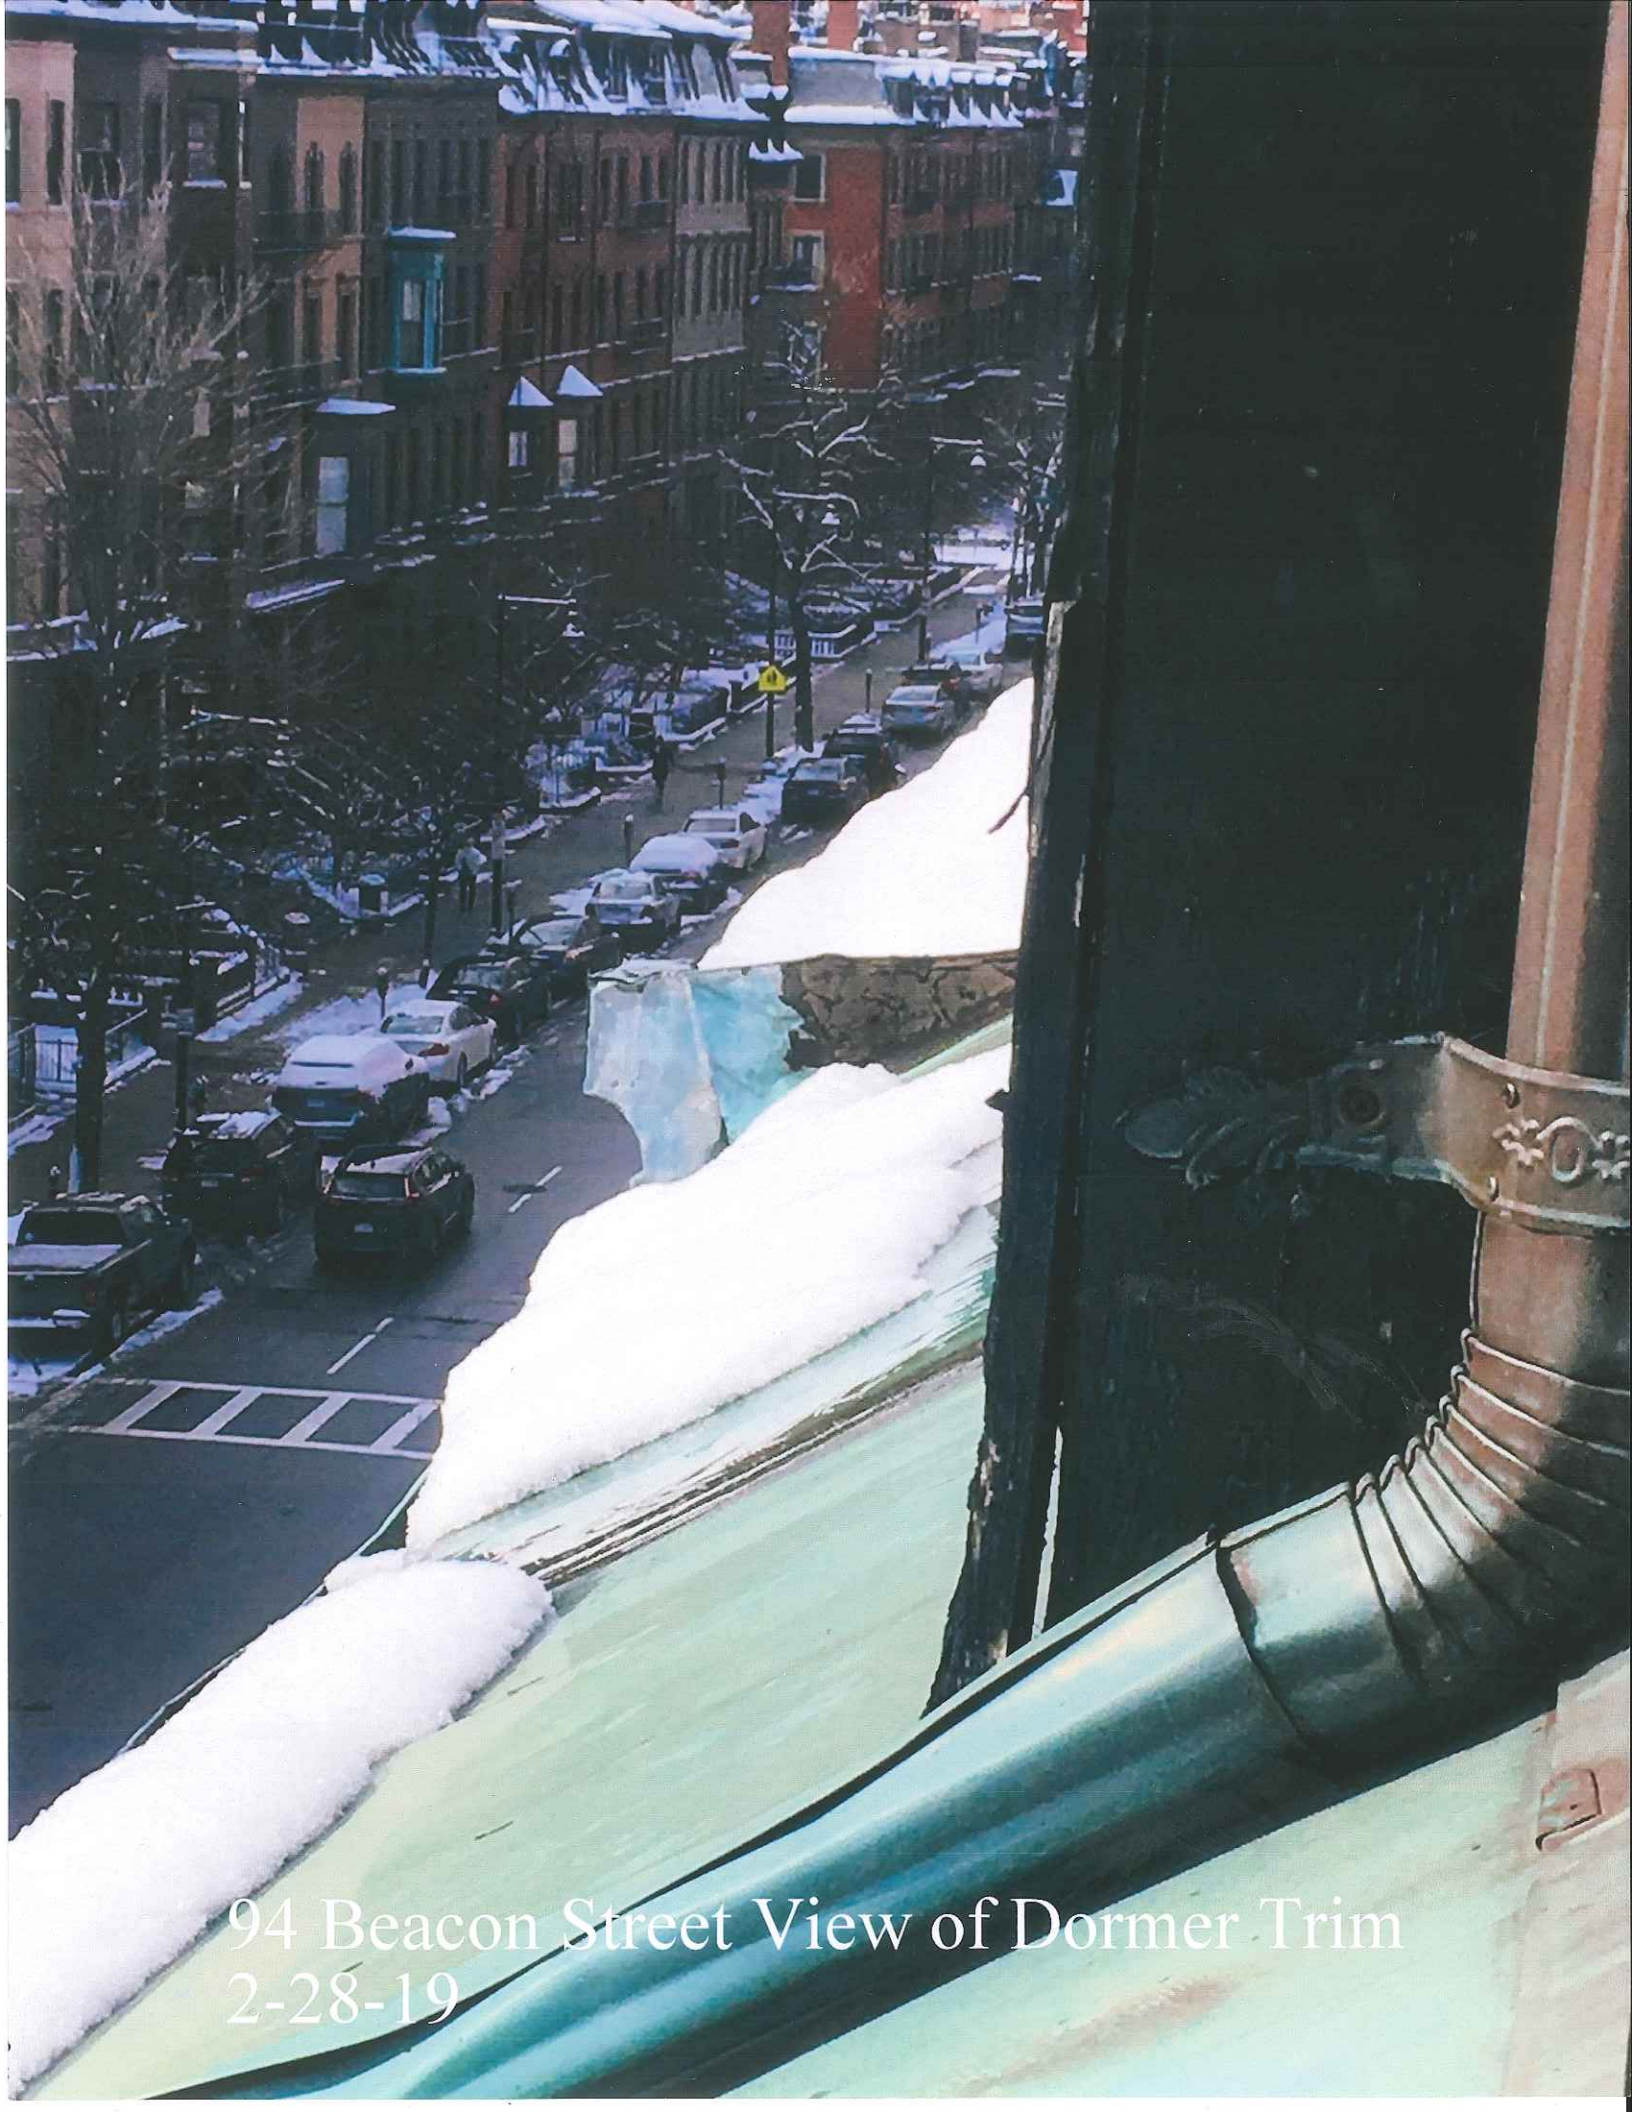
94 Beacon Street View of Dormer Trim
2-28-19

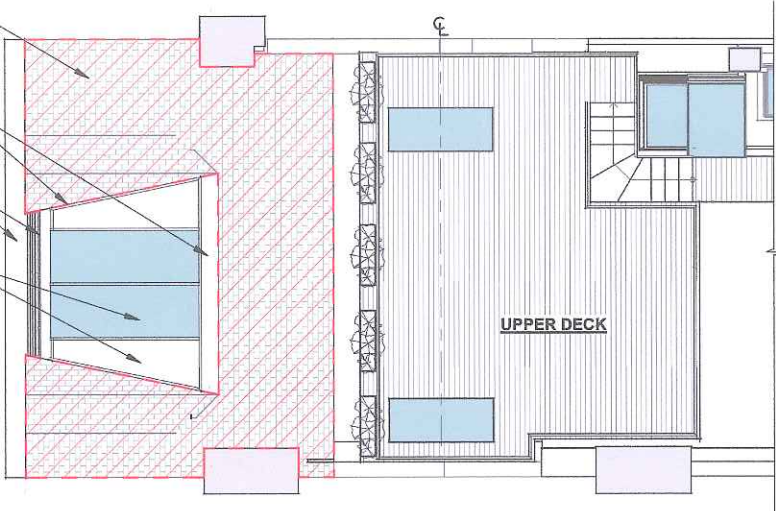
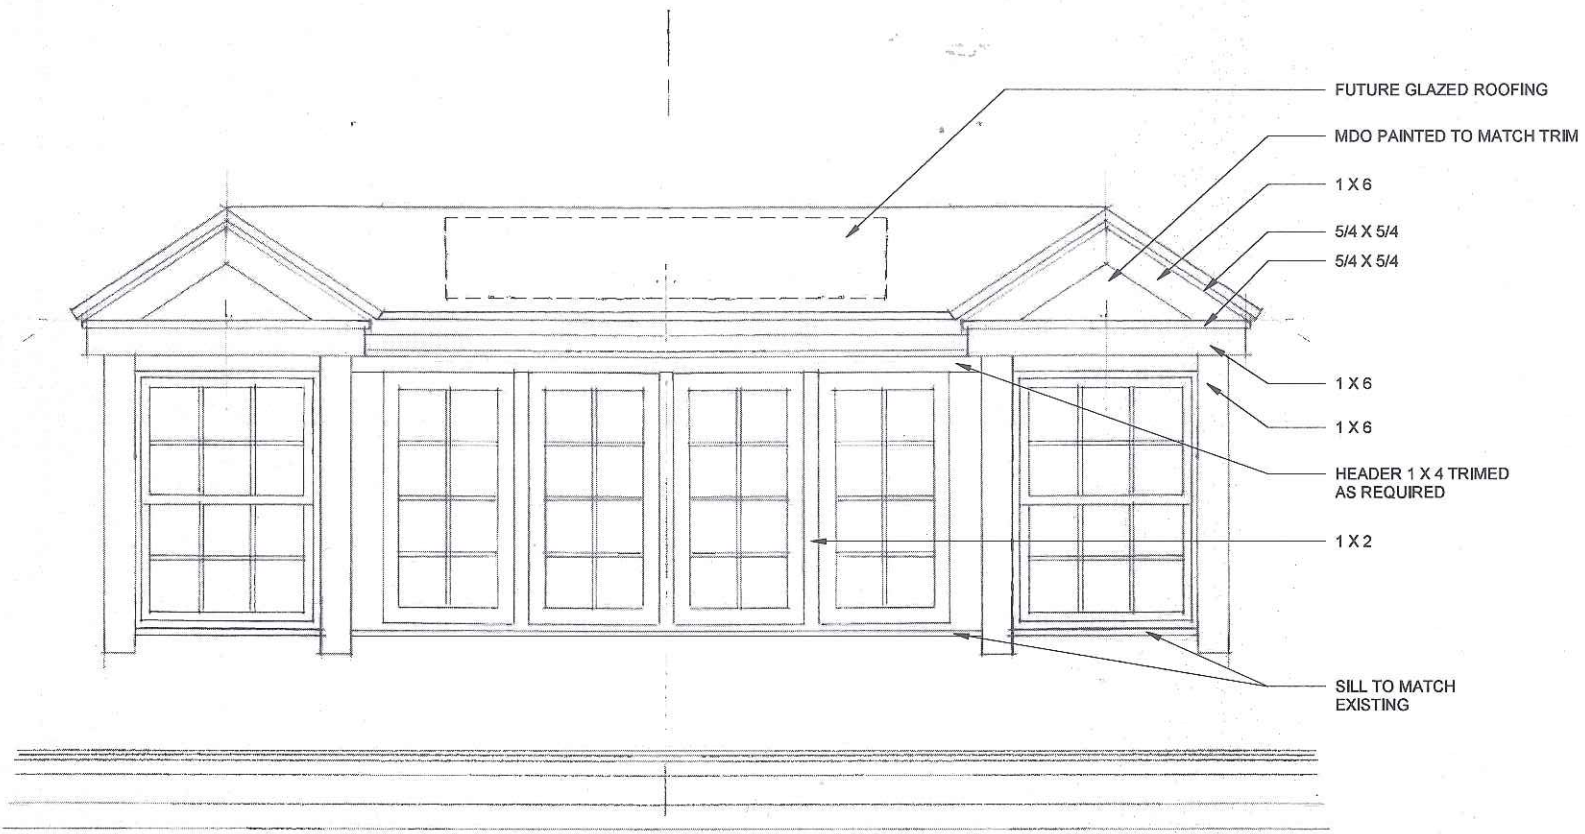
RED HATCHED AREA DENOTES AREA OF ROOF TO BE REPLACED WITH SALVAGED SLATE ROOF & NEW SLATE TO MATCH EXISTING, TYP.

NEW COPPER FLASHING @ GLAZED ROOF PERIMETER, TYP.

NEW COPPER GUTTER & FLASHING

GLAZED ROOF SYSTEM TO MATCH EXISTING ROOF PITCH. ALL EXTERIOR MULLION AND SOLID PANELS TO BE COPPER CLAD
