Notice of Intent

Single Family Residence Demolition
Stony Brook State Reservation
57 Dedham Street
Hyde Park, MA

Revision Date: February 5, 2020

MA Department of Conservation and Recreation
Stony Brook State Reservation
Notice of Intent Application
REVISED February 5, 2020

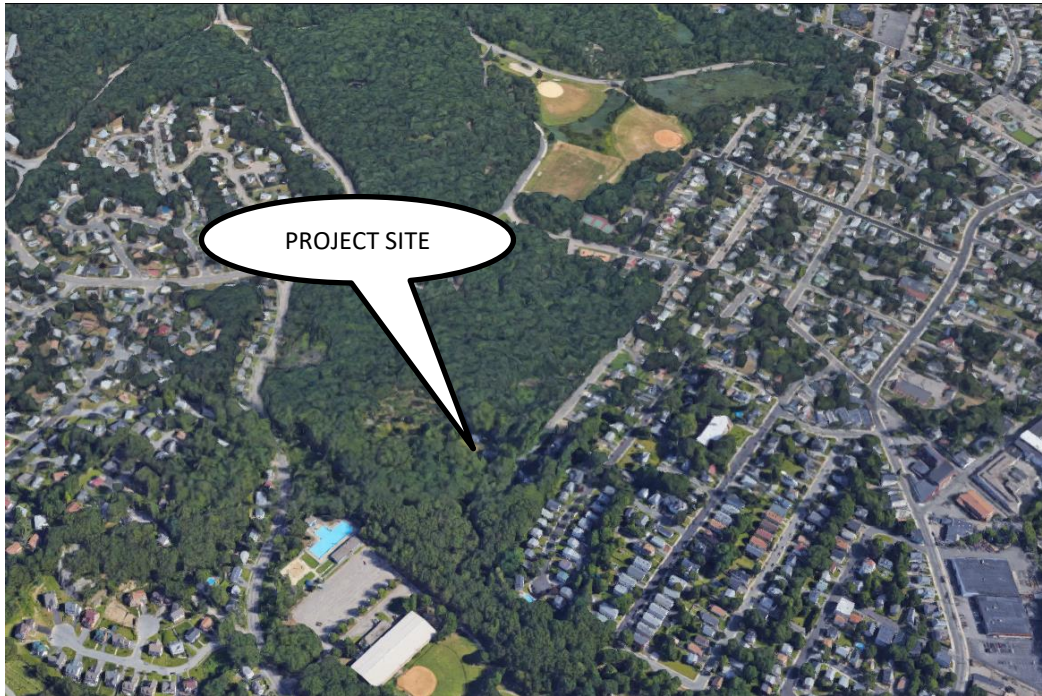
Figure 1: Aerial locus of project site located at 57 Dedham St.
Stony Brook State Reservation, Hyde Park, MA.

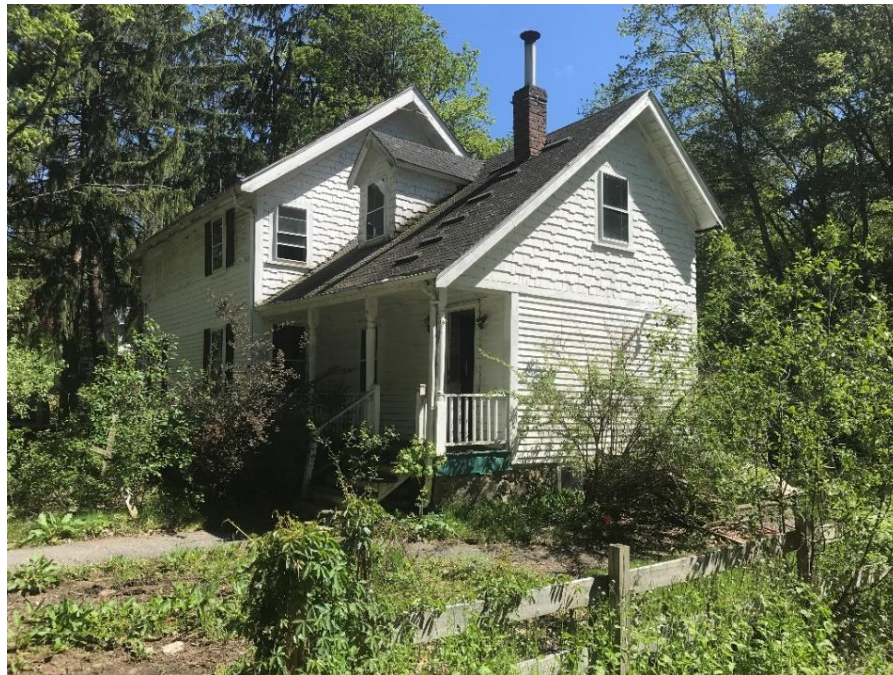
Photograph 1: Front view (looking southwest) of existing single family residence to be removed.

The project involves the demolition and removal of an existing $\pm 1,150$ SF single family residence that is located at 57 Dedham Street in Stony Brook State Reservation in Hyde Park. The building is in a severely deteriorated state. Once the structure has been removed, the existing foundation will be cut down to approximately ± 1 -foot below existing grade and then backfilled with clean granular material. The backfilled area will be finished off with ± 12 -

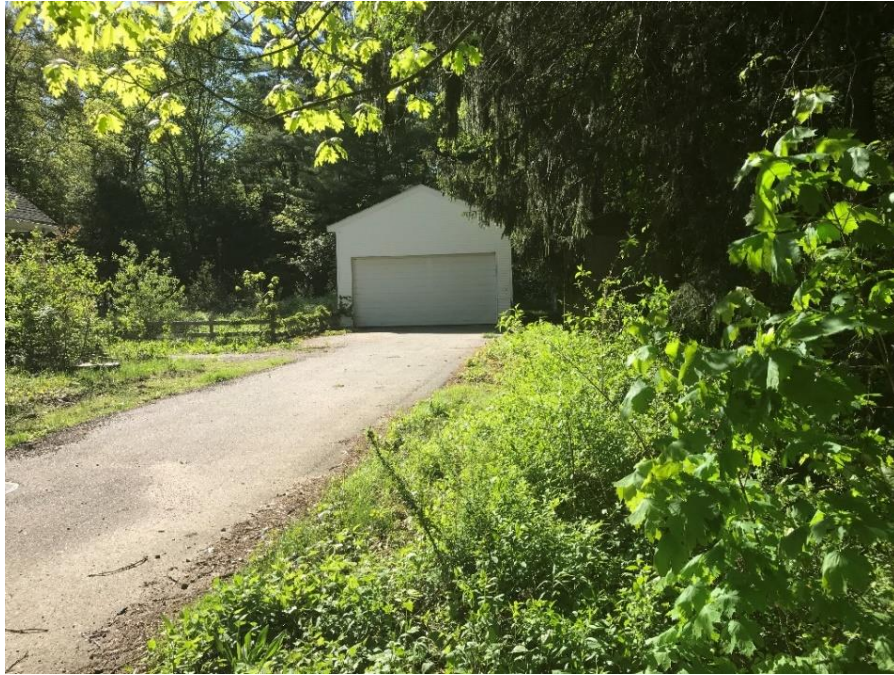
Photograph 2: View (looking west) of existing garage to remain on-site for dry storage of tools and equipment.

inches of loam that will be graded to match surrounding/adjacent grade(s) and then seeded with a native seed mix. Prior to backfilling the existing foundation, 3-inch diameter core holes will be drilled along the centerline of the basement slab at 10-feet on center to facilitate drainage. The existing stand-alone elevated deck (± 100 SF) and the elevated deck (± 250 SF) and porch (± 116 SF) structures that are attached to the south and east side of the residence, respectively, will also be removed as part of the proposed project. Existing timber posts that current support the decks and porch will be cut to ± 1 -foot below grade so that these areas can be then be graded with ± 12 -inches of loam to match surrounding/adjacent grade(s) and seeded with a native seed mix. The proposed site restoration plan is provide in **Exhibit D**. The existing garage that is located to the northwest of the residence and at the end of the existing driveway will remain in place and be utilized for future dry storage of gardening tools and equipment.

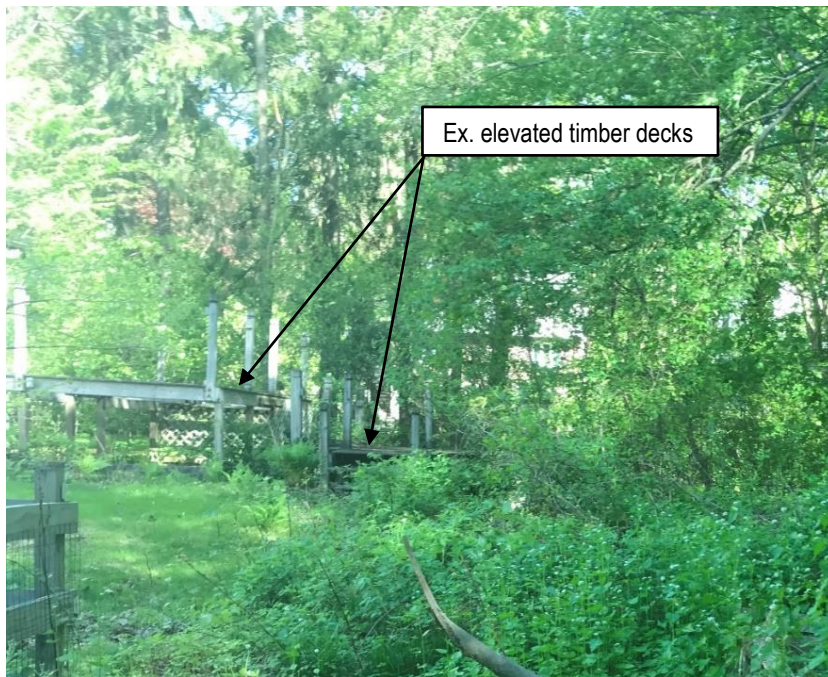
Photograph 3: View (looking east) of the existing elevated timber deck structures located in the backyard. Both structures will be removed as part of the proposed project.

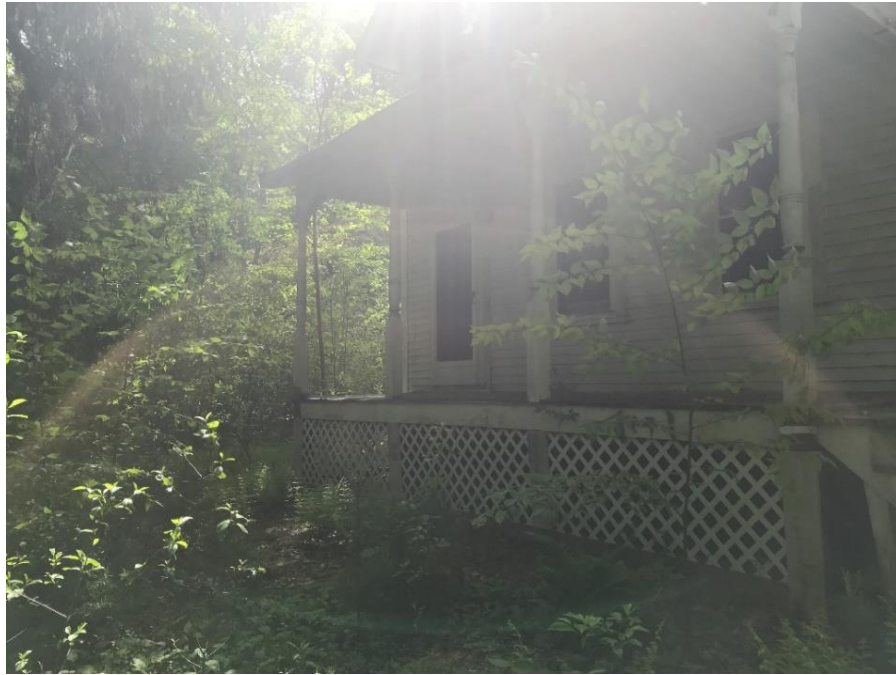
Photograph 4: View (looking west) of the existing elevated porch located on the east side of residence to be removed.

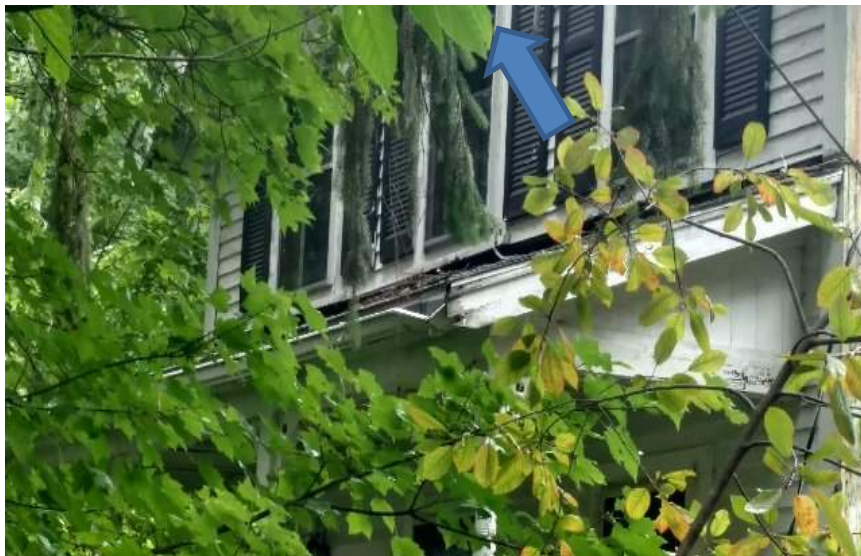
A visual inspection was completed on roof flashing (photo below) removal and tile removal (shown below). Roof flashing was removed on the perimeter of the roof. No remaining flashing was seen. Chimney caulking was also removed on the roof and within the house. The chimney was completely removed on the second floor.

Figure 2- Roof flashing was completely removed
