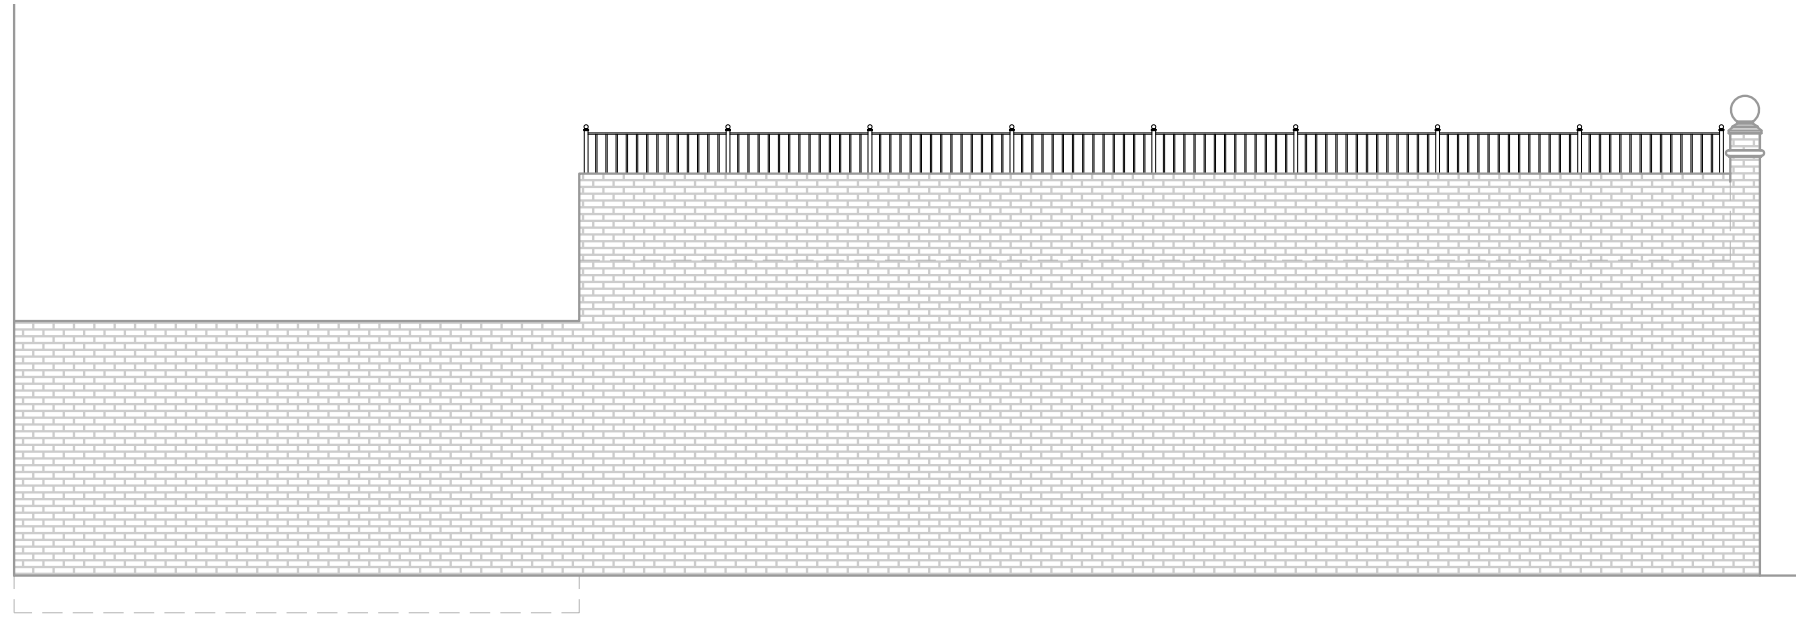
Existing East Elevation

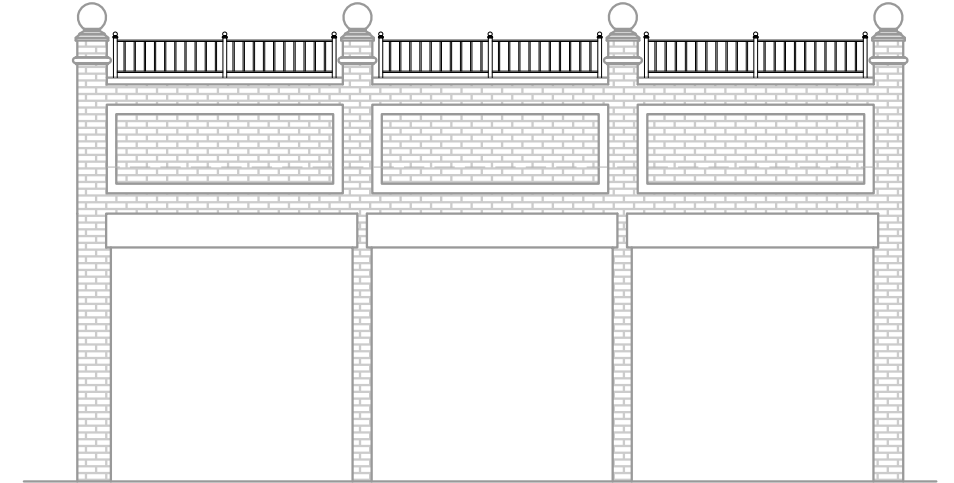
Existing North Elevation - along Back Street

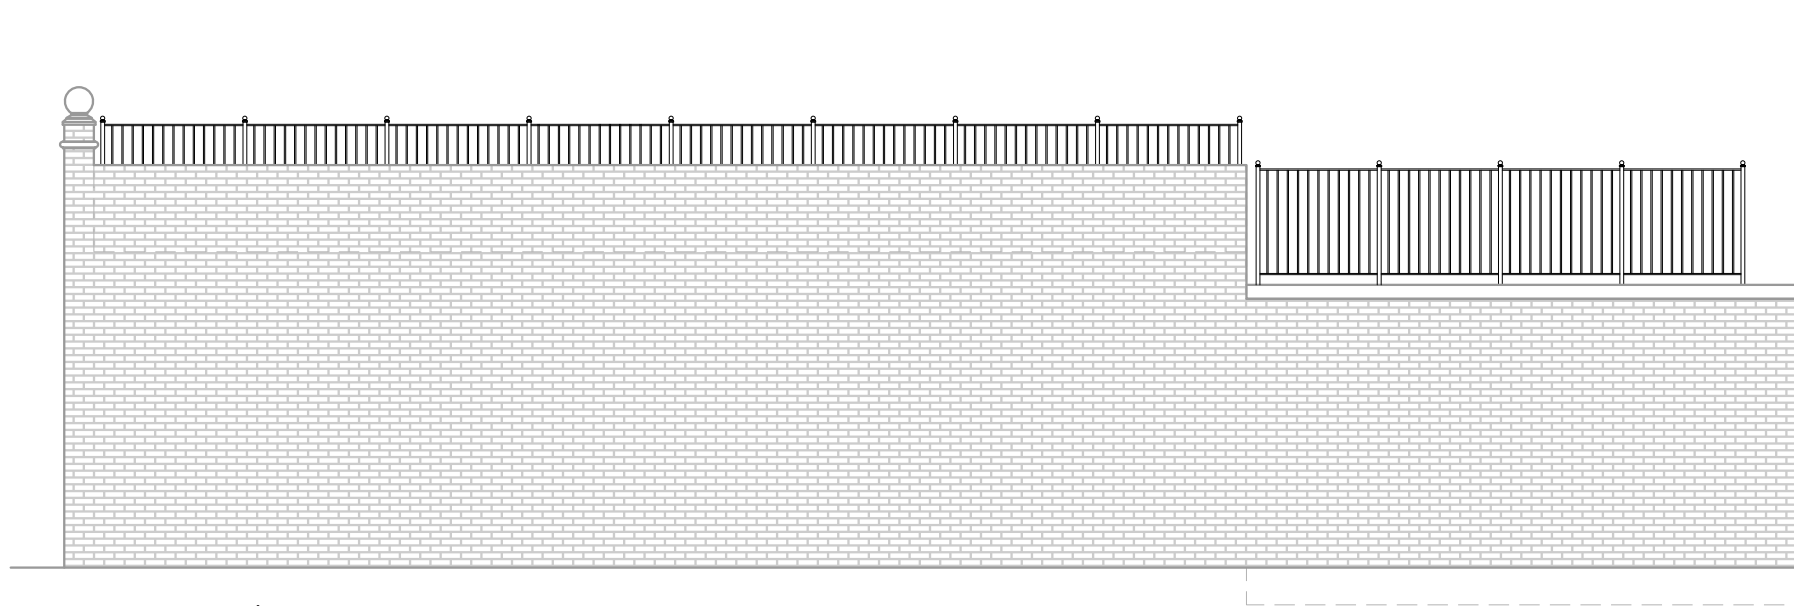
Existing West Elevation

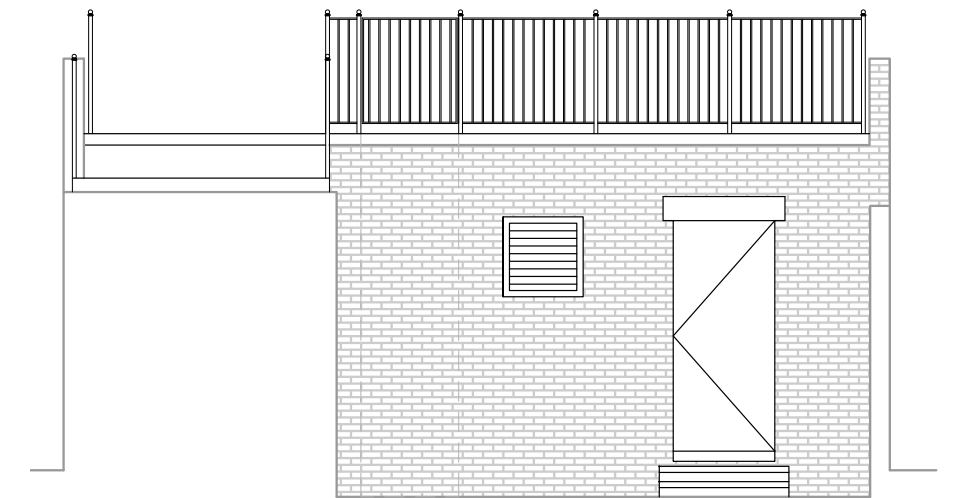
Existing South Elevation - as seen from enclosed terrace

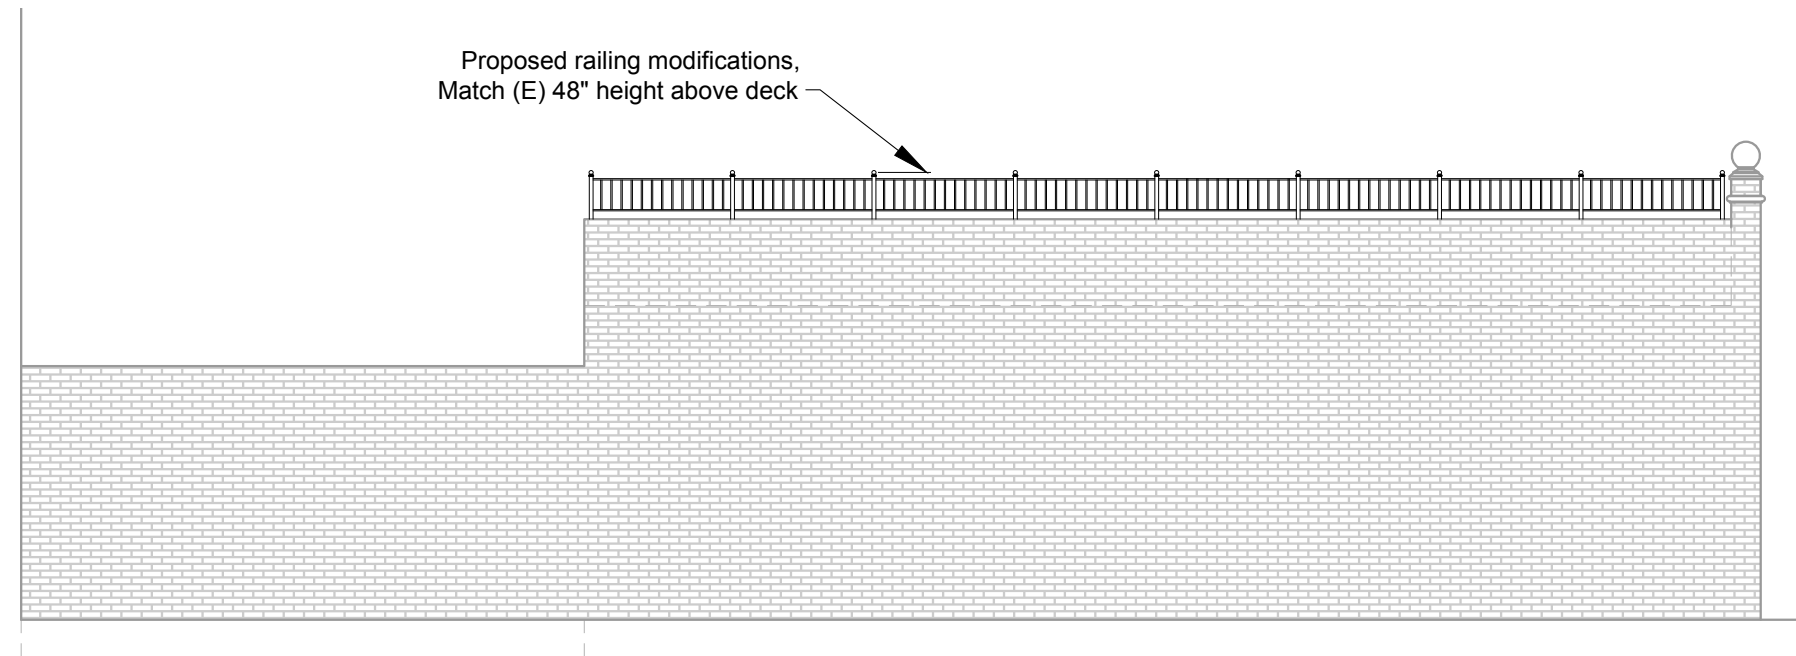
Proposed East Elevation - Modified Railings

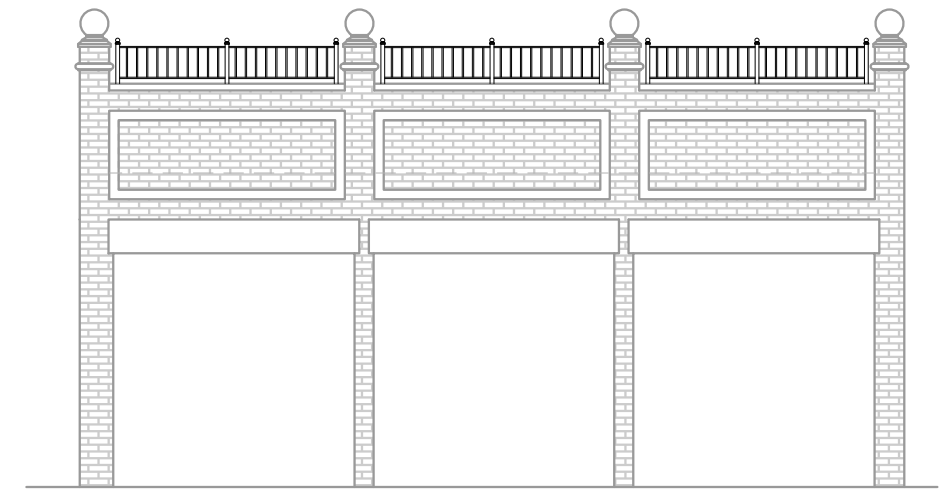
Proposed North Elevation - No Change

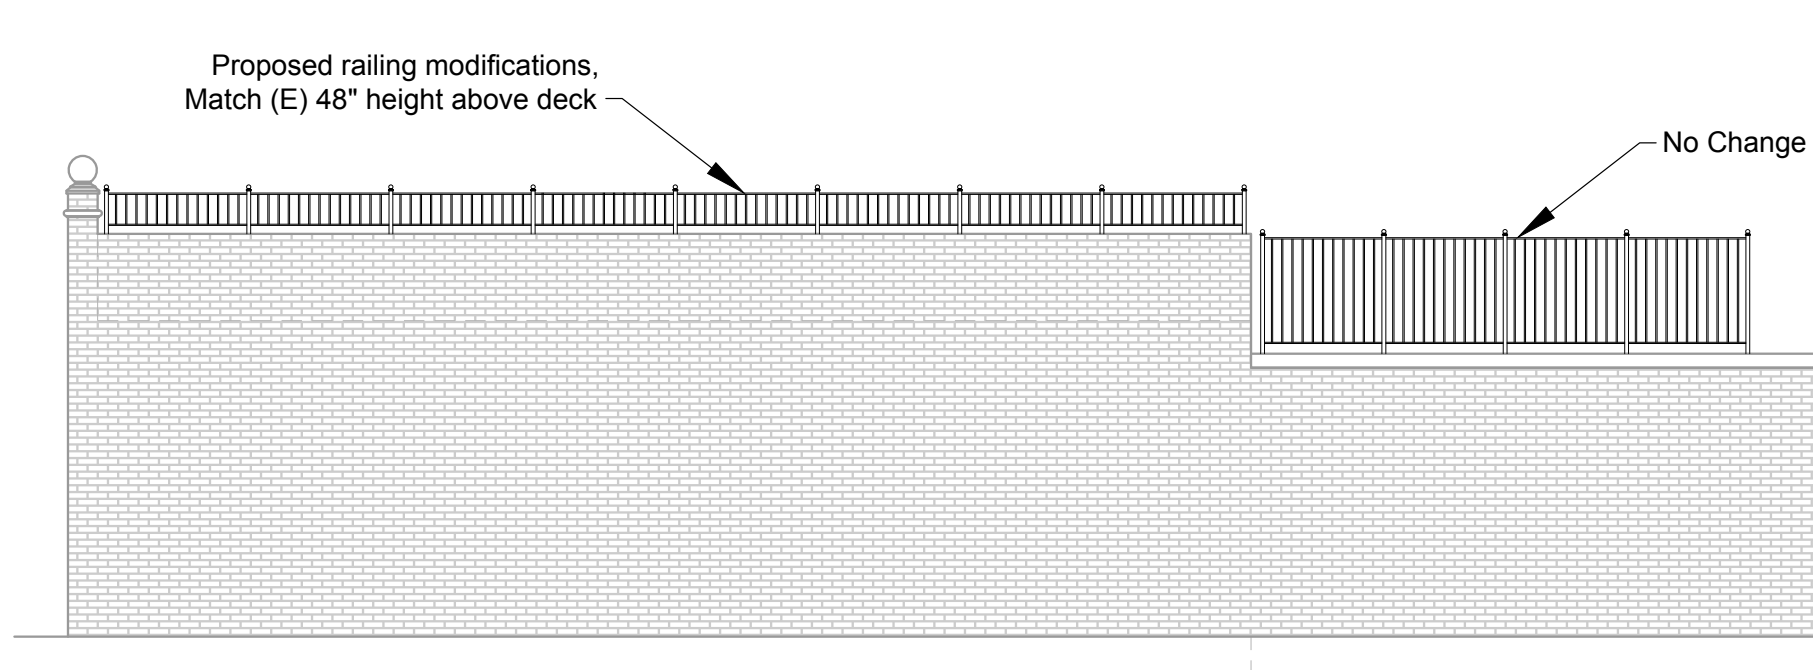
Proposed West Elevation - Modified Railings

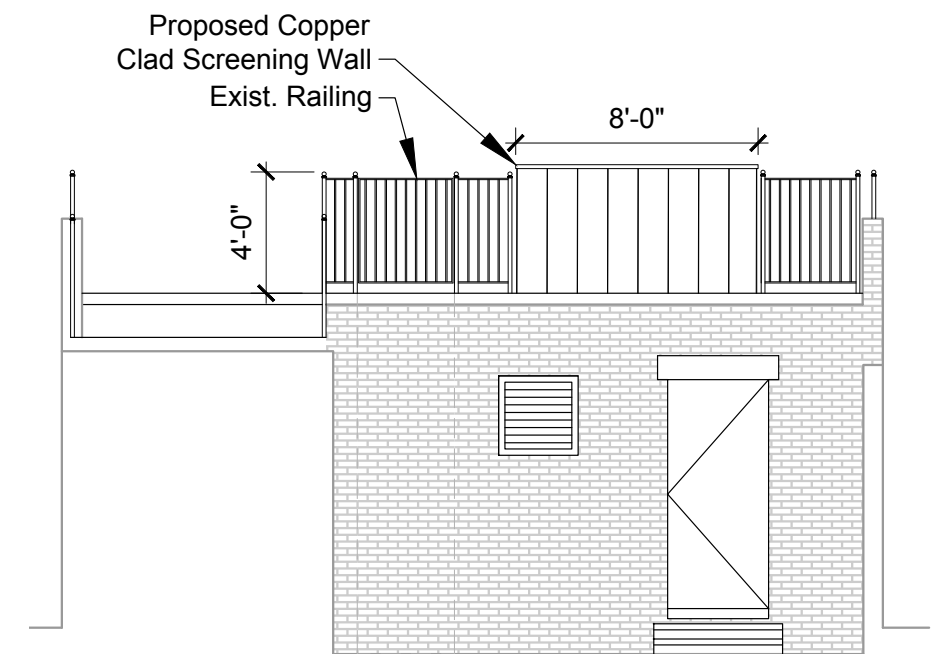
Proposed South Elevation - Screening Wall, standing seam copper to match surrounding roofing elements.

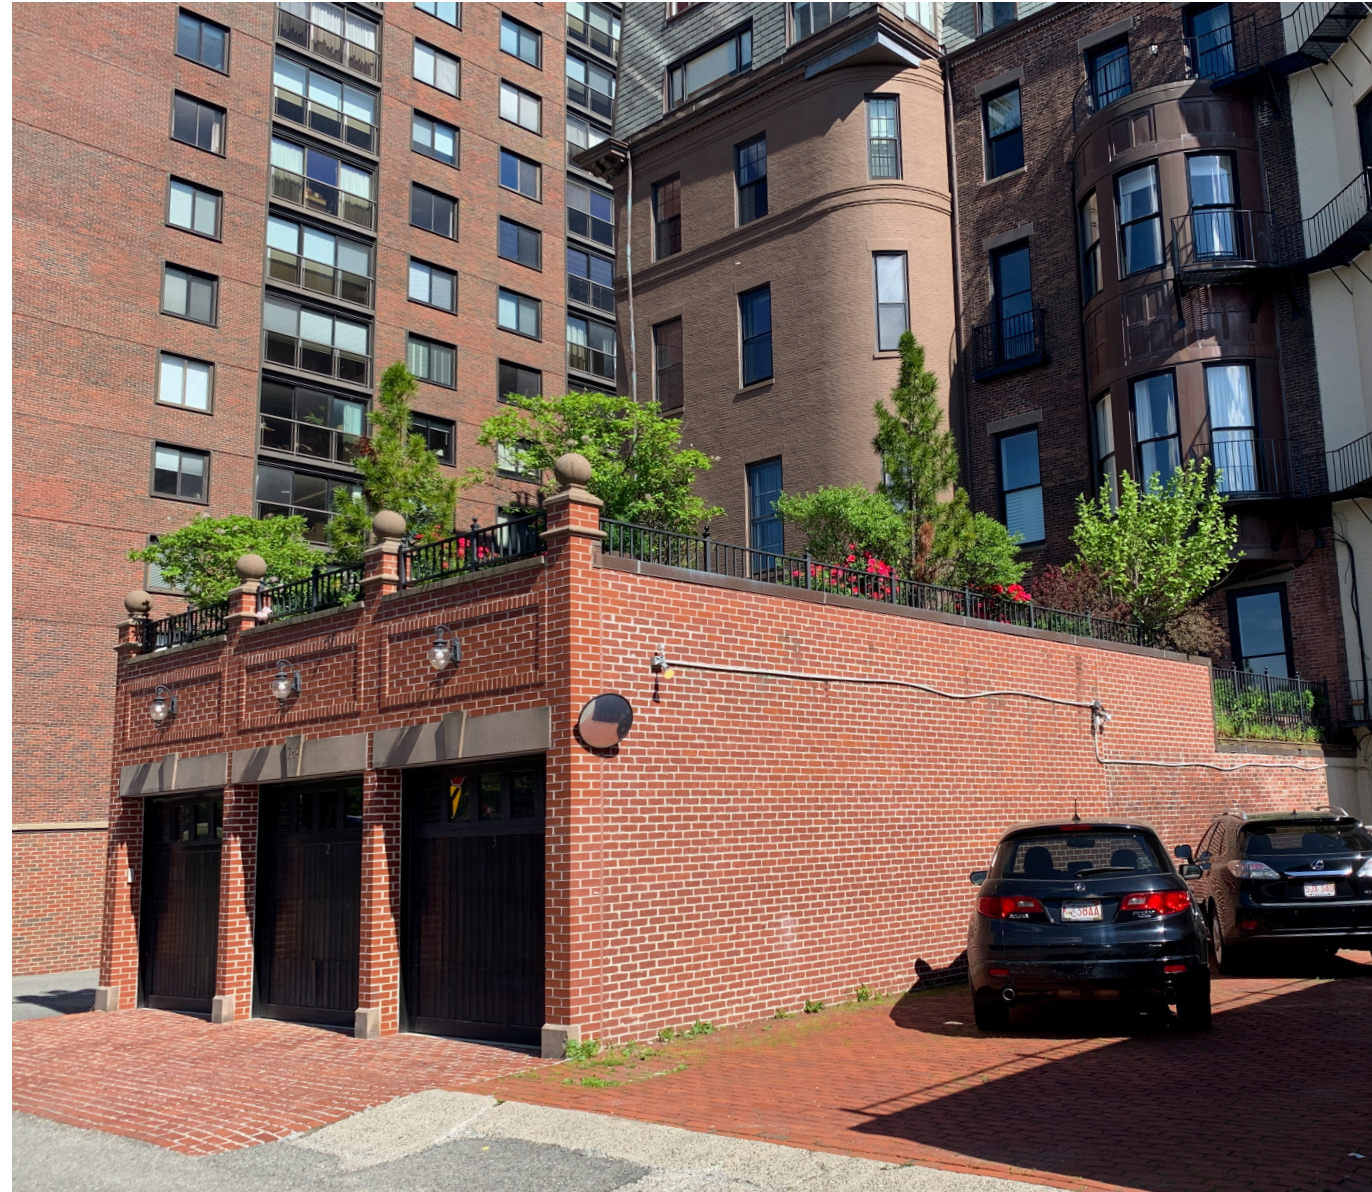
Existing North and West Elevations as seen from Back Street

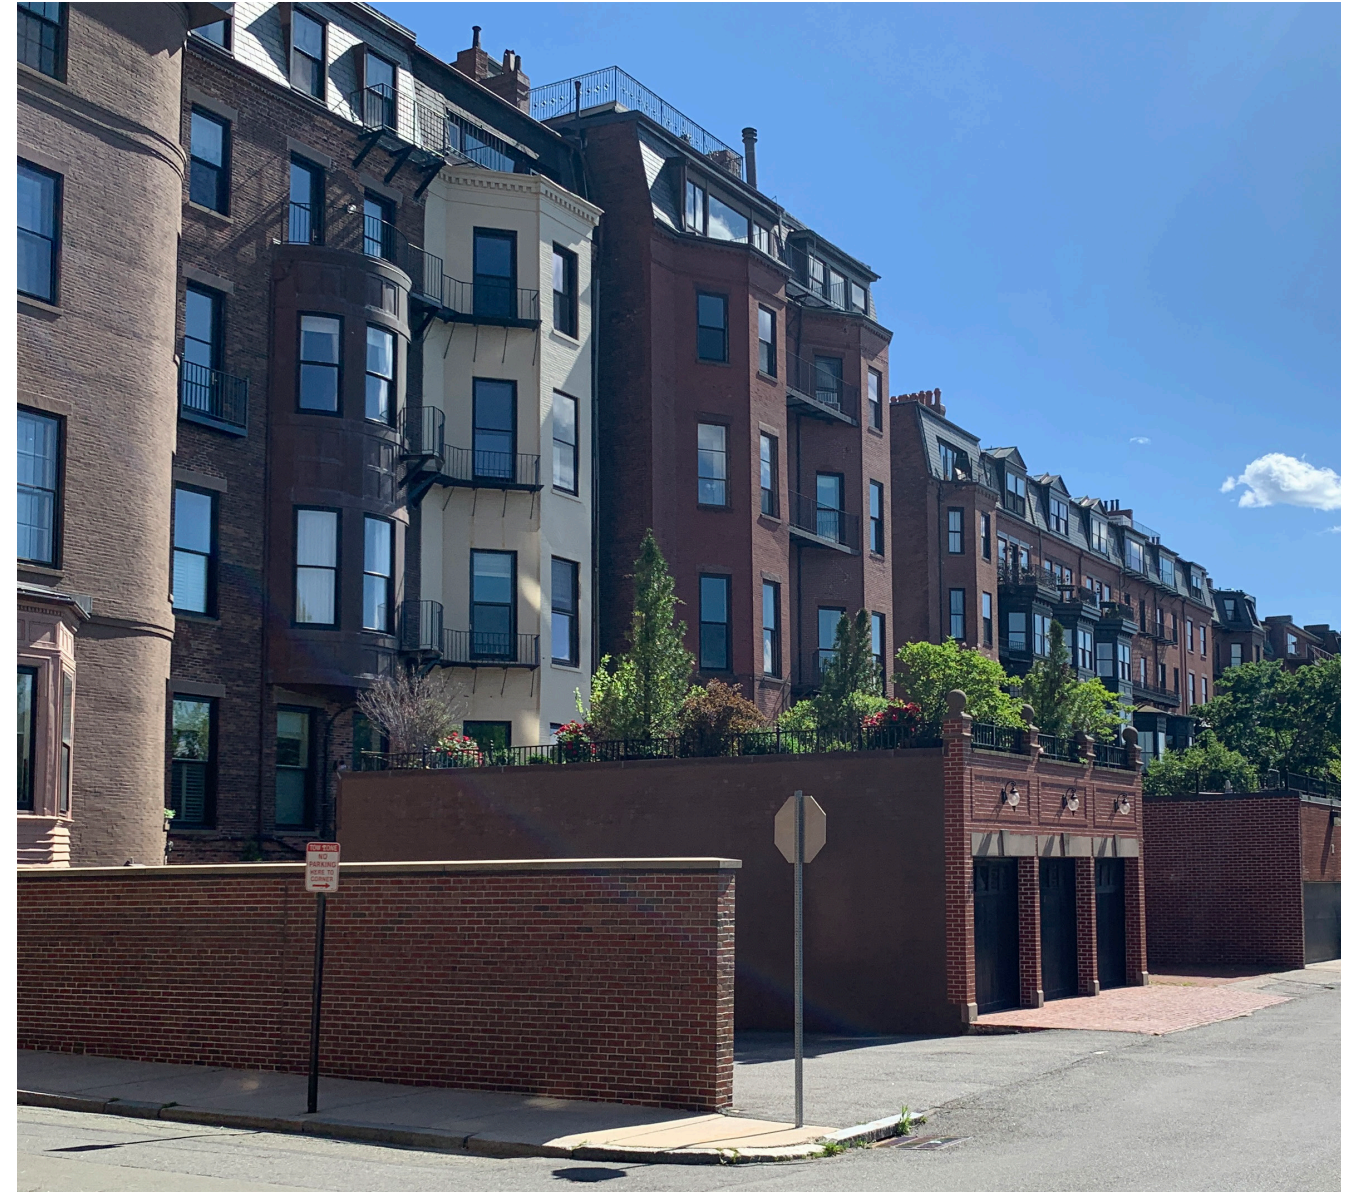
Existing East and North Elevations as seen from corner of Back and Clarendon Streets

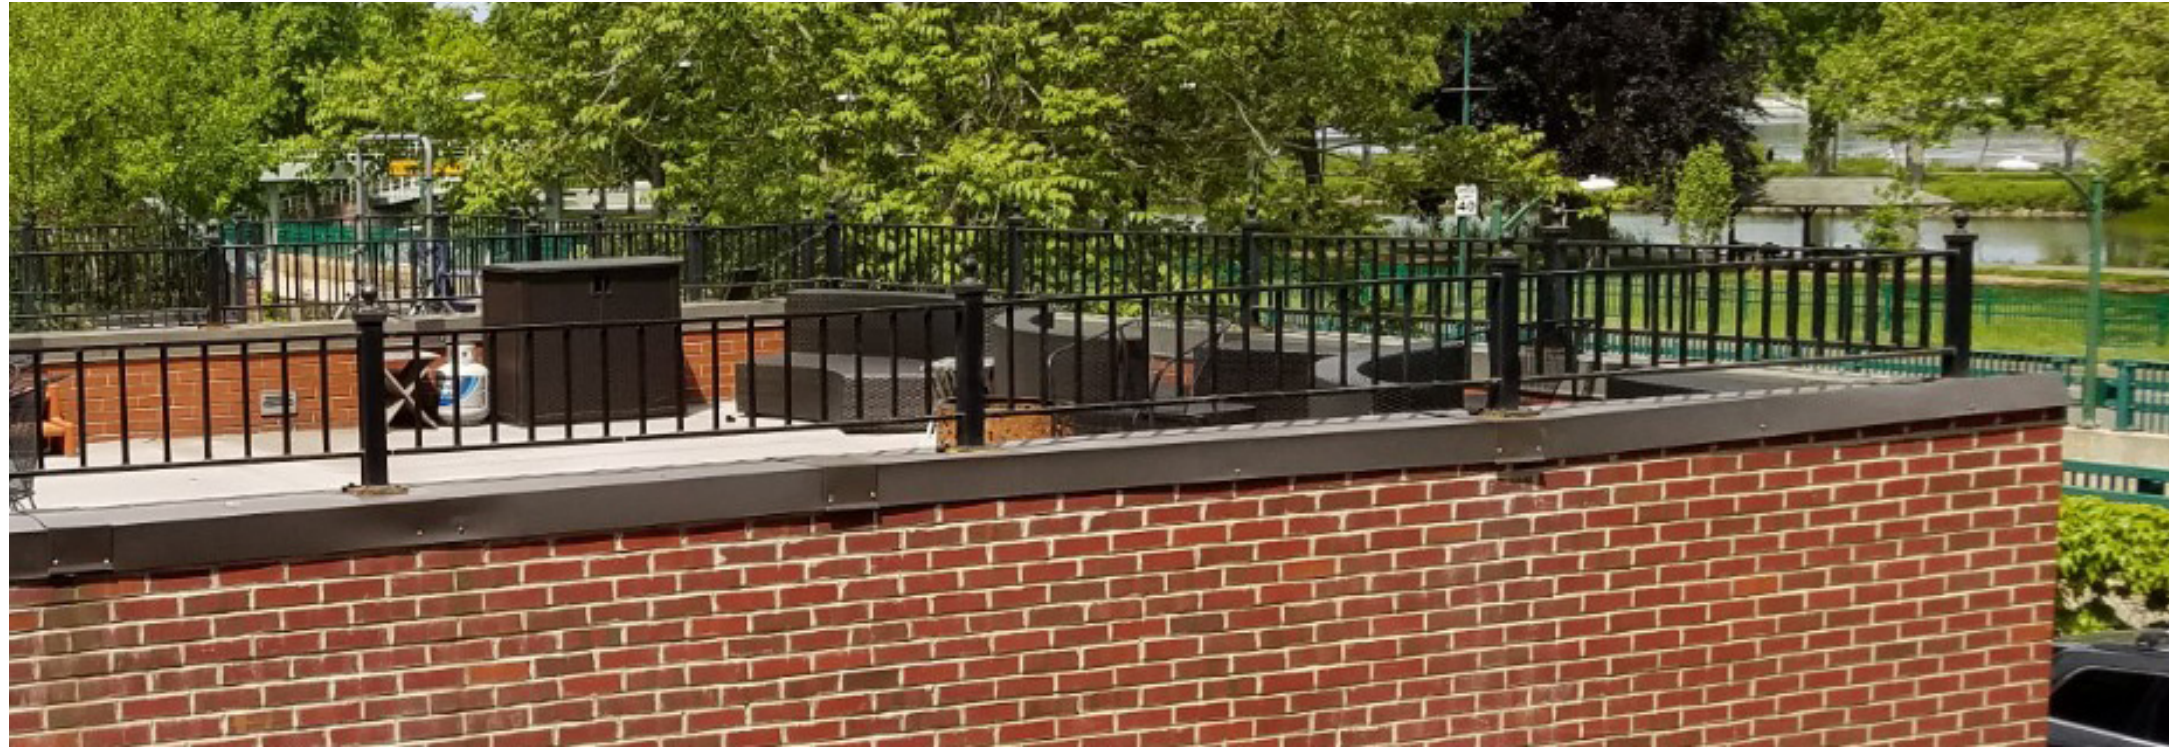
Neighboring deck example of railings installed on parapet wall

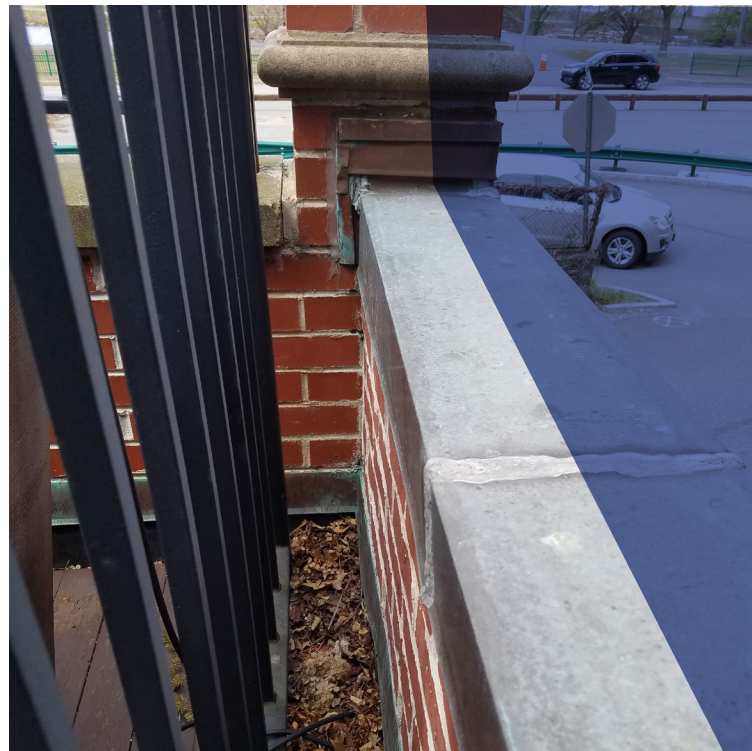
Far Left: Existing railing condition, the gap between railing and parapet is lost deck space and debris trap. Proposed railing location is highlighted in dark blue.

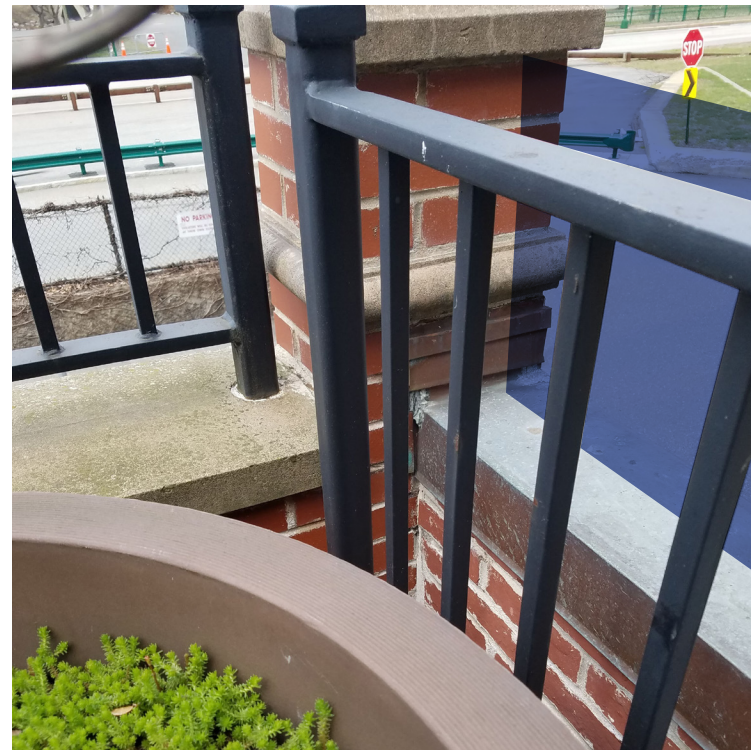
Left: Existing railing intersection at North elevation with proposed railing location highlighted in dark blue.

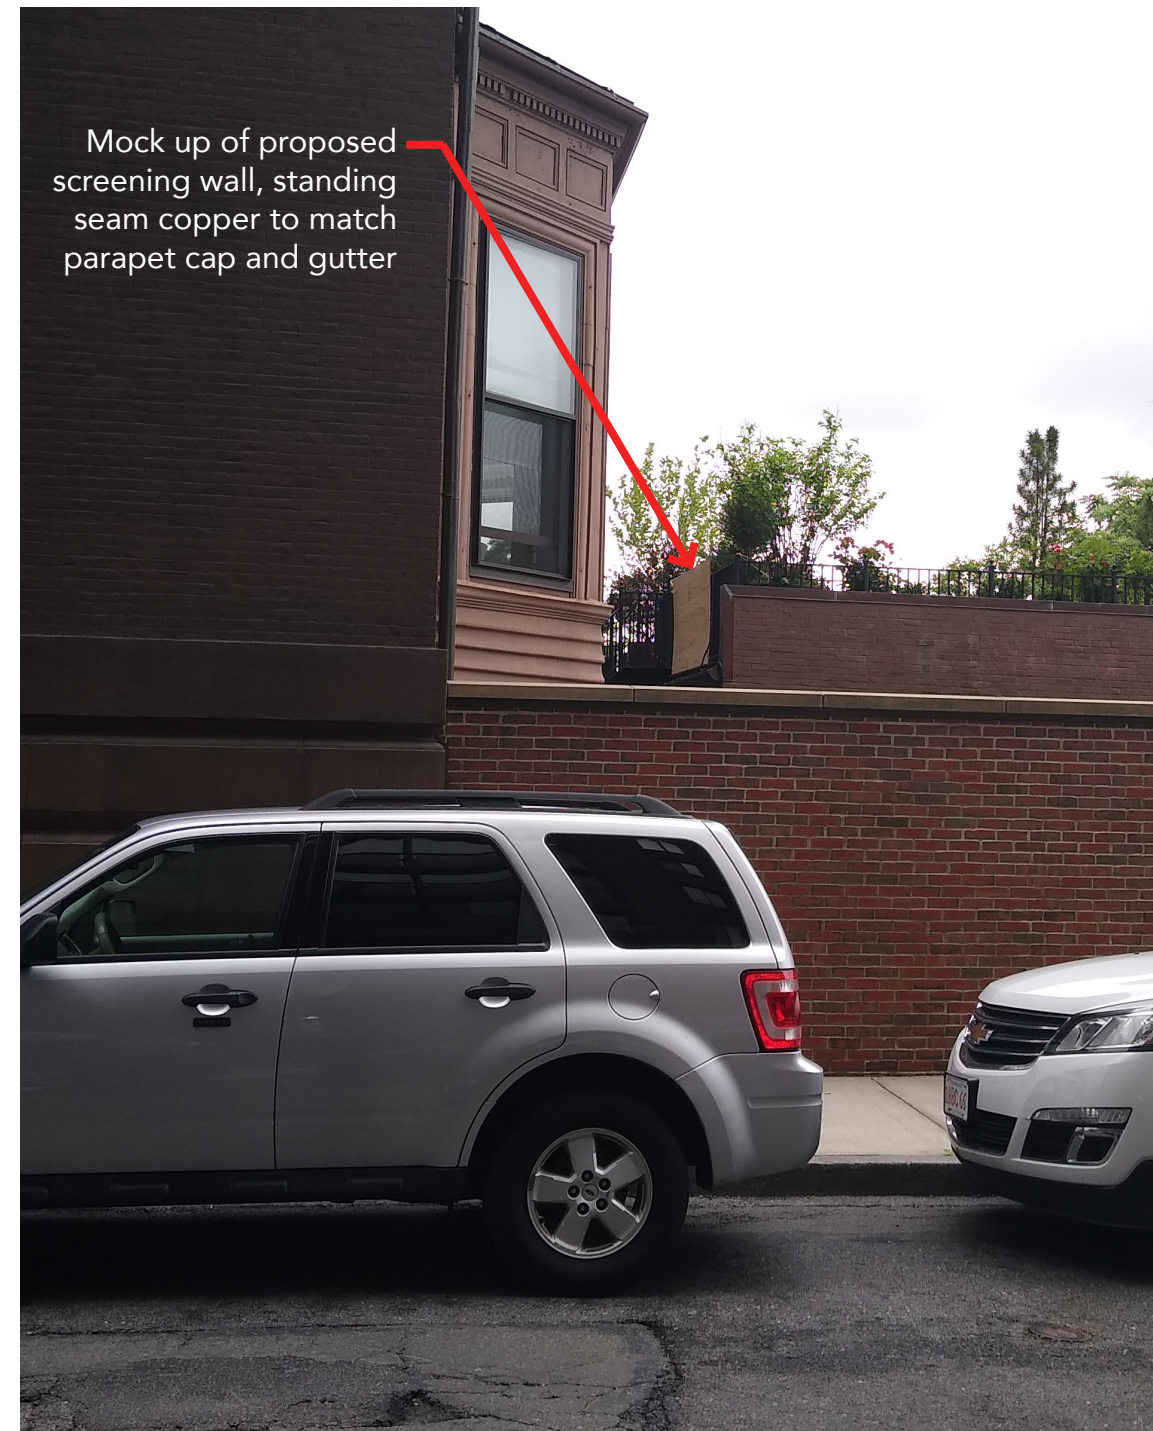
South Elevation with Screen Mock-up from Clarendon Street between Beacon and Back Streets

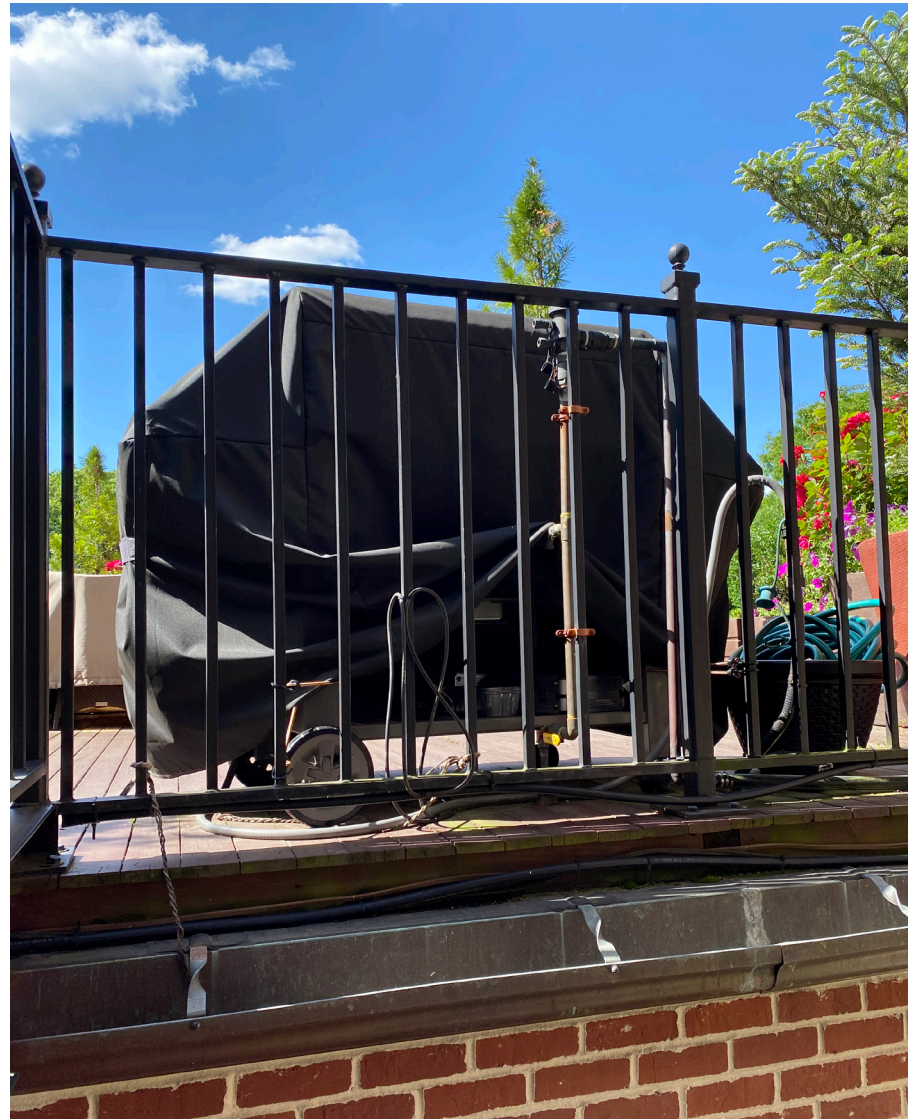
South Elevation Detail of existing exposed hard pipe grill and irrigation connections

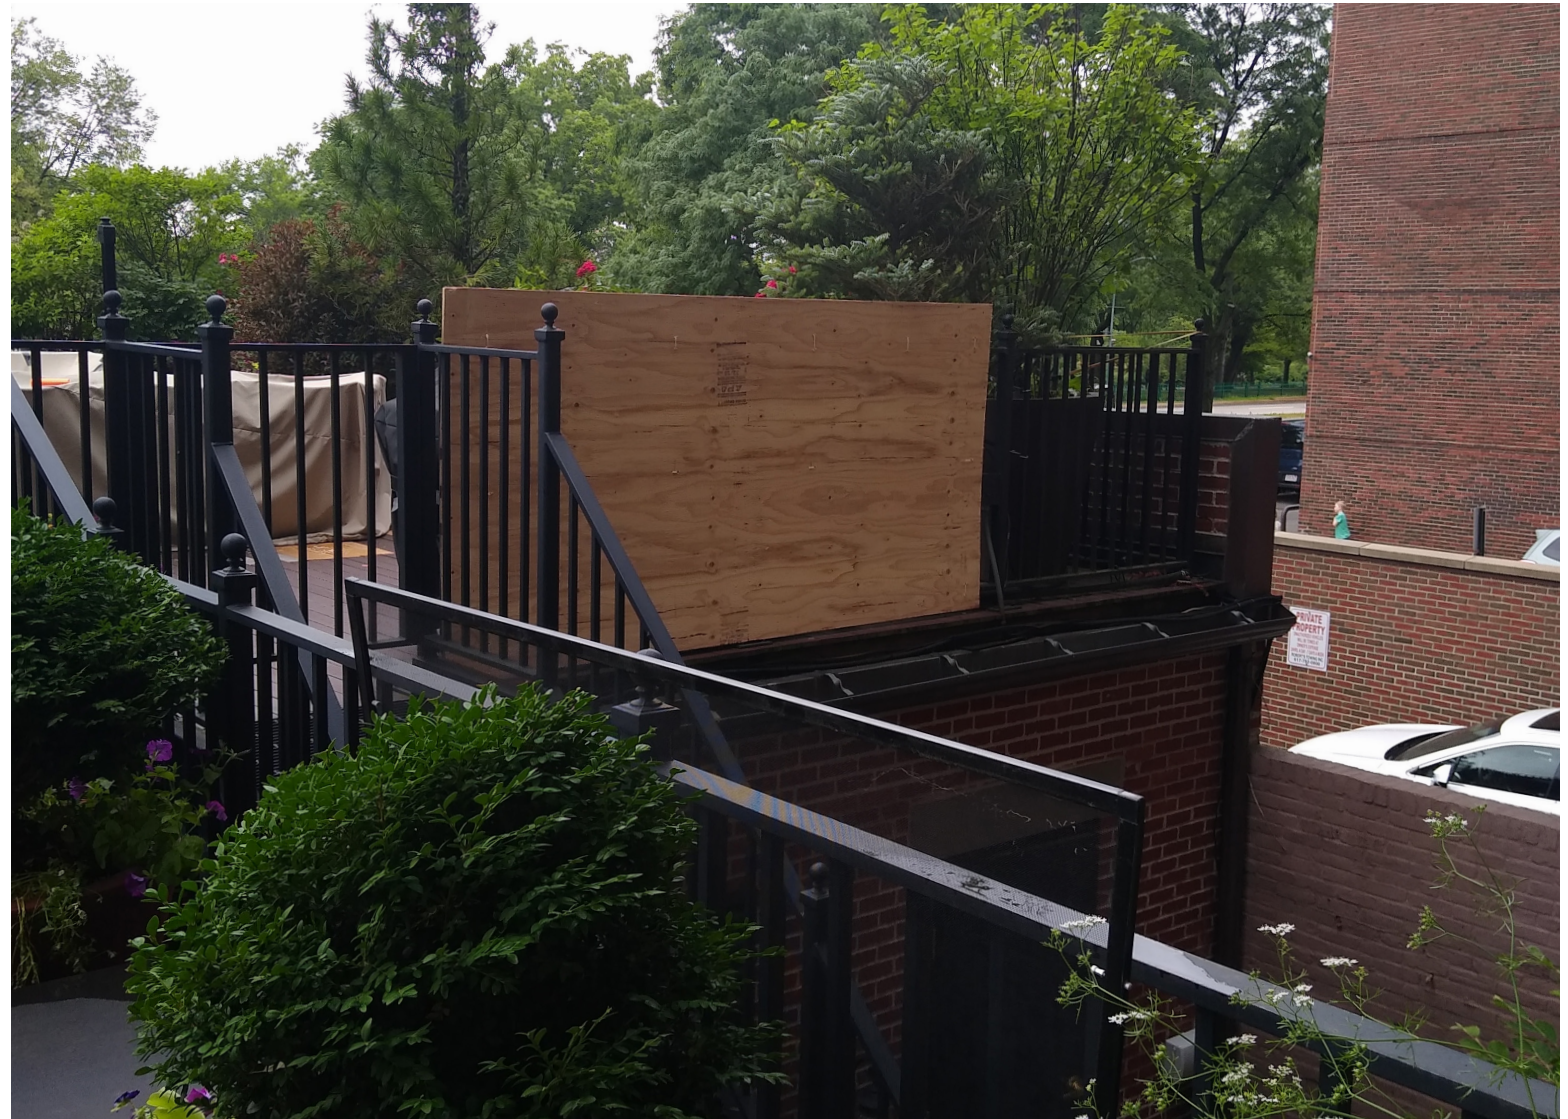
South Elevation from House, with screen wall mock-up located
