# Guidebook for Structural Approaches to Integrated Pest Management

Prepared by  
Dr. Mitchell D. Allen  
Boston Housing Authority  
2009

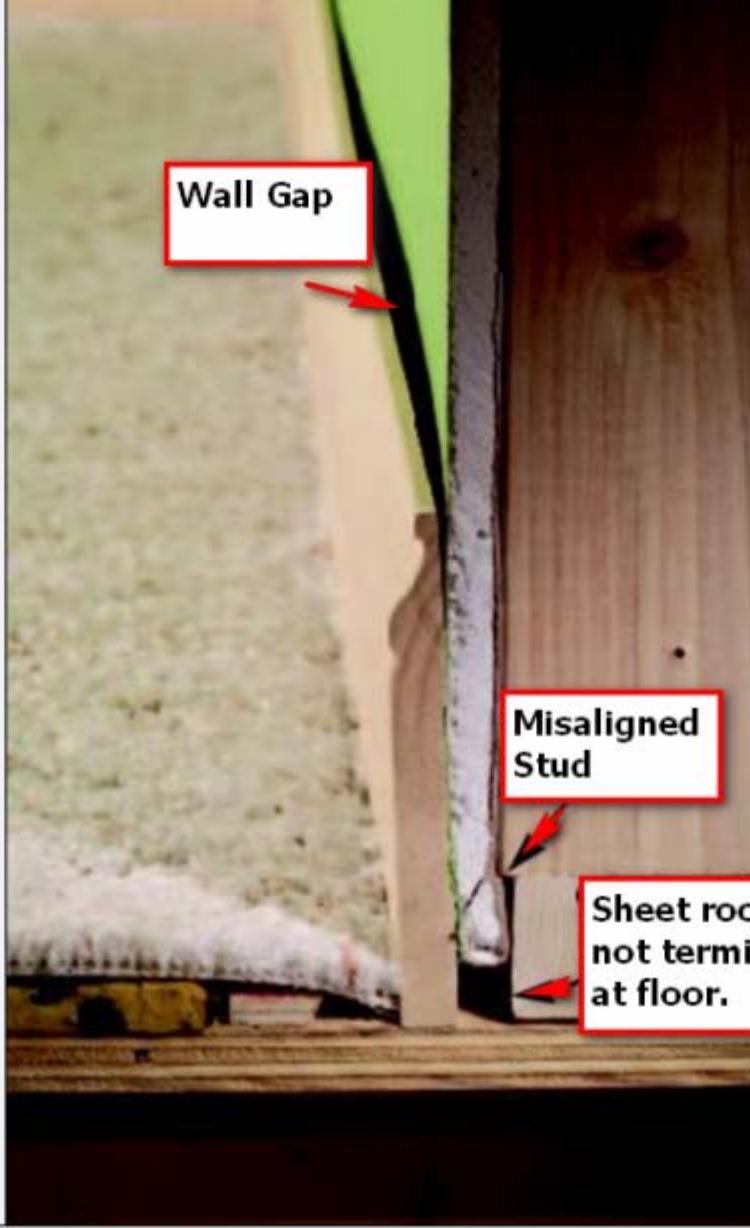
**Problem:** This is a cross section of a wall as actually installed, allowing for insect access and harborage.

**Solution:** Install correctly and inspect prior to acceptance of work.

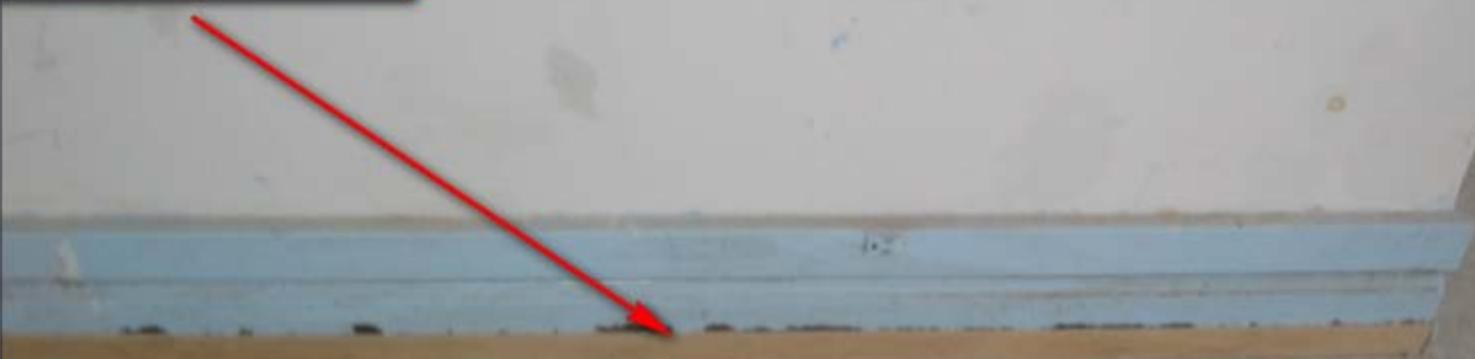
**At first glance, this wooden strip seals the old baseboard with the replacement tile floor.**

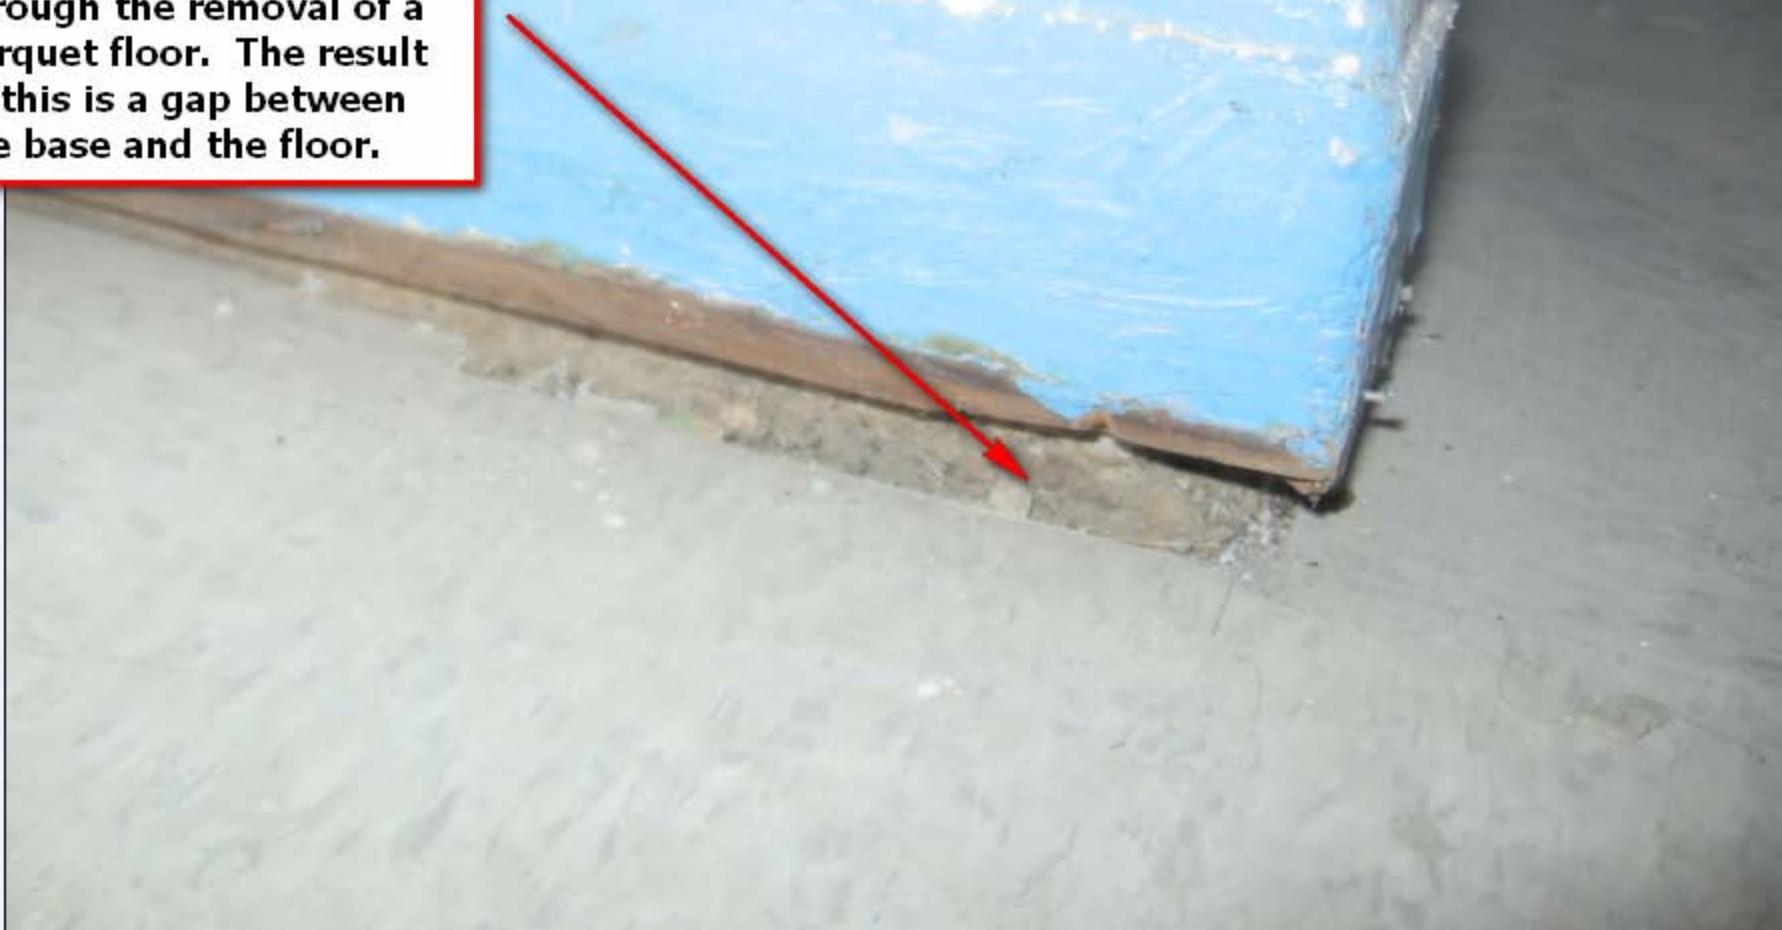
However, another view shows that the level of the floor has been dropped through the removal of a parquet floor. The result of this is a gap between the base and the floor.

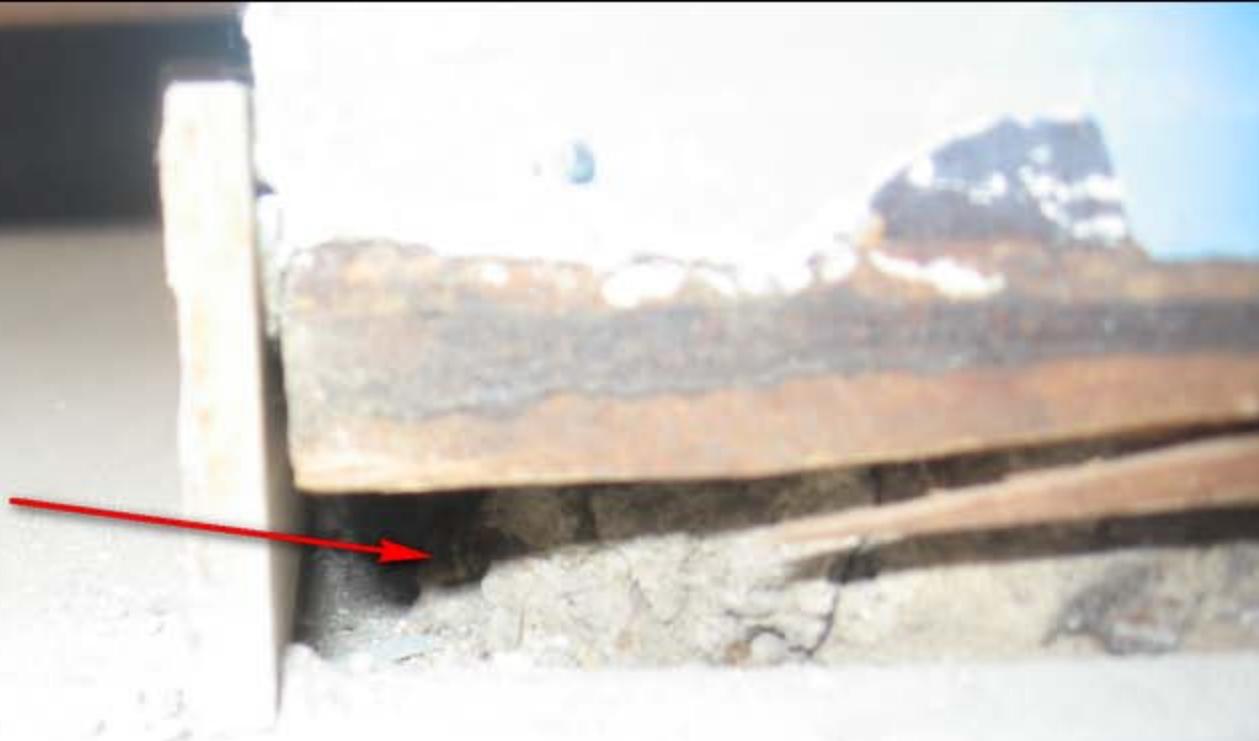
**Problem:** the installation of the new strip creates access and harborage for insects and if large enough, for mice.

**Solution:** Fill void with foam prior to installation of strip.

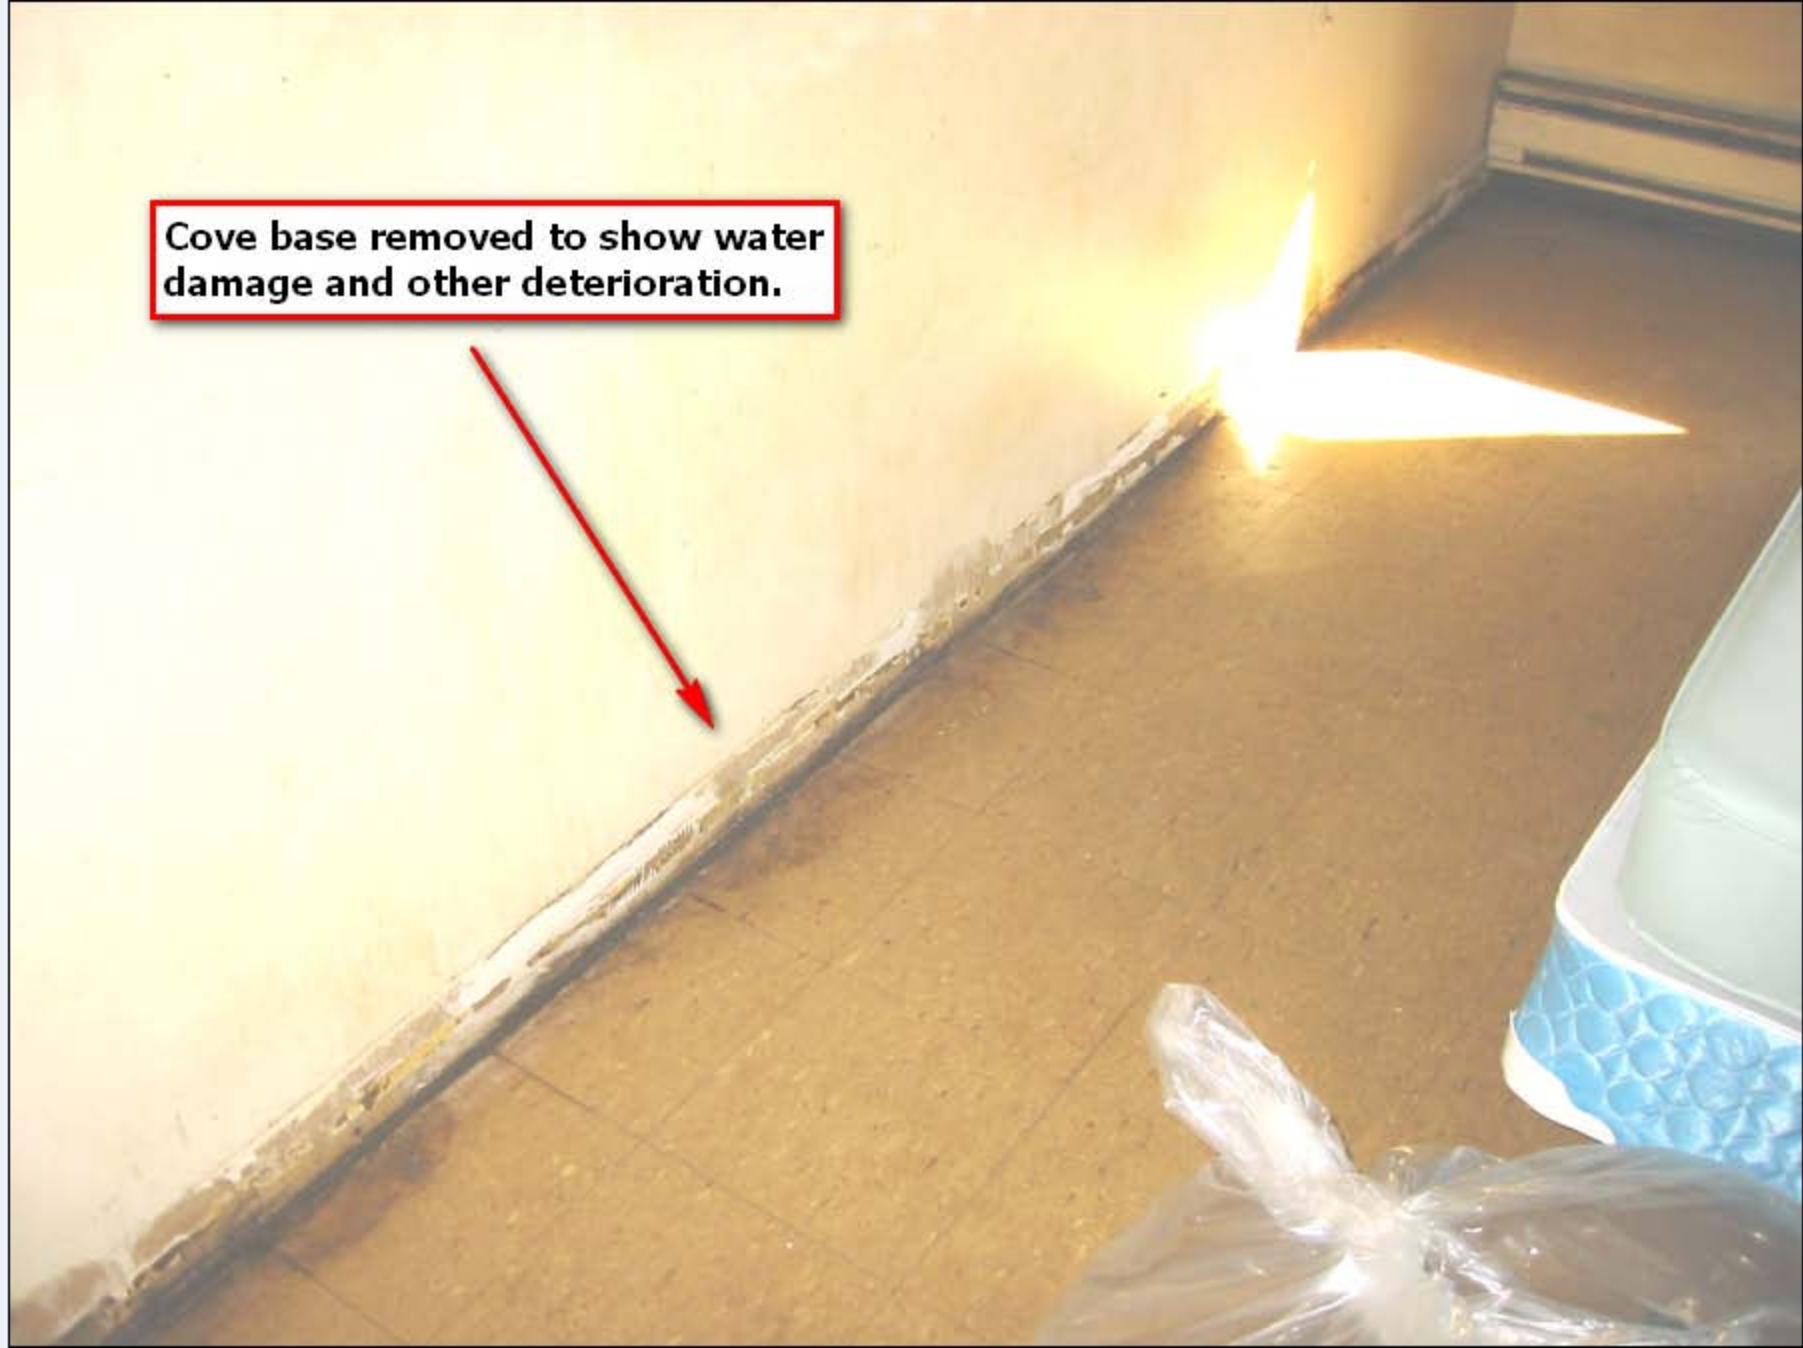
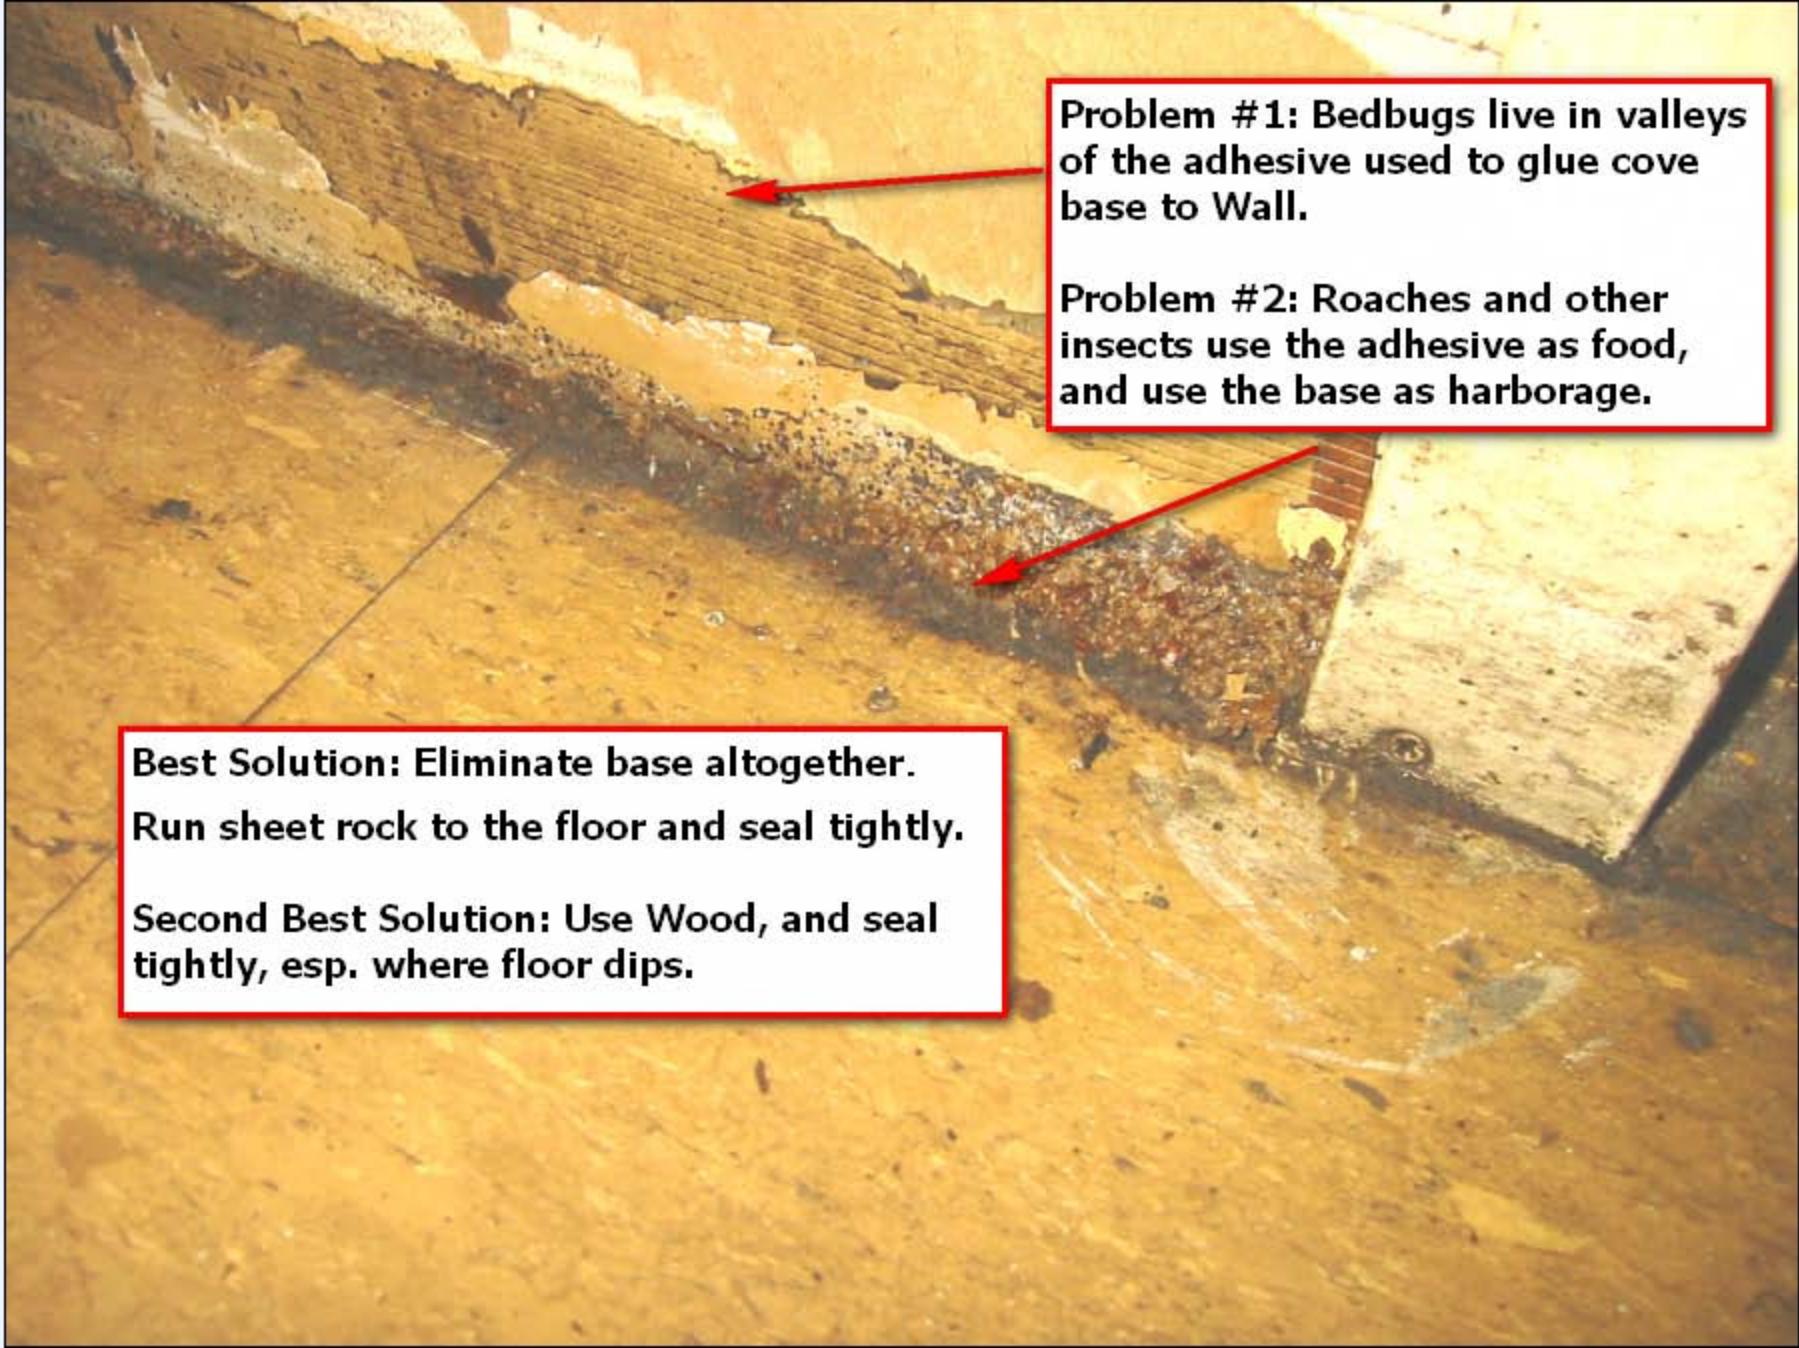
**Cove base removed to show water damage and other deterioration.**

**Problem #1: Bedbugs live in valleys of the adhesive used to glue cove base to Wall.**

**Problem #2: Roaches and other insects use the adhesive as food, and use the base as harborage.**

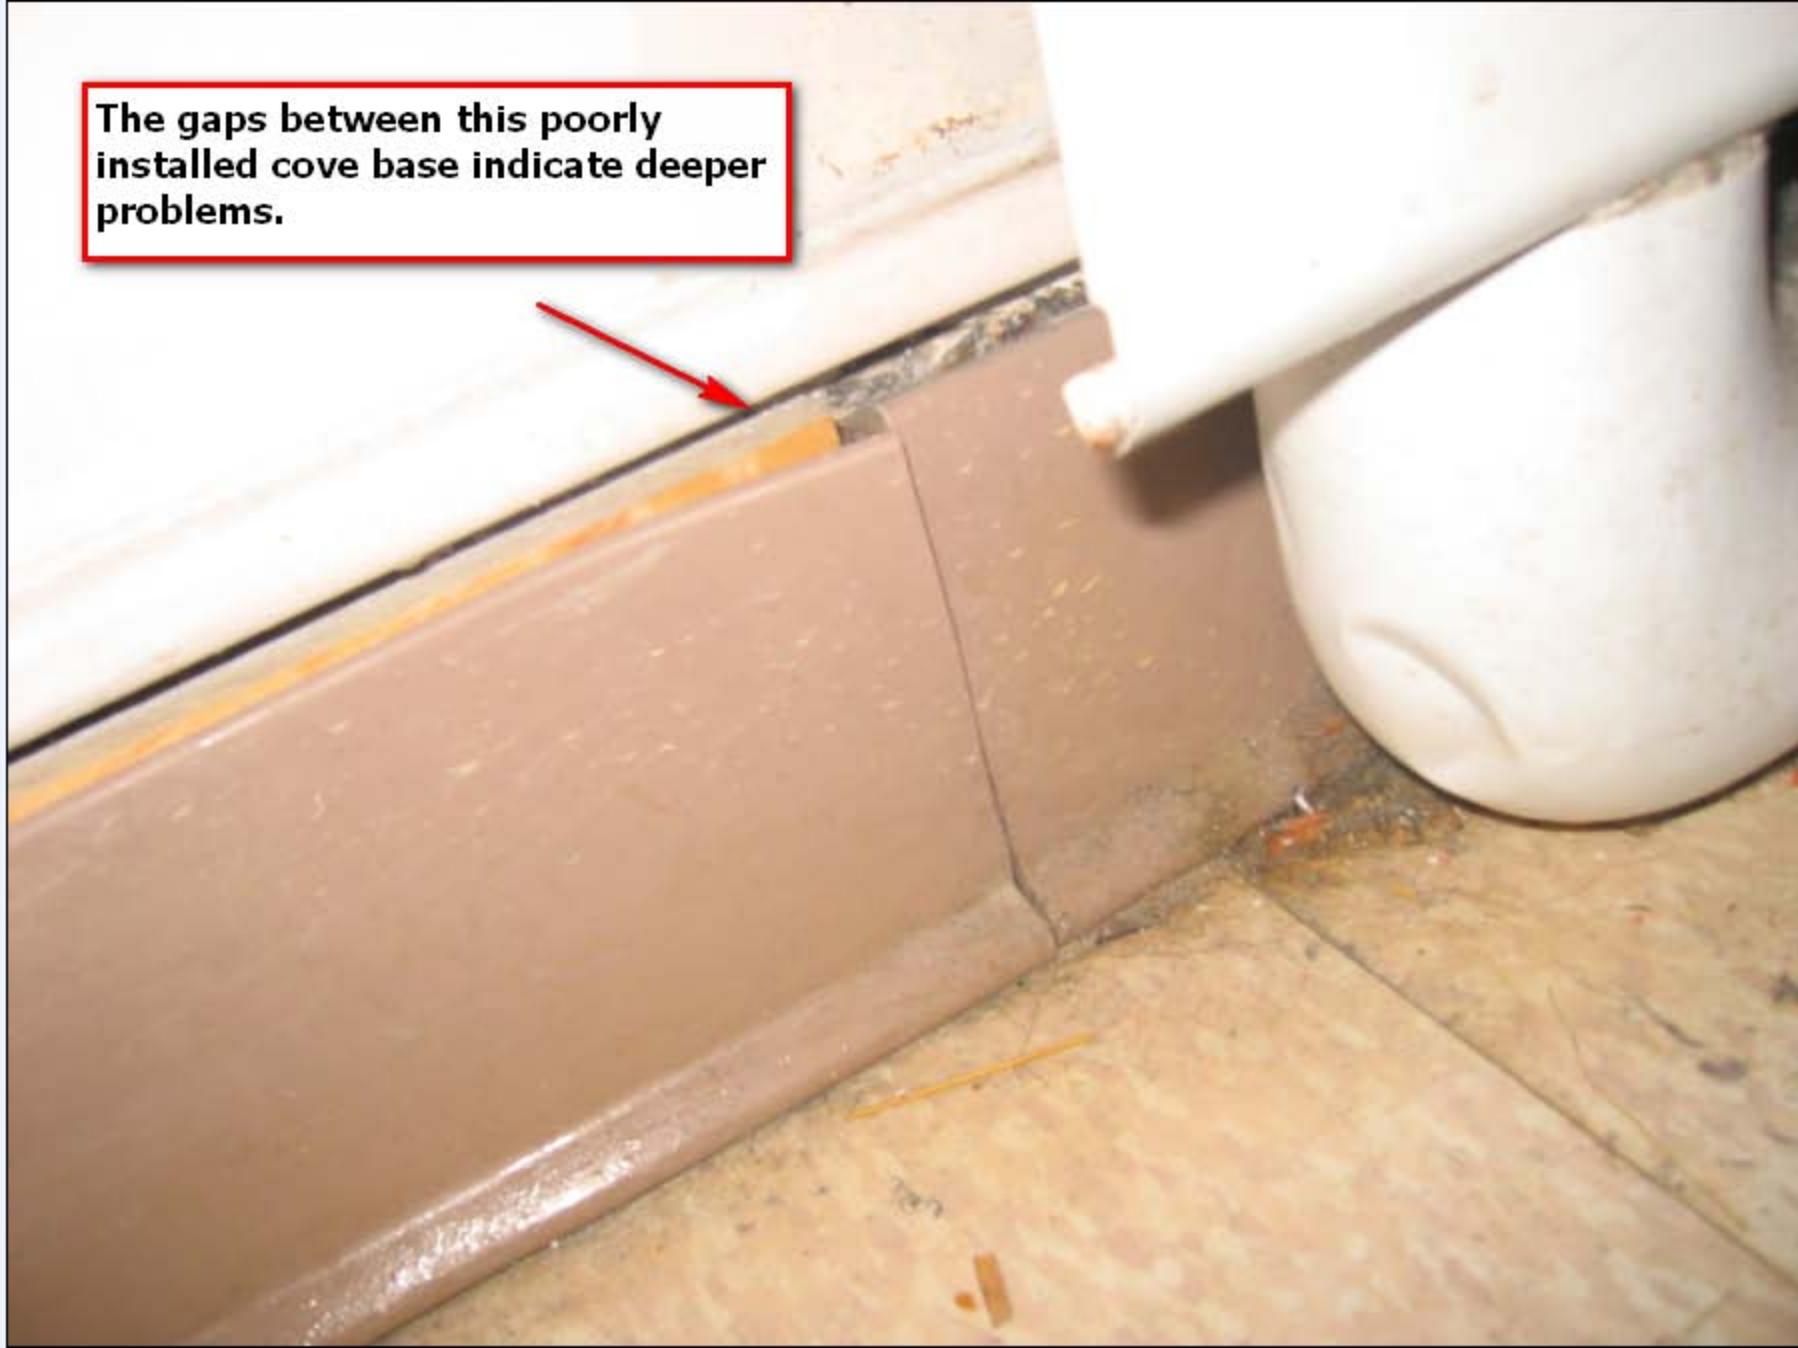
The gaps between this poorly installed cove base indicate deeper problems.

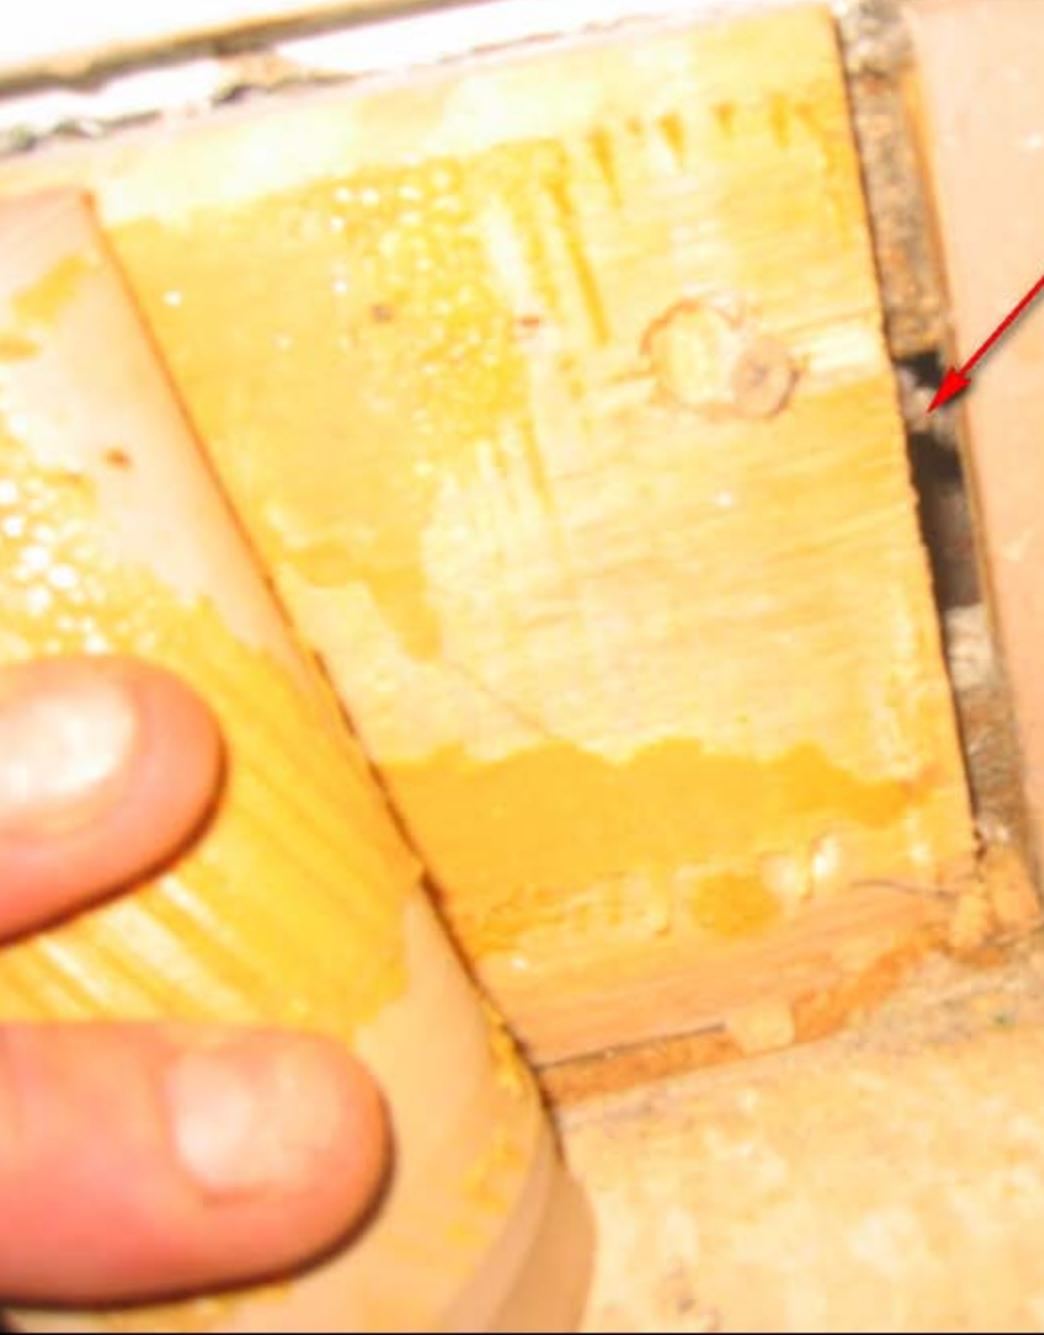
**Problem:** gap in wood backing gives pests access to wall cavity and other rooms.

**Solution #1:** Eliminate cove base and sheetrock to floor. Seal tightly.

**Solution #2:** Replace backing and install correctly, without gaps. Seal tightly and reinstall base.

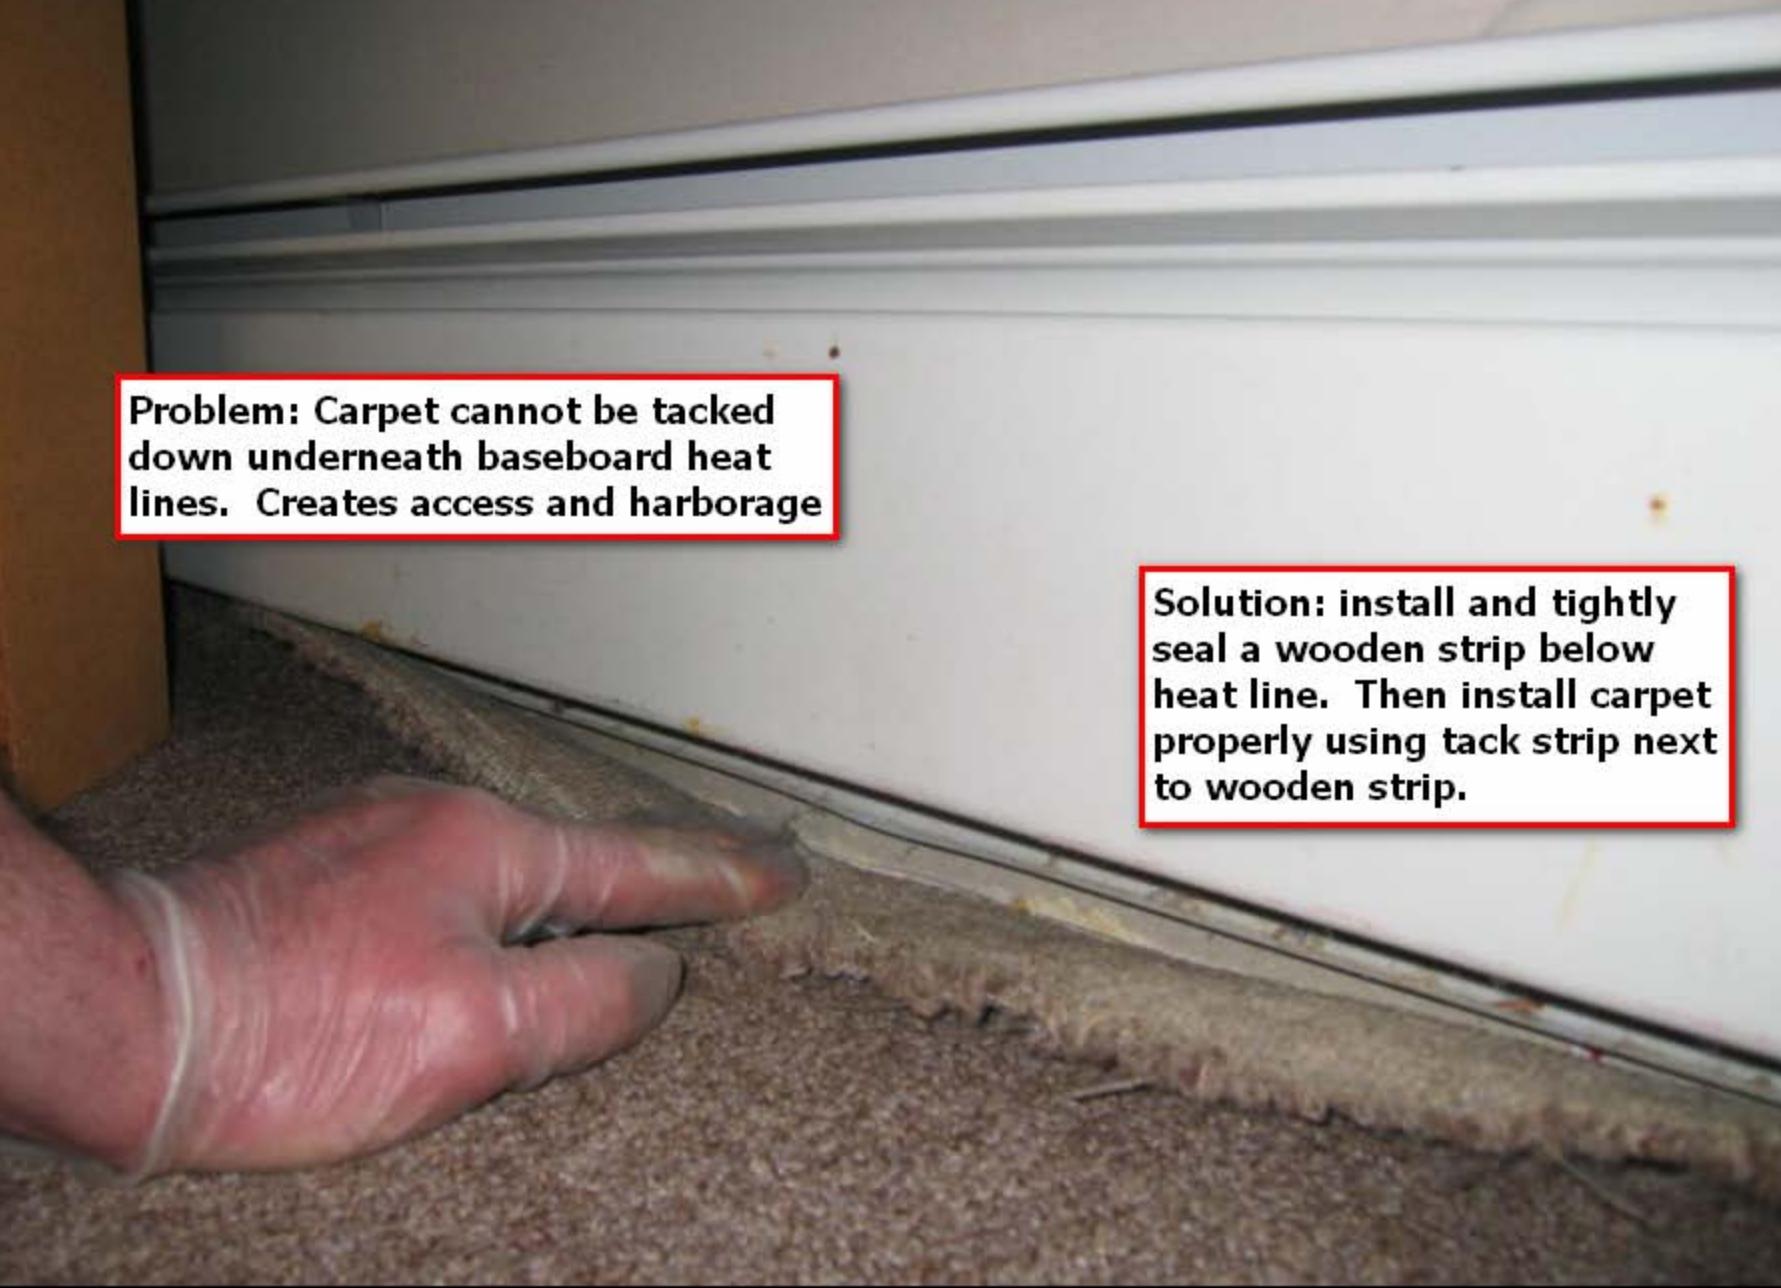
**Problem:** Carpet cannot be tacked down underneath baseboard heat lines. Creates access and harborage

**Solution:** install and tightly seal a wooden strip below heat line. Then install carpet properly using tack strip next to wooden strip.

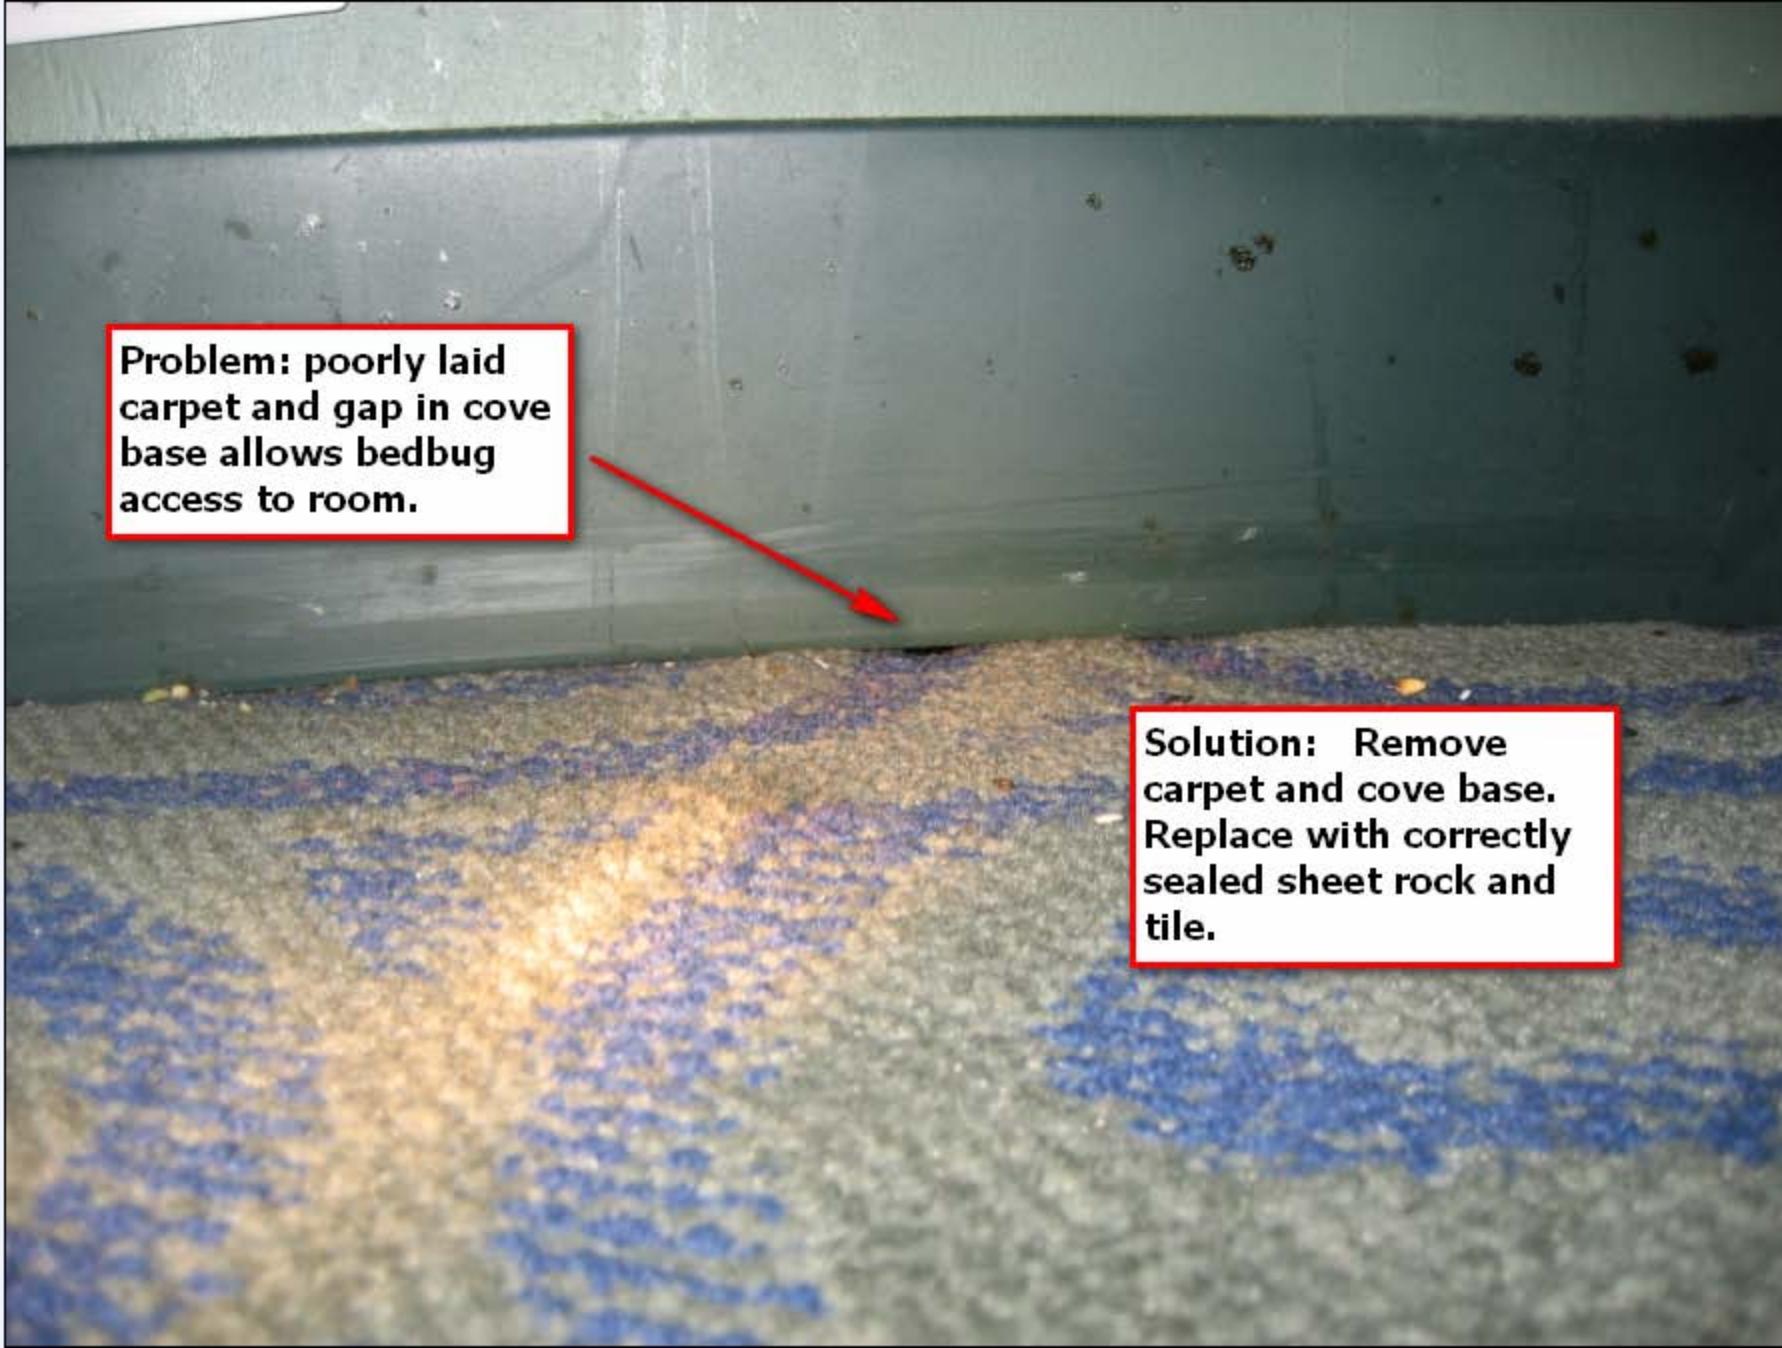
**Problem:** poorly laid carpet and gap in cove base allows bedbug access to room.

**Solution:** Remove carpet and cove base. Replace with correctly sealed sheet rock and tile.

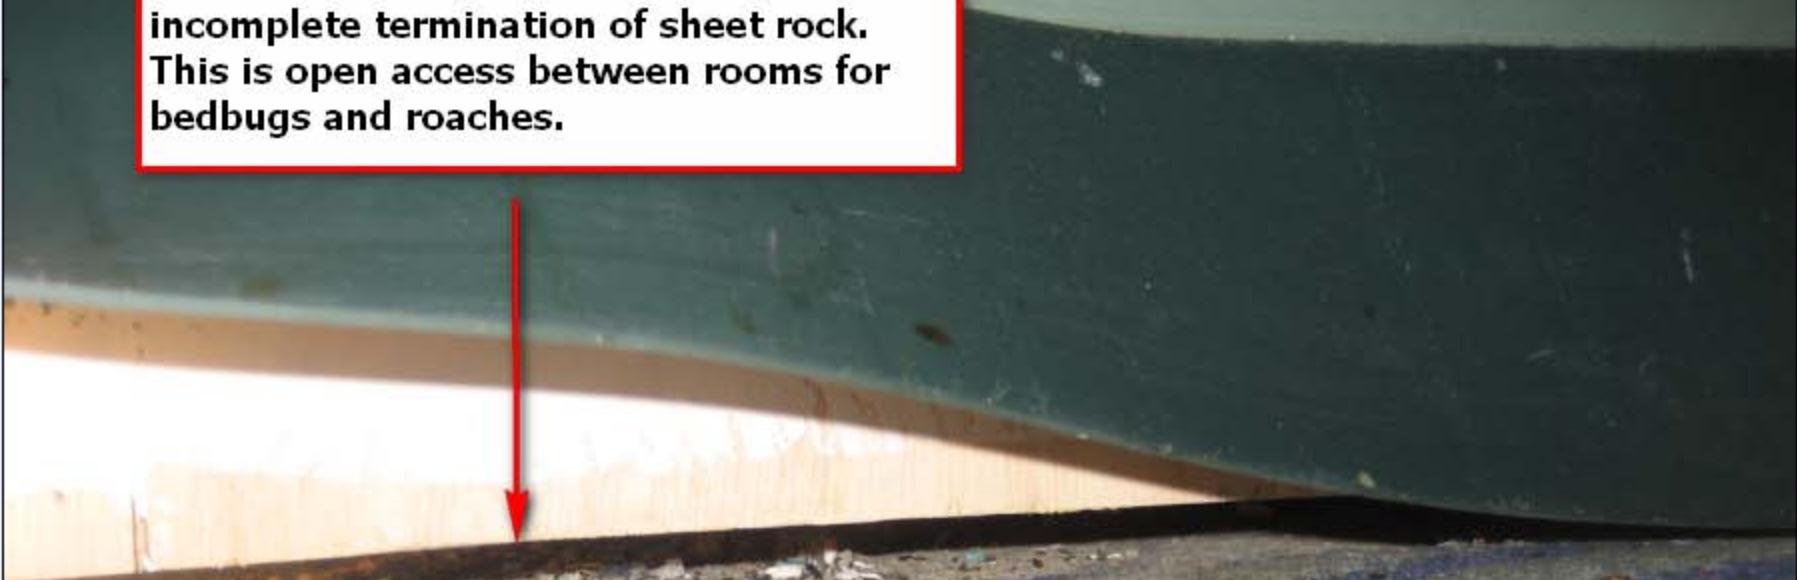
**Problem:** Removal of cove base shows incomplete termination of sheet rock. This is open access between rooms for bedbugs and roaches.

**Solution:** eliminate  
cove base and  
correct sheet rock  
installation.

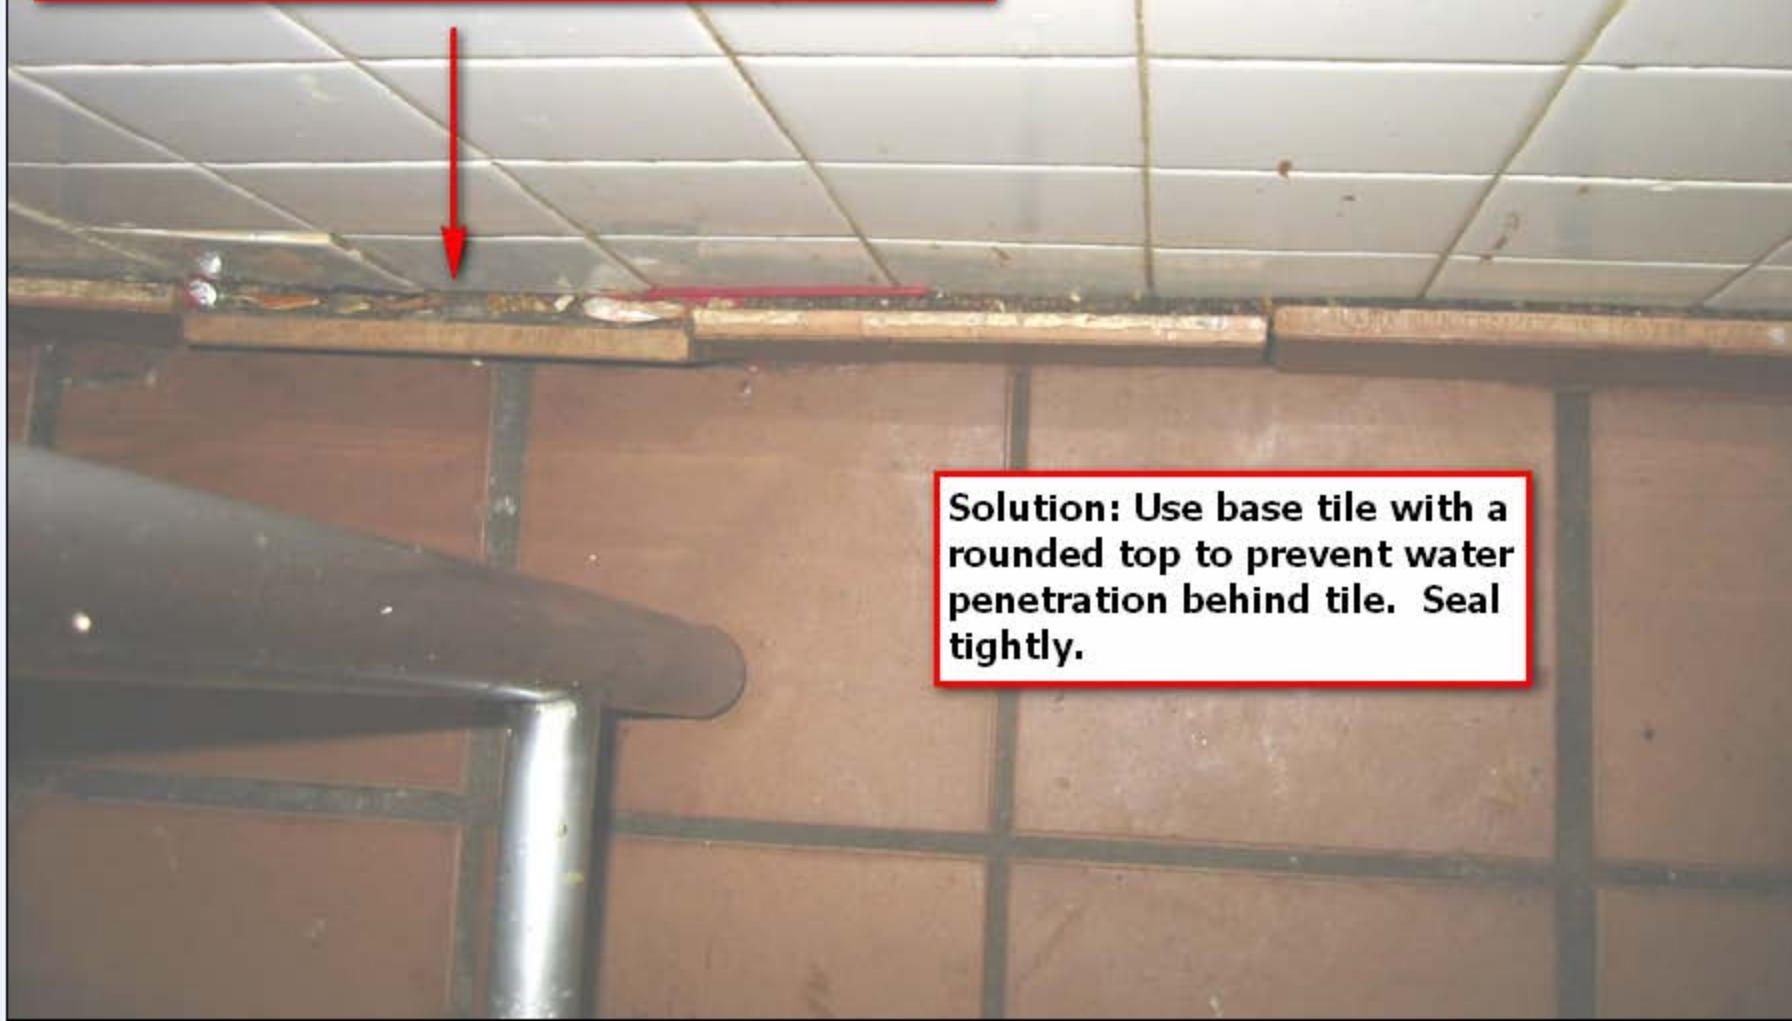
**Problem:** Incorrect use of floor tile as base tile allows water to settle on flat surface, and eventually penetrate behind the tile and pop them loose. This creates harborage and access for insects and a location of food for all pests.

**Solution:** Use base tile with a rounded top to prevent water penetration behind tile. Seal tightly.

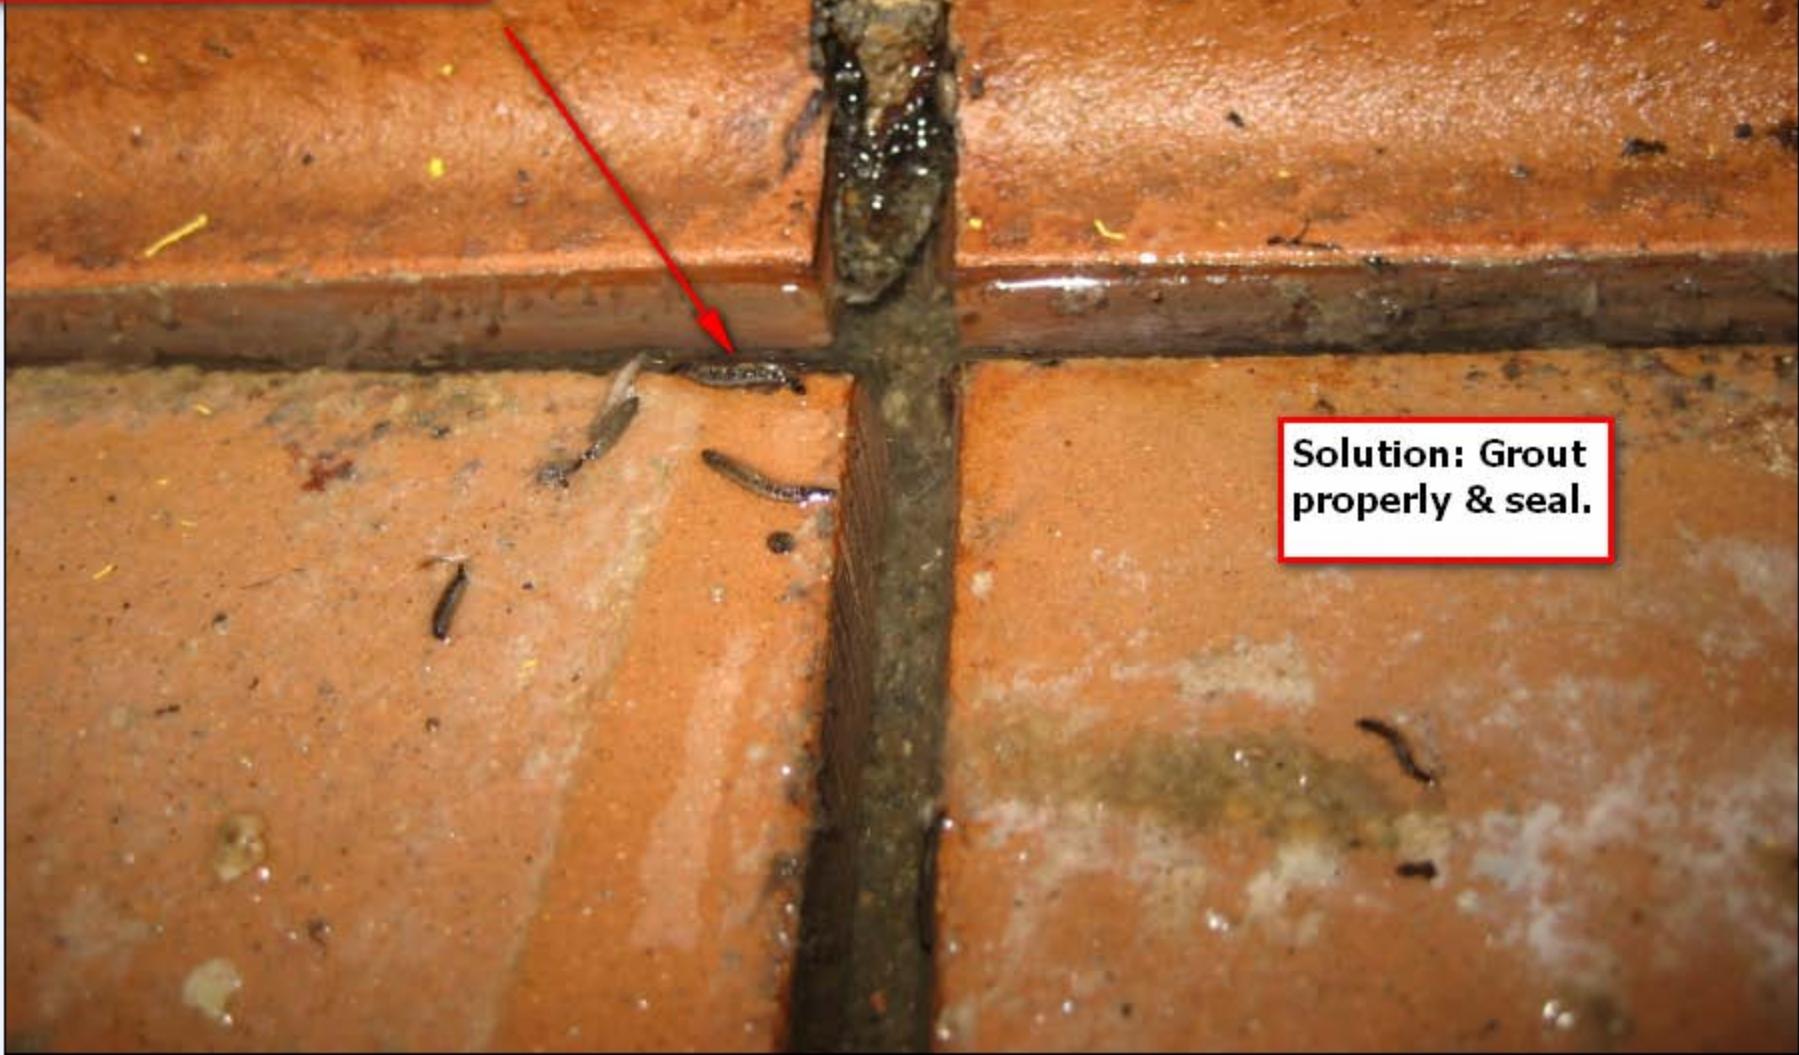
**Problem: UngROUTed floor tile creates standing water. Note fly larvae.**

**Solution: Grout properly & seal.**
