# Guidebook for Structural Approaches to Integrated Pest Management

Prepared by  
Dr. Mitchell D. Allen  
Boston Housing Authority  
2009

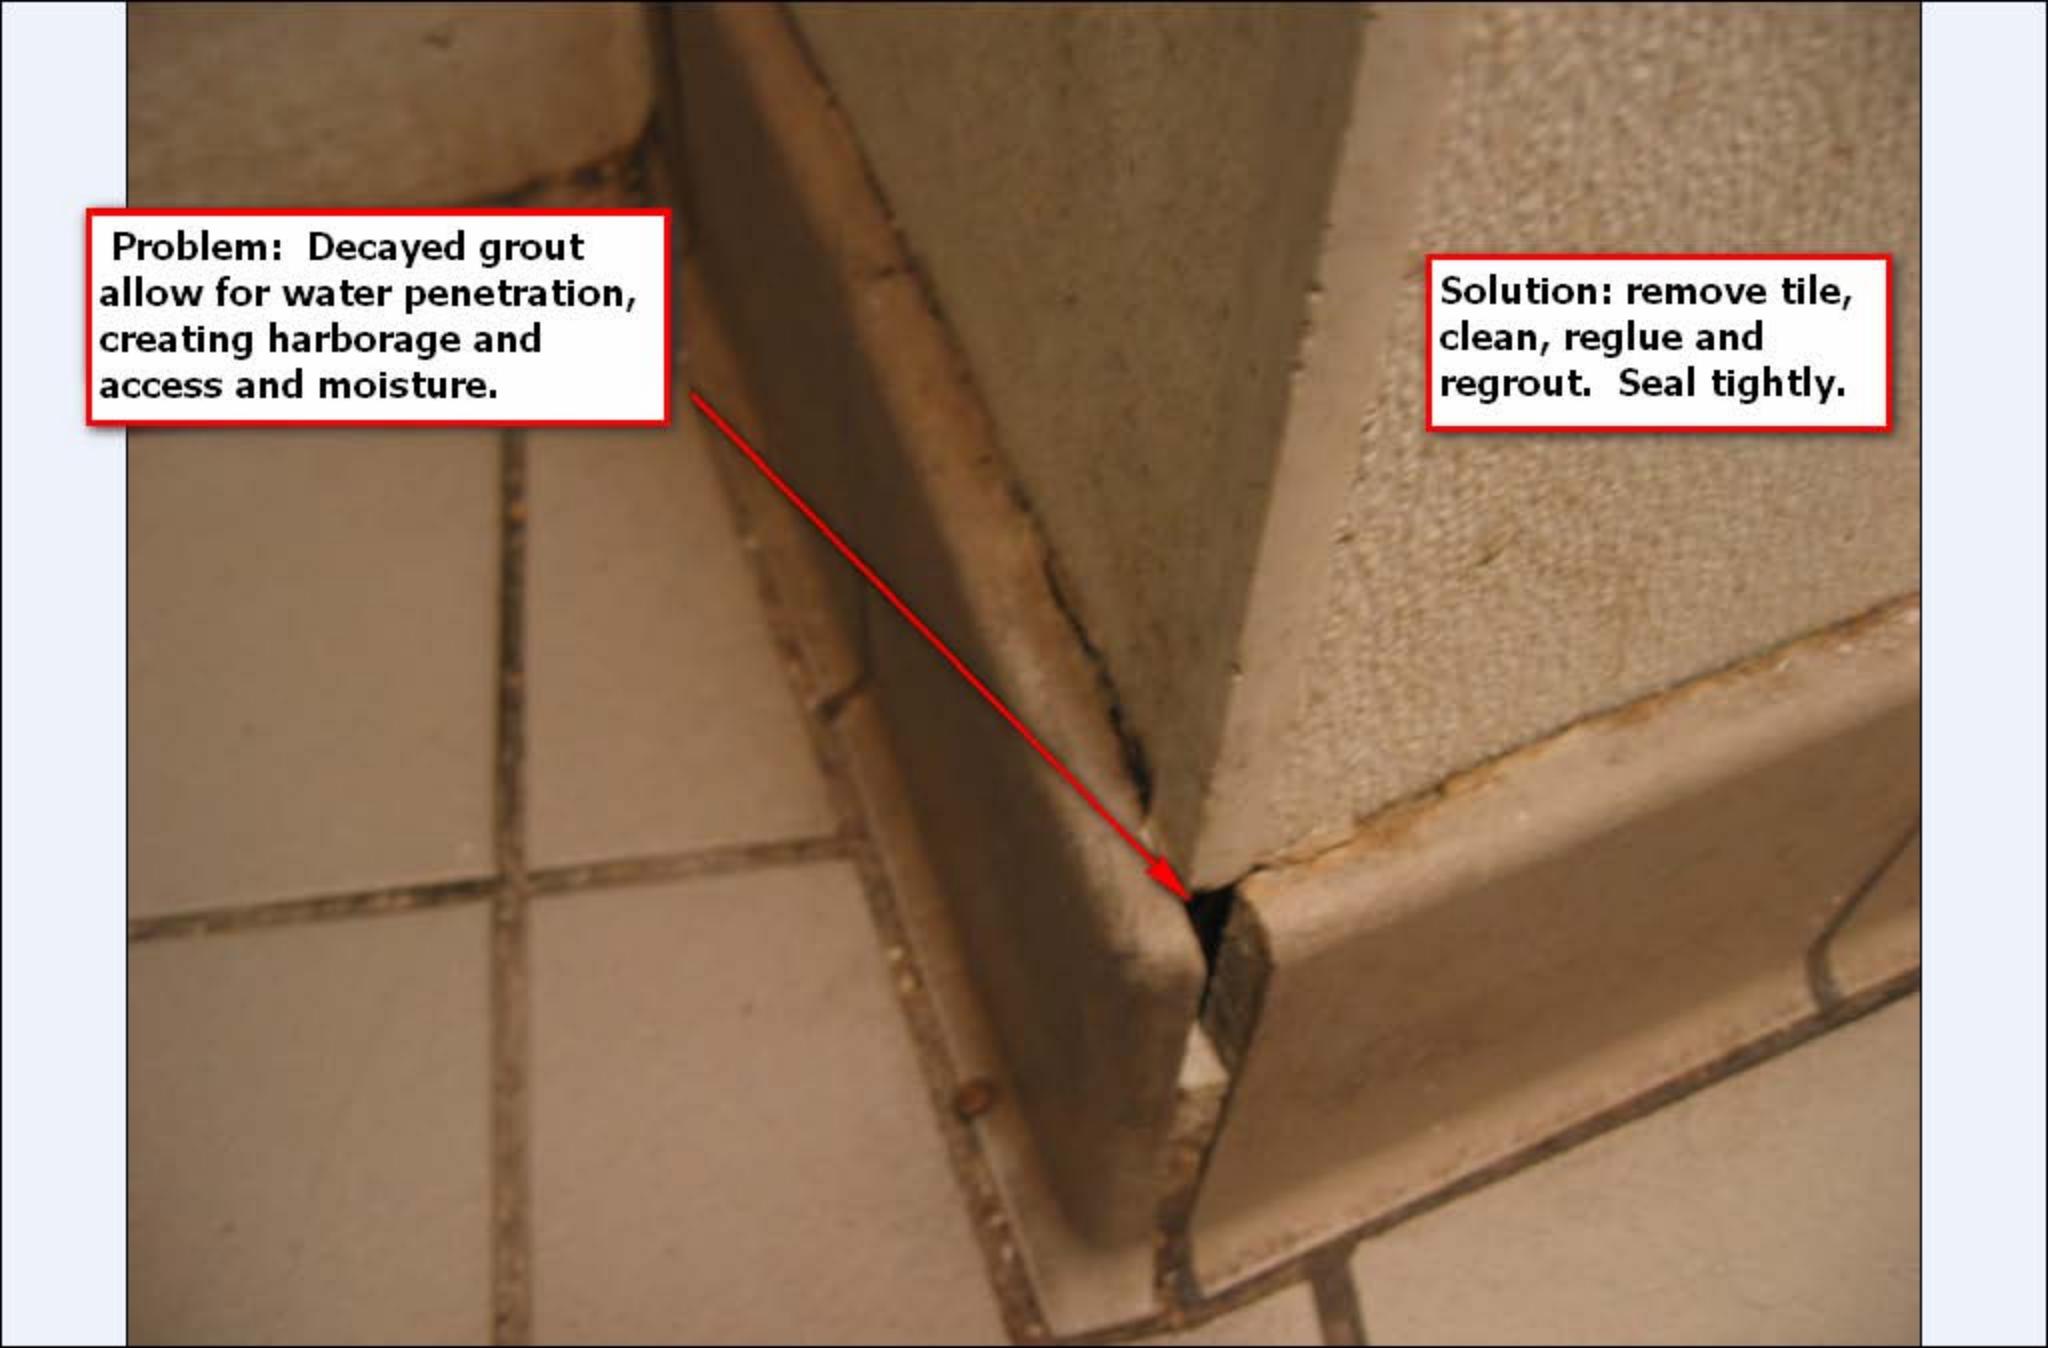
**Problem:** Decayed grout allow for water penetration, creating harborage and access and moisture.

**Solution:** remove tile, clean, reglue and regROUT. Seal tightly.

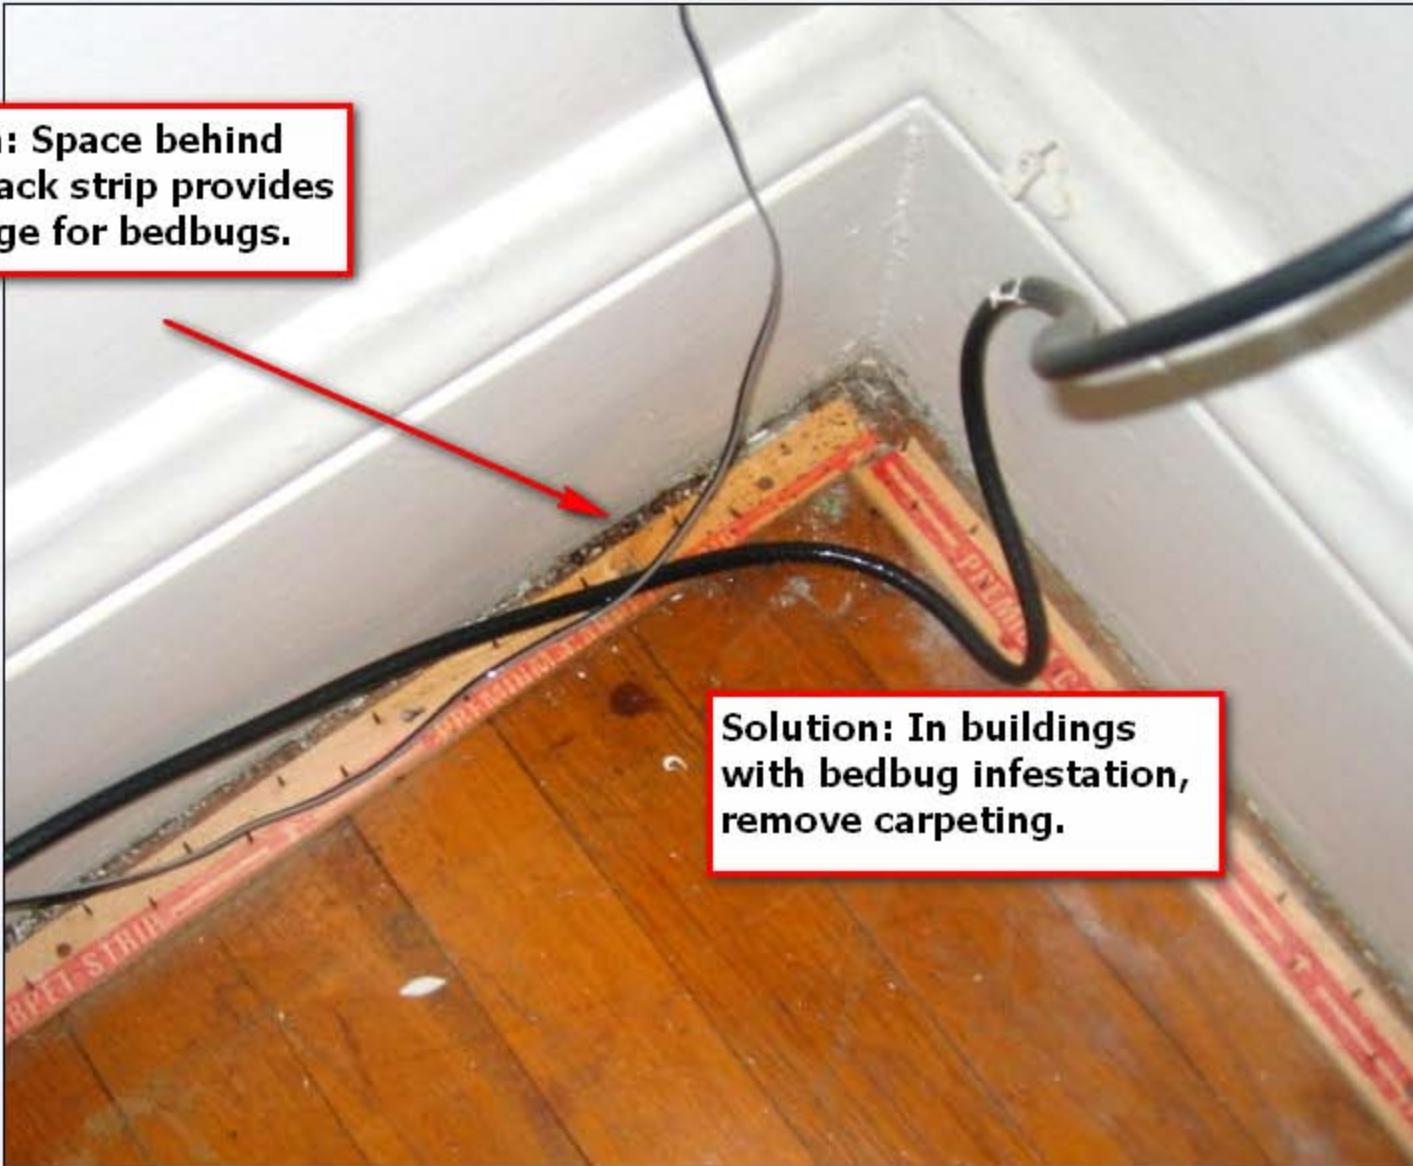
**Problem:** Space behind carpet tack strip provides harborage for bedbugs.

**Solution:** In buildings with bedbug infestation, remove carpeting.

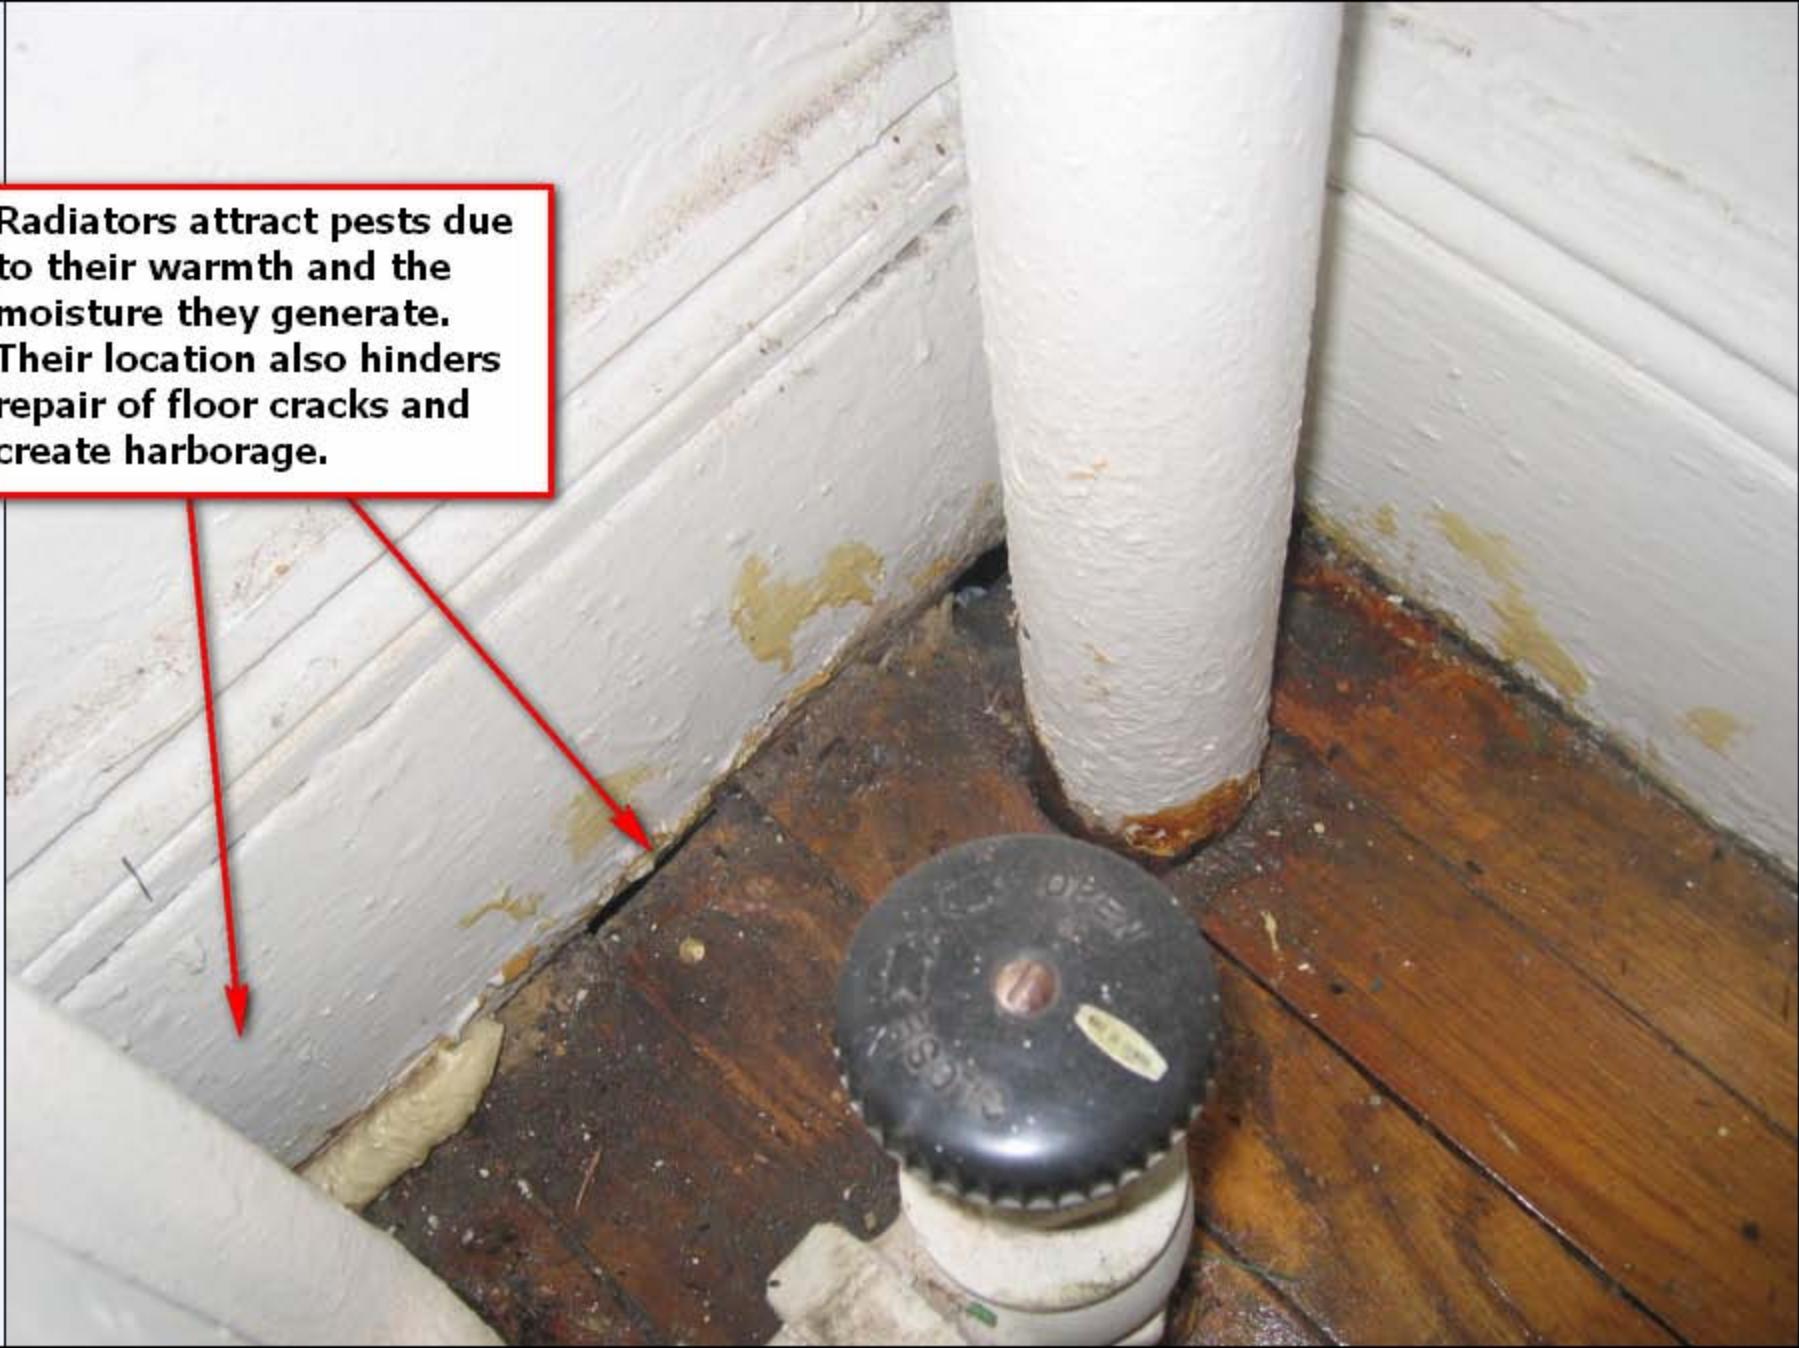
**Radiators attract pests due to their warmth and the moisture they generate. Their location also hinders repair of floor cracks and create harborage.**

**Problem:** Floor penetration and radiator conceal mouse hole.

**Solution:** Remove the radiator during repairs.  
Fill hole with copper wool  
and IPM foam prior to  
reinstalling the radiator.

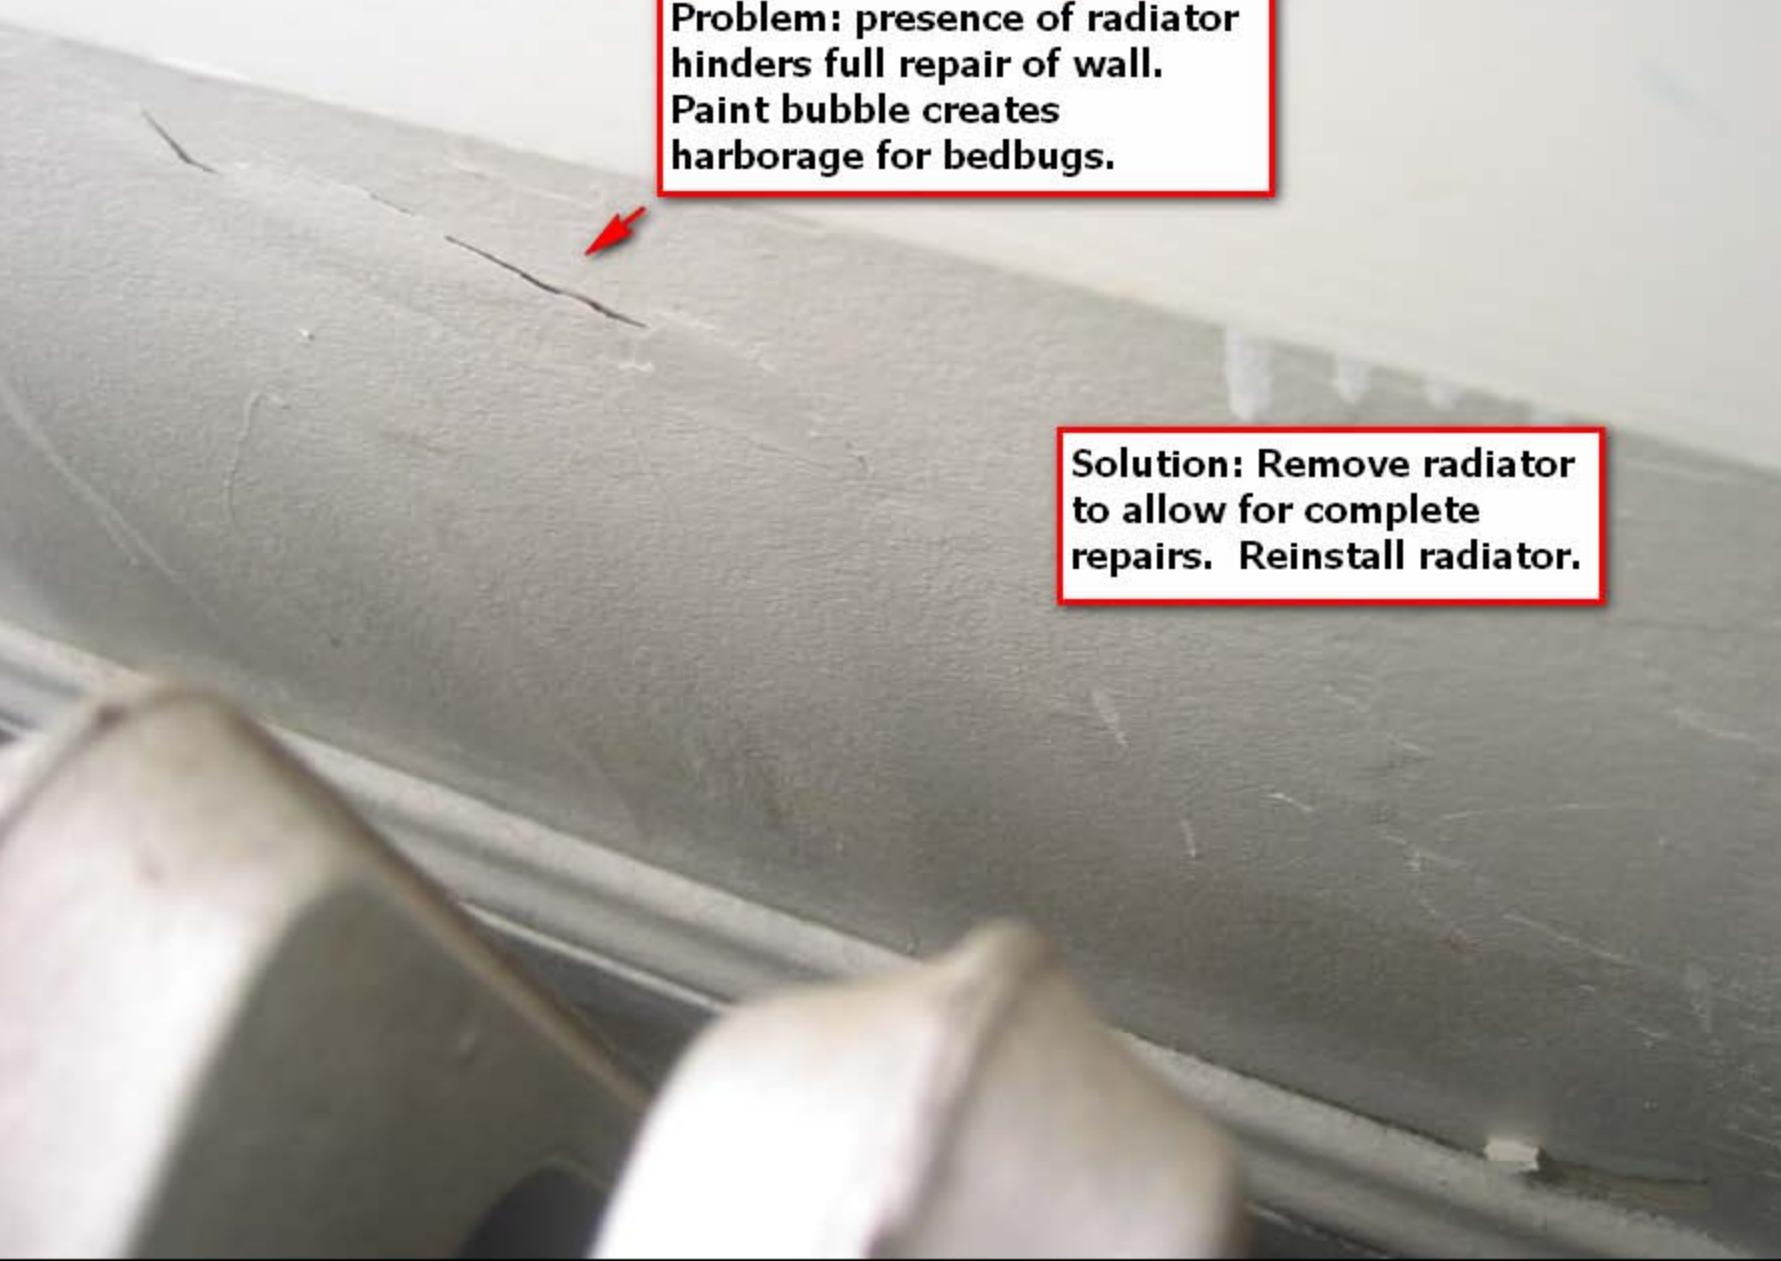
**Problem:** presence of radiator  
hinders full repair of wall.  
Paint bubble creates  
harborage for bedbugs.

**Solution:** Remove radiator  
to allow for complete  
repairs. Reinstall radiator.

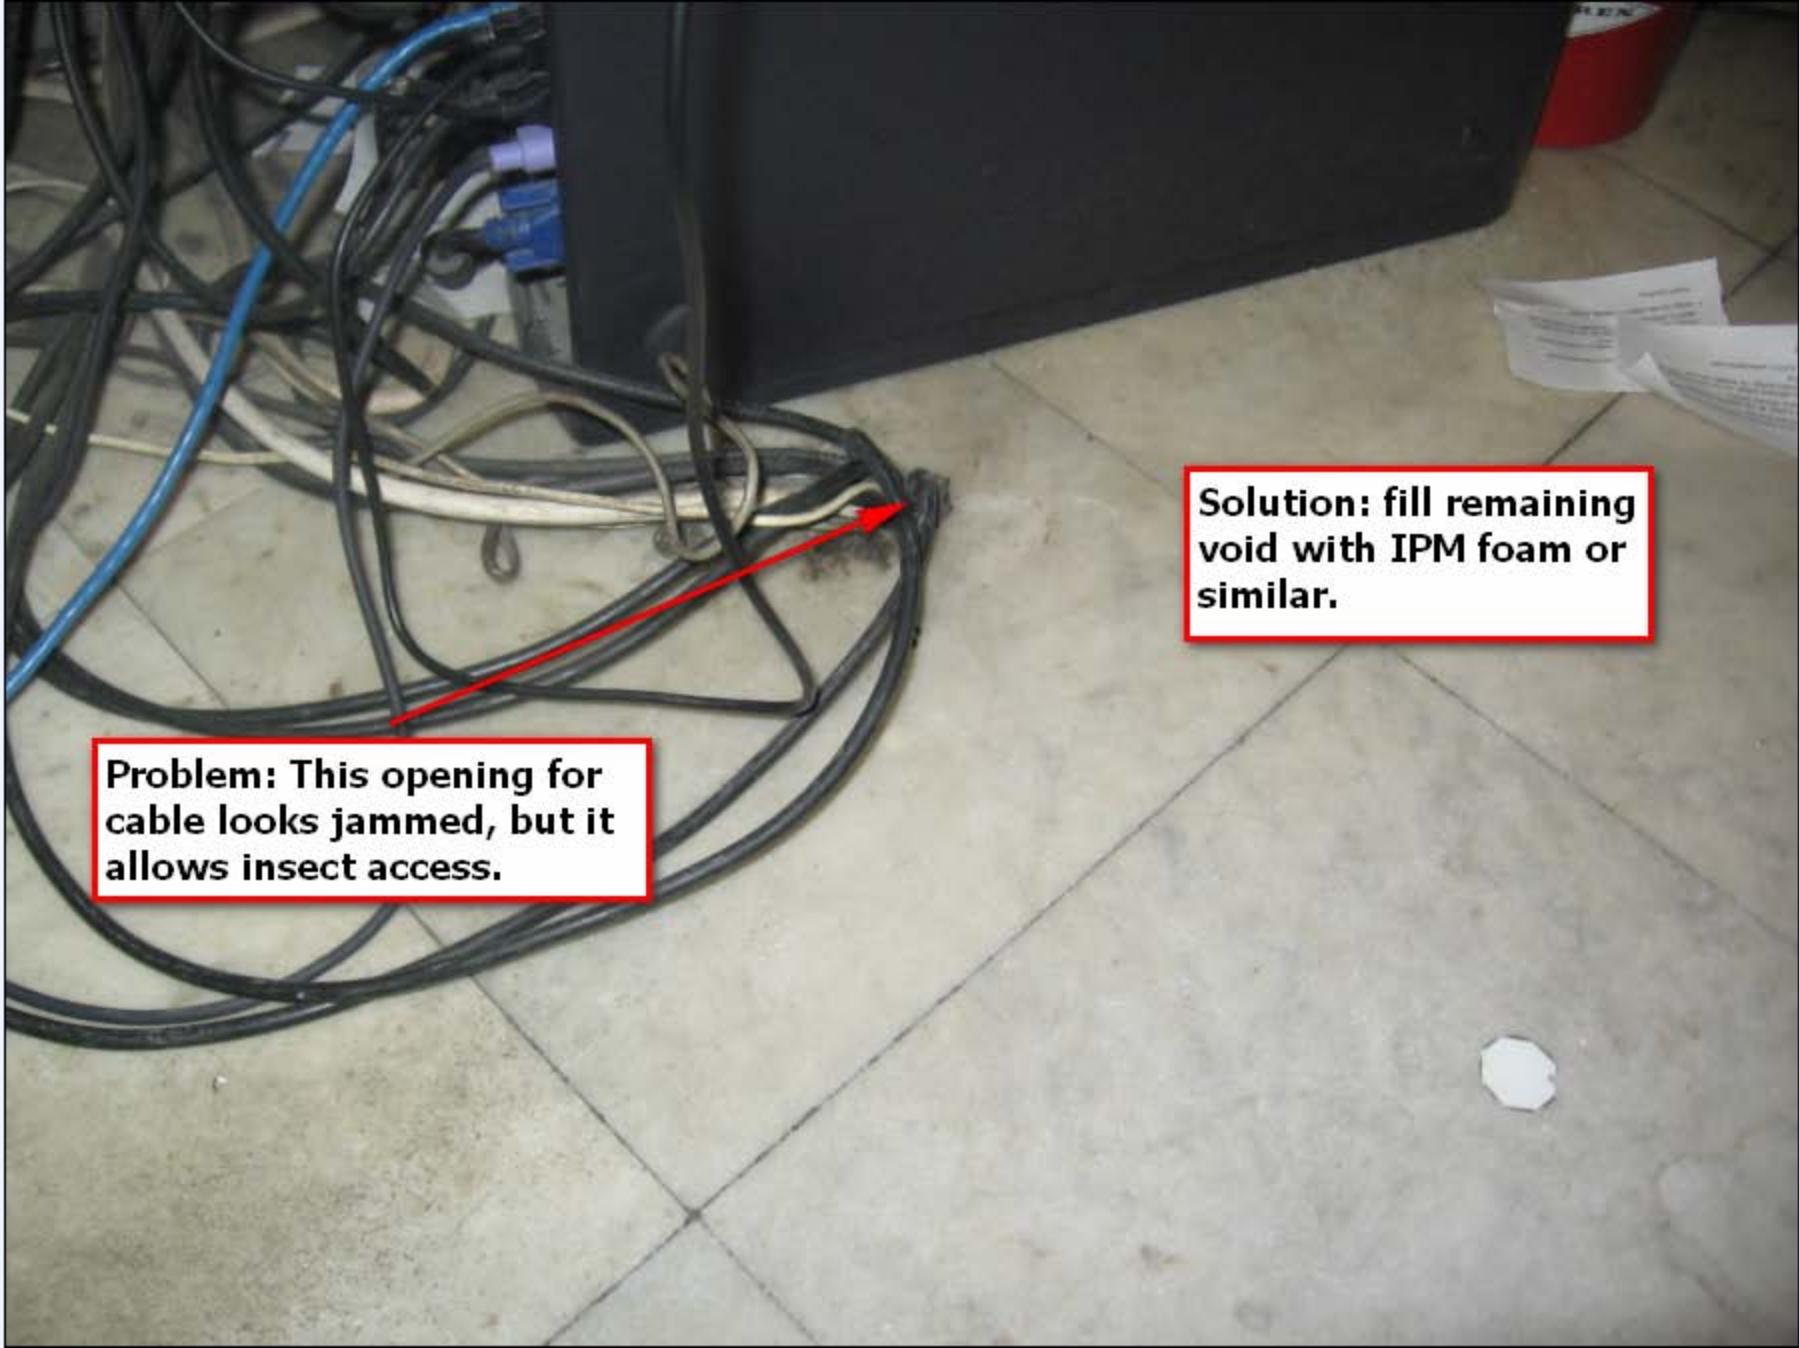
**Problem:** This opening for cable looks jammed, but it allows insect access.

**Solution:** fill remaining void with IPM foam or similar.

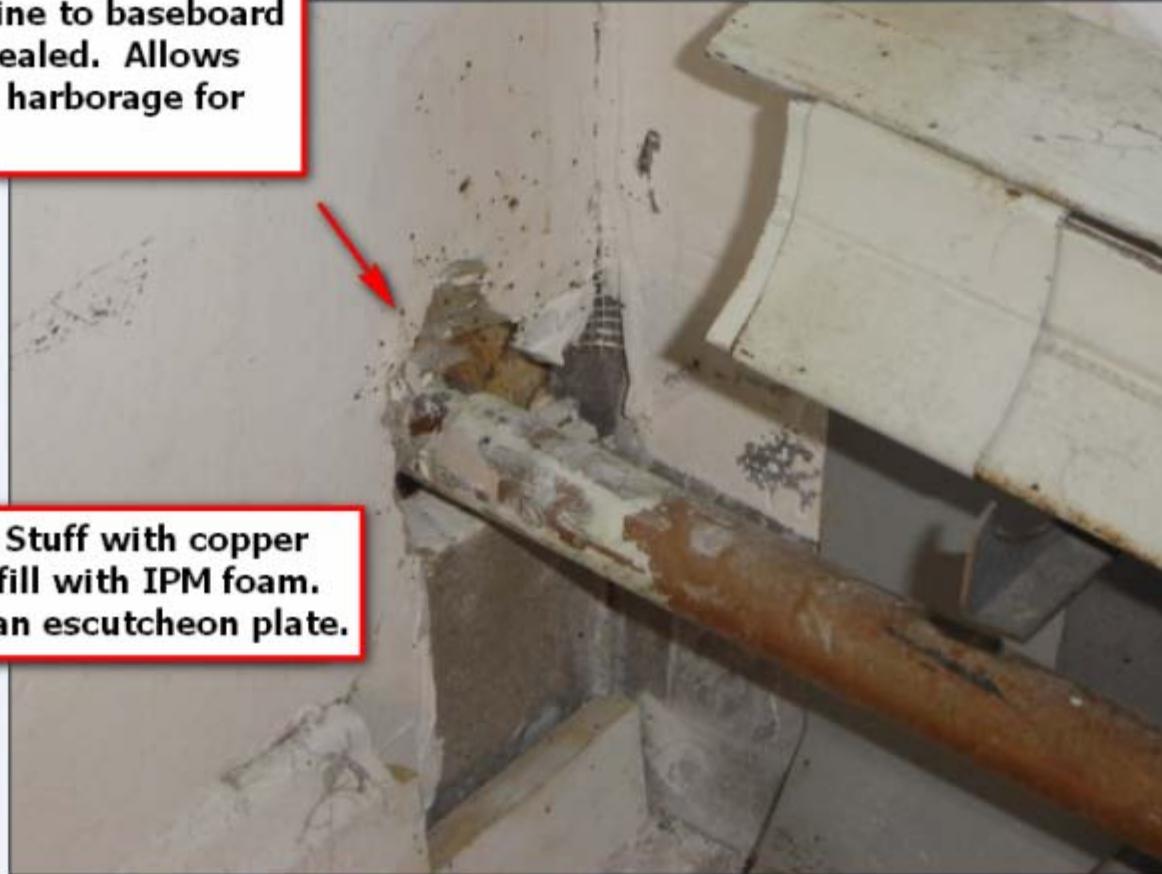
**Problem:** Wall penetration of copper line to baseboard heat is unsealed. Allows access and harborage for pests.

**Solution:** Stuff with copper wool and fill with IPM foam. Cap with an escutcheon plate.

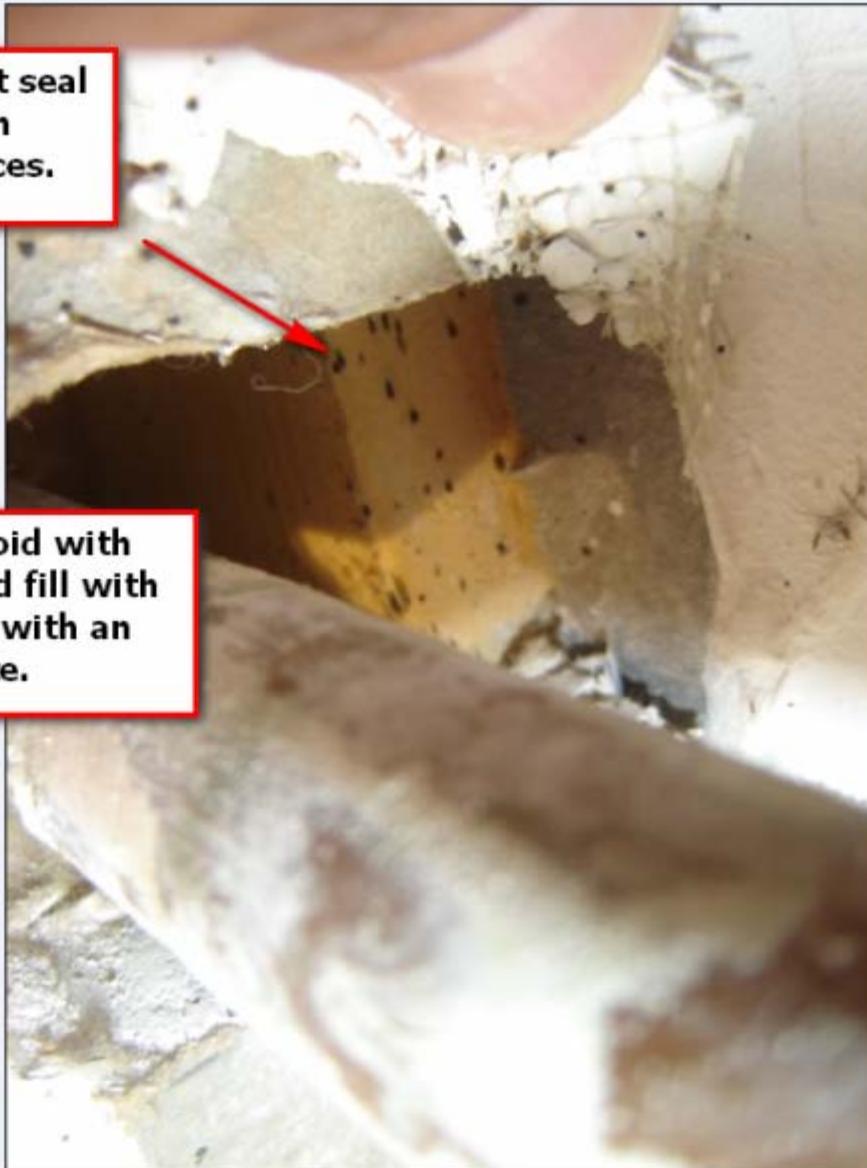
**Problem: Incorrect seal of wall penetration reveals bedbug feces.**

**Solution: Fill void with copper wool and fill with IPM foam. Cap with an escutcheon plate.**

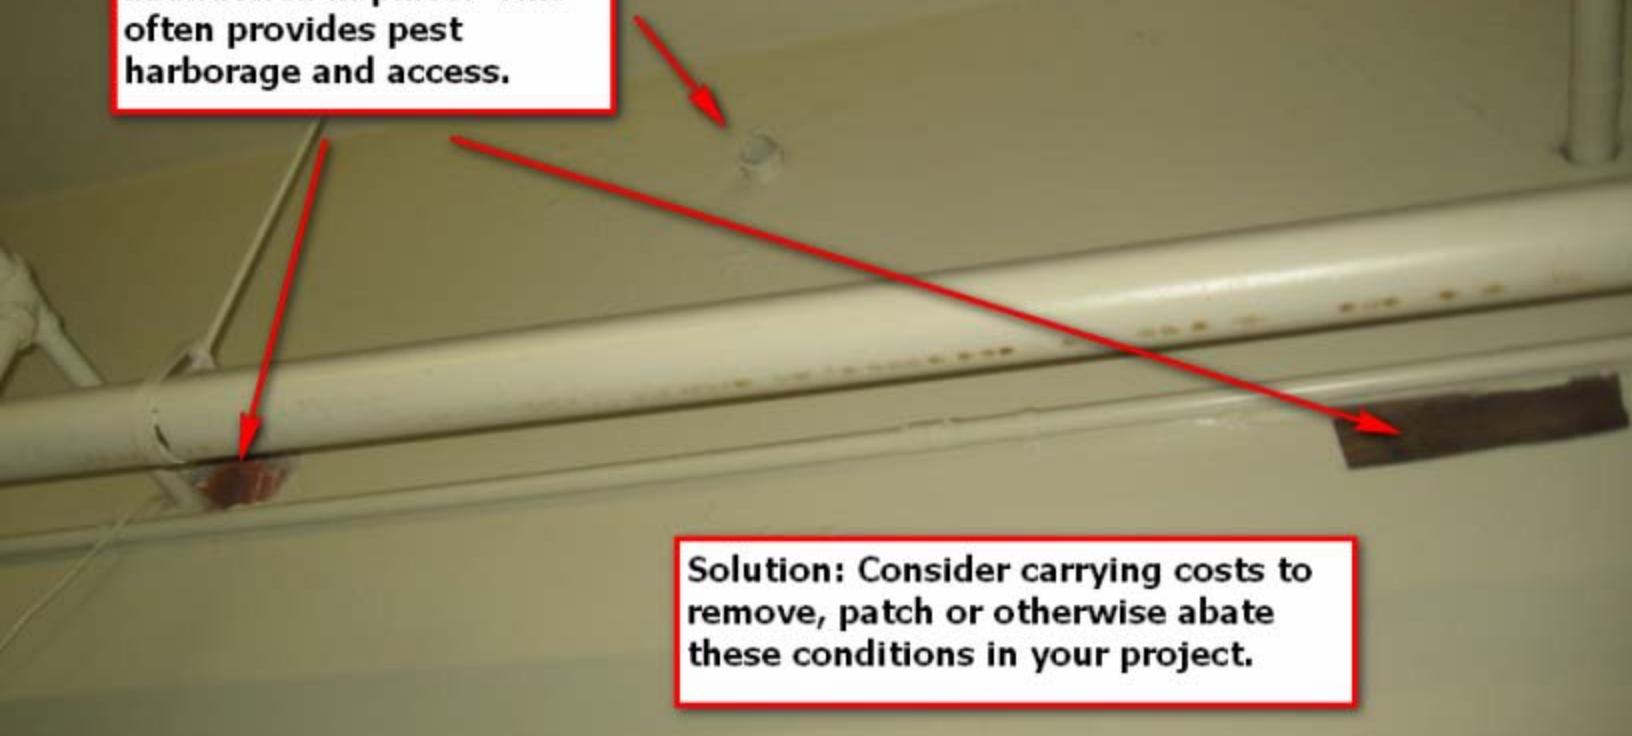
**Problem:** Many buildings contain remnants of old equipment that has been abandoned in place. This often provides pest harborage and access.

**Solution:** Consider carrying costs to remove, patch or otherwise abate these conditions in your project.

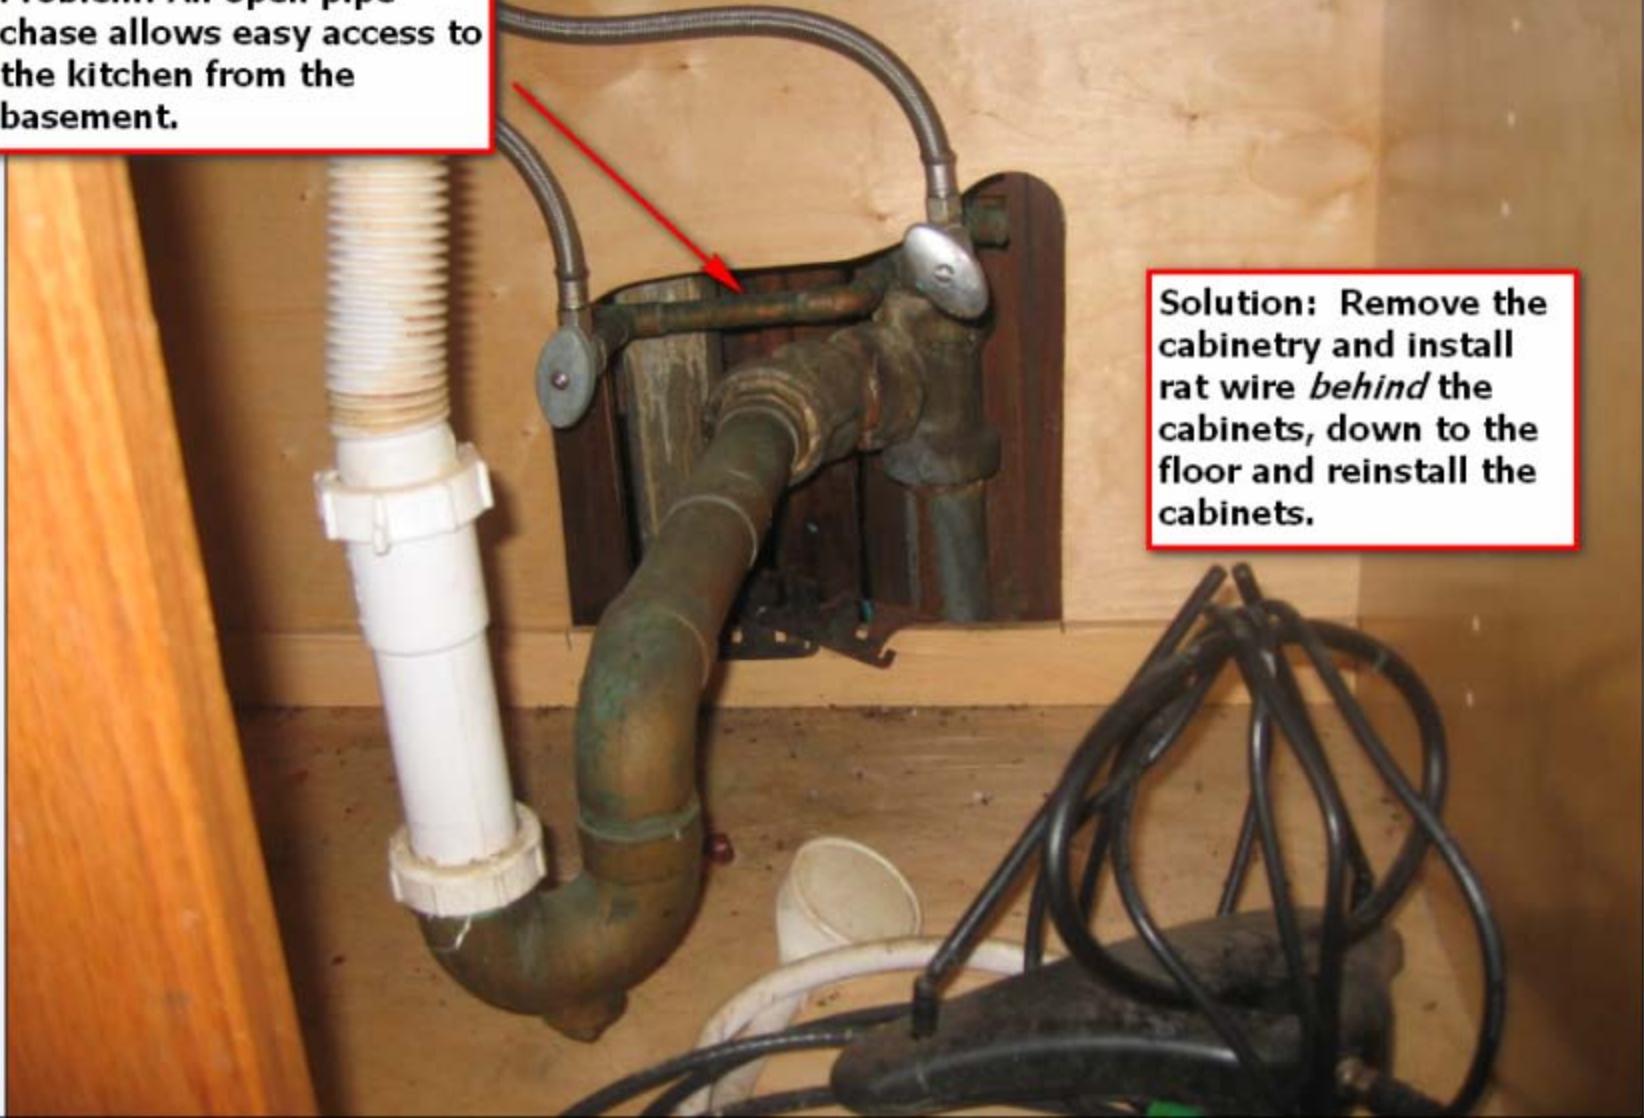
**Problem:** An open pipe chase allows easy access to the kitchen from the basement.

**Solution:** Remove the cabinetry and install rat wire *behind* the cabinets, down to the floor and reinstall the cabinets.

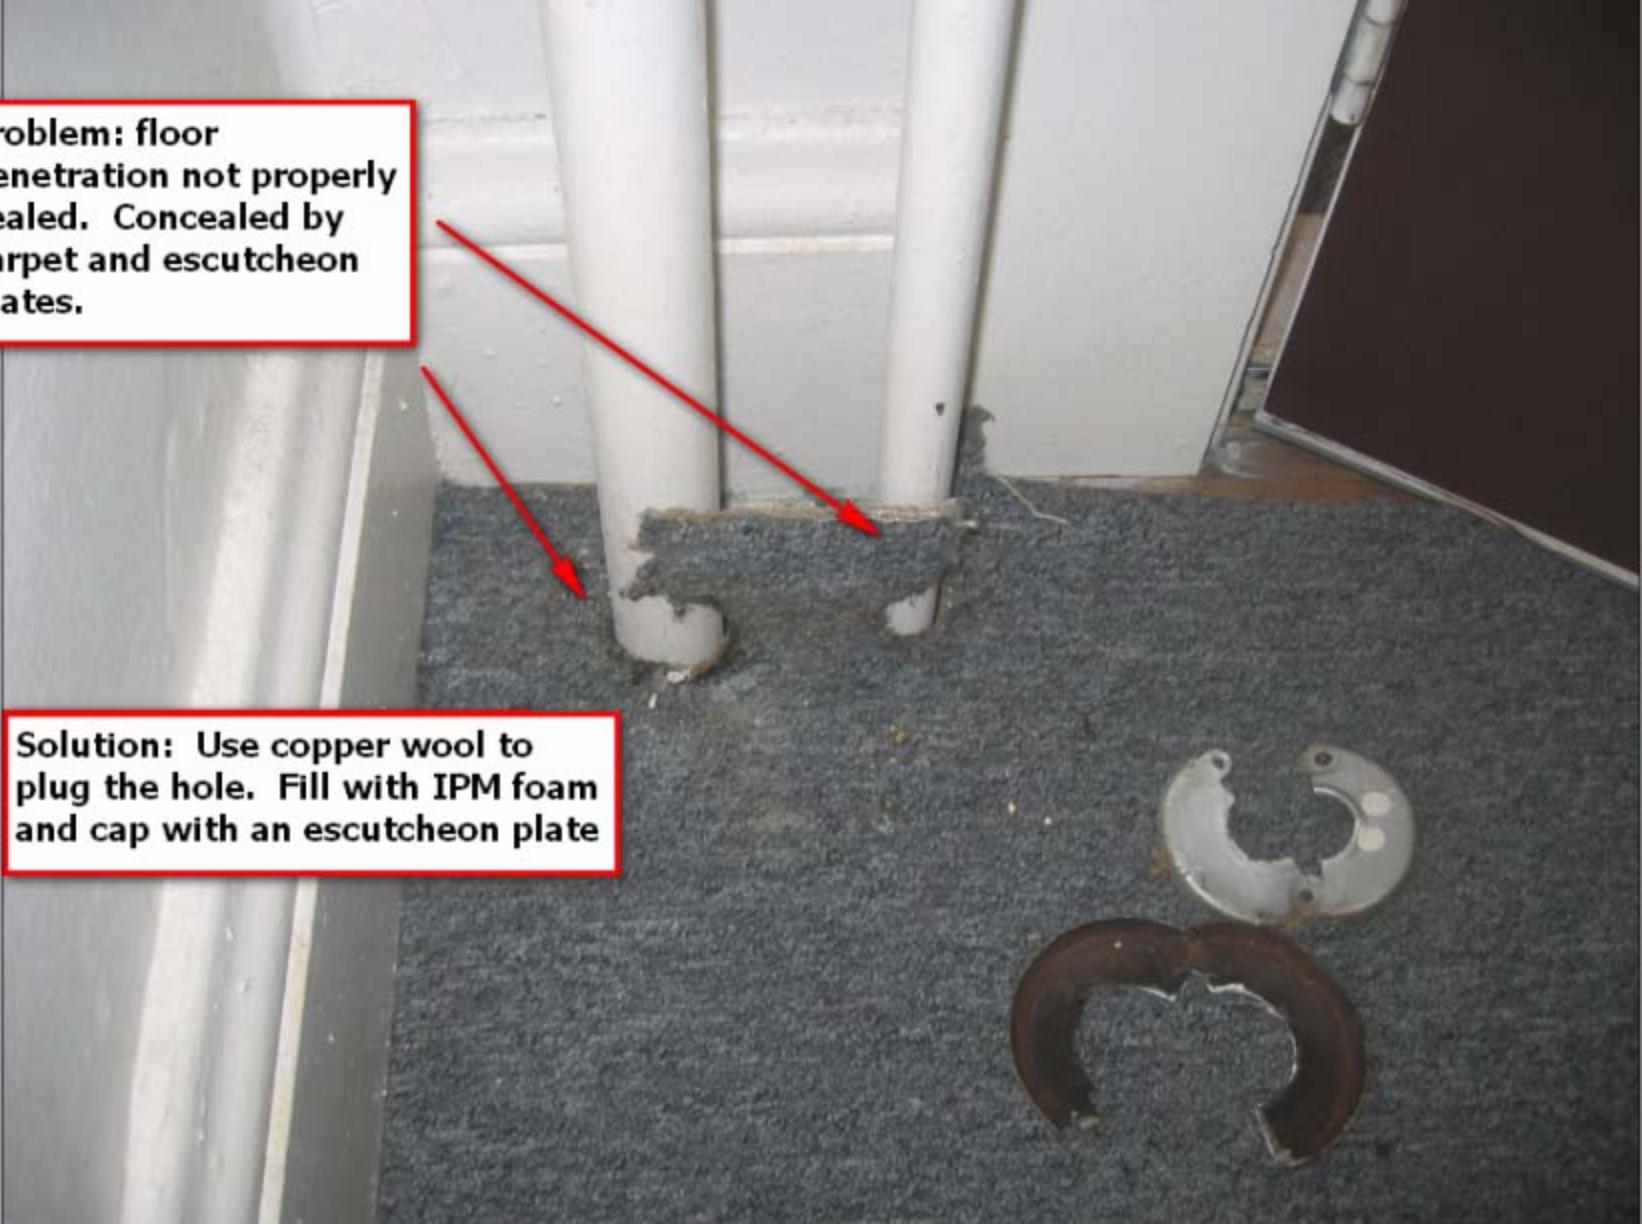
**Problem:** floor penetration not properly sealed. Concealed by carpet and escutcheon plates.

**Solution:** Use copper wool to plug the hole. Fill with IPM foam and cap with an escutcheon plate

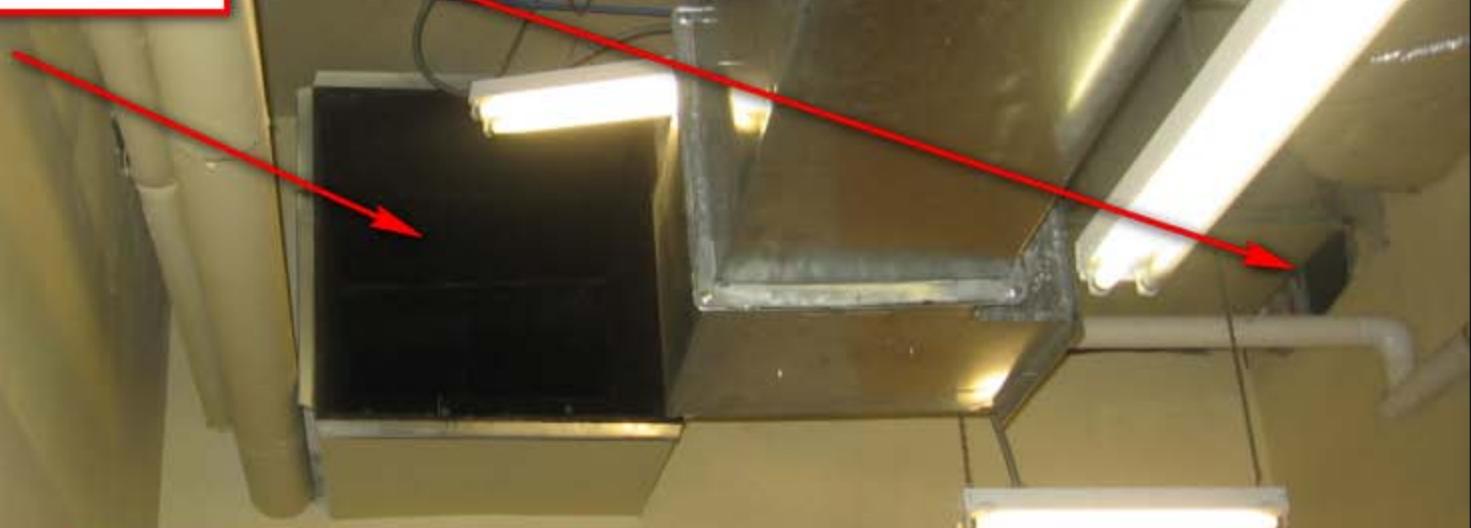
**Problem:** Open or incomplete ductwork provides easy access for rodents to much of the building.

**Solution:** Reconnect or cap open ductwork.

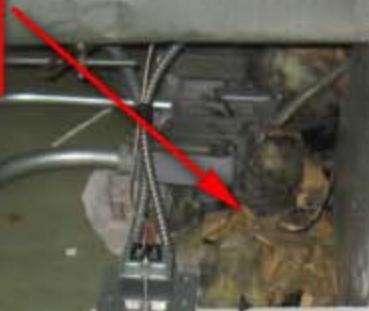
**Problem:** Open access to insulation can provide nesting space for rodents.

**Solution:** Encapsulate and seal tightly.

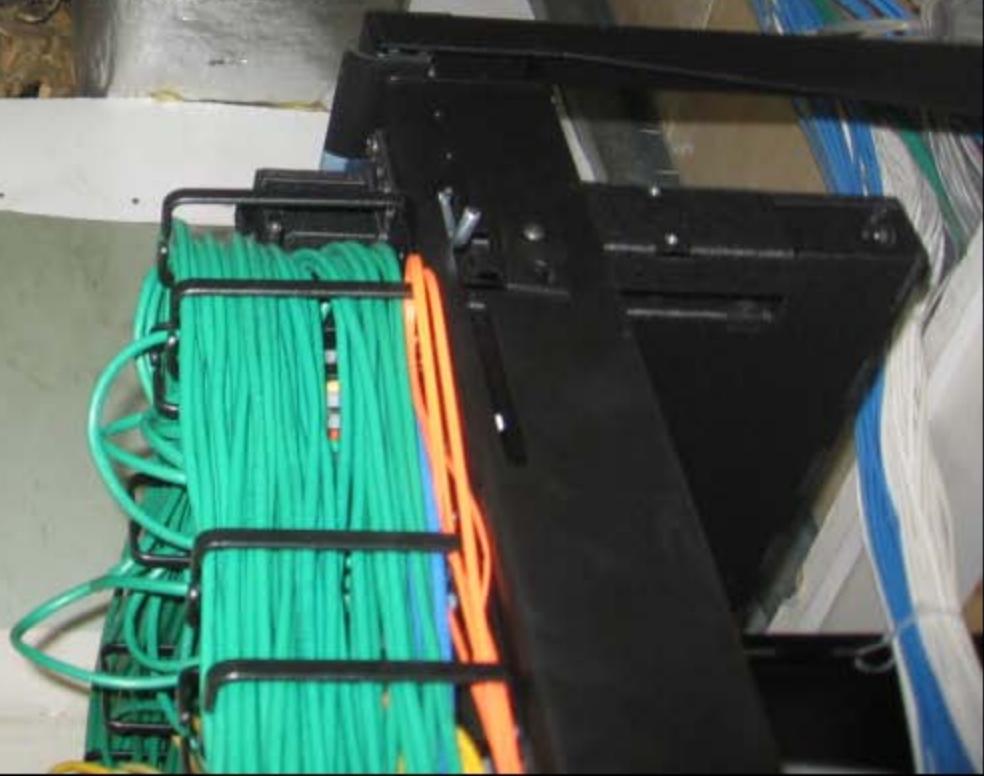
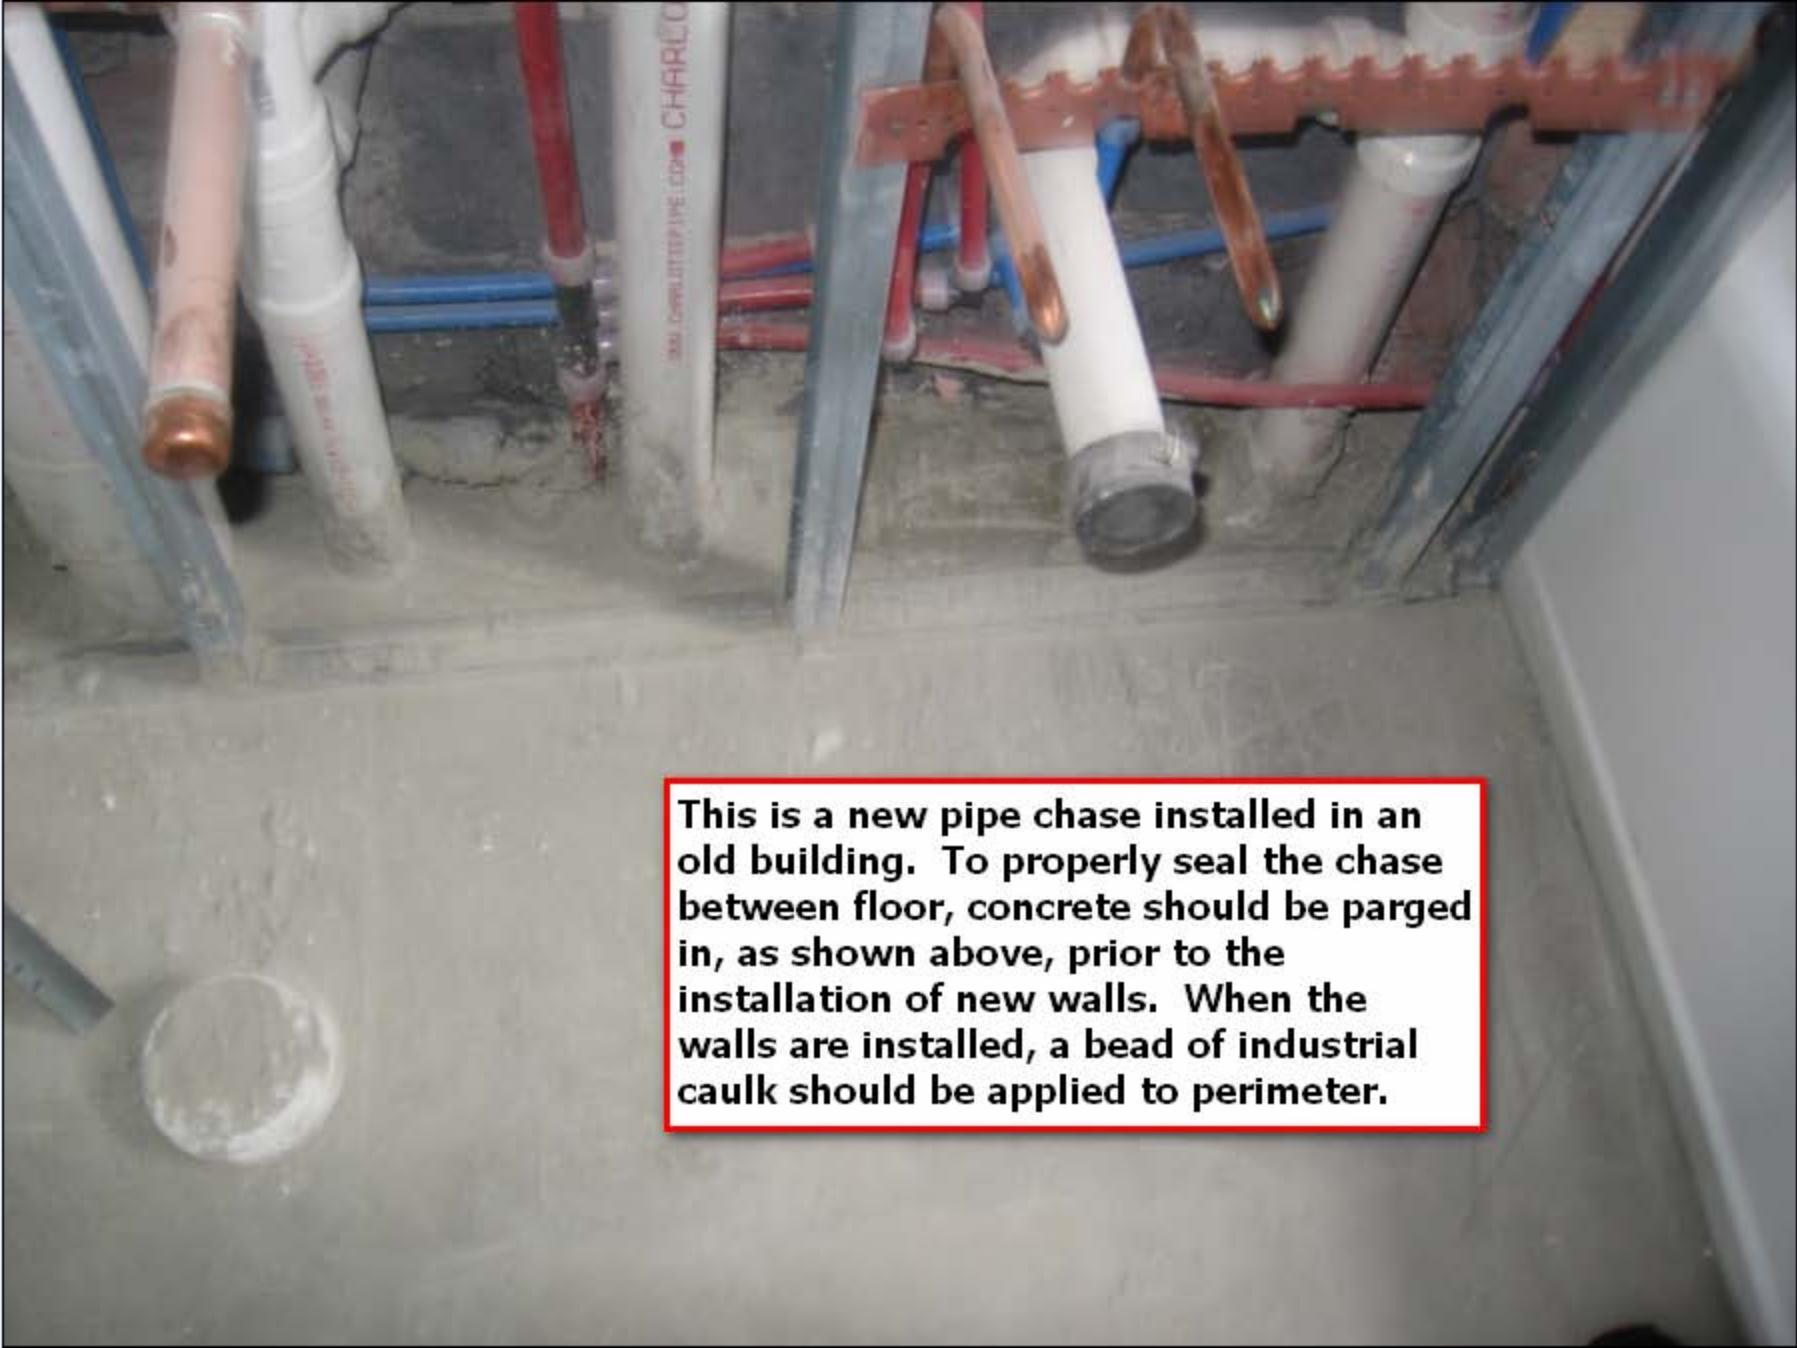
This is a new pipe chase installed in an old building. To properly seal the chase between floor, concrete should be parged in, as shown above, prior to the installation of new walls. When the walls are installed, a bead of industrial caulk should be applied to perimeter.
