# Guidebook for Structural Approaches to Integrated Pest Management

Prepared by  
Dr. Mitchell D. Allen  
Boston Housing Authority  
2009

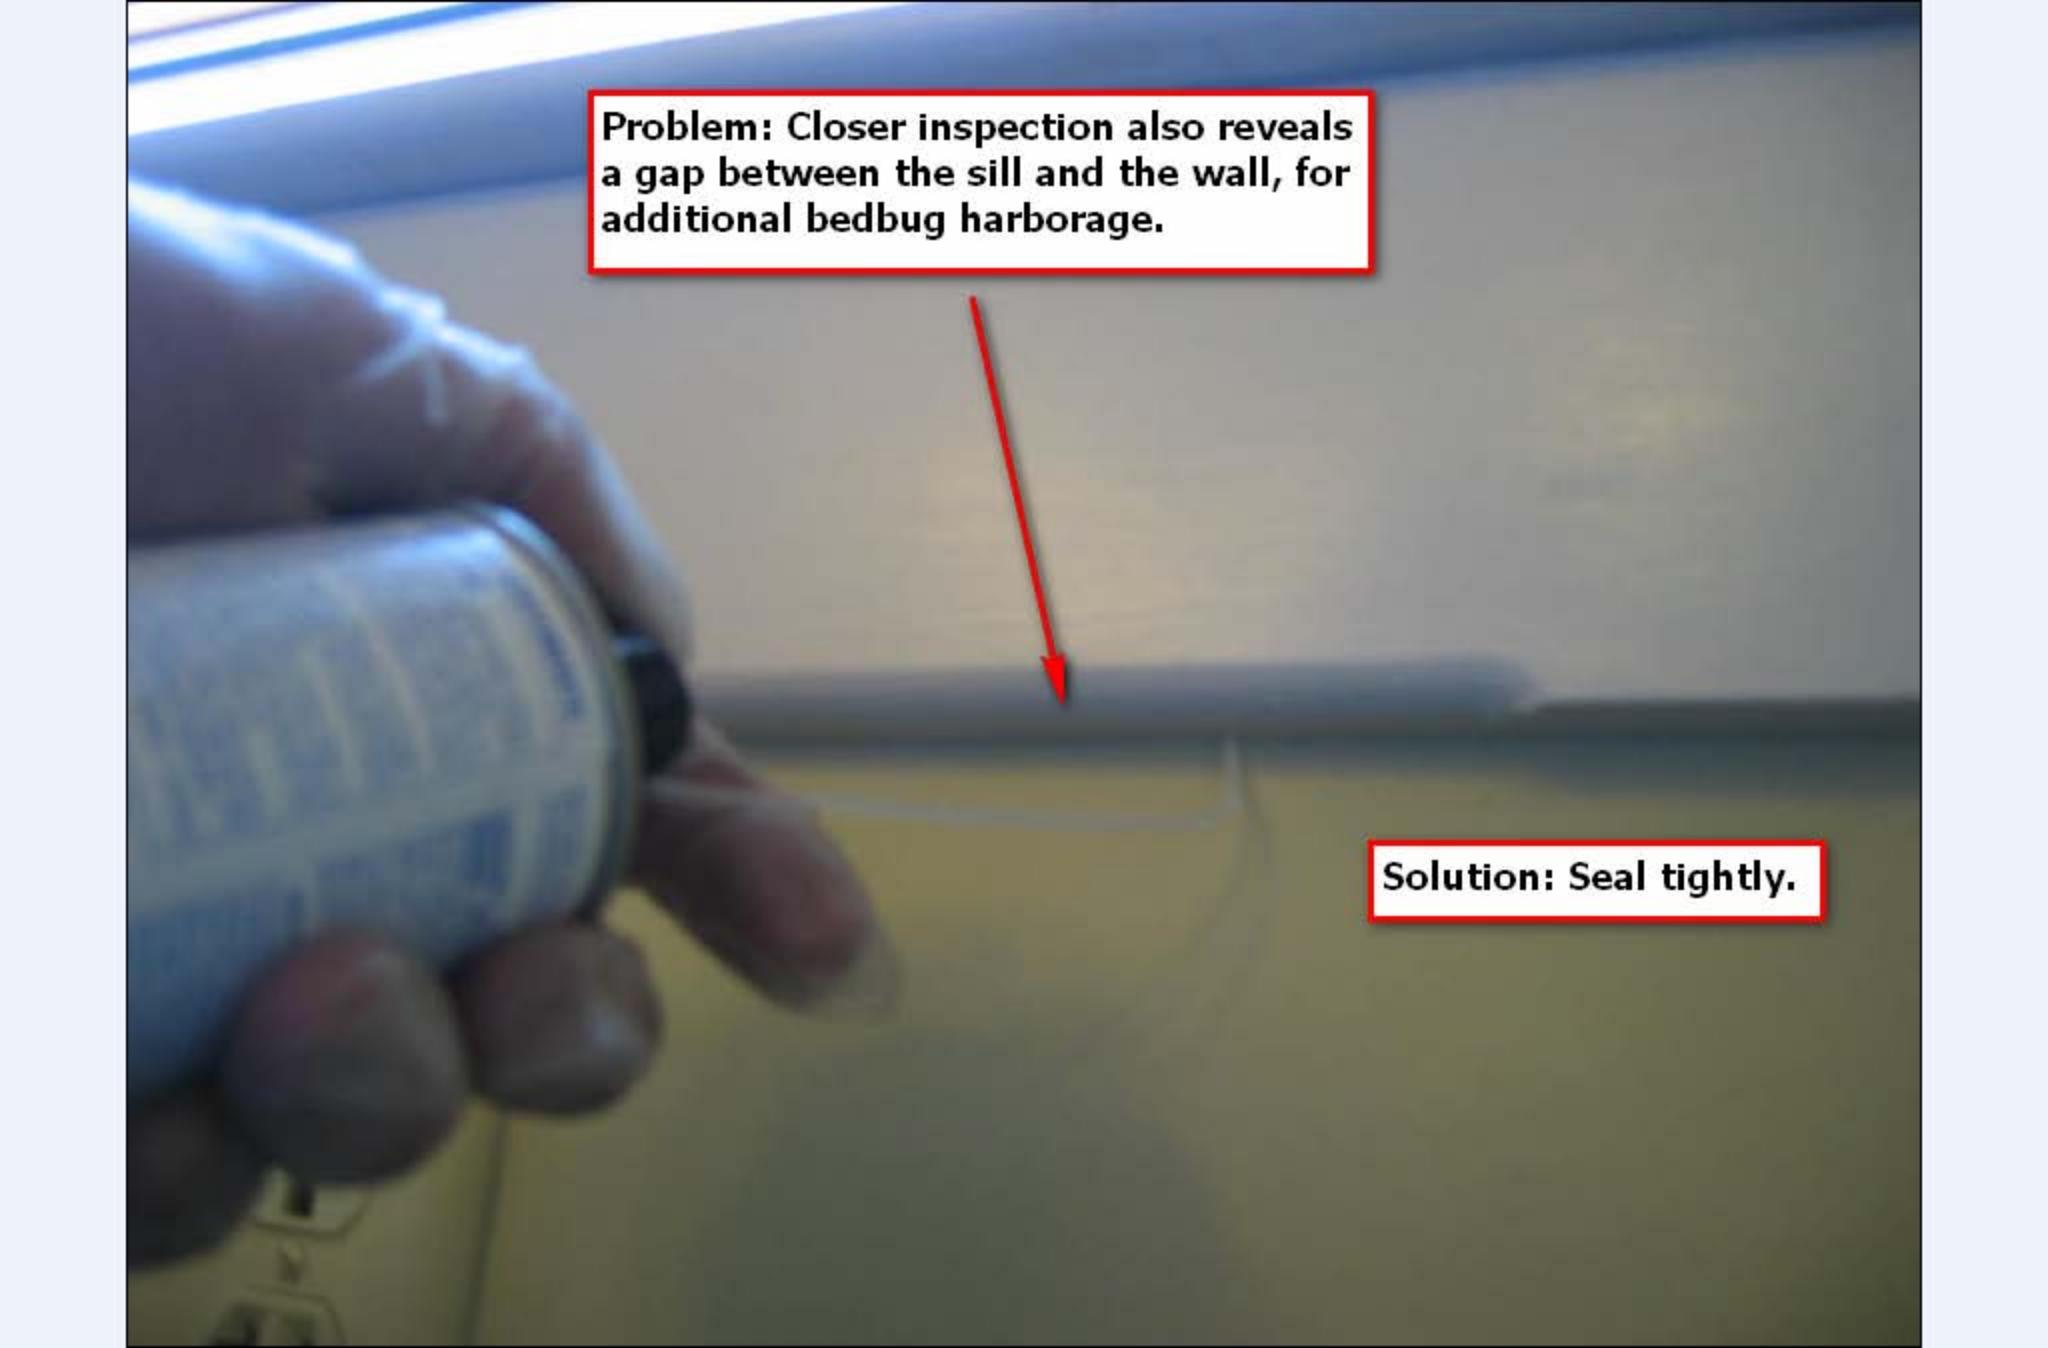
**Problem:** Closer inspection of this window sill reveal cracks for bedbug harborages and bedbug feces.

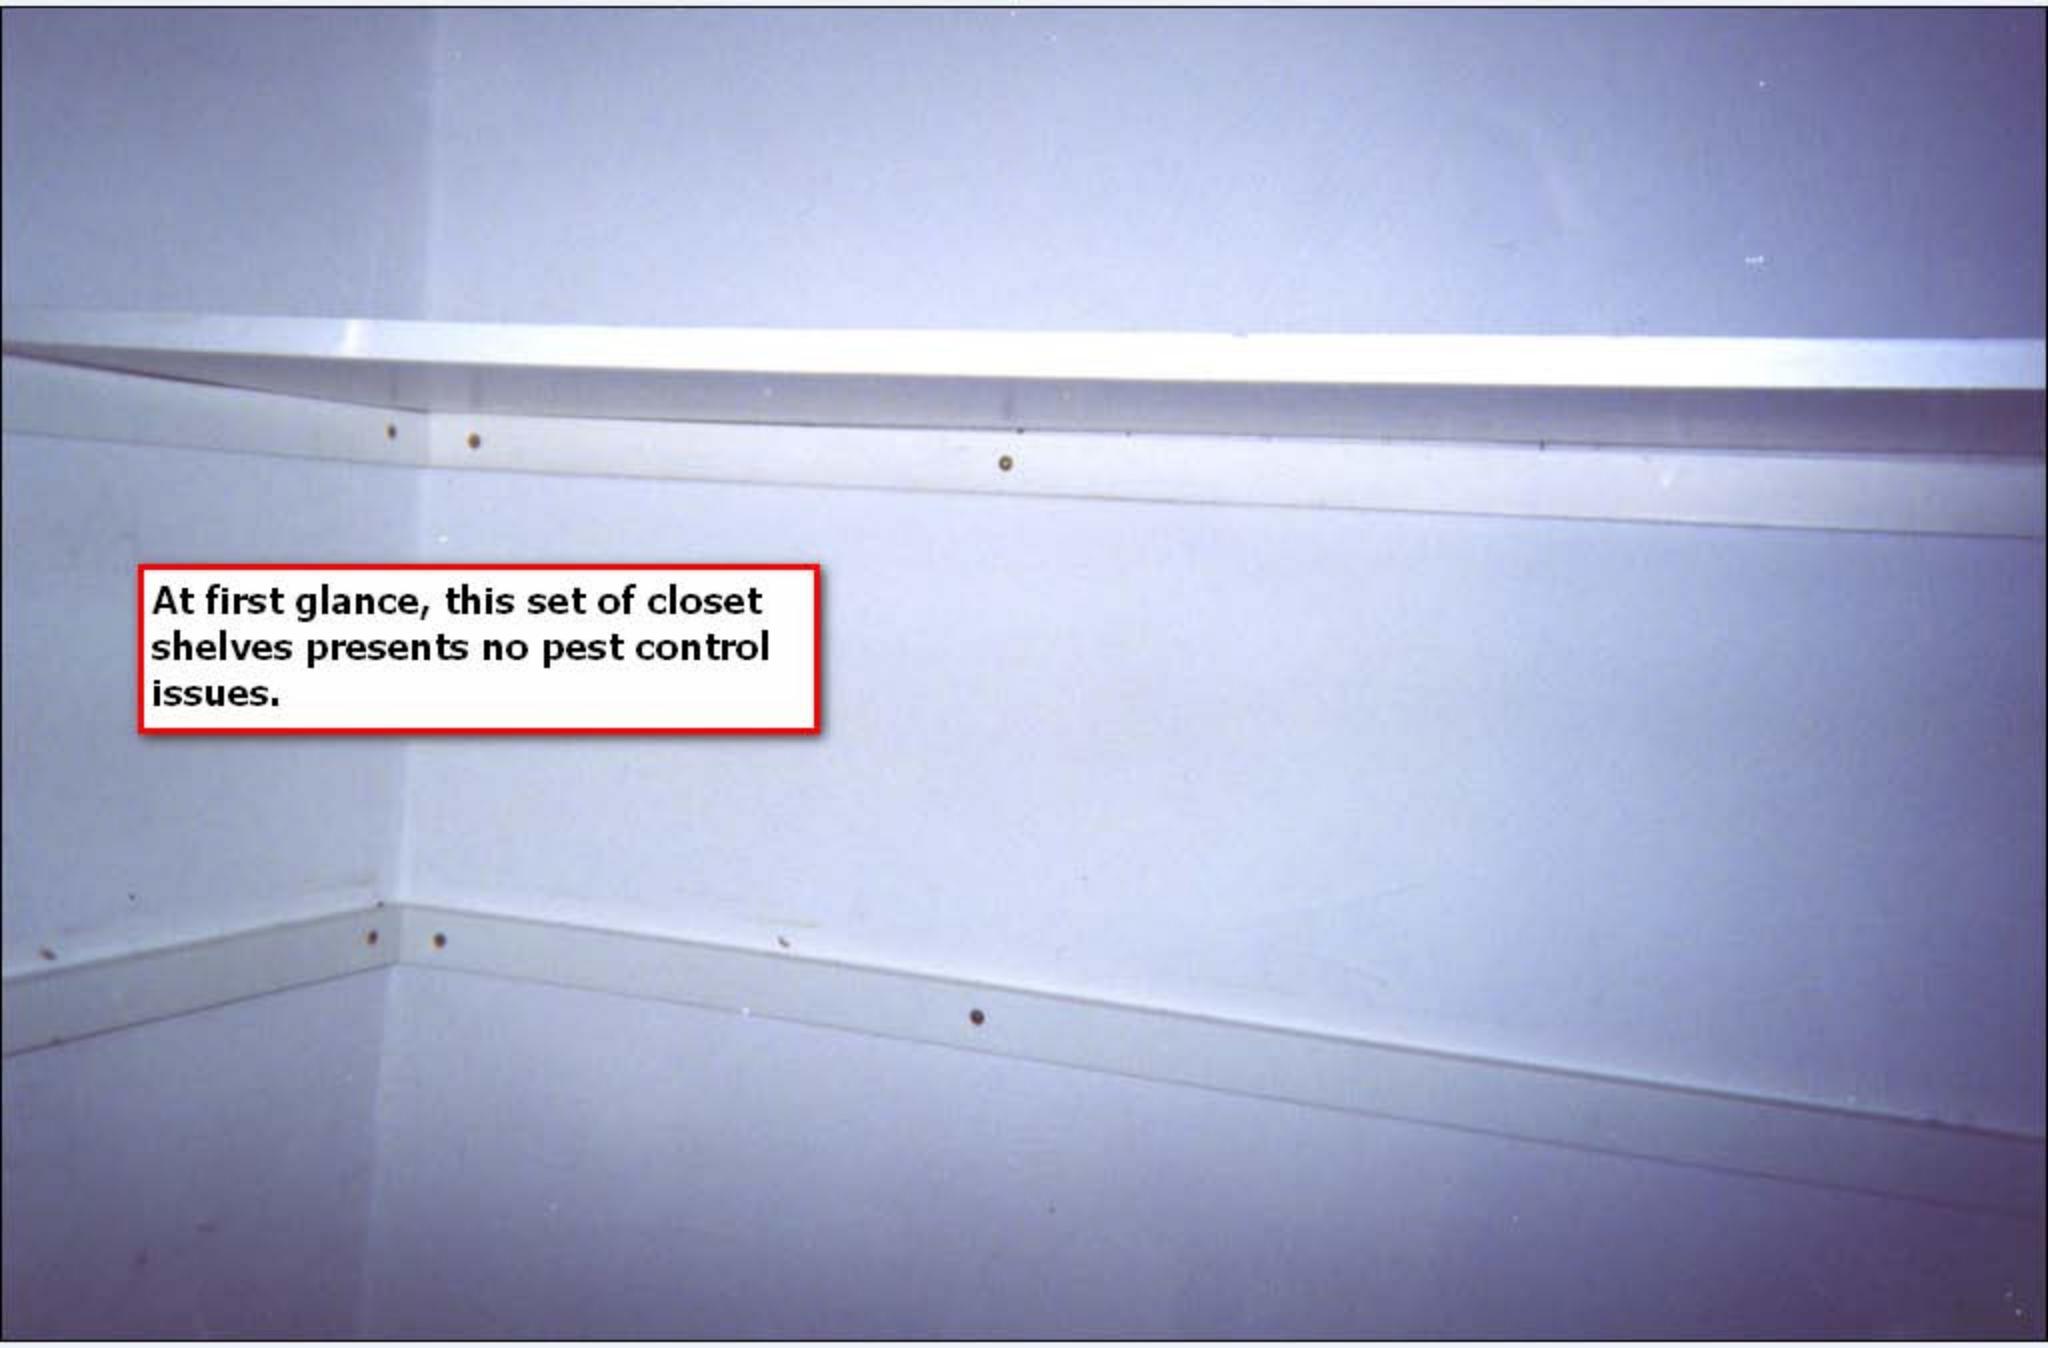
**Problem:** Closer inspection also reveals a gap between the sill and the wall, for additional bedbug harborage.

**Solution:** Seal tightly.

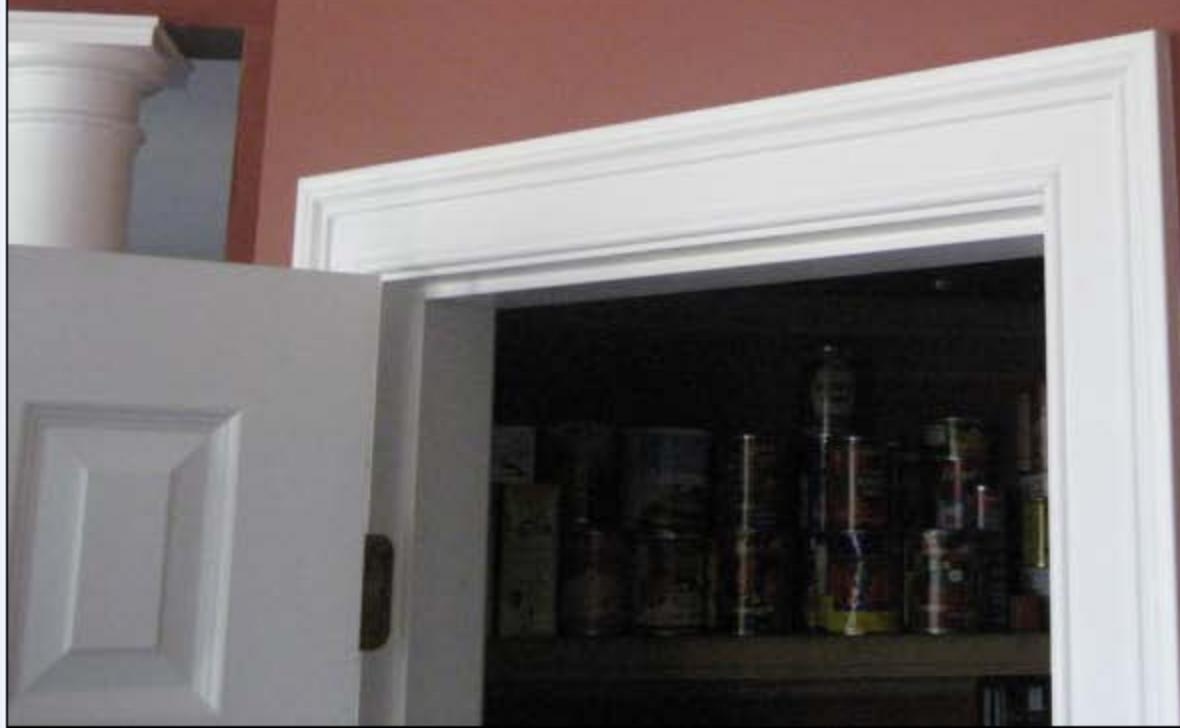
**This door frame appears  
to present no pest control  
issues from normal  
vantage points.**

**Problem:** A slight bow in wall creates access to this hollow door frame, and harborage for insects.

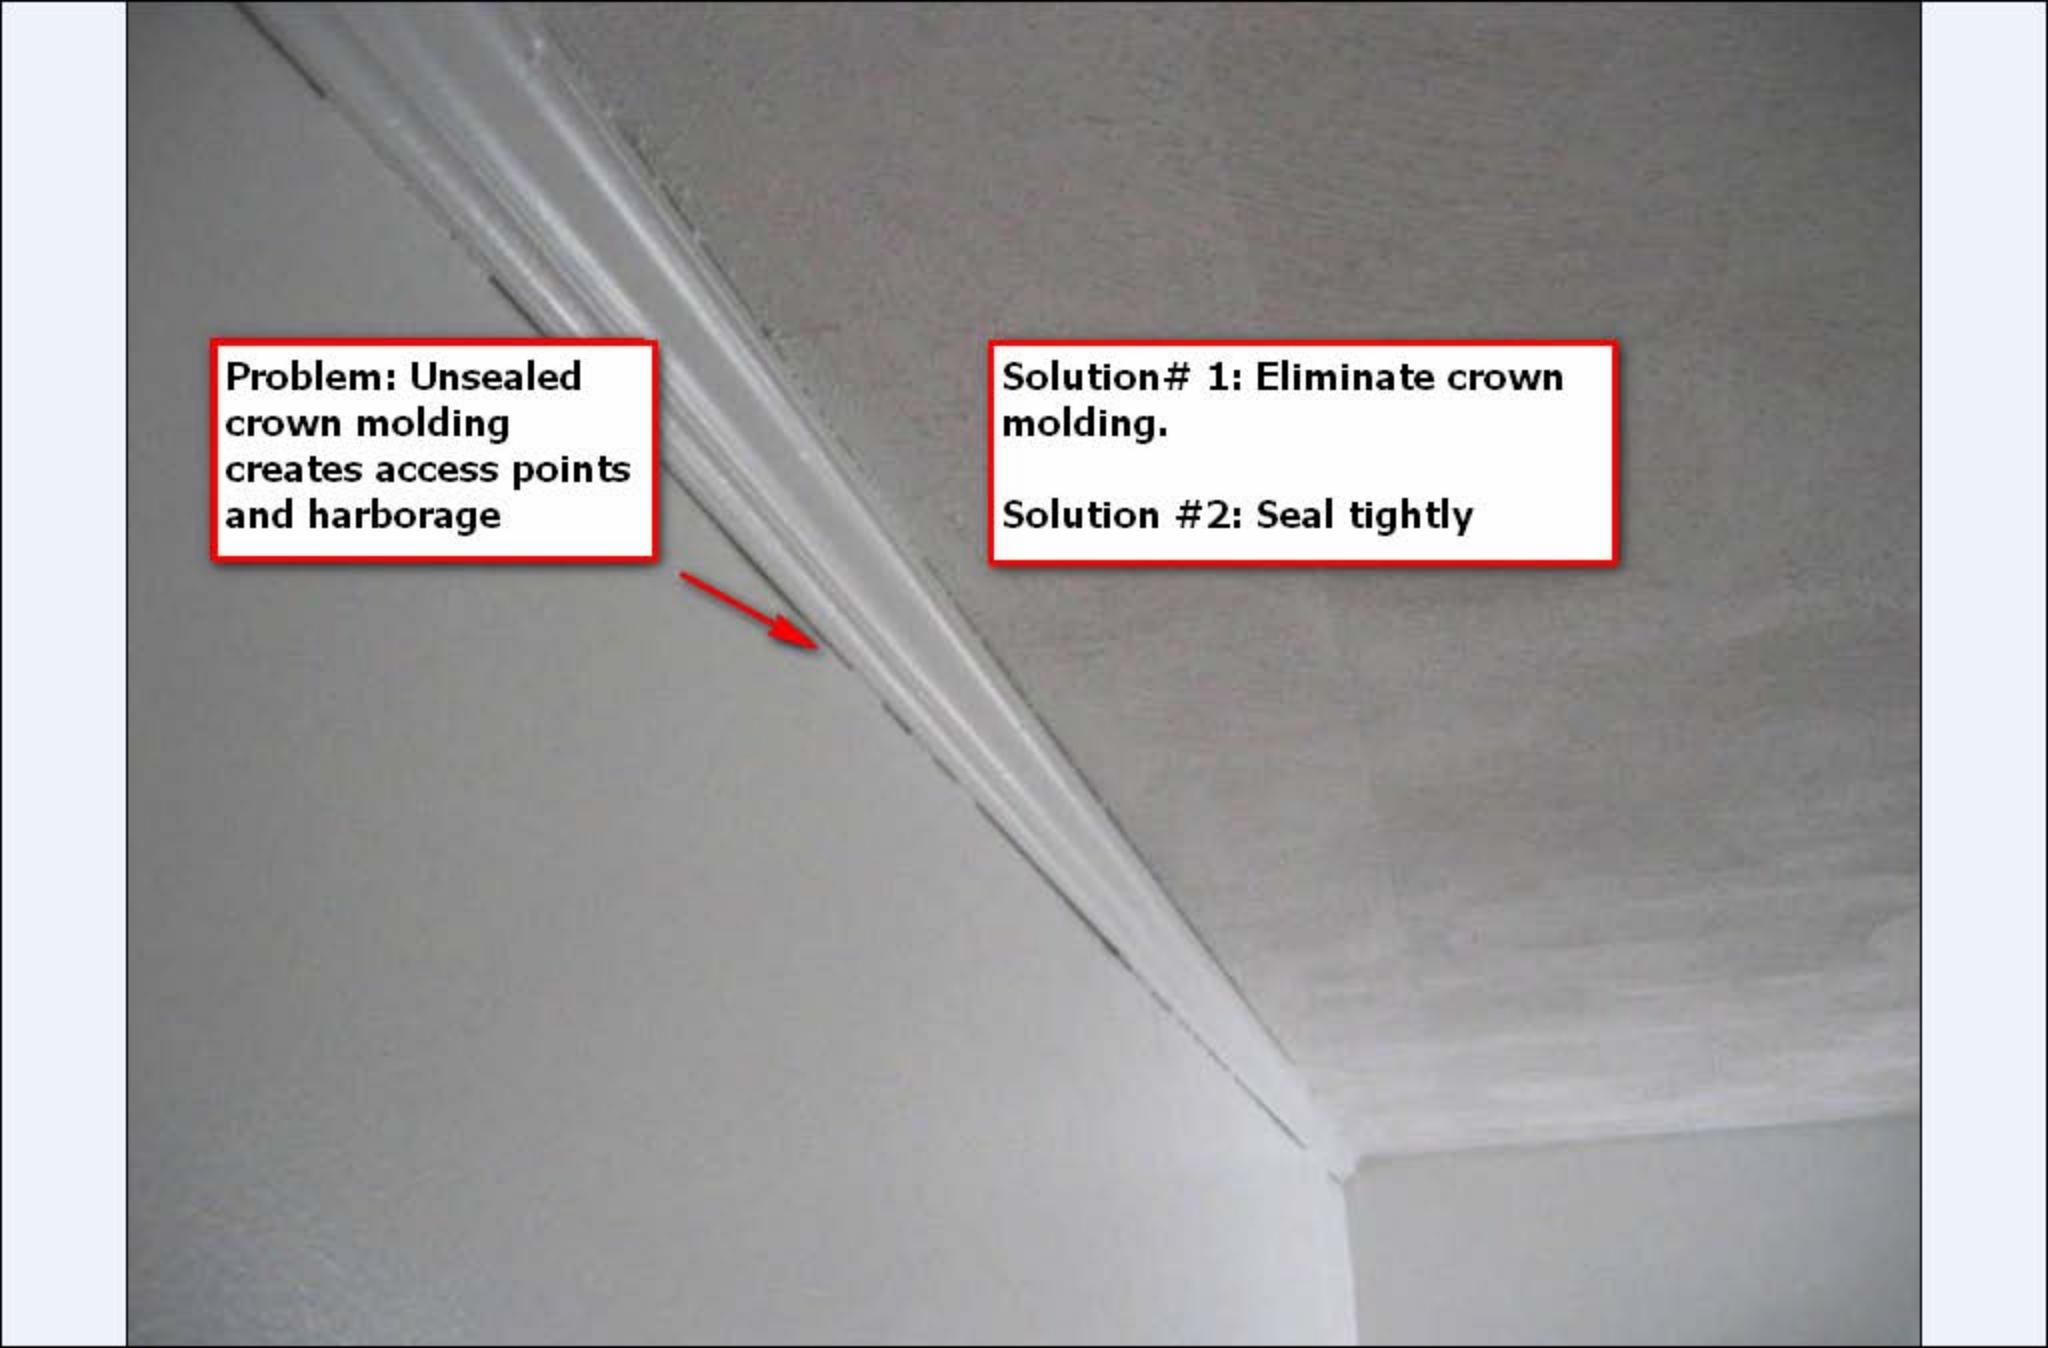
**Problem:** Unsealed crown molding creates access points and harborage

**Solution #1:** Eliminate crown molding.

**Solution #2:** Seal tightly

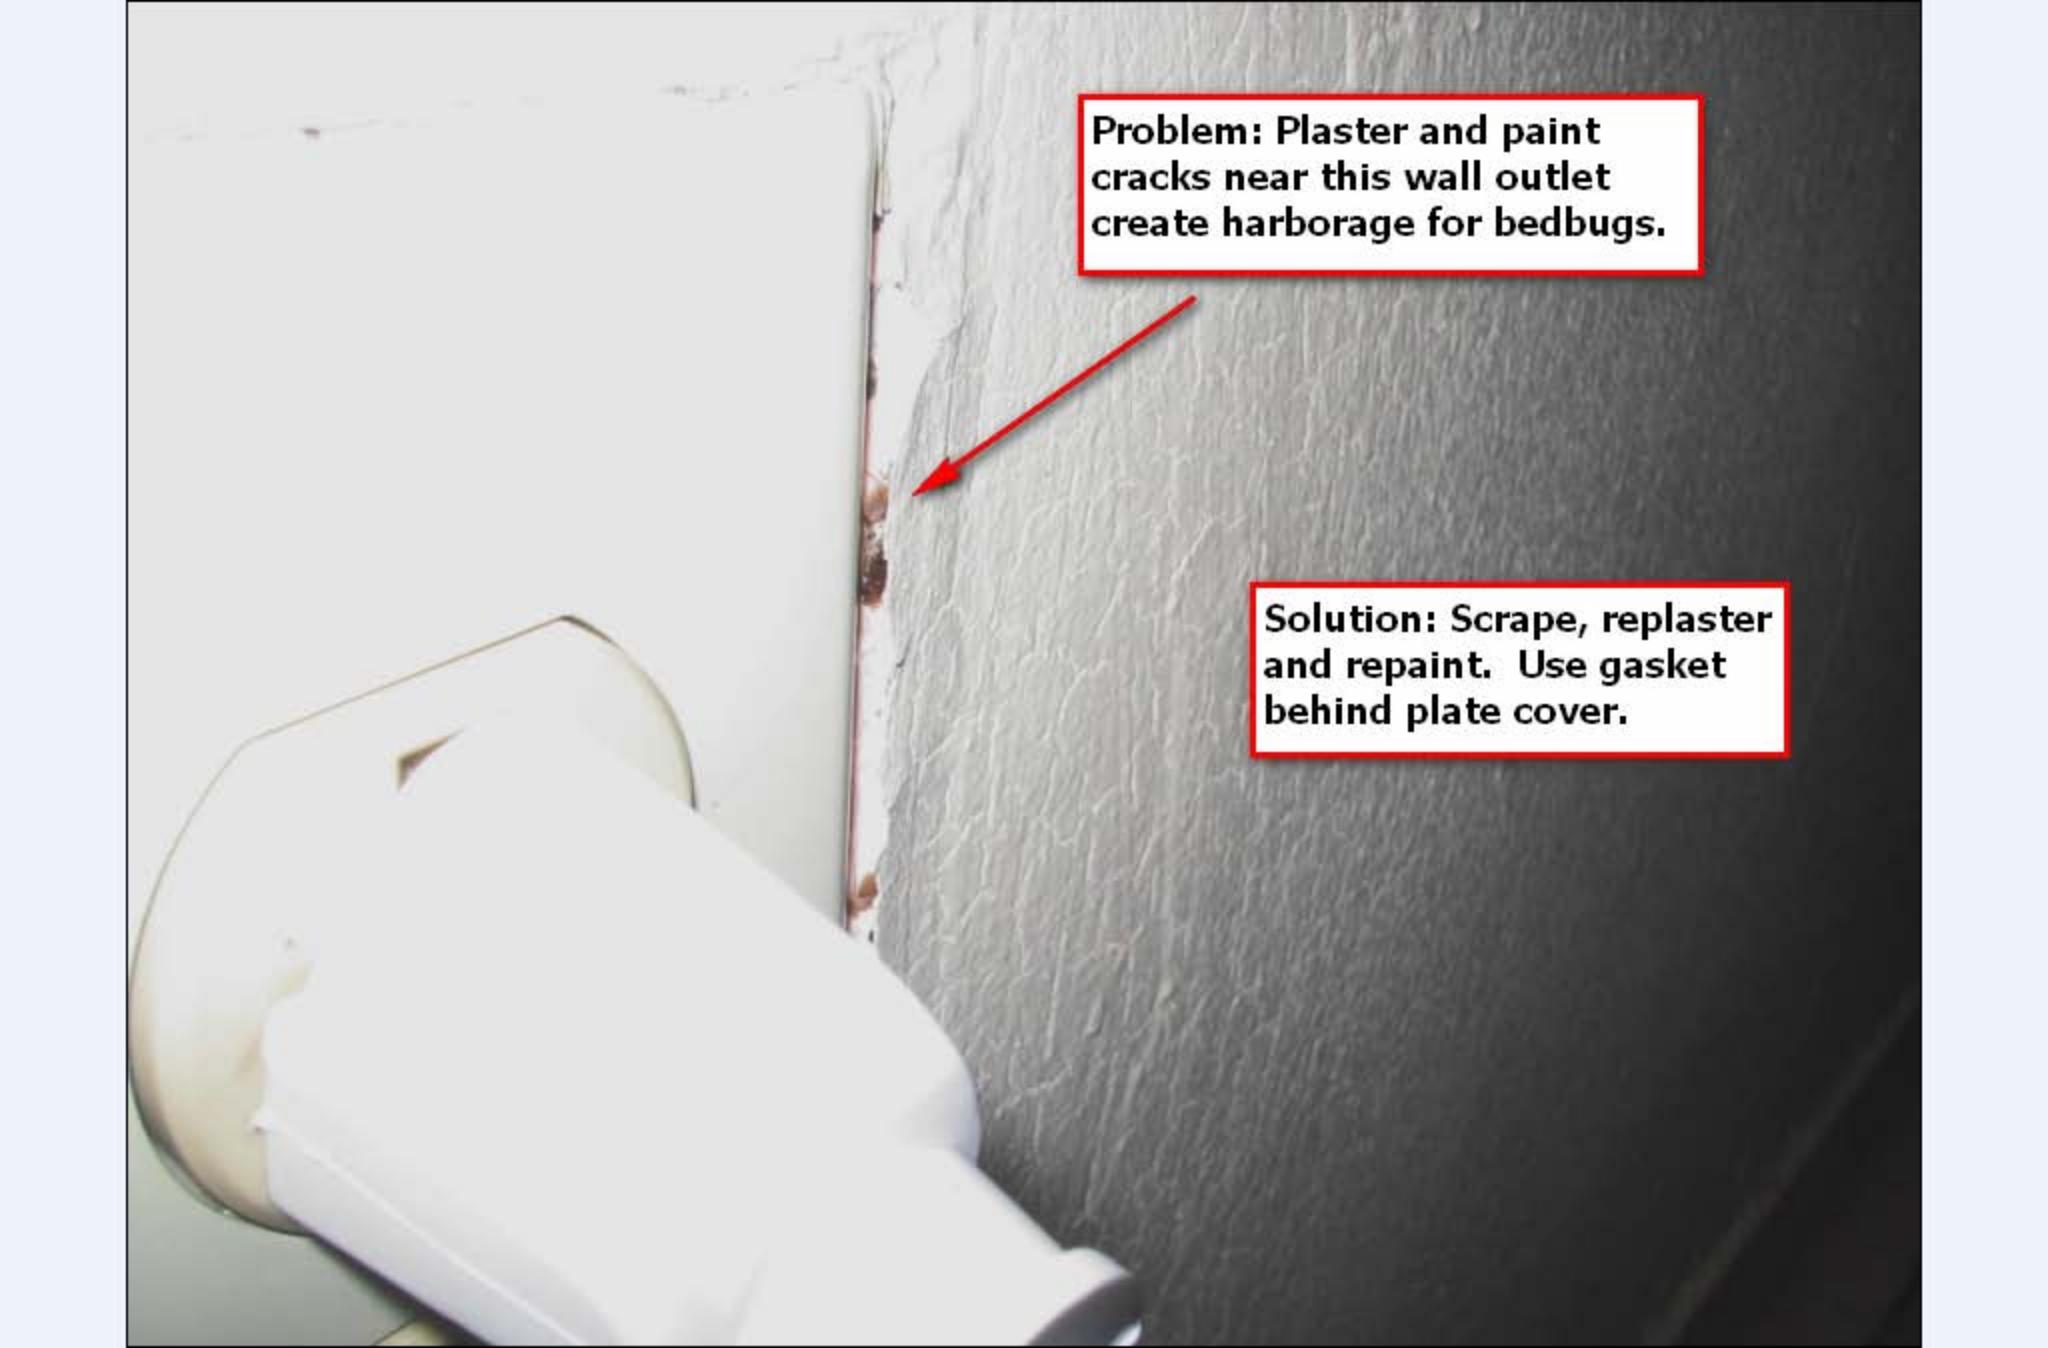
**Problem:** Plaster and paint cracks near this wall outlet create harborage for bedbugs.

**Solution:** Scrape, replaster and repaint. Use gasket behind plate cover.

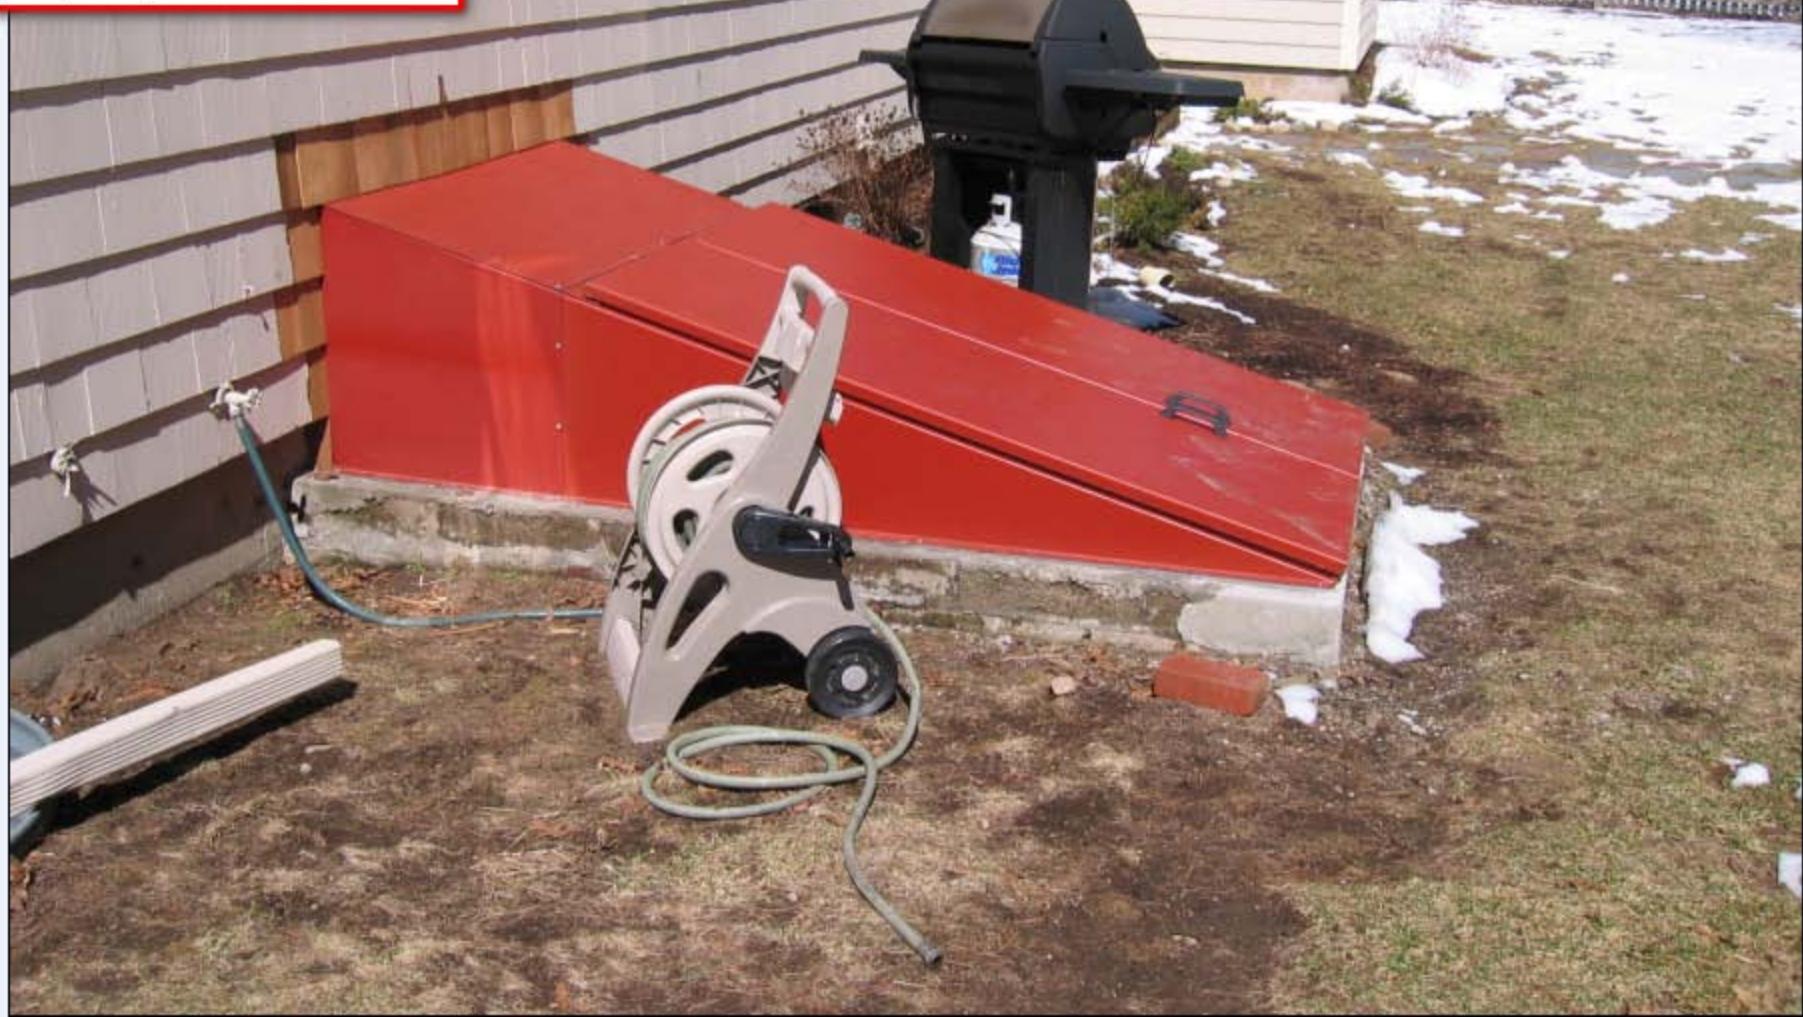
**From the exterior, this  
newly-installed  
bulkhead seems  
properly installed.**

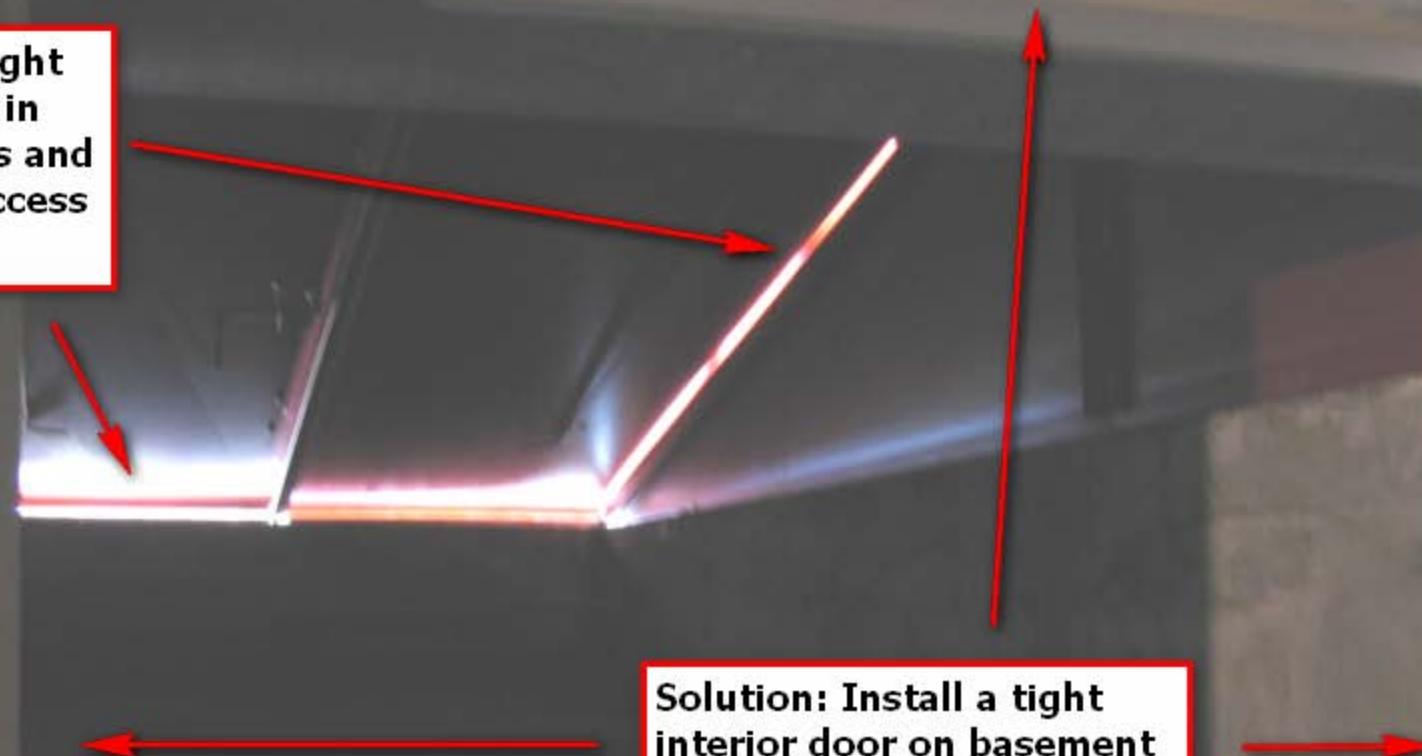
**Problem:** Daylight indicates gaps in bulkhead doors and frame. Easy access for pests.

**Solution:** Install a tight interior door on basement

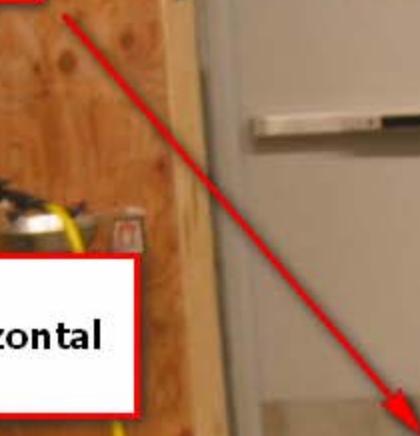
**Problem #1: Incorrect termination of this steel door frames allows access to mice.**

**Problem #2: lack of door sweeps allows access to mice, too.**

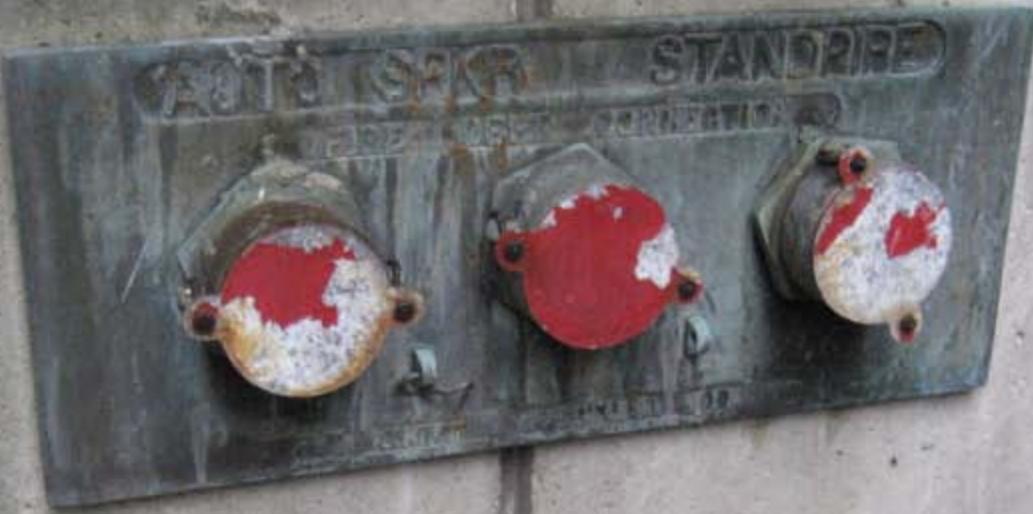
**From the front, this standpipe plate appears completely normal.**

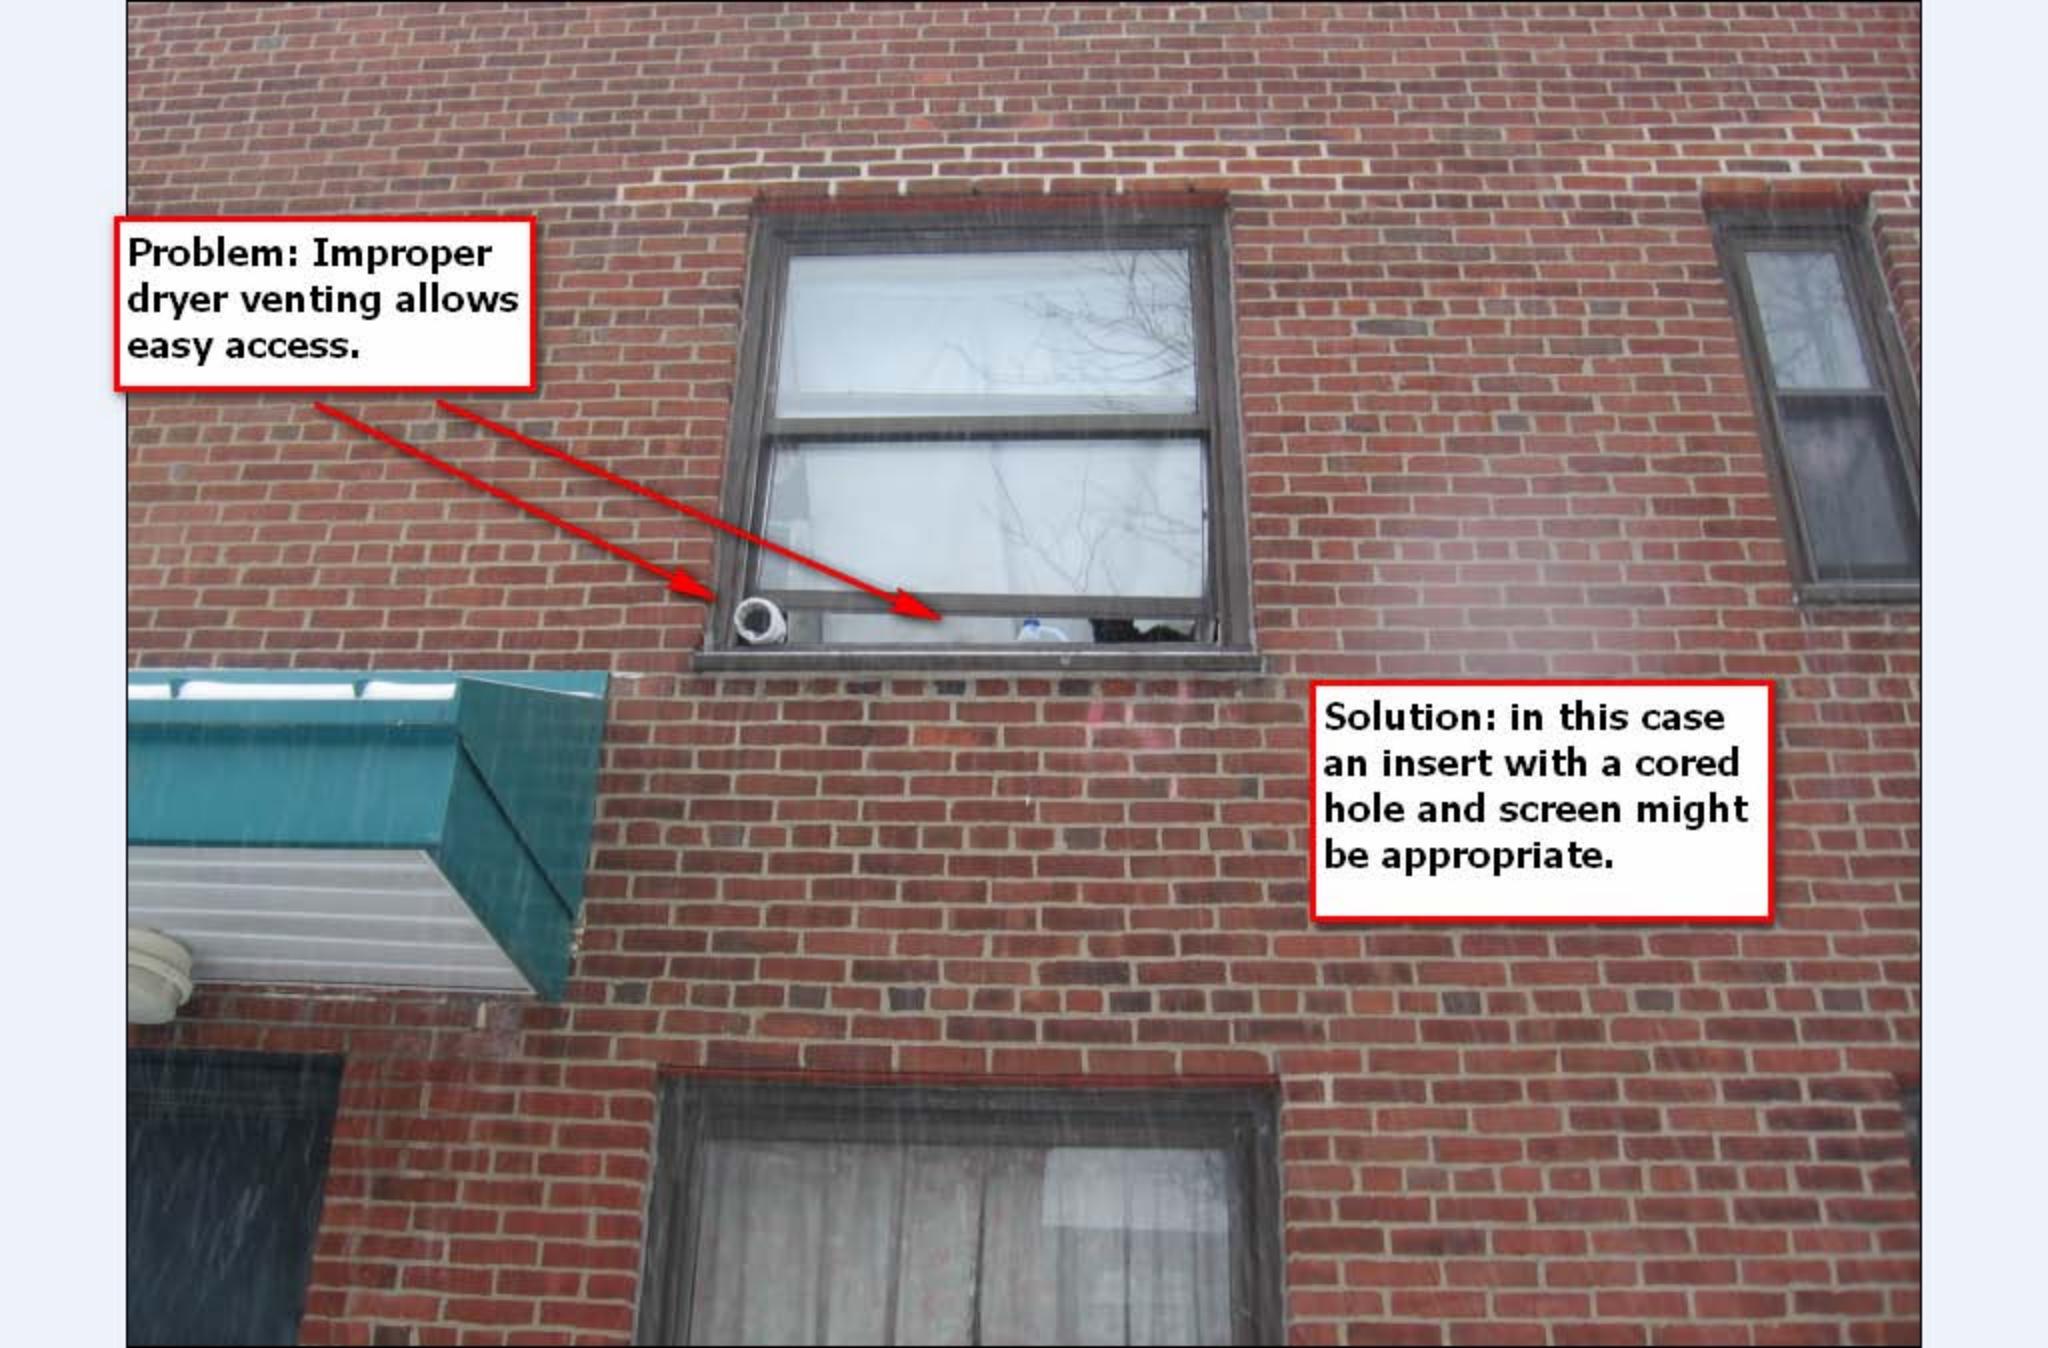
**Problem: Improper  
dryer venting allows  
easy access.**

**Solution: in this case  
an insert with a cored  
hole and screen might  
be appropriate.**

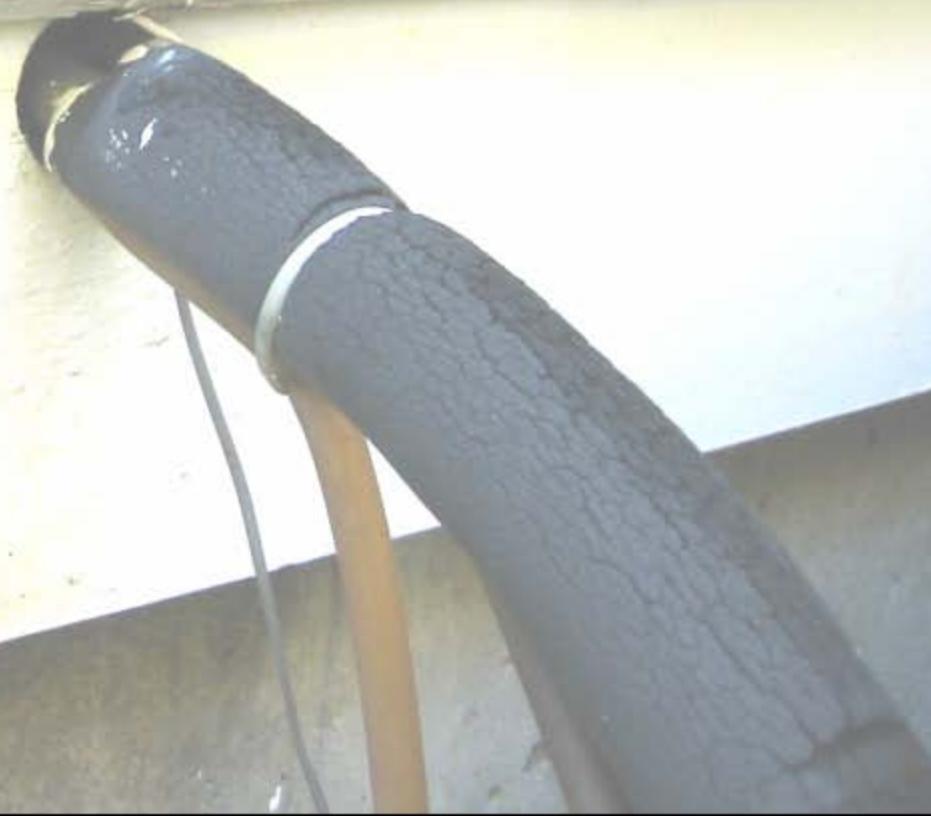
**Problem:** Air Conditioner  
line into house is unsealed,  
leaving open access to  
mice and insects. Note  
that mice have chewed  
foam insulation.

**Solution:** Plug with  
cooper wool and IPM  
foam.

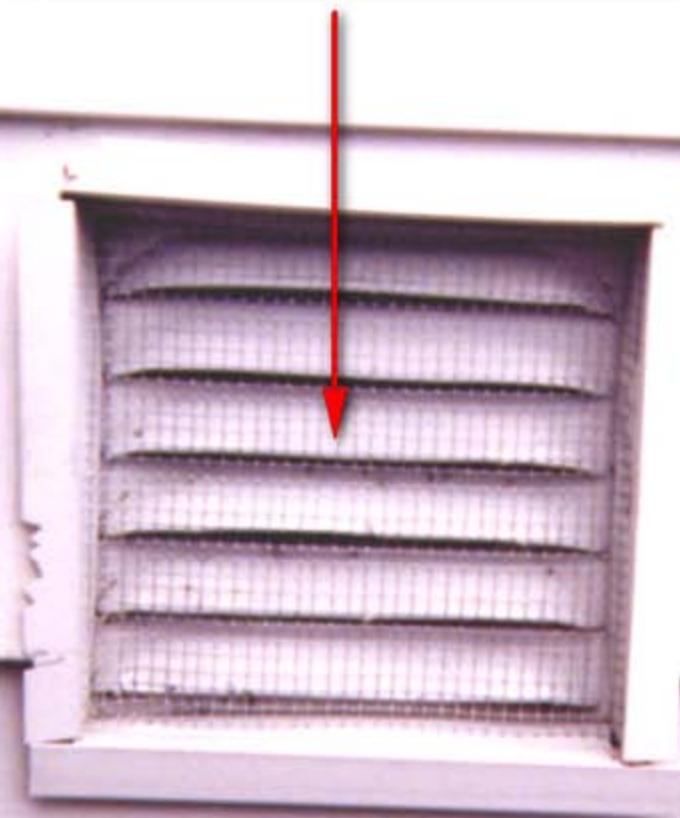
Prior to the installation of 3/4" Rat Wire, this dryer vent was accessible to rats and mice.

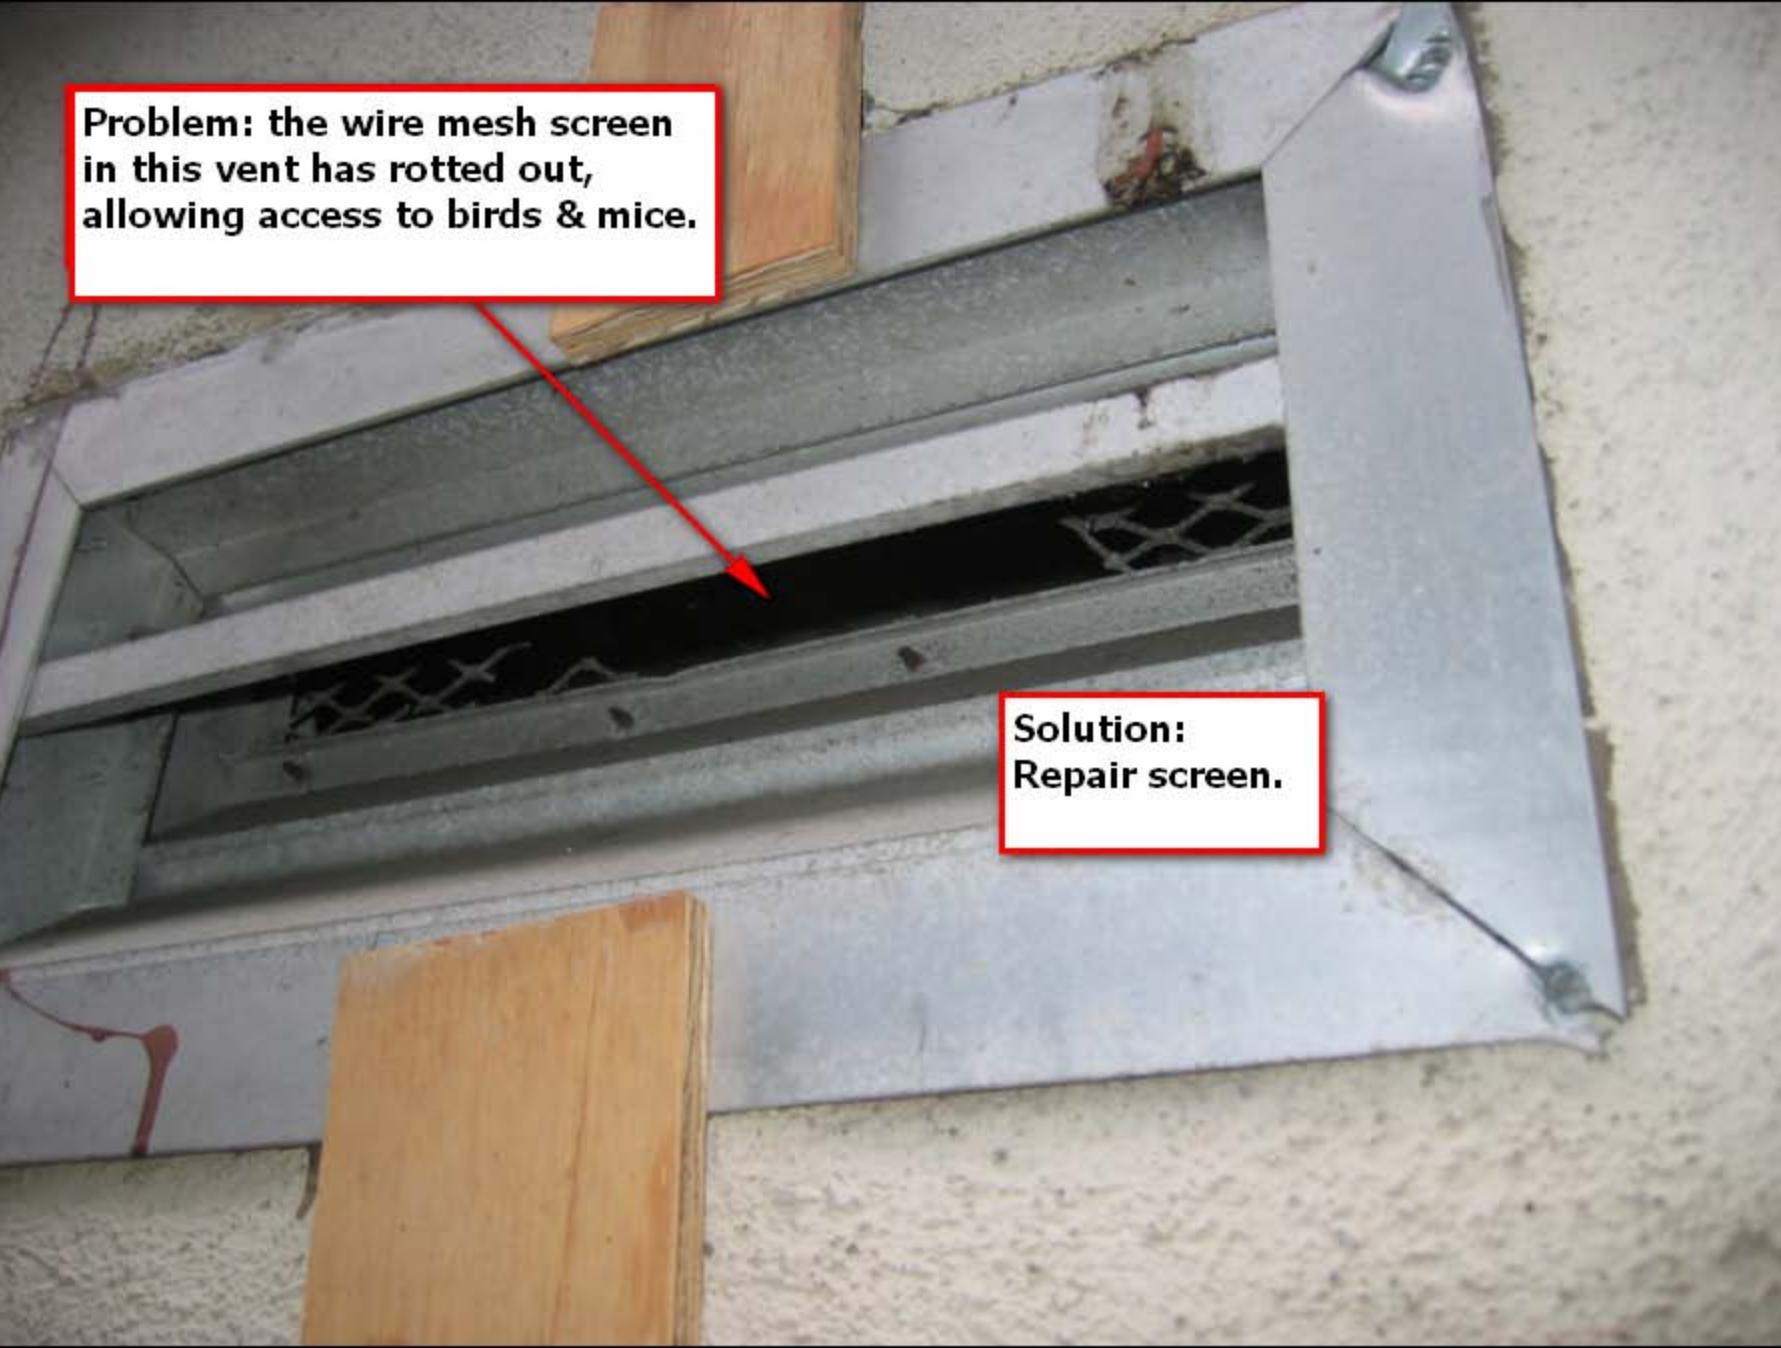
**Problem:** the wire mesh screen in this vent has rotted out, allowing access to birds & mice.

**Solution:**  
Repair screen.
