# Guidebook for Structural Approaches to Integrated Pest Management

Prepared by  
Dr. Mitchell D. Allen  
Boston Housing Authority  
2009

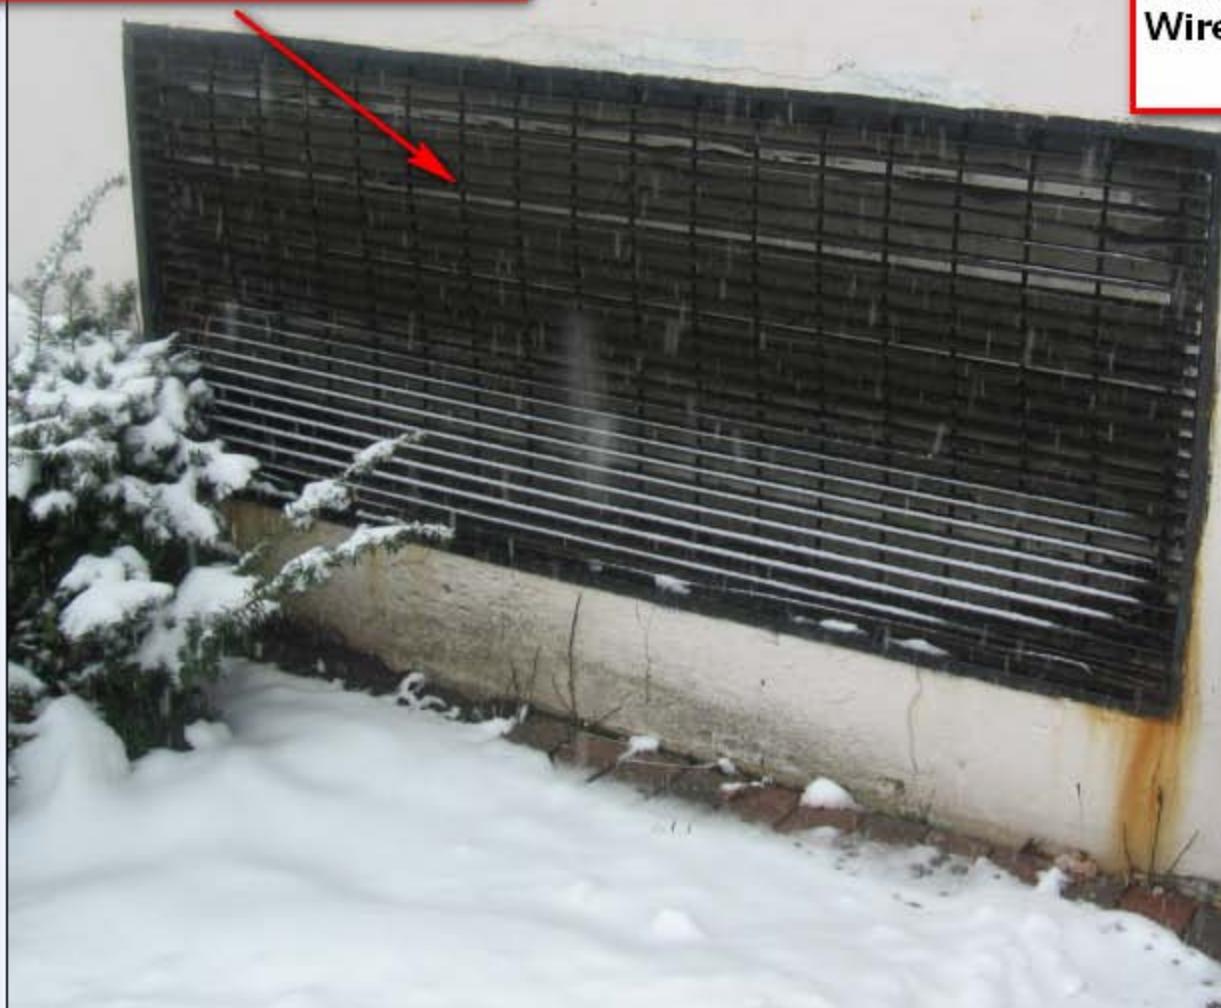
**Problem:** This grate is not intended for this use. It allows access to mice.

**Solution:** Install Rat Wire behind it.

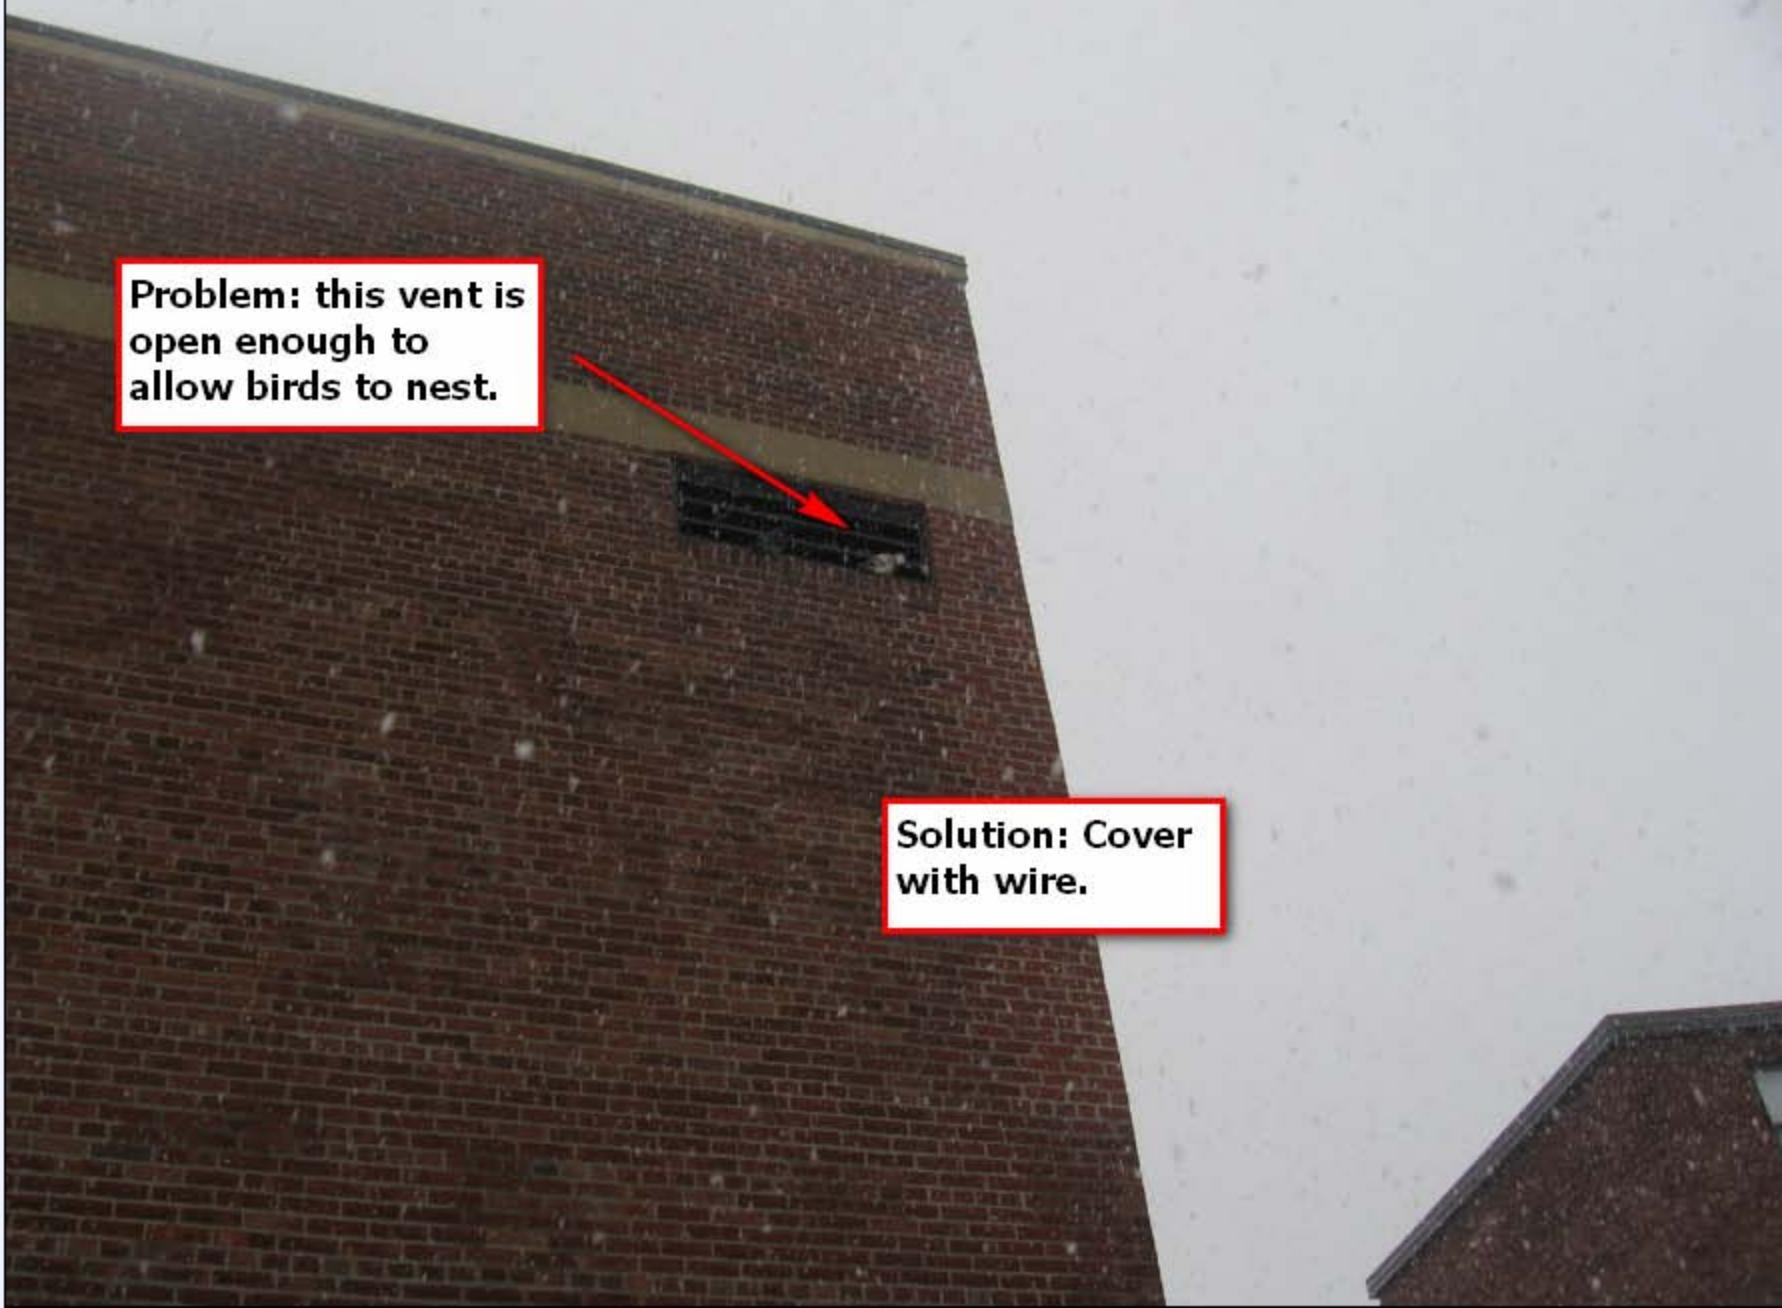
**Problem:** this vent is open enough to allow birds to nest.

**Solution:** Cover with wire.

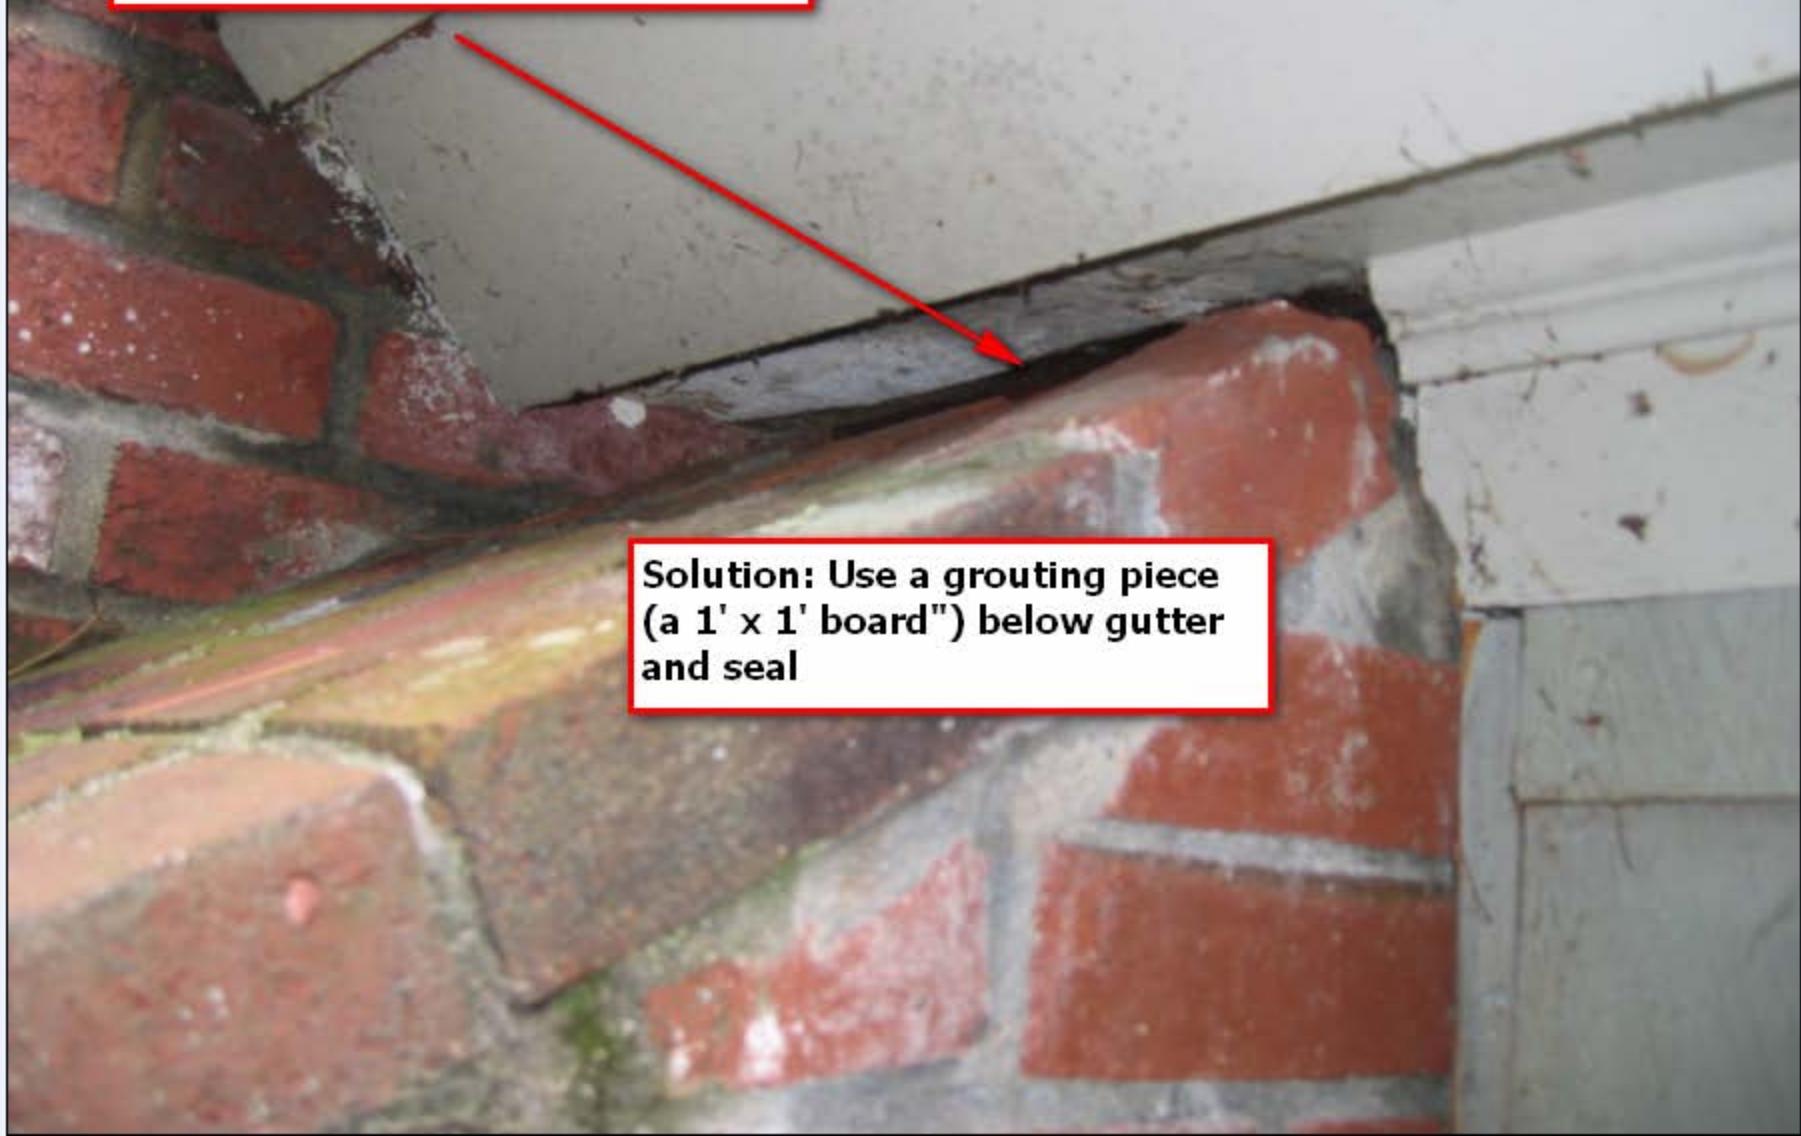
**Problem: Gap between Masonry  
and Gutter allows entry for mice.**

**Solution: Use a grouting piece  
(a 1' x 1' board") below gutter  
and seal**

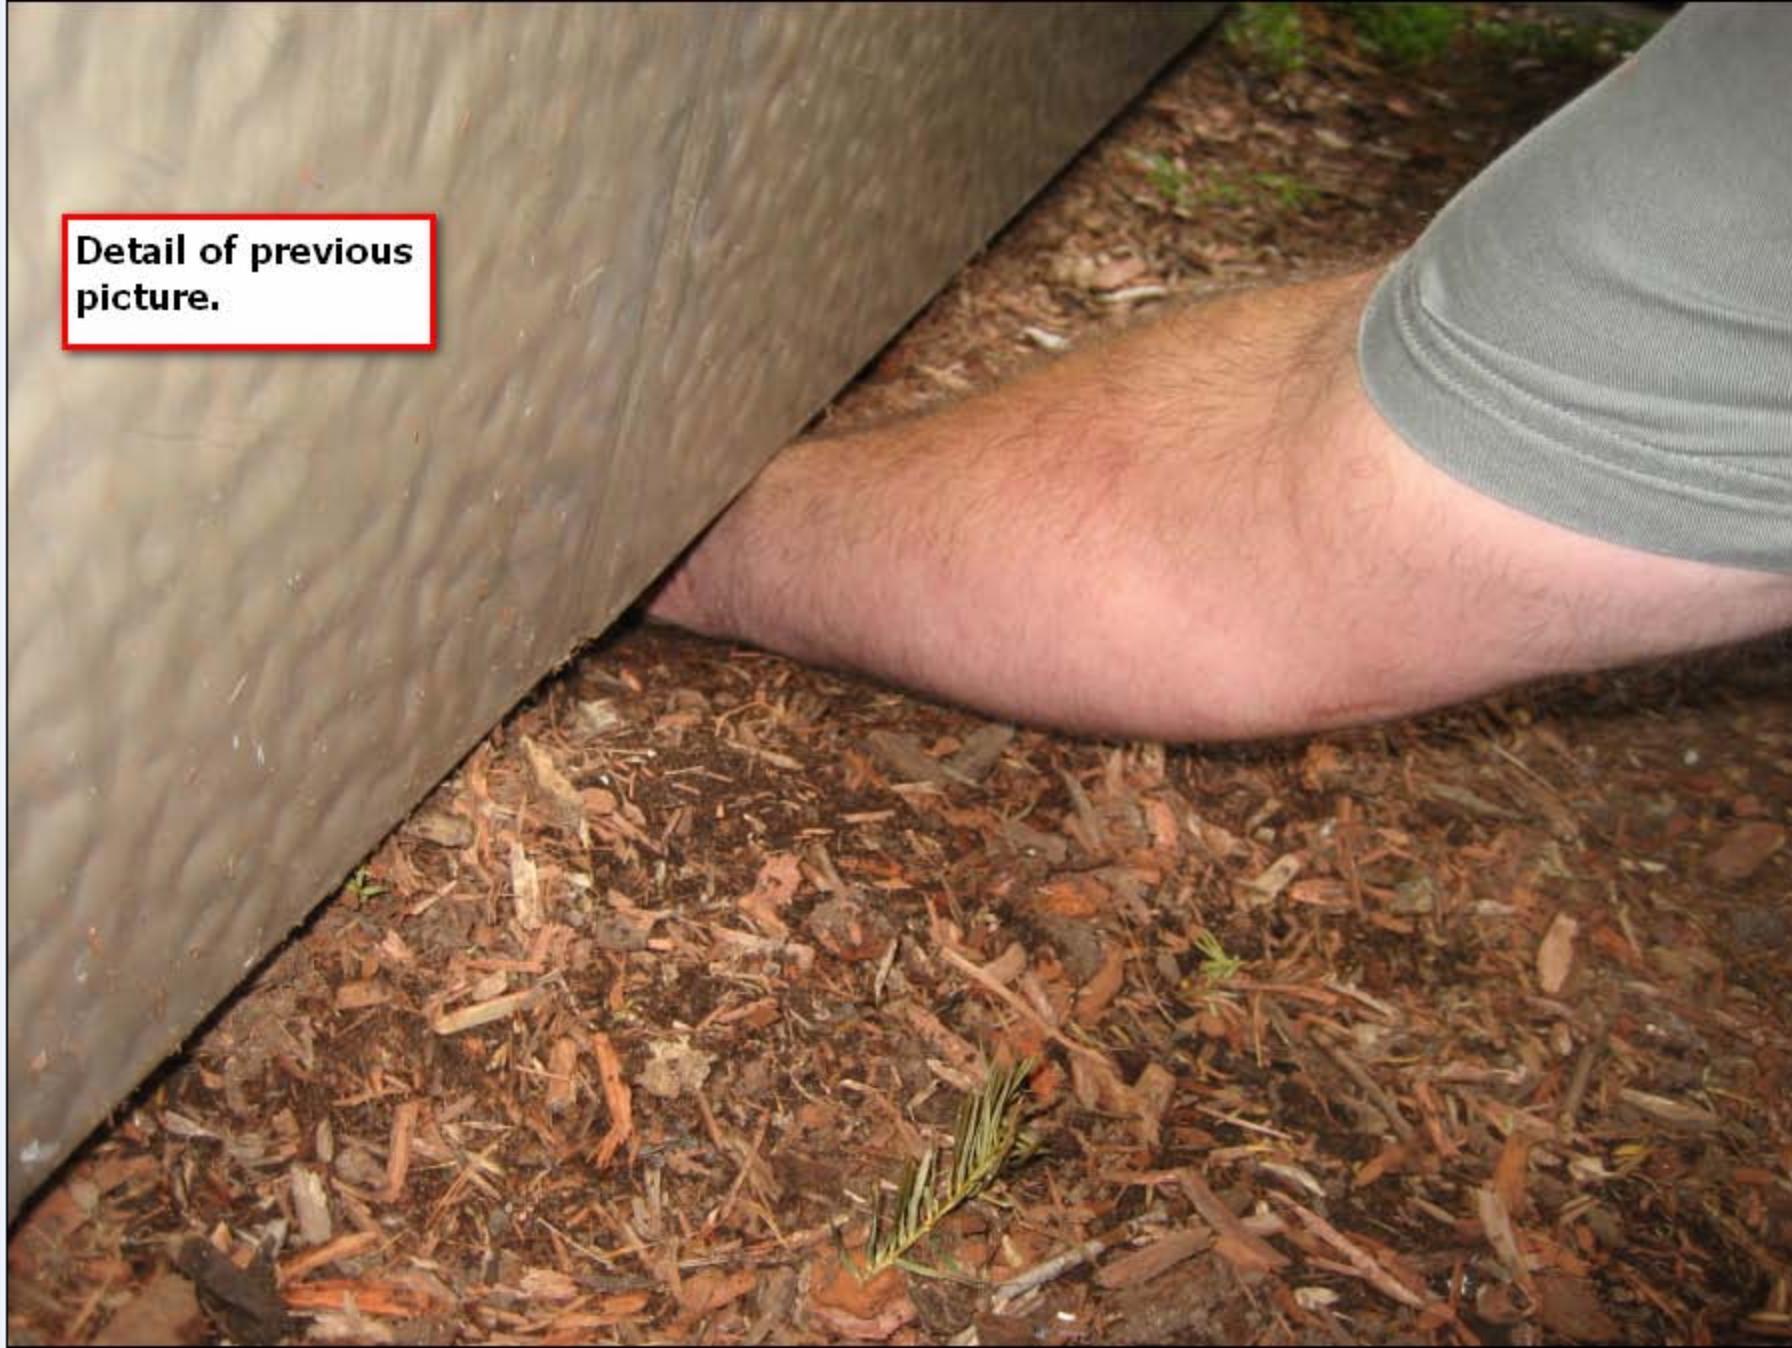
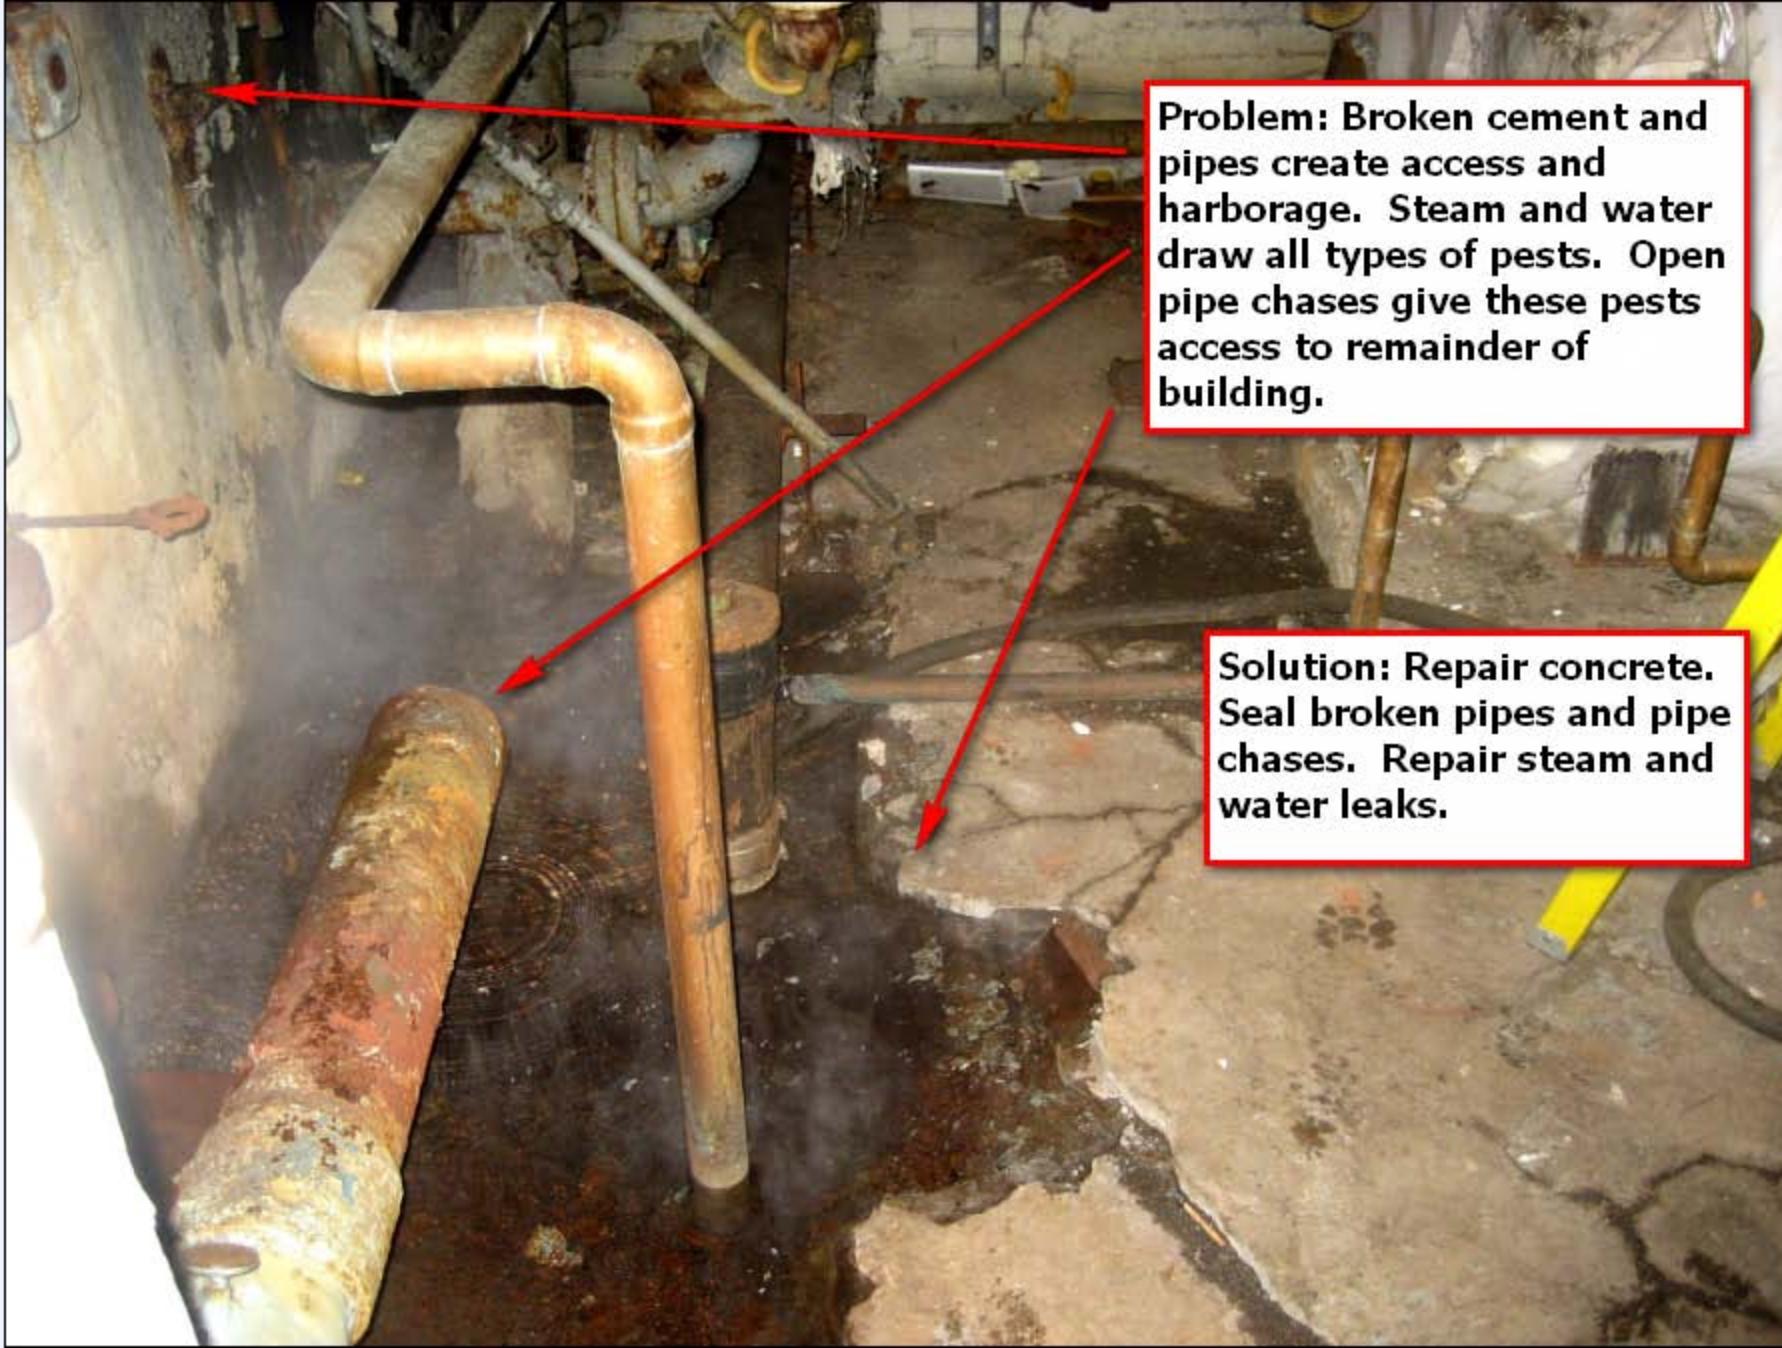
**Problem:** Broken cement and pipes create access and harborage. Steam and water draw all types of pests. Open pipe chases give these pests access to remainder of building.

**Solution:** Repair concrete. Seal broken pipes and pipe chases. Repair steam and water leaks.

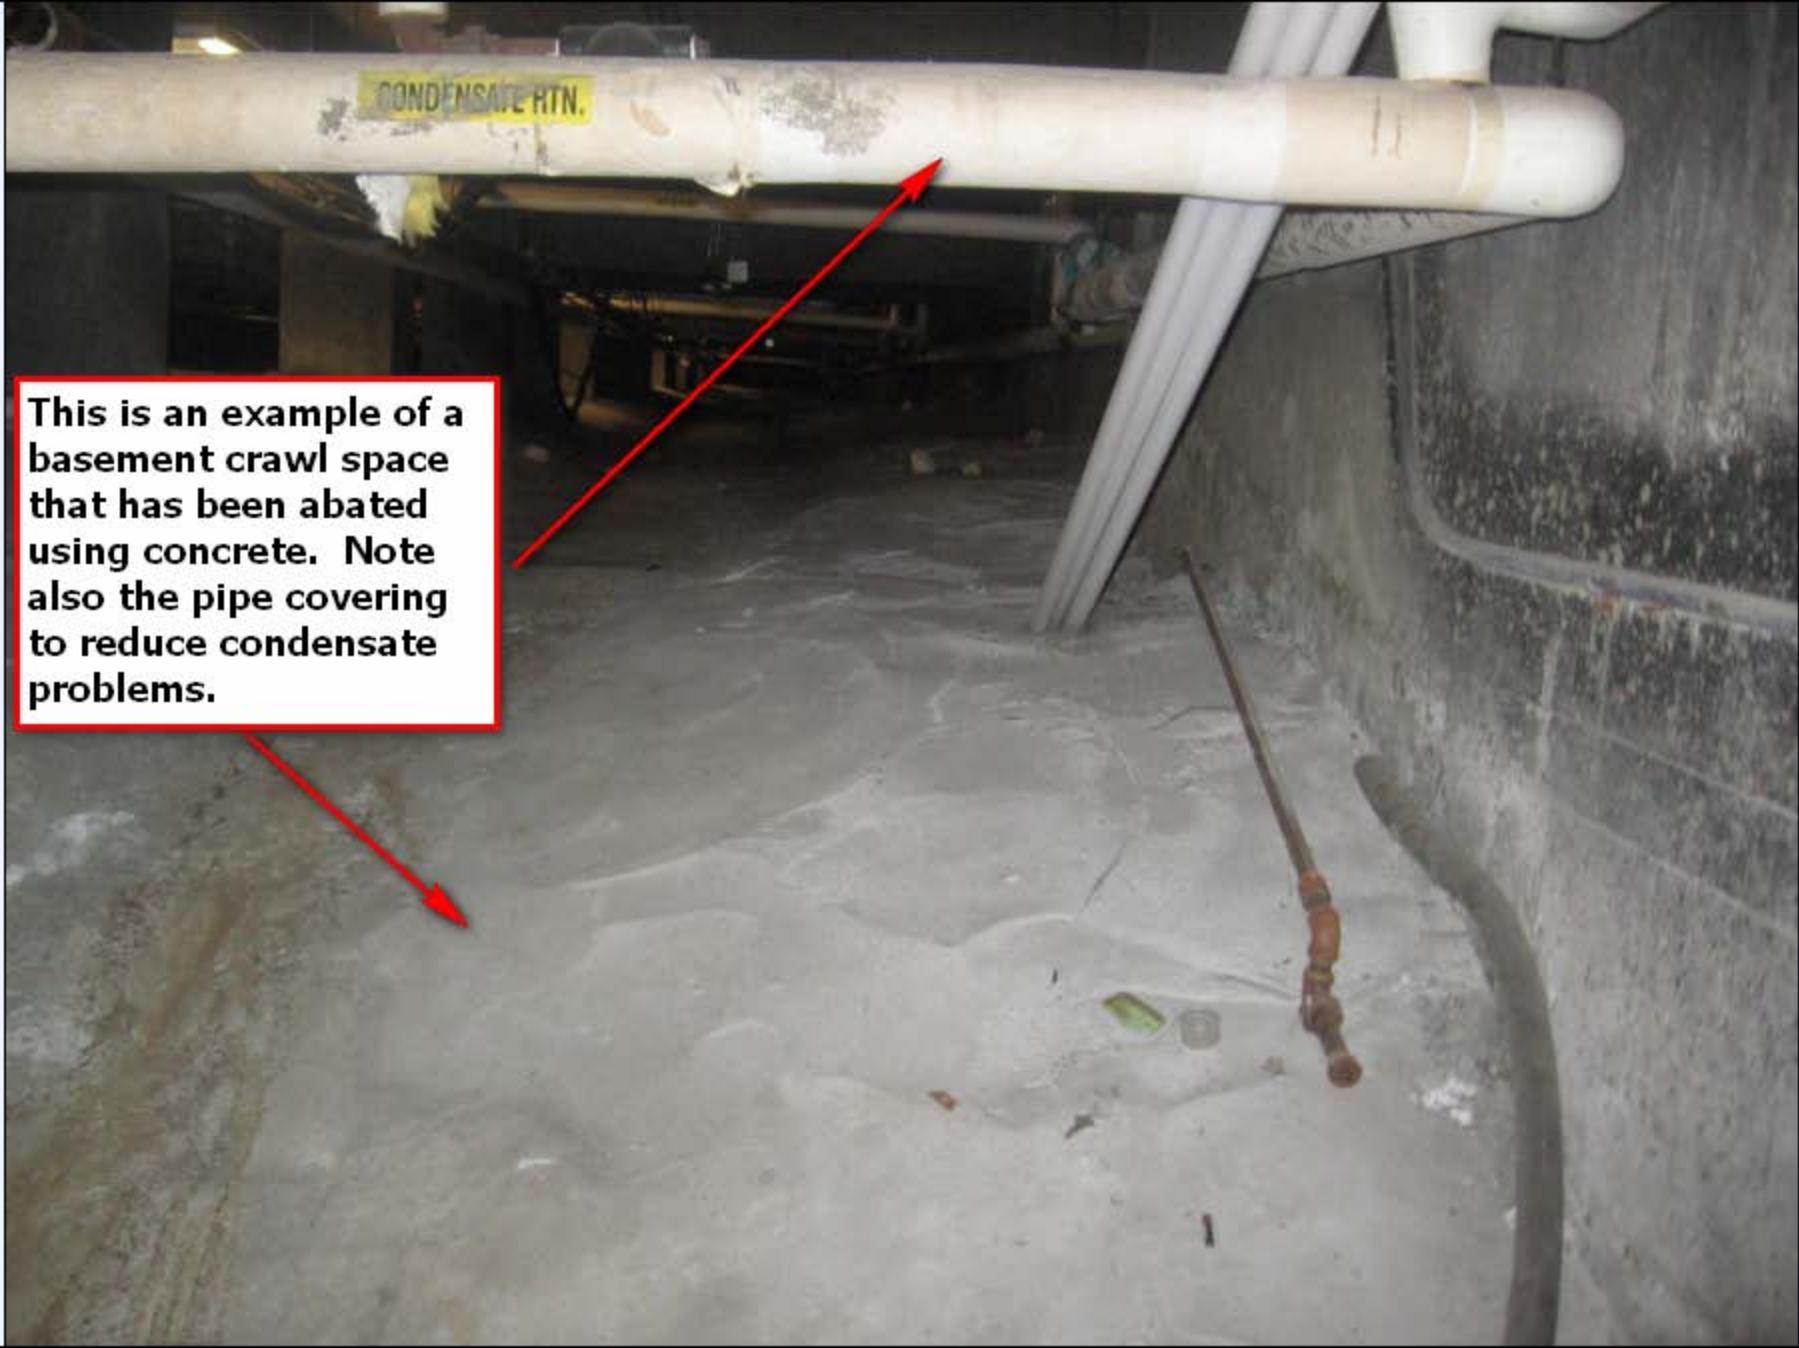
**Problem:** Dirt creates harborage and uncovered lines create moisture attraction to pests. Unsealed pipe chases allow pests access to remainder of building.

**Solution:** If possible, remove dirt and replace with concrete. Cover pipes and seal chases.
