SOUTH MARKET BUILDING

BOSTON LANDMARKS COMMISSION STUDY REPORT

Report on the Potential Designation of

South Market Building
100-199 Faneuil Hall Marketplace, Boston, Massachusetts

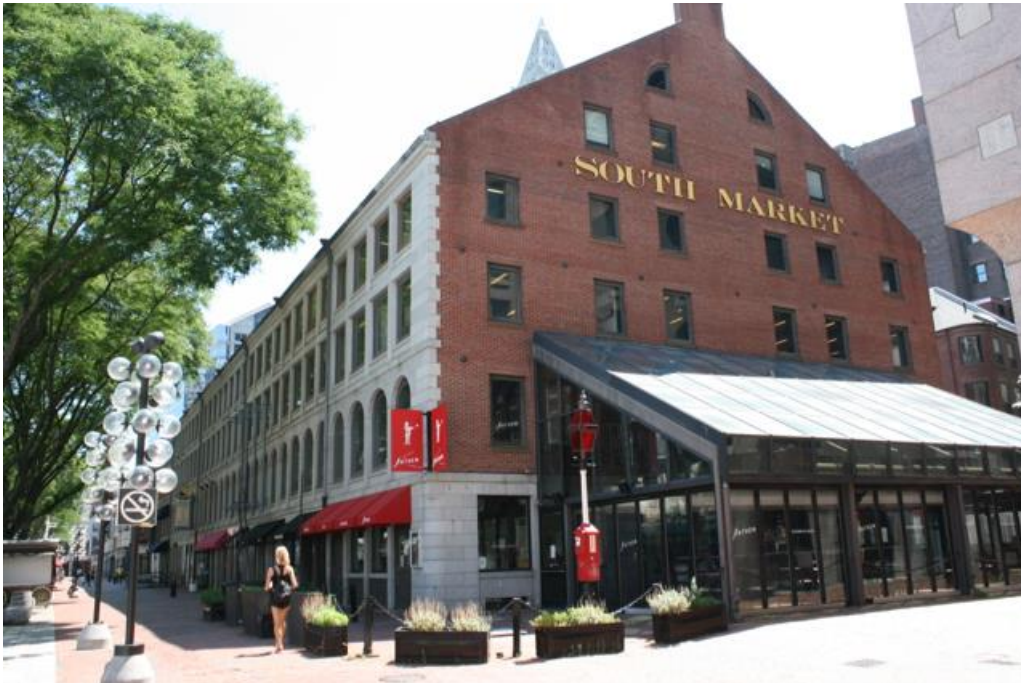
Figure 2. Façade (north) and west elevations, looking southeast.

The gable end elevations (Figures 2 and 12) are virtually identical. At the ground level, trabeated granite storefronts at the outer bays are separated by a center panel of granite block; all four building corners are rounded and feature chamfered tops (Figures 13 and 14). On the west elevation, a modern metal and glass greenhouse structure covers all but the outermost bays of the first floor (Figure 2). The second through fourth floors have six windows each, arranged with a single window at the outer bays and two sets of loosely paired windows in the middle. The fifth story of both side elevations has two pairs of windows centered about the midpoint of the wall, and the attic story has two small, quarter-circle windows centered about the midpoint.

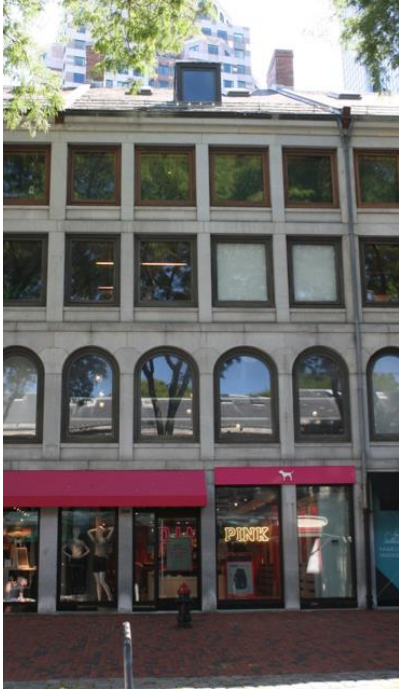
Figure 6. Façade (north elevation): Typical four-bay building unit.

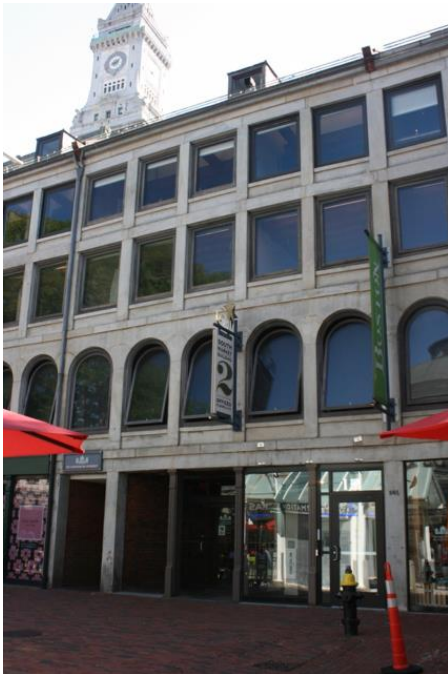
Figure 7. Façade (north elevation): Five-bay unit in center of block (includes Entrance 2 to upper levels of the block).

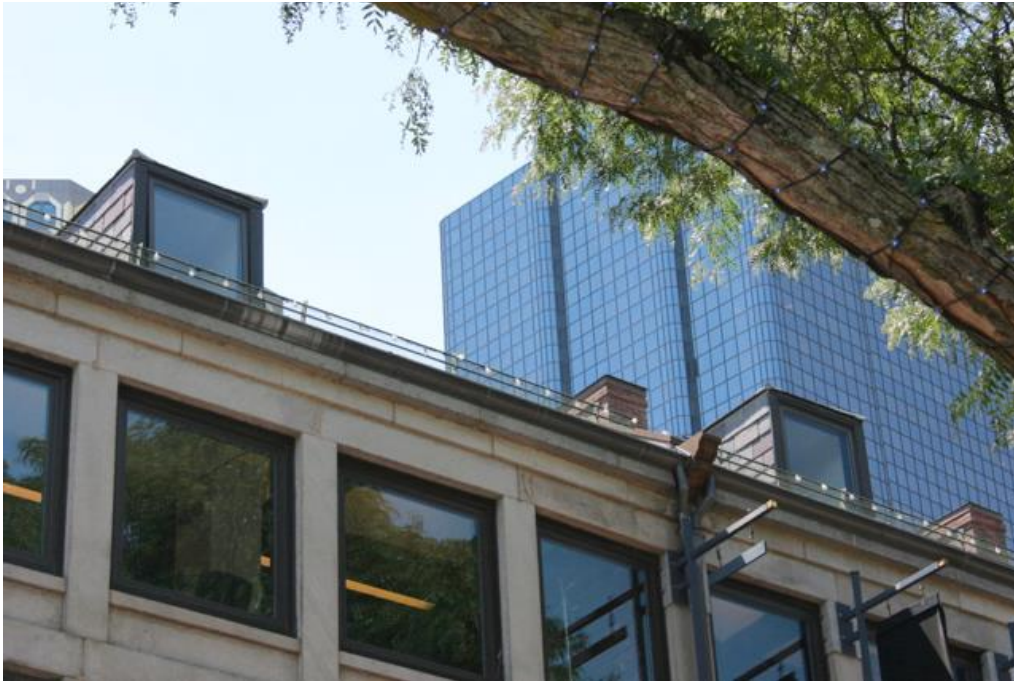
Figure 9. Façade (north elevation): Detail of roof edge.

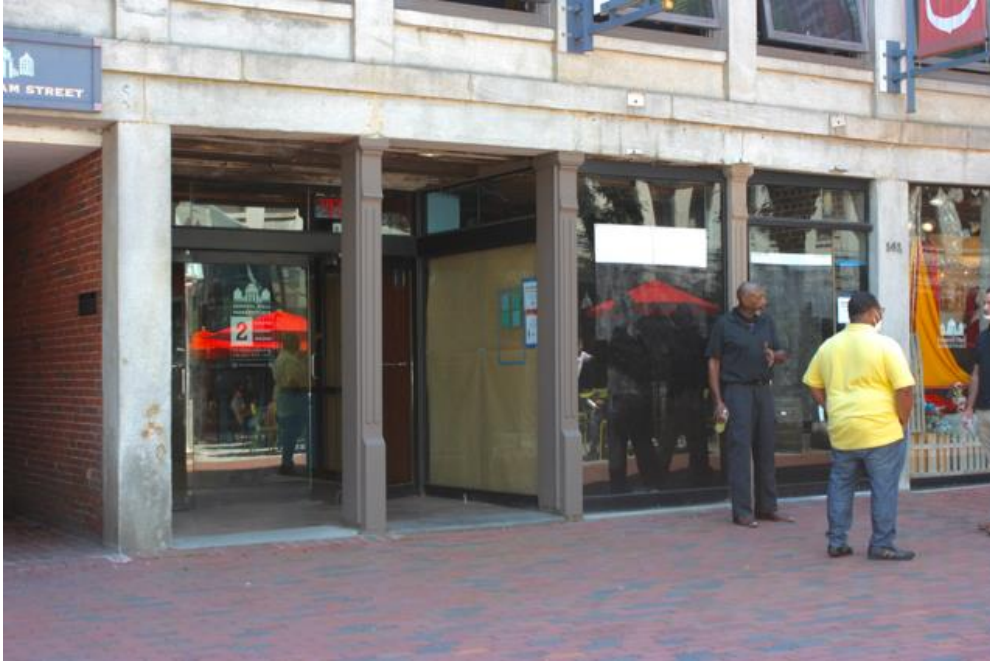
Figure 10. Façade (north elevation): Detail of storefront with cast iron piers.

While most of the South Market's storefronts retain granite post and lintel construction, the framing elements of numerous storefronts have been altered over time. Ornamental cast iron piers replace granite posts at four storefronts on the façade and two on the rear elevation (Figure 10). More boldly, two building units near the center of the façade display two-story high, metal storefronts with a pointed arch spanning the entire width of the unit. A more intact example, at 4 South Market Street, has a channeled frame and a decorative, circular metal plaque above the peak of the arch (Figure 11). Two subterranean storefronts have been added to the façade, accessed by granite stairways with metal railings.

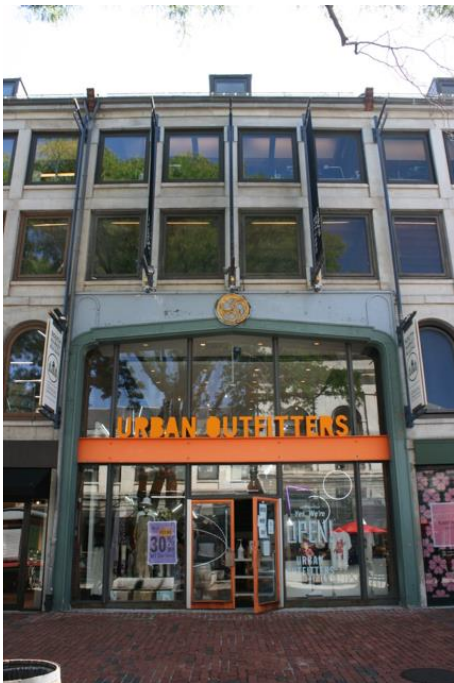
Figure 11. Façade (north elevation): Detail of storefront with two-story arched frame.

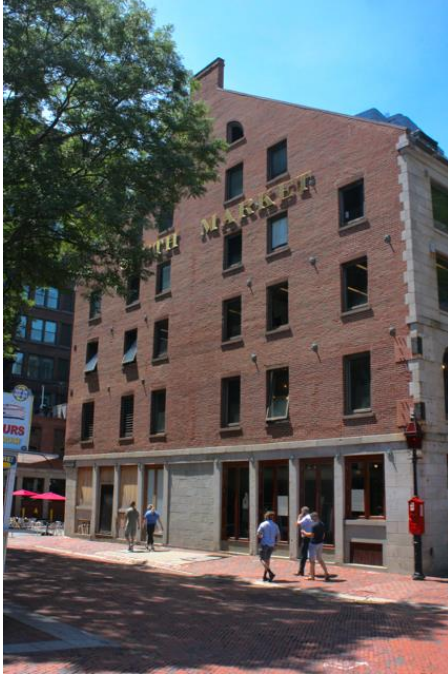
Figure 12. East elevation.

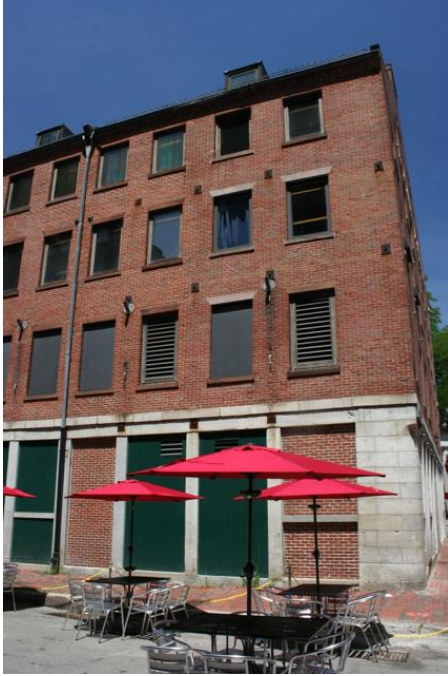
Figure 14. Back (south) elevation: East end of block with typical granite storefront.

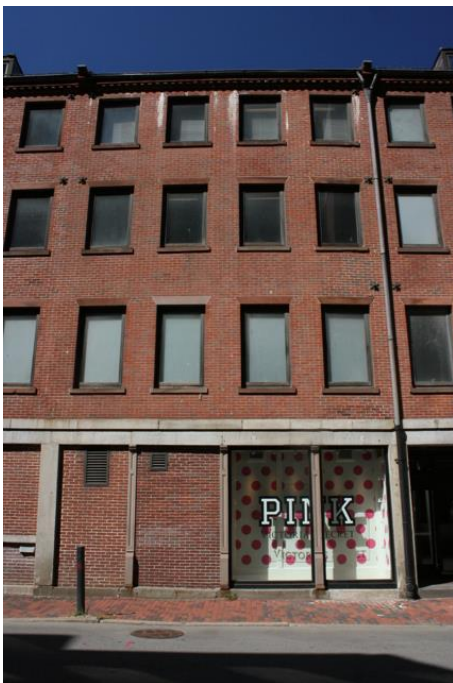
Figure 17. Back (south) elevation: Typical building unit with atypical cast iron pilasters at storefront.

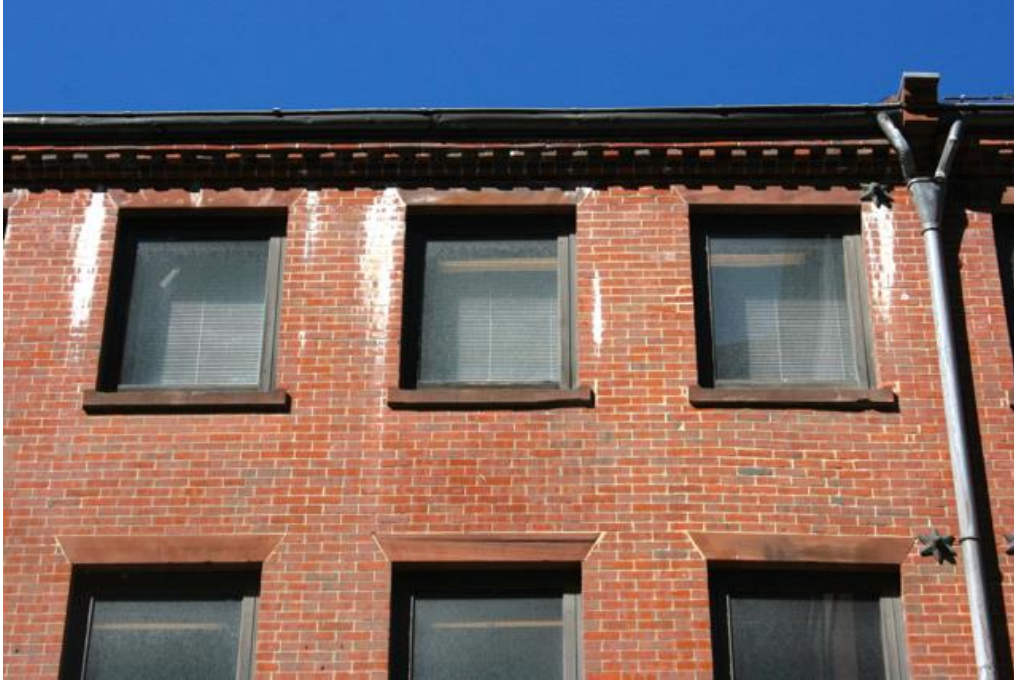
Figure 18. Back (south) elevation: Detail of windows and roof edge.

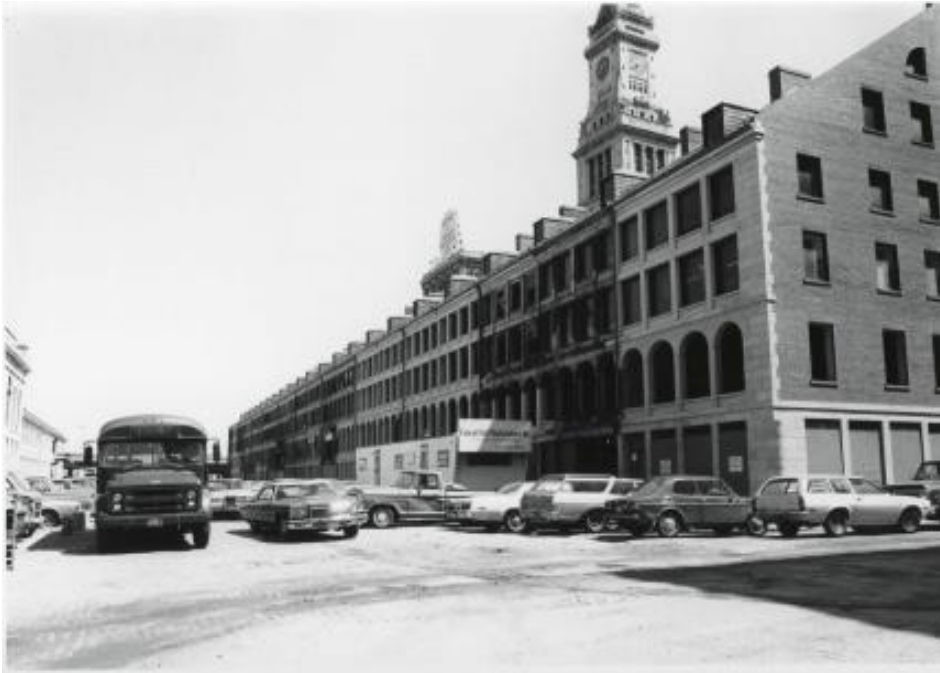
Historic Image 4. South Market undergoing rehabilitation, 1975. View east.
Courtesy of U.S. Department of the Interior, National Park Service.
