THE JEWELERS BUILDING

Boston Landmarks Commission Study Report

The Jewelers Building

371-379 Washington Street, Boston, Massachusetts

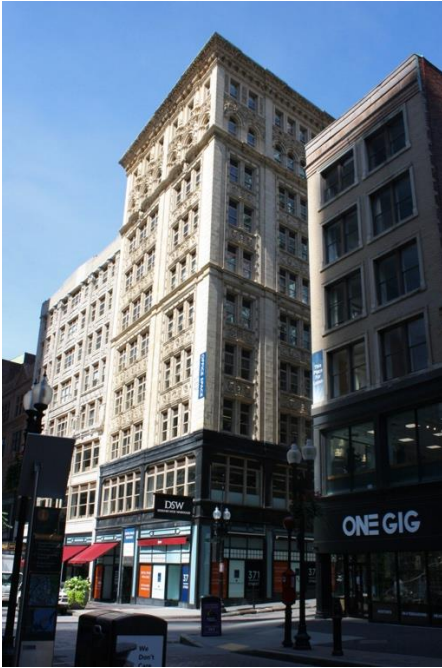
Figure 2. Washington Street (L) and Bromfield Street (R) facades.

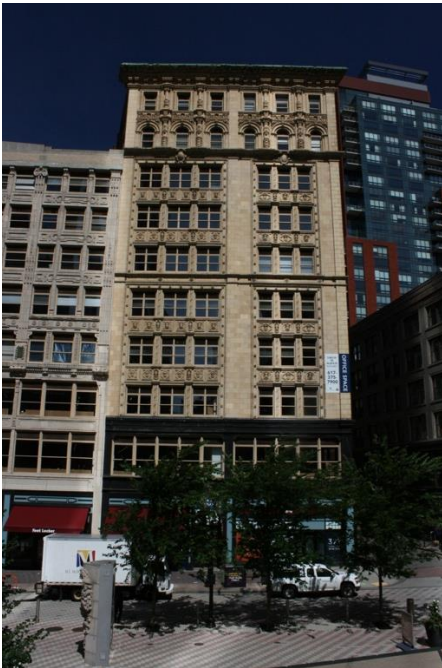
Figure 3. Washington Street (east) façade.

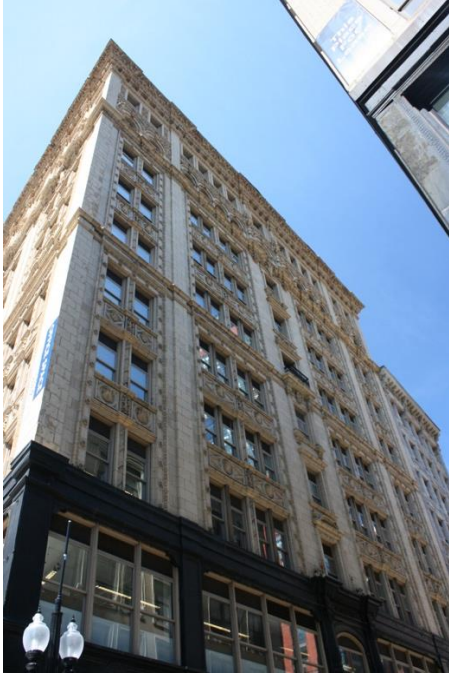
Figure 4. Bromfield Street (north) façade.

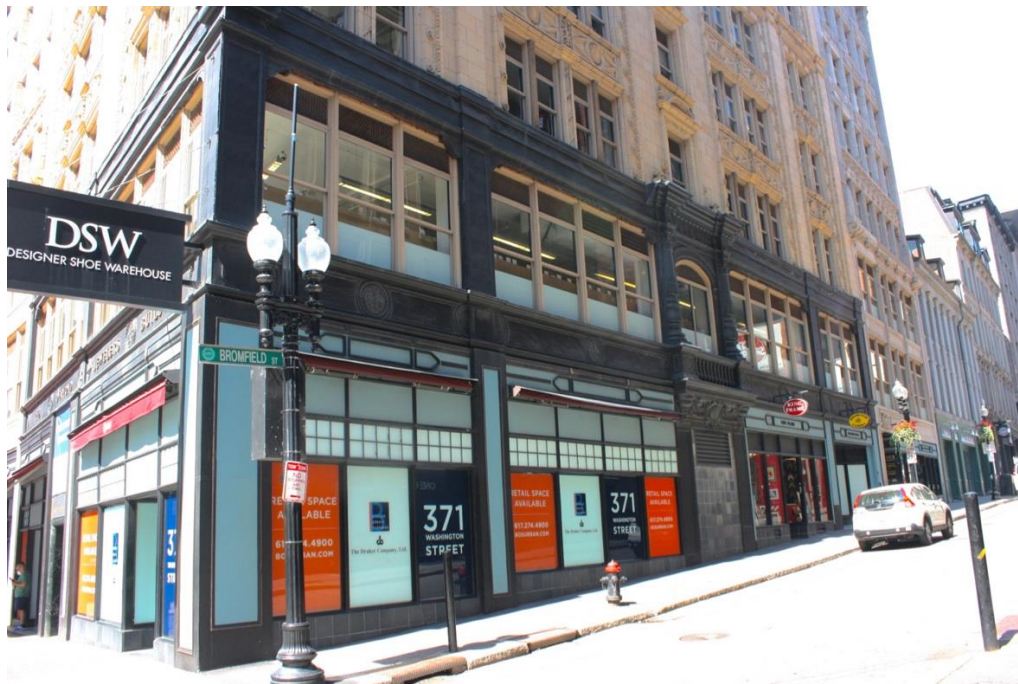
Figure 5. Bromfield Street facade, storefronts.

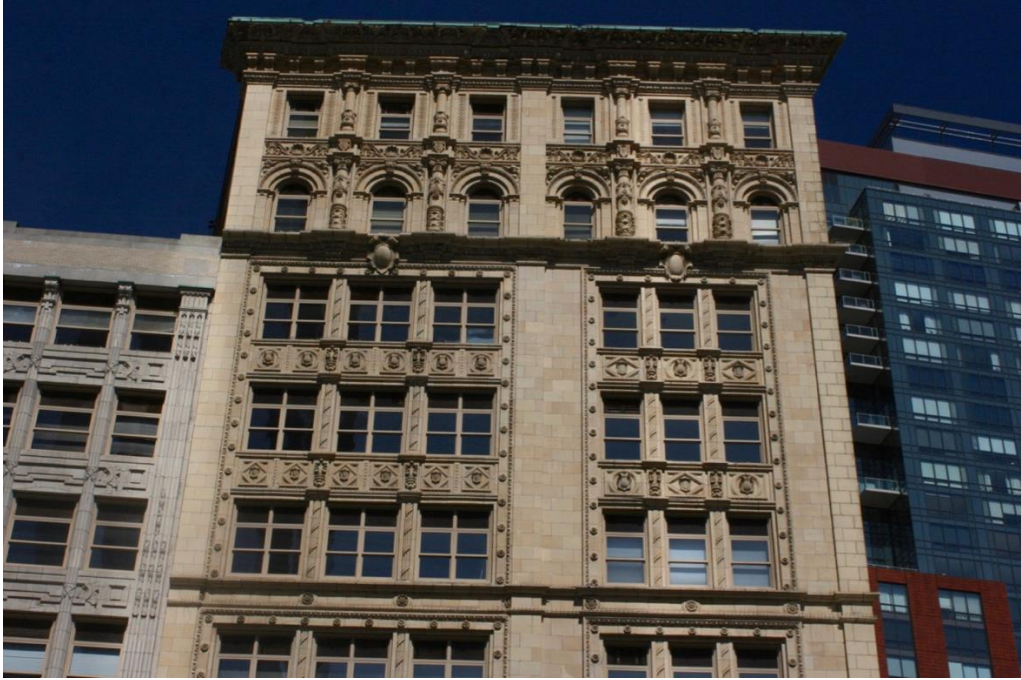
Figure 6. Washington Street façade, floors 6 through 10.

Above the two-story, cast iron base, the street facades are clad with terra cotta tiles on the piers and occasional flat wall surfaces, and with elaborate cast terracotta trim at the window openings, spandrel panels, and entablatures (Figures 3 and 4). Secondary elevations, including the top stories of the west and south elevations, are clad with course red brick having simple stone and brick trim around the window openings (Figure 10). Typical windows originally contained 1/1 double hung sash; most of these were replaced in 1989-1990 with 1/1 windows with transom panels above.

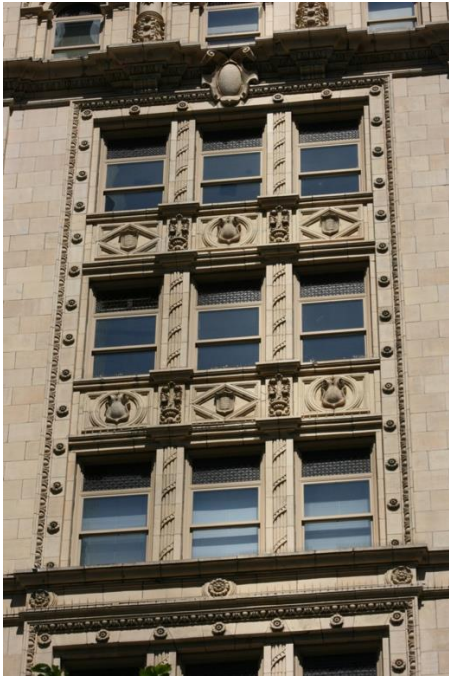
Figure 7. Washington Street façade, detail of floors 6, 7, and 8.

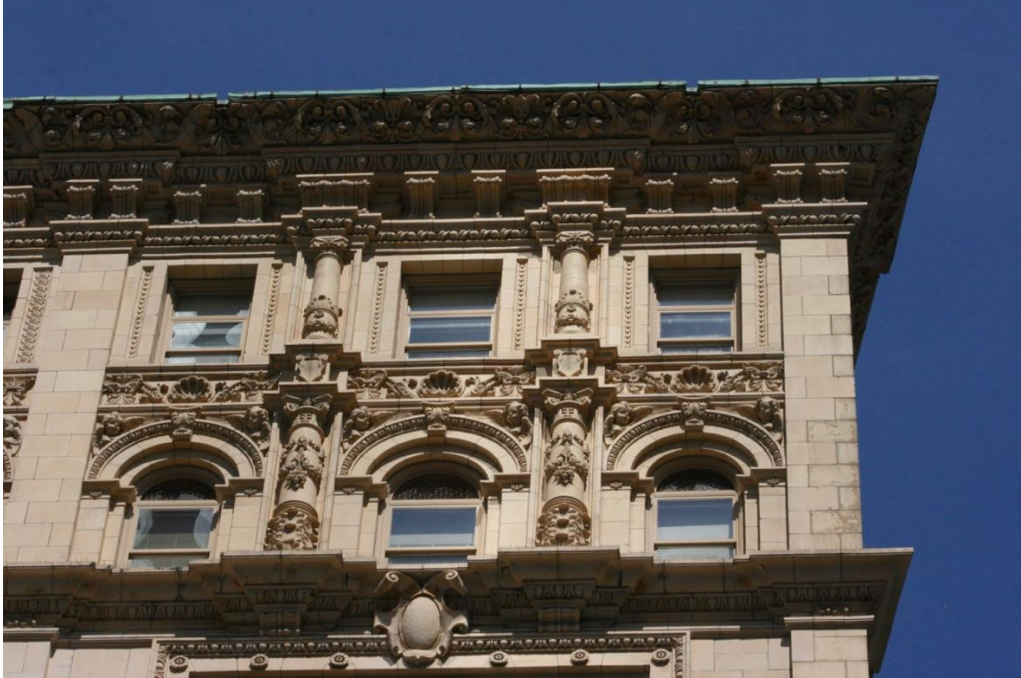
Figure 8. Washington Street elevation, detail of floors 9 and 10.

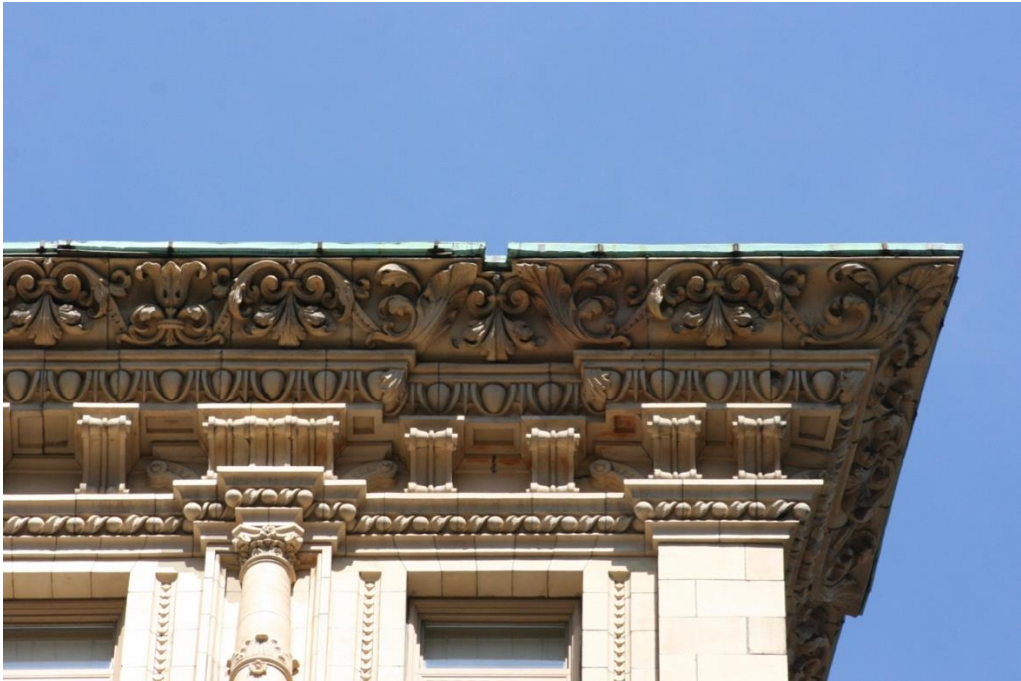
Figure 9. Washington Street elevation; detail of cornice.

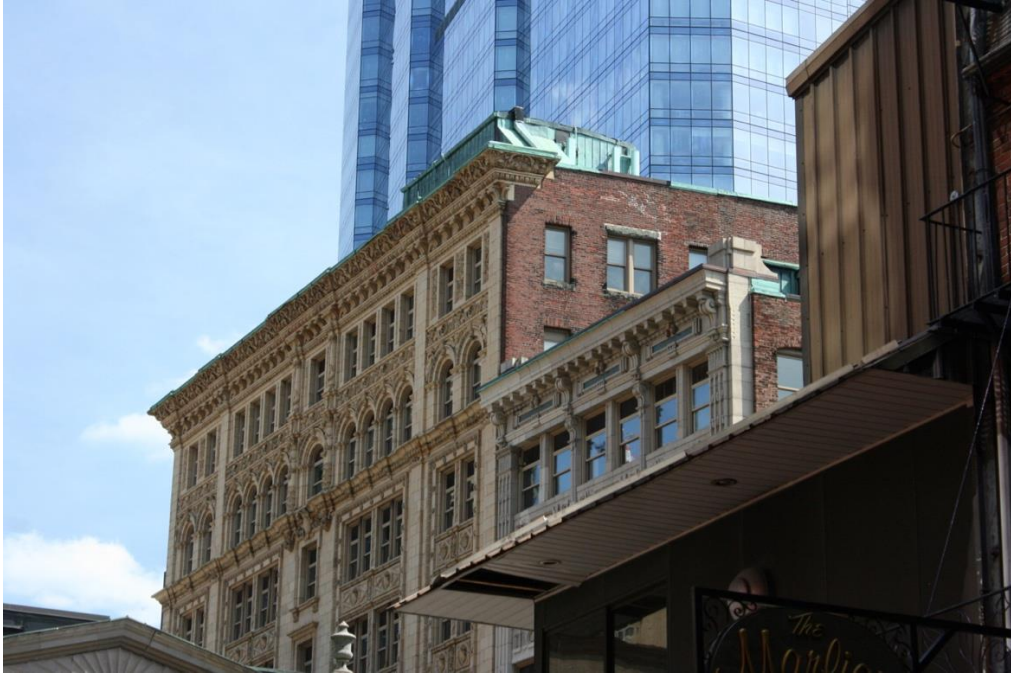
Figure 10. Bromfield Street (north) and west elevations.

Visible portions of the southern and western elevations of the Jewelers Building are utilitarian in character, with course red brick walls and single and paired, rectangular windows ornamented only with rock-faced granite sills and lintels of either rock-faced rectangular granite or brick soldier courses (Figure 10).

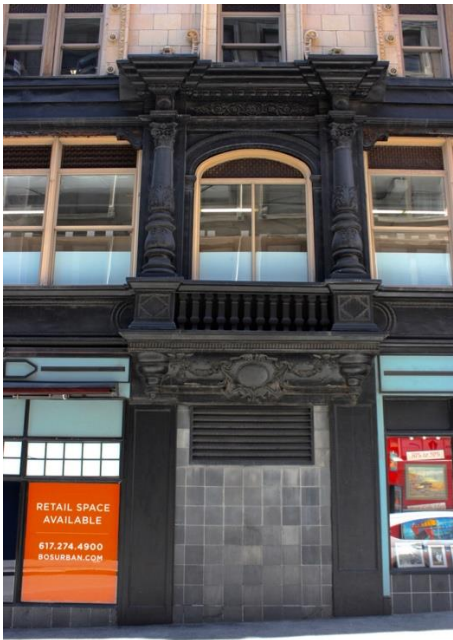
Figure 11. Bromfield Street building entrance.

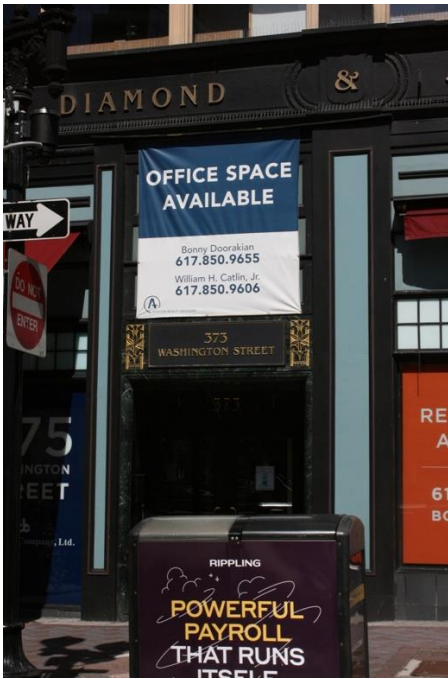
Figure 12. Washington Street building entrance.

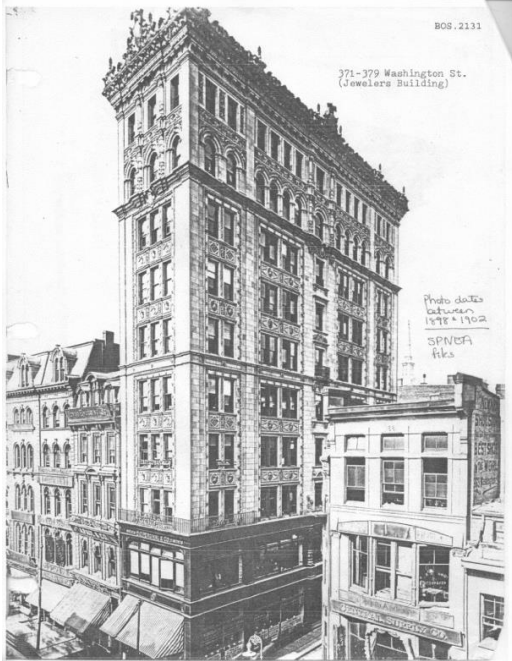
Historic Image 2. Original part of the Jewelers Building, ca. 1898-1902. Courtesy of Historic New England.
