34 FARNSWORTH STREET  
ROOF REPLACEMENT

BELOW IS THE REASON THAT THE CAPS NEED TO BE REMOVED AND REPLACED; TAKEN FROM THE SET OF CONSTRUCTION DOCUMENTS ISSUED FOR BID ON 9/27/2022.

SHEET TITLE:  
**ROOF DETAILS**

SHEET:  
**A-501**

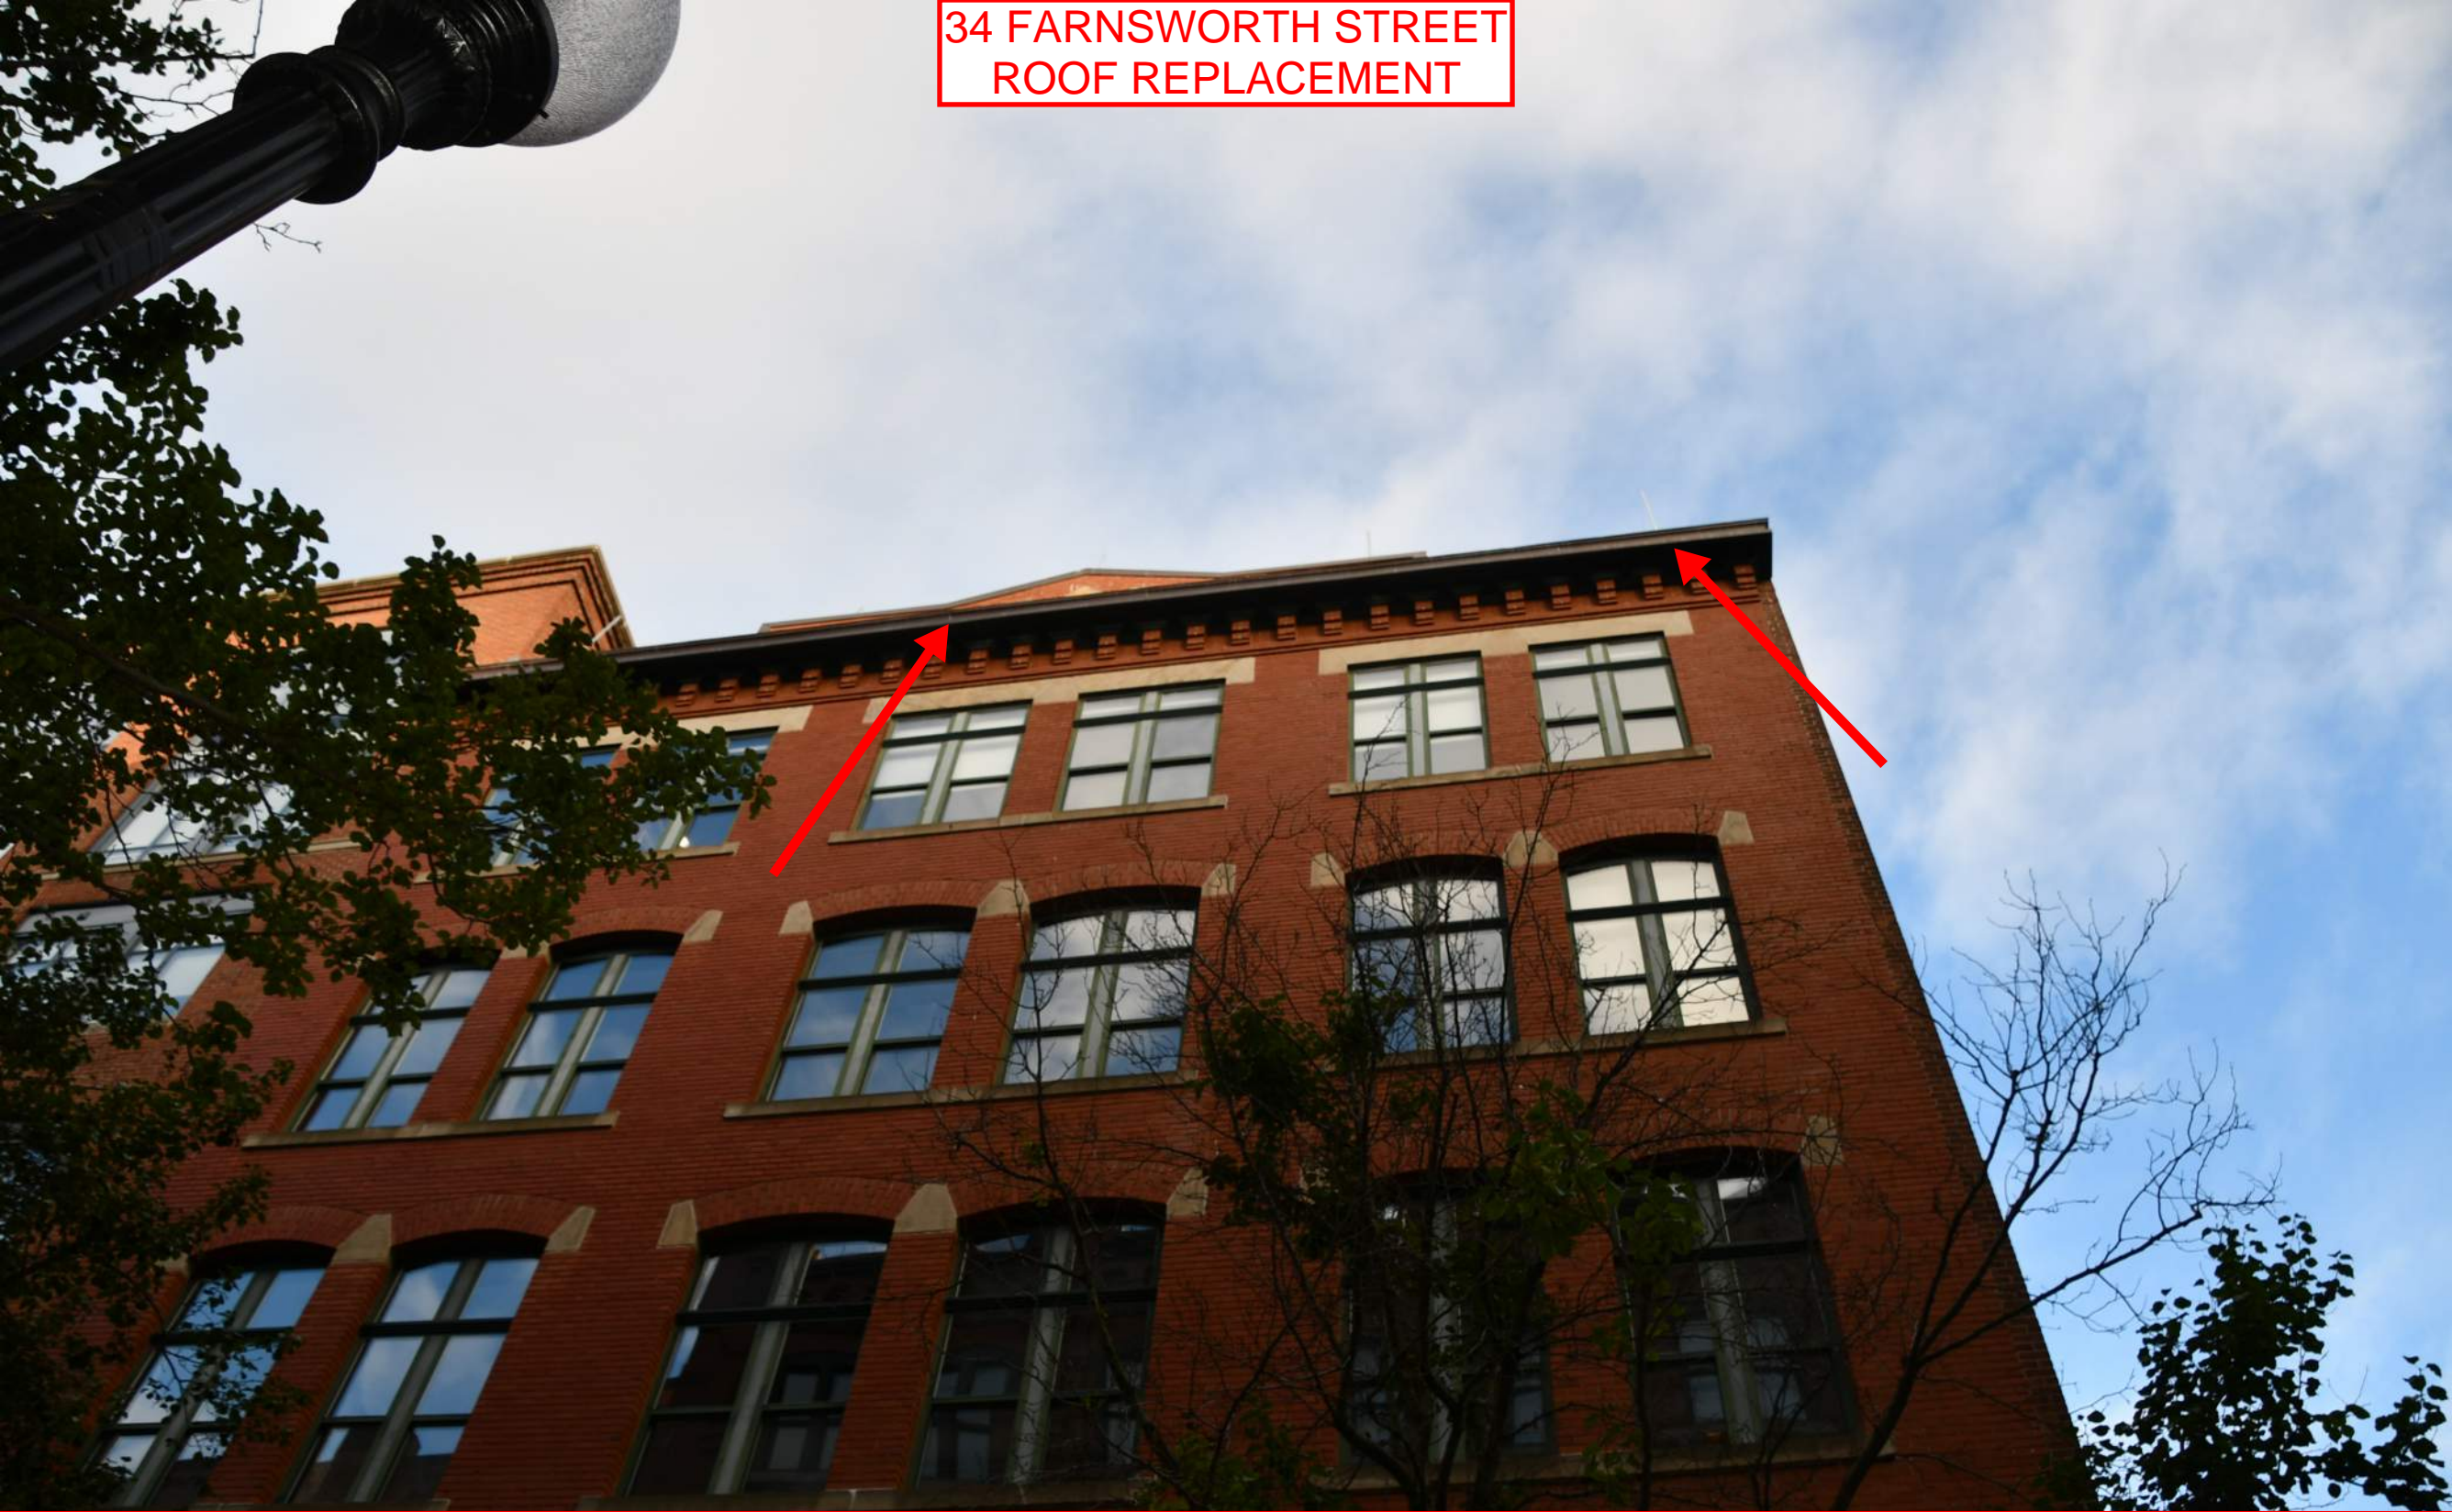
View of the upper floors of the East elevation of 34 Farnsworth along Farnsworth Street. Note the existing copper cornice below the roof edge. See the next photograph for a close-up view of this copper cornice, which is to remain.

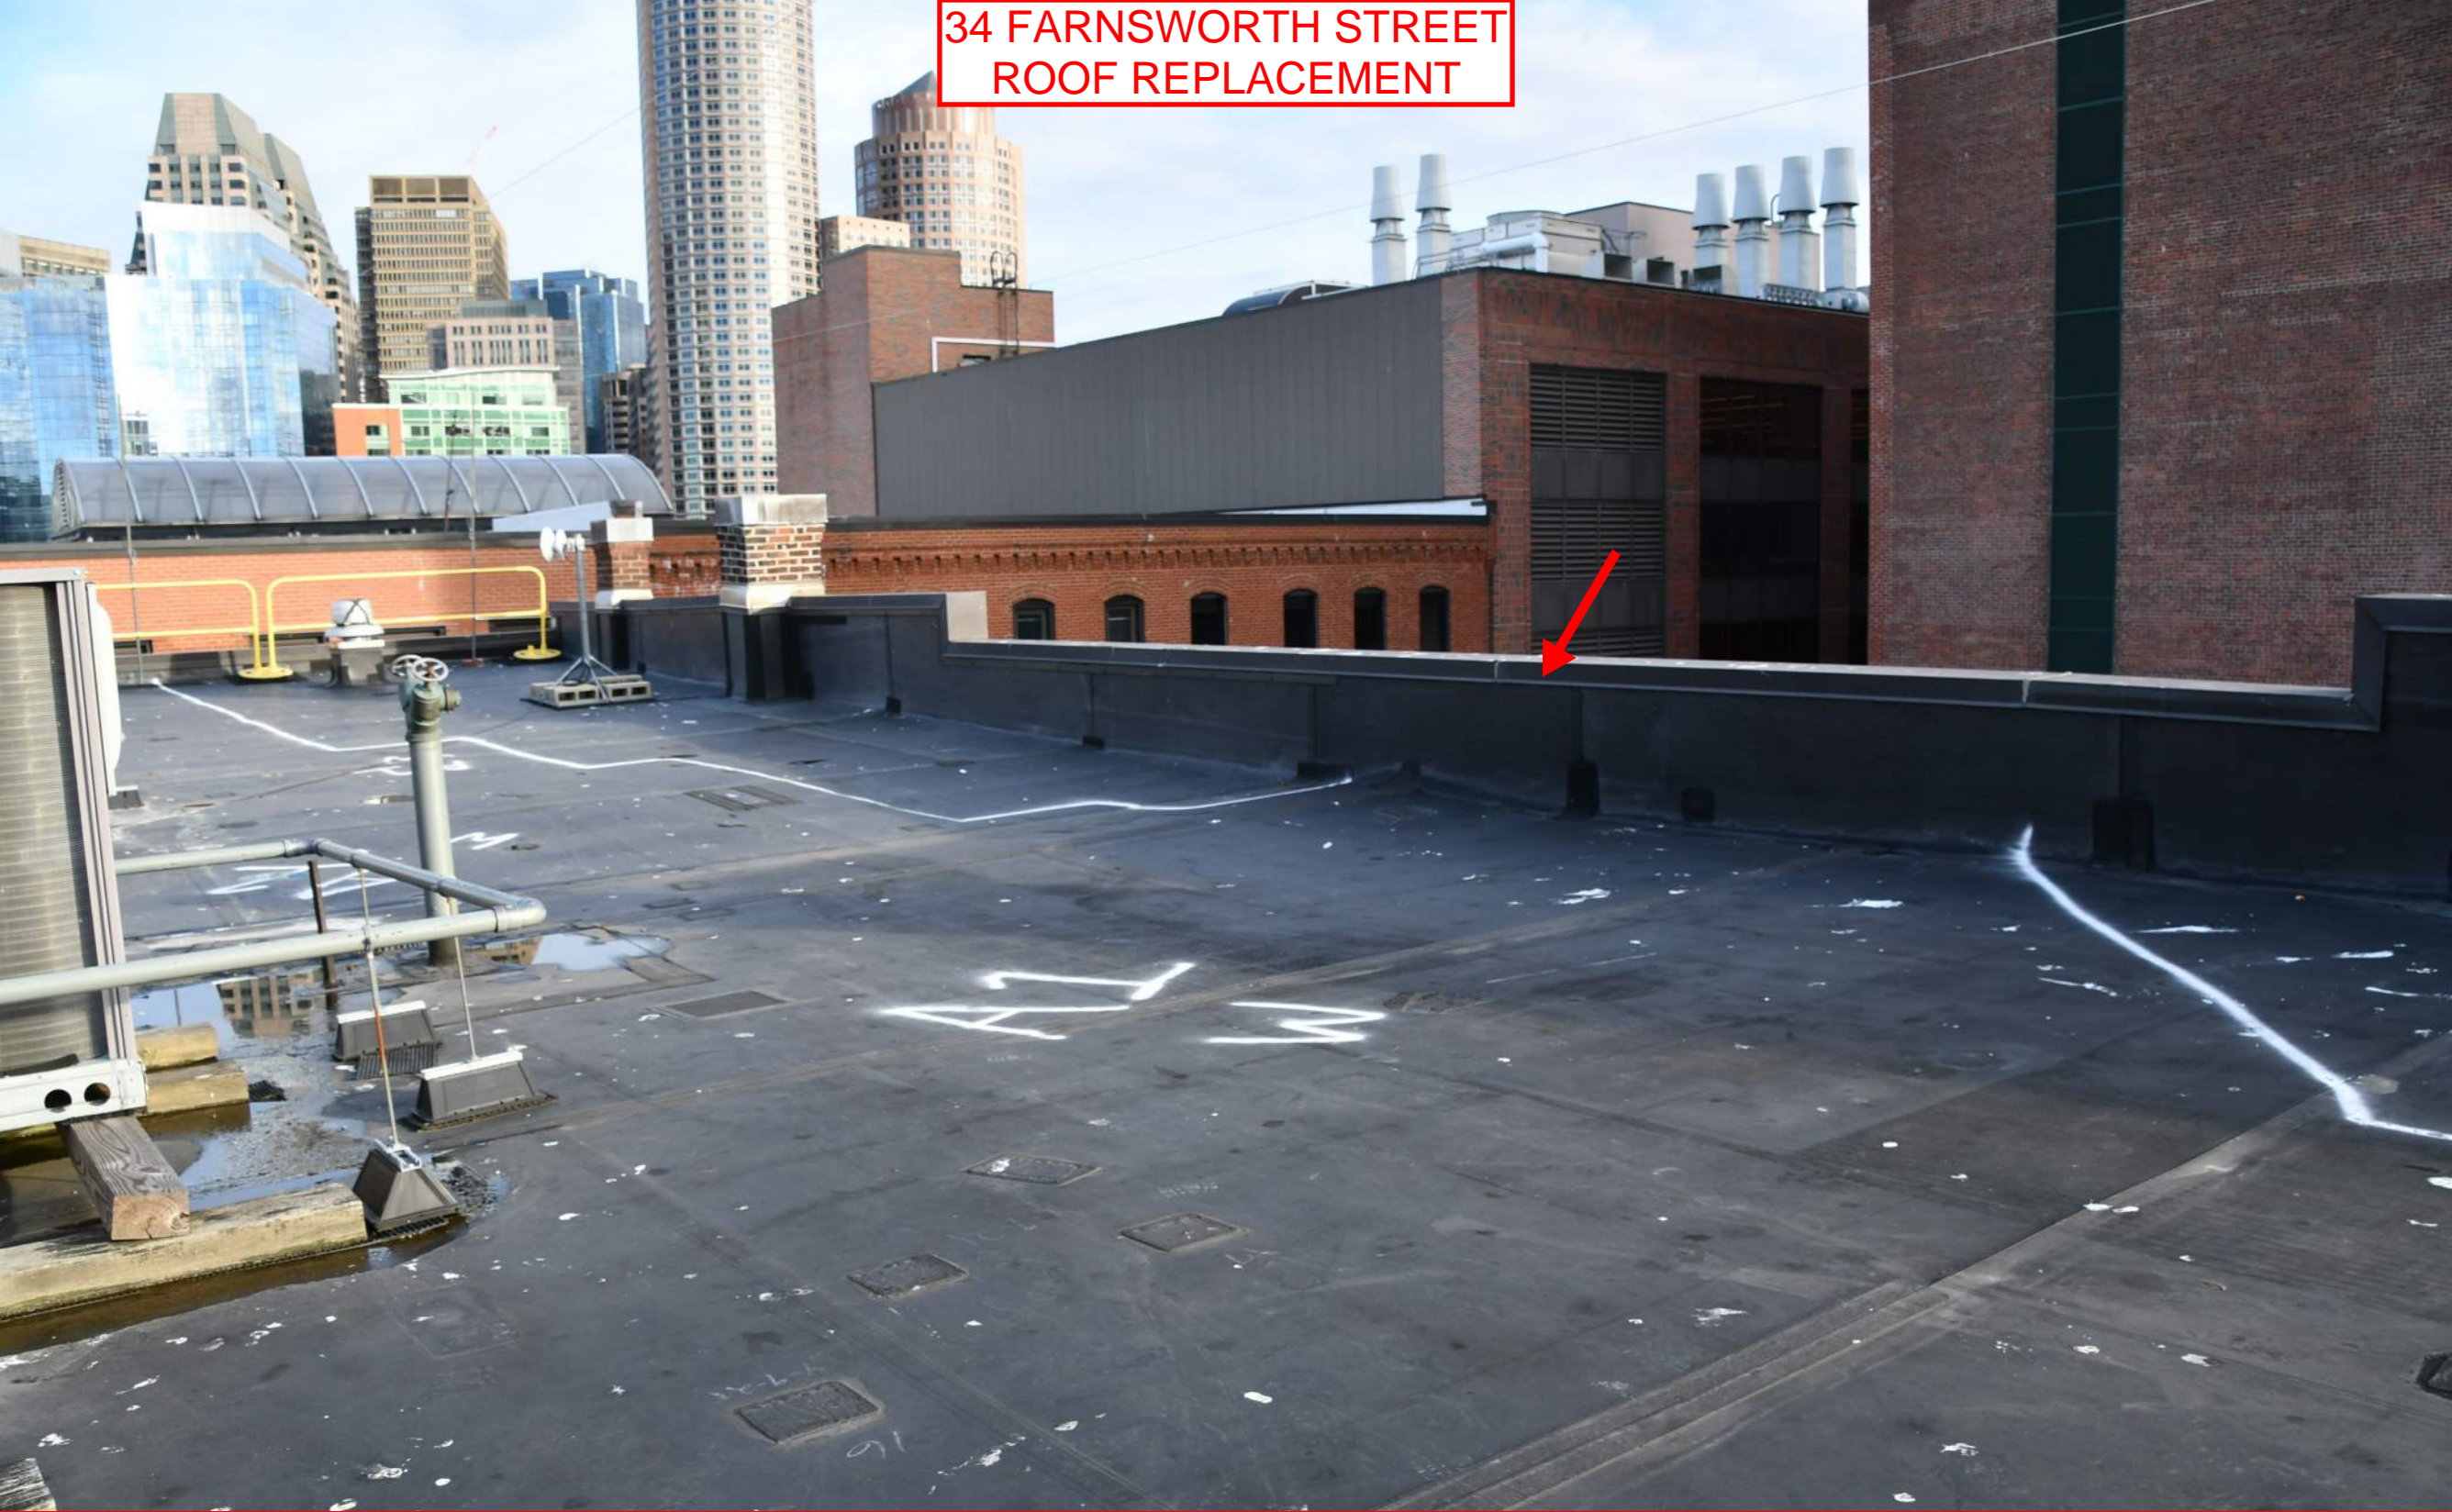
View of the existing EPDM roof at the main roof of the building, looking Northwest. Note the existing aluminum parapet caps which are to be replaced with copper caps. The EPDM goes up the wall and under the caps so the existing has to be removed in order to replace the entire roof system.

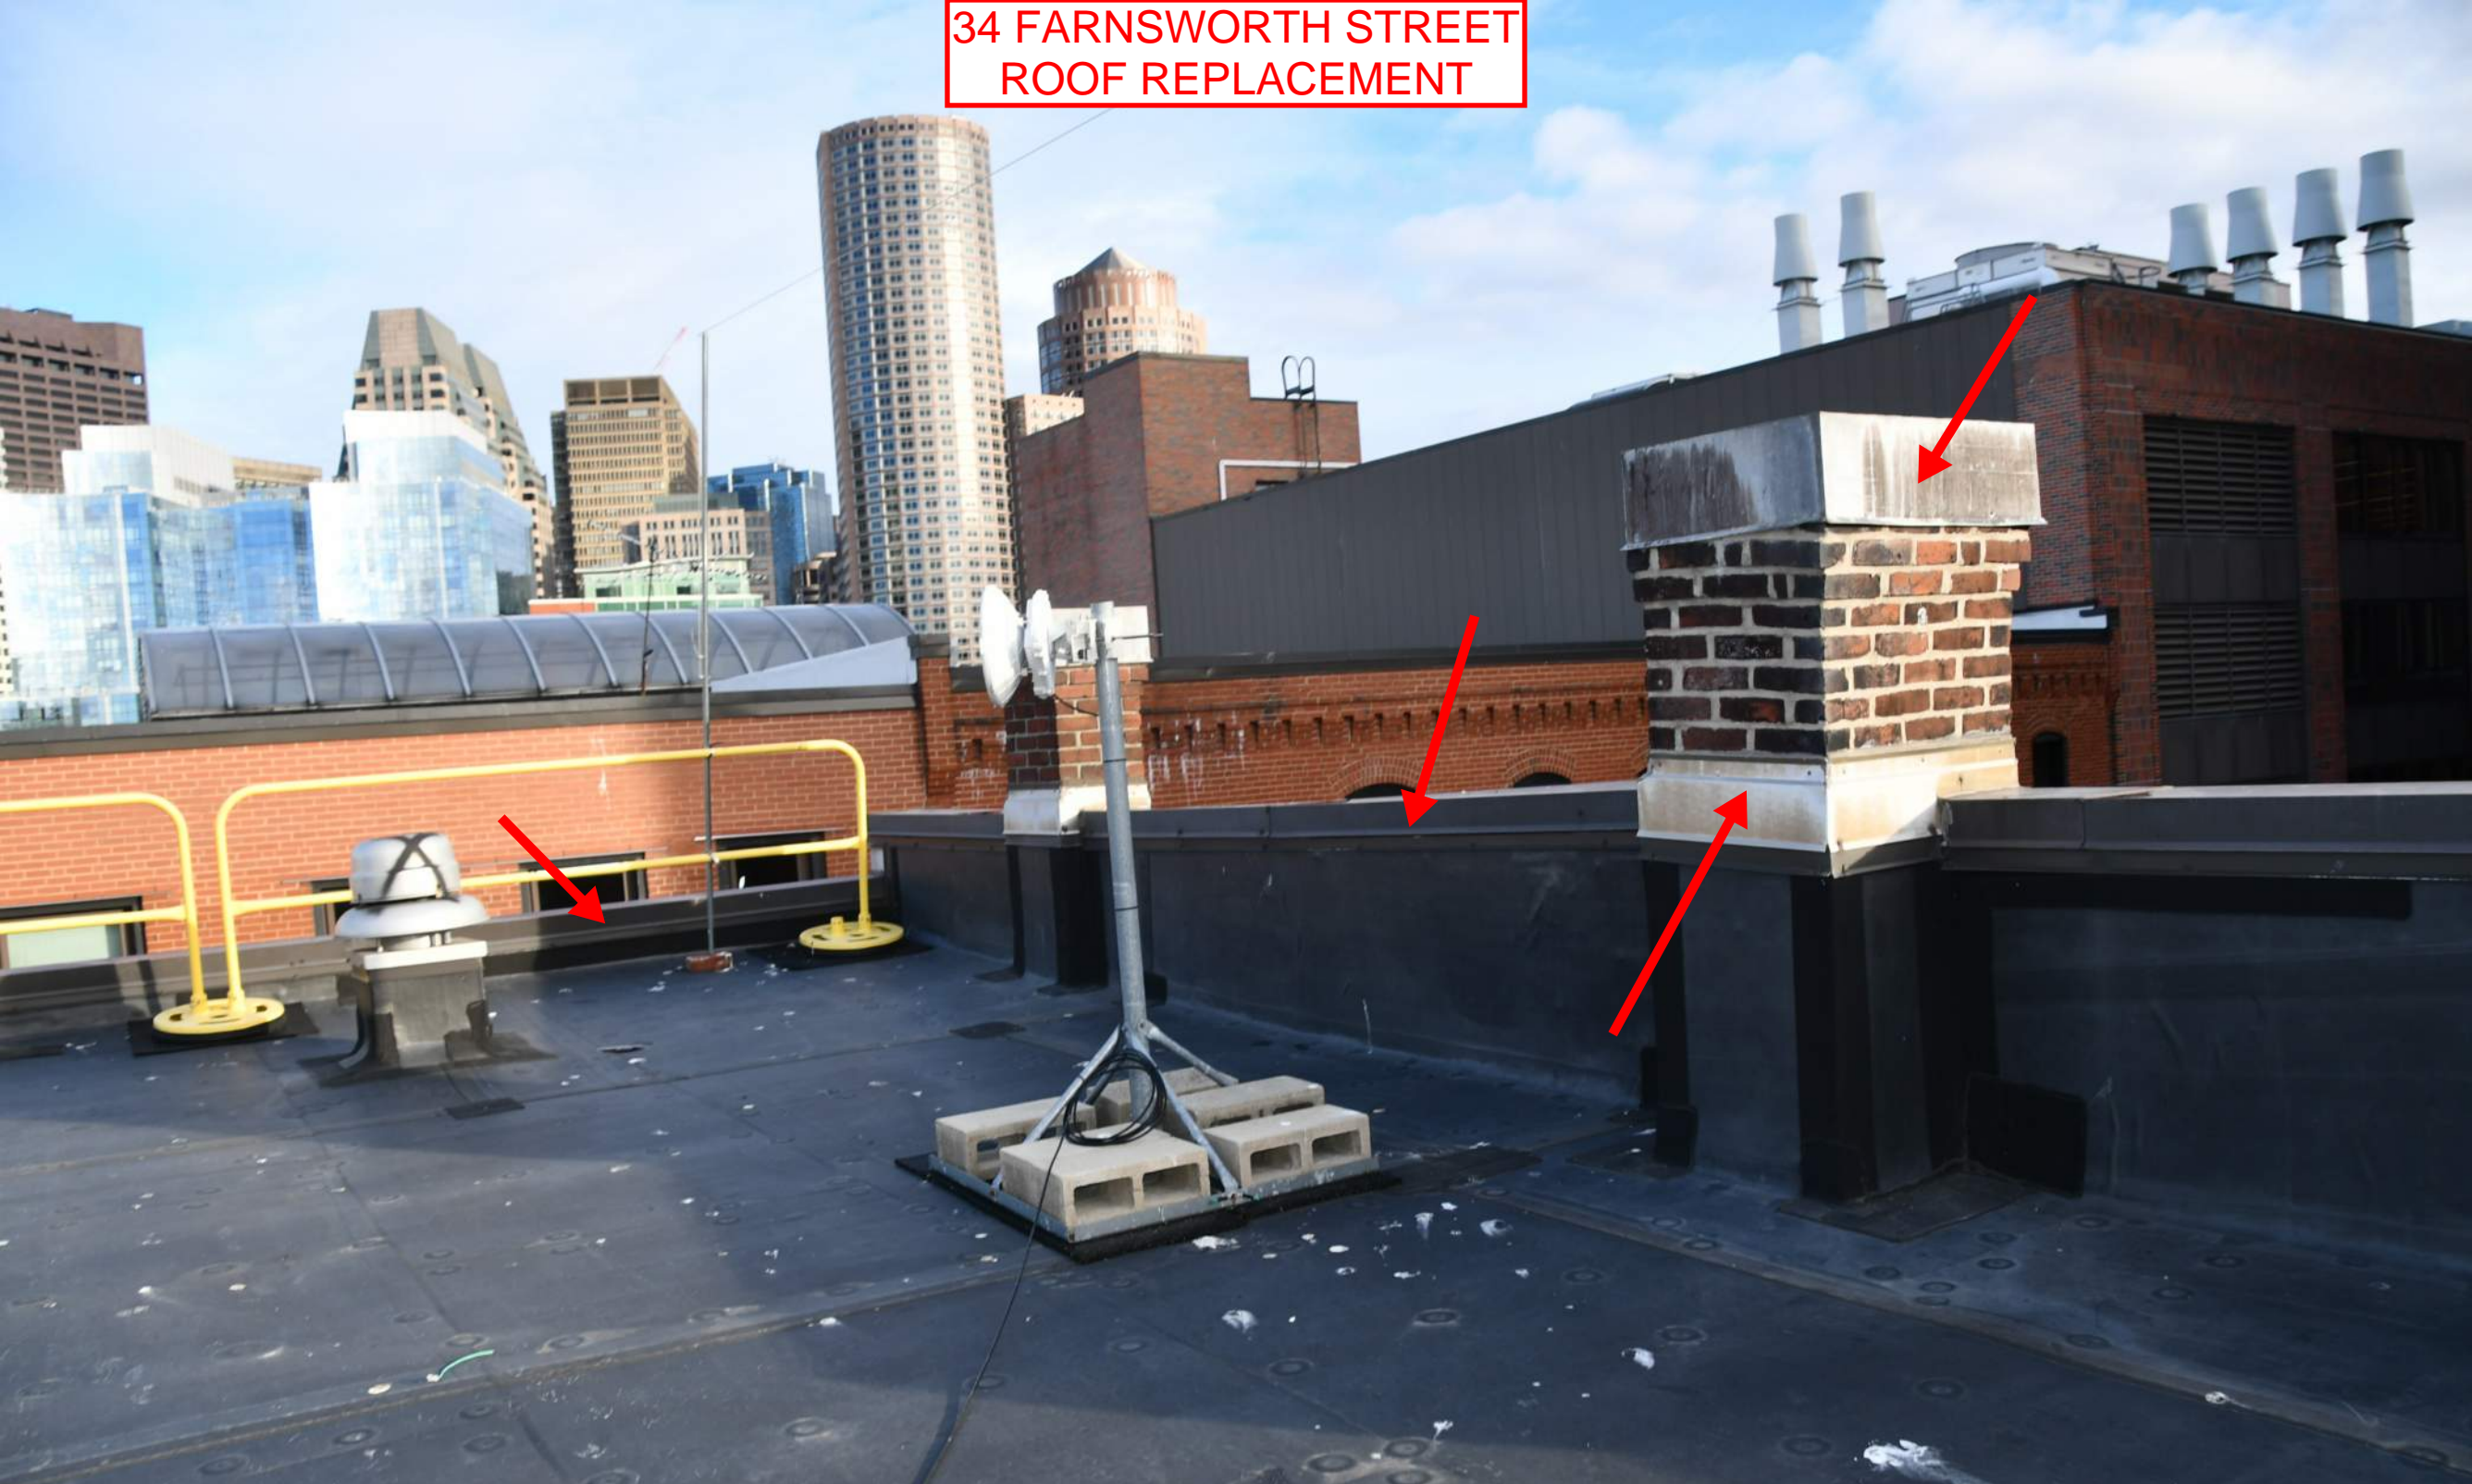
Additional view of the existing EPDM roof at the main roof of the building, looking Northwest. Note the existing aluminum parapet caps and lead-coated copper chimney caps / flashings. The aluminum and lead-coated copper flashings will be replaced with copper so they are more historically appropriate.

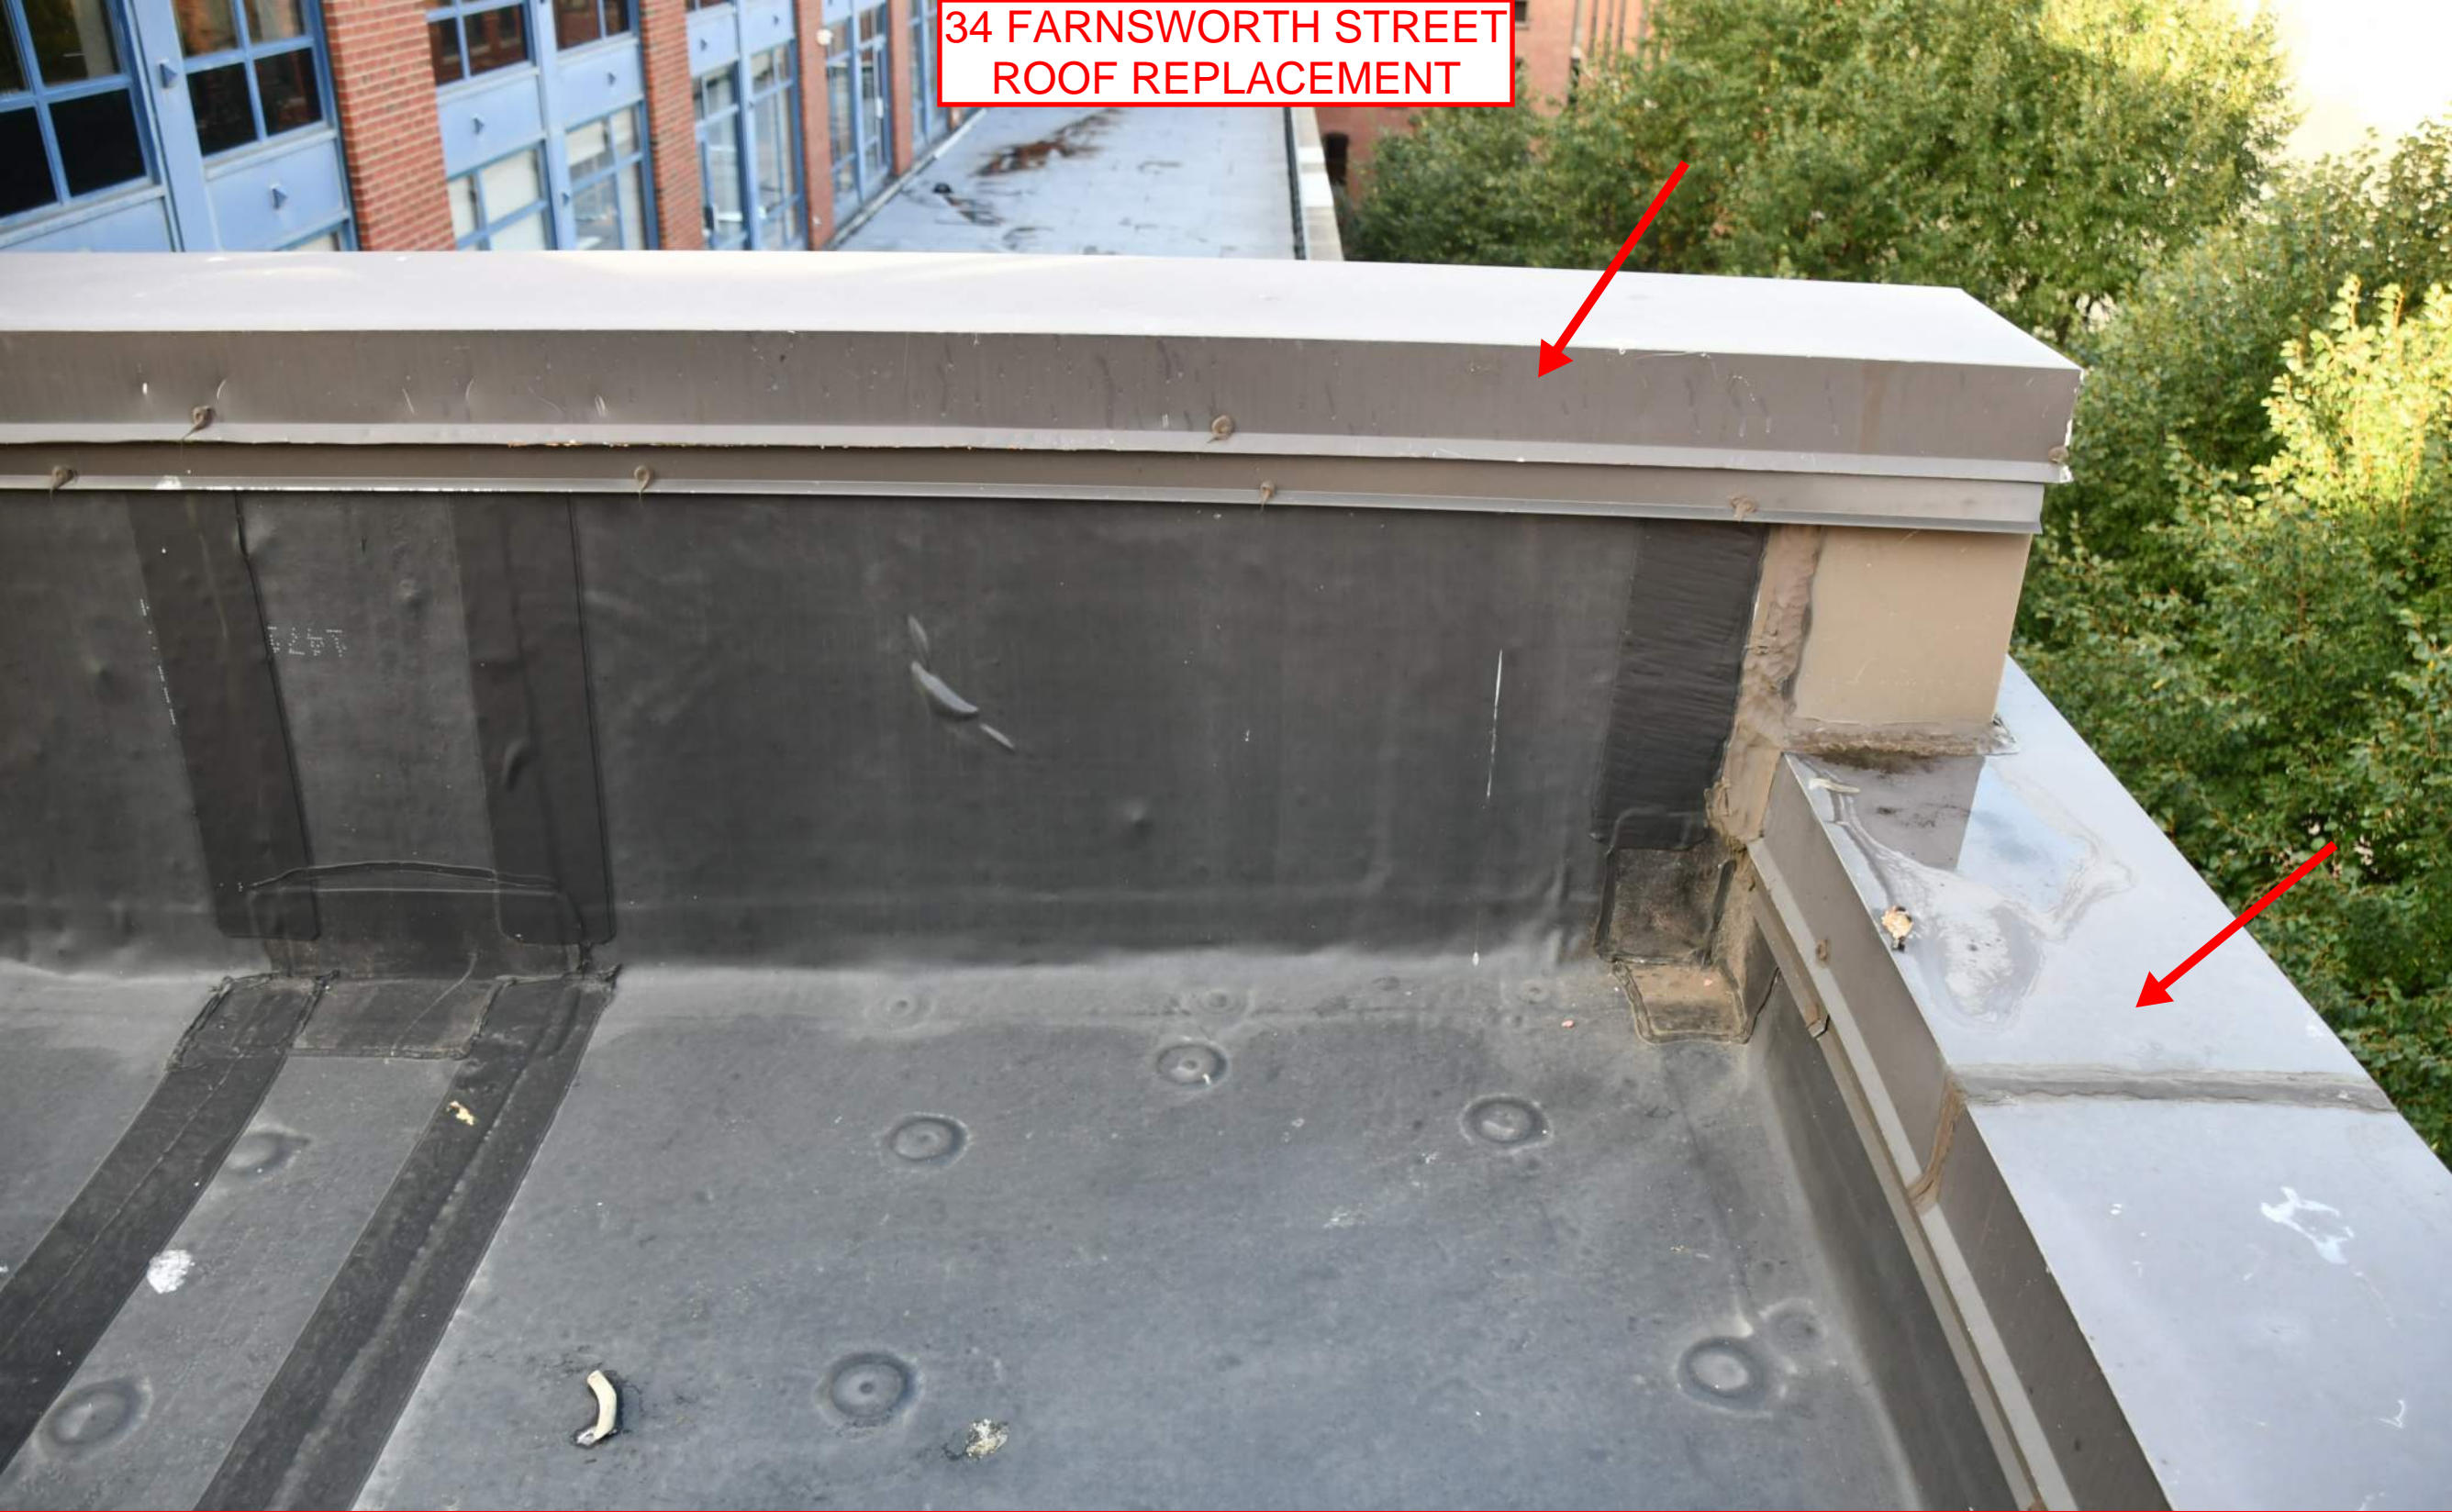
Close-up view of the existing aluminum parapet caps at the main roof, these will be replaced with copper caps. As you can see the EPDM membrane (black) runs under the caps and in order to replace the EPDM we need to remove the entire cap.

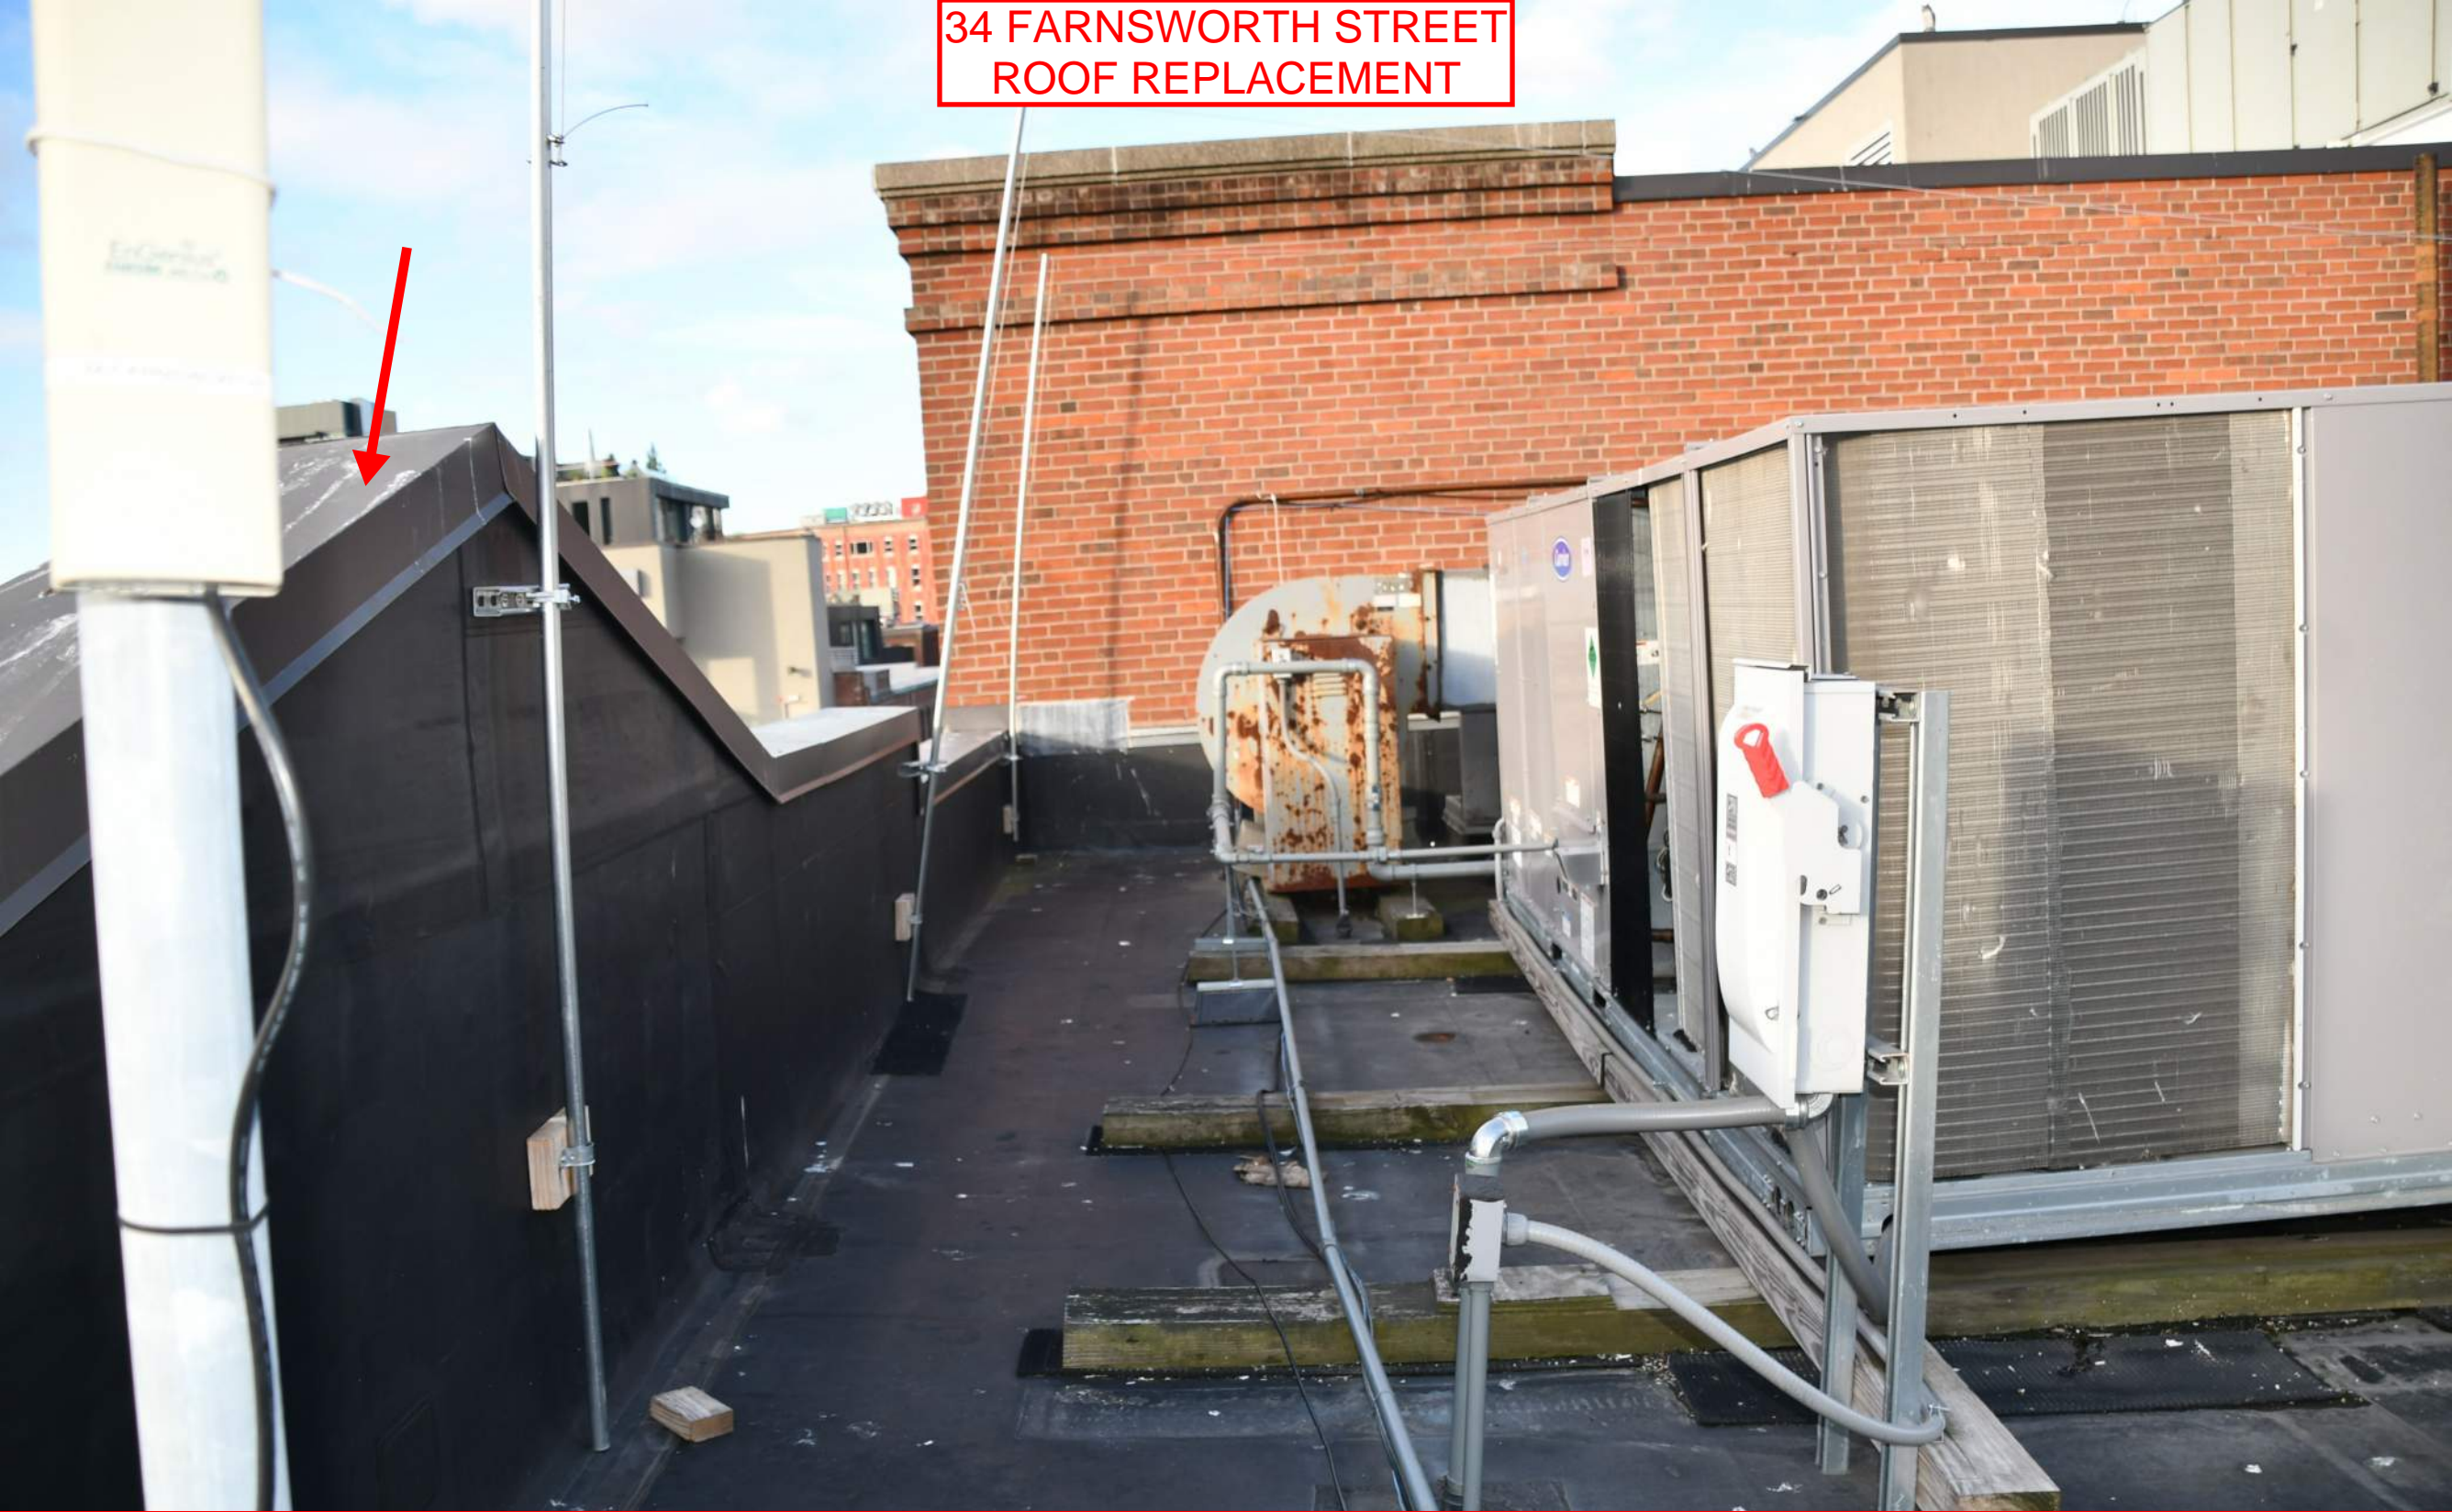
View of the East end of the main roof, looking South. Note the aluminum parapet caps that we would like to remove and replace with copper caps during the roof replacement.
