HISTORIC BURYING GROUNDS INITIATIVE NEWSLETTER

Preserving Boston's 16 Historic Burying Grounds

SPRING 2017
EDITION 10

FIELD NOTES: *TOMB REPAIRS AT BENNINGTON STREET CEMETERY*

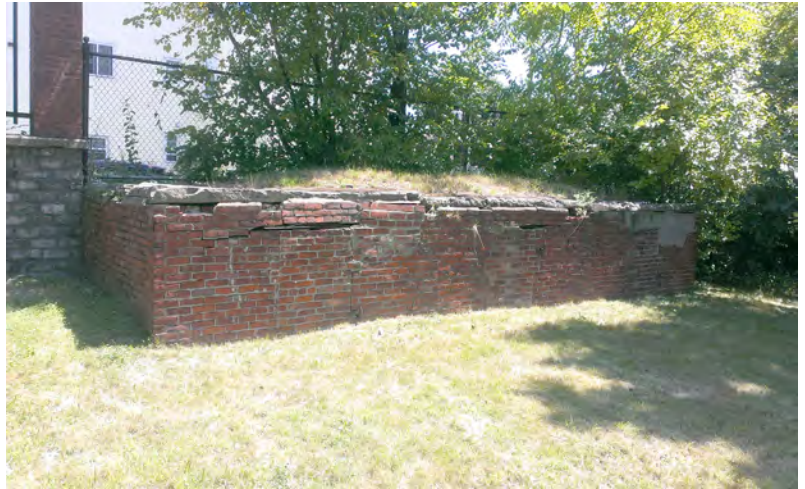
This is the east tomb structure before it was repaired. There are three individual tombs inside the structure. The doors have been bricked over. The trees behind the tombs ended up complicating the project greatly.

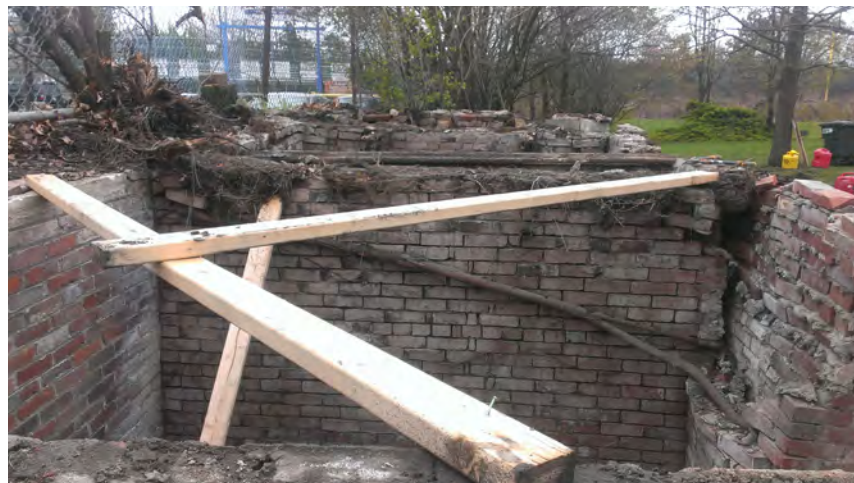
Inside the tomb once the roofs slabs have been removed. Some areas have missing mortar or bricks. Notice the the large root which has grown diagonally cross the tomb wall and into the brick on the lower front wall. Also notice the numerous small roots on top of the tomb wall which grew between the different layers of brick and compromised the structural stability of this wall.

root system of the trees were all entwined together and were much larger than we thought they would be. They ran under the stone roof slabs into the tombs. Some roots ran in between the layers of brick which broke the masonry bonds and rendered those areas of the wall structurally unstable.

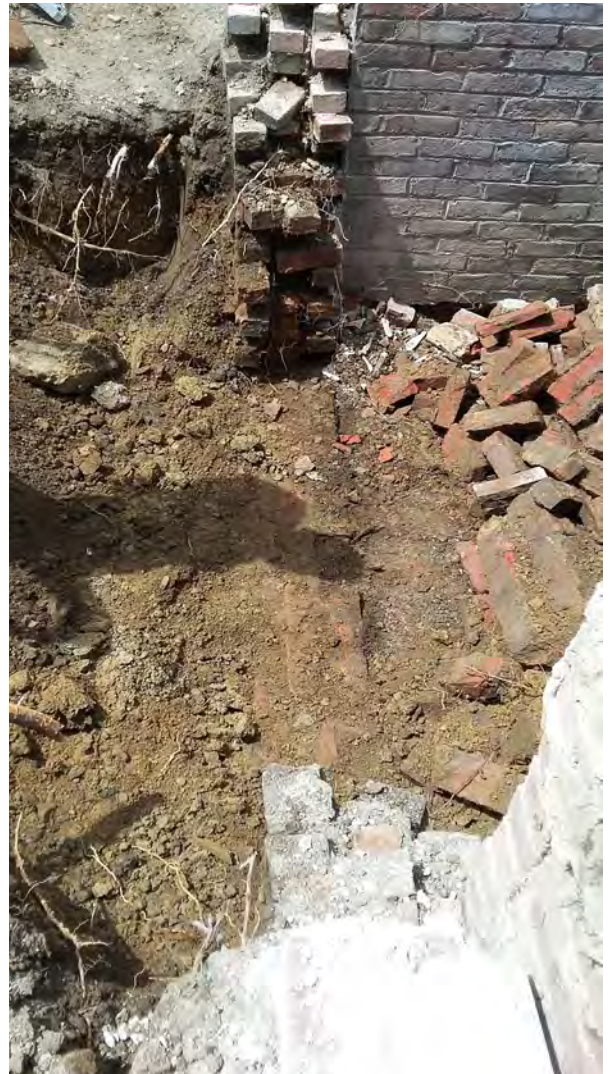
Upon closer inspection inside the tomb, it was discovered that the wall below the doorway on this tomb was unstable and had to be rebuilt.

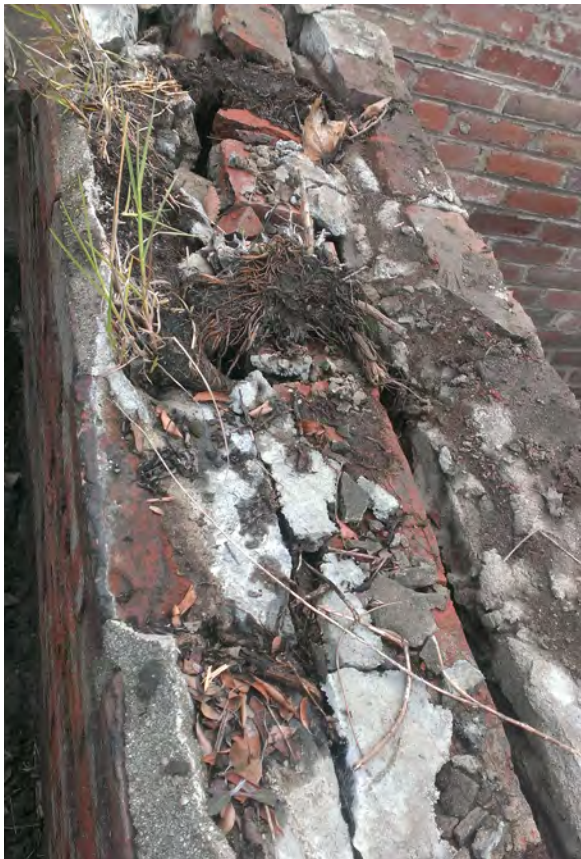
The different layers of brick in this sidewall had separated and were no longer structurally sound. A special structural grout was used to fill these cavities.

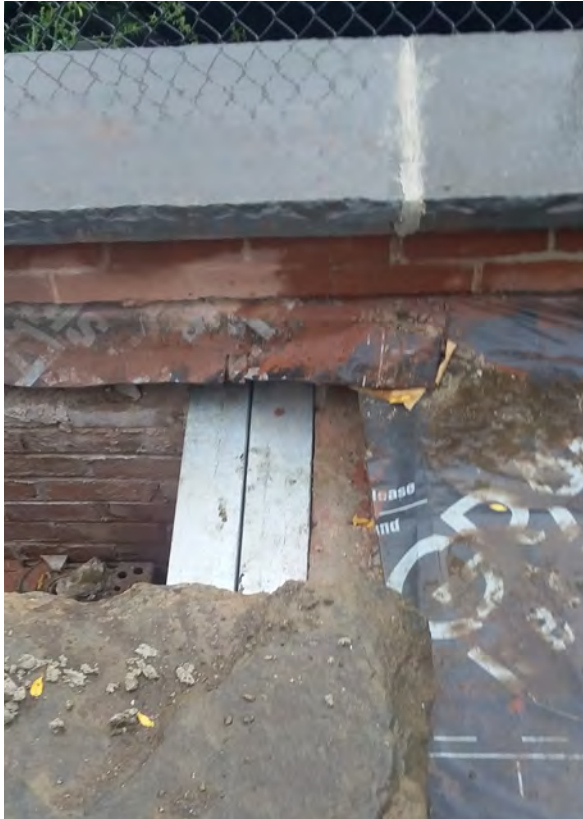
The most unexpected problem was the fact that the stone roof slabs were not large enough to cover the entire tomb and they left part of the side walls exposed. This condition would be very detrimental to the stability of the structure. The slabs we ordered were the same dimensions as the slabs they were replacing, but the inadequate dimensions had been concealed by the large root structure running across the back of the tomb. The problem was discovered after the new stone roof slabs arrived and were placed atop the tombs. It was impossible to return the large slabs to the quarry and get new larger ones, so we had to come up with a workable solution. It was necessary to create a small overhang on the outside walls so they

The new knee wall with bluestone cap is in the rear of the photo. The steel angle irons which support the gaps between the roof slabs are in the centre of the photo.

would be protected from water penetration. The stone roof slabs meet at, and are supported by, the interior tomb walls. Any solution had to guarantee adequate support for these slabs and protect the interior tomb walls too. After considering several ideas we decided to shift the slabs forward to create an overhang at the front wall and to build a low knee wall that extended up from the rear wall above the level of the roof slabs. We used thinner bluestone pieces as a capstone for the knee wall, which are readily available for landscaping and do not require a custom quarry order. Flashing was installed from the front of the knee wall over the roof slabs. In order to extend an overhang over the side walls, pieces from one of the unusable old bluestone slabs were mortared into a gap in the middle of the tomb. Steel angle irons were used to support the slabs which no longer joined together over the interior tomb walls. Finally, the roof slabs were covered with soil and grass seed, which was how they were originally designed.

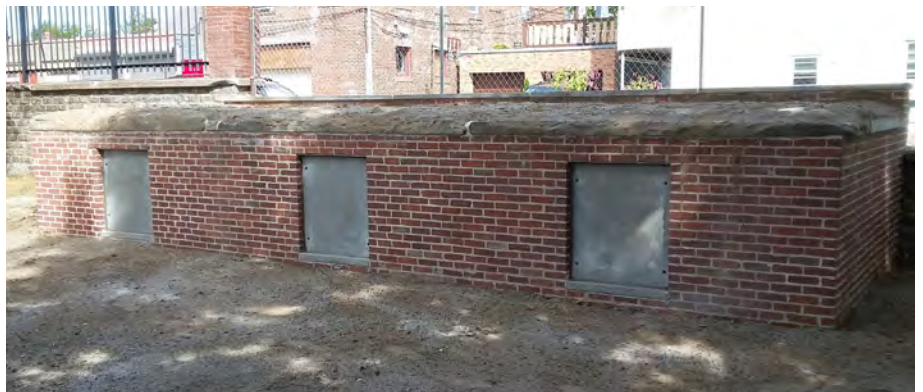
The tombs after the repair was completed (but before the grass seed grew in). The knee wall completely blends in with the original tomb wall.

slabs could be repaired and re-used safely. Another area where the re-use of materials came into question was with the bricks in the tomb walls. The walls of the tombs had been repaired many times and the tomb entrances had been bricked up. The repairs and the doorway fills were made of bricks of different colors and dimensions. Some of the faces of the original bricks had spalled off. We decided to replace the bricks along the front wall and one of the side walls since there were not enough usable original bricks to complete these walls. The north wall uses the original bricks.

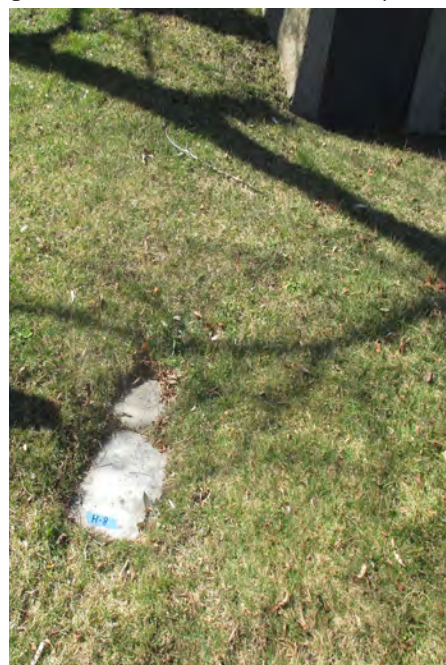
A1: These fragments had no lettering visible on them because they were upside down

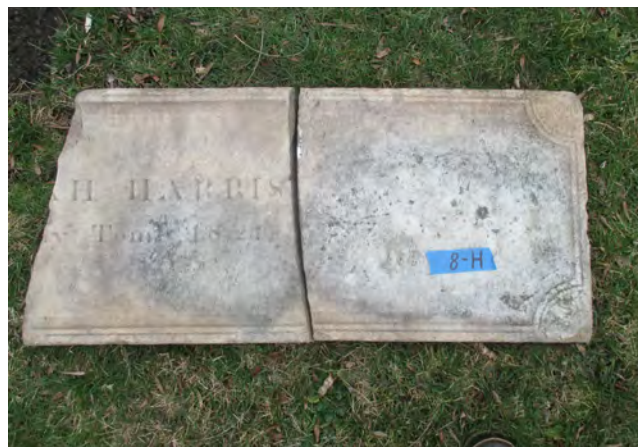
A.2: The two pieces of this tomb marker for Joseph Harris go together, but we were not able to find the third piece. Harris purchased tomb number 1 in 1821, but someone else purchased the tomb at some later point. The current name on the the tomb is Luther Russell, a glass manufacturer who died in 1851.

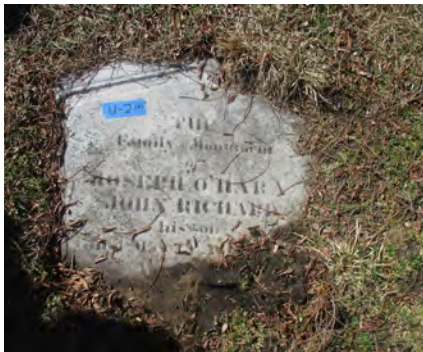
B.1: These two separate fragments in Union Cemetery are part of the same headstone.

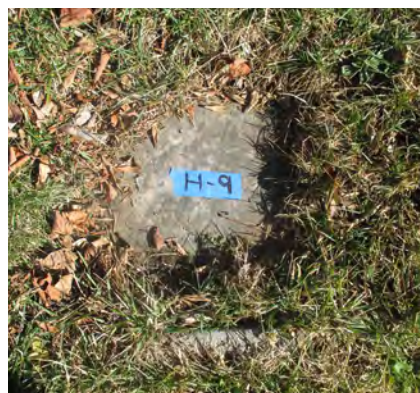
C.1: There are two fragments in this photo. One with the label H-9 and one directly in front of it set in the ground with just the top edge showing.

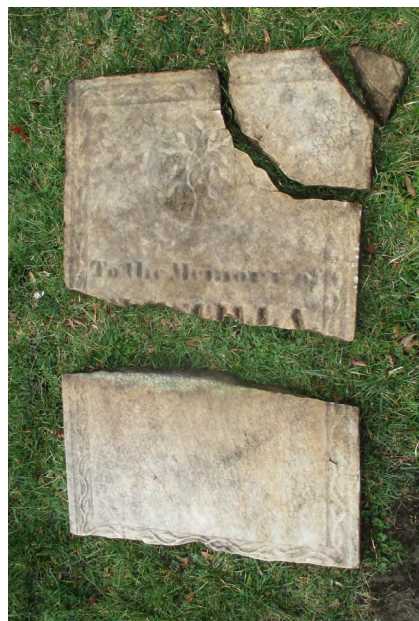
C.2: We found four pieces to this headstone, but a large part, including the main epitaph and the underground base, are still missing.
