Technical Report

**INTENSIVE ARCHAEOLOGICAL SURVEY
TRAINING FIELD/WINTHROP SQUARE PARK**

Boston, MA

City Archaeology Program

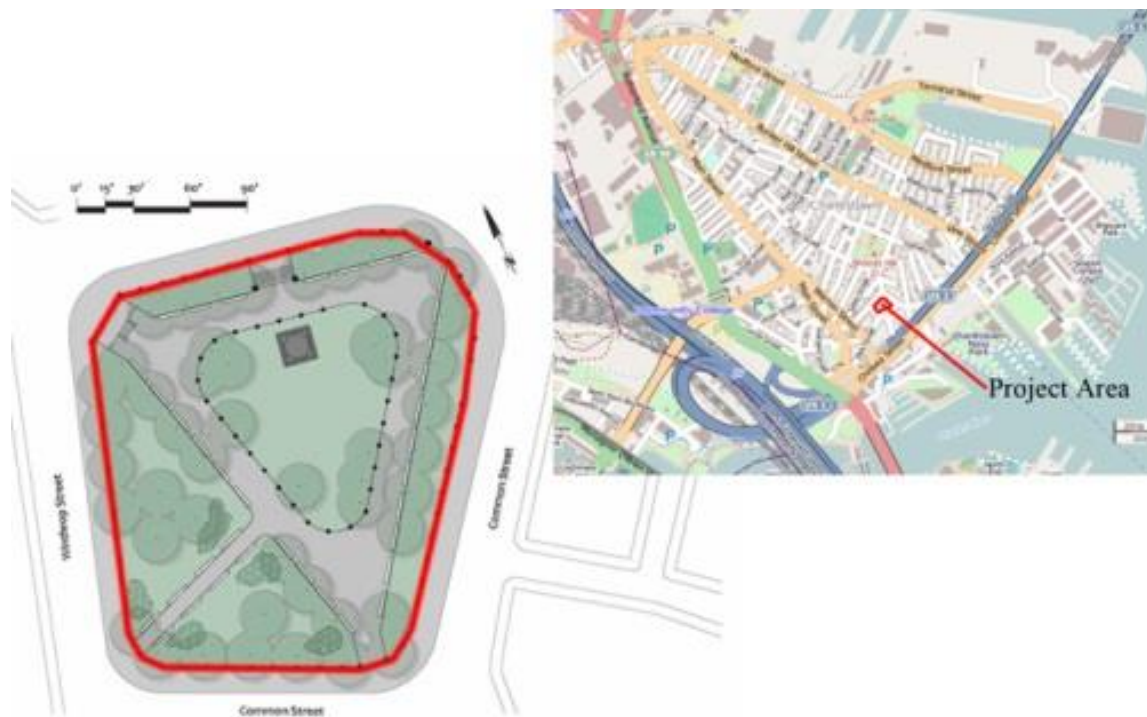
Figure 1- Project APE (red) and location within Charlestown neighborhood of Boston

In response to proposed park landscape improvements under development by the Boston Parks and Recreation Department (Parks) and at the urging of the Charlestown Preservation Society (CPS), the City Archaeology Program (CAP), under the direction of Joseph Bagley, City Archaeologist, and a team of volunteers has completed an intensive archaeological survey of the Training Field Park in the Charlestown Neighborhood of Boston, Massachusetts (Figure 1). The Parks Department is proposing to improve the public enjoyment and appearance of the park by remediating water runoff and soil erosion throughout the Park. These improvements are in developmental stage and will be mitigated by the results of this survey; however, possible improvements include processes with below-ground impacts. These include soil aeration to improve grass growth and reduce soil compaction, installation of drains and cisterns to capture water prior to its movement across the park, widening pathways, installation and modification of curbing, and possible removal of invasive plant species. Because these modifications cover most of the park, the area of potential effect (APE) includes the entire Training Field Park (Figure 1).

The Training Field Park lies within the New England Coastal Lowland physiographic zone. The soils overlie bedrock of Cambridge and Braintree argillite with later glacial drumlin and till deposits capping the bedrock. The Park lies at the outlet of the Charles River near the confluence of the Charles and Mystic rivers, within the Boston Basin and Charles River drainage basin, on a peninsula of land at the mouth of the Charles (Figure 1).

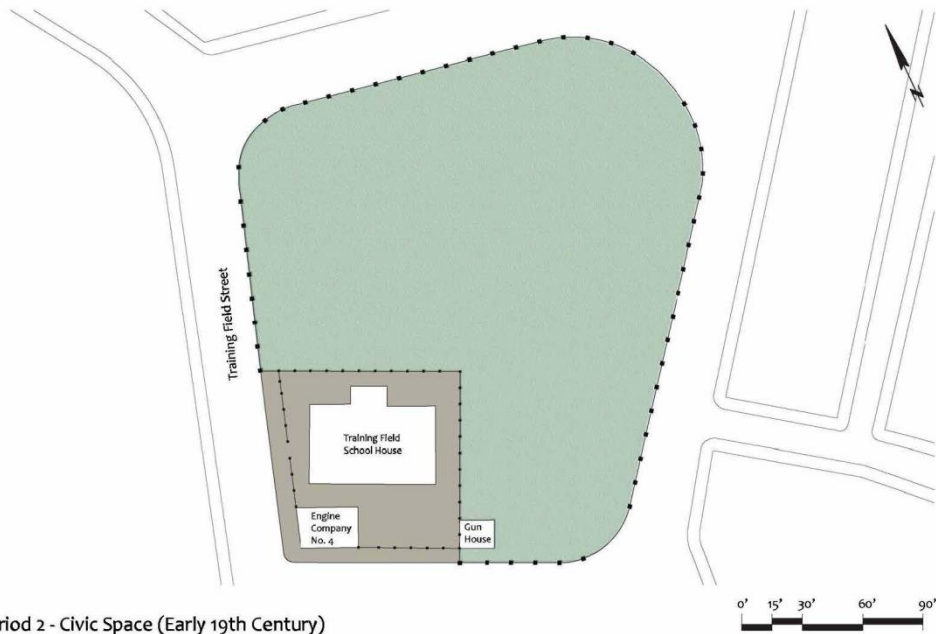
Period 2 - Civic Space (Early 19th Century)

Figure 4- Early 19th century park plan, courtesy of the Charlestown Preservation Society, Building locations estimated.

While the structures were standing within the park, no formal pathways existed, though it is highly likely foot-paths were created from daily use (Figure 4). In the 1840s, the park was named “Winthrop Square,” a name that is rarely used today, and formal pathways had been established across the park transforming the land into a formal urban park (Figure 5Figure 4).

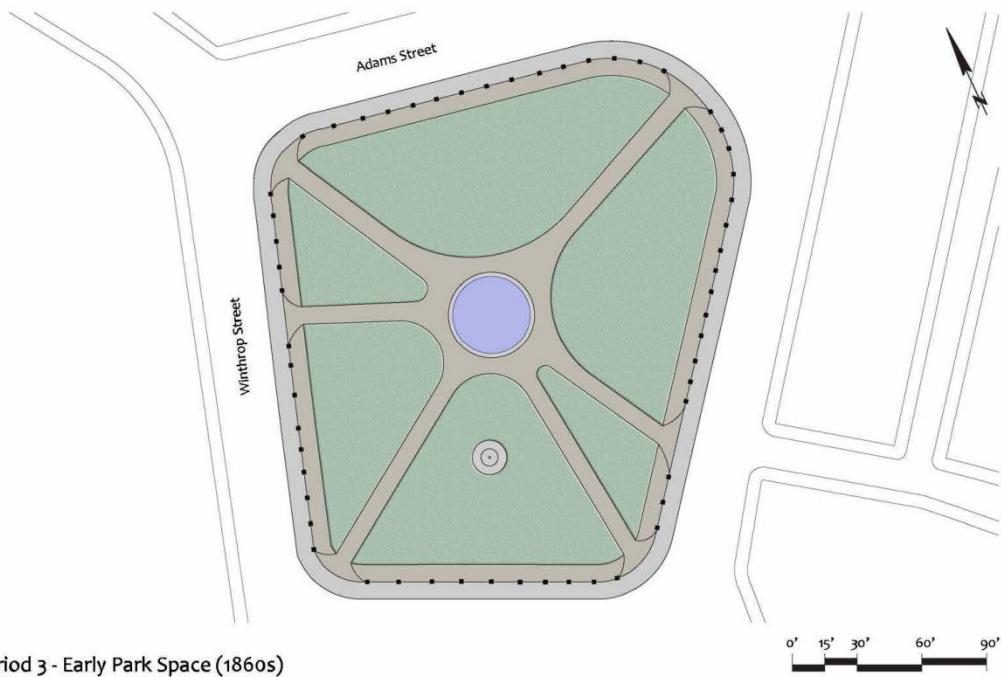
Period 3 - Early Park Space (1860s)

Figure 5- 1860s park plan, courtesy of the Charlestown Preservation Society, not to scale.

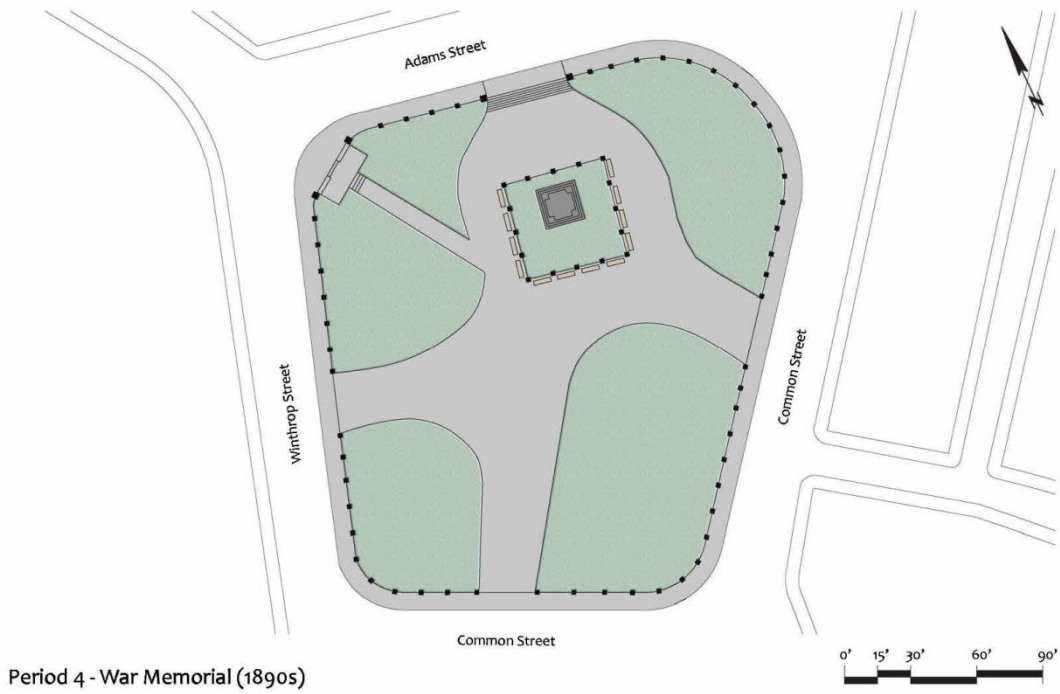
Figure 6- Post 1870 park plan, to scale, courtesy of the Charlestown Preservation Society.

This layout remained until the construction of the Soldiers and Sailors Monument in the northeast portion of the park in 1871. This layout modified the parks focus in its pathways to the new monument (Figure 6).

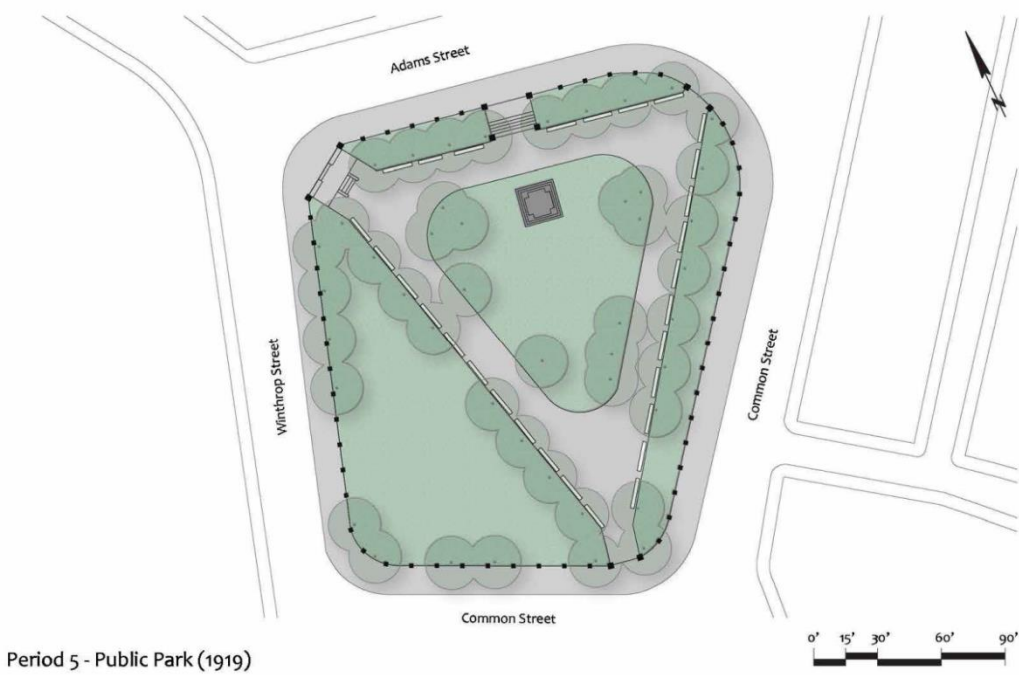
Figure 7- 1919 park plan, to scale, courtesy of the Charlestown Preservation Society.

In 1919, the park was reconfigured again, this time the pathways connected various corners and streets surrounding the park for ease of pedestrians, with the monument, in its original location, located within an open area (Figure 7). This overall design remains with a more recent renovation in the 1950s adding a path in the western corner of the park and minor modifications to entrance areas (Figure 8).

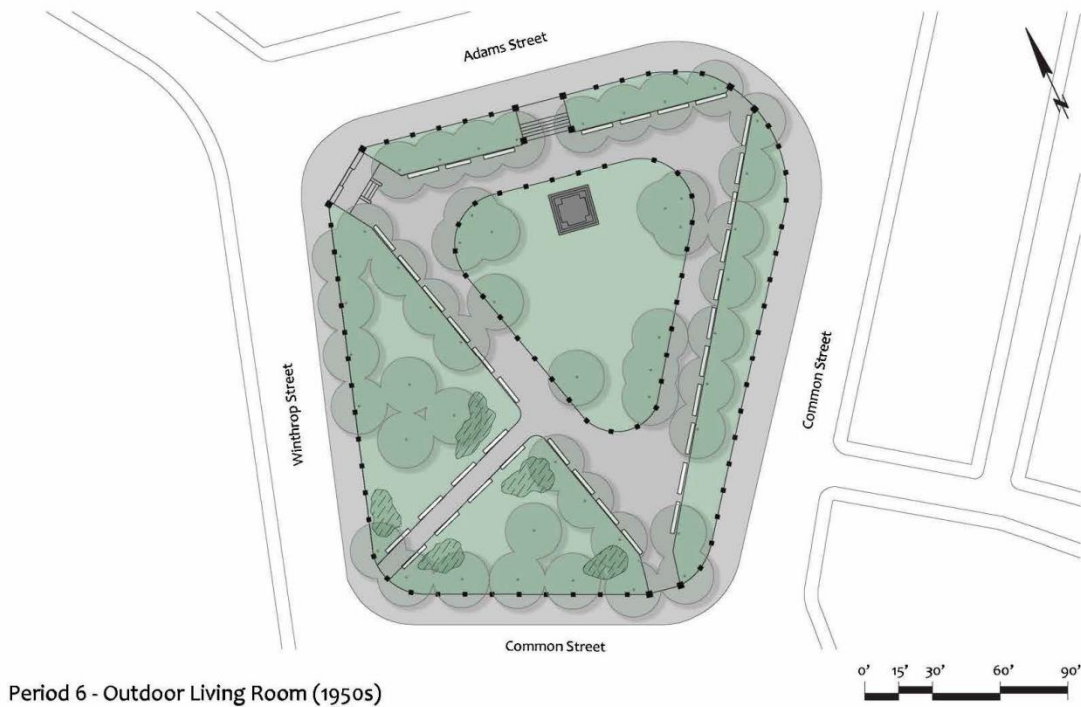
Figure 8- Contemporary park plan, to scale, courtesy of the Charlestown Preservation Society.

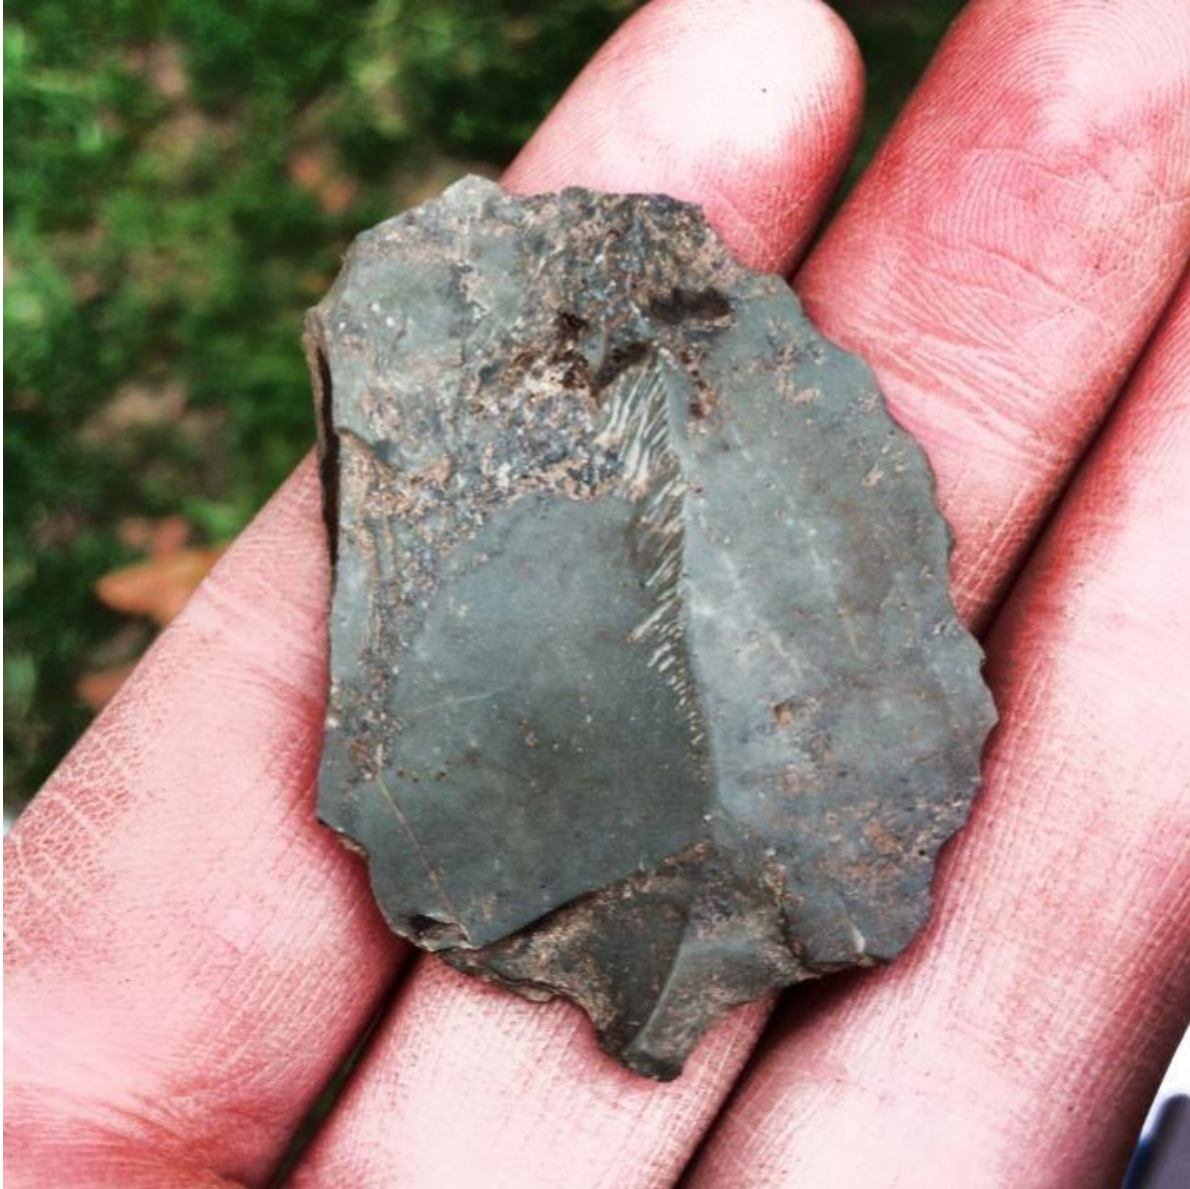
Figure 10- Large flake from Mishawum 2 site made from Melrose Green felsite

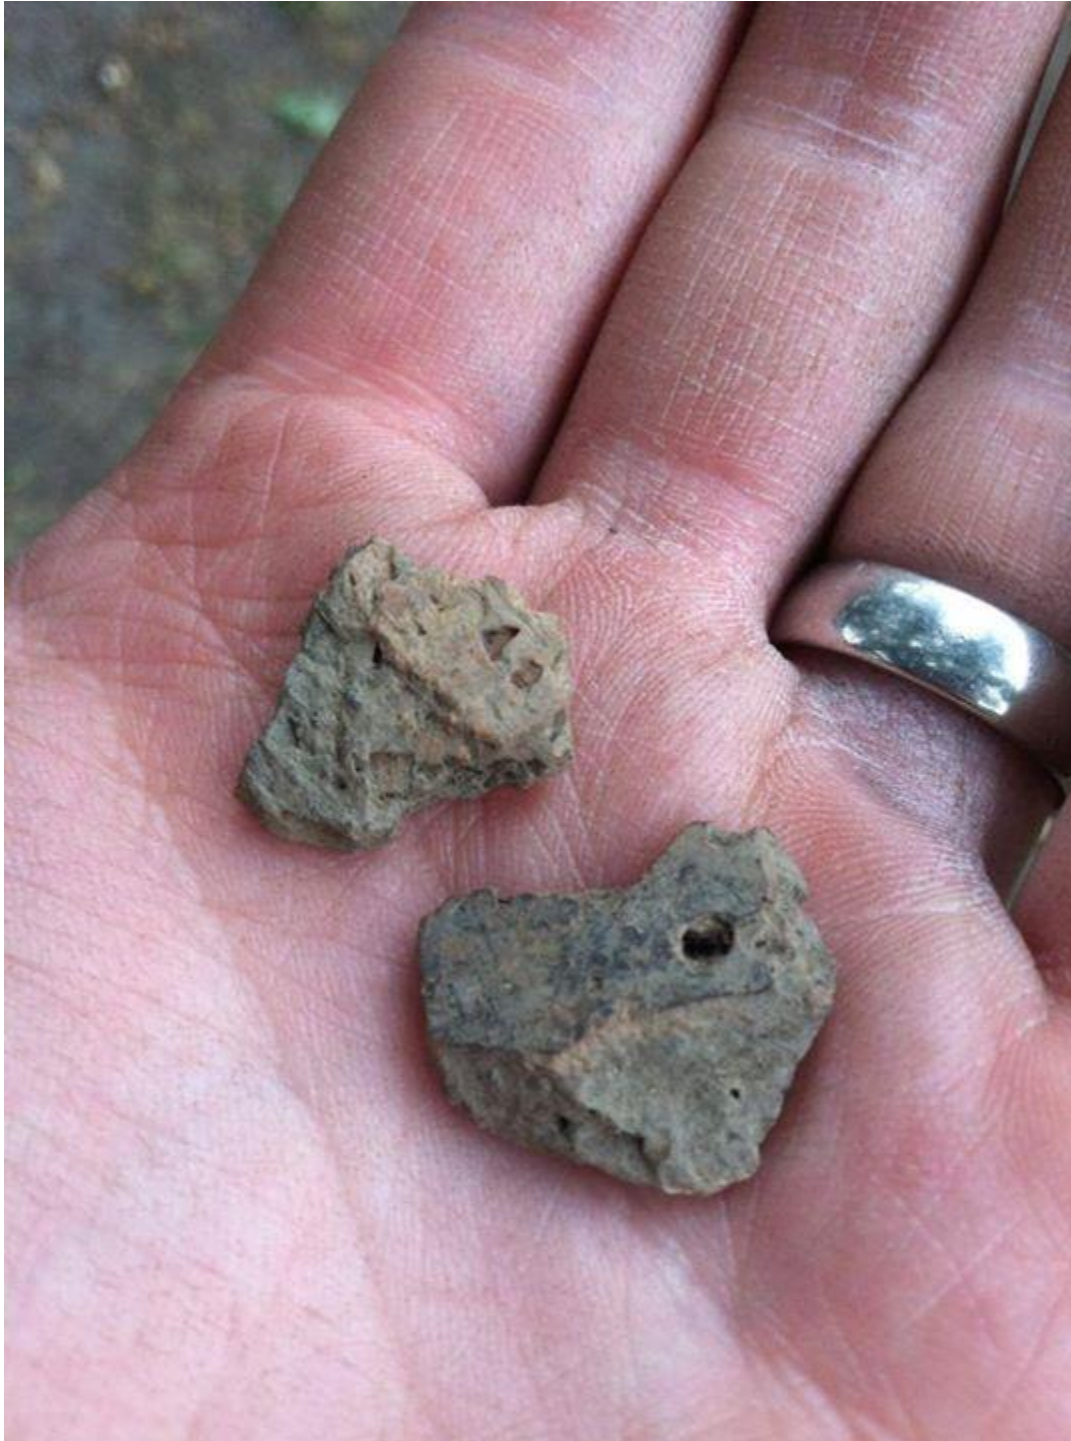
Figure 11- Native American pottery fragments from Mishawum 2 site.

In total, 13 flakes from lithic processing were found within Mishawum 2, along with three pieces of Native Pottery indicating a presence on the site during the Woodland period (3,000-400 BP) though more specific occupations are not possible without decorated pottery, and the lithic materials may be older than the pottery (figures 10-11). Regardless, Mishawum 2 represents a significant Native archaeological deposit on the western end of the Training Field Park.

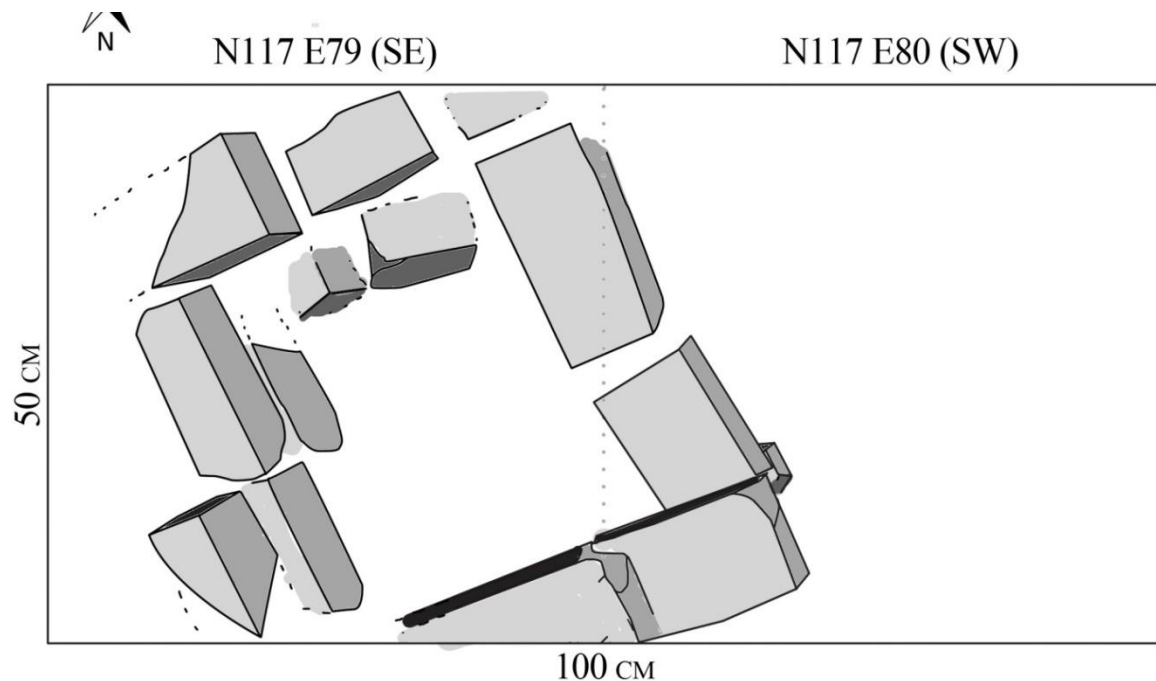
Figure 12- Brick feature in N117 E79 and E80

A rectangular brick feature containing a single piece of Albany Slipped stoneware (TPQ 1805 (Miller et. al 2000)) was found extending from A soils into B subsoils between 85 and 110 cmbs in N117 E80 and an expanded pit at N117 E79 (Figure 12). This feature measures approximately 50x50 cm and consists of a rectangular arrangement of mortared bricks, three courses tall, with infilling of brick fragments, mortar, and artifacts. It appears that this construction is the footing for some sort of structure, perhaps a temporary structure such as an outbuilding or privy that only needed corner-post foundations. Due to the TPQ date of its construction and location within the park it is highly likely that this structure is directly related to the school, perhaps its outhouse. Further excavations in the area would aid in determining the function of this structure.

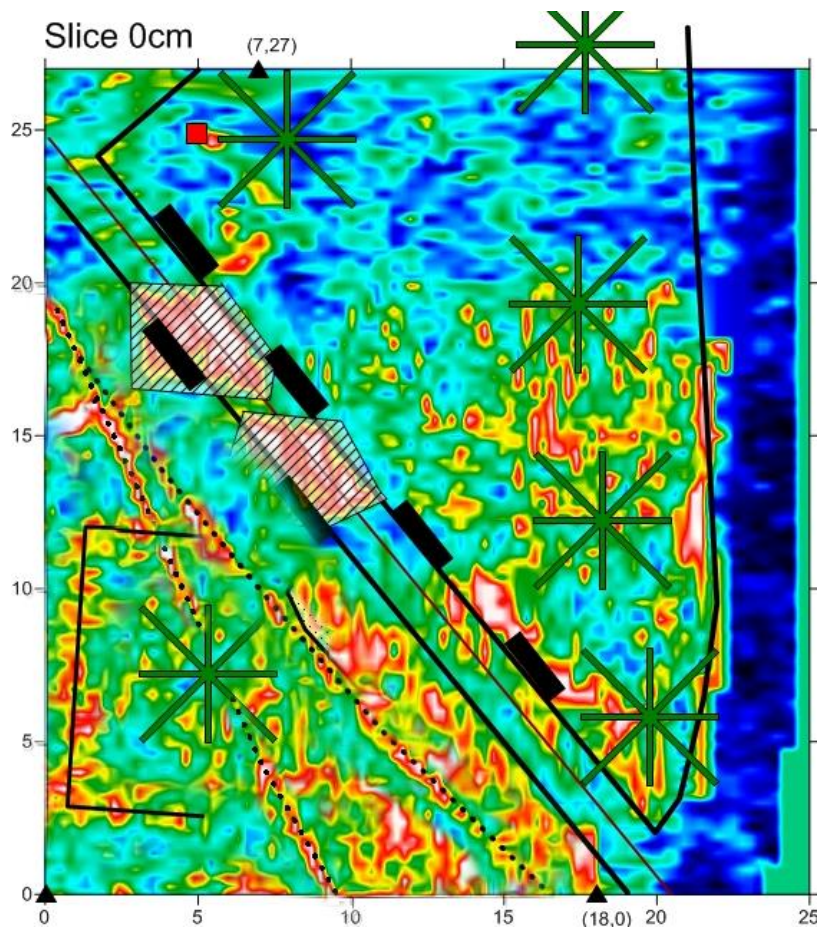
Figure 13- GPR slice (north to left) of west corner of Training Field park showing pathways and benches (central black elements), buried utilities (dotted line) and feature possibly associated with the foundations of the Training Field School (lower left)

Finally, Ground Penetrating Radar (GPR) used within this area of the park indicated the presence of a rectangular buried structure (figure 13). This shape appears to be a portion of the School House foundation, still remaining within the park. This report interprets the incompleteness of the foundation as a result of efforts to move the building. The two-story schoolhouse is made entirely out of brick, and moving the structure intact would have taken great effort in 1847. Movers would have needed to lift the building and move it across the open foundation. It is possible that part of the preparation for the move involved the removal of portions of the foundation in order to get under and eventually lift the structure off its footing. This may account for the partial preservation of the otherwise easily identifiable foundation fragment found in the Training Field School.
