St. Gabriel's Monastery

THE MONASTERY, BRIGHTON. MASS.

August 23, 2016

St. Gabriel's Monastery Renovation

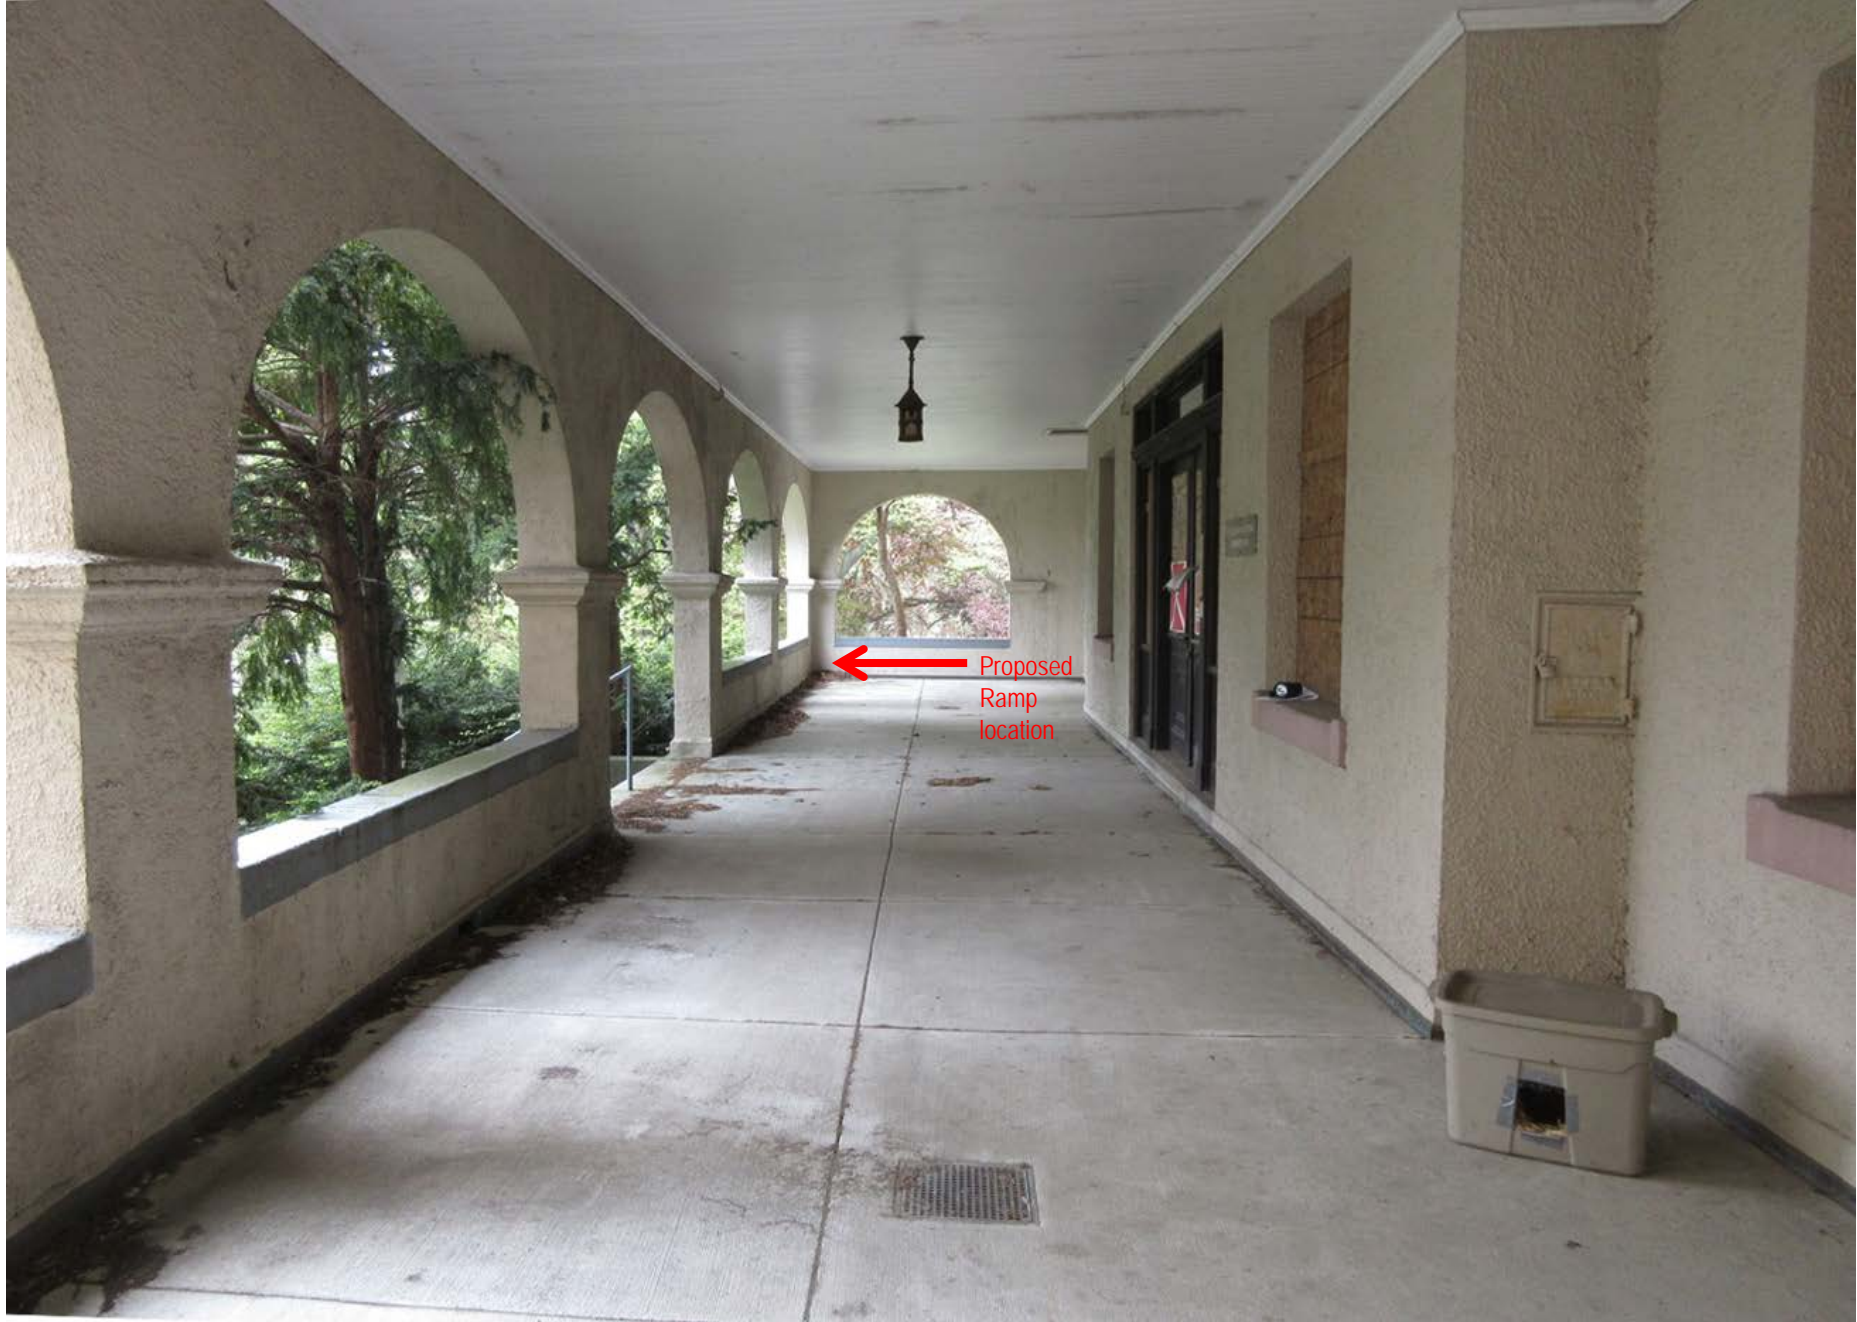
Main entry porch on east façade will be made accessible for those with physical disabilities with a new ramp concealed behind parapet wall

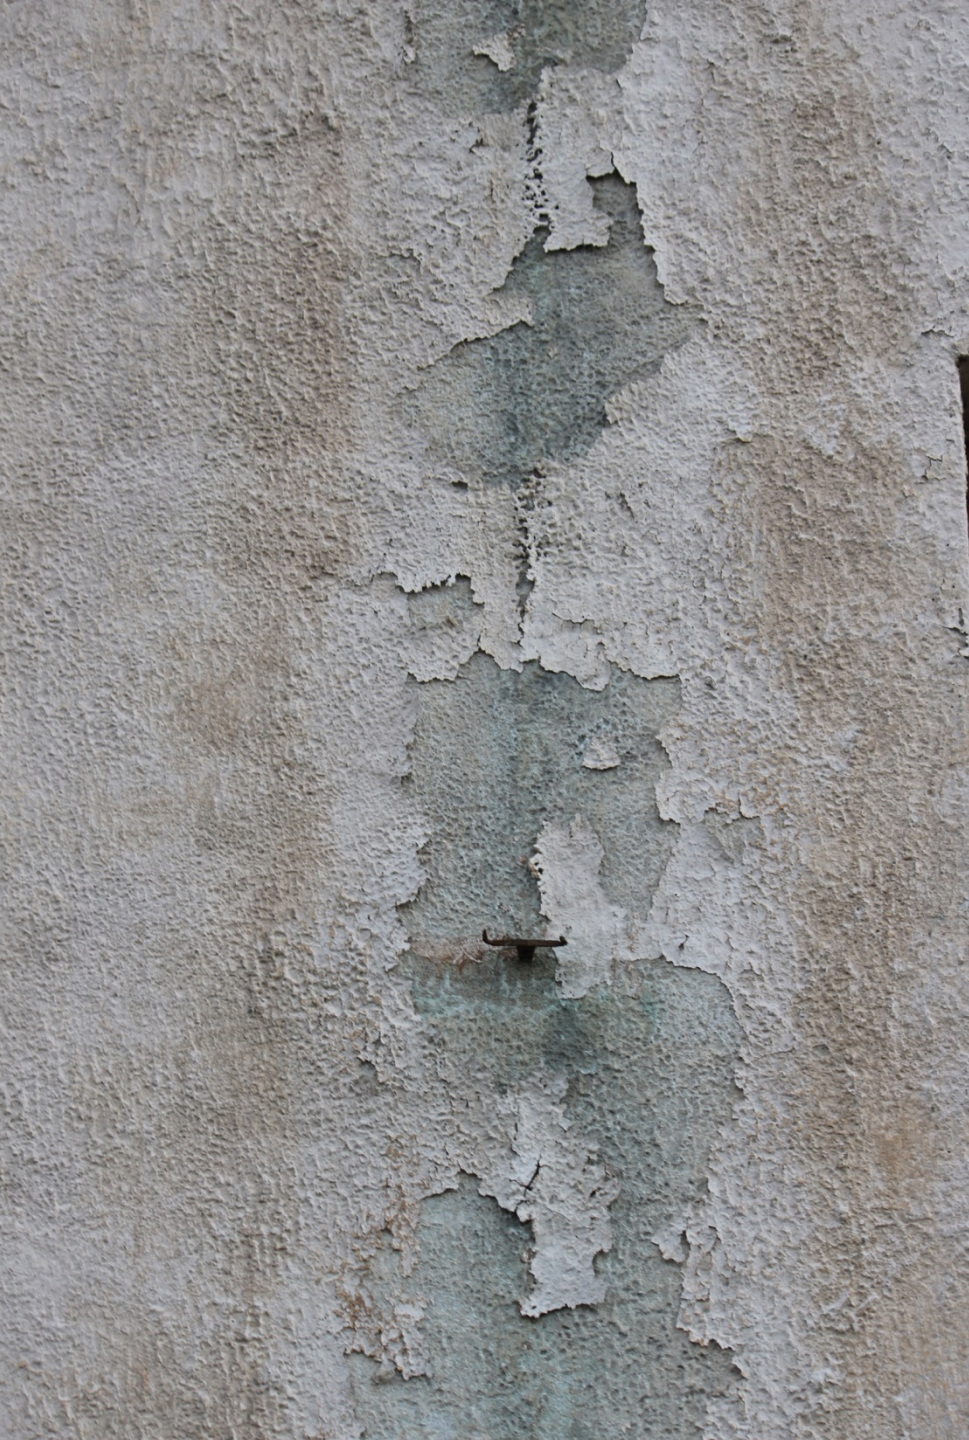
Stucco Conditions: Evidence of Previous Coating

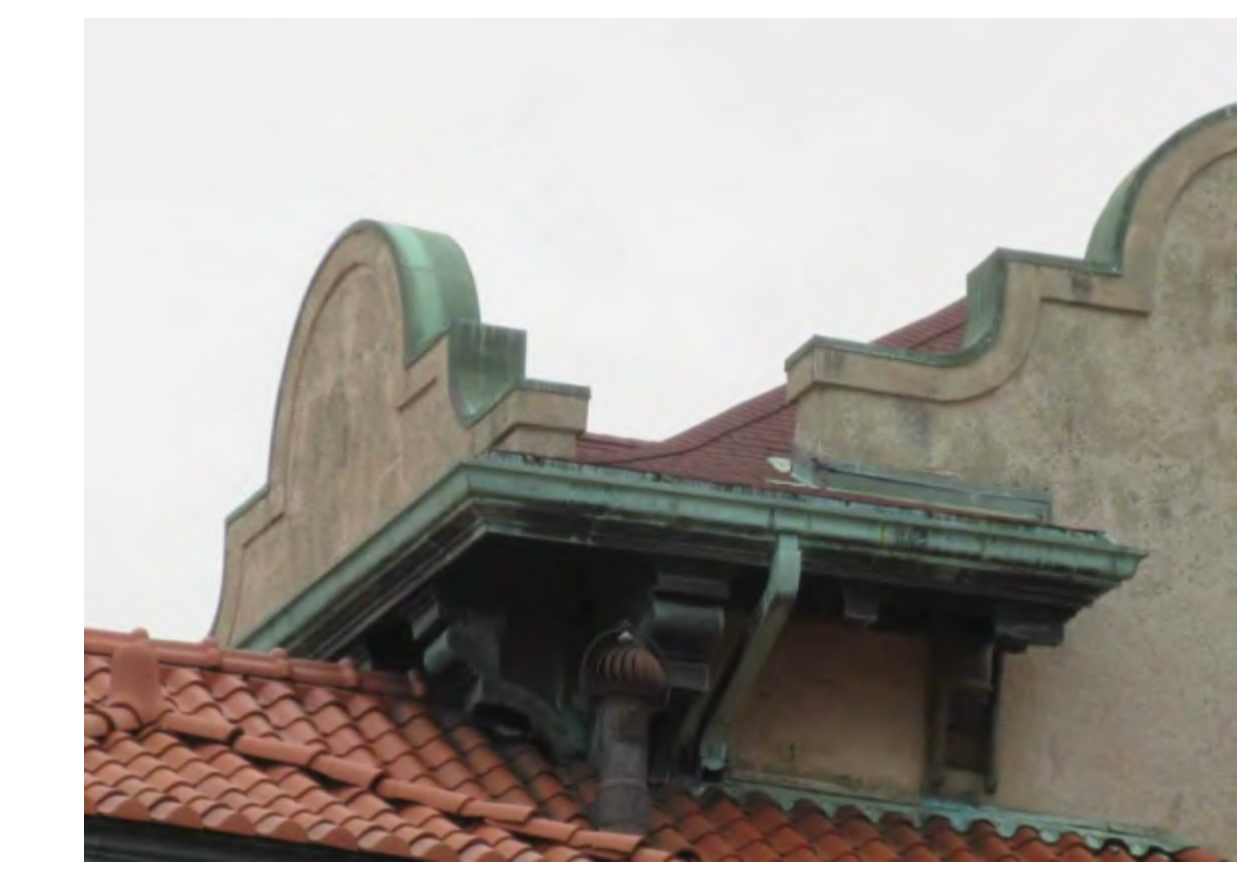
EXISTING ASPHALT SHINGLES AT TOWER ROOF

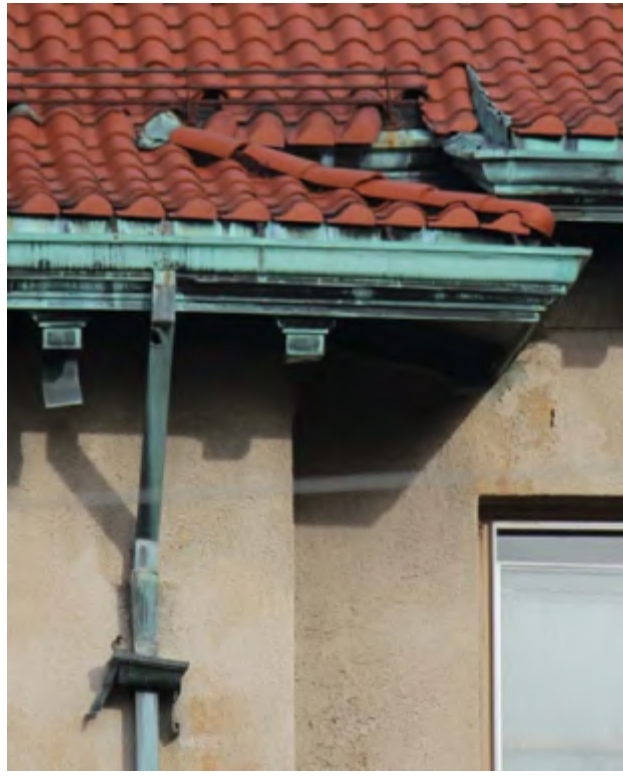
EXISTING COPPER DOWNSPOUTS ARE MISSING OR DAMAGED AT SOME LOCATIONS

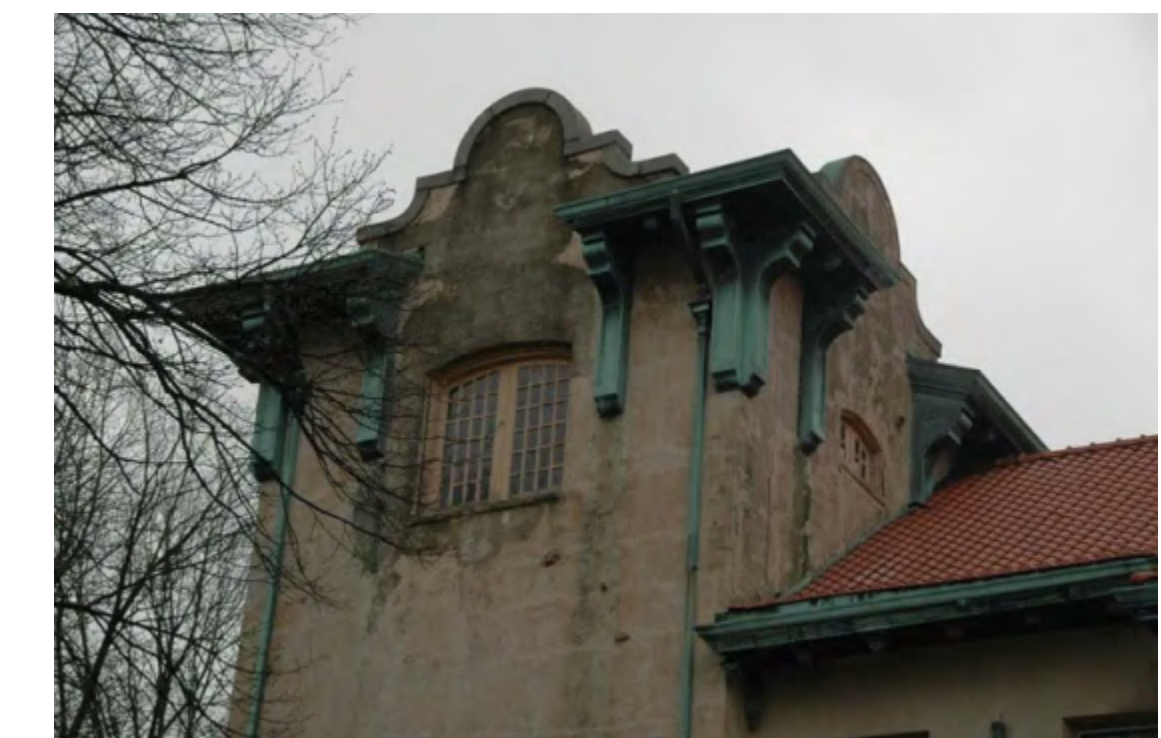
EXISTING COPPER BRACKETS, CORNICE, AND GUTTERS CAN LIKELY BE RETAINED.

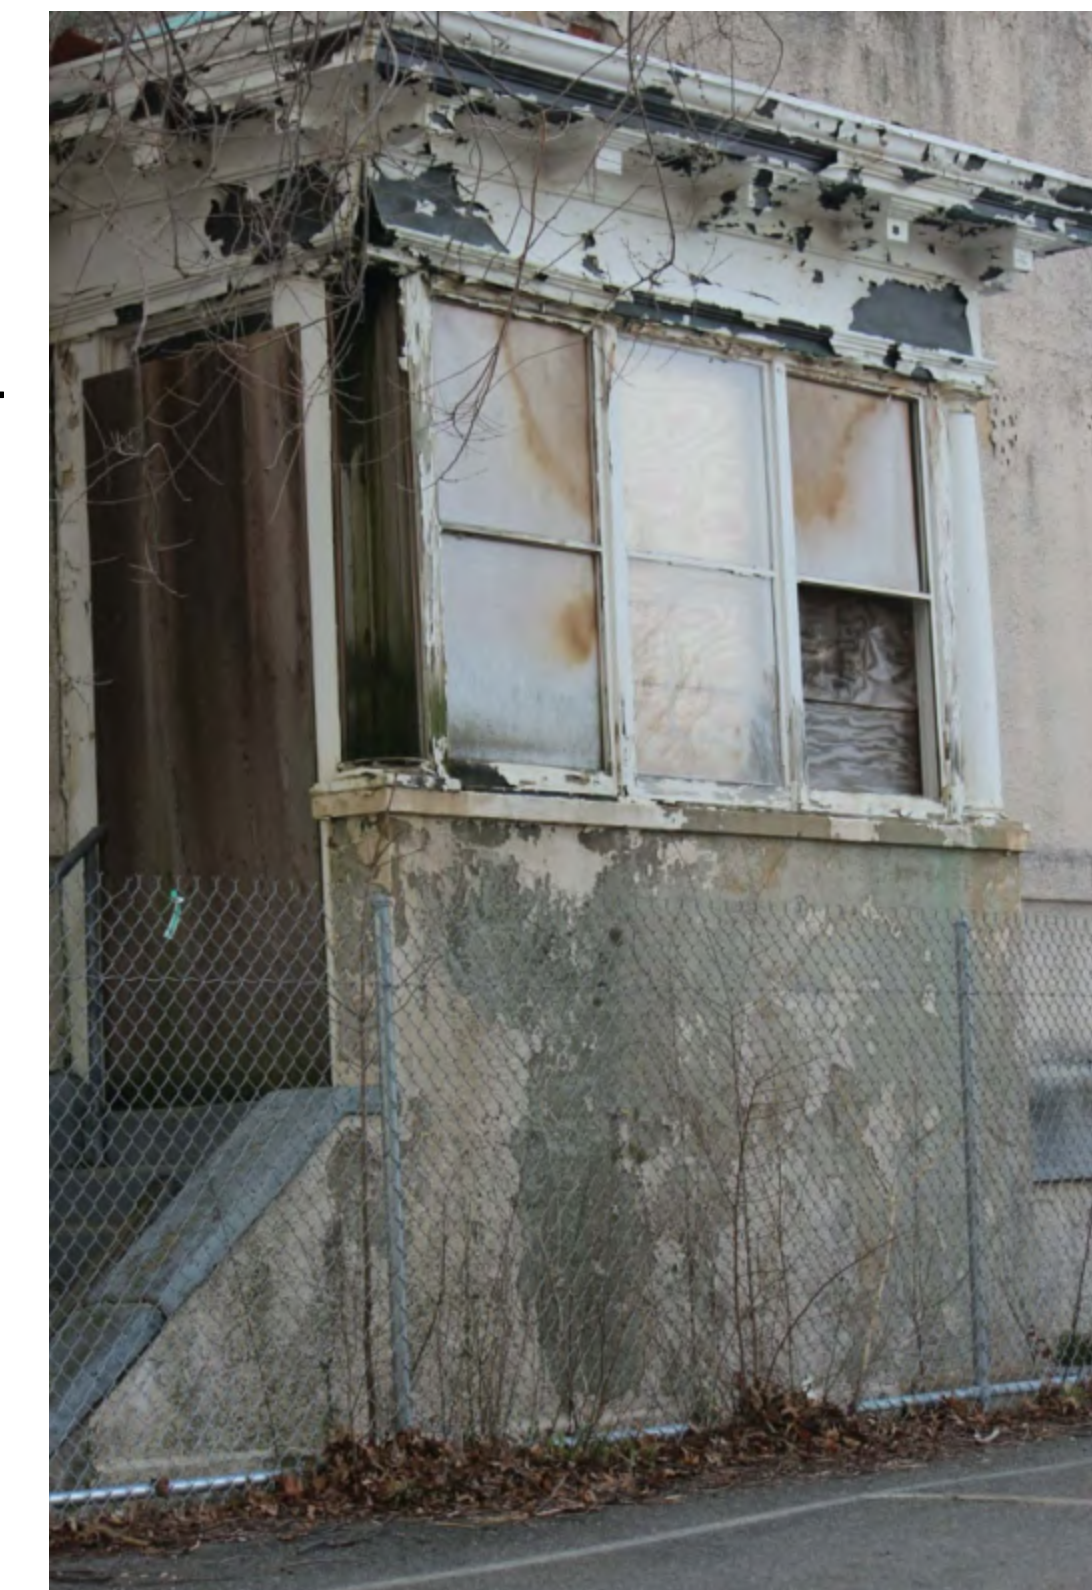
SMALL ENTRIES WERE ORIGINALLY OPEN PORCHES, AT SOME POINT ENCLOSED WITH WINDOWS AND DOORS.

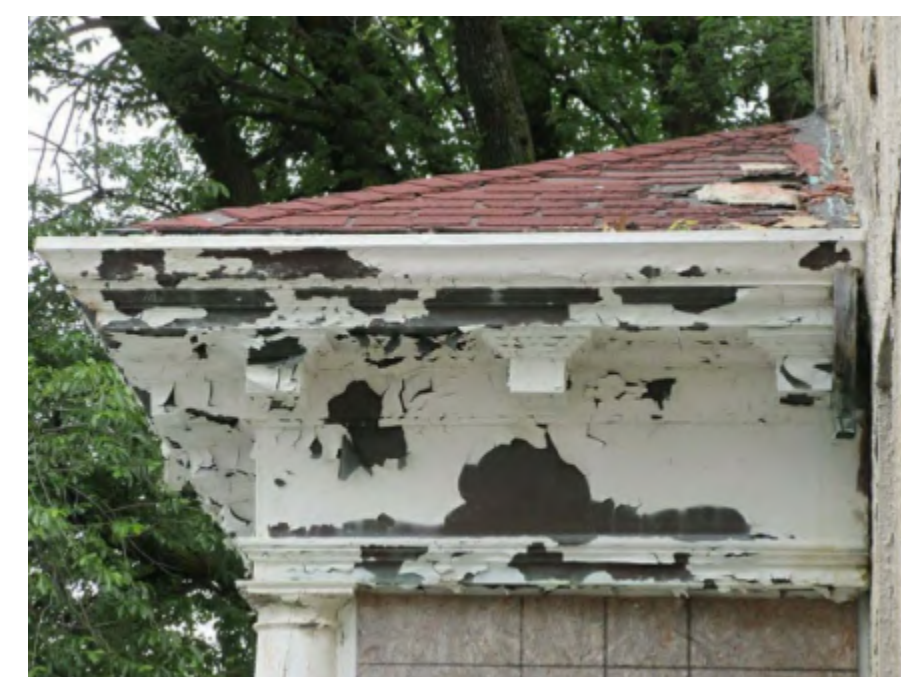
TYPICAL METAL CORNICE WITH PEELING PAINT AT COURTYARD ENTRY PORTICO AND ROOF

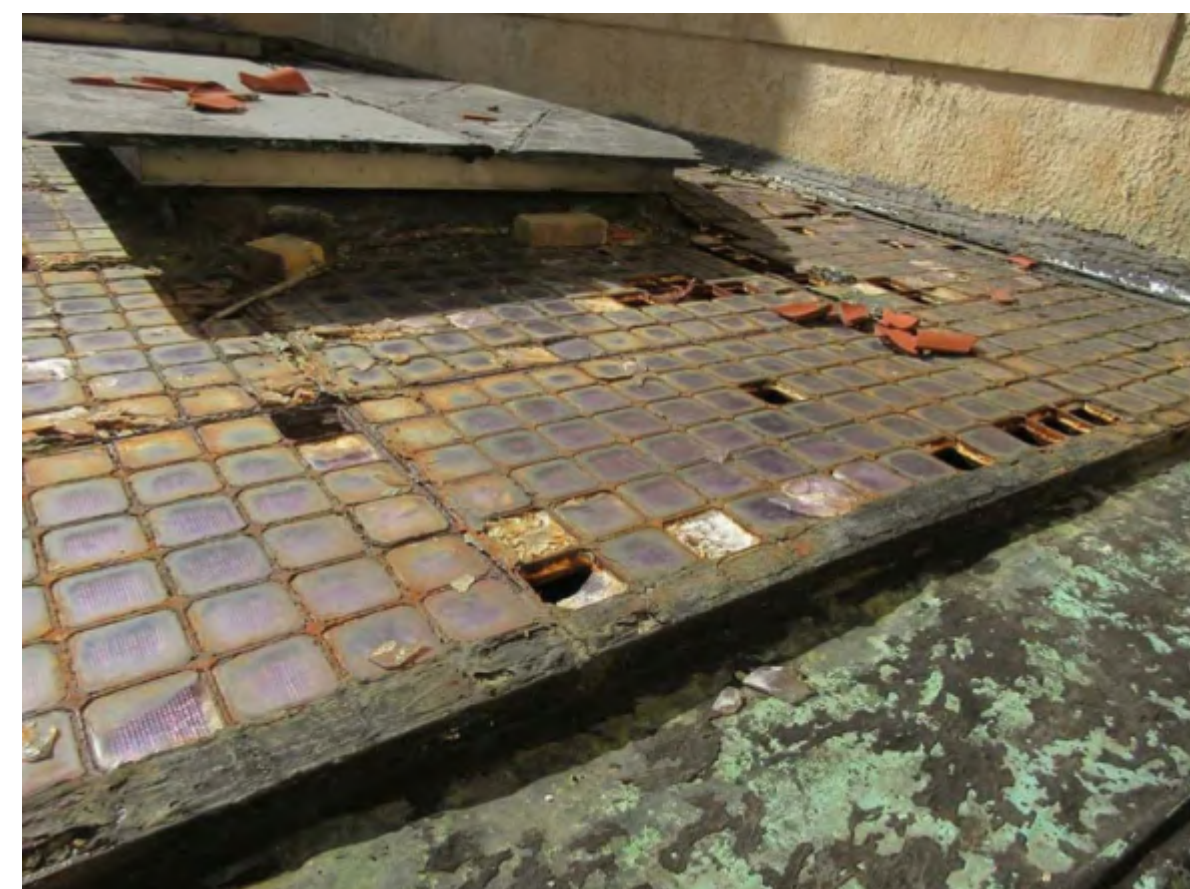
EXISTING SKYLIGHT AT COURTYARD

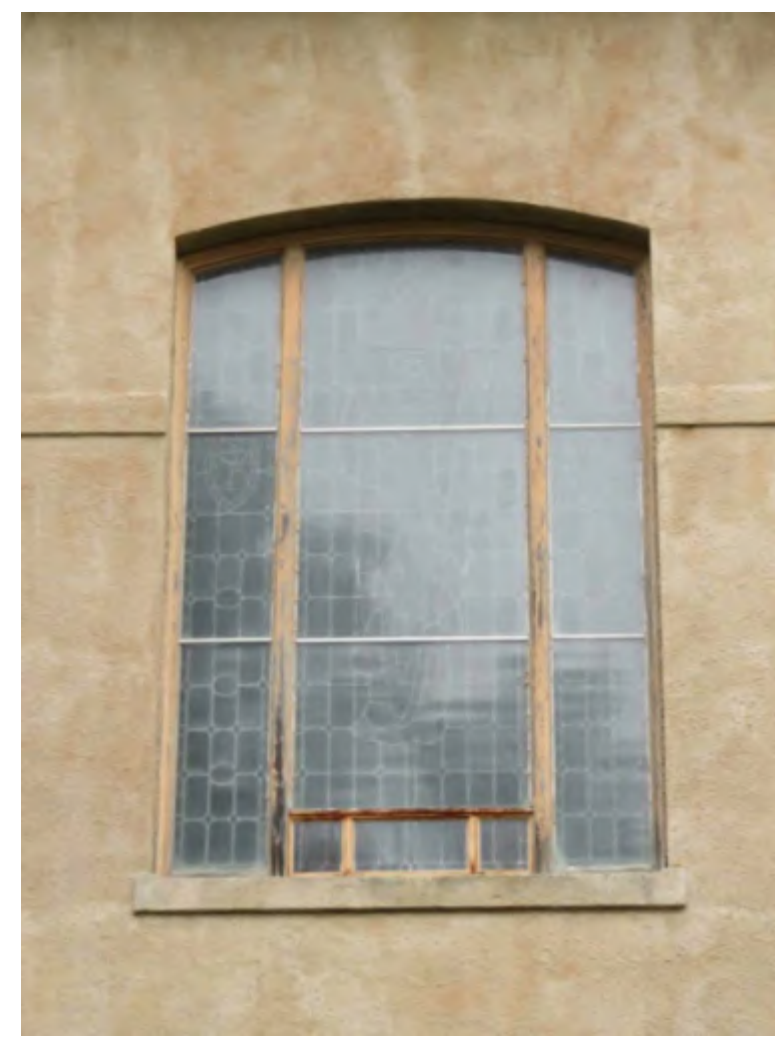
Photo showing exterior profiles of window and protective panel
