**CHARLES RIVER SPEEDWAY
BOSTON LANDMARKS COMMISSION APPLICATION**

Date: MARCH 5, 2019

1420-1440 SOLDIERS FIELD RD
BOSTON, MA 02135

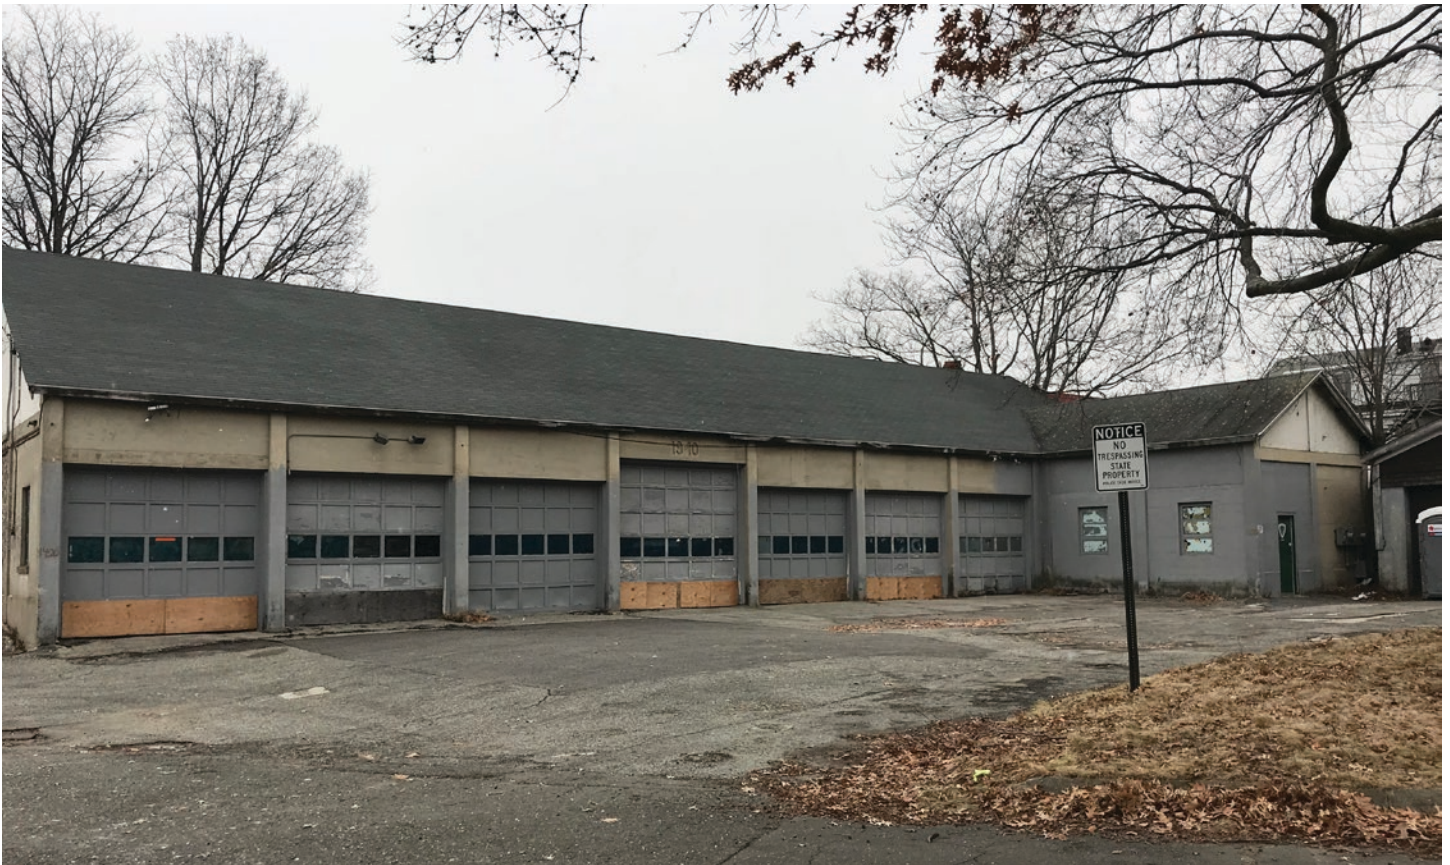
Figure 2: Building B Exterior

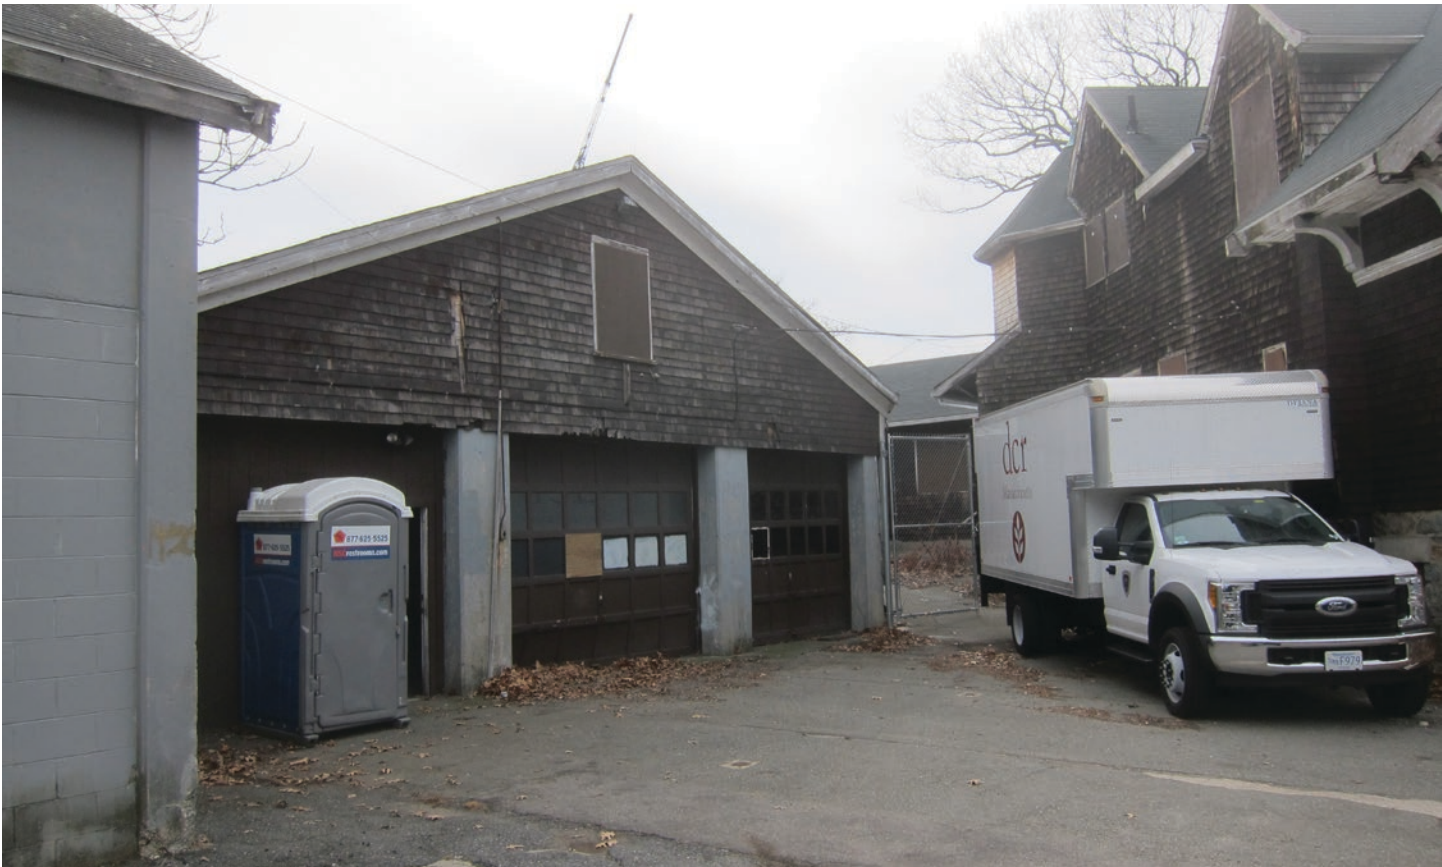
Figure 3: Building C Exterior

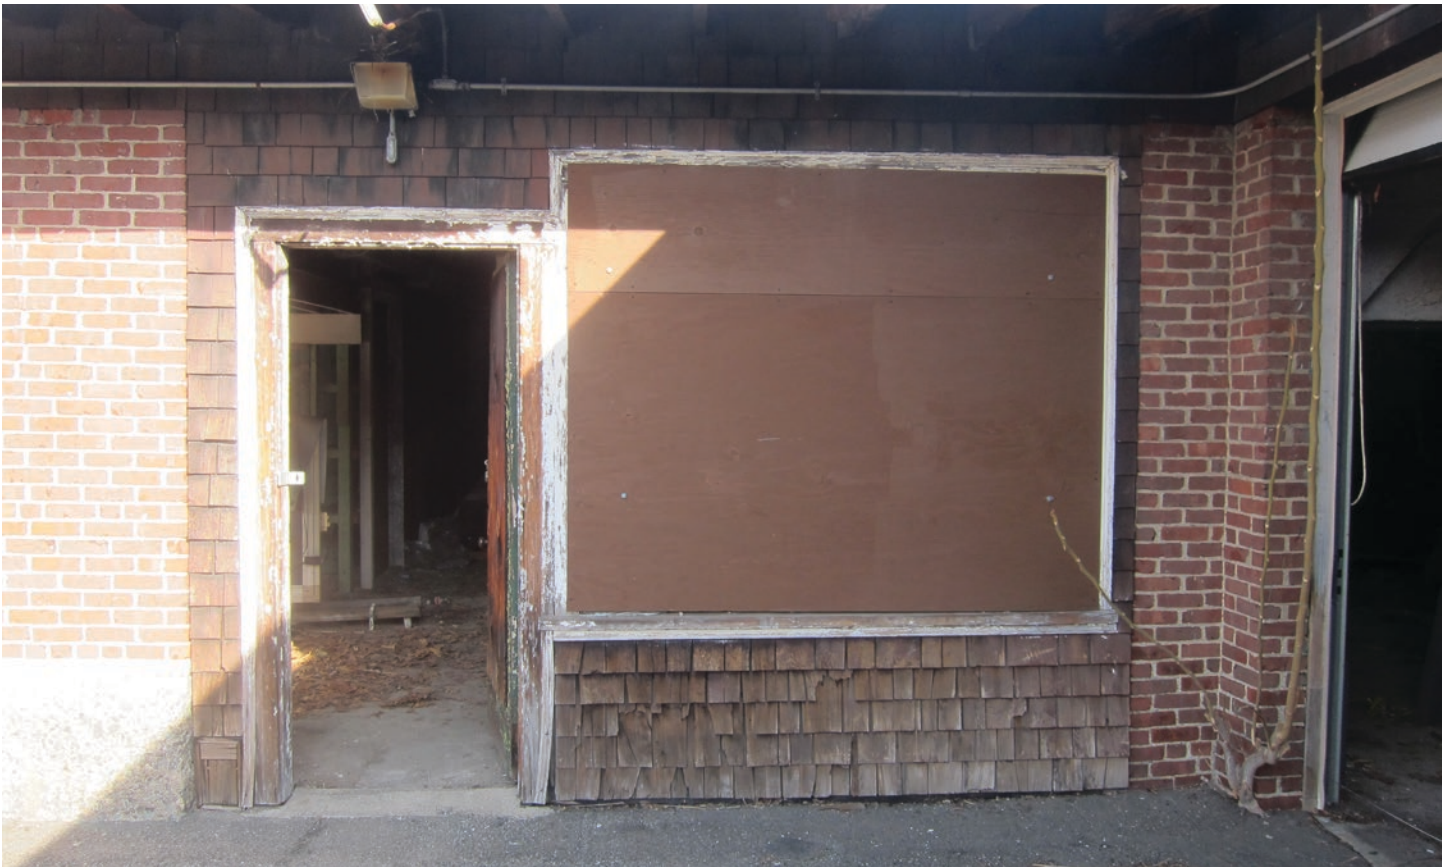
Figure 4: Building D Exterior

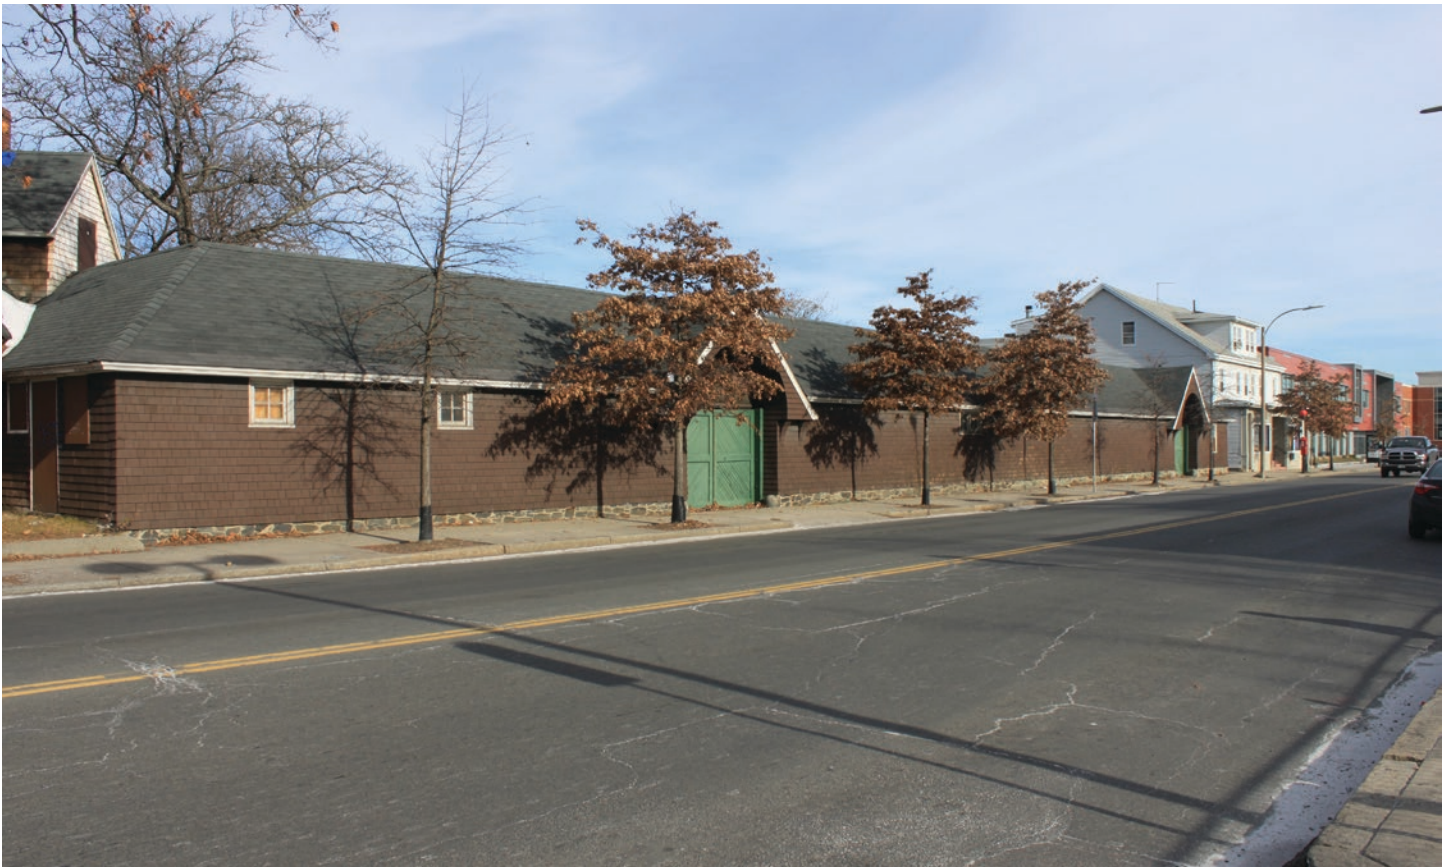
Figure 5: Building E Exterior

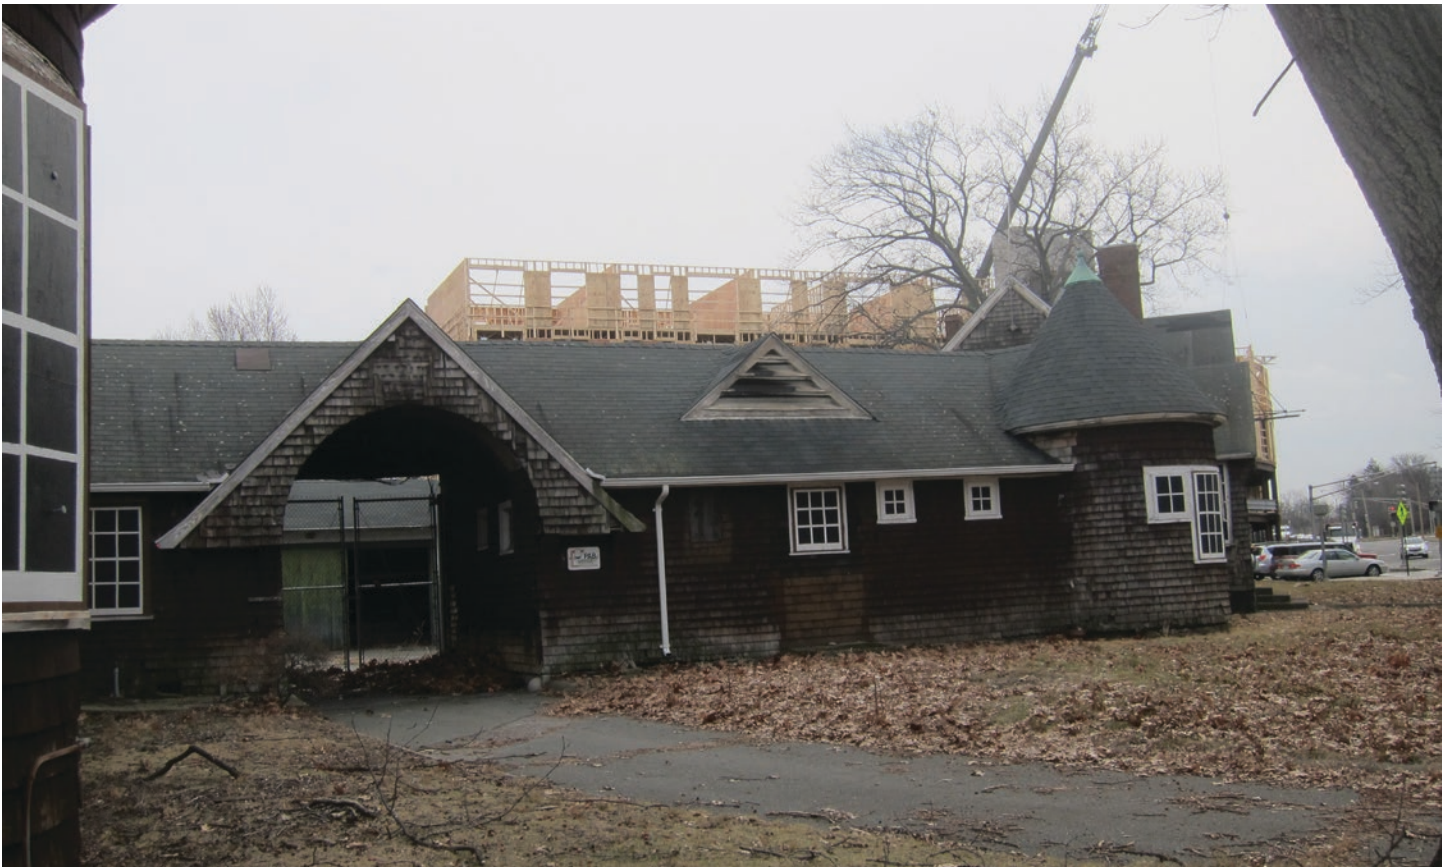
Figure 7: Building G Exterior

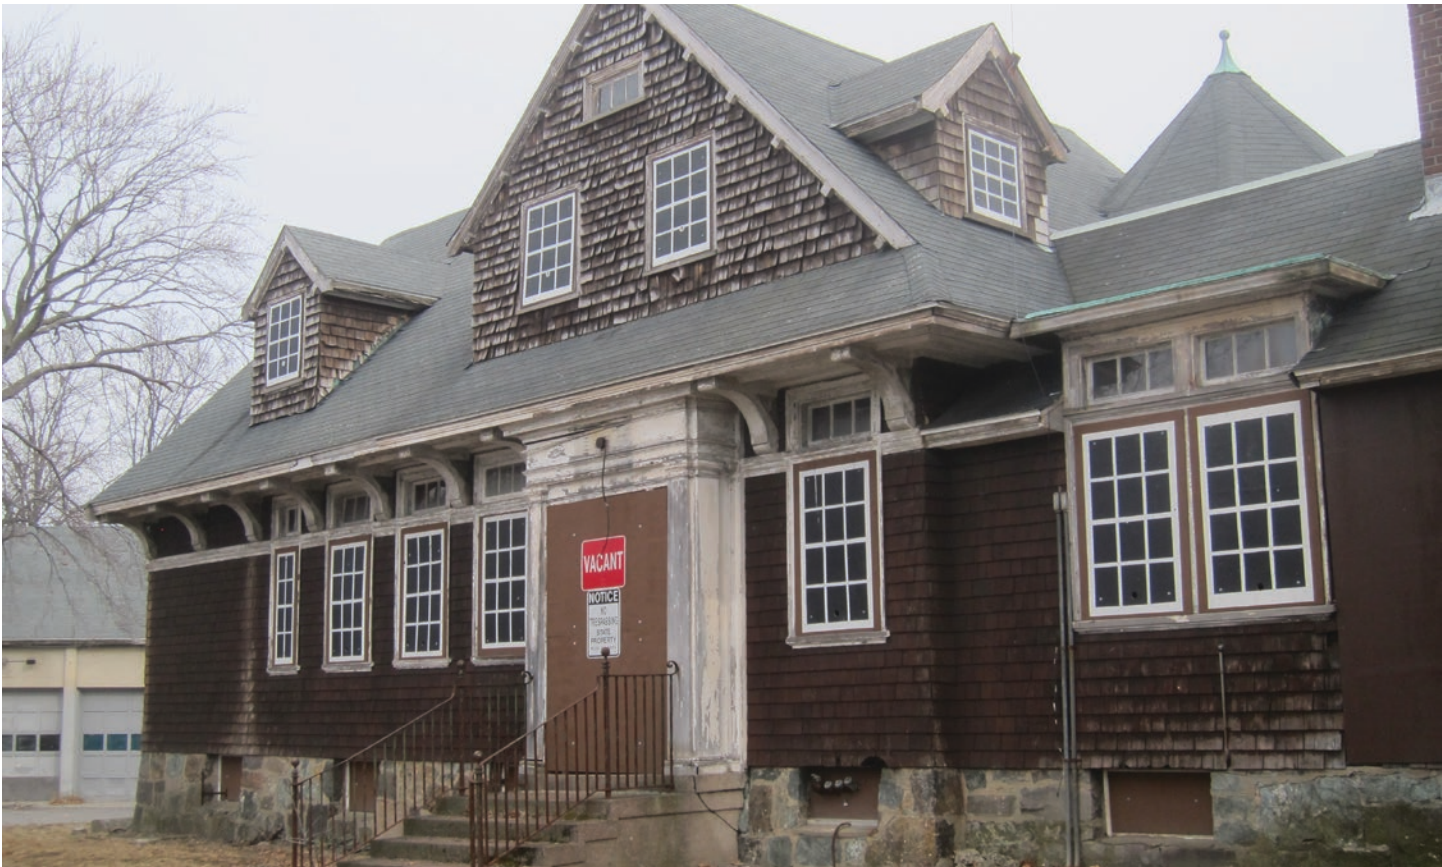
Figure 8: Building H Exterior

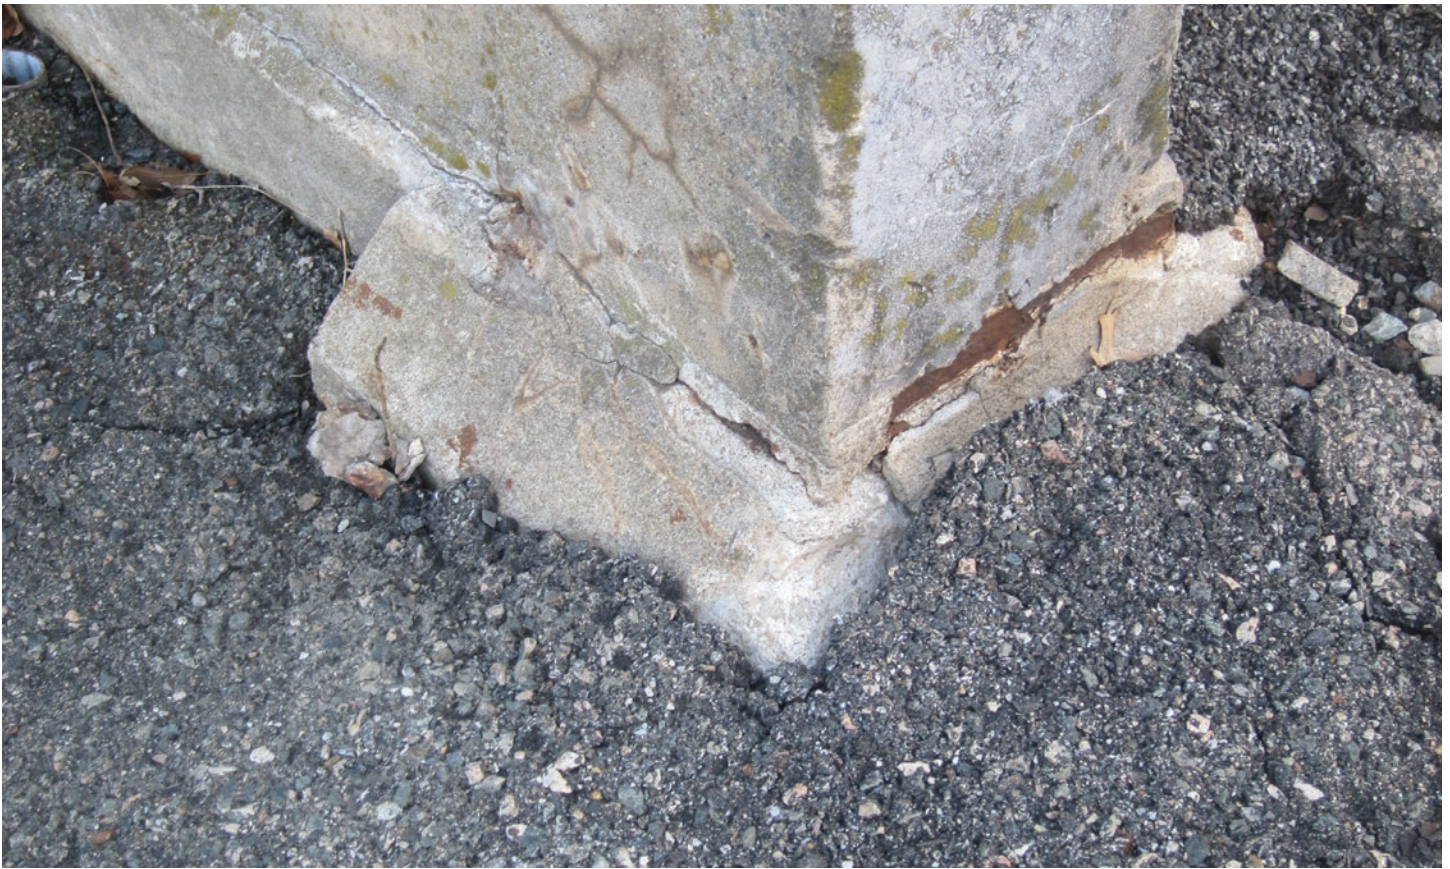
Figure 11: Building B Steel Column Baseplate

At Building B, steel columnar base plates will be protected against further corrosion. The steel plates will be exposed and will receive a zinc-rich coating. The concrete cover will then be reinstated.

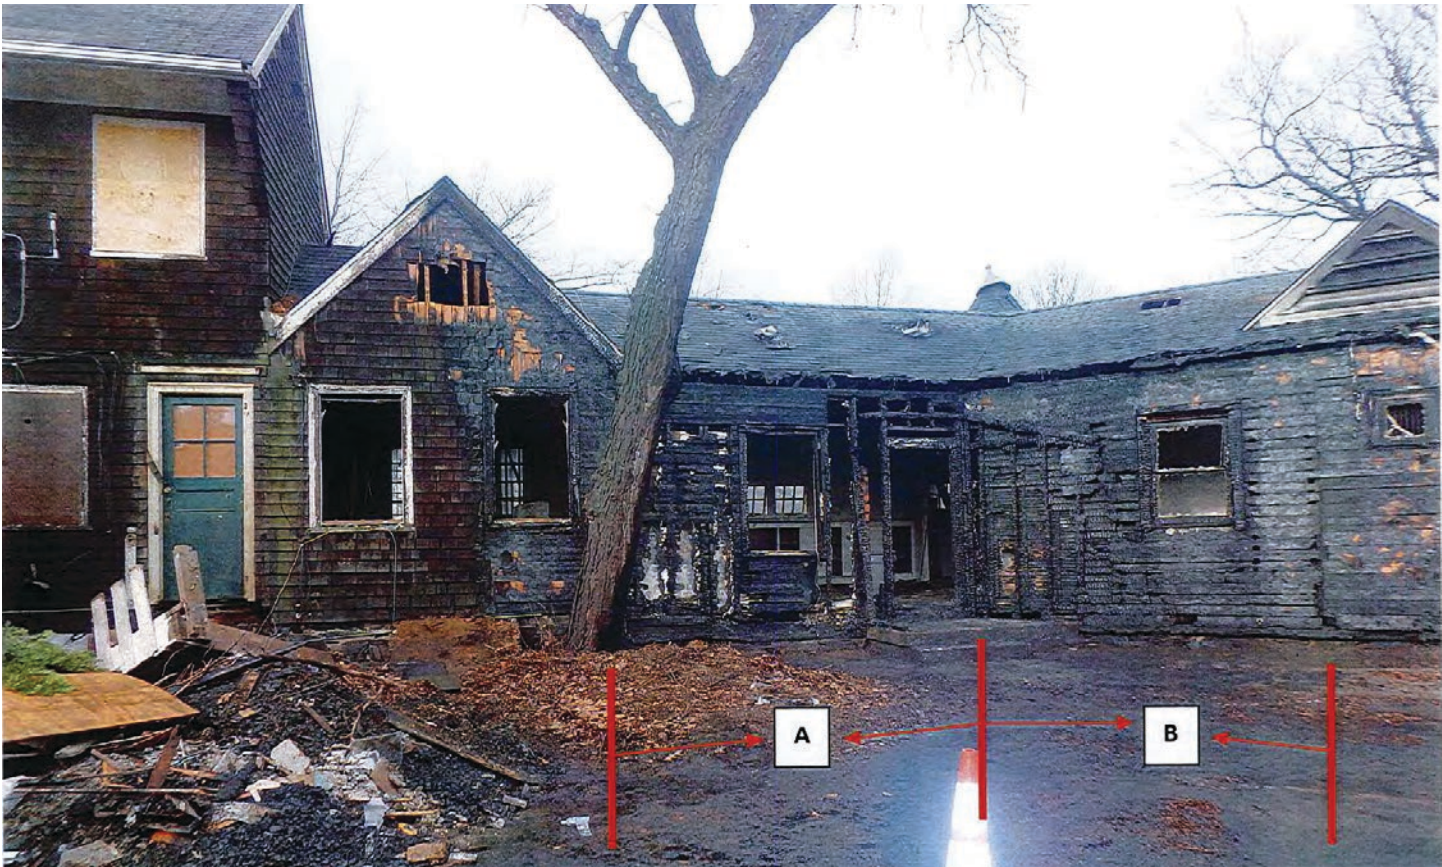
Figure 33: Building G Courtyard Entry Fire Damage

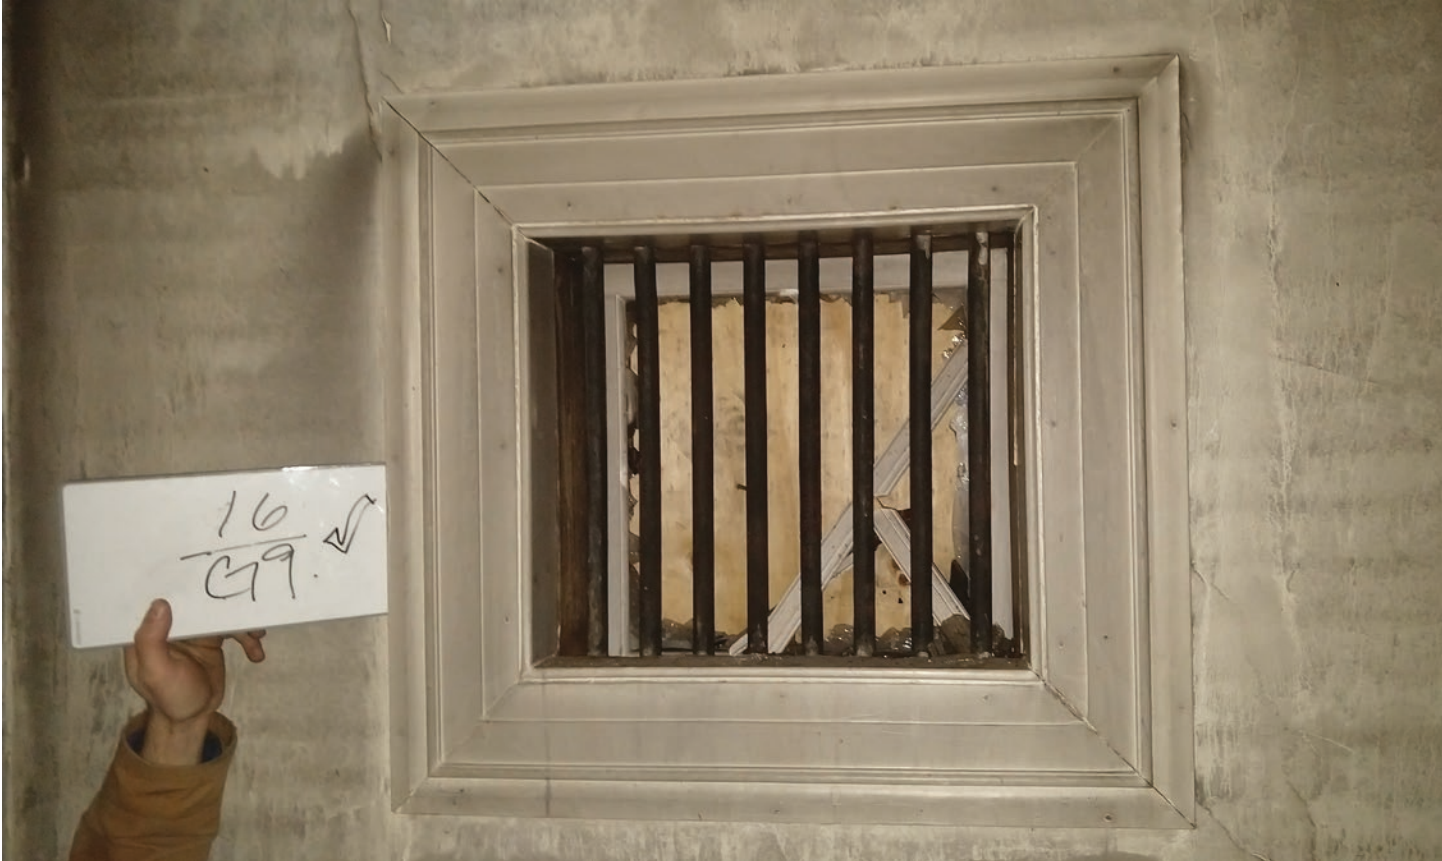
Figure 43: Building G Replacement Window

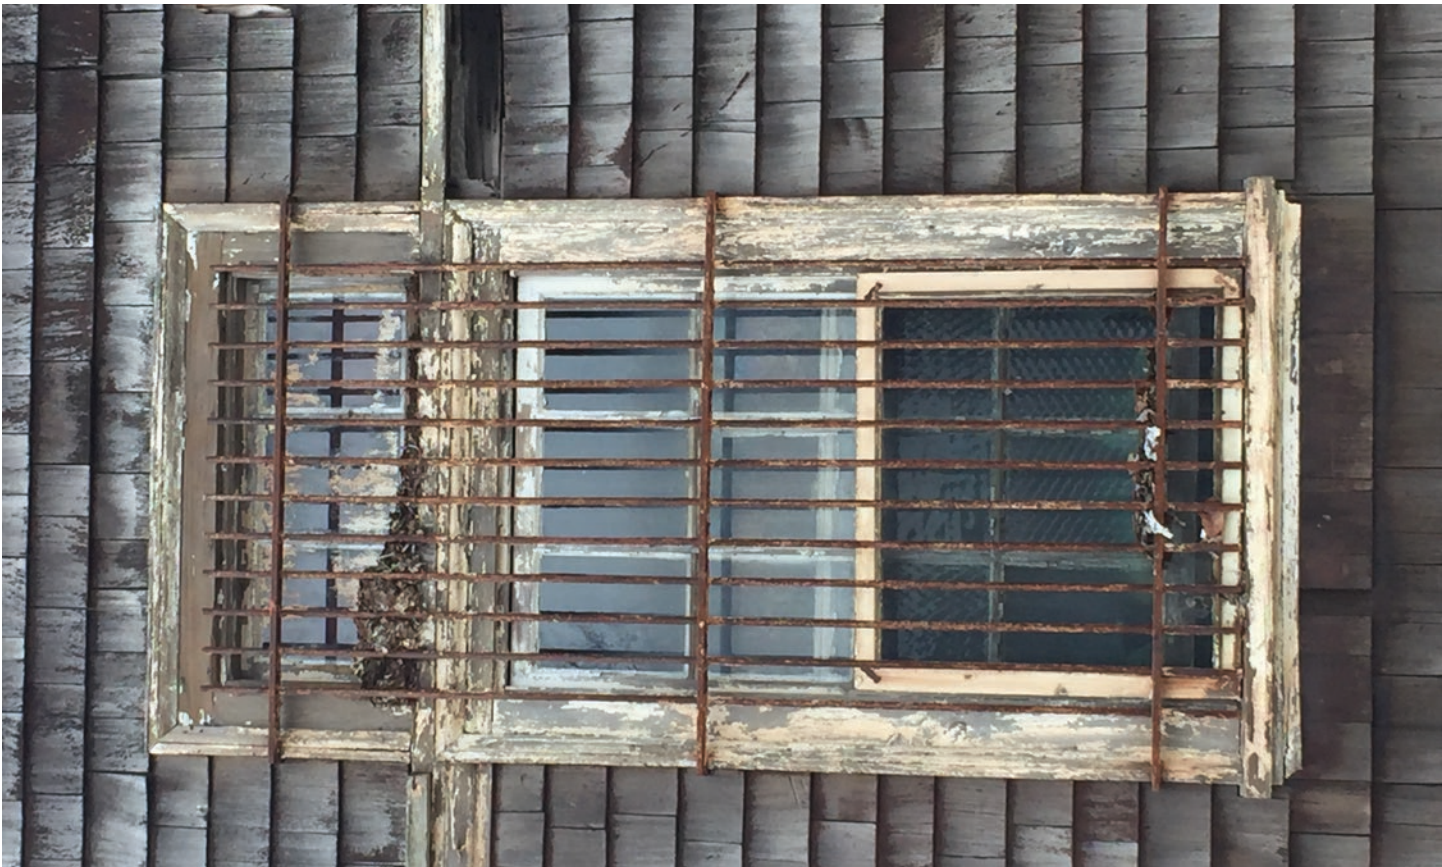
Figure 46: Building H Transom Window

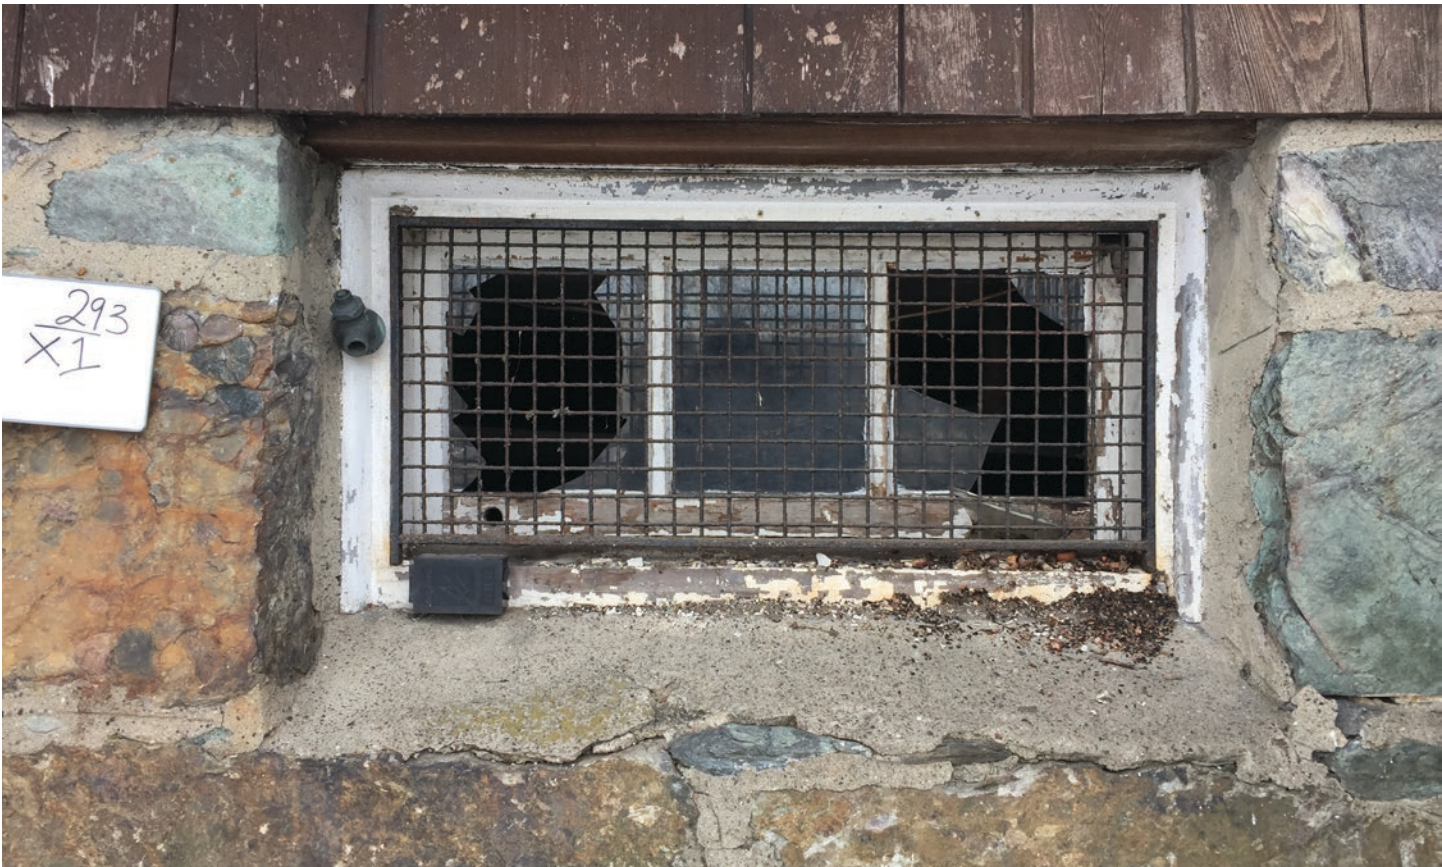
Figure 47: Building H Barred Window at Jail

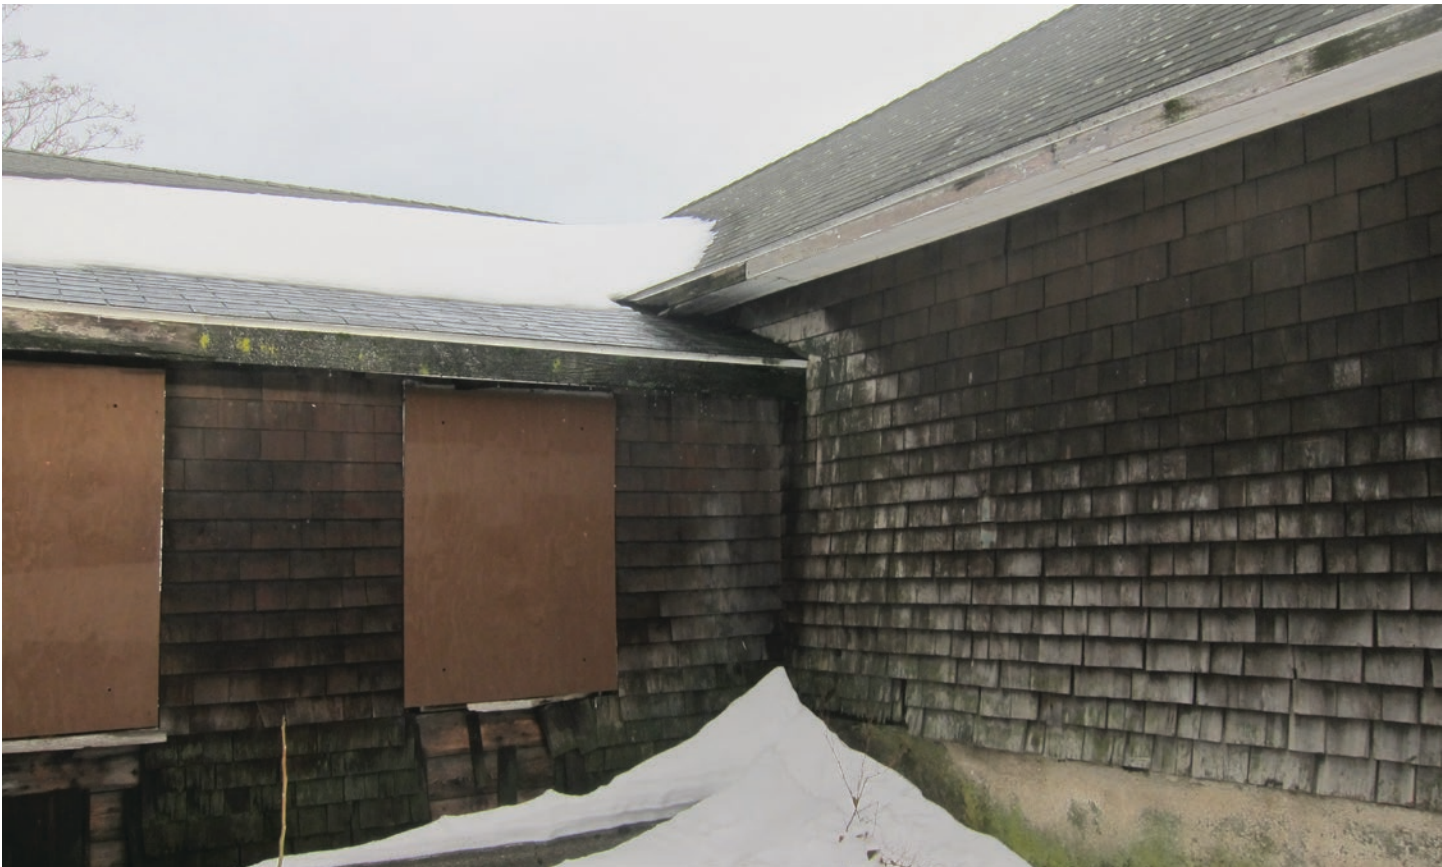
All roofs are now asphalt shingles that were installed in 1997-1998. They are in fair condition apart from where Building G was damaged by fire in 2015. That roof is lost and currently covered with a temporary EPDM covering. Building G has two large, painted steel dormer louvers that remain intact after the fire, but are heavily stained by smoke from the fire. Wood fascias and gutter boards are generally in very bad condition compared to soffits and rafter ends that support the overhanging eaves. Overall, copper flashings appear to be intact. The extended roof at the shed portion of Building H is in a different plane from the shed's main roof and in poor condition. At the Superintendent's Residence, the second-floor porch roof is a source of leaks into the house interior. There is also evidence of intermittent shingle installation on the main roof of Building F. Natural copper finials are intact over the conical roofs of circular bays at Buildings G and H.

Figure 52: Building B Roof

All existing asphalt shingles will be replaced with new asphalt shingles.

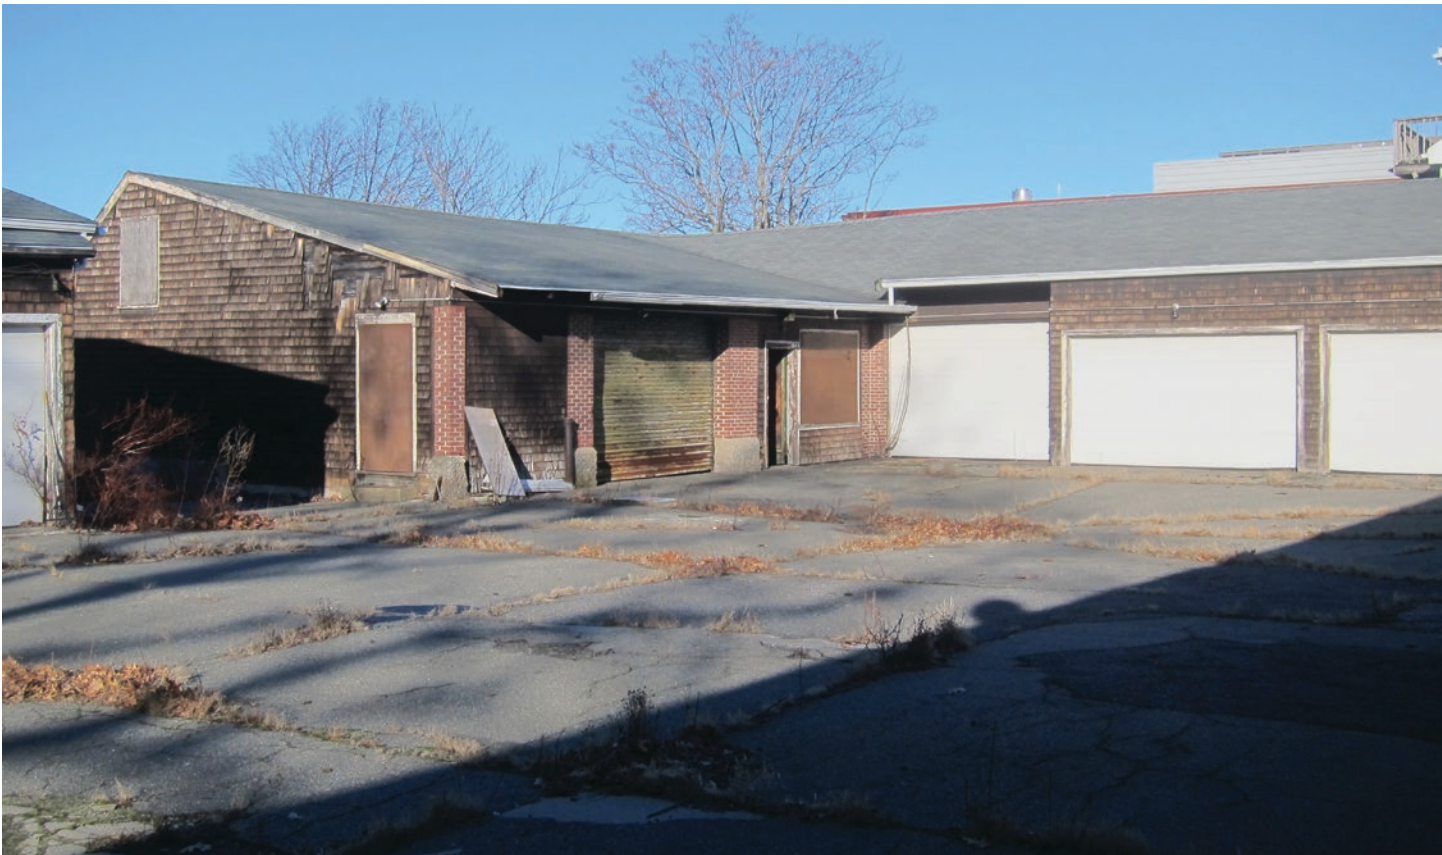
Figure 53: Building C and D Roofs

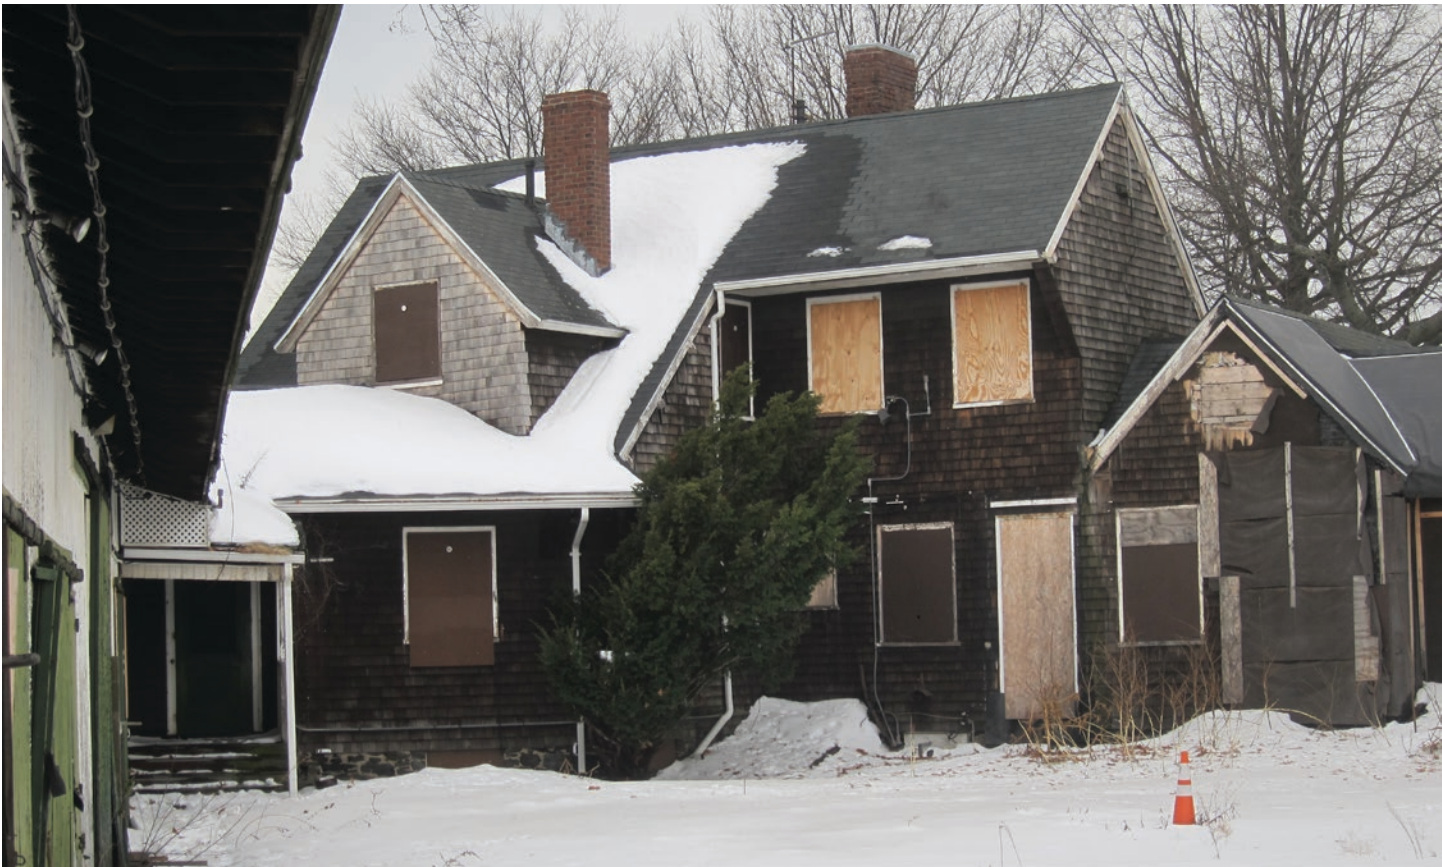
Figure 54: Building D Roof

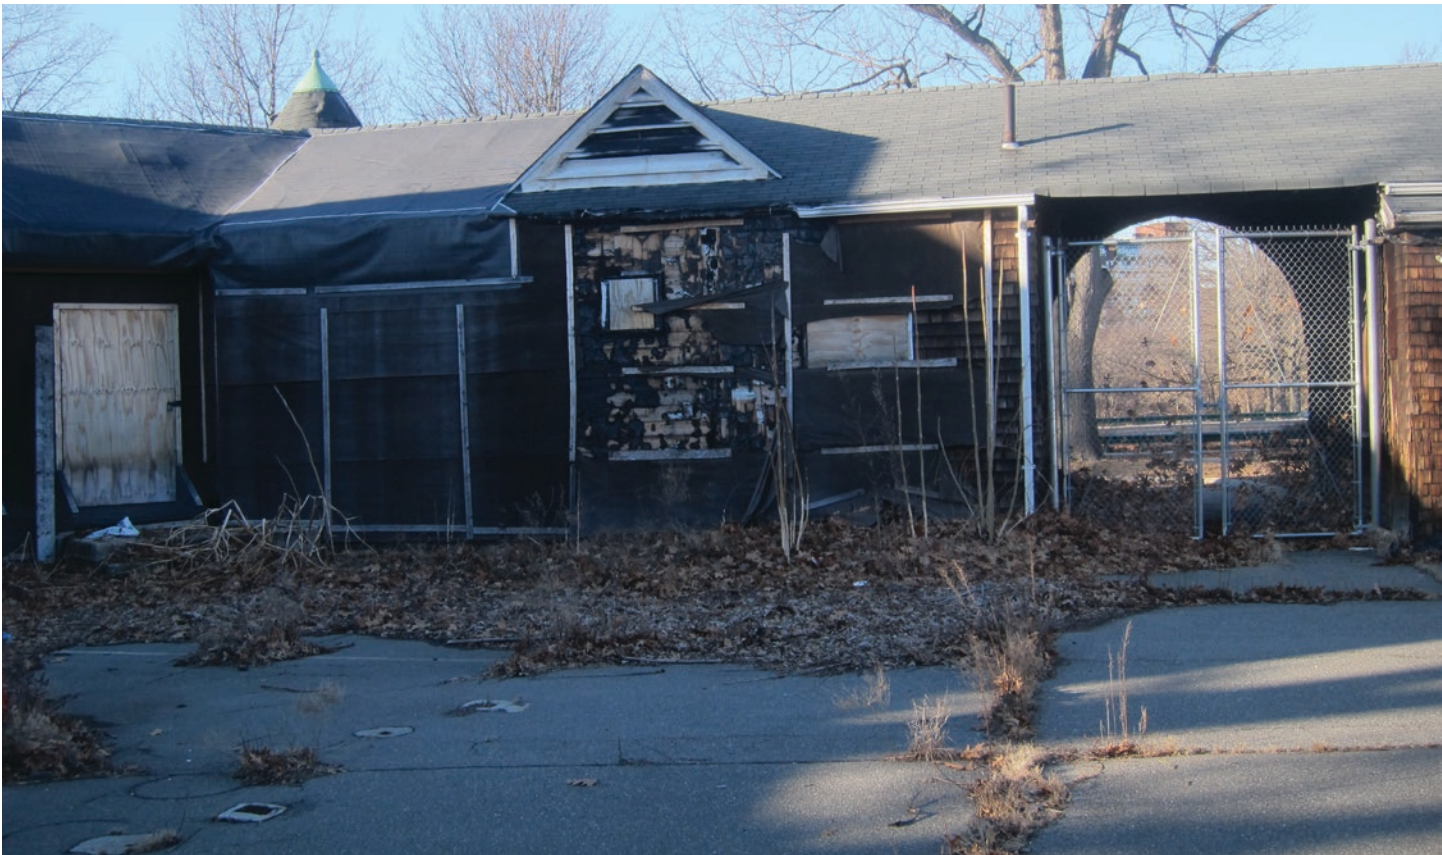
Figure 55: Building F Roof

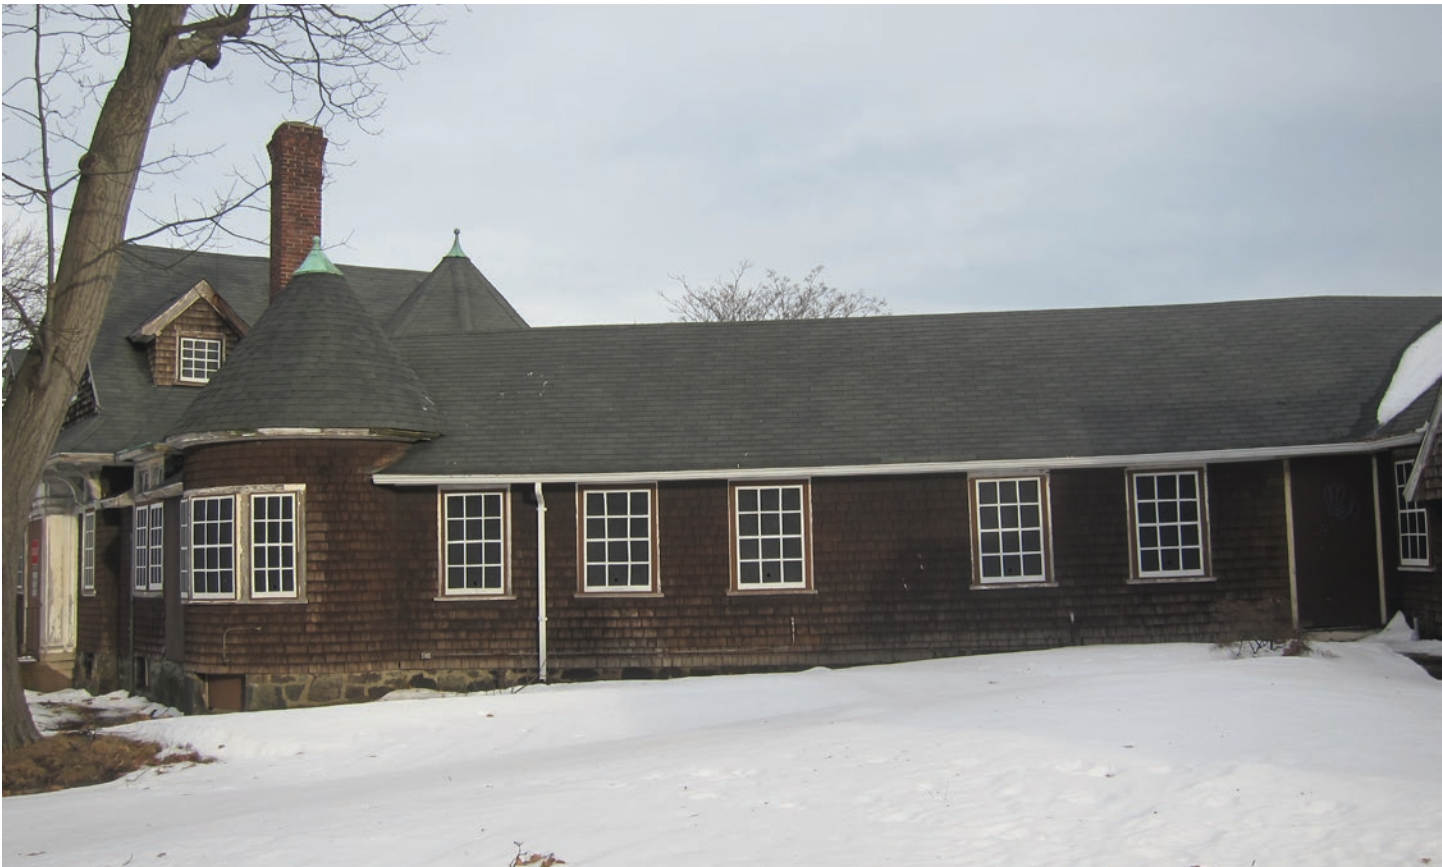
Figure 56: Building G Roof

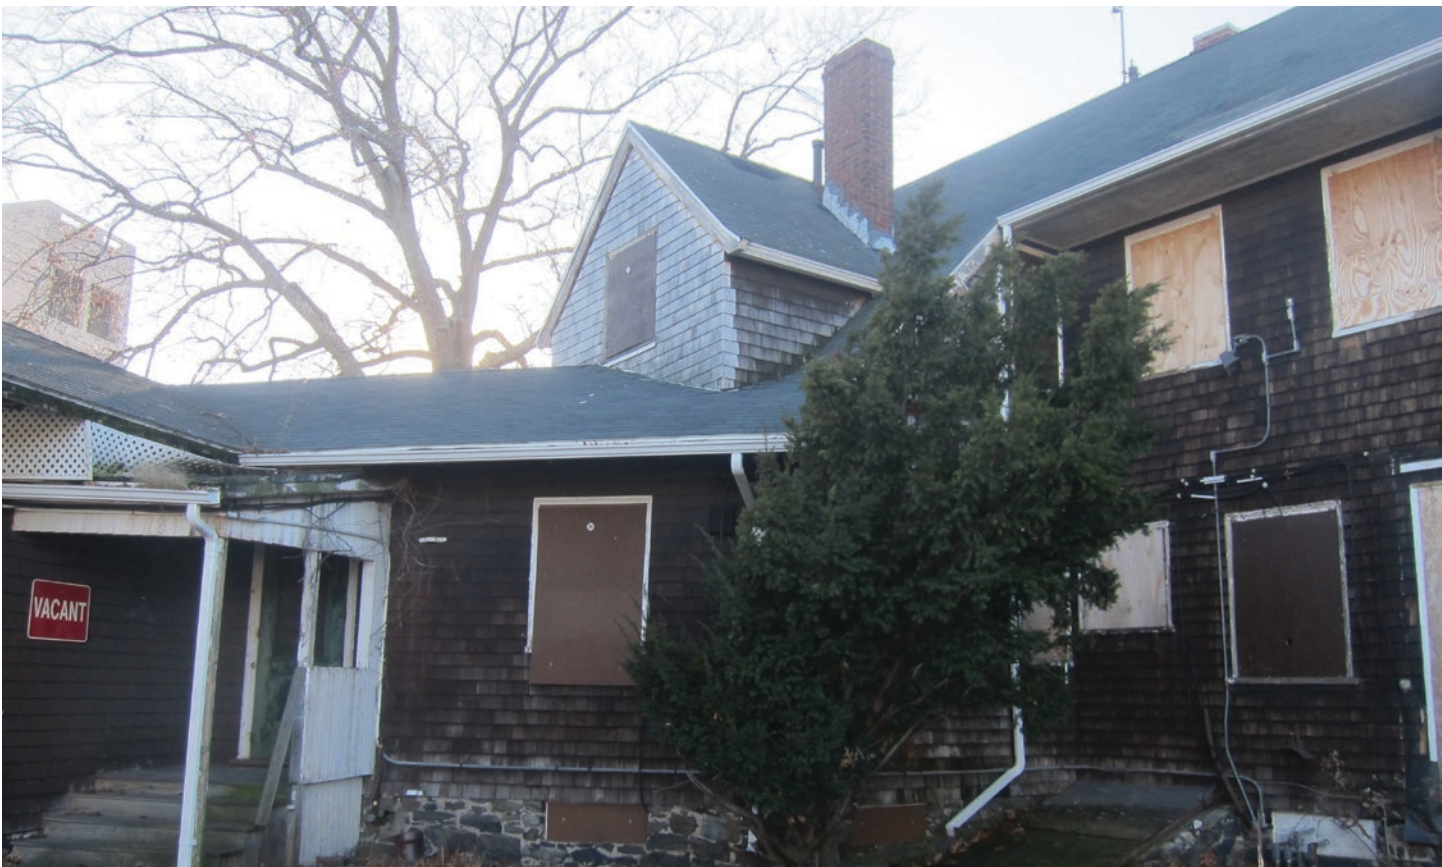
The chimneys have deteriorated, more significantly at the tops. The northernmost chimney at Building F appears to lean to the north. All roofs are in fair-to-poor condition.

Figure 59: Building B Chimney

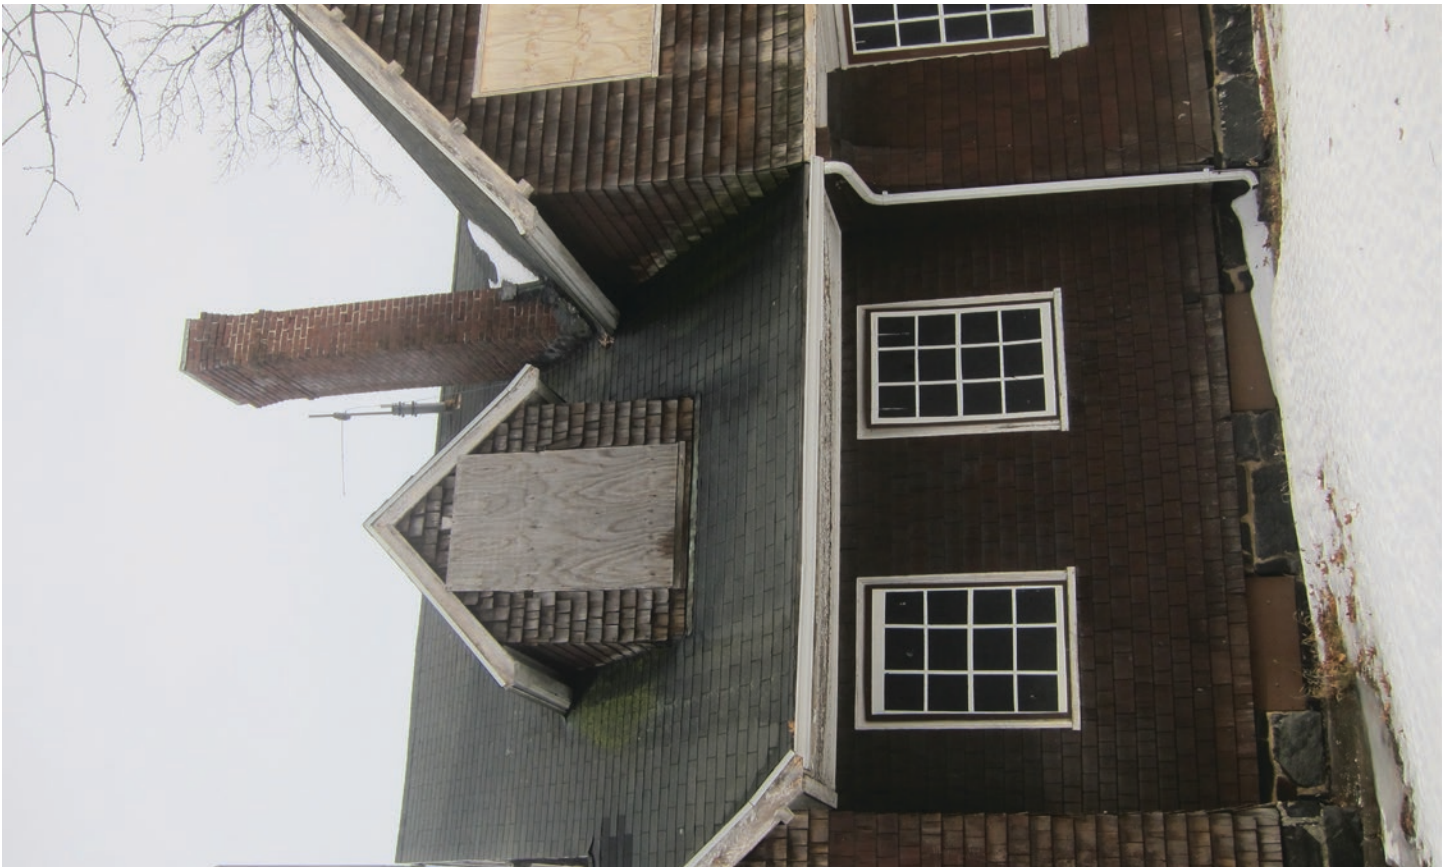
Figure 60: Building F Chimneys
