**CHARLES RIVER SPEEDWAY
BOSTON LANDMARKS COMMISSION APPLICATION**

Date: MARCH 5, 2019

1420-1440 SOLDIERS FIELD RD
BOSTON, MA 02135

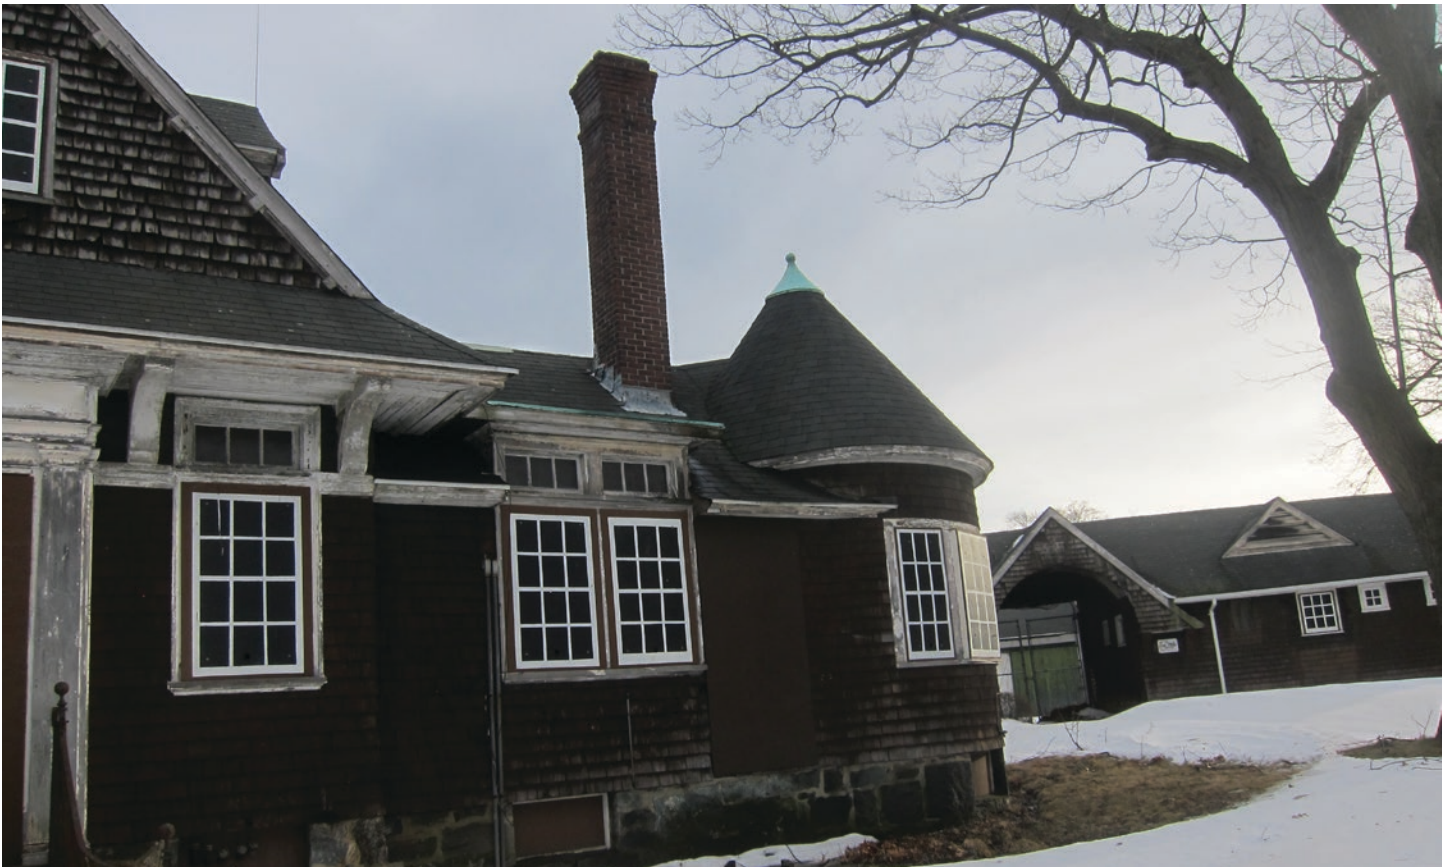
The chimneys have deteriorated, more significantly at the tops. The northernmost chimney at Building F appears to lean to the north. All roofs are in fair-to-poor condition.

Figure 61: Building F Chimney North

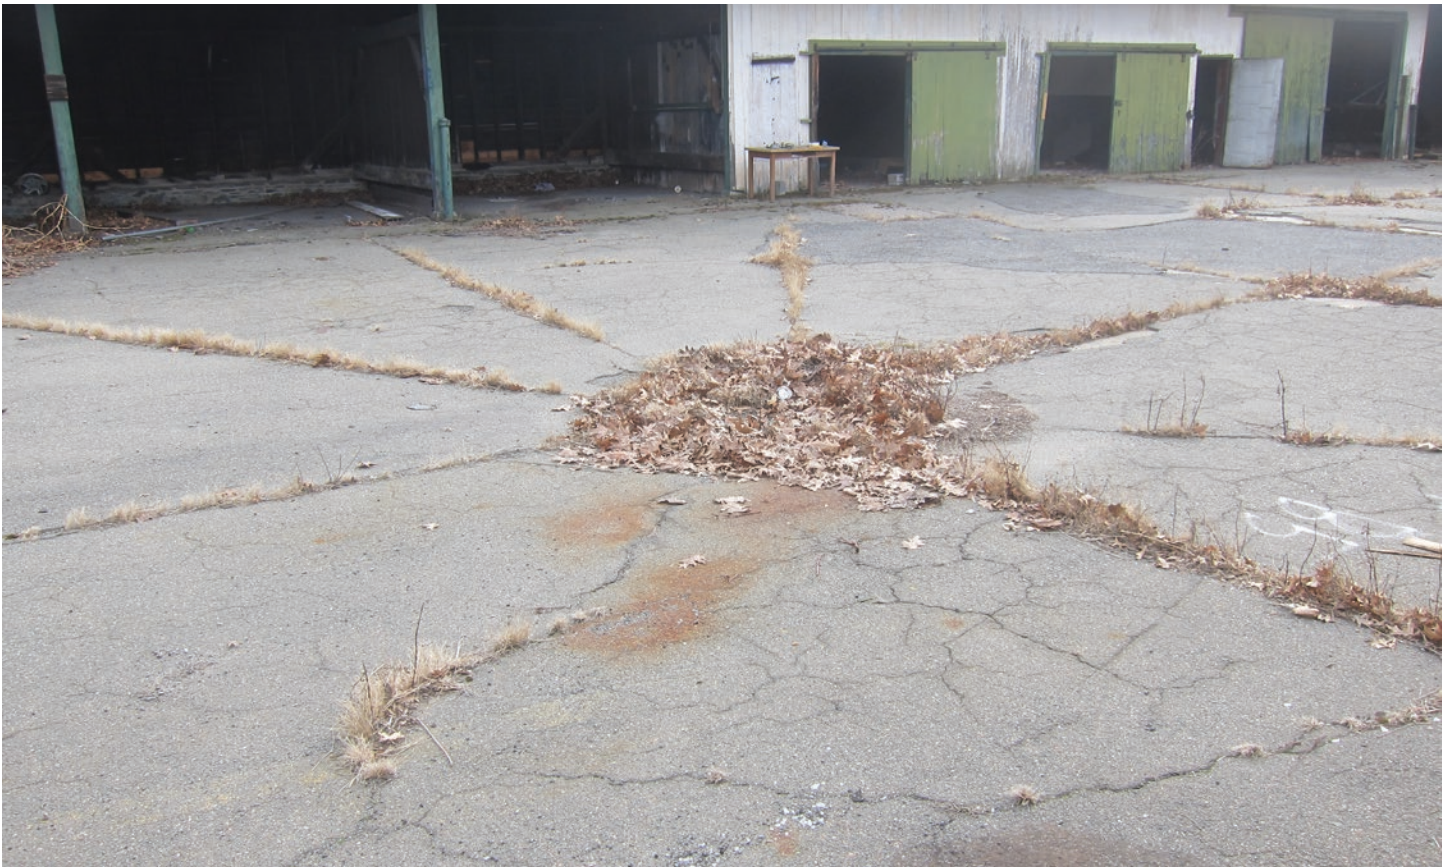
Figure 84: upper Courtyard Looking East

Concrete slabs have broken or settled along edges of their casting although their slopes to two catch basins in the upper Courtyard remain intact. Grass has established in cracks along cold joints. Much of the asphalt overlay has also broken down.

The Courtyards are in fair-to-poor condition.

Asphalt and concrete slabs will be broken up and removed. The in-ground drainage system will be removed and replaced with an infiltration system in the upper Courtyard space. The new surfaces of the upper Courtyard will include a mixture of masonry unit pavers and porous stabilized gravel to visually differentiate the spaces according to circulation and gathering areas.
