Existing Conditions and Proposed Scope of Work

Brownstone Facade Restoration: Existing Conditions

<p>BOSTON ANTHENAUEUM FACADE RESTORATION AND TERRACE REHABILITATION 10 1/2 BEACON STREET BOSTON, MA</p>	<p>BROWNSTONE RESTORATION - NORTH ELEVATION</p>	<p>SIMPSON GUMPERTZ & HEGGER Engineering of Structures and Building Enclosures</p> <p>480 Totten Pond Road Woburn, Massachusetts 02451 Phone: 781.907.7000 Fax: 781.907.7009 www.sgh.com</p> <p>Boston Chicago Los Angeles New York San Francisco Washington, DC</p>	<p>Project No. _____ Drawing No. _____ Scale: AS NOTED Date: _____ Checked: HMC Drawn: RML</p> <p>Project No. _____ Drawing No. _____ Scale: AS NOTED Date: _____ Checked: HMC Drawn: RML</p>
--	--	---	---

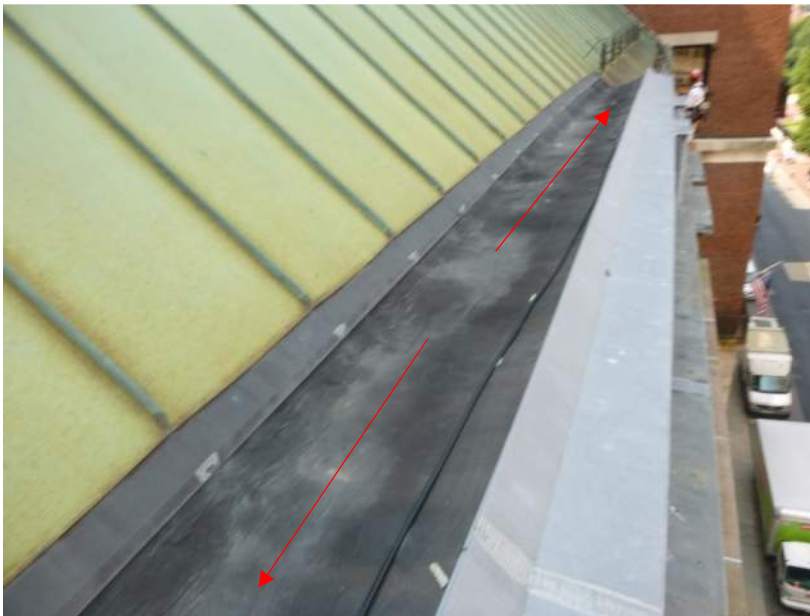
Photo 10

The standing-seam copper roof at the center bay at the north elevation above the main entrance drains into an EPDM-membrane-lined gutter. The EPDM membrane is sloped from the center toward the metal-lined built-in gutter on both sides (red arrows).

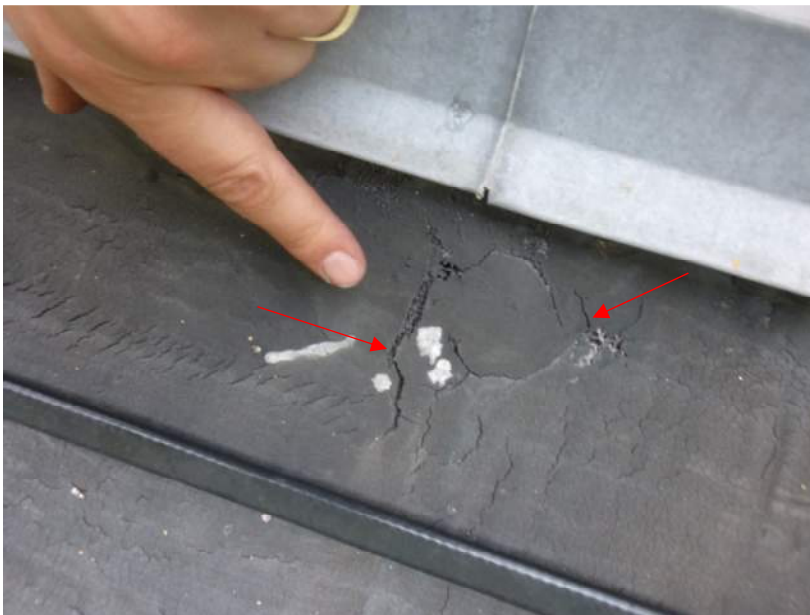
Photo 11

Arrows identify splits in the EPDM-membrane-lined gutter above the center bay at the north elevation.

- Repair-in-kind or replace existing deteriorated or leaking copper gutters with new copper gutters
- Restore cast stone upper north façade (set-back above roof):

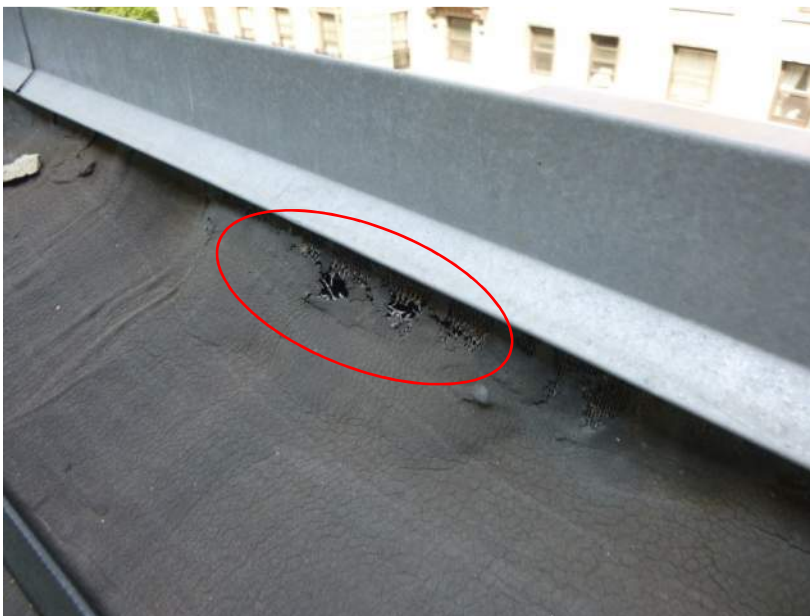
Photo 12

Holes in the EPDM-membrane-lined gutter at the center bay at the north elevation.

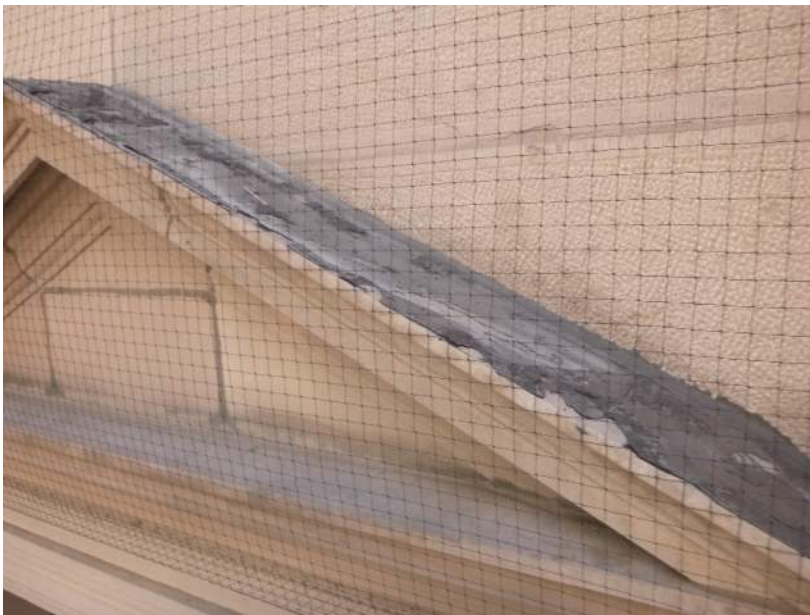
Photo 21

Remnants of self-adhered membrane above second-floor windows at Beacon Street facade.

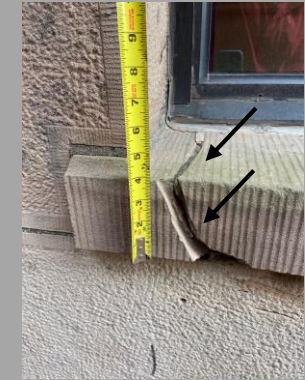
- Existing stone at north elevation is New Jersey Brownstone.
- Existing conditions consist of spalled, cracked or otherwise deteriorated stone and mortar that needs to be addressed for technical reasons, such as:
 - Spalled or delaminated stone pose potential life safety hazards (Photo 1).
 - Cracks in spanning stones alter the structural behavior of the stone (Photo 2).
 - Cracks and voids provide gross paths for water infiltration and increase the rate of future deterioration in the adjacent masonry (Photo 3).

PHOTO 3 – EXAMPLE OF CRACKED SILL STONE (ARROW).

- Repair cracked or deteriorated stone using new natural brownstone to match existing
- Repoint deteriorated mortar joints, with mortar to match existing

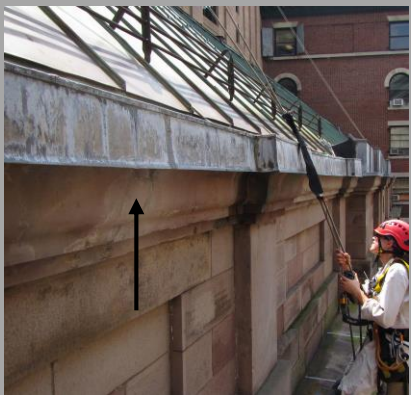
- In addition to scattered brownstone issues described previously (e.g. at lintels, sills, field stones), there are concentrated areas of spalled, eroded and delaminated brownstone are primarily due to:
 - Leakage at the third-floor gutter (Photos 4 to 6).
 - Unprotected sky-facing ledges, such as above the main entry (Photos 7 and 8).
- The fundamental cause for third-floor gutter leakage is inadequate provision for drainage (only two down leaders are present at small alleyways (returns) on the north elevation, indicated by red in the elevation at right, and inadequate provision for thermal movement).

PHOTO 4 – OVERVIEW OF THIRD-FLOOR GUTTER ABOVE MASONRY CORNICE.

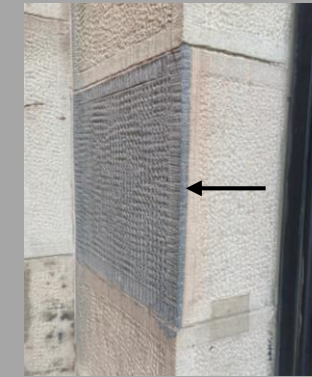
- Previous repair campaigns relied on pigmented repair mortar mixes, rather than in-kind replacement with natural stone, and create a range of mis-match repairs on the primary north façade (Photos 9 to 11).
 - Some previous repairs are not durable and/or are already failed (e.g. eroded, cracked, debonded from the parent stone, etc.).
 - Some previous repairs provide a better visual match to the existing natural stone than others, both in color and texture.
 - Some previous repairs are more conspicuous due to their geometry and proximity to the main entrance and terrace.
- The brownstone features a variety of surface stains, such as biological growth, dark carbon staining, water staining, etc. (see elevation).

PHOTO 9 – EXAMPLE OF MIS-MATCH PREVIOUS REPAIRS (ARROWS).

- Tier 2 (medium priority): To the extent the budget and schedule allow, replace previous (intact) mis-match repairs that are highly visually conspicuous (e.g. do not provide a reasonable match to the existing stone color/texture AND are located within the vicinity to the main terrace and entry).

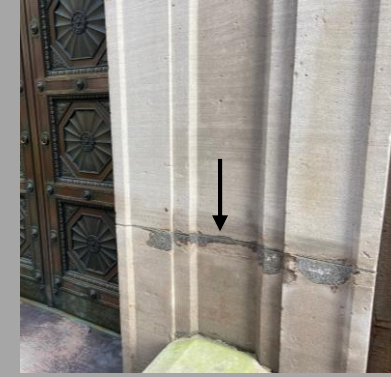
PHOTO 10 – EXAMPLE OF MIS-MATCH PREVIOUS REPAIR THAT IS SEPARATED FROM PARENT STONE (ARROW).

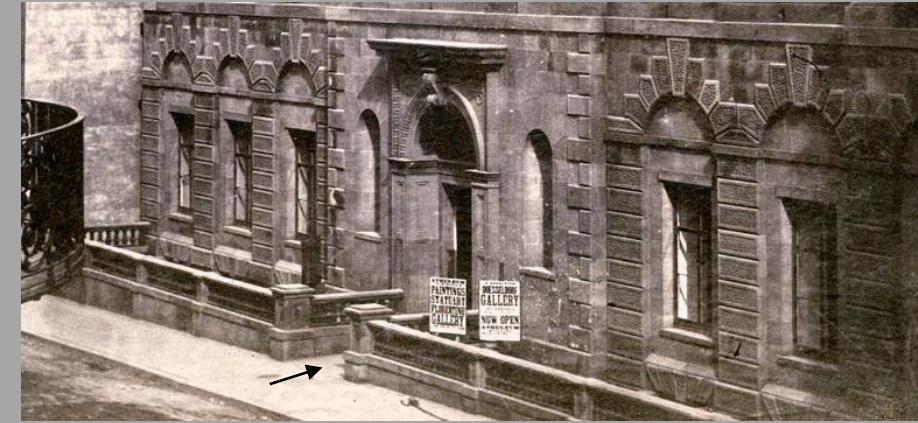
- The original terrace wall was a free-standing wall at the perimeter of a light well, and the sidewalk elevation was maintained up to the building entry (Photo 15). In the 1950's to 1960's, the lightwell was infilled to create the existing terrace and, as a result, the free-standing walls became a retaining wall for the new infill. At this time, the stairs were moved closer to the sidewalk to provide accessible entry at the terrace level.

PHOTO 15 – HISTORIC PHOTOGRAPH FROM BOSTON ATHENAEUM WEBSITE INDICATING ORIGINAL LIGHTWELL AND FREE-STANDING PERIMTER WALL. NOTE THAT EXISTING STAIRS (ARROW) NOT PRESENT.

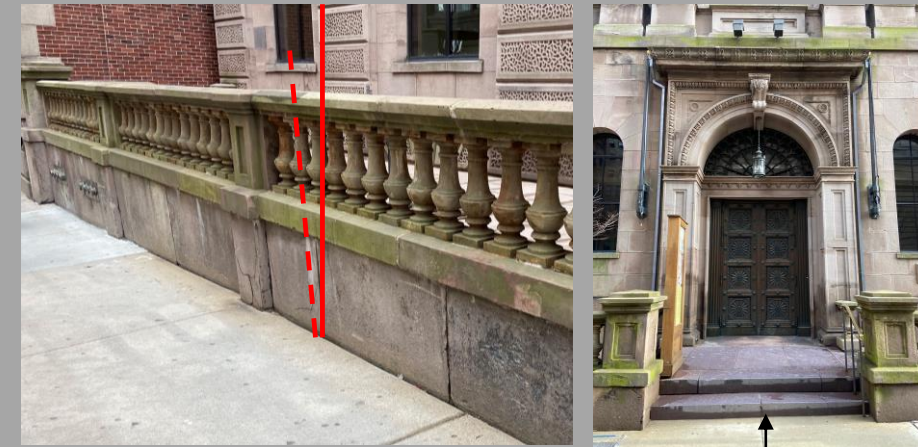
- Due to lateral loads associated with the infill, the terrace walls are rotated out outward from the terrace, toward the sidewalk (Photo 16). Additionally, the terrace is not well designed to drain and currently requires frequent use of de-icing salts in winter months to reduce slip hazards, which adversely affects the condition of the adjacent historic masonry.

PHOTO 16 – LEFT: ORIGINAL FREE-STANDING WALL AT INFILLED TERRACE IS ROTATED (DOTTED RED LINE RELATIVE TO SOLID RED LINE) DUE TO LATERAL PRESSURES FROM INFILLING THE LIGHTWELL. RIGHT: EXISTING LOCATION OF STAIRS.

- Reconstruct leaning terrace retaining wall by dismantling the existing deteriorated and displaced brownstone wall, constructing a new structural reinforced concrete retaining wall behind, an installing a new 4" thick outer wythe of natural brownstone to match the original brownstone in size, color, and coursing/joint layout, with mortar to match existing

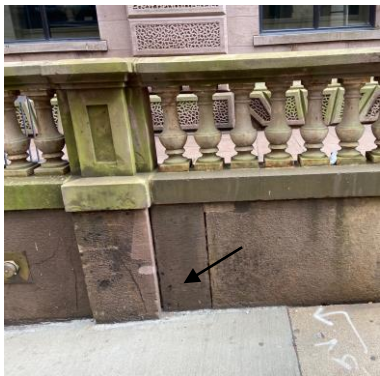
- Additionally, the following elements associated with the terrace are deteriorated:
 - Brownstone at or near grade is damaged and deteriorated in many locations, which is consistent with frequent use of deicing salts and snow removal at the sidewalk (Photo 17).

PHOTO 17 – OVERVIEW OF TERRACE WALL, WITH CRACKED STONE (ARROW) NEAR GRADE.

- Restore cracked or deteriorated brown stone using new natural brownstone to match existing
 - Obtain variance from City for the lower-than-code-required height and unknown strength of the refurbished historic balustrade. If variance is not granted, install new slender black metal railing behind the existing balustrade that meets current code requirements, and is in keeping with the character of other historic ironwork on the building exterior.

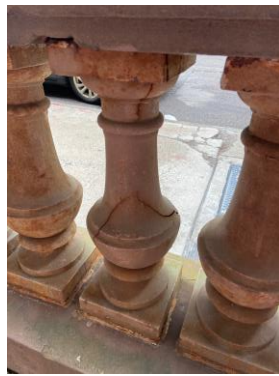
- Cast iron balustrade is corroded, cracked and spalled in some locations, and much of the sand-finished paint is missing (Photo 18).
- The terrace features a non code-compliant railing and uneven walking surface (Photos 19 and 20).

PHOTO 18 – VIEW OF CORRODED AND CRACKED BALUSTRADE.

- Cast iron baluster restoration to include cleaning and removal of corrosion scale and staining, and existing sanded-paint from all balusters, replacing the worst damaged balusters with "attic stock" originals in storage in the building, and repairing remaining less damaged balusters

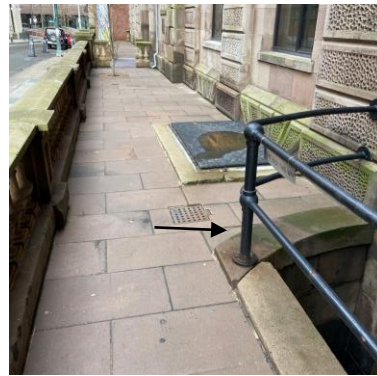
PHOTO 19 – NON CODE-COMPLIANT RAILING (ARROW).

- Replace non-code compliant railing atop basement stairwell at employee entrance. Current 20th century pipe railing creates dangerous fall hazard to concrete stairwell below on busy street. Replace with code-compliant railing with traditional appearance that is in keeping with the original character of the building.

- Replacement of non code-compliant railing at staff entry with historically appropriate railing.
 - Coordinated with City to adjust sidewalk elevation offset relative to accessible terrace entrance.

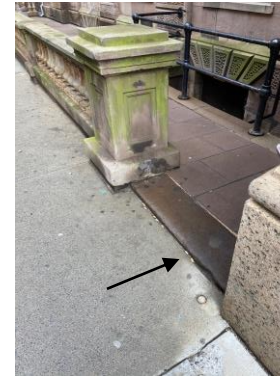
PHOTO 20 – VERTICAL OFFSET BETWEEN SIDEWALK AND STONE TREAD (ARROW).

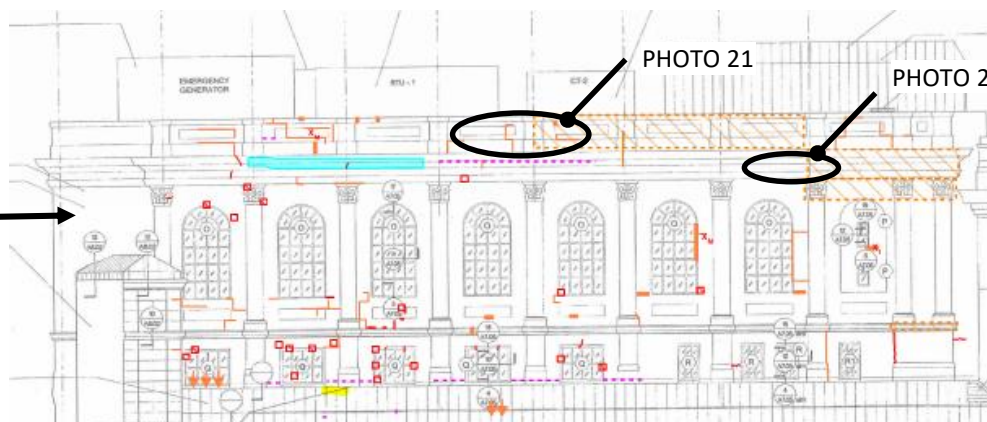
CAST STONE FACADE EXISTING CONDITIONS

- Cast stone is deteriorated and/or stained in several locations, as indicated in the annotated elevation.
- Cast stone, like the brownstone below, has undergone numerous repair campaigns (Photos 21); however, these repairs are less visually conscious due to the cast stone being several stories above and set back from grade.
- Thus, the base scope of this project includes:
 - Cast stone repair only where required to address potential falling hazards, structural issues, and improve the overall water-tightness of the façade.
 - Cast stone cleaning to address dark staining (Photo 22).
