CERTIFICATE OF APPROPRIATENESS APPLICATION

Date: April 29, 2021

Re: Replacement of Downspout Brackets
119 Tremont Street / Park Street Church

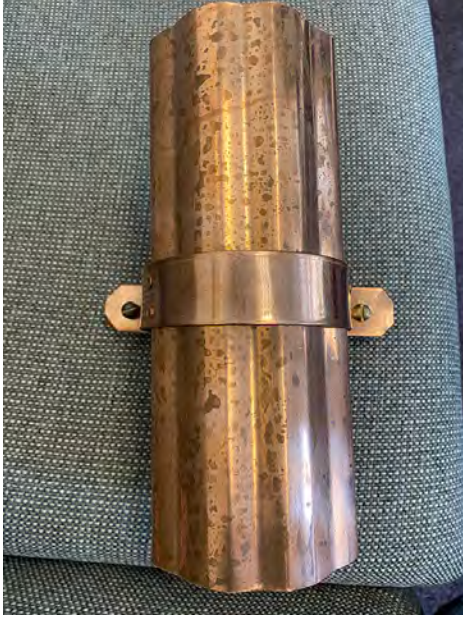
210428-IMG_9064.JPG

SAMPLE OF REPLACEMENT BRACKET

- Remove painted metal and wire brackets from existing painted copper downspouts.
- Install painted copper downspout brackets with secure attachment to downspouts and walls.
- Provide fasteners into mortar joints in order to avoid damage to individual bricks.
- Replacement brackets shall be painted to match existing downspouts.

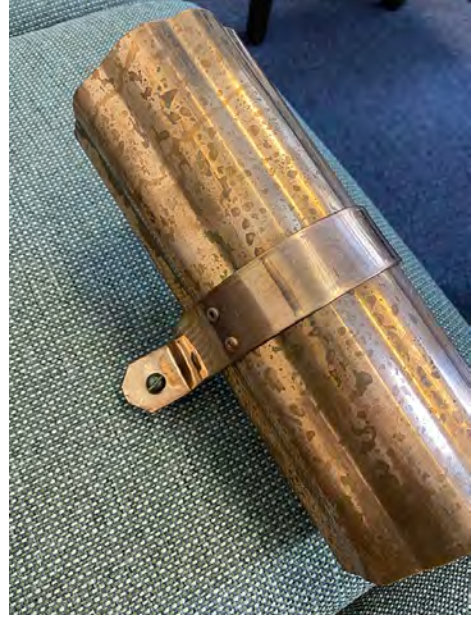
210428-IMG_9065.JPG

SAMPLE OF REPLACEMENT BRACKET
