## The Cornerstone Project

# 97-101 NEWBURY St. – FRONT ENTRY LANDSCAPE BACK BAY ARCHITECTURAL COMMISSION

01 / 11 / 2023

Tree Report at 97 Newbury St, Boston, MA

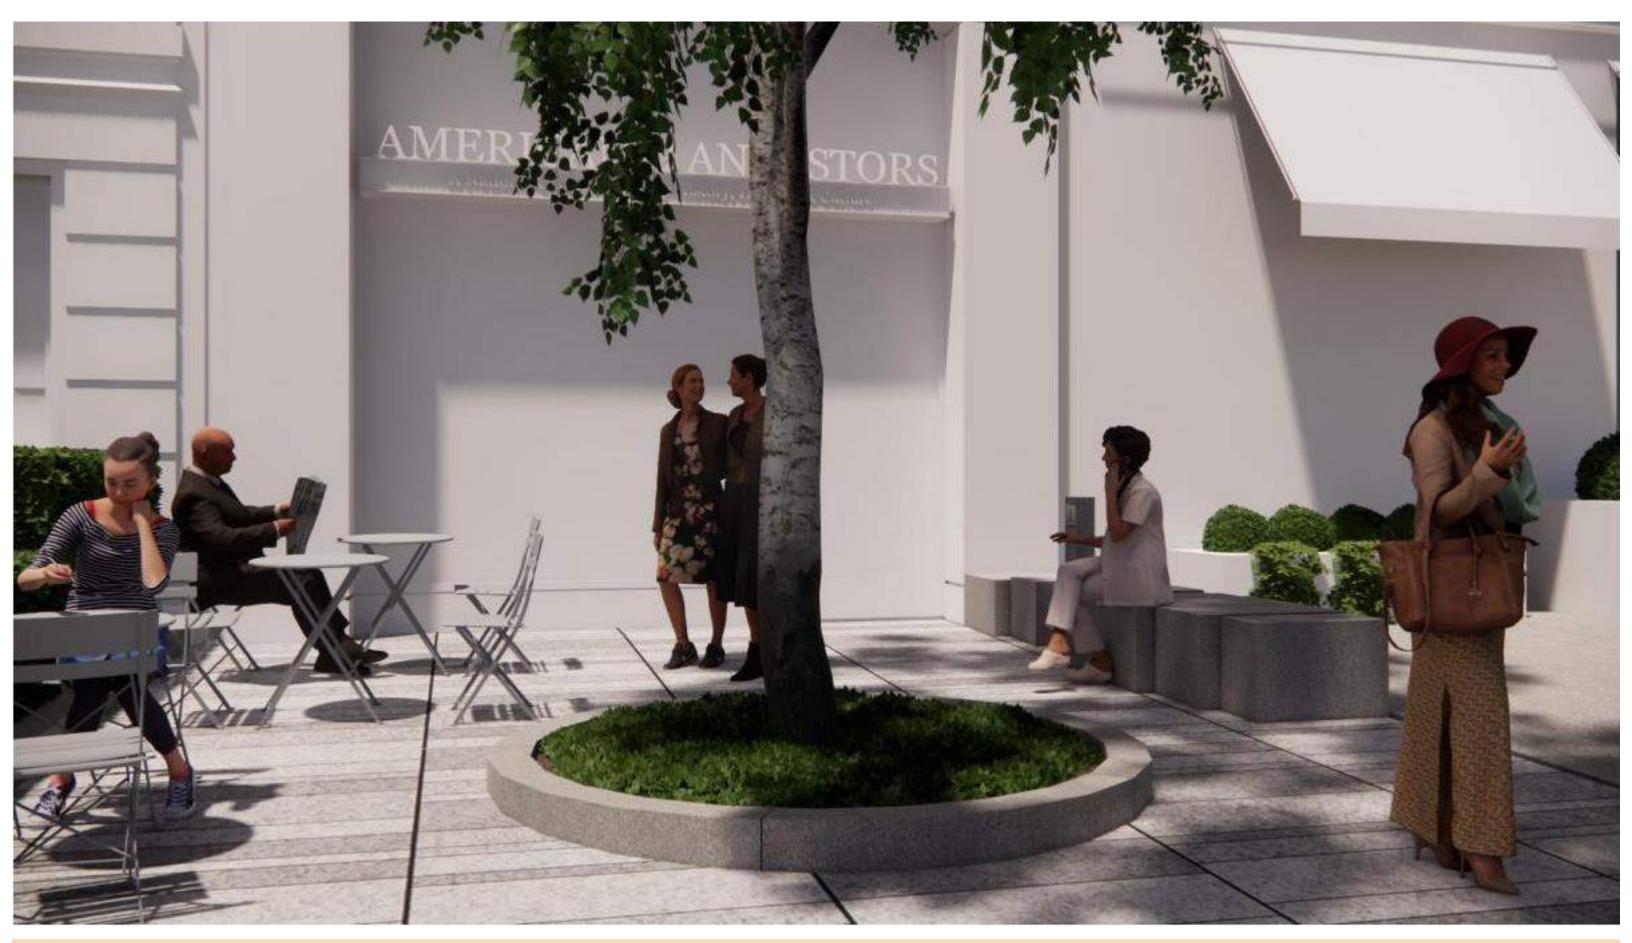
A European birch (*Betula pendula*) tree was growing within a raised granite planter in front of the building. This tree was determined to be in poor condition (Photo 1). The birch had a trunk diameter of 13 inches and was located within a raised planter with limited soil volume.

The tree is in poor condition. There is significant dieback in the upper canopy. European birch is especially susceptible to bronze birch borer. The dieback may be attributed to these borers. Additionally the upper canopy was thin and leaf size was reduced when compared to the lower canopy. These are symptoms of a decline in tree health/vigor.

This birch tree will be recommended for removal in order to complete this construction
