Details of Scope of Work for Final Phase of First Church in Roxbury Exterior Renovation Continued from page 1

FIRST CHURCH ROXBURY
UNITARIAN UNIVERSALIST URBAN MINISTRIES

COMMUNITY OUTREACH GROUP FOR LANDSCAPE DESIGN

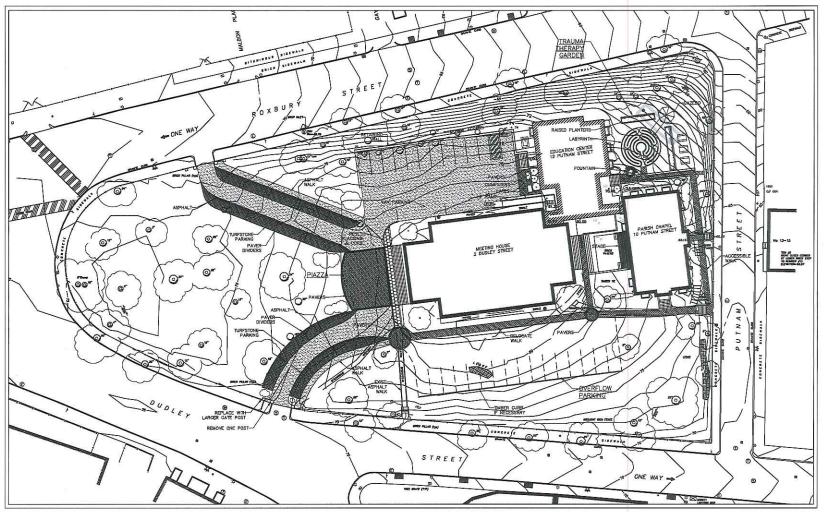
The proposed paving will re-establish the historic drives and paths on the west elevation of the Meetinghouse. This work will include rebuilding the semi-circular drive that connects the north and south vehicle/pedestrian gates. It will re-design the parking at the west elevation (front) of the building to minimize its impact on the view of the historic Meetinghouse. It will also create additional parking on the north side of the building.

The drives that surround the Meetinghouse are presently packed dirt and mostly surfaces that have been adopted for parking without suitable subsurface preparation. Their surfaces are uneven. They are muddy in spring and difficult to plow in winter. The poor condition of the drives precludes good maintenance of the grounds and the random parking on the property presents safety issues when events are held in the Meetinghouse.

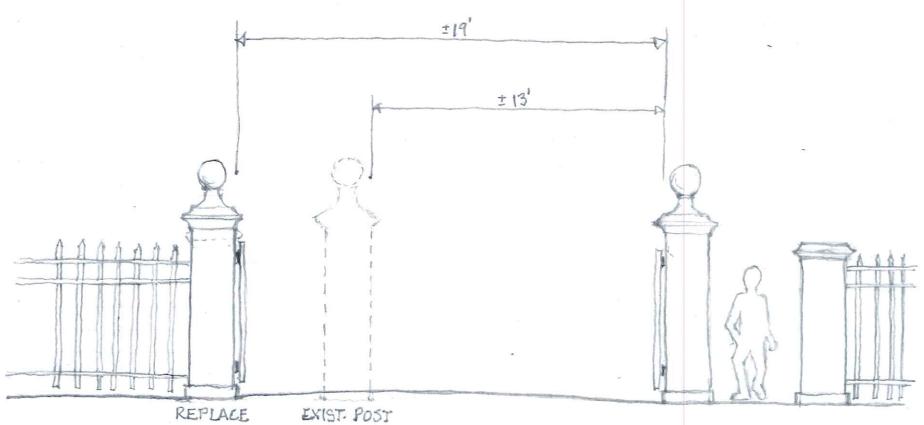
DUDLEY ST. GATE

EXIST. POST

The proposed work will rebuild the gates using the existing ironwork, but will eliminate one of brick piers on each side of the gates. The brick piers will be disassembled and rebuilt in their new location. The ironwork will be removed and shop-treated – existing paint removed, damaged ironwork repaired, repainted and reinstalled. At the completion of the work, the gates, which currently are not operable, will open and close.

When rebuilt, the brick piers will be wired so that they will have lamps at their tops rather than cast stone finials, as was their original design. The existing cast stone finials have multiple cracks and one is missing. They are not in a condition where they can be repaired.
