PROPOSED BUILDING RENOVATION

541 MASSACHUSETTS AVENUE BOSTON, MA

SCOPE OF EXTERIOR WORK

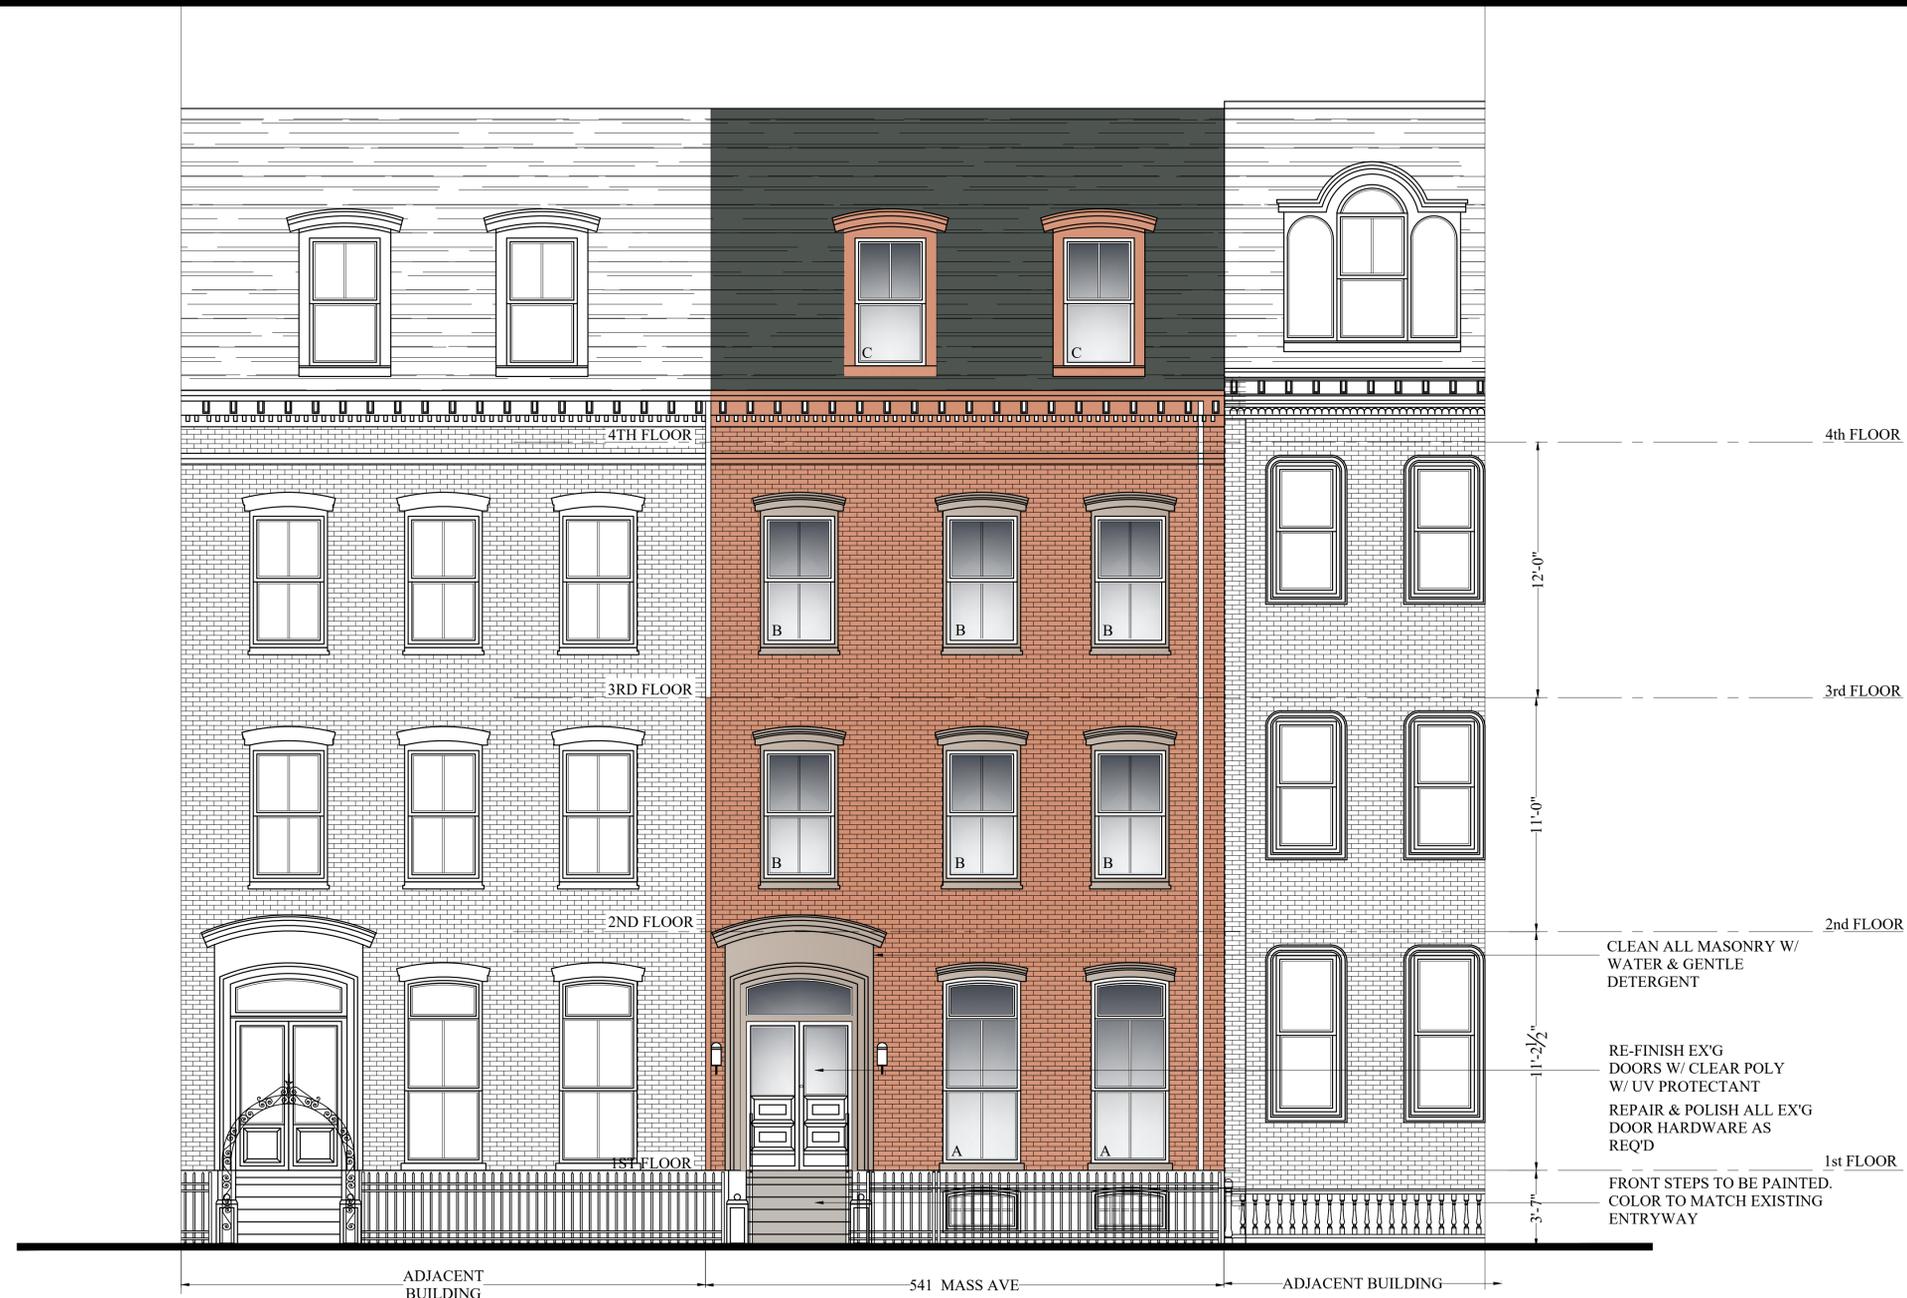
PROPOSED FRONT (MASSACHUSETTS AVE) ELEVATION
1/4" = 1'-0"

- BUILDING TO BE WASHED DOWN WITH WATER ONLY TO WET SURFACES INITIALLY. DILUTED CLEANING PRODUCT (DILUTION RATES TO BE DETERMINED DURING SAMPLE PHASE) TO BE APPLIED TO SURFACE AND SCRUBBED INTO WALL. WALL TO BE RINSED WITH WATER.
- TYPICALLY USE PROSOCO FAMILY OF CLEANING PRODUCTS VARYING FROM MILD TO STRONGER CLEANERS DEPENDING ON RESULTS ACHIEVED.
- SAMPLE CLEANING OF DISCREET LOCATIONS USING VARIOUS MEANS AND METHODS INCLUDING DIFFERENT PRODUCTS TO BE COMPLETED AND REVIEWED IN ADVANCE.

- IF REPOINTING IS NEEDED EXISTING MORTAR JOINTS TO BE CUT OUT USING A COMBINATION OF MECHANICAL GRINDERS AND HAND TOOLS TO COMPLETE HEAD JOINTS.
- SAMPLES OF REPOINTING TO BE COMPLETED IN ADVANCE FOR REVIEW AND APPROVAL OF COLOR AND FINISH.

- IF BROWNSTONE NEEDS REPAIRS, CUT BACK TO STABLE MATERIAL AND REPLACE WITH CONCRETE/STUCCO MIX AND BROWNSTONE COAT.

EXISTING WINDOWS ARE NOT ORIGINAL, THEY ARE VINYL WINDOWS. WINDOWS TO BE REPLACED WITH JELD-WEN SITELINE WINDOWS. (SEE DETAILS ON A-3.2)

EXISTING TO REMAIN. RE-FINISH WITH CLEAR POLY WITH UV PROTECTANT. REPAIR AND POLISH ALL EXISTING DOOR HARDWARE AS REQUIRED.
