149 WEST NEWTON STREET
SITE LOCATION & SITE PLAN

149 WEST NEWTON STREET

DESCRIPTION OF PROPOSED WORK

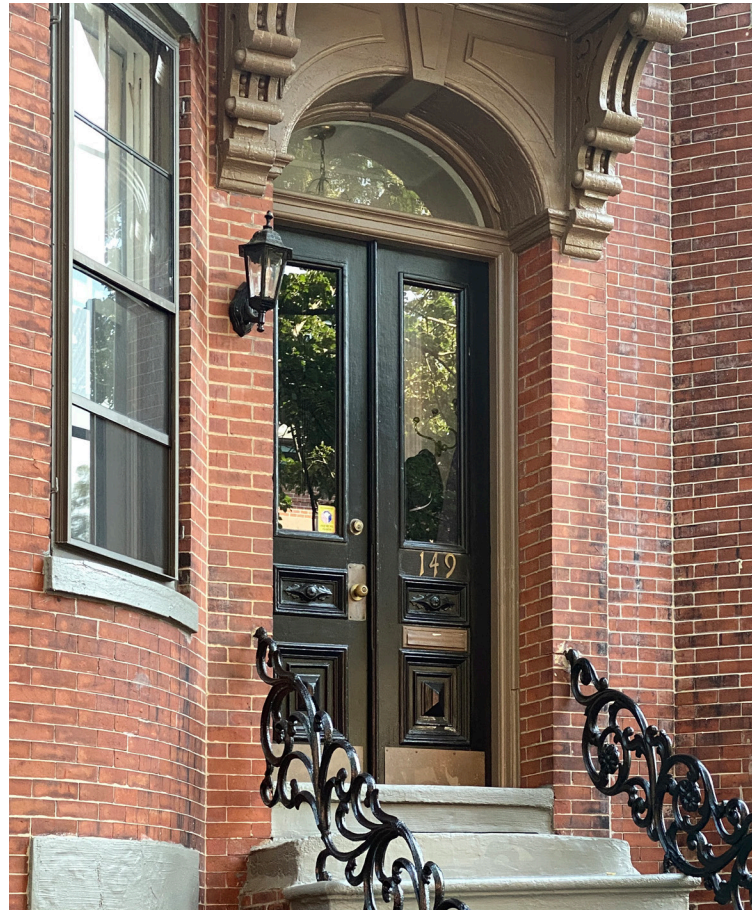
WINDOWS

FRONT ENTRY DOOR

- EXISTING FRONT ENTRY DOOR AND TRANSOM TO BE RESTORED & REPAINTED W/ NEW GOLD LEAF STREET NUMBER
- EXISTING TRANSOM GLASS INFILL TO BE CLEANED

SIDE ENTRY DOOR

- RESTORE MASONRY OPENING
- INSTALL NEW HISTORICALLY ACCURATE ARCHED-TOP WOODEN DOOR TO MATCH CONTEXT

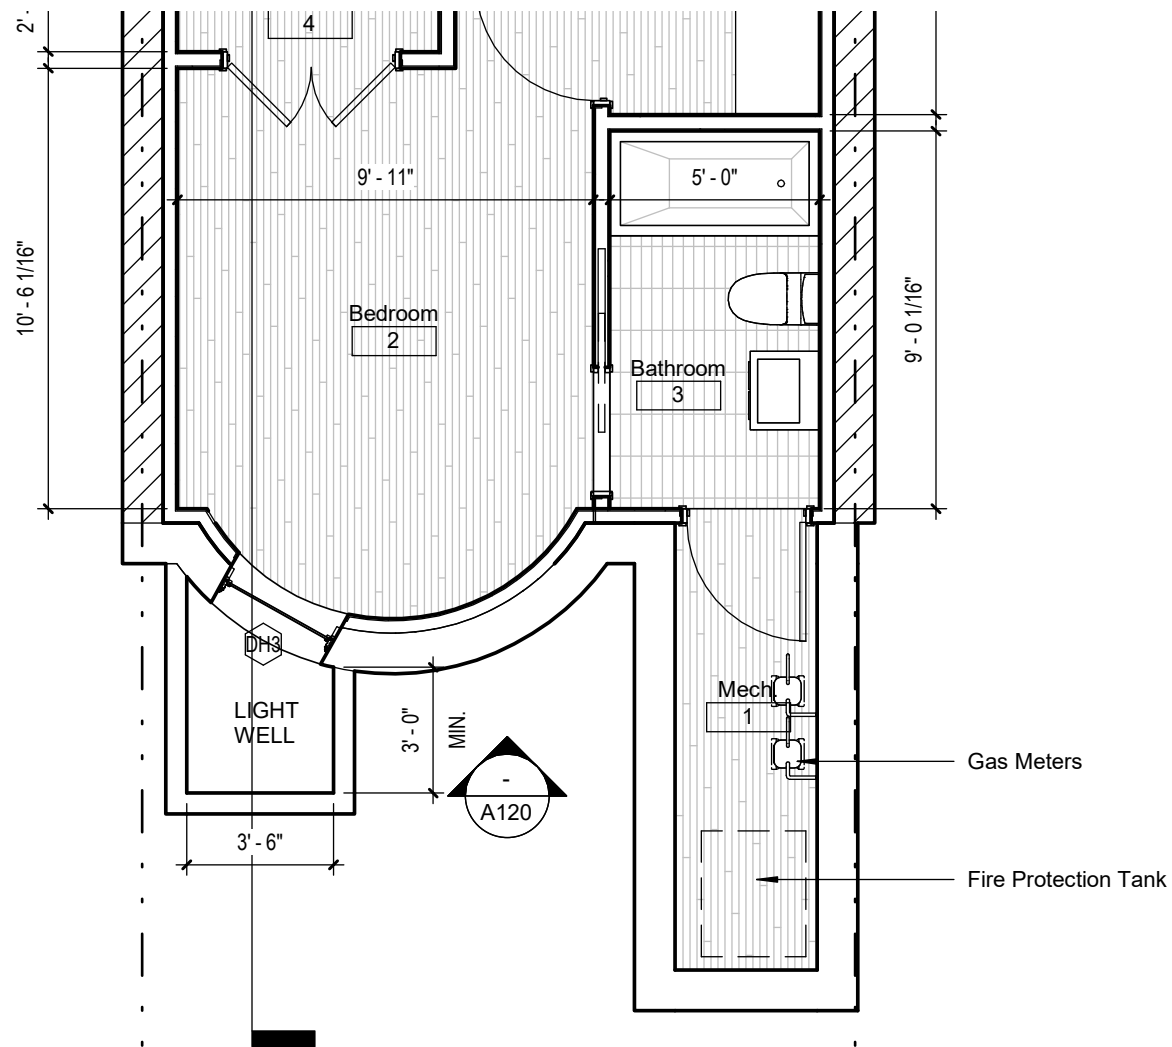
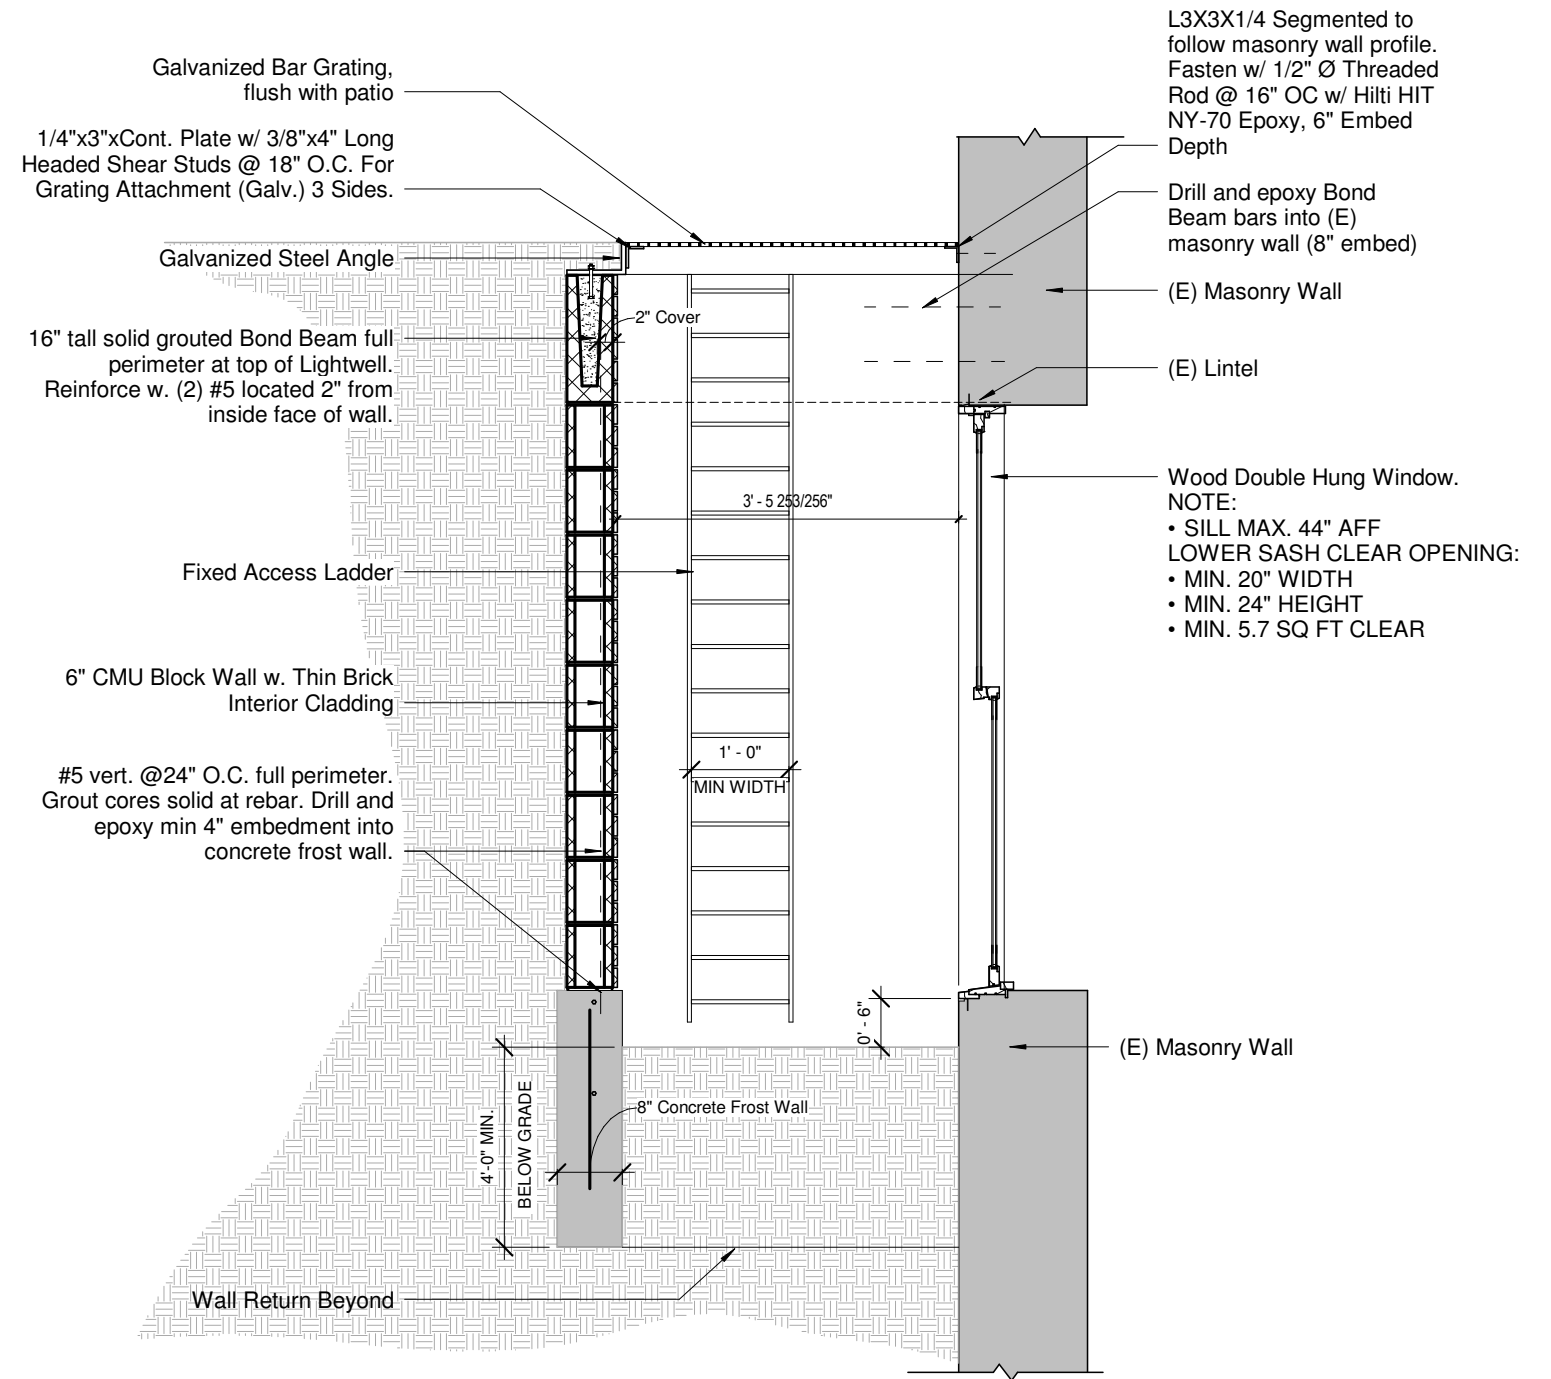
RESTORE ORIGINAL LIGHTWELL AT GARDEN LEVEL

REMOVE CMU INFILL WALL

20. Repair (1) lightwell at garden level with access to street level. Refer to attached drawings.
21. Recreate steps down to side entry door at stoop. Refer to attached drawings.
