BUILDING ENVELOPE RESTORATION

50 BEACON STREET, BOSTON, MA

ISSUED FOR BOSTON LANDMARKS COMMISSION
BEACON HILL ARCHITECTURAL DISTRICT REVIEW 01/27/22

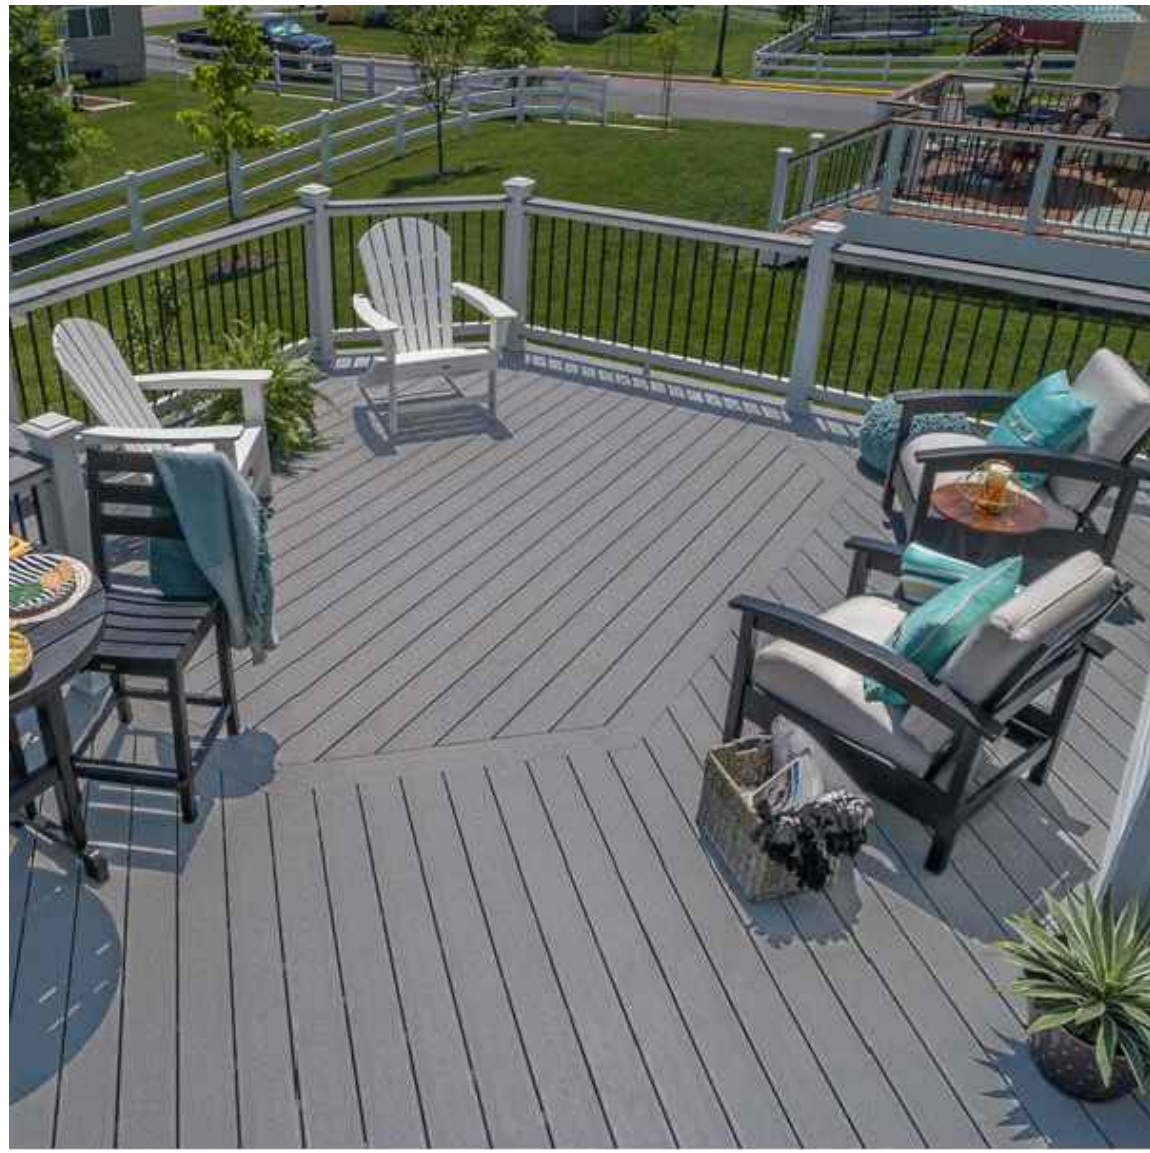
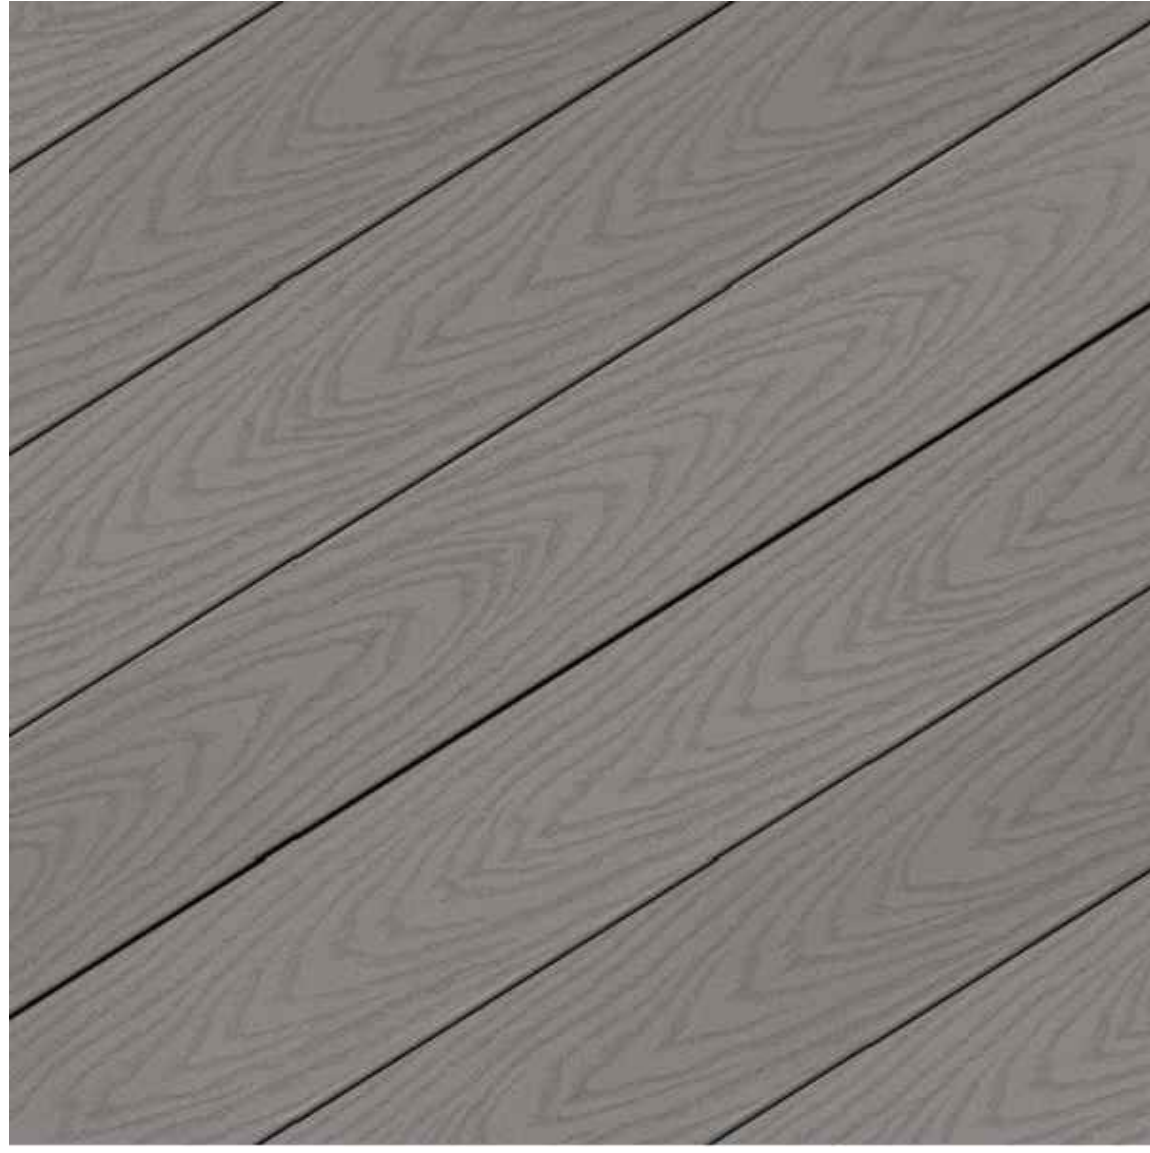
2 SAMPLE IMAGES OF TREX COMPOSITE DECKING MATERIAL - PEBBLE GREY
N.T.S.

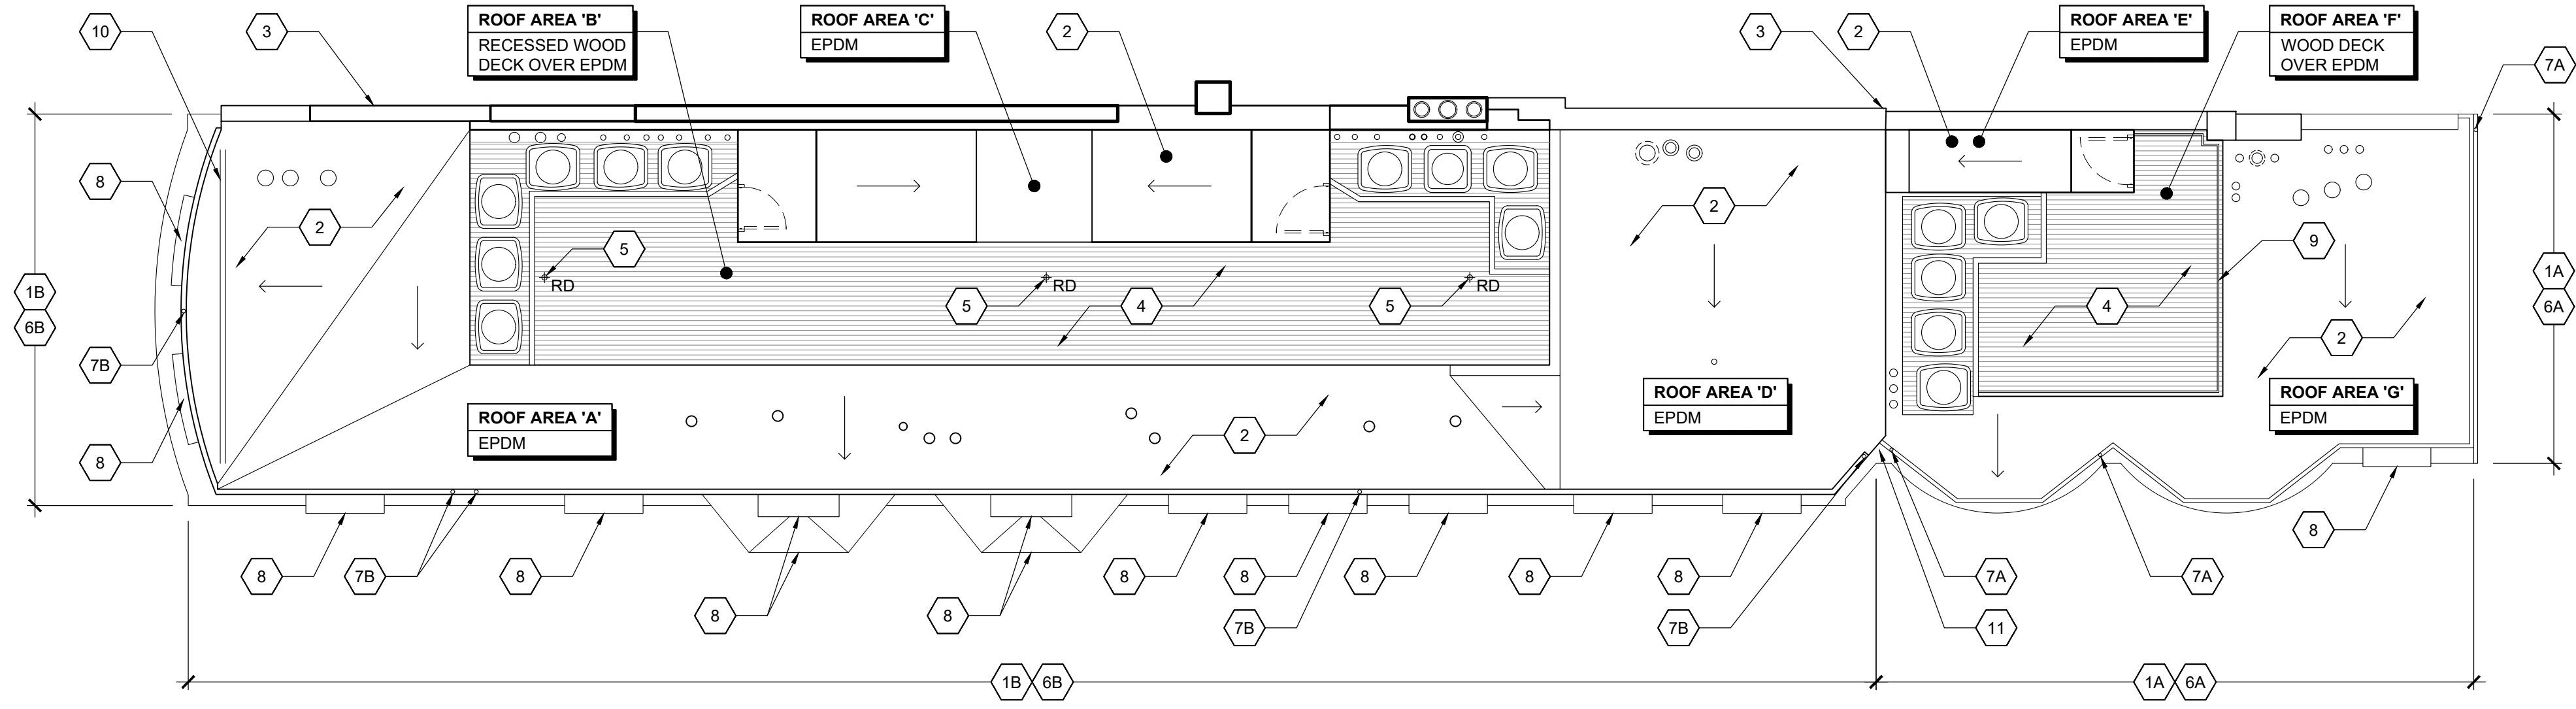
1 ROOF PLAN
1/8"=1'-0"

KEY NOTES		
TAG	CONDITION	REPAIR
1A	MISSING / BROKEN SLATE	REMOVE AND REPLACE MISSING AND BROKEN SLATE IN DESIGNATED AREAS OF THE ROOF.
1B	DAMAGED SLATE	NEW SLATE ROOF TO MATCH EXISTING.
2	EXISTING EPDM ROOF	REMOVE AND REPLACE WITH NEW EPDM ROOF.
3	DAMAGED METAL FLASHING	INSTALL NEW COPPER FLASHING WITH APPROPRIATE FASTENERS.
4	EXISTING WOOD DECK	REMOVE AND REPLACE WITH COMPOSITE MATERIAL - TREX COMPOSITE DECKING - 'PEBBLE GREY'.
5	EXISTING ROOF DRAIN	REMOVE AND REPLACE ROOF DRAINS.
6A	EXISTING GUTTER TO REMAIN	INSPECT AND REPAIR EXISTING GUTTERS.
6B	DAMAGED EXISTING GUTTER	NEW COPPER GUTTER AND FLASHING TO MATCH EXISTING.
7A	EXISTING DOWNSPOUT TO REMAIN	INSPECT AND REPAIR EXISTING DOWNSPOUTS AT AREAS OF GUTTERS TO REMAIN.
7B	EXISTING DOWNSPOUT LOCATION	INSTALL NEW DOWNSPOUTS IN DESIGNATED AREAS OF NEW GUTTERS.
8	EXISTING EPDM ROOF OVER WINDOW SURROUNDS / BAY WINDOWS	REMOVE EXISTING EPDM ROOF AND INSTALL NEW FLAT SEAM COPPER ROOF.

9	EXISTING GUARDRAIL	REPLACE IN KIND NEW GUARDRAIL TO MATCH EXISTING.
10	EXISTING SNOW RAIL	REMOVE EXISTING SNOW RAIL AND INSTALL NEW 3-RAIL BRONZE SNOW RAIL
11	NEW DOWNSPOUT	ADD SECOND DOWNSPOUT FOR ROOF DRAINAGE.

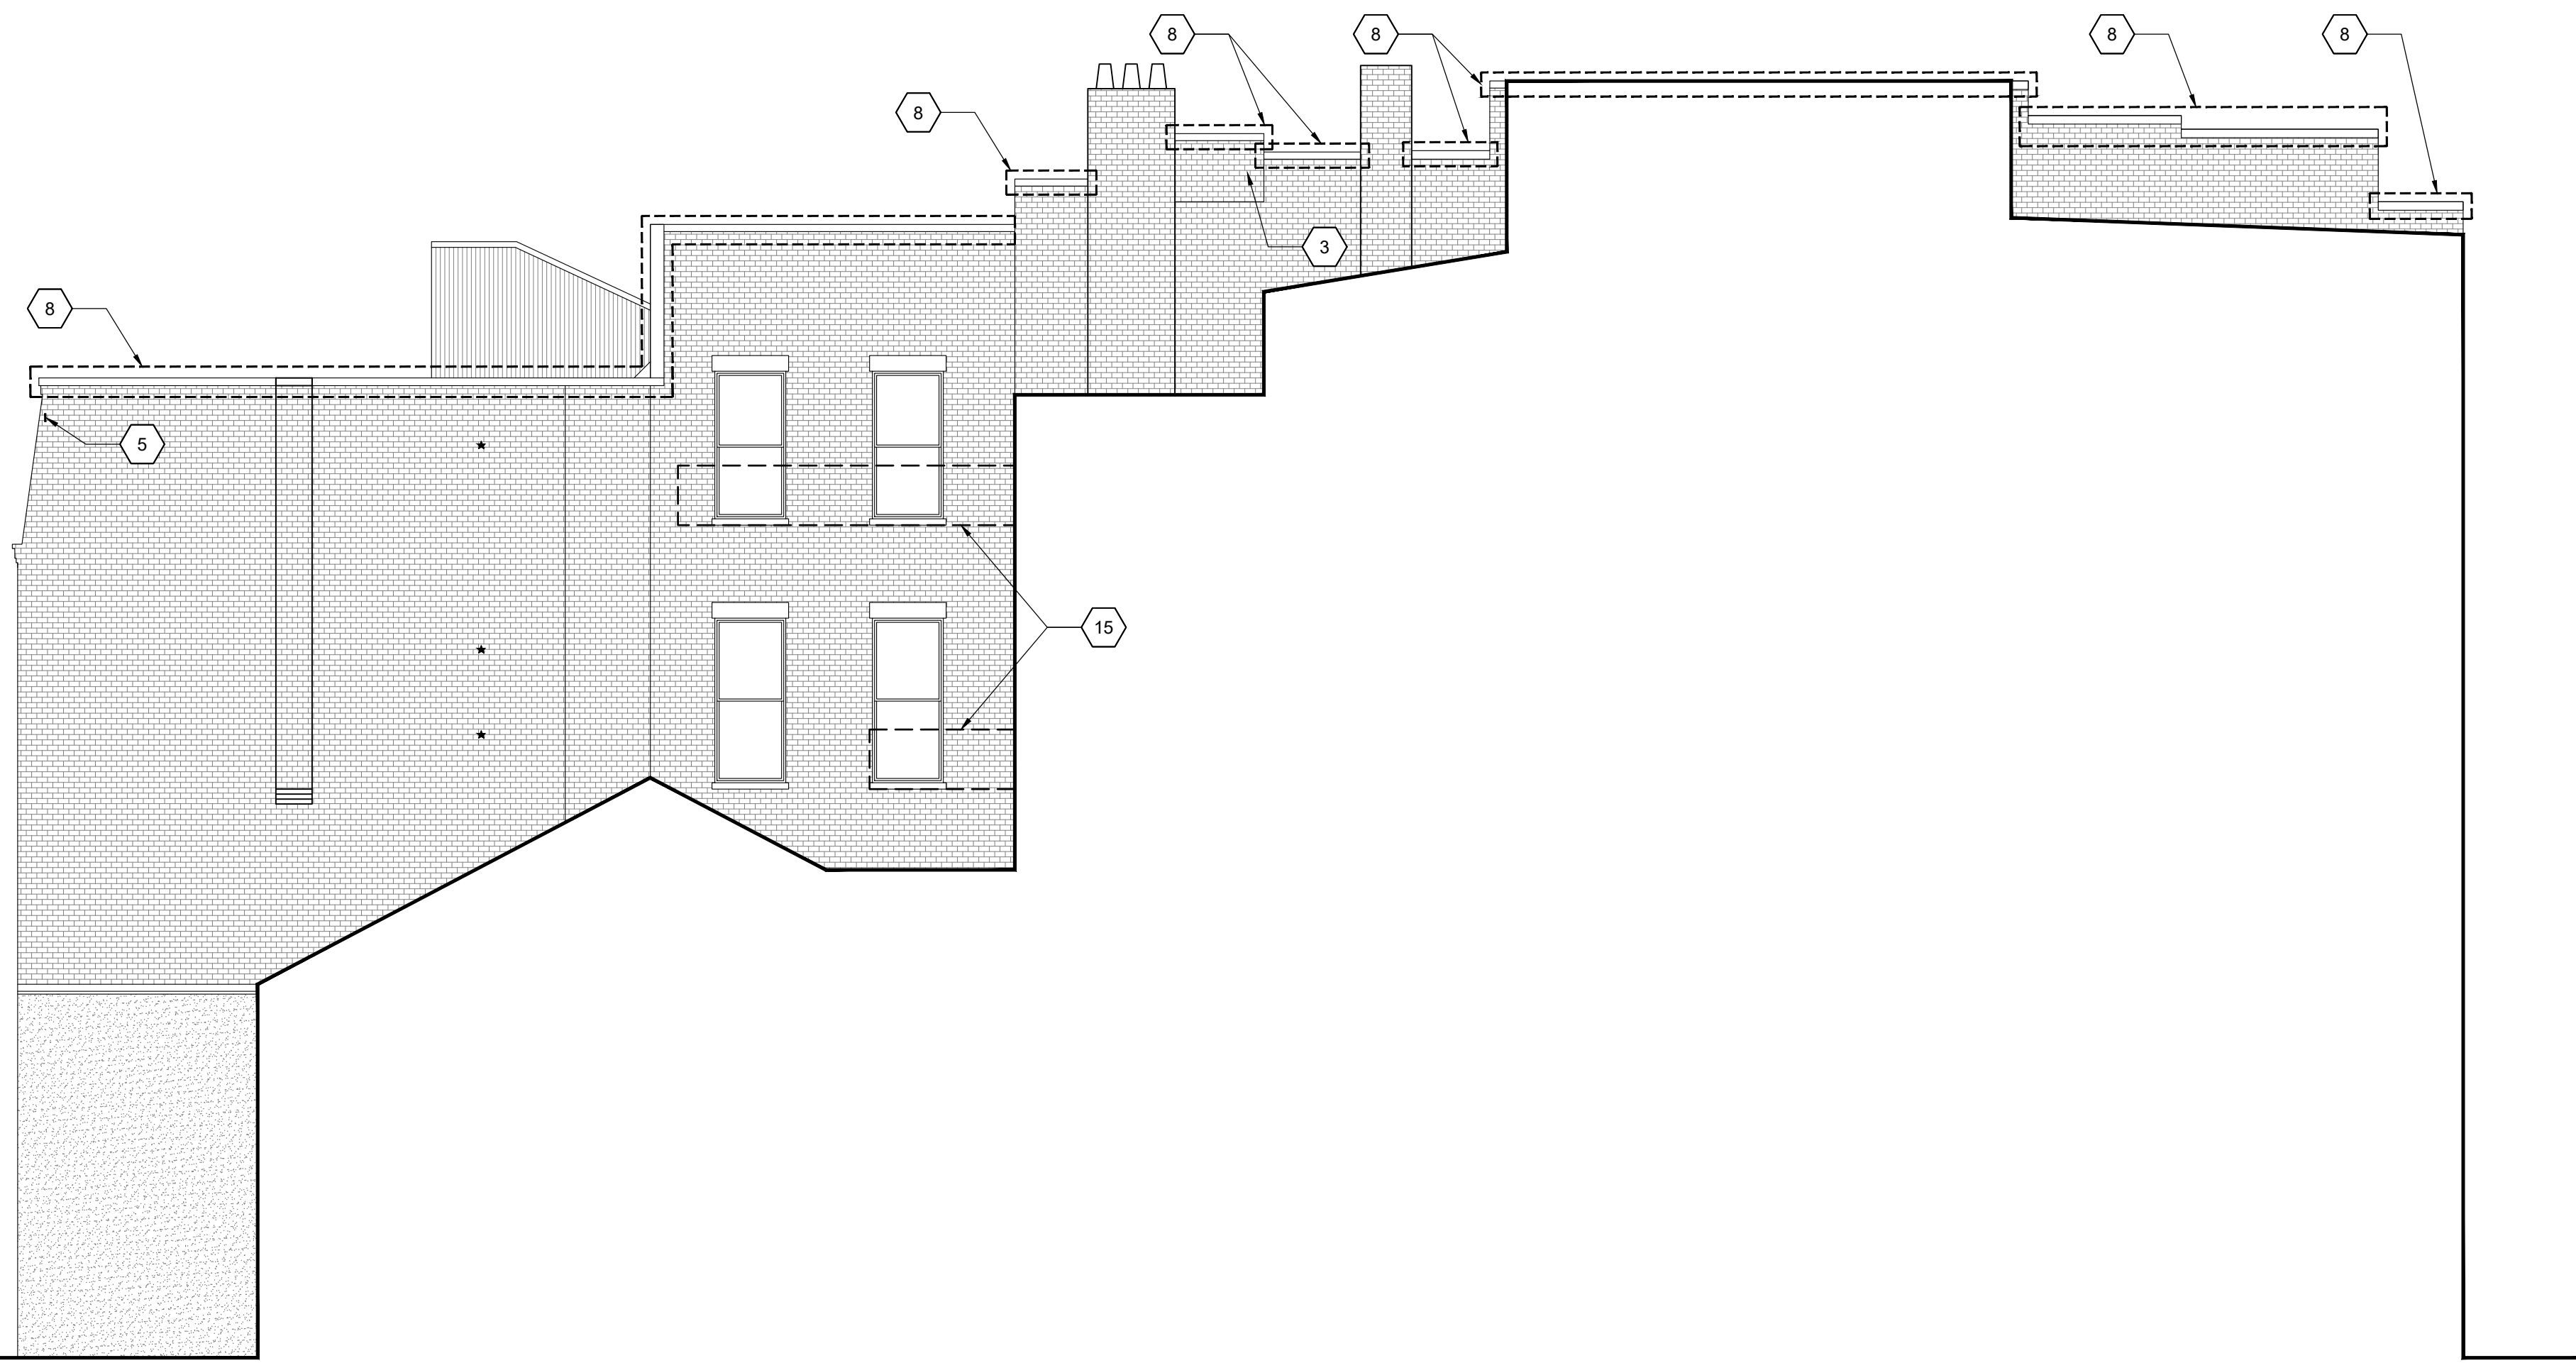
2 WEST ELEVATION
1/8"=1'-0"

KEY NOTES		
TAG	CONDITION	REPAIR
1	DETERIORATED MORTAR JOINTS	NEW MORTAR TO MATCH EXISTING ORIGINAL MORTAR IN COLOR, TEXTURE, STRENGTH, AND TOOLING.
2A	SPALLED / DETERIORATED / CRACKED STONE	FOR SURFACES DETERIORATED LESS THAN OR UP TO 1/2" INCH - REMOVE LOOSE MATERIAL AND ABRUPT EDGES. FOR DETERIORATION OVER 1/2", PREPARE REPAIR AREA TO HAVE SIMPLE GEOMETRY AND SQUARE SHOULDERS 1/2" DEEP MINIMUM. REPAIR WITH JAHN M70.
2B	SPALLED / DETERIORATED / CRACKED STONE (ORNAMENTAL STONE AT BASE WALL)	REMOVE DAMAGED STONE FACE AND INSTALL NEW STONE DUTCHMAN WITH MATCHING ORNAMENTAL CARVING.
3	STAINED BRICK / EFFLORESCENCE AT BRICK	CLEAN EXISTING BRICK MASONRY WITH JAHN LIGHT AND HEAVY DUTY CLEANERS AS APPROPRIATE.
4	DAMAGED / CRACKED / MISSING BRICK	REMOVE / REPLACE EXISTING BRICK MASONRY.
5	RUSTED METAL EMBEDDED IN BRICK	REMOVE RUSTED METAL. FILL IN EXISTING HOLE AT MASONRY WITH MATCHING BRICK.
6	SPALLED / CRACKED SILL OR HEADER	REPAIRS TO BE MADE WITH CONPROCO INJECTION GROUT OR APPROVED EQUAL.

7	RUSTED METAL / FAILED COATING AT DORMER	CLEAN AND REPAINT WITH RD ELASTOMETAL COATING.
8	DETERIORATED / DAMAGED FLASHING	INSTALL NEW COPPER FLASHING WITH APPROPRIATE FASTENERS.
9	FAILED COATING AT STONE / MASONRY	REMOVE EXISTING COATINGS AND PREVIOUS REPAIRS BACK TO ORIGINAL STONE MATERIAL. REPAIR AS REQUIRED IN NOTE #2A. REPAINT BRICK AT DORMERS, TYPICAL.
10	FAILED SEALANT JOINTS	REMOVE EXISTING SEALANT AND INSTALL NEW BACKER ROD AND SEALANT.
11	RUST STAINS AT STONE	CLEAN / REMOVE RUST STAIN WITH JAHN RUST REMOVER.
12	ENVIRONMENTAL STAINING AT STONE	CLEAN / REMOVE ENVIRONMENTAL STAINING WITH JAHN LIGH AND HEAVY DUTY CLEANERS AS APPROPRIATE.
13	DETERIORATED STONE FOUNDATION	REPOINT AREA OF STONE FOUNDATION.
14	ROTTED WOOD TRIM / SILL	WOOD REPAIRS TO BE PERFORMED WITH WOOD DUTCHMAN OR WOOD COMPONENT REPLACEMENT WITH THE SAME WOOD SPECIES WHEN POSSIBLE. REPAIRS TO BE PERFORMED TO MINIMIZE THE AMOUNT OF ORIGINAL MATERIAL BEING REMOVED. REPAINT, TYPICAL.

15	FIRE BALCONIES (NOT SHOWN FOR CLARITY)	REVIEW AND REPAIR TO BE PERFORMED UNDER DIRECTION OF FIRE ESCAPE CONSULTANT.
16	EXISTING EPDM ROOF OVER WINDOW SURROUNDS	NEW FLAT SEAM COPPER ROOF AND FLASHING AT DORMER WINDOWS, TYPICAL.
17	EXISTING EPDM ROOF OVER WINDOW BAY WINDOWS	NEW FLAT SEAM COPPER ROOF, FLASHING, AND GUTTERS, TYPICAL.
18	DAMAGED EXISTING GUTTER	NEW COPPER GUTTER AND FLASHING TO MATCH EXISTING.
19	EXISTING GUTTER TO REMAIN	INSPECT AND REPAIR EXISTING COPPER GUTTER AND FLASHING.
20	IRON WINDOW GRATE	REPAIR, REPAINT, AND FIX CLOSED.
21	ENTRANCE ROOF	REMOVE EXISTING COPPER FLASHING/ GUTTER AND ASPHALTIC MATERIAL. INSTALL NEW COPPER FLASHING/ GUTTER.
22	IRON RAILING	REPAIR AND REPAINT EXISTING IRON RAILING.
23	BAY WINDOW	CLEAN SURFACE AND REPLACE SEALANTS, TYPICAL.

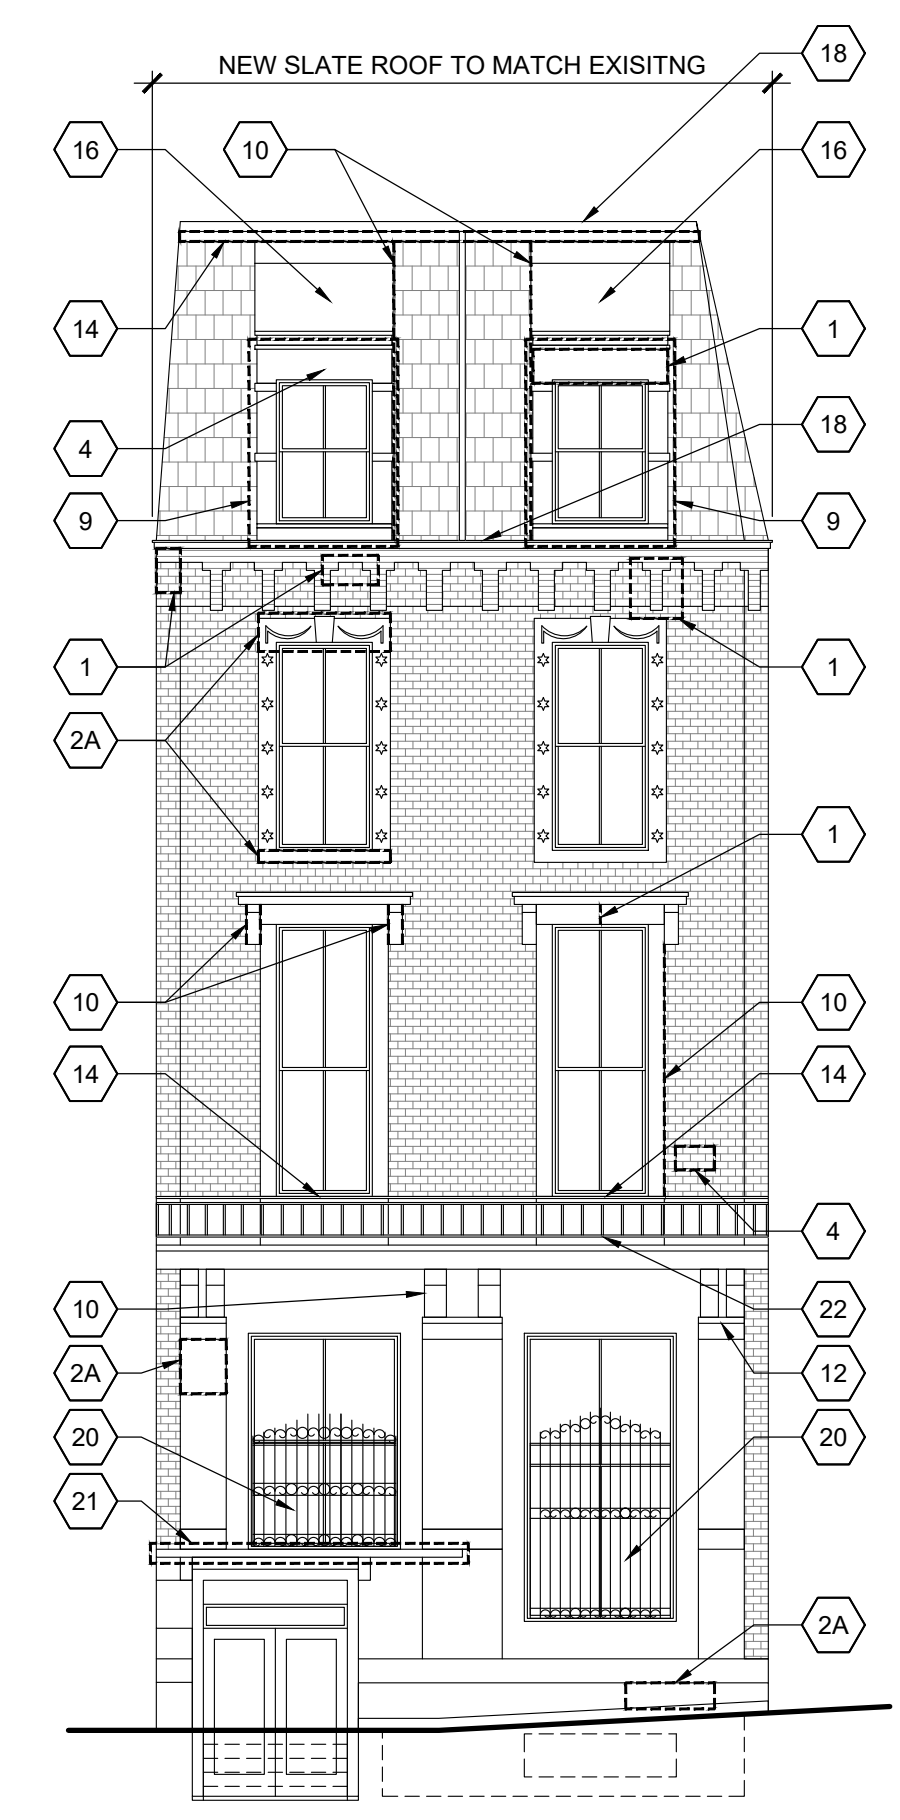
1 SOUTH ELEVATION - BEACON STREET
1/8"=1'-0"

KEY NOTES		
TAG	CONDITION	REPAIR
1	DETERIORATED MORTAR JOINTS	NEW MORTAR TO MATCH EXISTING ORIGINAL MORTAR IN COLOR, TEXTURE, STRENGTH, AND TOOLING.
2A	SPALLED / DETERIORATED / CRACKED STONE	FOR SURFACES DETERIORATED LESS THAN OR UP TO 1/2" INCH - REMOVE LOOSE MATERIAL AND ABRUPT EDGES. FOR DETERIORATION OVER 1/2", PREPARE REPAIR AREA TO HAVE SIMPLE GEOMETRY AND SQUARE SHOULDERS 1/2" DEEP MINIMUM. REPAIR WITH JAHN M70.
2B	SPALLED / DETERIORATED / CRACKED STONE (ORNAMENTAL STONE AT BASE WALL)	REMOVE DAMAGED STONE FACE AND INSTALL NEW STONE DUTCHMAN WITH MATCHING ORNAMENTAL CARVING.
3	STAINED BRICK / EFFLORESCENCE AT BRICK	CLEAN EXISTING BRICK MASONRY WITH JAHN LIGHT AND HEAVY DUTY CLEANERS AS APPROPRIATE.
4	DAMAGED / CRACKED / MISSING BRICK	REMOVE / REPLACE EXISTING BRICK MASONRY.
5	RUSTED METAL EMBEDDED IN BRICK	REMOVE RUSTED METAL. FILL IN EXISTING HOLE AT MASONRY WITH MATCHING BRICK.
6	SPALLED / CRACKED SILL OR HEADER	REPAIRS TO BE MADE WITH CONPROCO INJECTION GROUT OR APPROVED EQUAL.

7	RUSTED METAL / FAILED COATING AT DORMER	CLEAN AND REPAINT WITH RD ELASTOMETAL COATING.
8	DETERIORATED / DAMAGED FLASHING	INSTALL NEW COPPER FLASHING WITH APPROPRIATE FASTENERS.
9	FAILED COATING AT STONE / MASONRY	REMOVE EXISTING COATINGS AND PREVIOUS REPAIRS BACK TO ORIGINAL STONE MATERIAL. REPAIR AS REQUIRED IN NOTE #2A. REPAINT BRICK AT DORMERS, TYPICAL.
10	FAILED SEALANT JOINTS	REMOVE EXISTING SEALANT AND INSTALL NEW BACKER ROD AND SEALANT.
11	RUST STAINS AT STONE	CLEAN / REMOVE RUST STAIN WITH JAHN RUST REMOVER.
12	ENVIRONMENTAL STAINING AT STONE	CLEAN / REMOVE ENVIRONMENTAL STAINING WITH JAHN LIGH AND HEAVY DUTY CLEANERS AS APPROPRIATE.
13	DETERIORATED STONE FOUNDATION	REPOINT AREA OF STONE FOUNDATION.
14	ROTTED WOOD TRIM / SILL	WOOD REPAIRS TO BE PERFORMED WITH WOOD DUTCHMAN OR WOOD COMPONENT REPLACEMENT WITH THE SAME WOOD SPECIES WHEN POSSIBLE. REPAIRS TO BE PERFORMED TO MINIMIZE THE AMOUNT OF ORIGINAL MATERIAL BEING REMOVED. REPAIR, TYPICAL.

15	FIRE BALCONIES (NOT SHOWN FOR CLARITY)	REVIEW AND REPAIR TO BE PERFORMED UNDER DIRECTION OF FIRE ESCAPE CONSULTANT.
16	EXISTING EPDM ROOF OVER WINDOW SURROUNDS	NEW FLAT SEAM COPPER ROOF AND FLASHING AT DORMER WINDOWS, TYPICAL.
17	EXISTING EPDM ROOF OVER WINDOW BAY WINDOWS	NEW FLAT SEAM COPPER ROOF, FLASHING, AND GUTTERS, TYPICAL.
18	DAMAGED EXISTING GUTTER	NEW COPPER GUTTER AND FLASHING TO MATCH EXISTING.
19	EXISTING GUTTER TO REMAIN	INSPECT AND REPAIR EXISTING COPPER GUTTER AND FLASHING.
20	IRON WINDOW GRATE	REPAIR, REPAINT, AND FIX CLOSED.
21	ENTRANCE ROOF	REMOVE EXISTING COPPER FLASHING/ GUTTER AND ASPHALTIC MATERIAL. INSTALL NEW COPPER FLASHING/ GUTTER.
22	IRON RAILING	REPAIR AND REPAINT EXISTING IRON RAILING.
23	BAY WINDOW	CLEAN SURFACE AND REPLACE SEALANTS, TYPICAL.
