41 BERKELEY STREET

SOUTH END LANDMARKS ADVISORY 3
APRIL 2022

41 BERKELEY STREET | SOUTH END LANDMARKS ADVISORY MEETING | 19 APRIL 2022

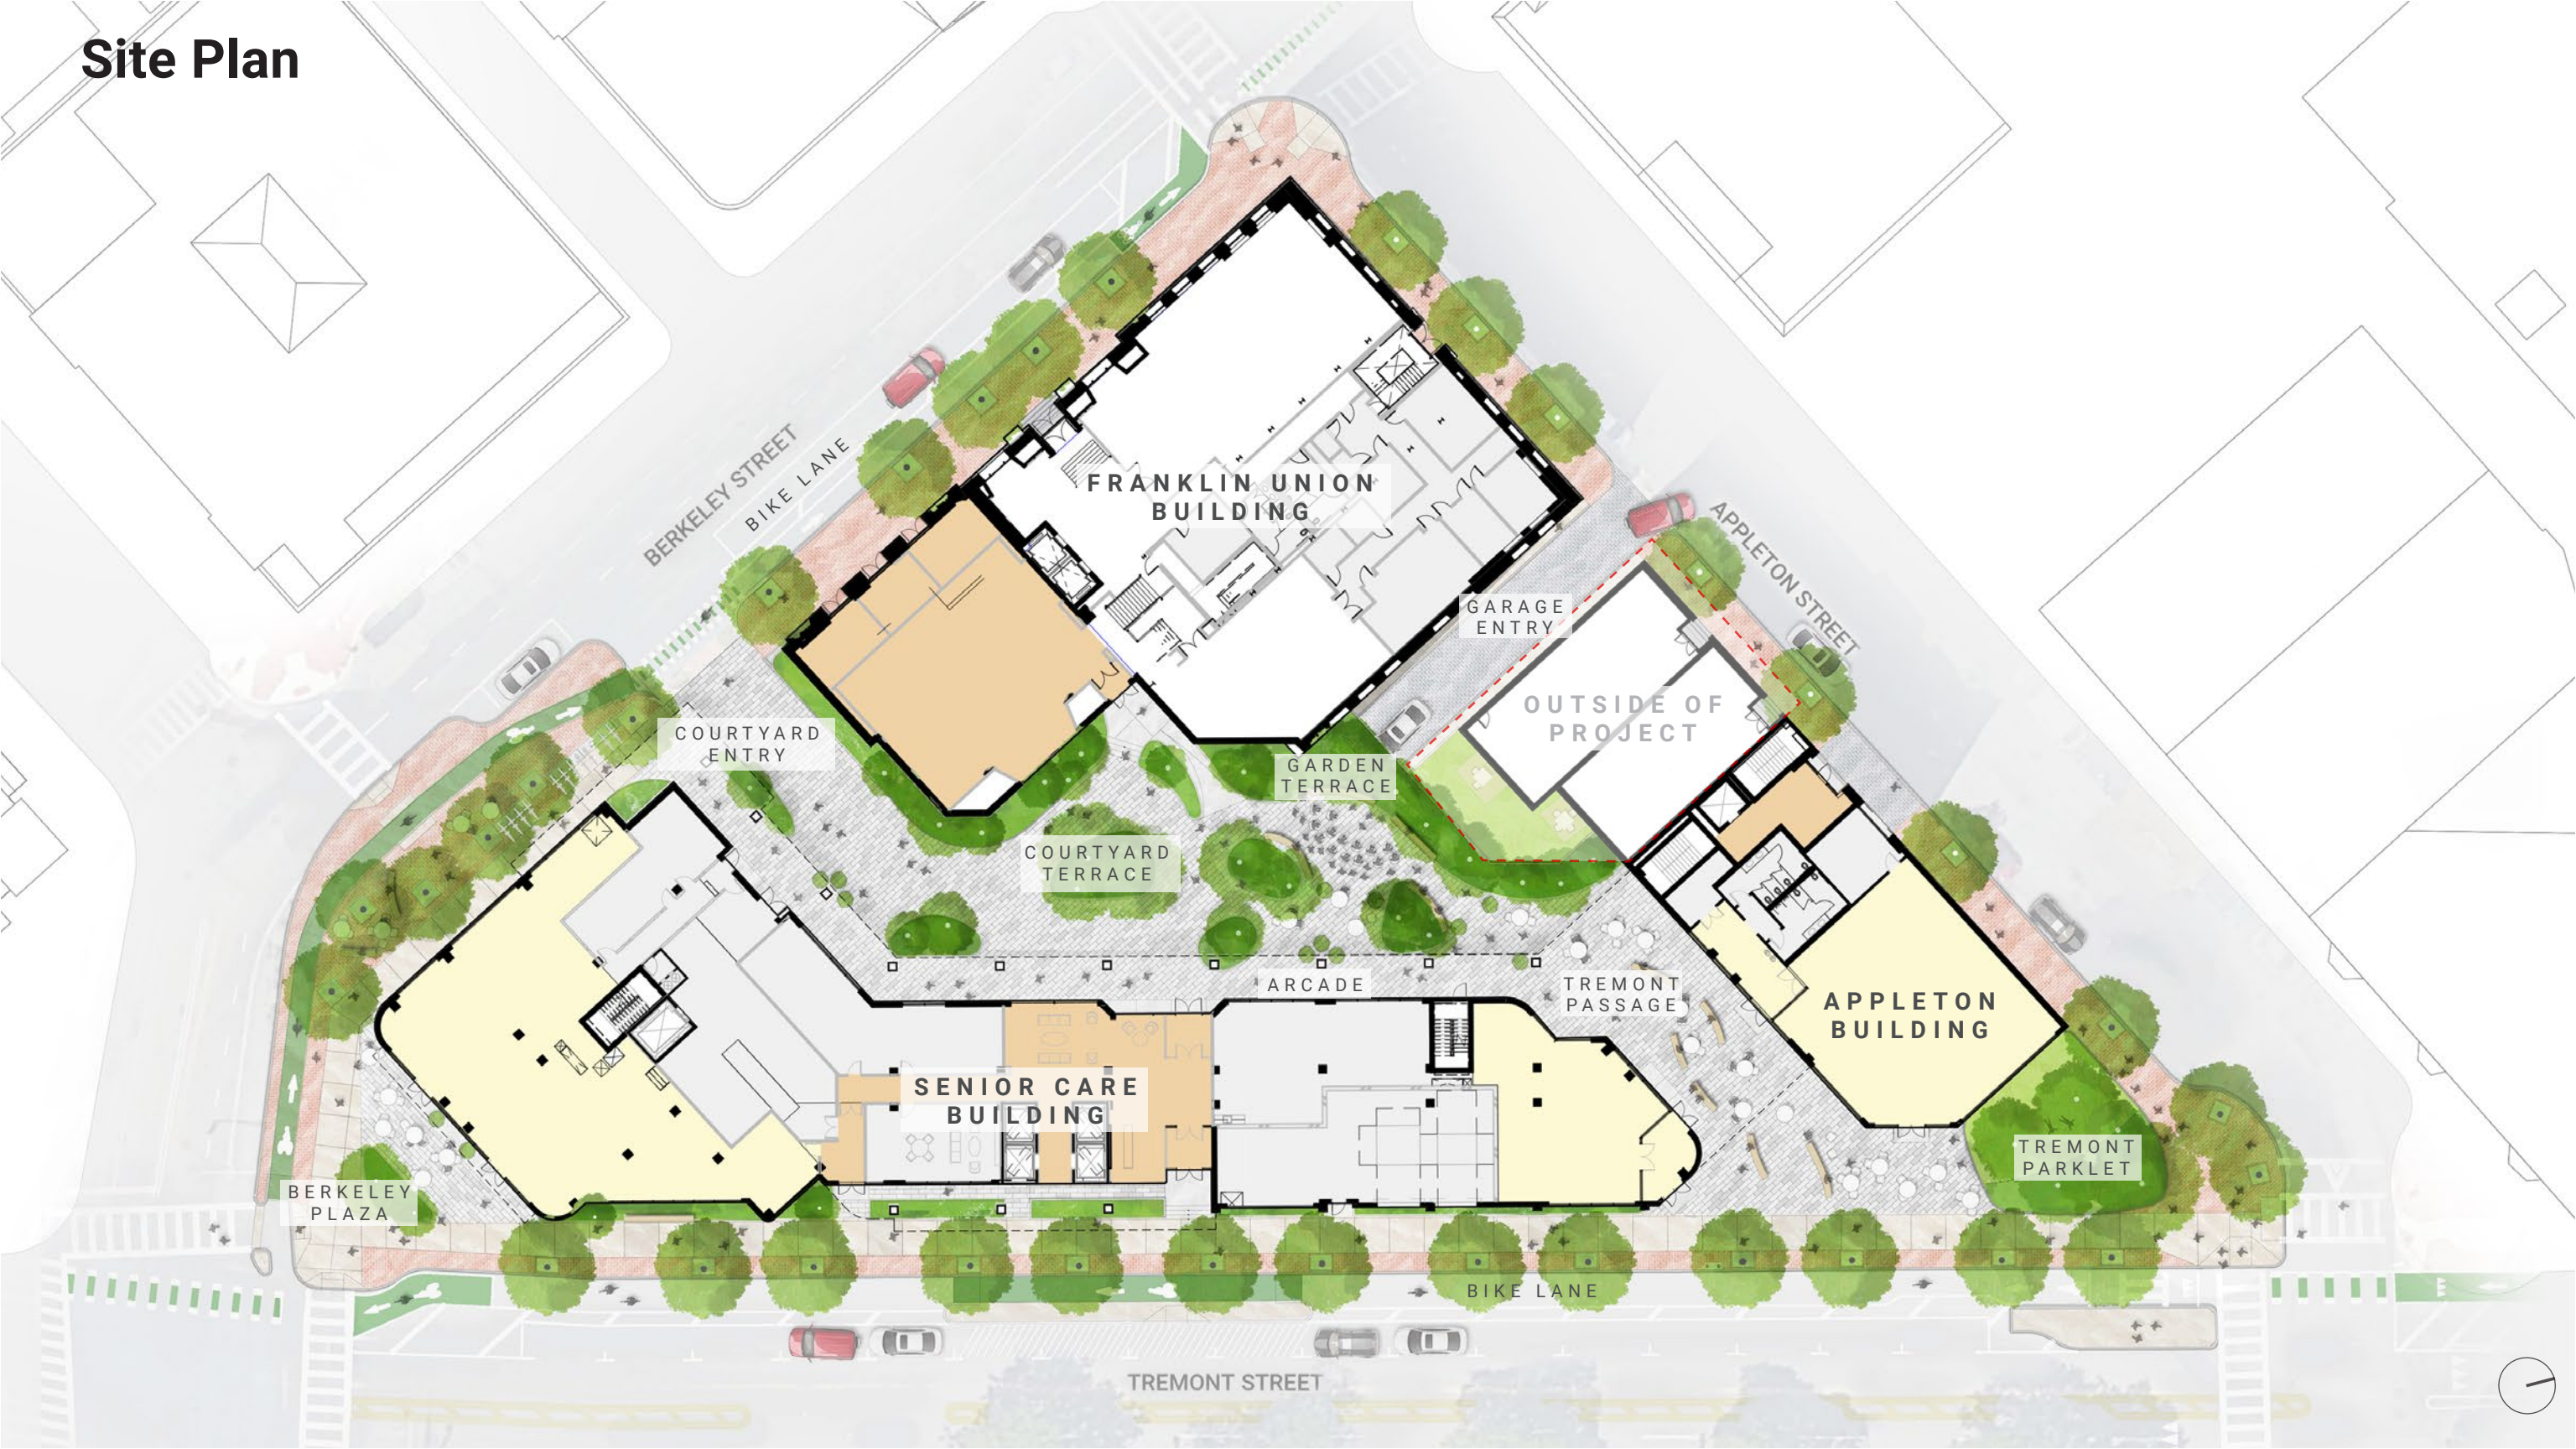
Site Plan

BERKELEY STREET
BIKE LANE

FRANKLIN UNION
BUILDING

GARAGE
ENTRY

APPLETON STREET

COURTYARD
ENTRY

GARDEN
TERRACE

COURTYARD
TERRACE

ARCADÉ

TREMONT
PASSAGE

APPLETON
BUILDING

SENIOR CARE
BUILDING

TREMONT
PARKLET

BERKELEY
PLAZA

TREMONT STREET

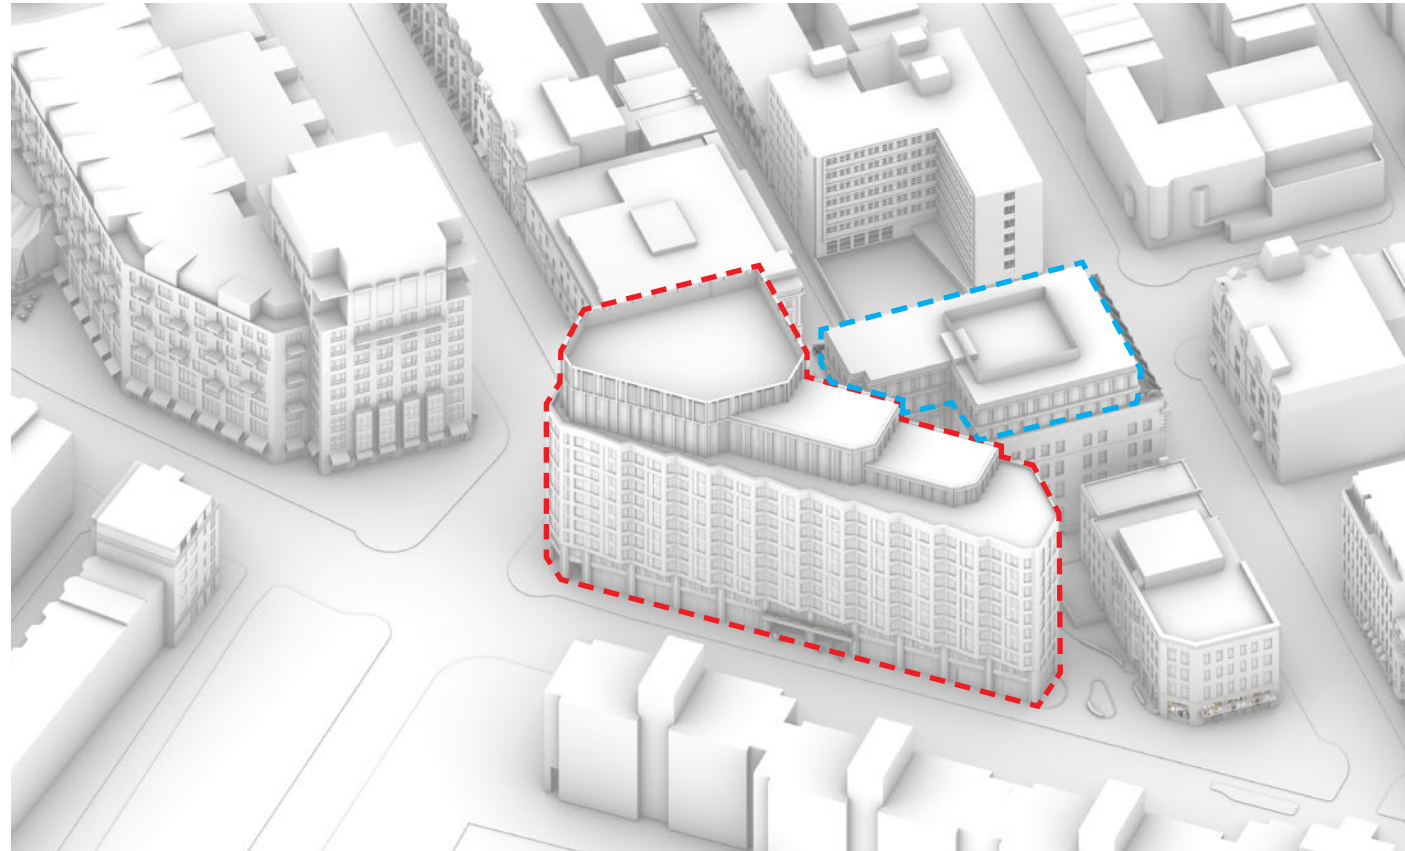
2020 Design

PNF vs Zoning Compliant Schemes

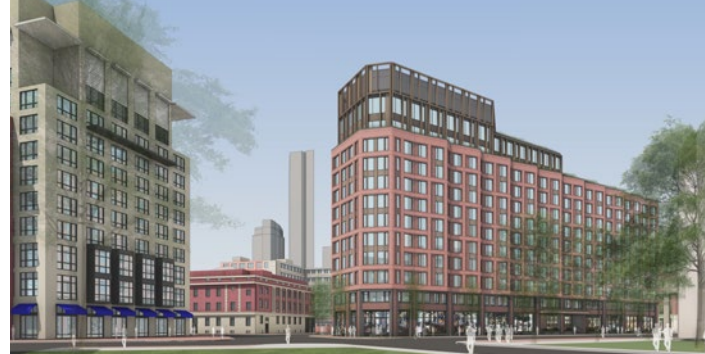
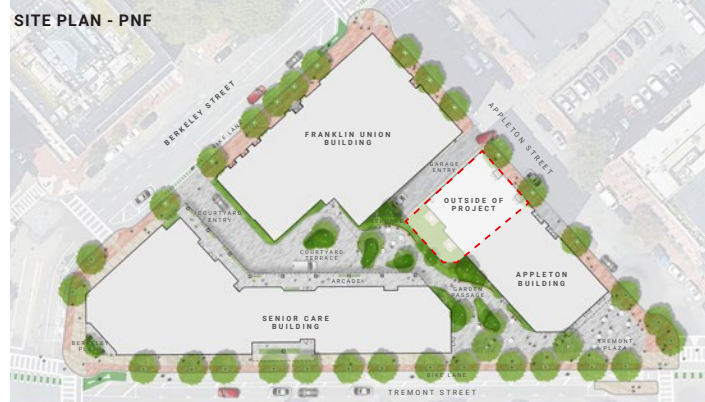
2020 PNF Plan

PNF vs Zoning Compliant Comparison

Project Areas	Senior Care	206,800	Senior Care	190,000	Senior Care	(16,800)
	Union Building (Office)	76,000	Union Building (Office)	55,000	Union Building (Office)	(21,000)
	Affordable Housing	17,500	Affordable Housing	13,000	Affordable Housing	(4,500)
	Retail + Affordable Cultural	10,700	Retail + Affordable Cultural	9,500	Retail + Affordable Cultural	(1,200)
	Total	311,000	Total	267,500	Total	(43,500)
FAR	5.85		5.00		-0.85	
Height	145 feet		110 feet		-35 feet	
# of Stories - Senior Care	13 stories		10 stories		-3 stories	
# of Stories - Union Building	6 stories		5 stories		-1 story	
Open Space	12,750 SF (24%) open to sky 2,100 SF (4%) covered public		12,875 SF (24%) open to sky 4,960 SF (9%) covered public		+125 SF open to sky +2,860 SF covered public

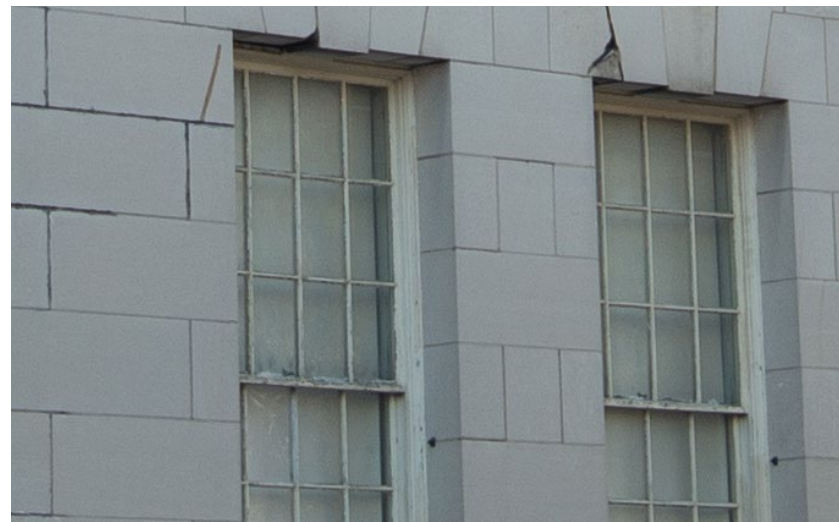
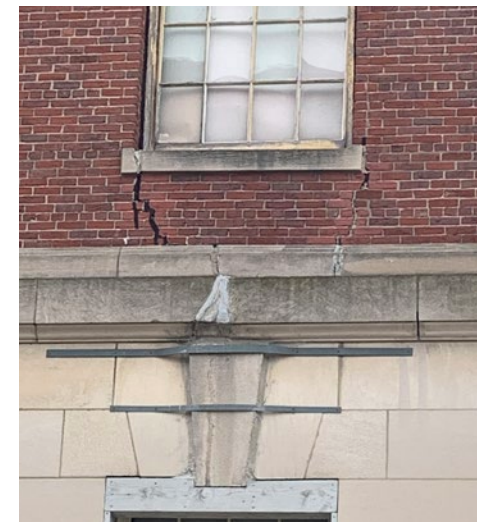
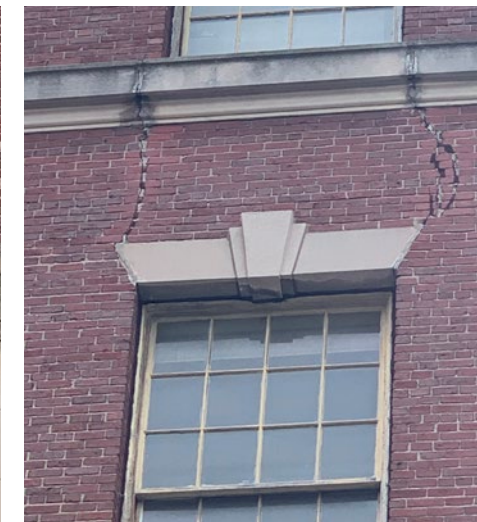
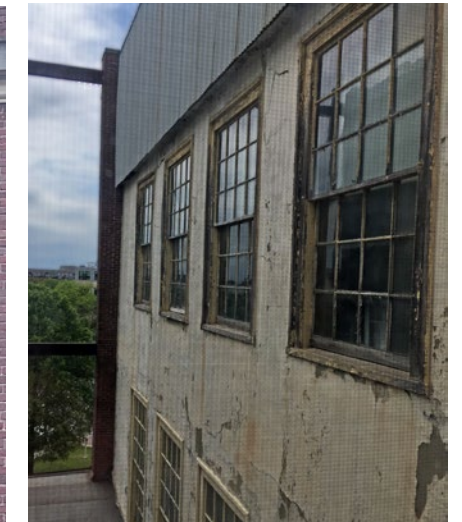
Preservation Challenges - Franklin Union Building

- Concrete pile caps supported by wood piles.
- Wood piles in average conditions with light soft rotting occurring, cracking at concrete pile caps.
- Supplemental piles and underpinning required to maintain existing loads.

- Load-bearing mass masonry supporting interior floors and roof and providing weather resistance.
- Deferred maintenance + deterioration requires full masonry repair, steel corrosion occurring on structural elements from failed weatherproofing.
- Repoint 100% of Brick Façade + 50% of Stone Masonry
- At all masonry repairs, assume the inner wythe will require rebuilding

- Wood framed with monolithic glazing and paint finish at window exteriors.
- Severely deteriorated, sills, jambs, sashes and perimeter blocking are checked, perimeter sealant joints fail. Replacement recommended.
- All windows are beyond their useful life, need full overhaul or replacement

- No life safety sprinkler system.
- Steam heating system, no HVAC or fresh air.

- Roof needs replacement
- Slab underside concrete repairs at roof
- Rebuild spalled brick at all interior basement walls

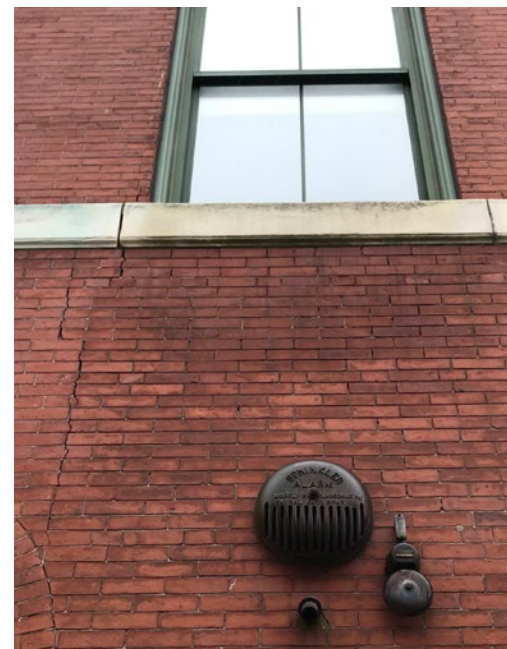
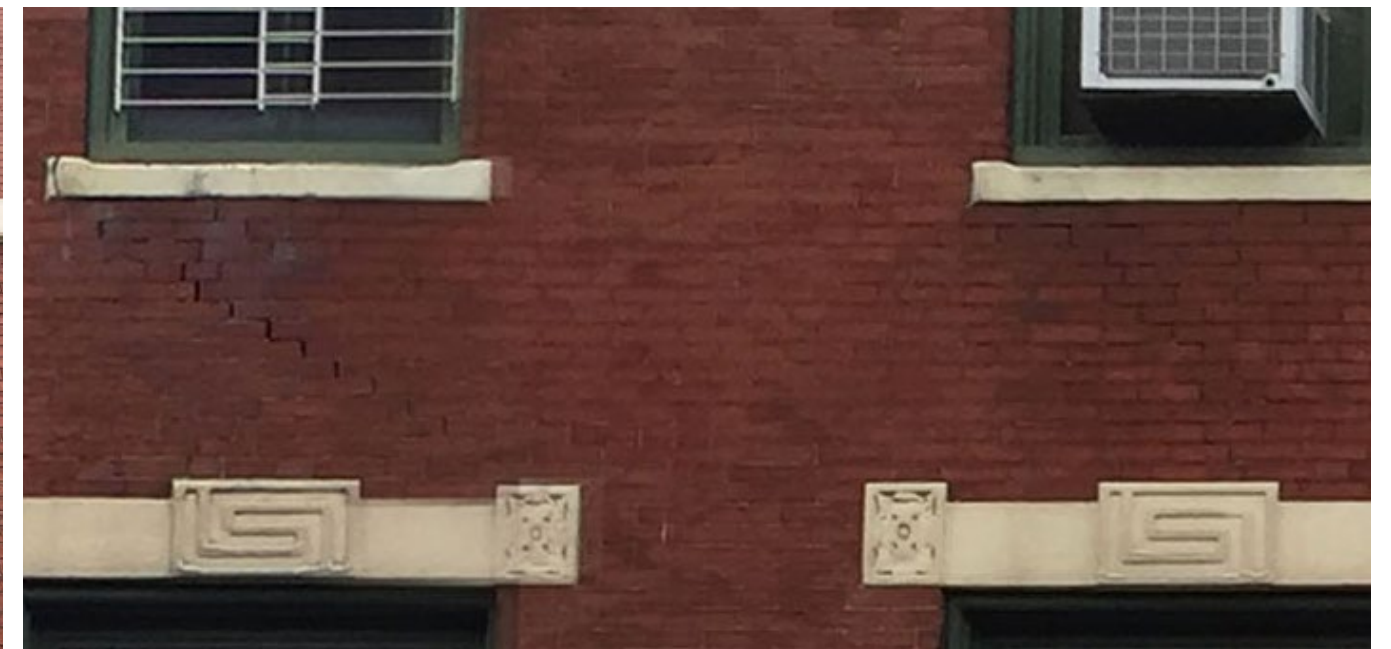
Preservation Challenges - 4 Appleton

- Front facade window surrounds and arch expression remain, cornice is lost, left arch has been infilled with a concrete stair landing.
- Existing windows are metal replacements.
- Left side elevation is a blank party wall.
- Rear facade includes 1980's stair tower addition.

- Interior heavily modified, existing structure does not meet fire resistance standards required by new Type 1 high-rise building.

- Existing wood piles deteriorated, cracking visible on facade.
- Basement and foundations of new senior care building require excavation of most of building footprint.

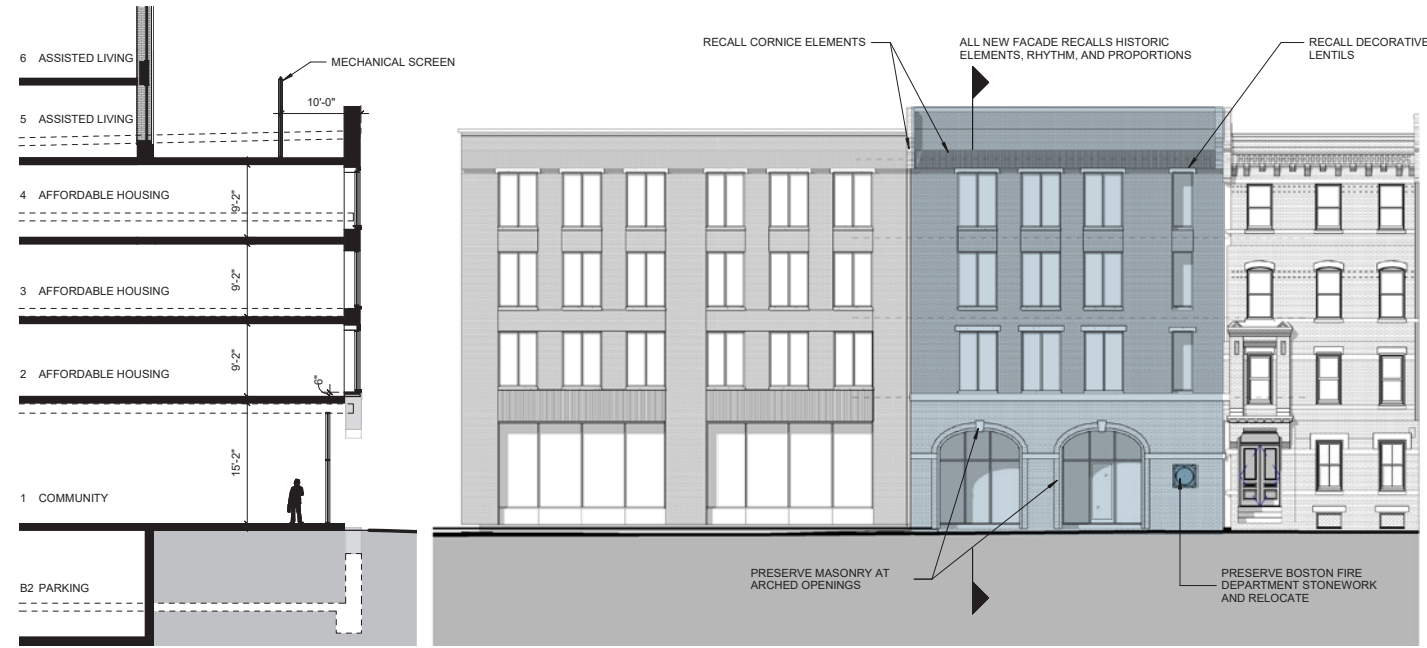
Design Proposal - Construct New in the Spirit of the Old

4 Appleton Design Evaluation

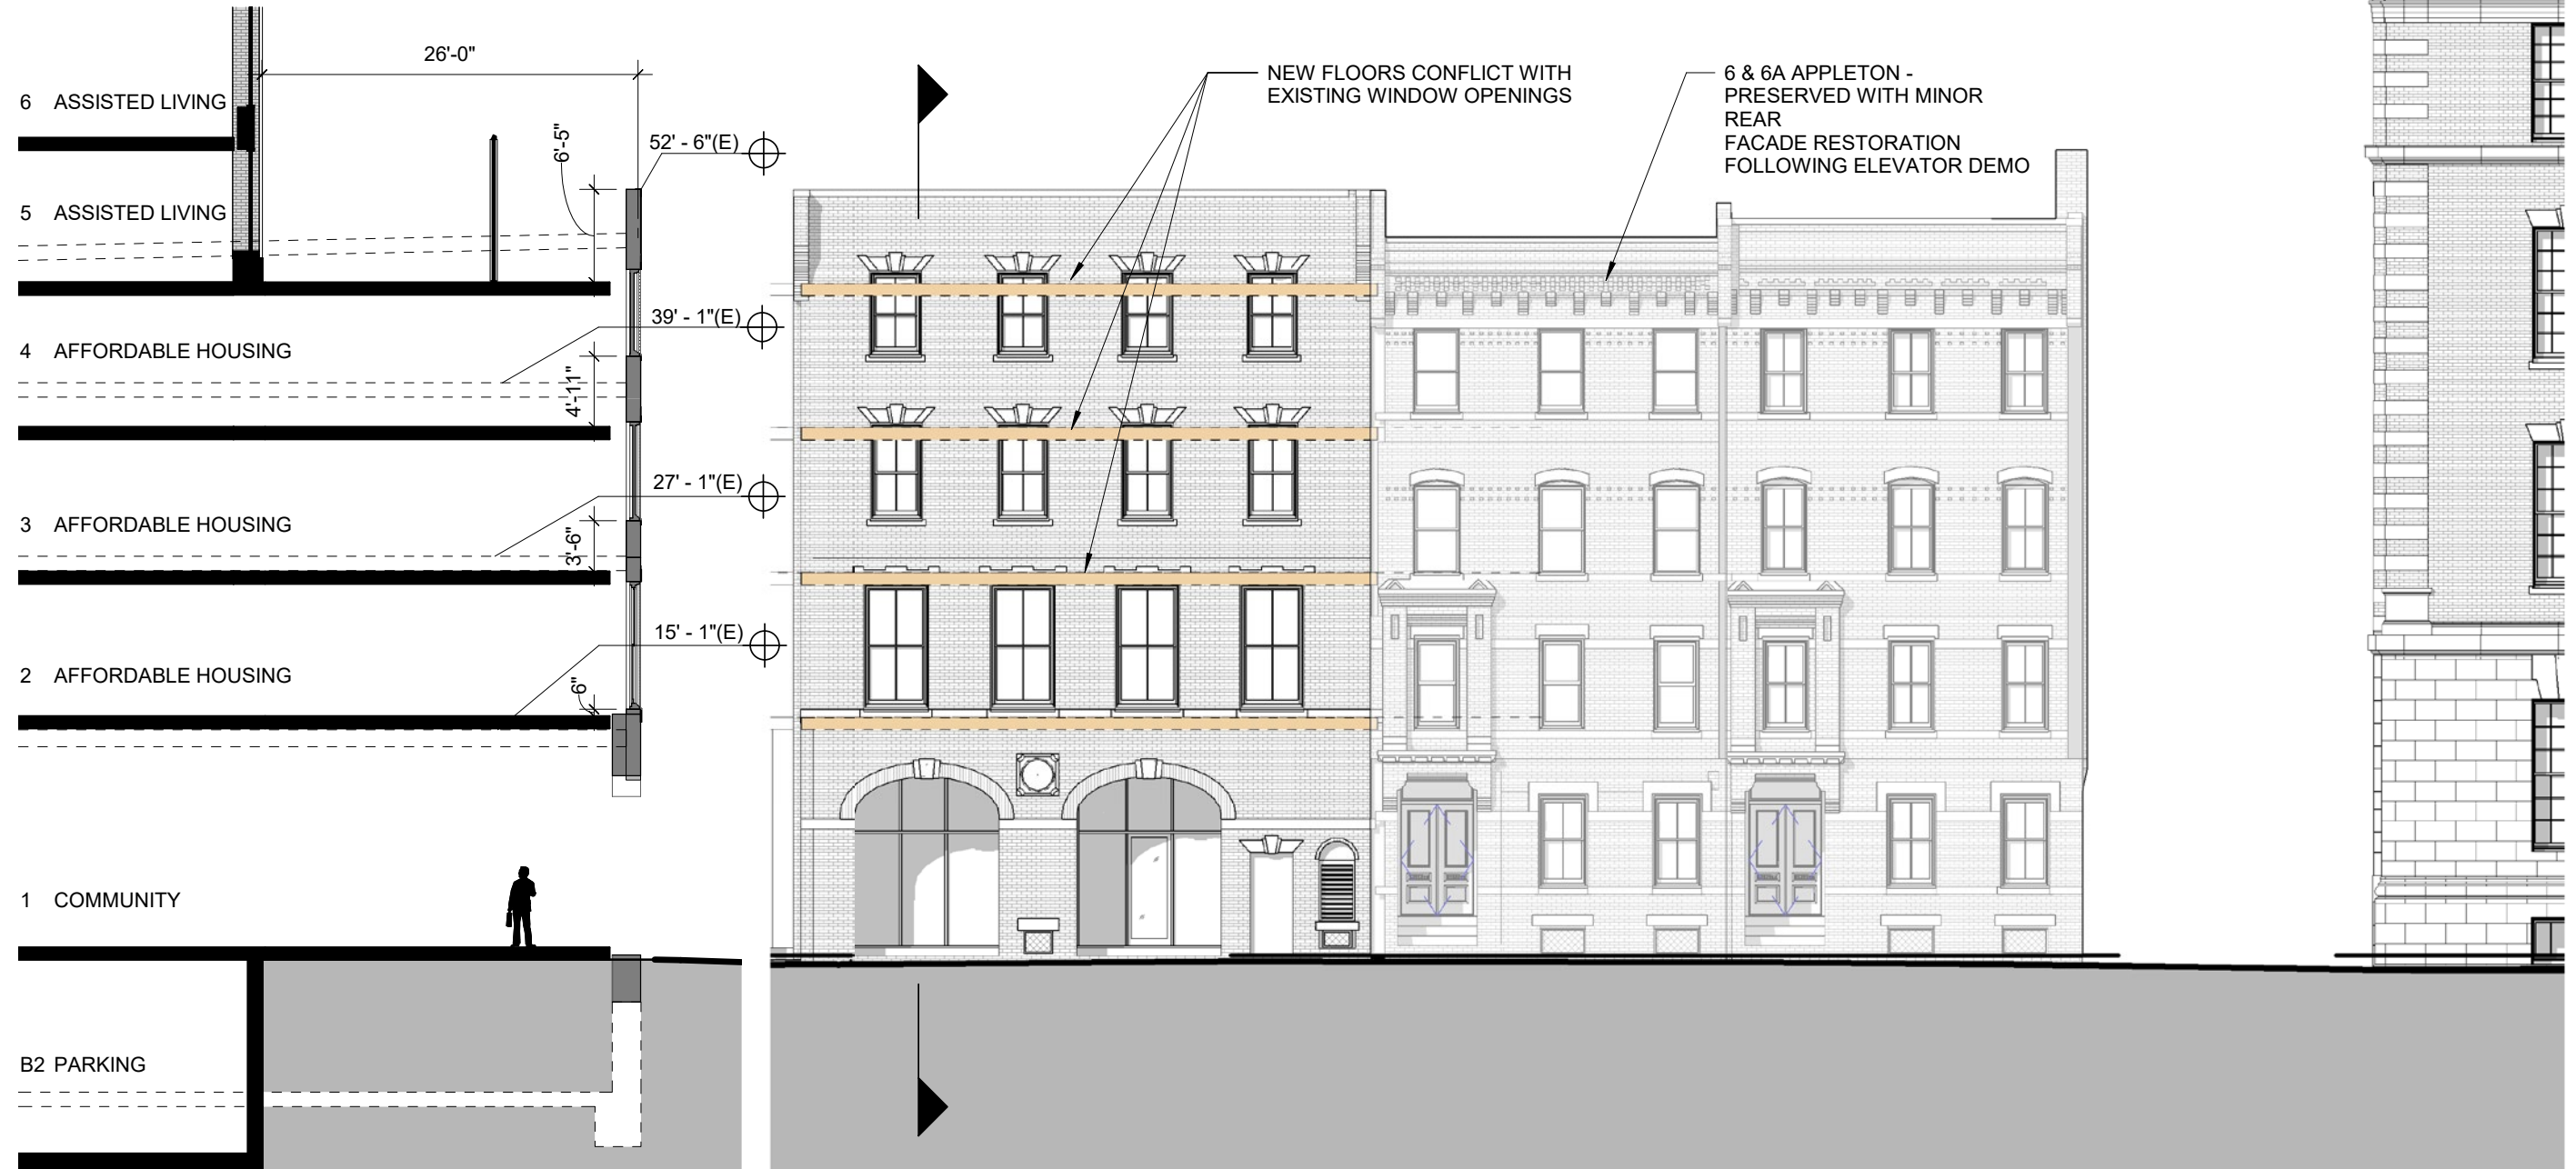
4 Appleton Section and Elevation

New Construction Diagram with Existing Conditions

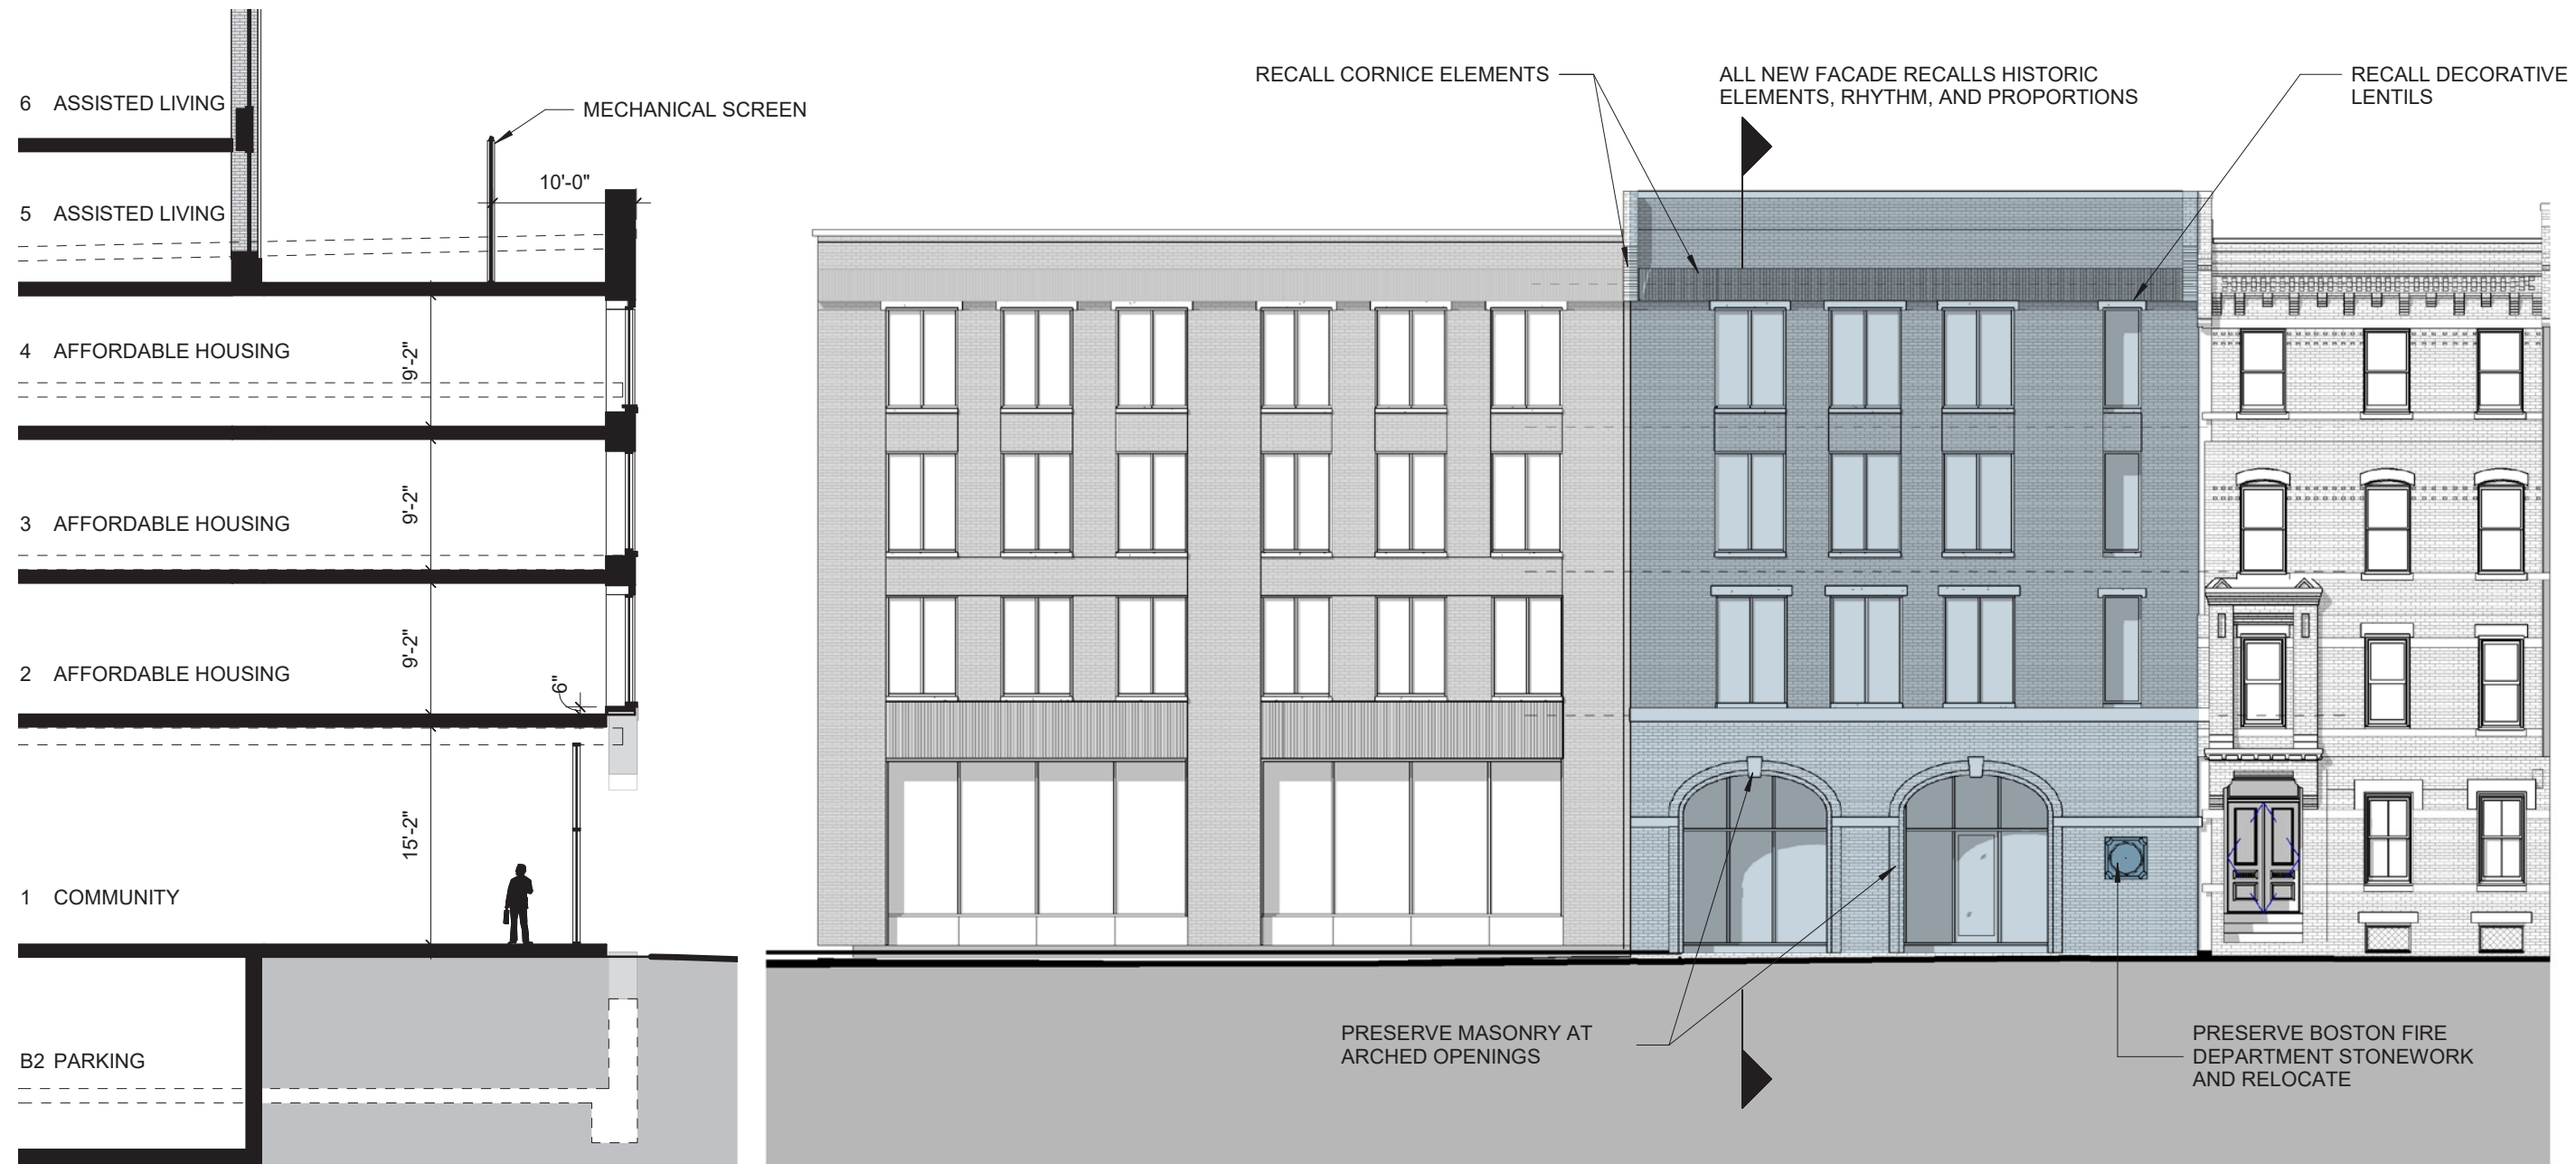
4 Appleton Section and Elevation

New Facade Using Existing Elements and Proportions Interpreted from Original
