Roof Deck Replacement

117 Saint Botolph Street, Boston, MA

Architect: **ARTIOS ARCHITECTS**
 4 KILCOMMONS DRIVE, UNIT #11
 PEMBROKE, MA 02359

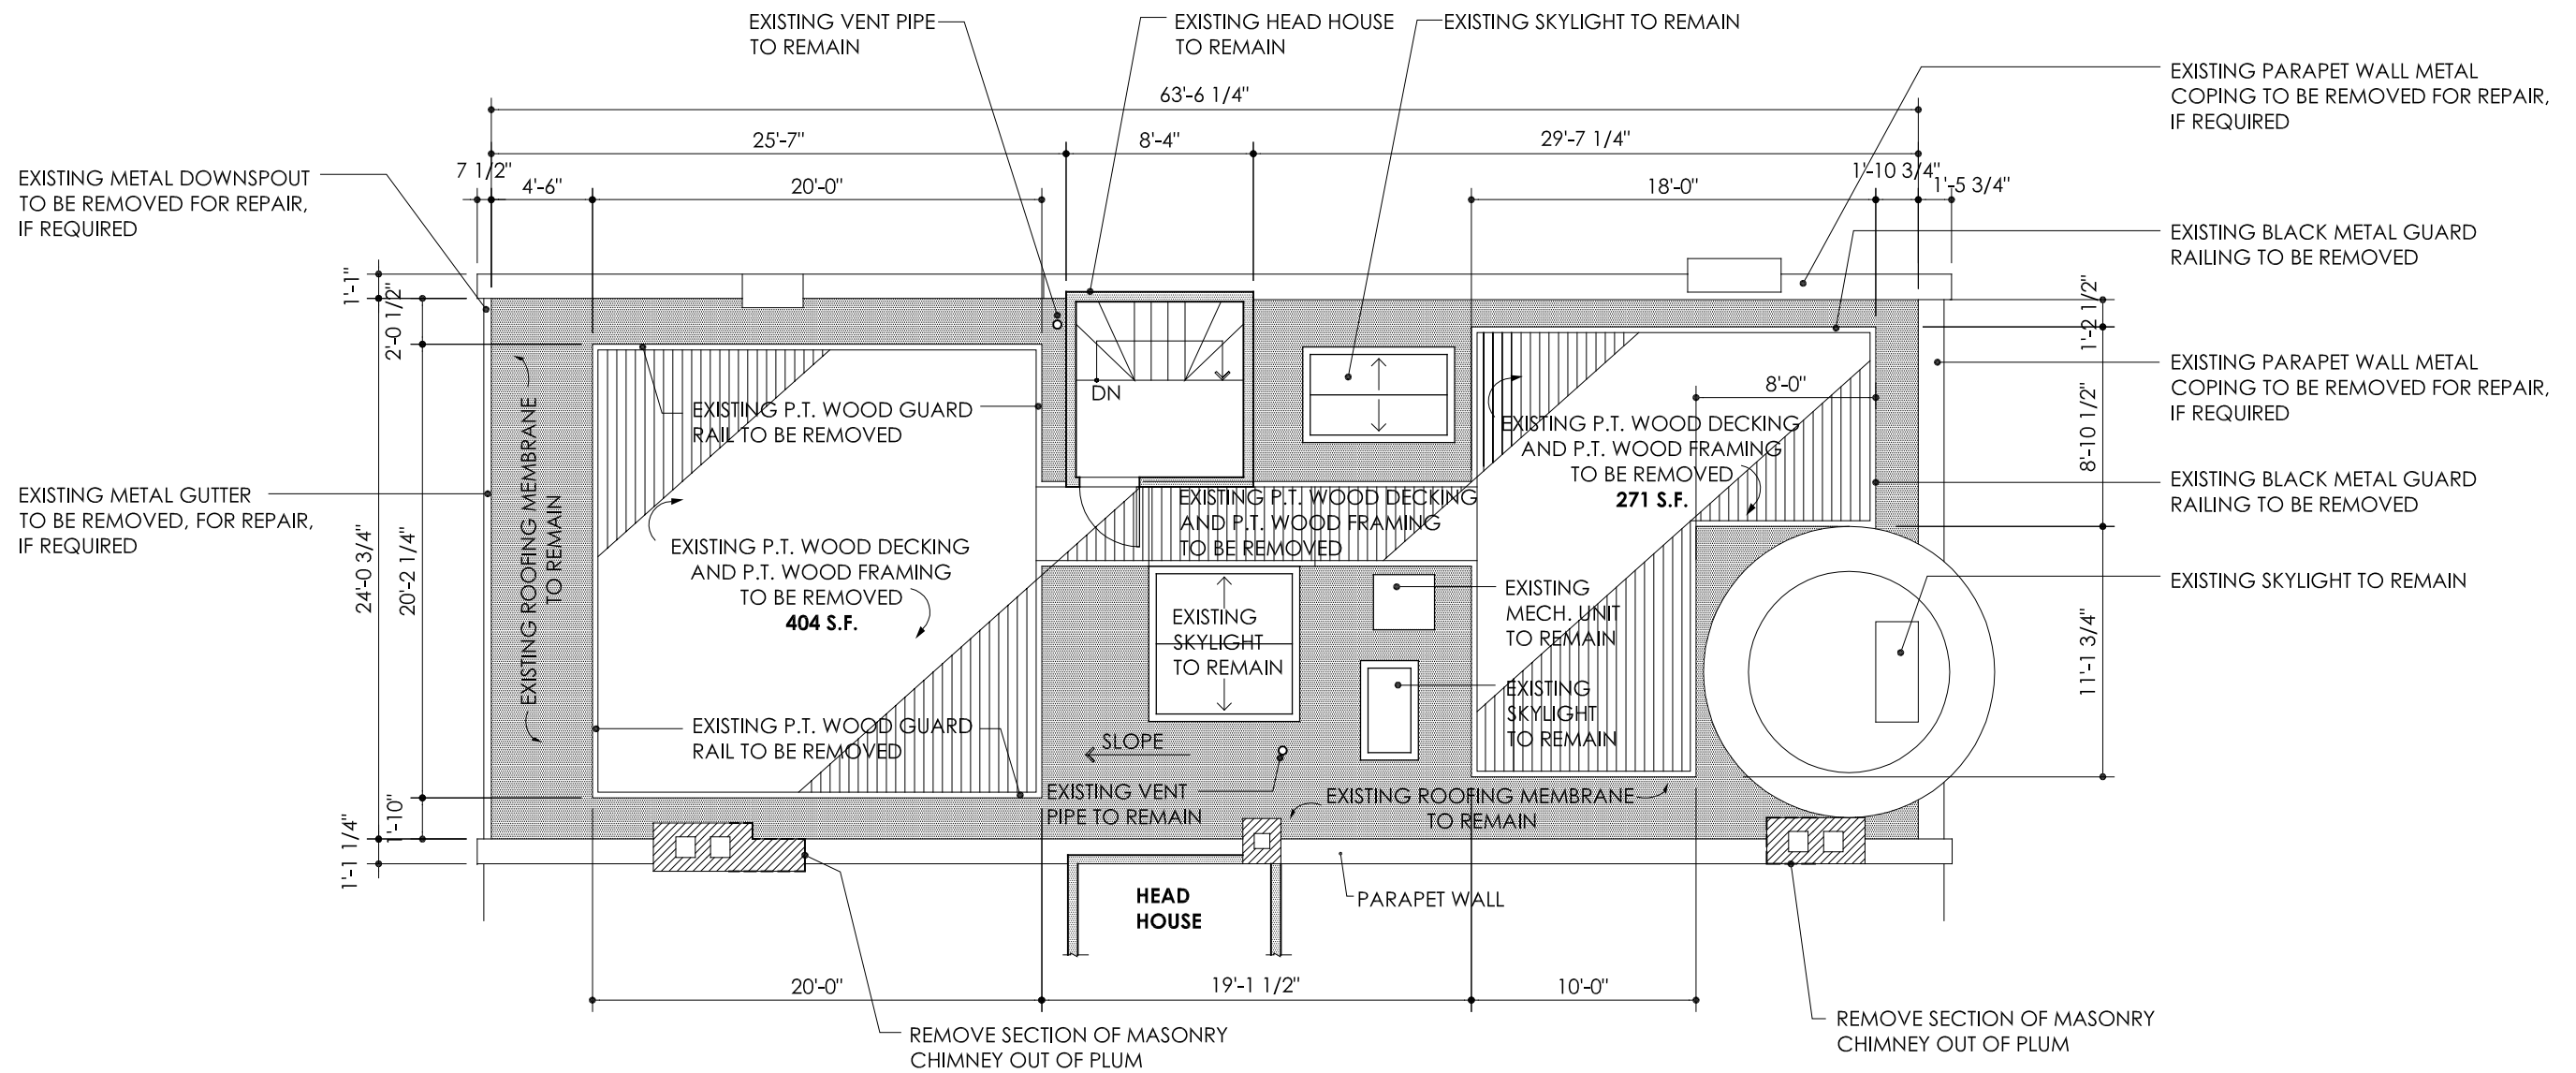
1 EXISTING/ DEMOLITION ROOF PLAN

- EXISTING WALLS TO REMAIN
- EXISTING ROOFING MEMBRANE
